SPLITROCK
ENVIRONMENTAL
SEKW'EL'WÁS

FINAL REPORT 2016 -17

Powerhouse Foreshore Restoration Project

Maintenance Program Year 3

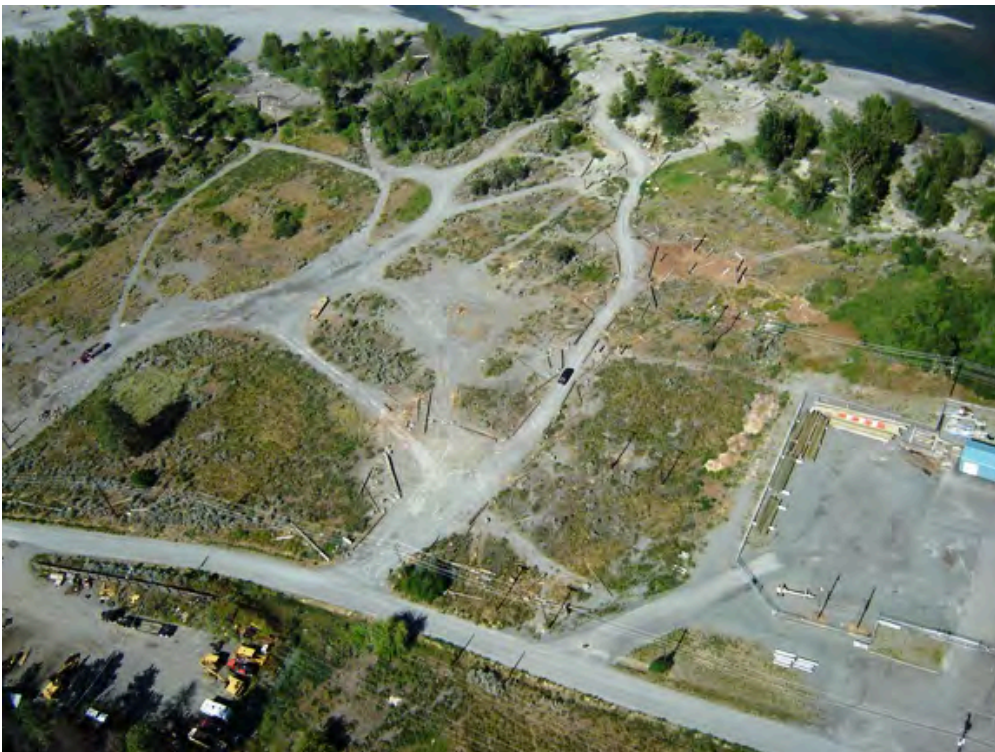
Figure 2 Section of upland bench – compacted soils, roads and invasive species prevalent on site 11 July 2008

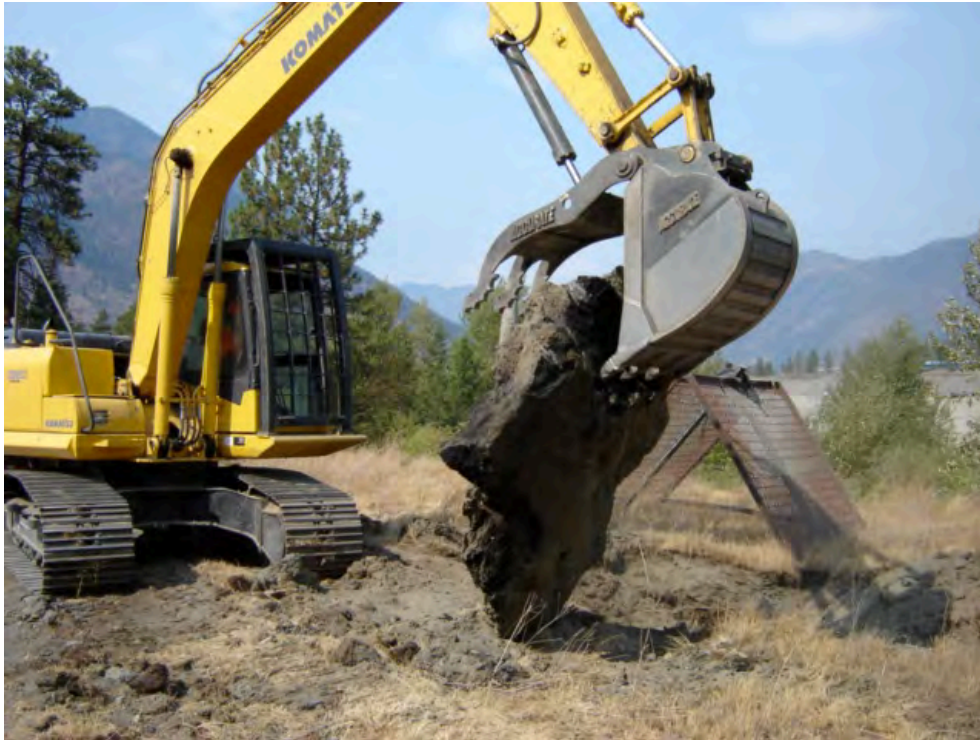
Figure 5 Asphalt chunk being dug up - evidence of MOT operations - this area continues to be difficult to plant into August 2009

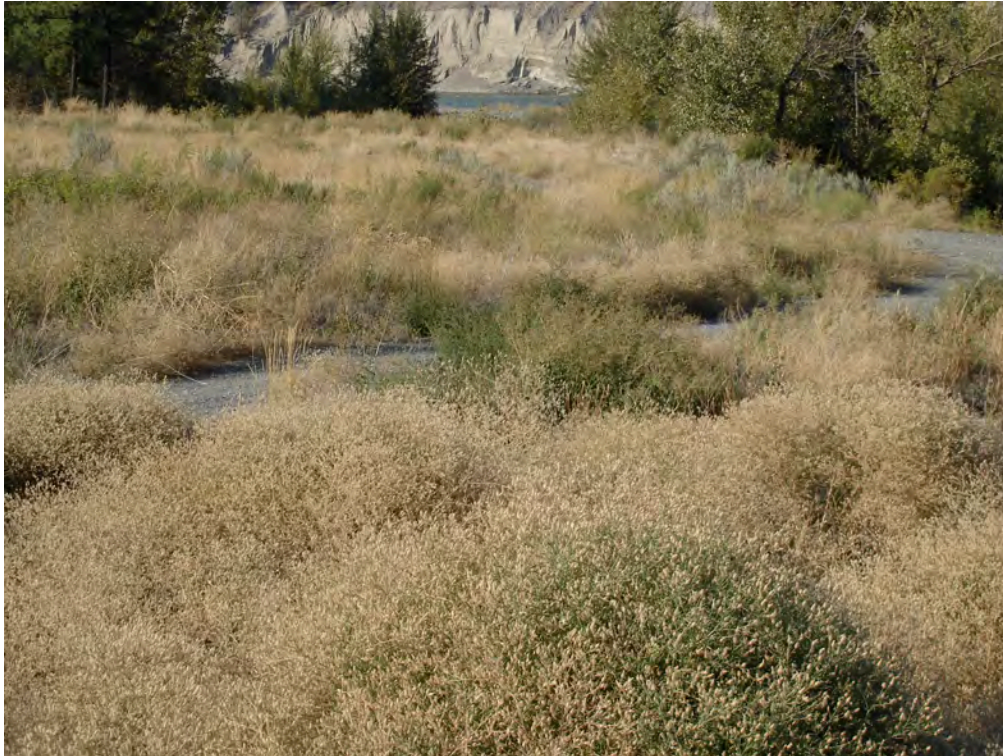
Figure 7 Diffuse Knapweed covered the site before restoration works began August 2009.

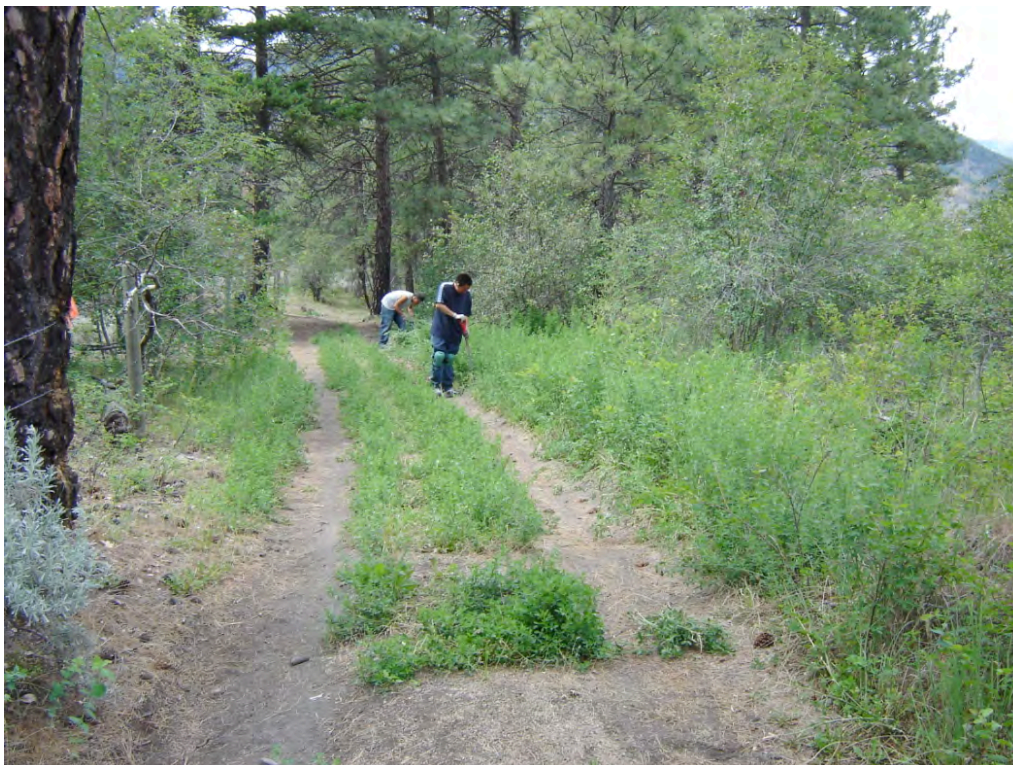
Figure 8 Old roadbed showing the extent of alfalfa that is very difficult to remove August 2009

Alfalfa was again removed by digging in locations where only a few plants were observed on the upland bench, and in all other areas the plant was trimmed back using a weed trimmer, with only one pass along the riparian trail. As noted in previous reports, alfalfa is much harder to remove during fast-paced weed blitz as it requires a sustained effort of digging out to remove the long taproots and so this species continues to remain a problem on the site, especially on the edges of restored lands and along trail systems where it grows large and outcompetes native species. A few hours were spent removing alfalfa and white clover from the gravel bar.

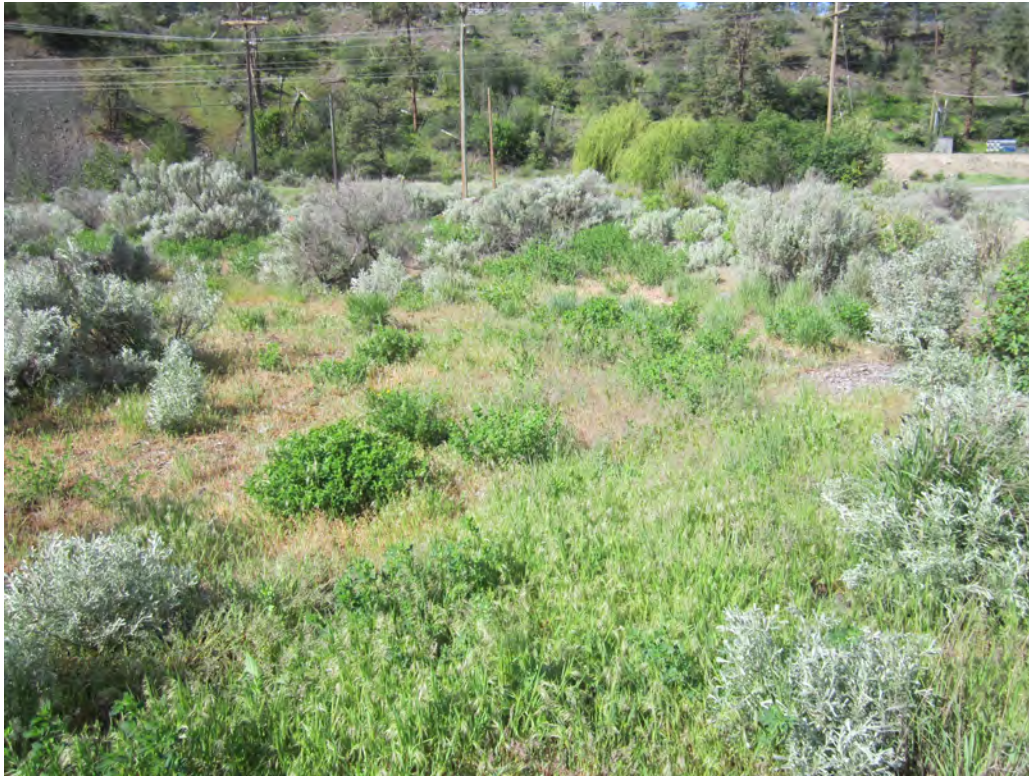
Figure 10 View from the hydro yard showing alfalfa, cheat grass, Dalmatian toadflax (looking west running parallel to the hydro yard area) 25 April 2016. Note: a shrub layer has been planted just to the right of this site with the ultimate goal of reducing windblown seed from entering restoration site.

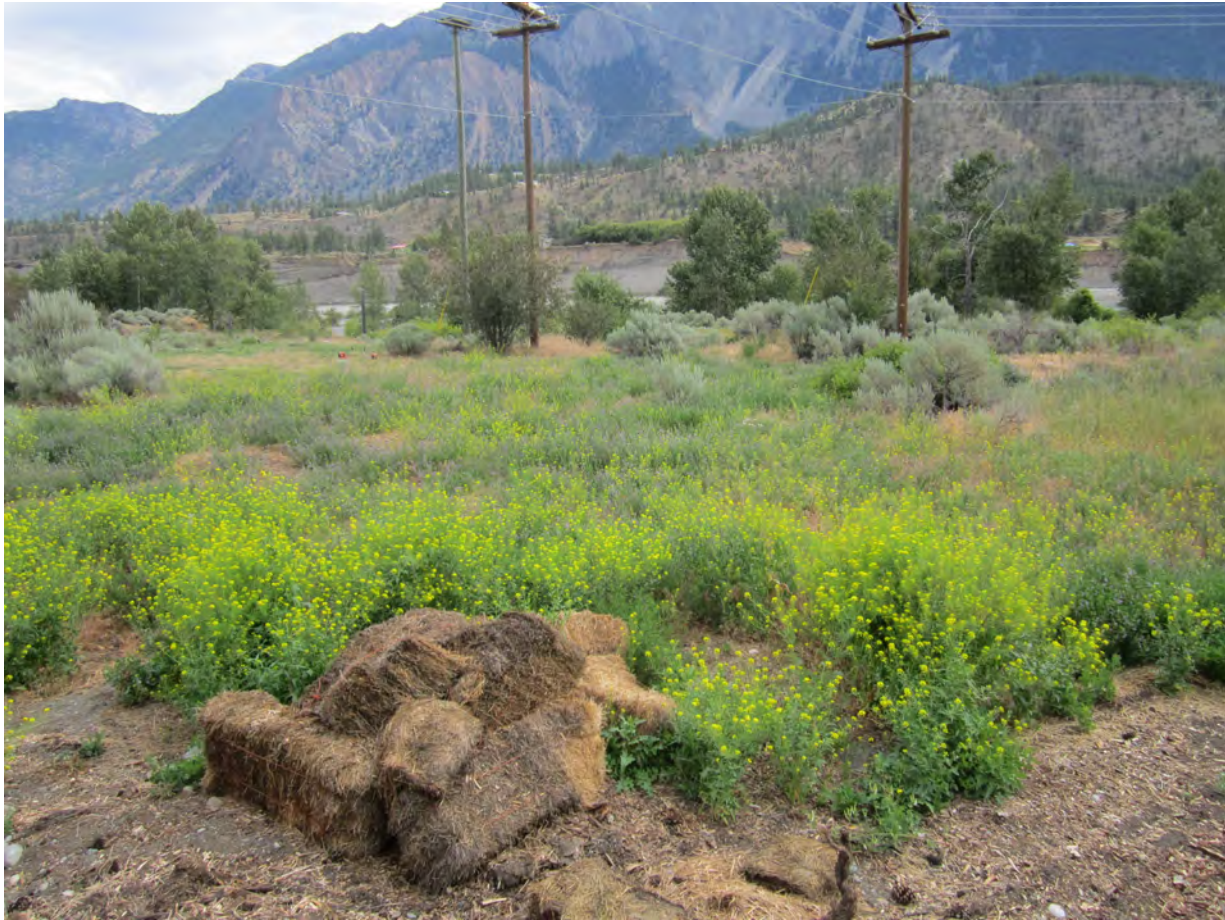
Figure 12 Area beside hydro yard showing mustard and returning alfalfa cover (looking north from hydro yard area towards restoration site) 21 June 2016

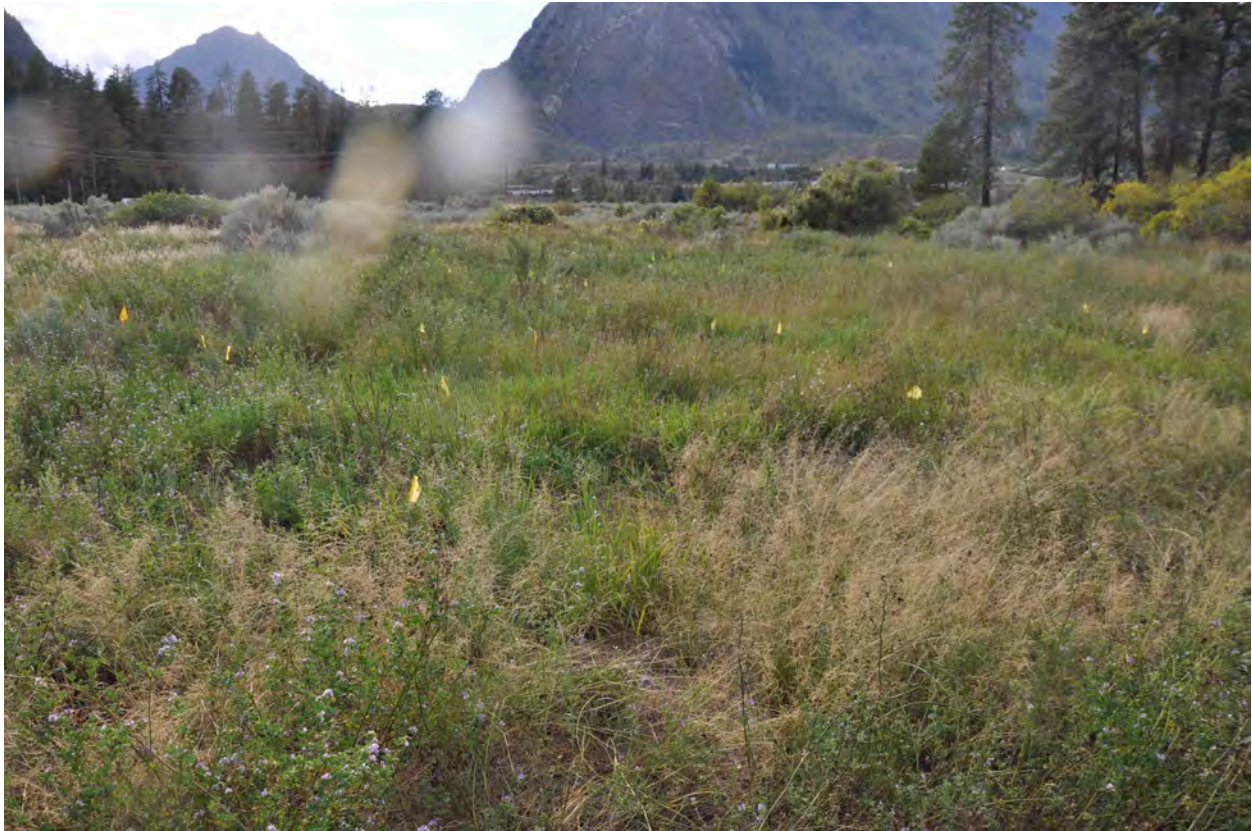
- Polygons 4 and 12 (Map 4); Just before riparian trail: is an area where no machine work was used to prepare soil for planting during the original restoration works, due to the fact that large chunks of asphalt were found buried deep in the soils. The area was overplanted with ponderosa pine trees in 2012 and again in 2014. The trees are still quite small and can easily become overwhelmed by the weedy species found there. Removal of alfalfa predominately, as well as mustard, kochia and cheat grass, occurred in 2016.

Figure 13 Polygon 4 (Map 4) showing area that was not treated by machine due to the large chunks of asphalt found buried in the ground in this area while attempting soil manipulation. Ponderosa pine trees were planted over the invasive weeds in 2012, and infilled in 2014, with the ultimate goal of shading out and mulching the weeds with naturally falling pine needles. The plants are flagged for watering. 23 May 2016

- **Polygon 4 and 12:** This area is a transition between riparian and upland habitats planted out in the past with Ponderosa pine and shrubs. During the restoration process, soils in this area were not decompactd or contoured due to the fact that large slabs of asphalt were found in the soils. On discussions with MOE it was recommended that the asphalt be left in place as they were more detrimental to the environmental being unearthed. A total of 20 trees, 62 shrubs and 6 giant wildrye were planted over a 560 sqm area. The goal was to extended the riparian and Ponderosa pine forest out into an area that is predominately invasive weed species.

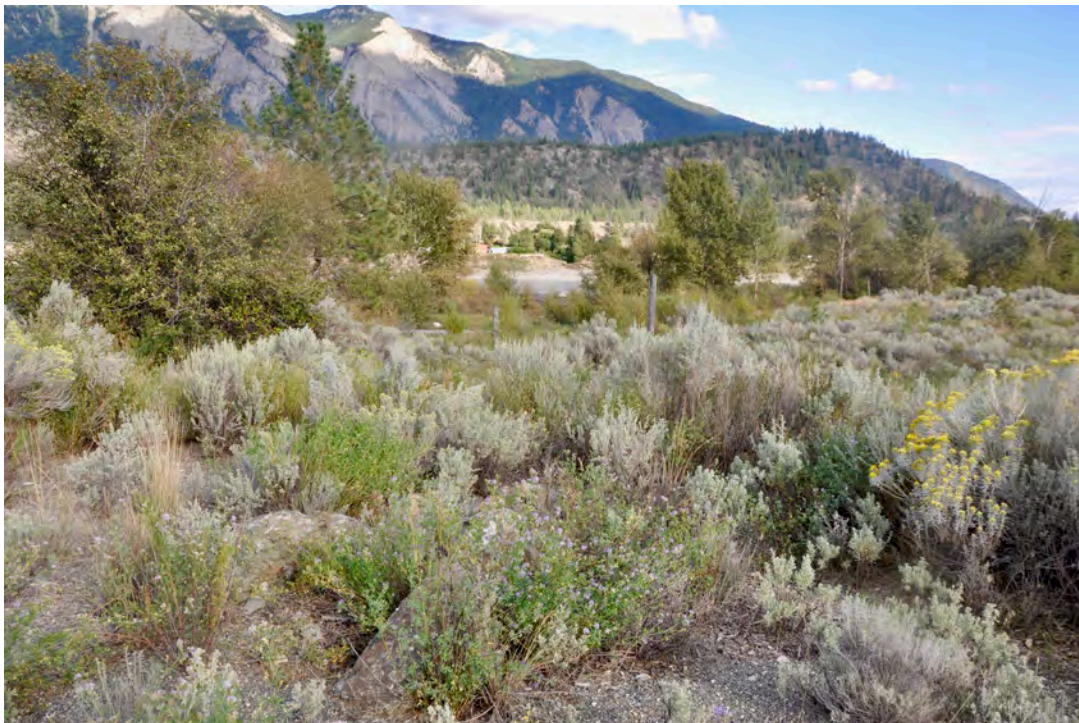
Figure 16 Polygon 12 (Map 4) just across from Polygon 4 showing alfalfa again going to flower in fall at same time rabbitbrush is blooming 04 Sept 2016

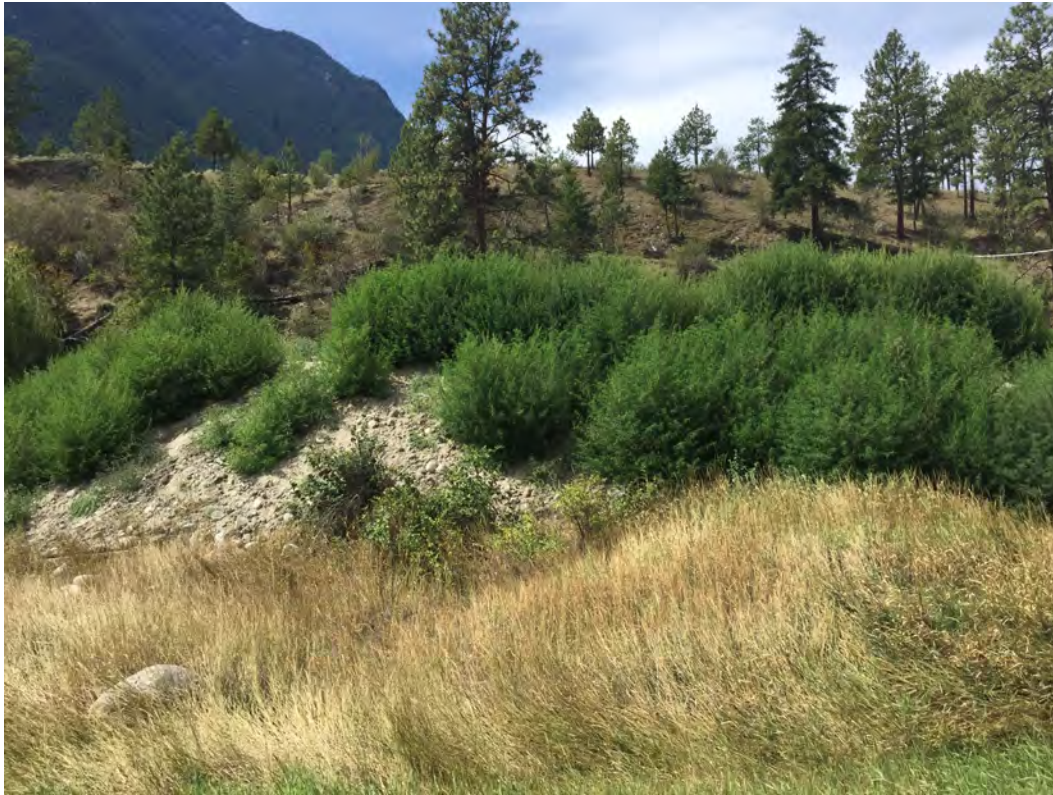
Figure 17 Location across the Powerhouse Road, used by hydro for transmission line laydown area during 2015/2016. This site is now covered with Kochia as a result of that work. These weeds used to be prevalent on the Powerhouse site but have been mostly controlled. Future monitoring will identify if this site used by hydro will impact on the Powerhouse site. 25 July 2016

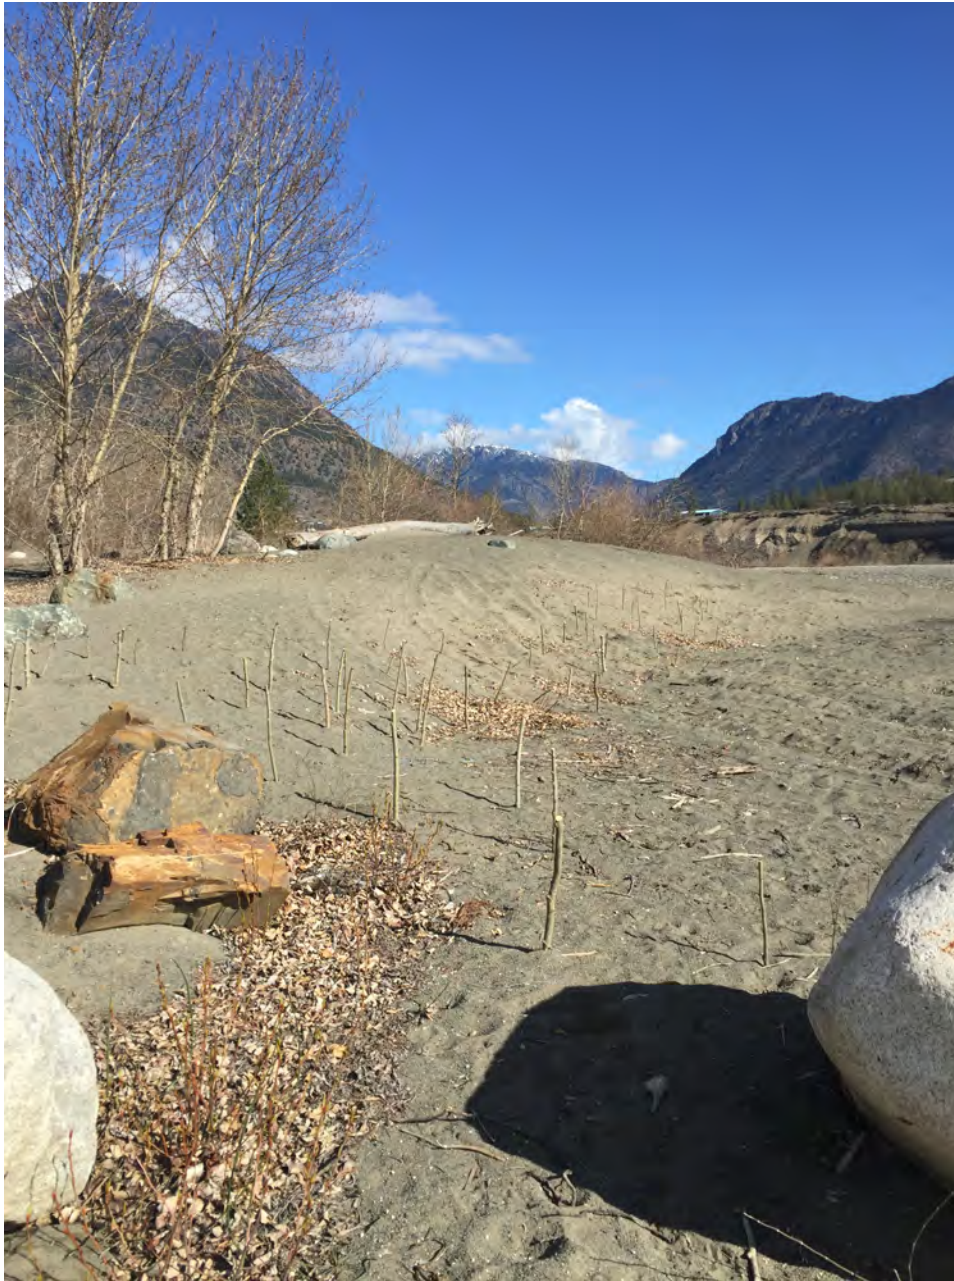
Figure 19 Boulder cluster and cottonwood cuttings at B18 29 March 2017

- **Gravel Bar (B18):** As a result of ongoing field visits to the Powerhouse site to ensure adaptive management strategies are incorporated into each year's work, it was observed that vehicles were driving up over a sandbank and entering the riparian area to the south of the main access road. To mitigate further entry, an excavator placed four large boulders into the gap being used by off-road vehicles, and Black cottonwood cuttings were planted across the area to decrease the likelihood of further encroachment by off-road vehicles. A total of 96 cuttings were struck into the edge of the riparian area at the base of the sandbank over a 78 sqm area. The goal was the create additional habitat for species-at-risk, in particular the Western screech-owl and to decrease fragmentation.

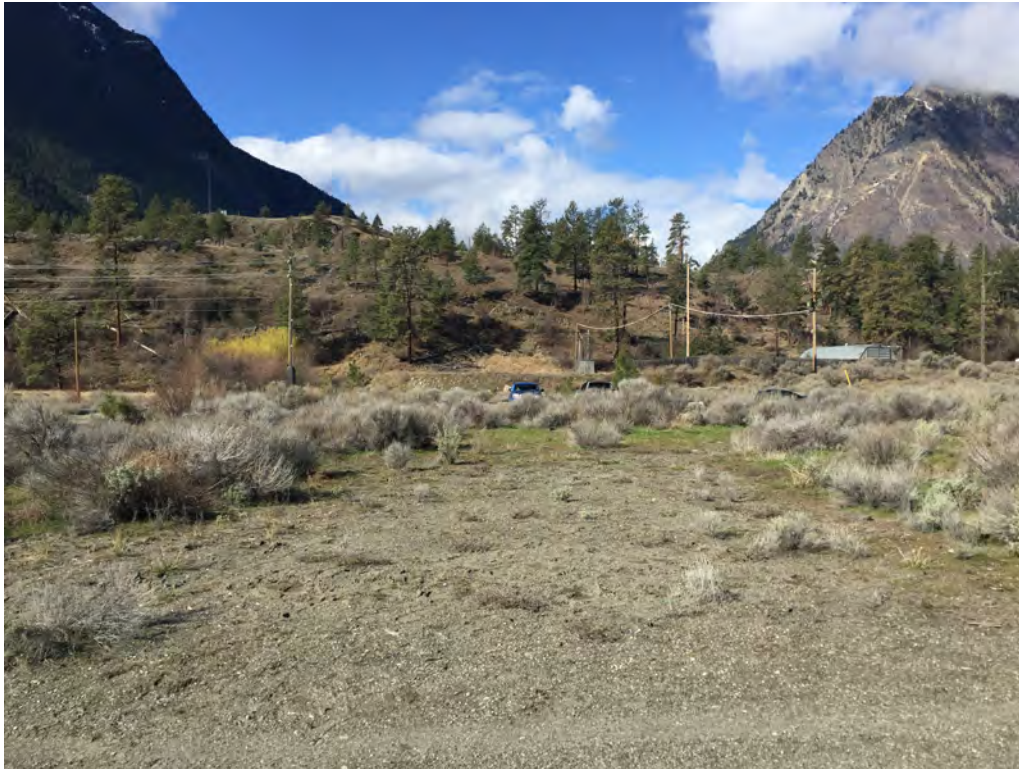
Figure 20 Polygon 13-11 planted with predominately grassland plugs, some saskatoon and ponderosa pine 07 April 2017

- **Polygon 13 – 11:** This area has very sandy, oily soils and is close to an historical highways re-fuelling area, and has shown limited success of revegetation. Some plants (mostly bunchgrasses and golden aster) are continuing to persist. A total of 4 trees, 30 shrubs and 231 bunchgrasses were planted into an 271sqm area.

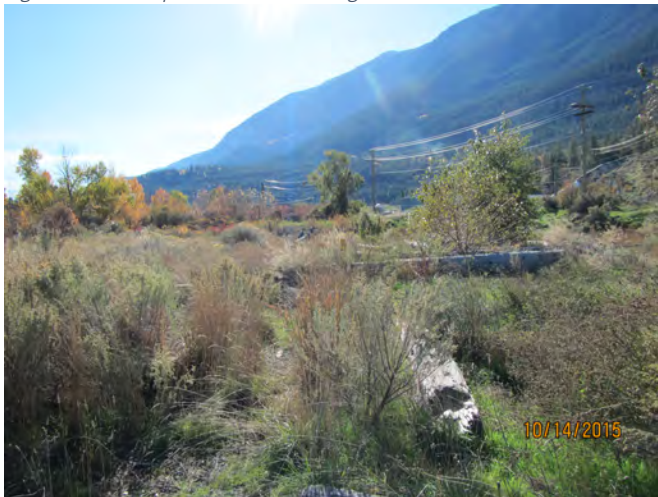
Figure 36 Photopoint 03 Lower Snag Area: showing good tree and shrub growth, but also encroachment of alfalfa and other invasive weeds 14 October 2015

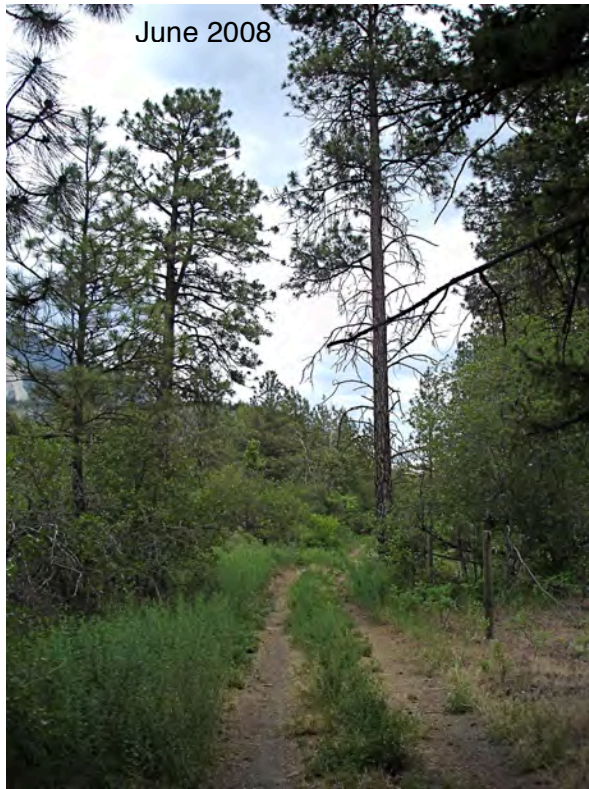
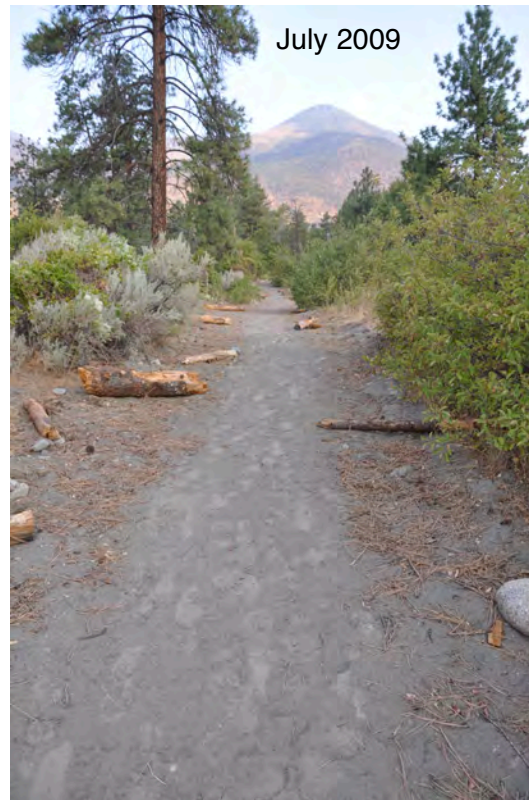
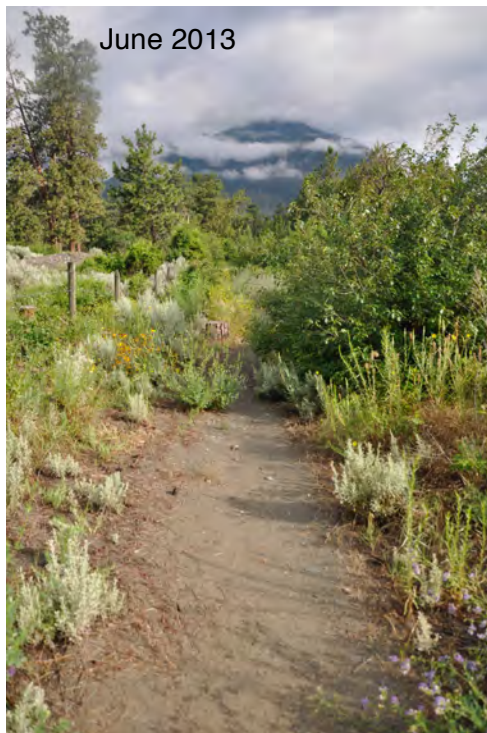
Figure 44 Riparian Trail: Series of photos showing pre-restoration invasive weed cover to a more diverse ecosystem June 2008 - June 2013 During 2014-15 alfalfa seed in the ground has grown back into the riparian trialside.
