# Gates Creek Level 2 Fish and Riparian Habitat Survey (COA-F18- F-2438)

Implementation Year: 2018

April, 19, 2018

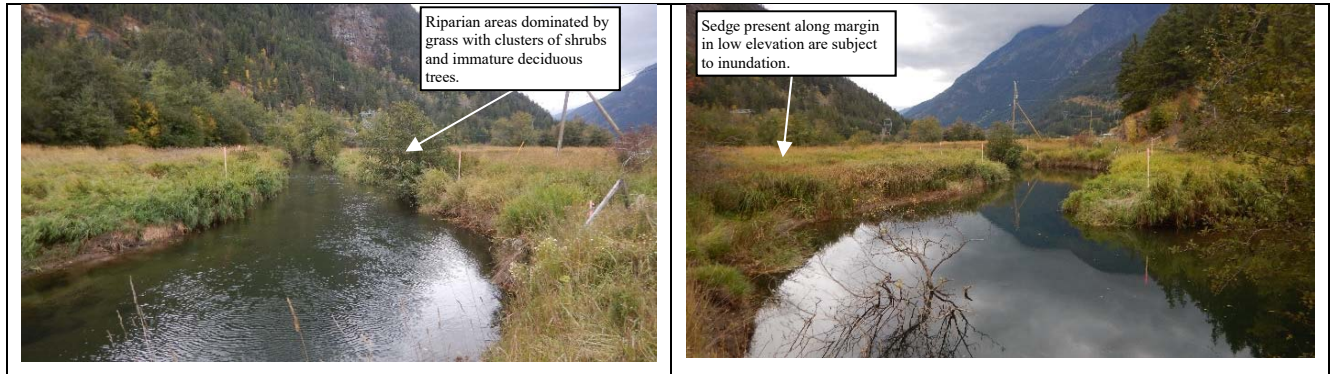
Figure 6. Riparian vegetation at 9523 Portage Road in October 2017. Left: view of typical channel and riparian habitat conditions at 9523 Portage Road. Right: view of typical channel and riparian habitat conditions at 9523 Portage Road.

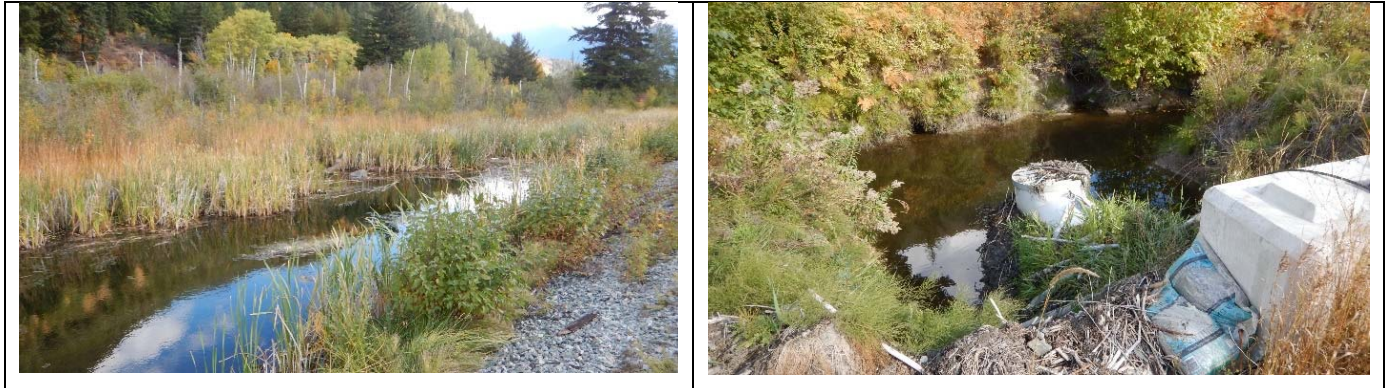
Figure 9. Left: open water wetland upstream (north) of the CN Track on 9484 Portage Road, and west of the BPAO. A second wetland is also located on the south side of the track in this area. Right: Beaver proof add-on (BPAO) attached to the upstream end of the CN culvert. Despite the name this structure is still affected by beaver activity. s

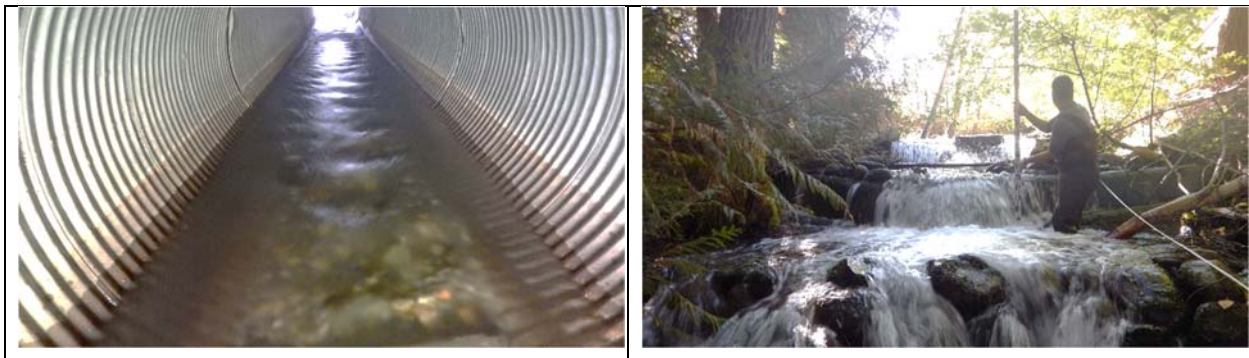
The Portage Road crossing of Blackwater Creek consists of a 21 m long corrugated metal pipe (CMP) culvert, with a diameter of 1,550 mm. At the time of the survey, culvert slope did not appear to be causing an impediment to fish passage as the culvert had a relatively consistent depth (0.3 - 0.4 m) with moderate velocity (Figure 11), and no drop existed at the culvert outfall. Downstream of the culvert outfall a series of weirs have been constructed to improve fish passage (Figure 11). These weirs have been constructed with a combination of natural substrate and concrete blocks with drop heights ranging from 0.4 m to 0.7 m. Pool depth to drop height ratios were between 0.43:1 and 1.73:1 (Figure 12) for individual steps. While these weir structures may be passable by some species and/or age classes at various stream stages, most of the jump heights<sup>4</sup>, and pool depth to jump height ratios<sup>5</sup> measured during this survey did not meet published criteria for fish passage of salmonids (Whyte et. al. 1997).

Figure 11. Left: Observed depth and velocity conditions inside the Portage Road crossing of Blackwater Creek appeared to meet criteria for fish passage. Right: Drop heights, and pool depth to jump height ratios associated with weirs downstream of the Portage Road crossing of Blackwater Creek did not meet criteria for fish passage.

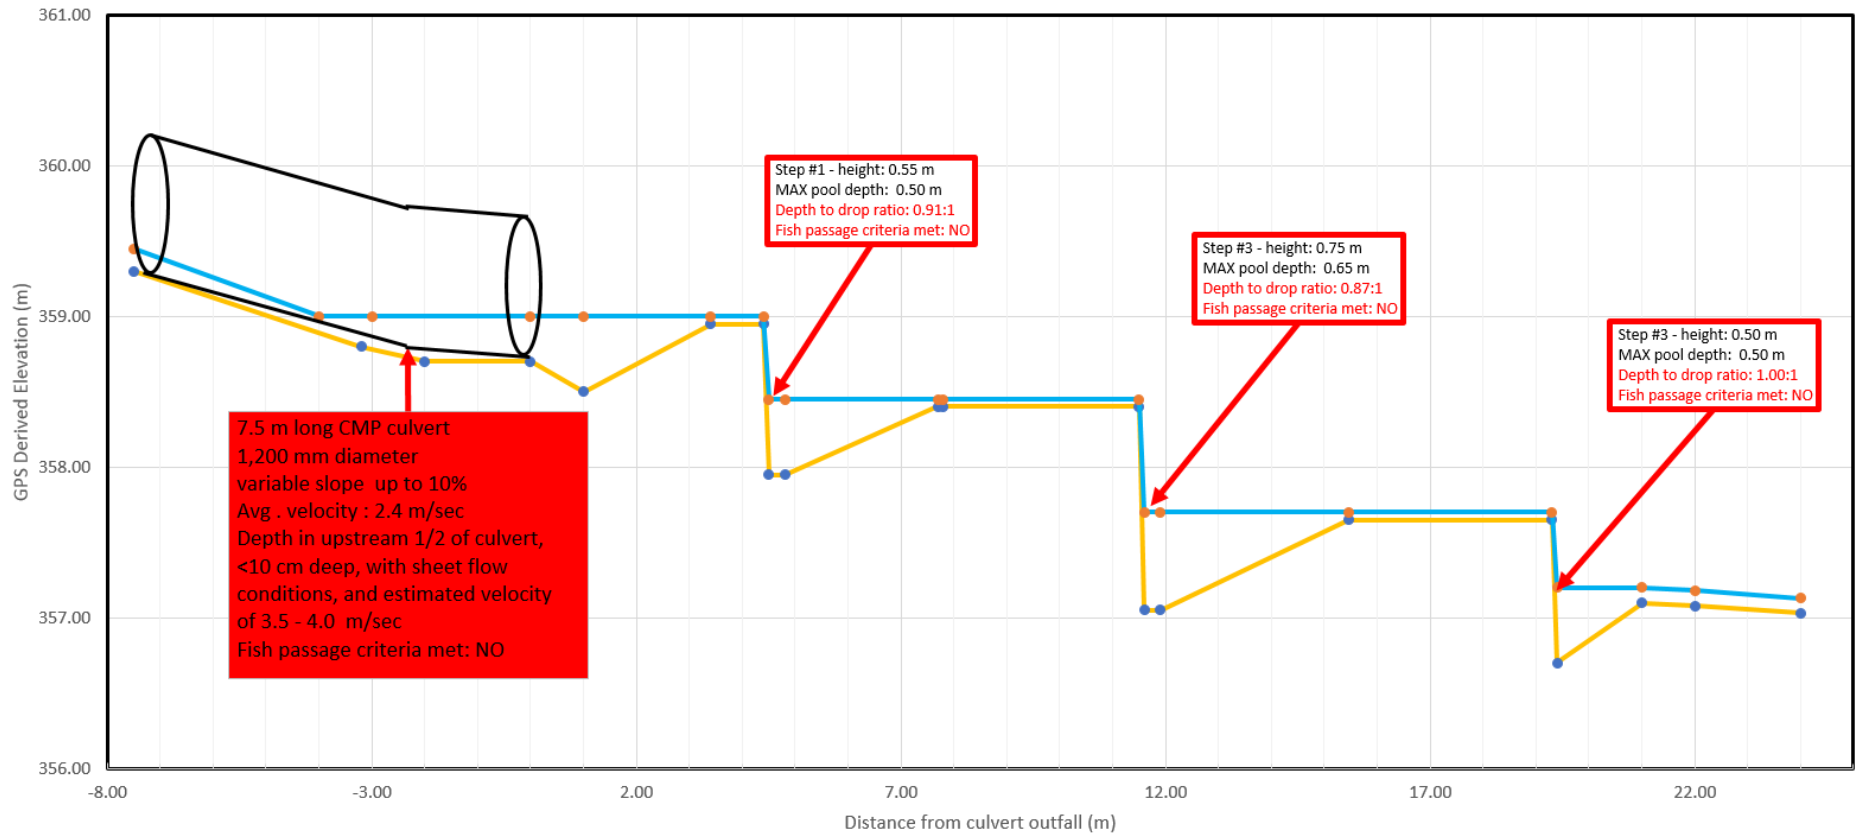
Figure 13. Graphical representation of the BCH ROW culvert crossing of Blackwater Creek

The BC Hydro (BCH) transmission line right of way (RoW) road crossing of Blackwater Creek consists of a 7.5 m long CMP culvert, with a diameter of 1,200 mm. The culvert had an average velocity of 2.4 m/sec over the full length of the culvert. Culvert slope (up to 10%) was identified as an impediment to fish passage due to sheet flow conditions (Figure 13) created in the upstream half of the culvert (*e.g.*, depth < 10 cm and velocity 3.5 to 4.0 m/sec<sup>6</sup>, Figure 14). There was no drop at the culvert outfall, however, downstream of the culvert outfall a series of three (3) weirs have been constructed to improve fish passage (Figure 13). These weirs were also constructed with a combination of natural substrate and concrete blocks. Drop heights for the weirs range between 0.5 m and 0.65 m. Pool depth to jump height ratios were between 0.87:1 and 1.00:1 (Figures 13 & 14). While the weir structures may be passable by some species and/or age classes of fish at various stream stages, the jump heights, and pool depth to jump height ratios, measured during this survey did not meet published criteria for fish passage of either adult or juvenile salmonids (Whyte et. al. 1997).

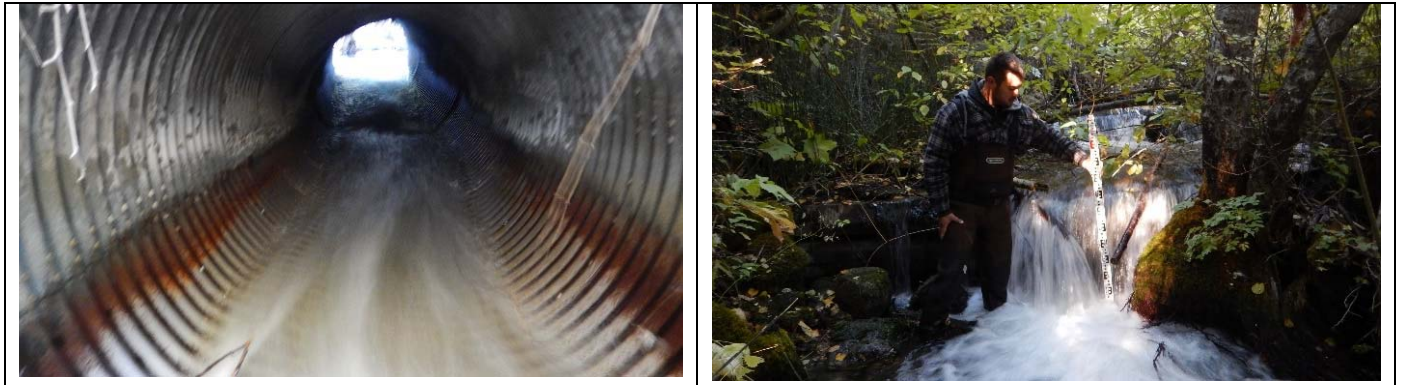
Figure 14. Left: Depth and velocity conditions inside the BCH RoW crossing of Blackwater Creek were characterized by sheet flow conditions, which did not meet criteria for fish passage. Right: Drop heights, and pool depth to jump height ratios associated with weirs downstream of the BCH RoW crossing of Blackwater Creek did not meet criteria for fish passage.

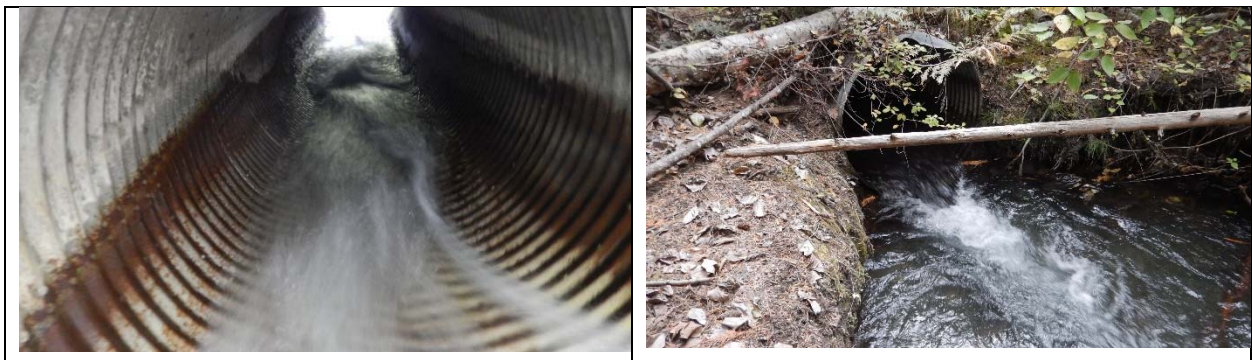
The private driveway crossing of Blackwater Creek located near 3465 Blackwater Lake Road consists of a 7.5 m long CMP culvert, with a diameter of 1,200 mm. The culvert slope (up to 10%) was identified as an impediment to fish passage (Figure 15). The culvert had an average velocity of 2.4 m/sec over the full length of the culvert. In addition, the culvert slope created sheet flow conditions in the upstream half of the culvert (*e.g.*, depth <10 cm and velocity 3.5 to 4.0 m/sec; Figure 15). Velocity at the culvert outfall was also high and there was a drop of approximately 10 cm (Figure 15, Figure 16). There were no weirs or gradient barriers observed upstream or downstream of the culvert. While the crossing may be passable by some species and/or age classes of fish at other stream stages, conditions during this survey did not meet published criteria for fish passage of salmonids (Whyte et. al. 1997).

Figure 15. Left- Depth and velocity conditions inside the driveway crossing of Blackwater Creek were characterized by sheet flow conditions, which did not meet criteria for fish passage. Right- The outfall of the driveway crossing of Blackwater Creek was indicative of the high culvert velocity which did not meet criteria for fish passage

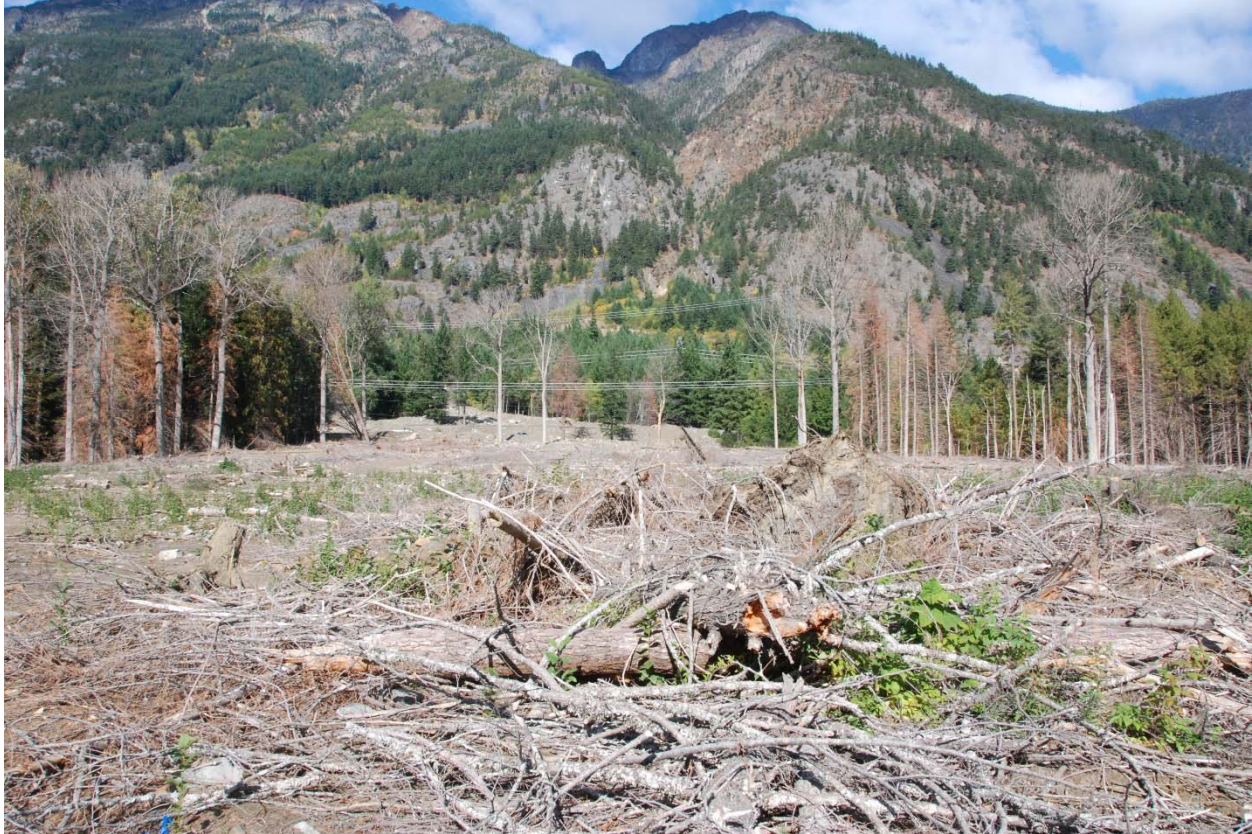
Roads and trails used to harvest dead trees were still visible during this survey. The areas that had experienced vehicle traffic were visibly compacted, which appeared to be suppressing natural succession. Harvesting wood has also smoothed the surface of the ground as the large logs were yarded across the fresh debris flow surface. The compacted roads and smoothed ground surfaces associated with the timber harvesting limit rainfall absorption, and instead cause the rainsplash erosion (Polster 2011), to mobilize and carry the sediment into Gates Creek. The patterns of smooth surfaces and areas that have remained rough from the original debris flow can be seen in the patterns of vegetation establishment. Vegetation has started to establish in areas where the surface remained rough while areas that were smoothed by log yarding have limited vegetation (Figure 19).

Figure 19. Photograph of 9282 Portage Road property on October 5<sup>th</sup>, 2017 (two years after debris flow event). Areas near woody debris had patches of denser vegetation while areas with-out woody debris or with obvious soil compaction have lower densities of seedlings.

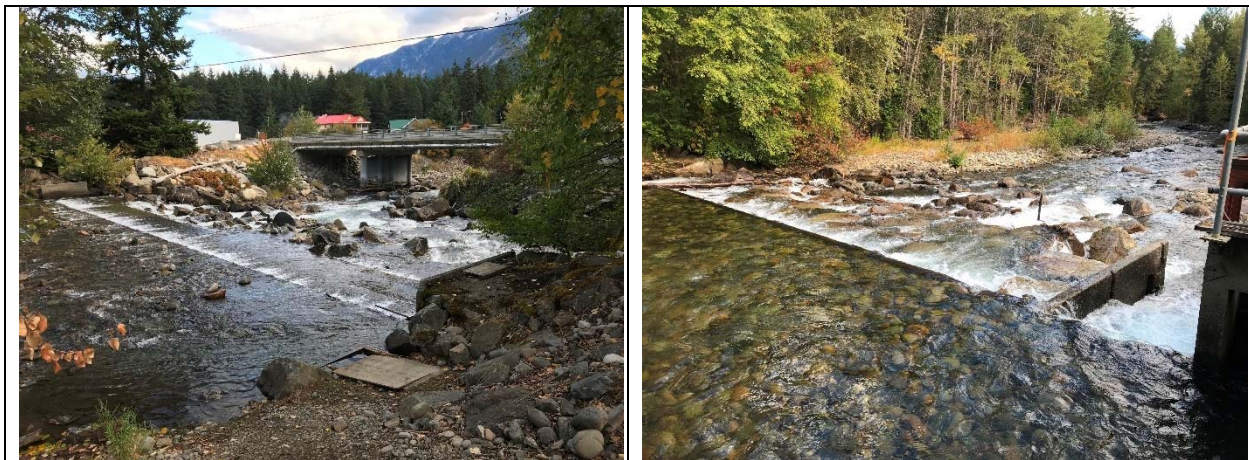
There are two channel wide riffles in lower Gates Creek constructed to facilitate operation of the Sockeye salmon spawning channel (Figure 22). The downstream riffle was constructed to direct returning adults towards the outlet of the spawning channel (Figure 22). The upstream riffle was constructed to provide head for channel operation by raising the water level (Figure 22). These riffles create gradient conditions estimated at 5 to 7% over a linear stream distance of approximately one channel width (*i.e.*, 20 to 30 m). At some discharge levels these constructed riffles could create conditions that impede upstream fish passage particularly for young-of-year fry, and rearing juveniles. These conditions include; increased velocities, hydraulic jumps created by boulders, and sheet flow conditions created by the upstream control weirs (Figure 22).

Figure 22. Left: Downstream view of riffle constructed to direct adult Sockeye into the spawning channel. Note sheet flow conditions at the upstream control weir, as well as hydraulic jumps, and increased velocity through the riffle. Right: Downstream view of riffle constructed as part of the spawning channel intake. Note hydraulic jumps, and increased velocity created by the riffle, and the concrete fish ladder along the right margin.

Despite the concerns regarding fish passage at these two riffles, no modifications to either of these riffles are proposed at this time due to the potential impact on the spawning channel functionality.

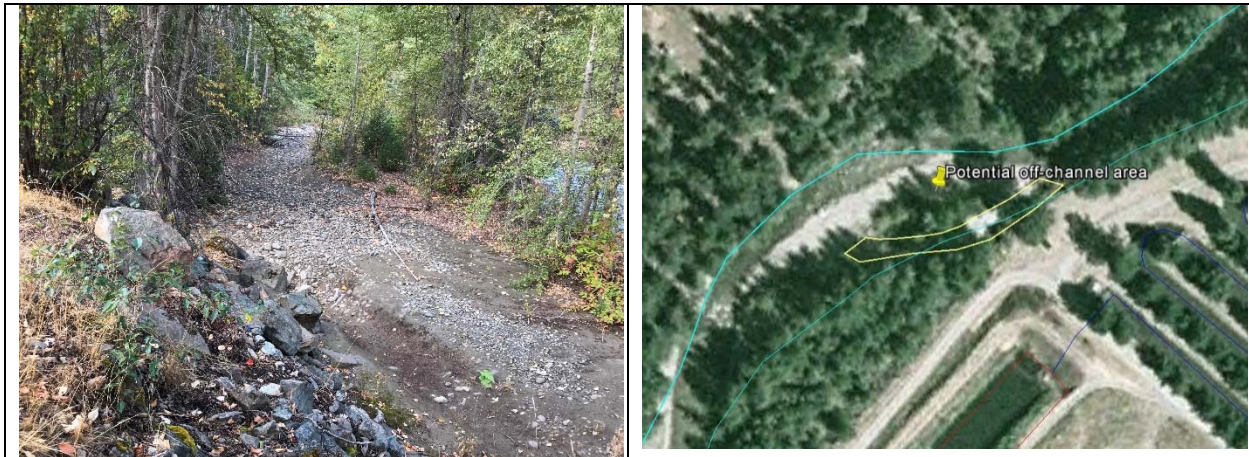
The existing channel is approximately 60 m long, and 10 m wide. Based on observed conditions (*i.e.*, bed scour, Figure 23) the channel is active during typical high-water events and freshet, although it was dry at the time of the survey. Excavating the channel to intercept the water table and adding habitat features (*e.g.*, LWD), could extend the seasonal range of habitat availability in this channel for salmonids. However, modifications to deepen and extend the seasonal availability of habitat could also result in a change to channel dynamics in this area, and or channel morphology. If the enhanced channel is protected from high flows (*i.e.*, with an upstream berm to create off-channel refuge), the modifications could result in increased velocities in the main channel during high water events and changes to the opposing bank. If the channel is excavated to make the channel active at all stages, it could result in a shift in channel morphology.

Figure 23. Left: Upstream view of an existing side channel near the Sockeye spawning channel that could be enhanced to extend the seasonal availability of this habitat. Right: Yellow line indicates approximate extent of potential off-channel area that could be enhanced along the right (south) margin.

In summary, no modifications are proposed at this time, due to the potential impact on the channel morphology in this area.

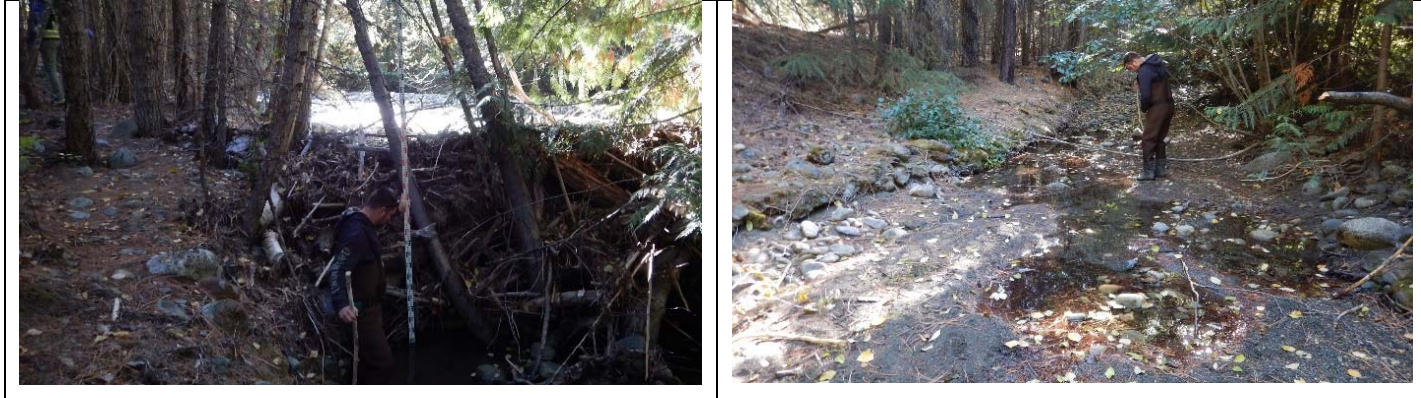
In summary, field observations indicate that Haylmore Creek channel is unstable, and subject to changes in channel morphology. In addition, observations in the side channel area, indicates the area has poor sub-surface flow conditions, despite the channel gradient and large substrate. In combination these factors would seem to limit the feasibility of any habitat enhancement such as excavating off-channel habitat, or channel manipulations to install structures and/or increase pool habitat.

Figure 26. Left: The base of this log jam at the upstream end of a side channel in Haylmore Cr was approximately 1.5 m below the water surface of the adjacent main channel < 5 m away. Right: Despite the observed difference in elevation from the adjacent main channel (Photo 27) there was only a limited amount of flow in the side channel.
