## Project Title: Stave River Spawning Restoration Project: Rewatering Centre-Right (Channel 5) and Addressing Right Bank Erosion

FWCP Project No. COA-F-2851-DCA

March 27, 2019

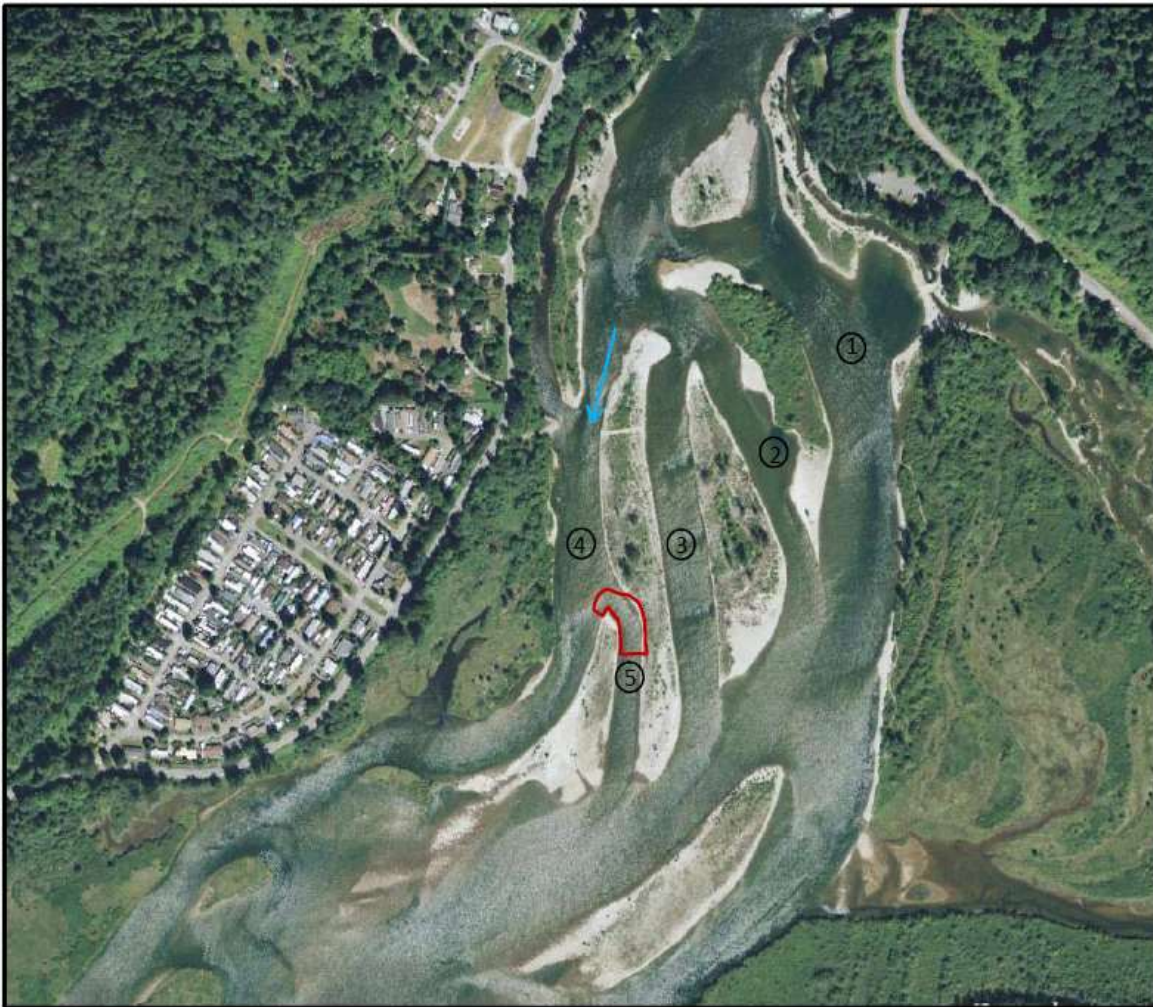
*Figure 1. Extracted from Greenback report 2017, red polygon illustrates gravel blockage to channel 5 and significant high-velocity flows down channel 4.*

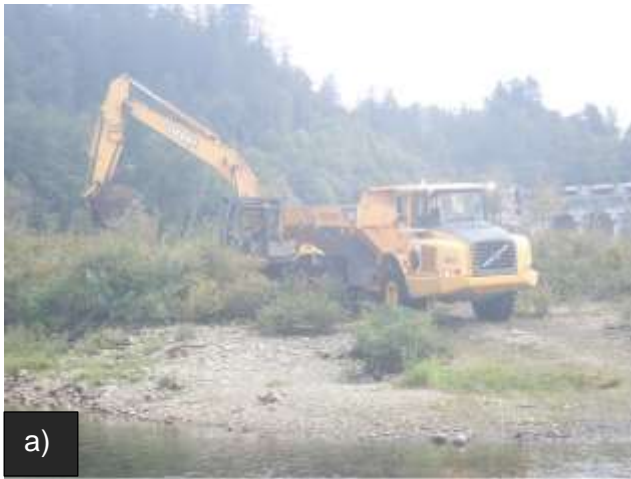
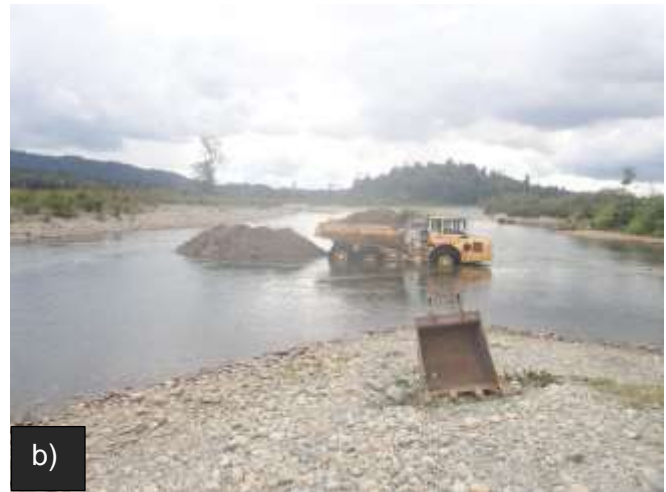
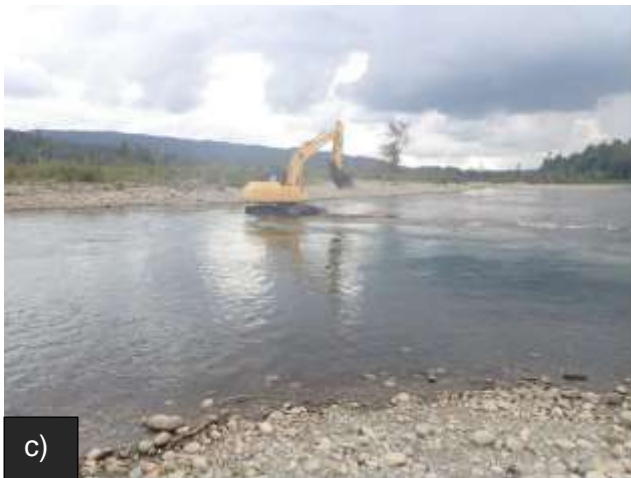
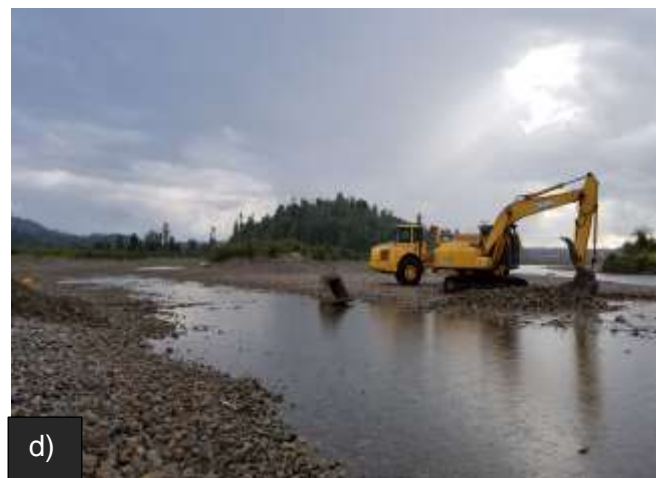
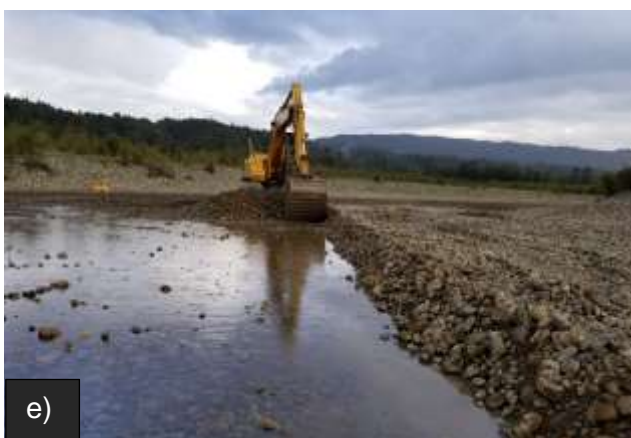
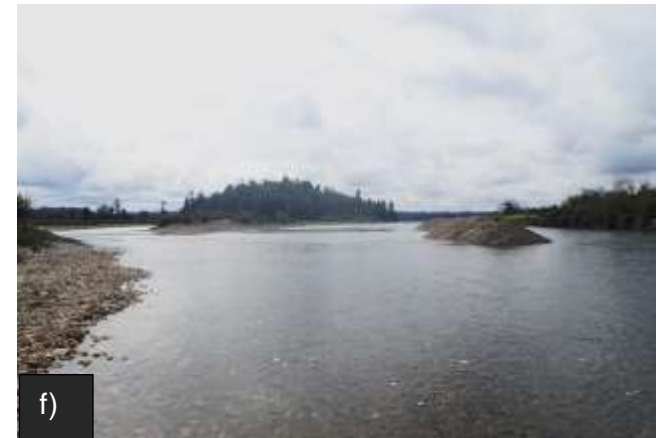
Figure 2. Mainstem rewatering of channel 5. a) excavating berm to create the access path to cross the Stave River. b) Moving gravels to create the access route. c) Excavator safely crosses upstream of Channel 5. d) Re-grading and surveying of gravels begin (notice the dry Channel 5 in proximity to Channel 4). e) east-view illustrating the height of gravel blockage at the upstream end of Channel 5. f) Almost completed Channel 5 watered, needing to push gravels to Channel 4.

In September 2018, FVWC contracted engineering expert M.Landiak and Mission Contractors to begin re-grading the dry channel and move the excavated gravels from Channel 5 to Channel 4, which was important in completing first before working on objective 2, Figure 1. The channel was re-graded using large 200-series excavators and articulated Volvos to move the gravels, Figure 2, Figure 3.

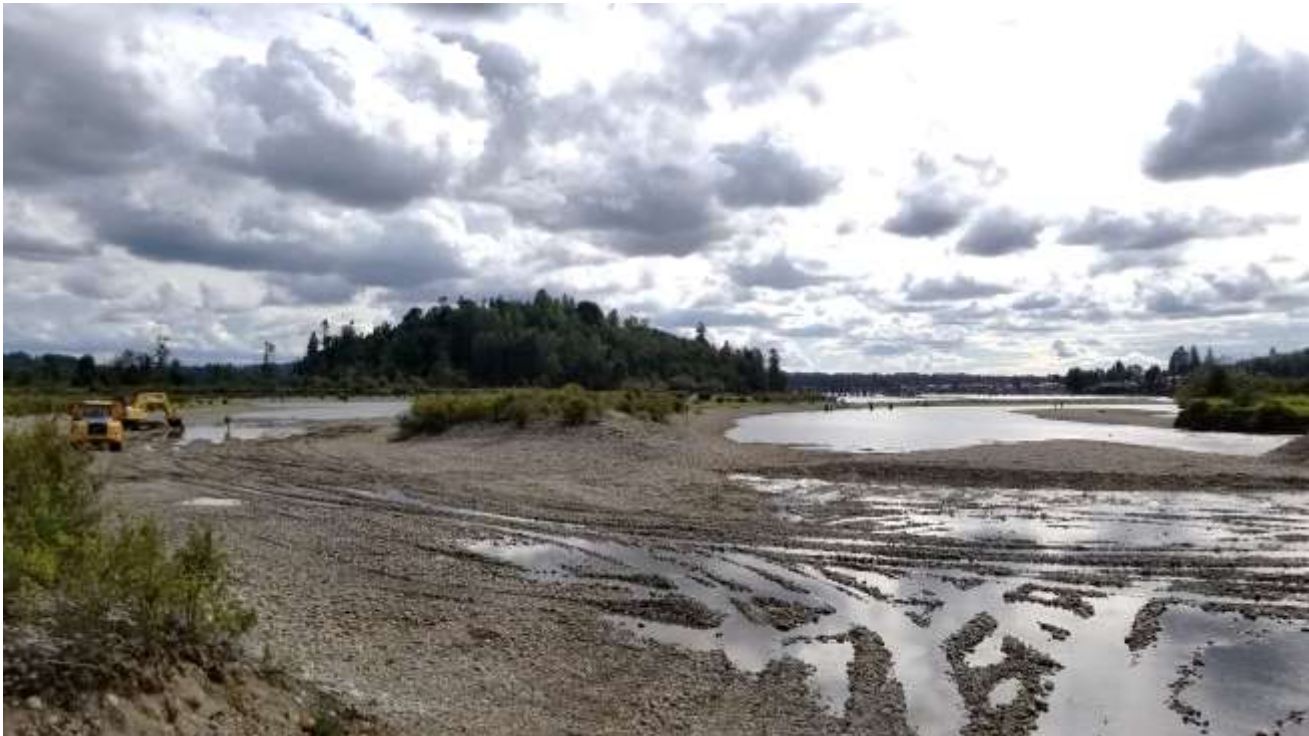
Figure 3. South-view, downstream of project site showing (left) dry channel 5 and channel 4 with the elevation drop, during construction.

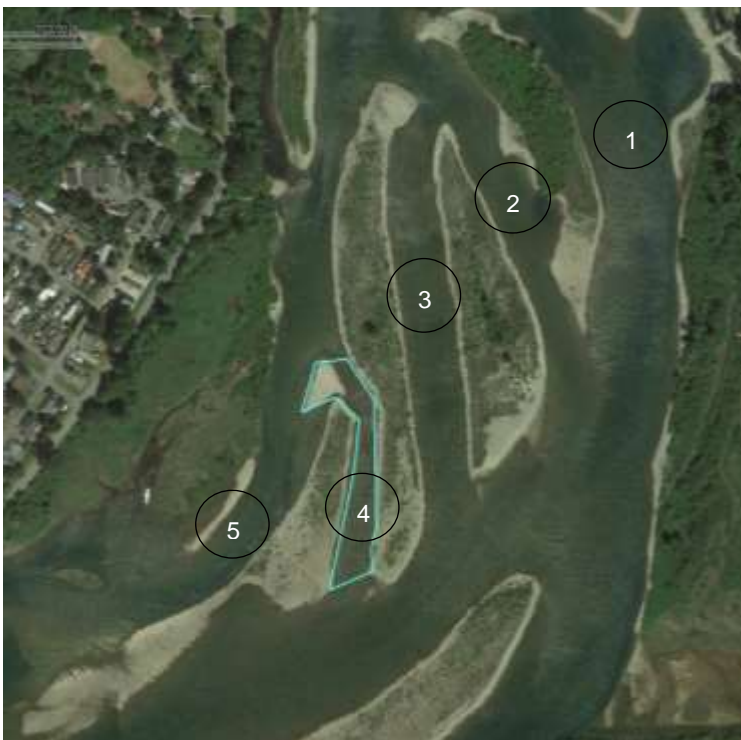
Map 2. Actual area 6,000m<sup>2</sup> shown as a blue line excavated and re-graded to restore flows into Channel 5. (Channels illustrated by circled number)

**Details:** The original target of 500 m<sup>2</sup> was estimated as needed to remove a gravel barrier at the top end of the channel 5. This gravel barrier caused the downstream dewatering effect. During the instream works, the actual excavation and regrading of the channel involved removing the 500m<sup>2</sup> gravel barrier at the top end of the channel 5 and the regrading of the entire downstream channel length to restore flows at a suitable spawning gradient for salmon.

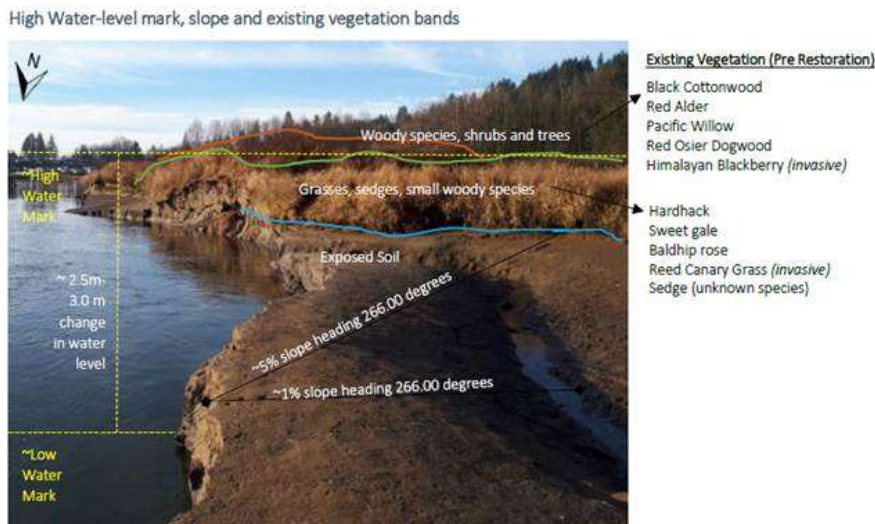
Figure 4. Annotated photo of project site. Notice the erosion of the bank and the lack of existing native trees, shrubs in the riparian. Also notice the presence of invasive reed canary grass. High water mark may be related to higher tail-water flows and freshet levels.

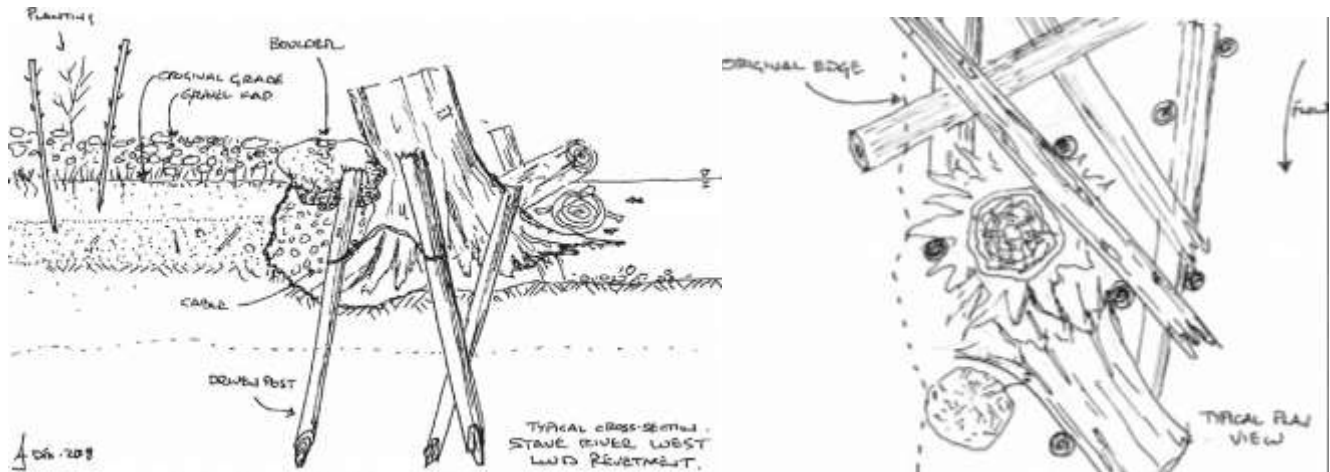
Figure 5. Original conceptual design for river bank works to benefit cultural site and support complex salmon habitat. Copyright DFO AJonsson.

Since the vertical extent of the eroding face was about 60-90cm in the area of works, logs placed horizontally below artifacts depth, would provide support to the face and isolate it from flowing water. The logs were anchored in place through a combination of boulder ballast and vertically driven timber piles. Logs were also lapped such that the downstream end of one always overlapped the upstream end of the log adjacent. River cobble was then placed behind the logs and over-top the native silts as a final cap.

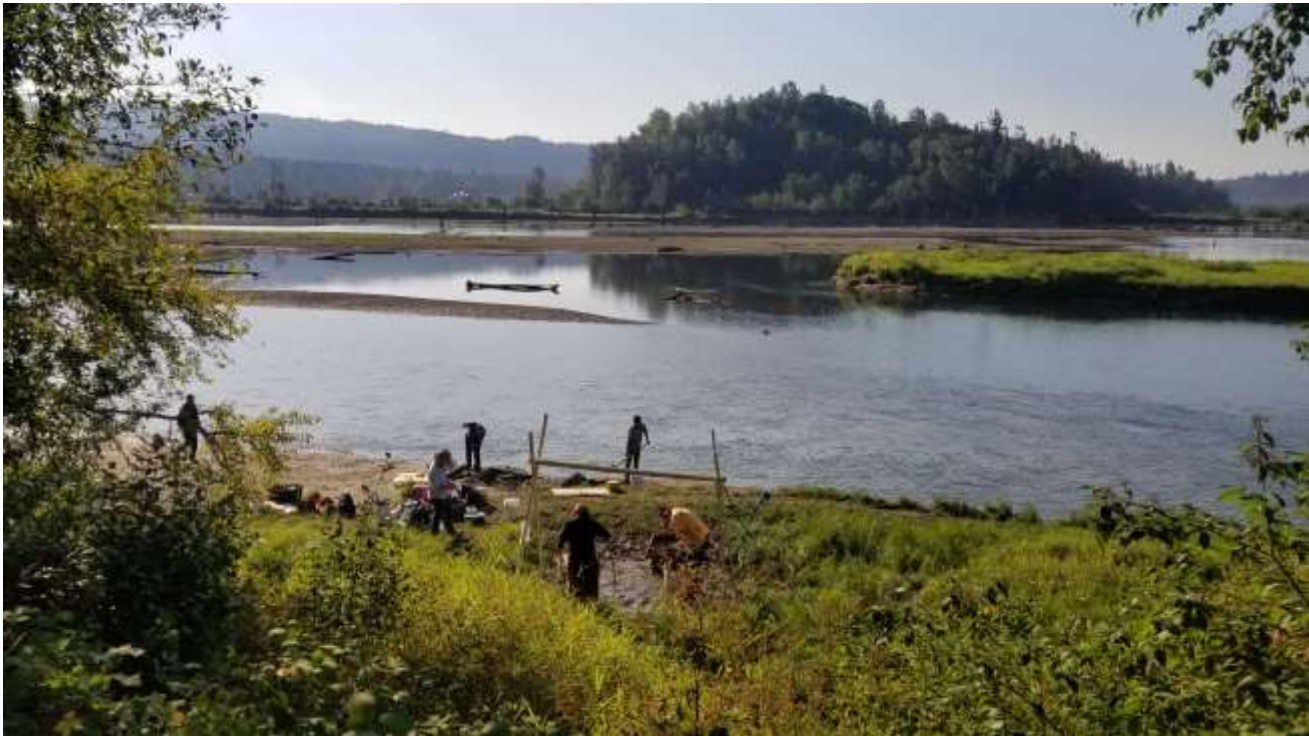
*Figure 6. Site preparation and archaeological artifact retrieval by Kwantlen First Nation and Cordillera Archaeology*

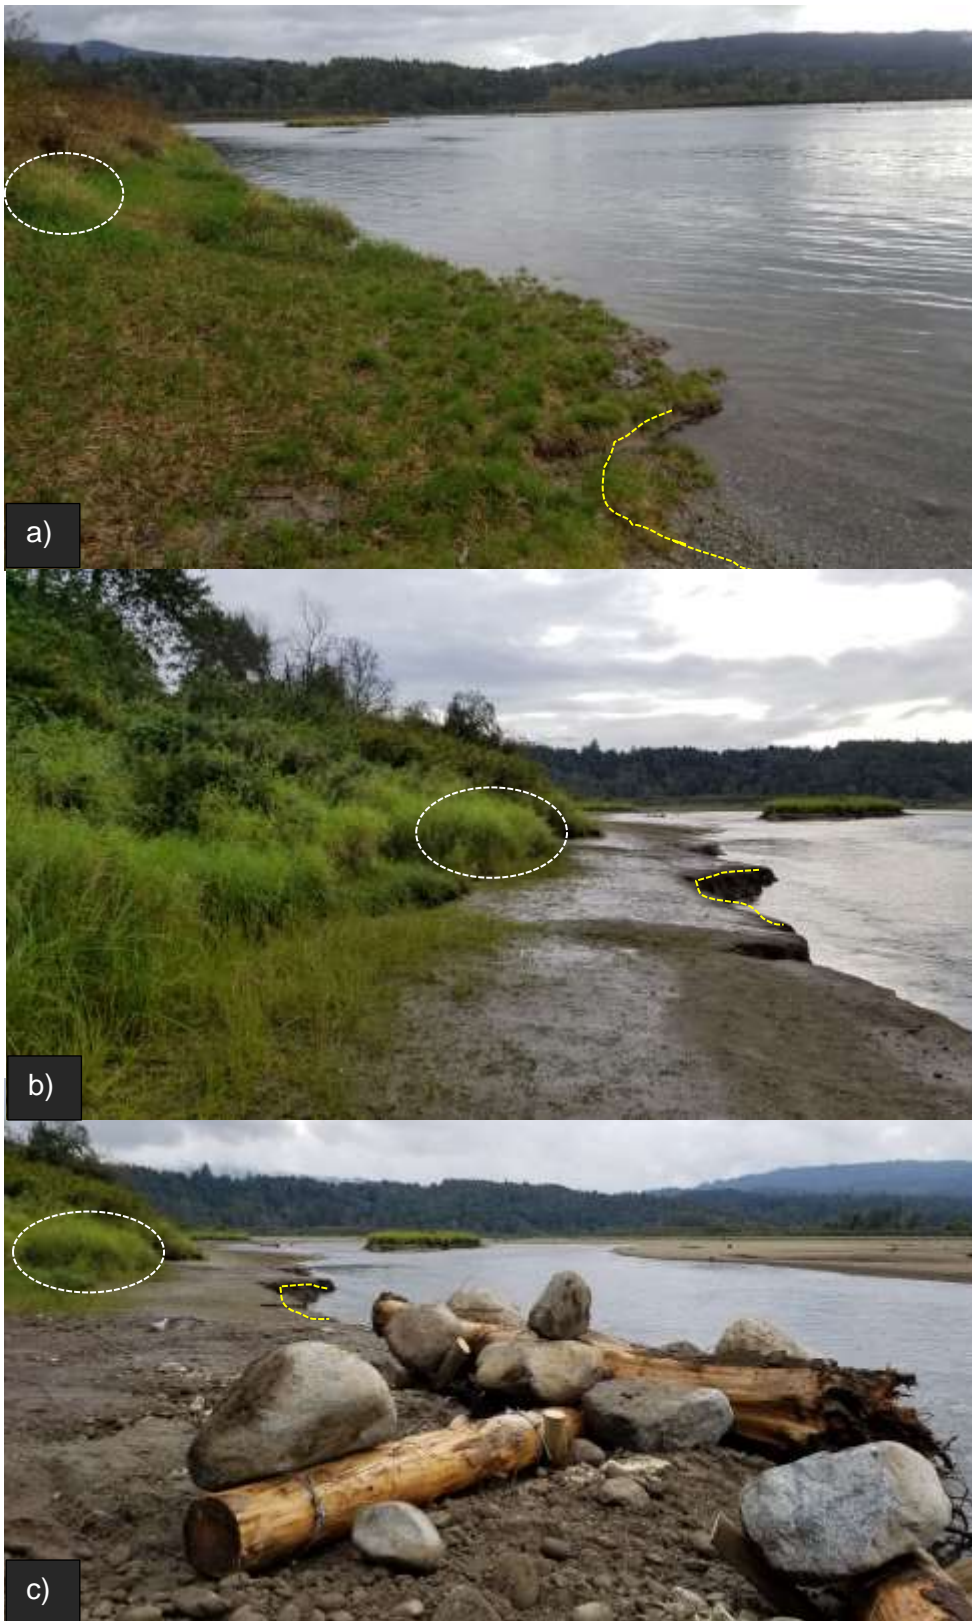
*Figure 7. Upstream transition of right bank. a) Before works (May 2018) b) Before works (September 2018) c) after works October 2018. White dashed polygons are location reference points. Yellow dashed lines indicate erosion reference points.*

linear meters of bank protection works and complete a small pilot project that resulted in 27 linear meters of actual “reef” protection. In addition to the actual reef construction, monitoring at the site and approximately 50 m upstream and downstream will be assessed to understand the effectiveness of the project and ensure desired outcomes are achieved before expanding the project scope. Figure 7 and 8 illustrate the upstream and downstream views of the project works.

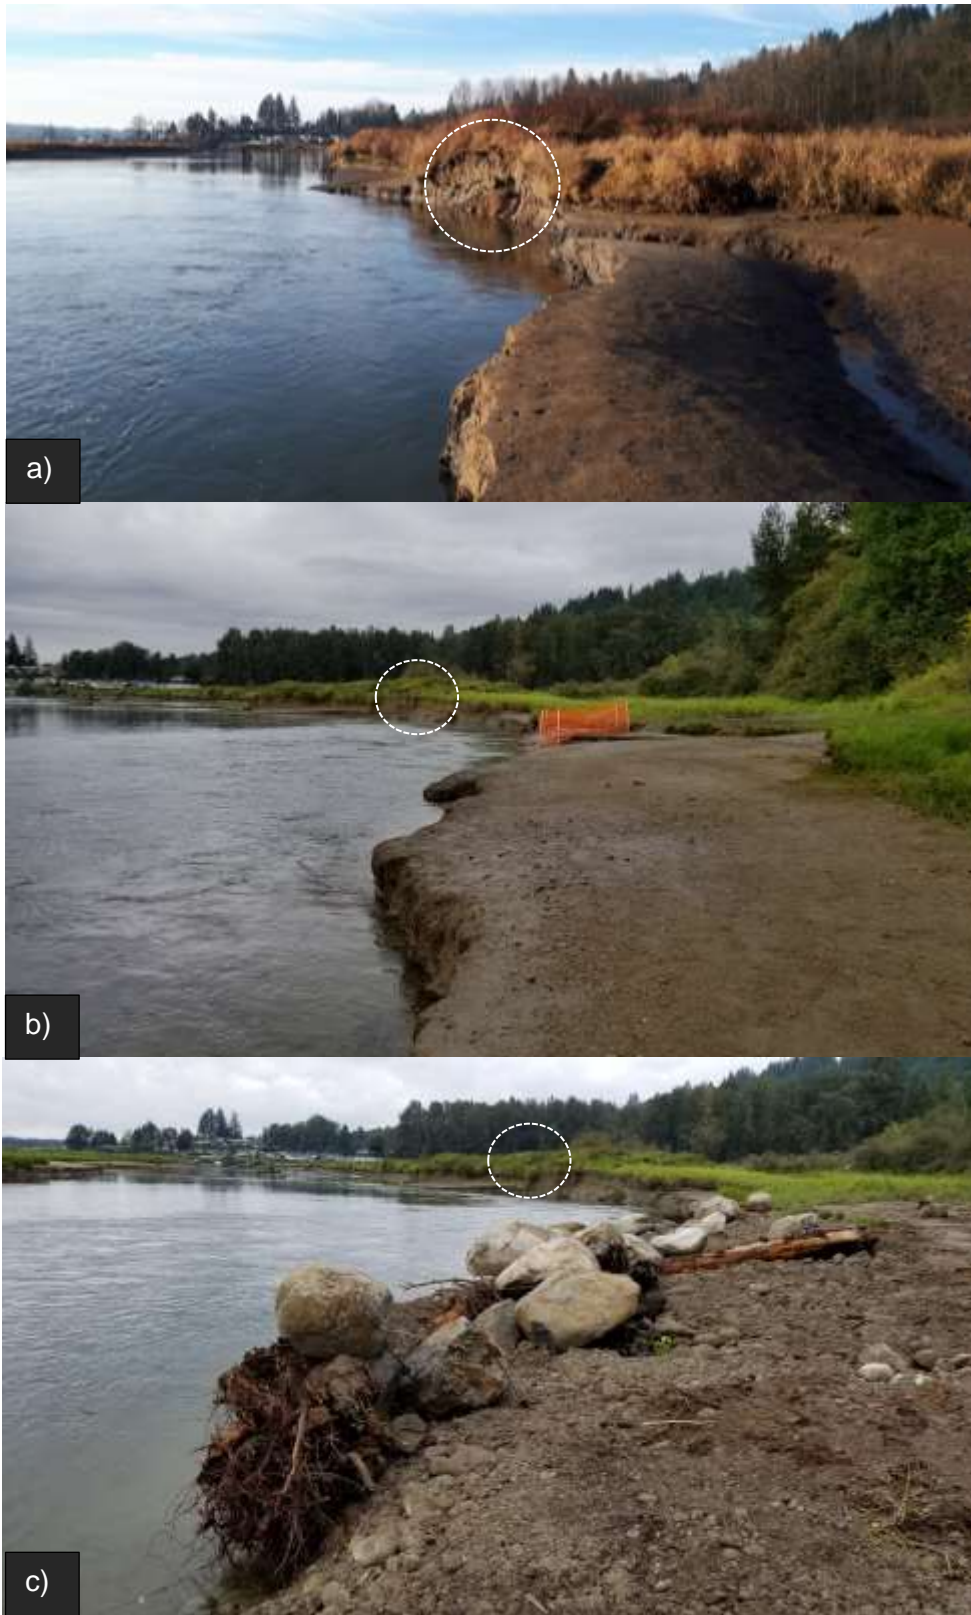
*Figure 8. Downstream transition of right bank. a) Before works (extracted from Cordillera Archaeology report) b) Before works (September 2018) c) after works October 2018. White dashed polygons are location reference points.*

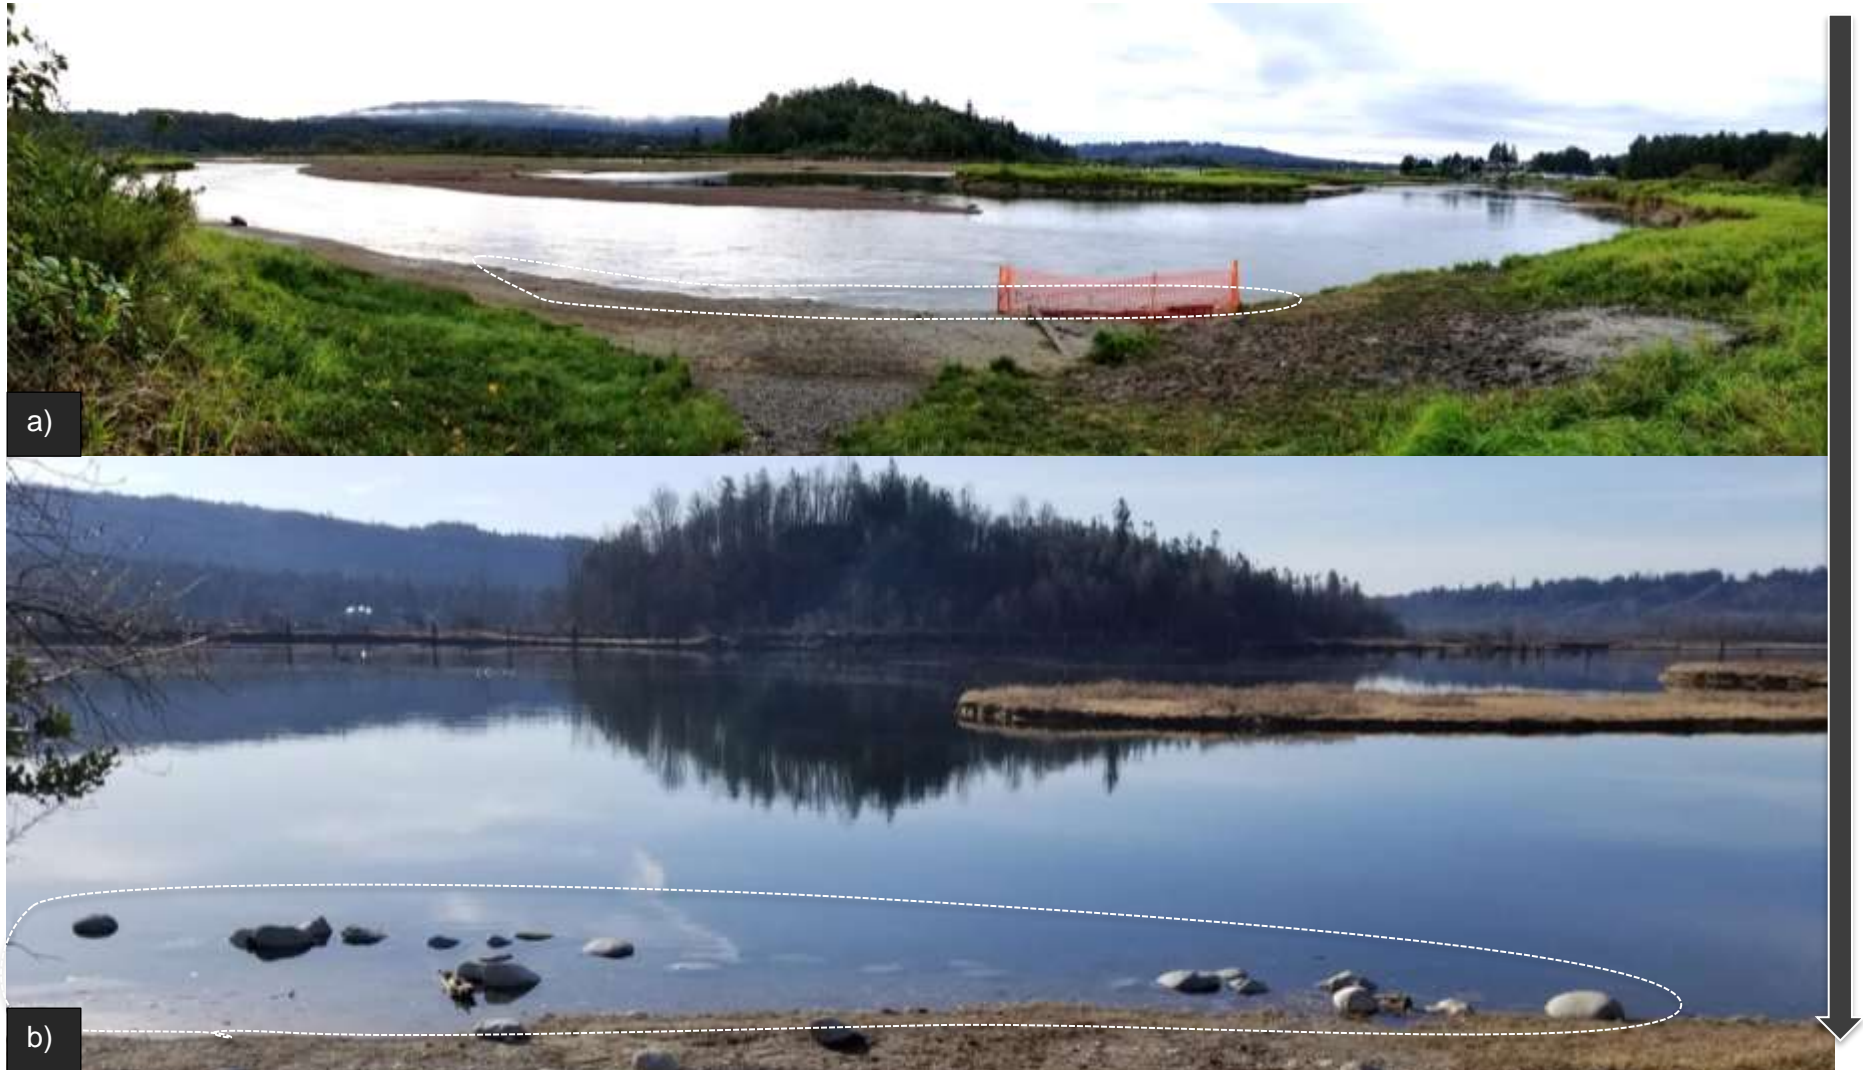
Figure 9. Eastview of the right bank project. a) before reef installed and after excavation of sensitive cultural artifacts. b) After works March 2018 during tail water release. White dashed line delineates reef location.
