Groundwater Division

SUBJECT: PRELIMINARY NOTES ON HYDROGEOLOGY AT THE SITE OF THE PROPOSED DEVELOPMENT ON GLOVER ROAD NEAR LANGLEY, B.C.

Water Investigations Branch

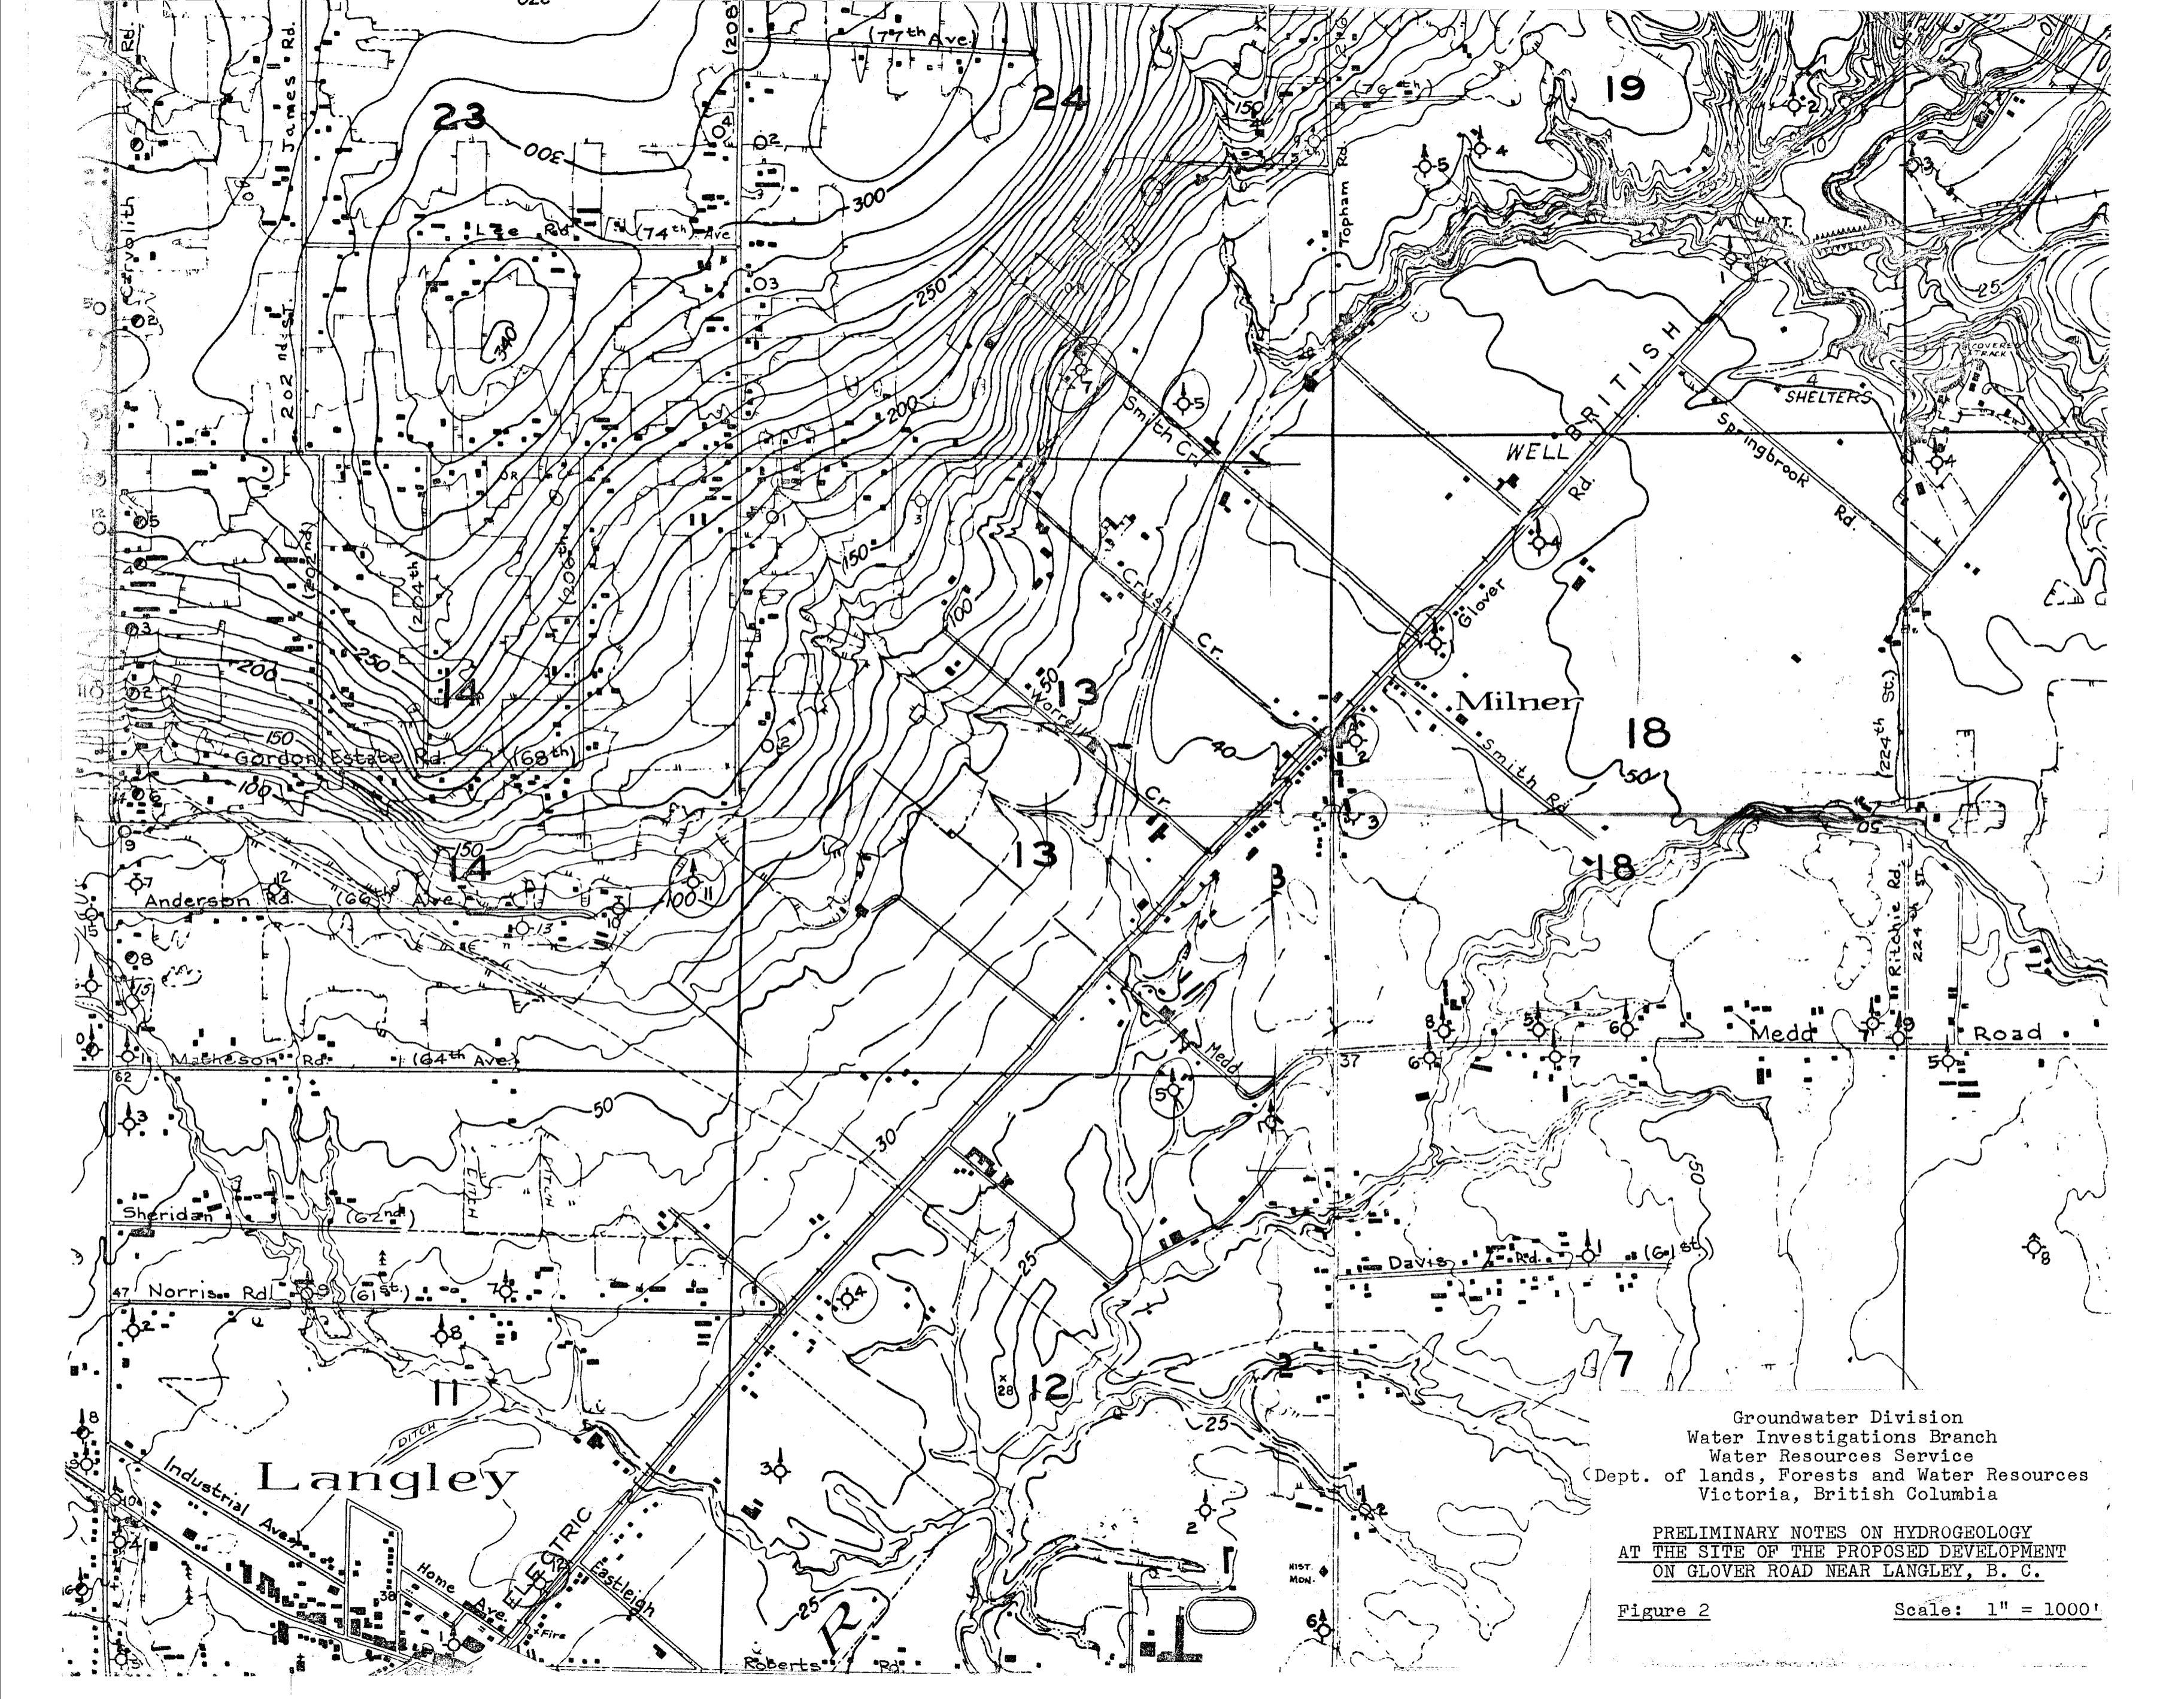
- Figure 1: Location of proposed development.
- Figure 2: Well location map.

Referring to Figure 2, section 18, well Nos. 1, 2, 3 and 4, we find the well logs show clay and silt extending to depths of from 100 up to 400 feet before any water-bearing silty sand and gravel suitable for well completion is encountered.

At the project site area which is closer to the valley wall than the above mentioned wells, the thickness of clay or silty clay overlying coarser beds is much thinner and only reaches a depth of 128 feet at production well #6. Well No. 4, Thatchers Well, and No. 5 in Section 12, show well completion depths of 365 feet and 590 feet respectively. Howeven no detailed well logs are available.

Referring to Figure 2, Section 11, well No. 12, the log for the well shows a 260 foot deep well drilled for Potters Distilleries Ltd. There is an aquifer at this site under artesian pressure between 237 and 260 feet and the well yield is 300 gallons per minute at a pumping depth of 160 feet. The source or sources of recharge and the extent of the aquifer are not known.

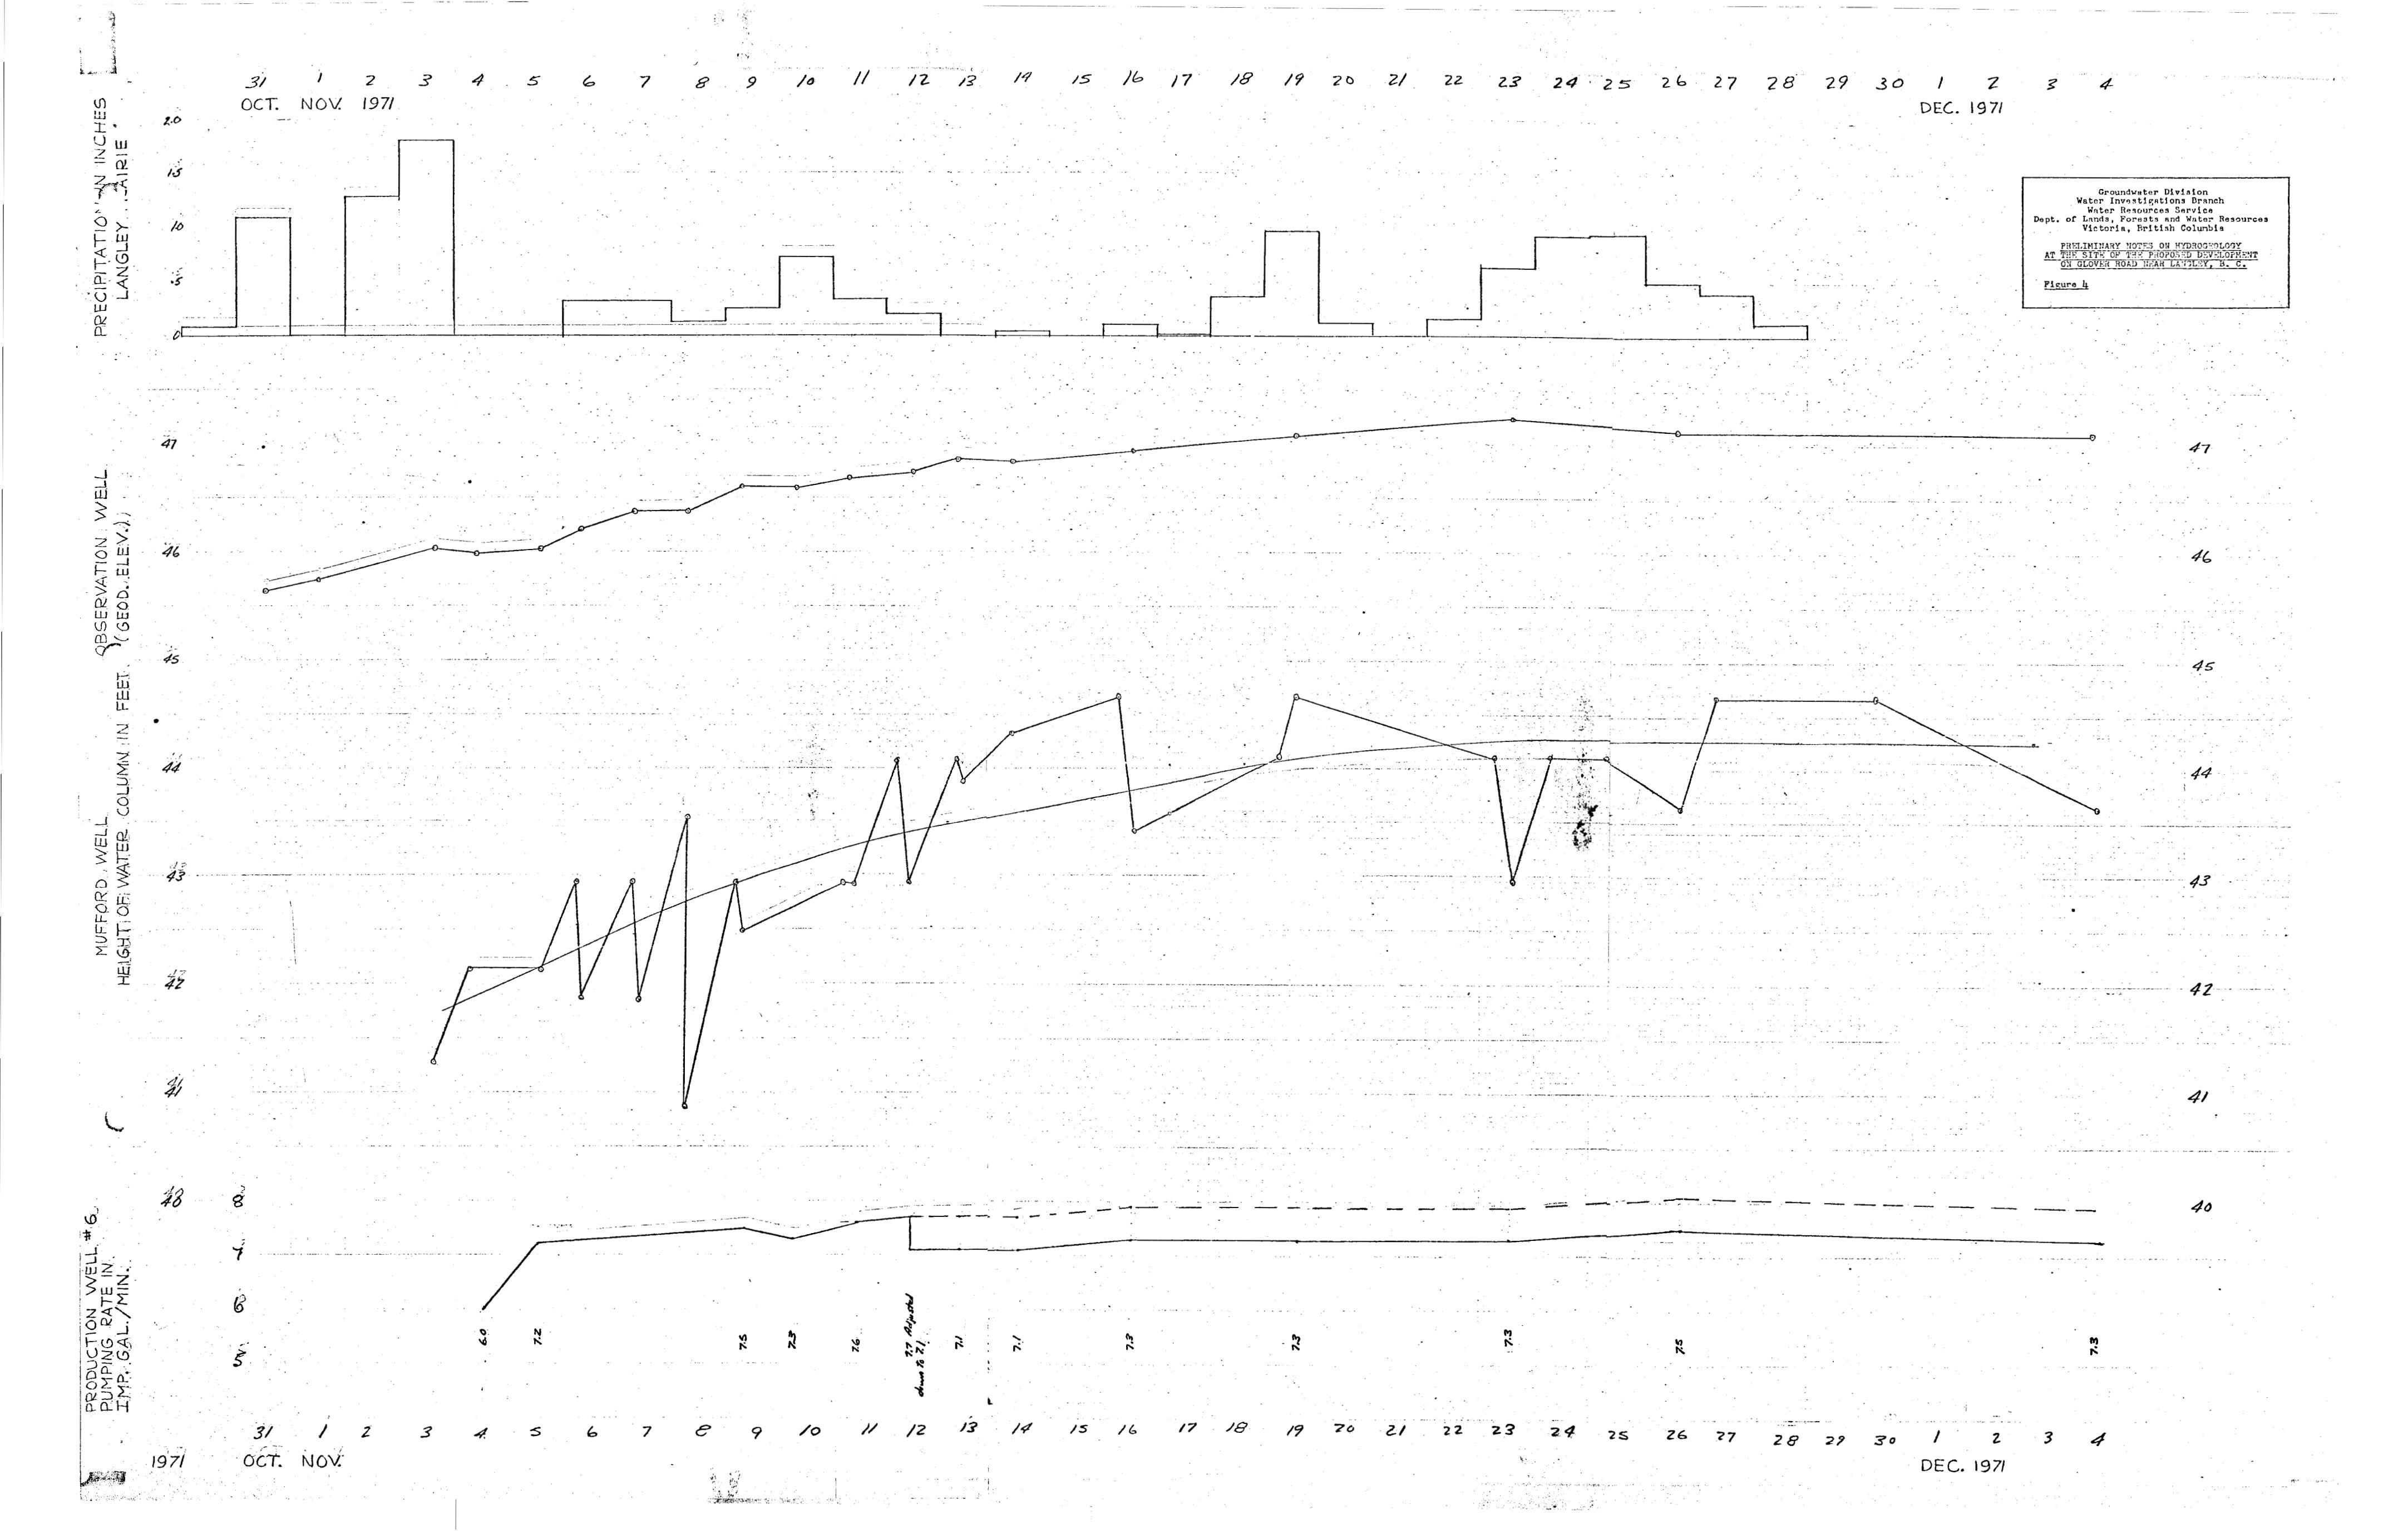
- Figure 3: Map showing locations of observation wells and production well.
- Figure 4: Graphical representation of data collected from observation wells and production well #6, and precipitation data following the completion of grouting operation on well No. 6 on October 28th, 1971.

From an inspection of Figure 4, we can make some observations and speculations about relationships that may exist between the production well No. 6, the observation well, Mufford's well and the daily precipitation record.

The curve for the piezometric level fluctuations in the observation well and an "average value" curve drawn through the readings for Mufford's well both show a similar rise from early November, and reach a peak and then a "stabilized" condition in the last part of November. The abrupt fluctuations in Mufford's well readings may, in part, be due to the pressure gauge used to make readings and to the drain off for domestic supply requirements.

The flow measurements in the production well have also been represented graphically in Figure 4 and the curve, after allowing for a correction, shows a somewhat similar pattern to the piezometric head curves for the other two wells. There is a rise at the beginning of the month and then a stabilized condition.

The first part of all three curves are interpreted to be a response to the recovery of the piezometric surface following the marked reduction in flow of well No. 6 after the casing was sealed by grouting. The latter part of the curves are interpreted as a normal response after recovery and "stabilization" of the aquifer has taken place.

Because the aquifer is a leaky artesian situation, recharge will be slow and the response to any sudden increase in precipitation will be slow.

The histogram in Figure 4, of the daily precipitation records for Langley Prairie, do not show any marked correlation on a <u>day to day</u> basis with the other curves. For example, the general "stabilization" of the curves near the end of November occurs at a time of increased precipitation.
