# **Construction of Artificial Fish Habitat in the Englishman River, 2004**

**M.P. McCulloch  
Fisheries Technician  
Greater Georgia Basin Steelhead Recovery Plan  
BC Conservation Foundation  
Nanaimo, BC**

**January 2005**

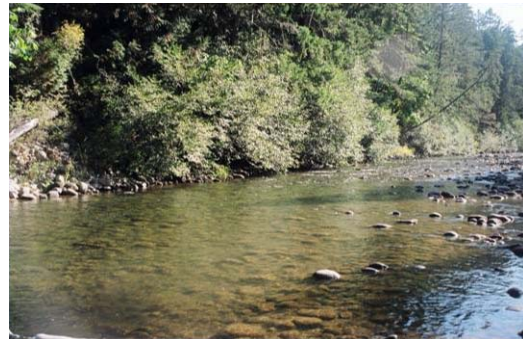
Photo 4. Looking upstream at site 3+800 pre-construction.

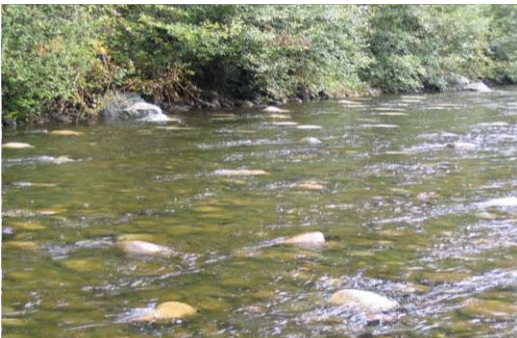
Photo 5. Looking upstream at site 3+800 post-construction.

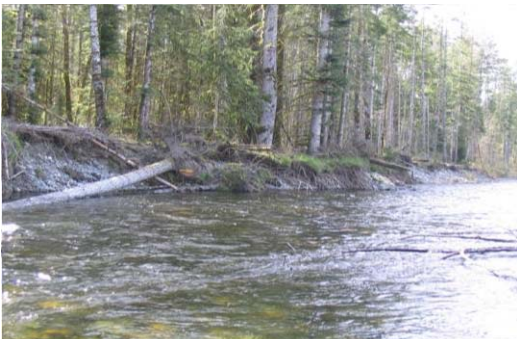
Photo 7. Looking upstream at 5+690 and 5+730 pre-construction.

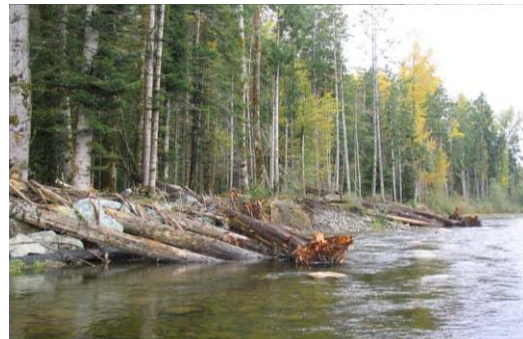
Photo 8. Looking upstream at sites 5+690 and 5+730 post-construction.

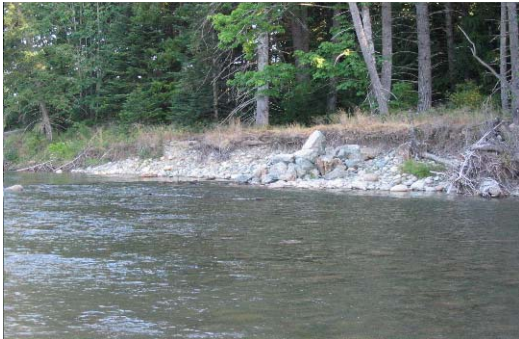
Photo 11. Looking upstream at site 6+140 pre-construction.

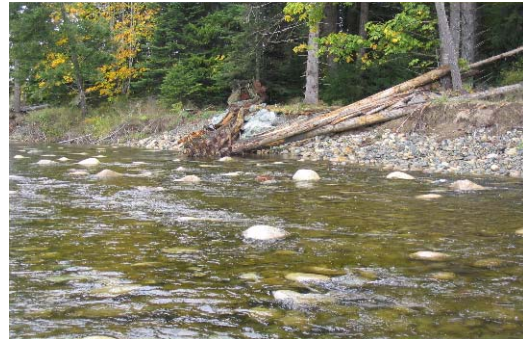
Photo 12. Looking upstream at site 6+140 post-construction.

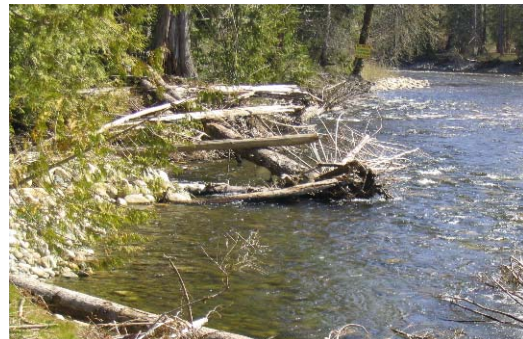
Photo 14. Looking downstream at site 7+120 further modified in 2004 to capture debris.

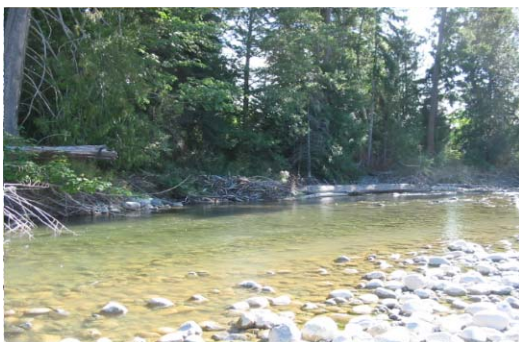
Photo 15. Looking downstream at site 7+105 pre-construction.

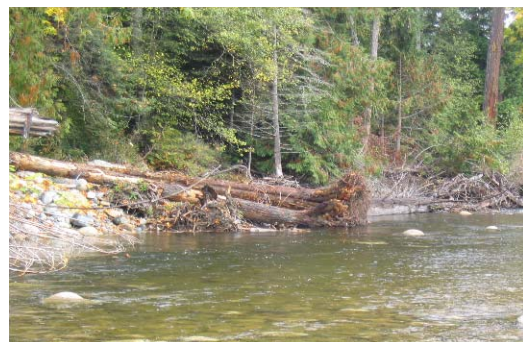
Photo 16. Looking downstream at site 7+105 post-constriction.

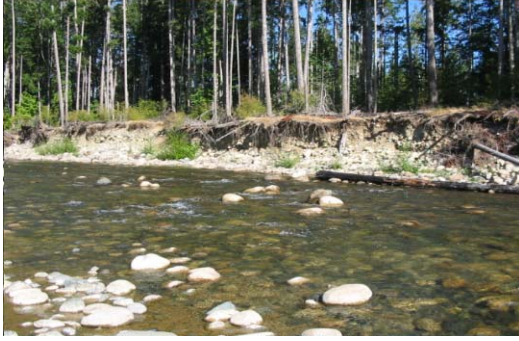
Photo 17. Looking upstream at site 7+180 pre-construction.

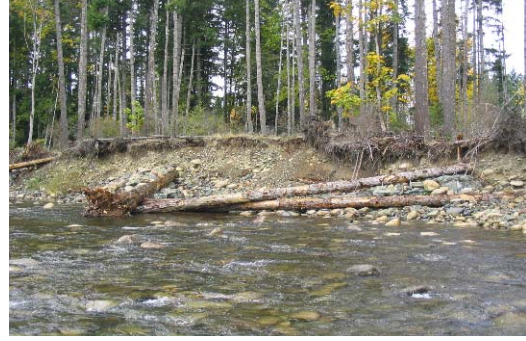
Photo 18. Looking downstream at site 7+180 post-construction.

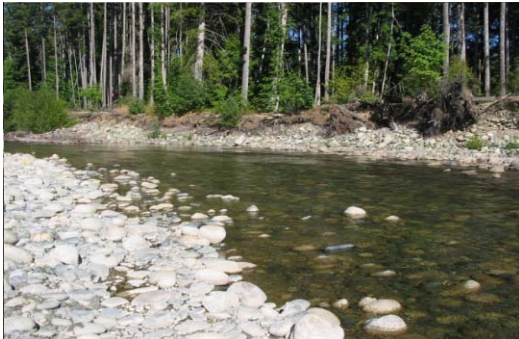
Photo 19. Looking upstream at site 7+220 pre-construction.

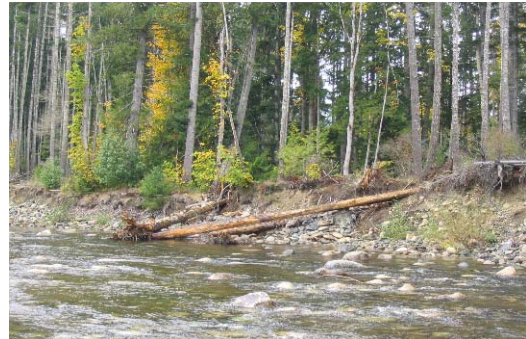
Photo 20. Looking upstream at site 7+220 post-construction.

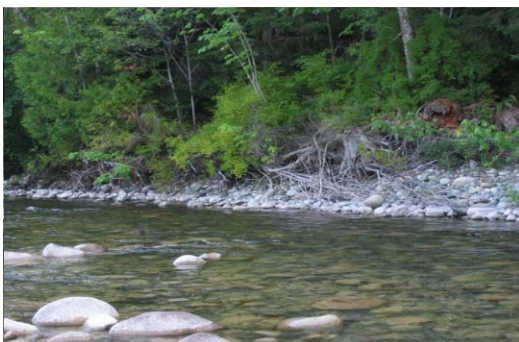
Photo 23. Looking upstream at site 8+980 pre-construction.

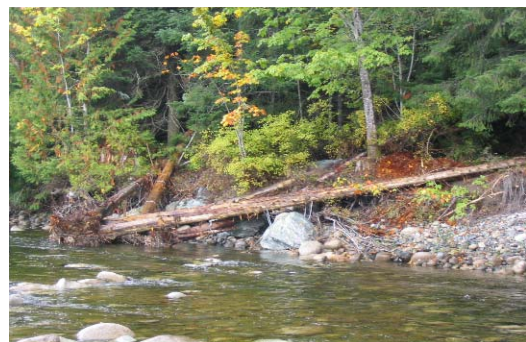
Photo 24. Looking upstream at site 8+980 post-construction.
