April 27, 2020

Thompson Creek Fish ladder, Replanting and Assessments Stave River Watershed- Restoring Salmon Habitat

Prepared for:
Fish Wildlife Compensation Program
Project number: COA-F20-F-3110

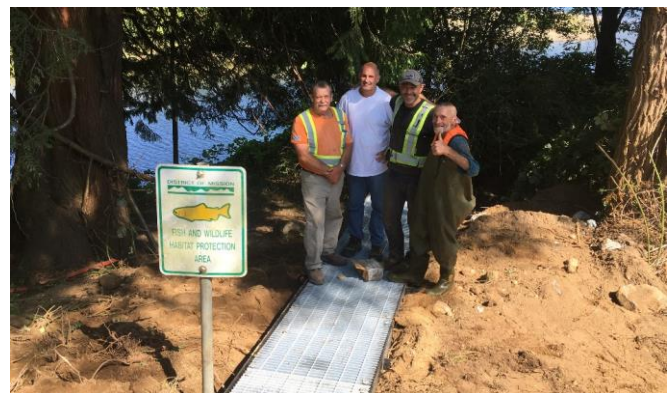
Figure 2. Installed fish ladder with partners and local steward.

The installation of the new fish ladder at Thompson creek resulted in the stabilization and enhancement of the habitat below the ladder and fish passage approximately 400 linear meters upstream (~600m²) representing year-long observed aquatic habitat, as per District of Mission webmap watercourse data (Appendix A; Appendix B).

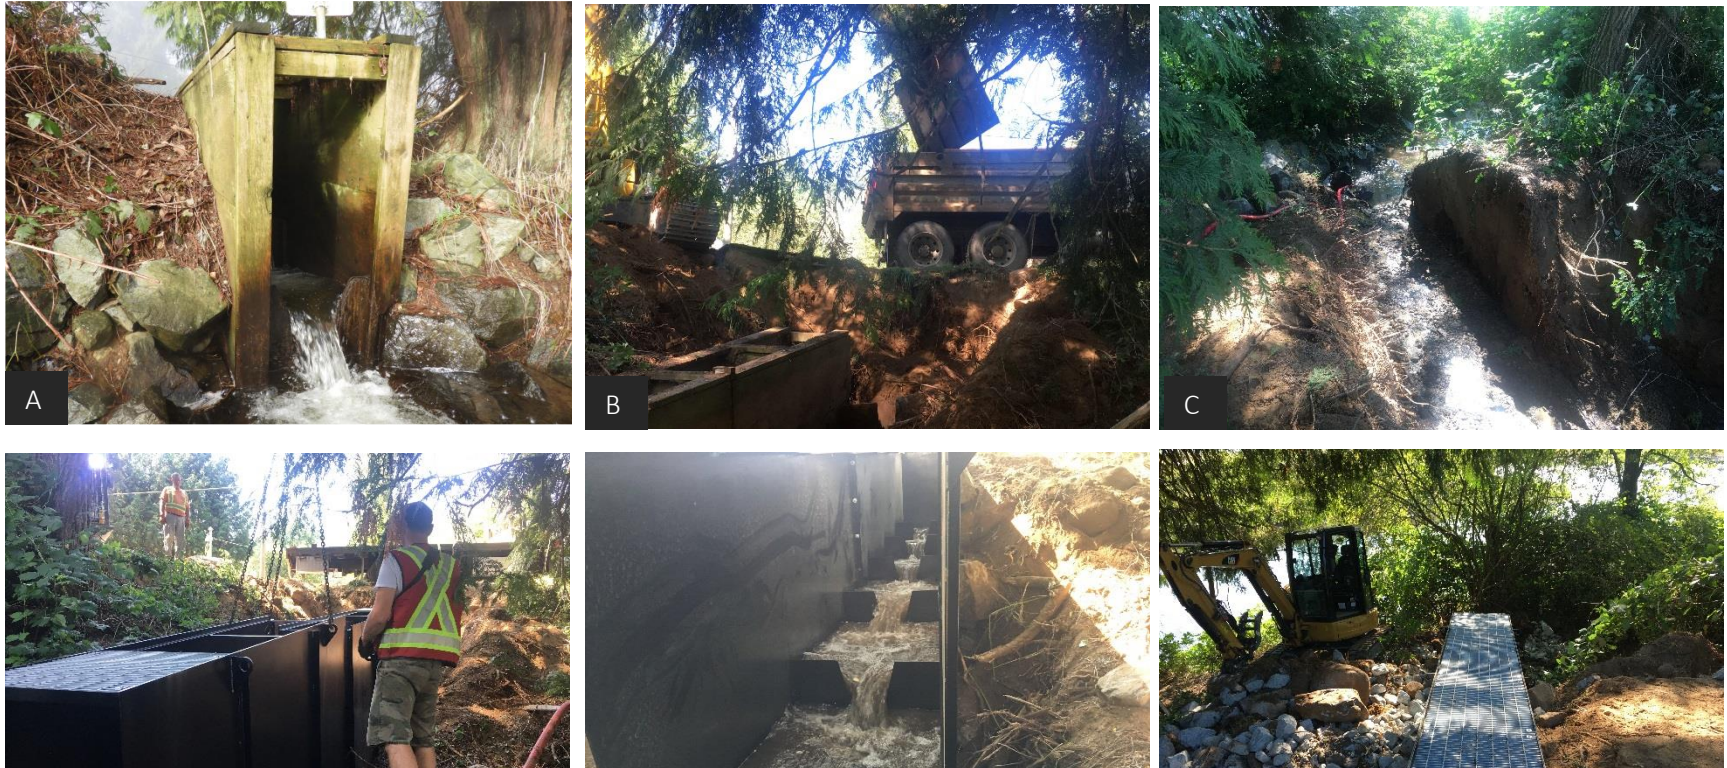
Installation of Thompson Creek fish ladder Mission BC.

A. Wooden fish ladder to be replaced B. Excavator removes wooden fish ladder. C. Gravel added to site for correct grade. D. Steel fish ladder being lifted into place with crane truck. E. First water flowing through new fish ladder. F. New fish ladder installed and habitat below being enhanced and stabilized

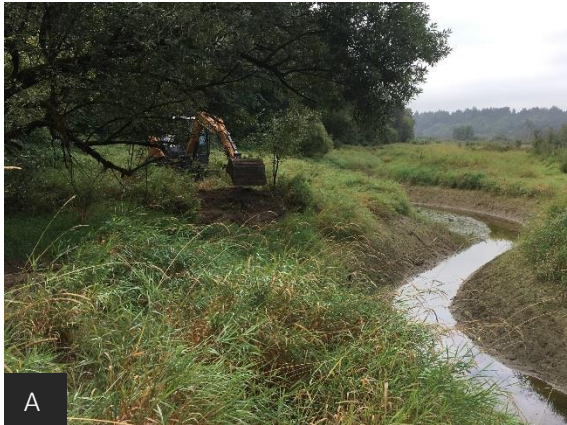
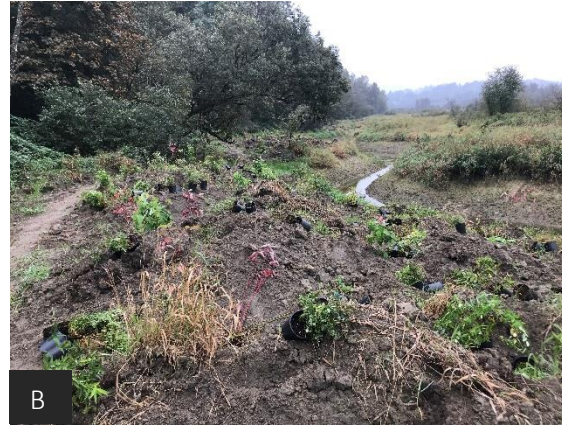
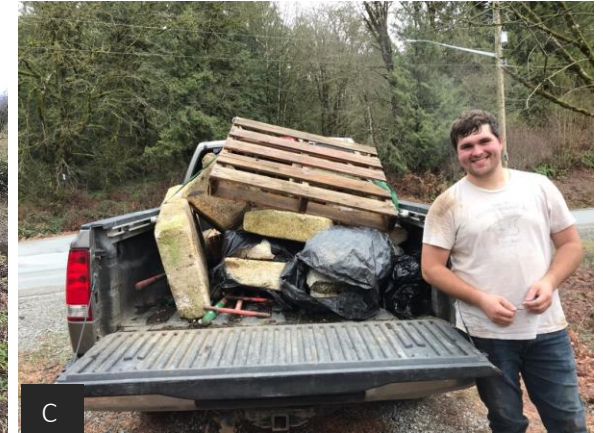
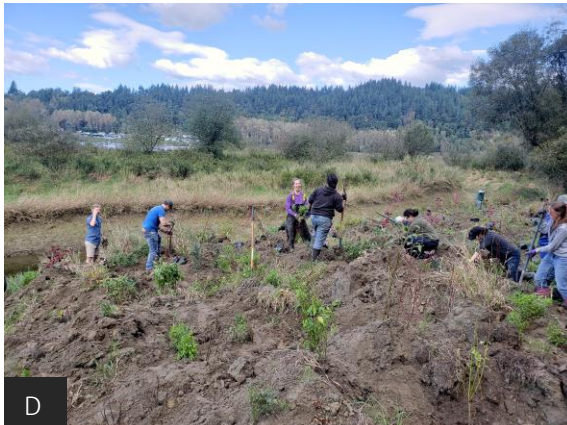
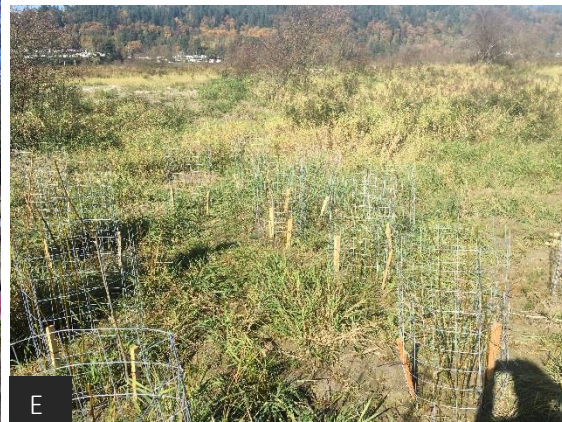
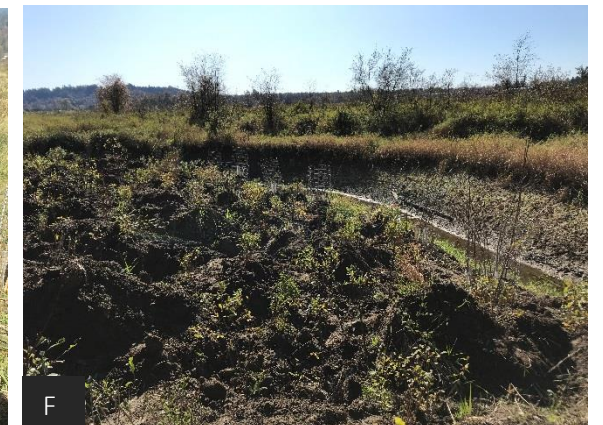
Shrub planting on Stave site #2 Mission BC.

A. Excavator preparing site for fall planting. B. Plants laid out for volunteer planting C. 190 kg garbage removed from the site and disposed of properly. D. Volunteers planting. E. Shrubs guarded against beavers. F. Newly planted riparian area on Stave site #2

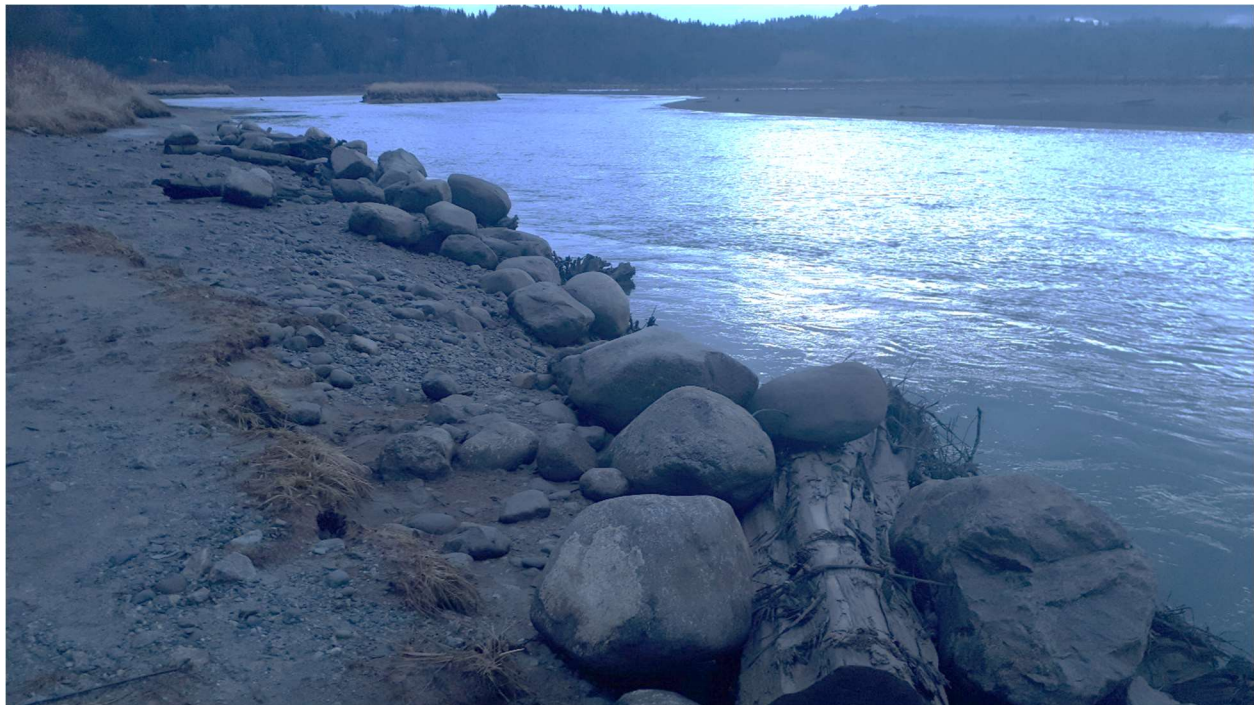
Figure 1. Artificial reef (photographed during current site visit) looking north (upstream) at DhRo-1.

1. The artificial reef appears to be doing a very good job at protecting the areas where it is installed. Not only is the reef holding the cut bank in place, but the gravels on top are preventing more erosion on the surface of the site. Geomatic mapping funded by grants from the Fish Wildlife Compensation Program (applied for by the Fraser Valley Watershed Coalition) should be able to confirm this qualitative observation with empirical data.

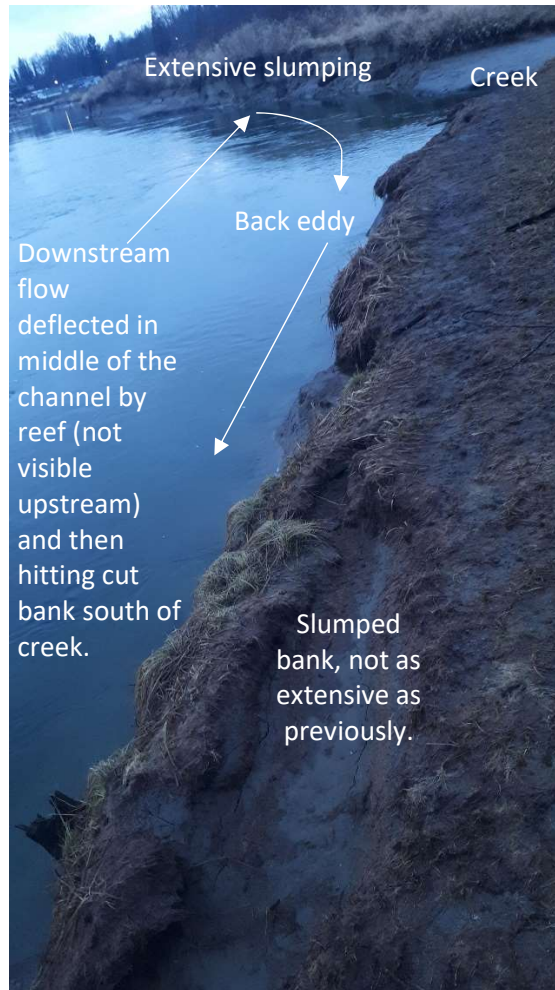
2. While the reef is protecting the cut bank, downstream from the reef the bank is still slumping and slowly eroding. In the past it was eroding much more quickly due to direct, fast-flowing water from upstream. What we observed is that this area is now a back eddy: the fast-flowing water has been deflected into the middle of the channel by the artificial reef, and then is hitting the bank south of the creek outflow (and causing significant erosion there), while the back eddy causes minor slumping/erosion to the area adjacent to the reef. Figure 3 below shows what we believe is occurring.

Figure 3. Slumping of the bank to the south (downstream) from artificial reef. Note extensive erosion of cut bank at top of image where downstream flows hit the bank, and then presumably back eddy towards the artificial reef.

- Continued monitoring of the area (when feasible) should be undertaken to identify any archaeological remains eroding from the bank and to assess erosion. This can be conducted opportunistically *en route* to other archaeological projects when time and tides permit.
- Evaluative testing should be conducted (one or two 50x50 cm units) just south of the creek outflow to assess the density of organic archaeological material eroding from Layer IV. This area appears most susceptible to erosion due to back eddying and stream downcutting. Tides will likely need to be below 0.4 m in order to excavate here.
- Follow-up with BC Hydro, Kwantlen and the Fraser Valley Watershed Coalition once the results of the mapping are known.
- Follow up with all stakeholders listed above to discuss the possibility of extending artificial reef south (downstream) as far as the small creek outflow.

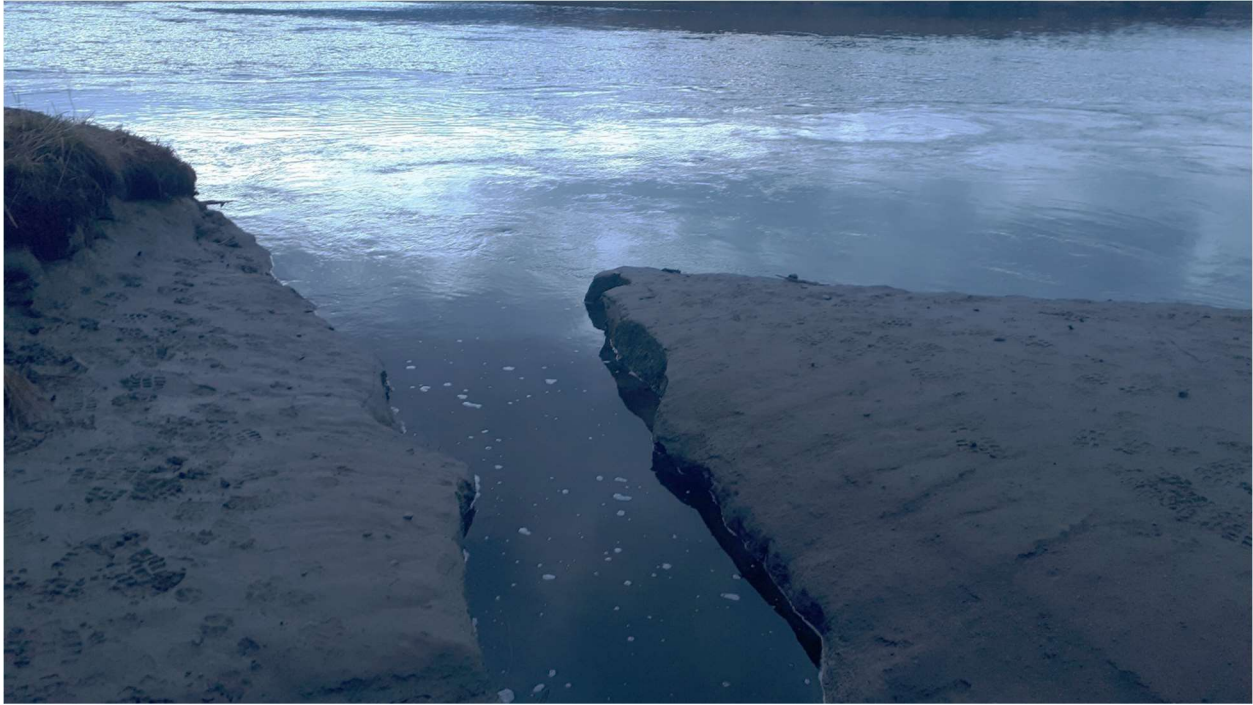
3. The small creek which flows into the main Stave River delta channel is down cutting significantly (Figure 4). Perhaps the reef is removing the deposition of sediments from upriver where this creek located, or perhaps some other factor is at play, but sediments are both washing away and being down cut at the mouth of this creek.
4. A new exposure of the organic layer has been identified. We suspect this is the Layer IV from the large excavation from which many of the baskets and other cultural materials were recovered. The exposure of this layer is located just south of the creek mouth. This layer was 35 cm below water surface at 8:00 am. The location of this exposure is shown in Figure 5 and Figure 6 below.

Figure 4. Creek downcutting and emptying into Stave River channel.

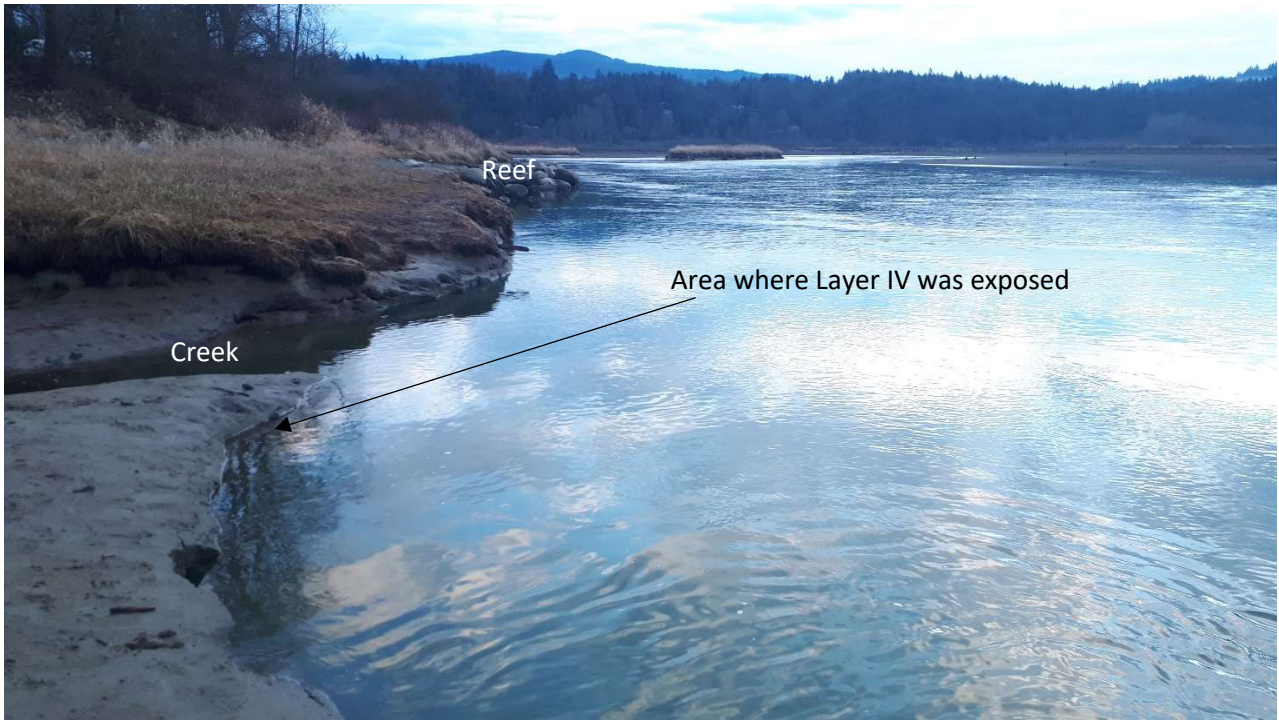
Figure 5. Showing location of exposed organic layer. Photo looking upstream (north).

exacerbating downcutting by a small stream in the same area. However, we assess this new erosion to be significantly reduced compared to the previous erosion downriver flows before the reef was installed. We also observed an exposed organic layer we suspect may have significant numbers of organic artifacts directly south of the creek outflow; this area should be subsurface tested when feasible.

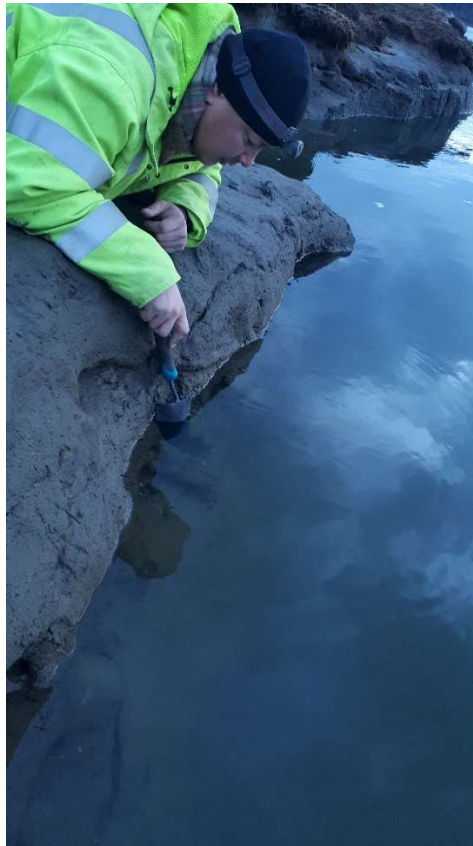
Figure 6. Joey Antone pointing trowel at organic layer underwater.

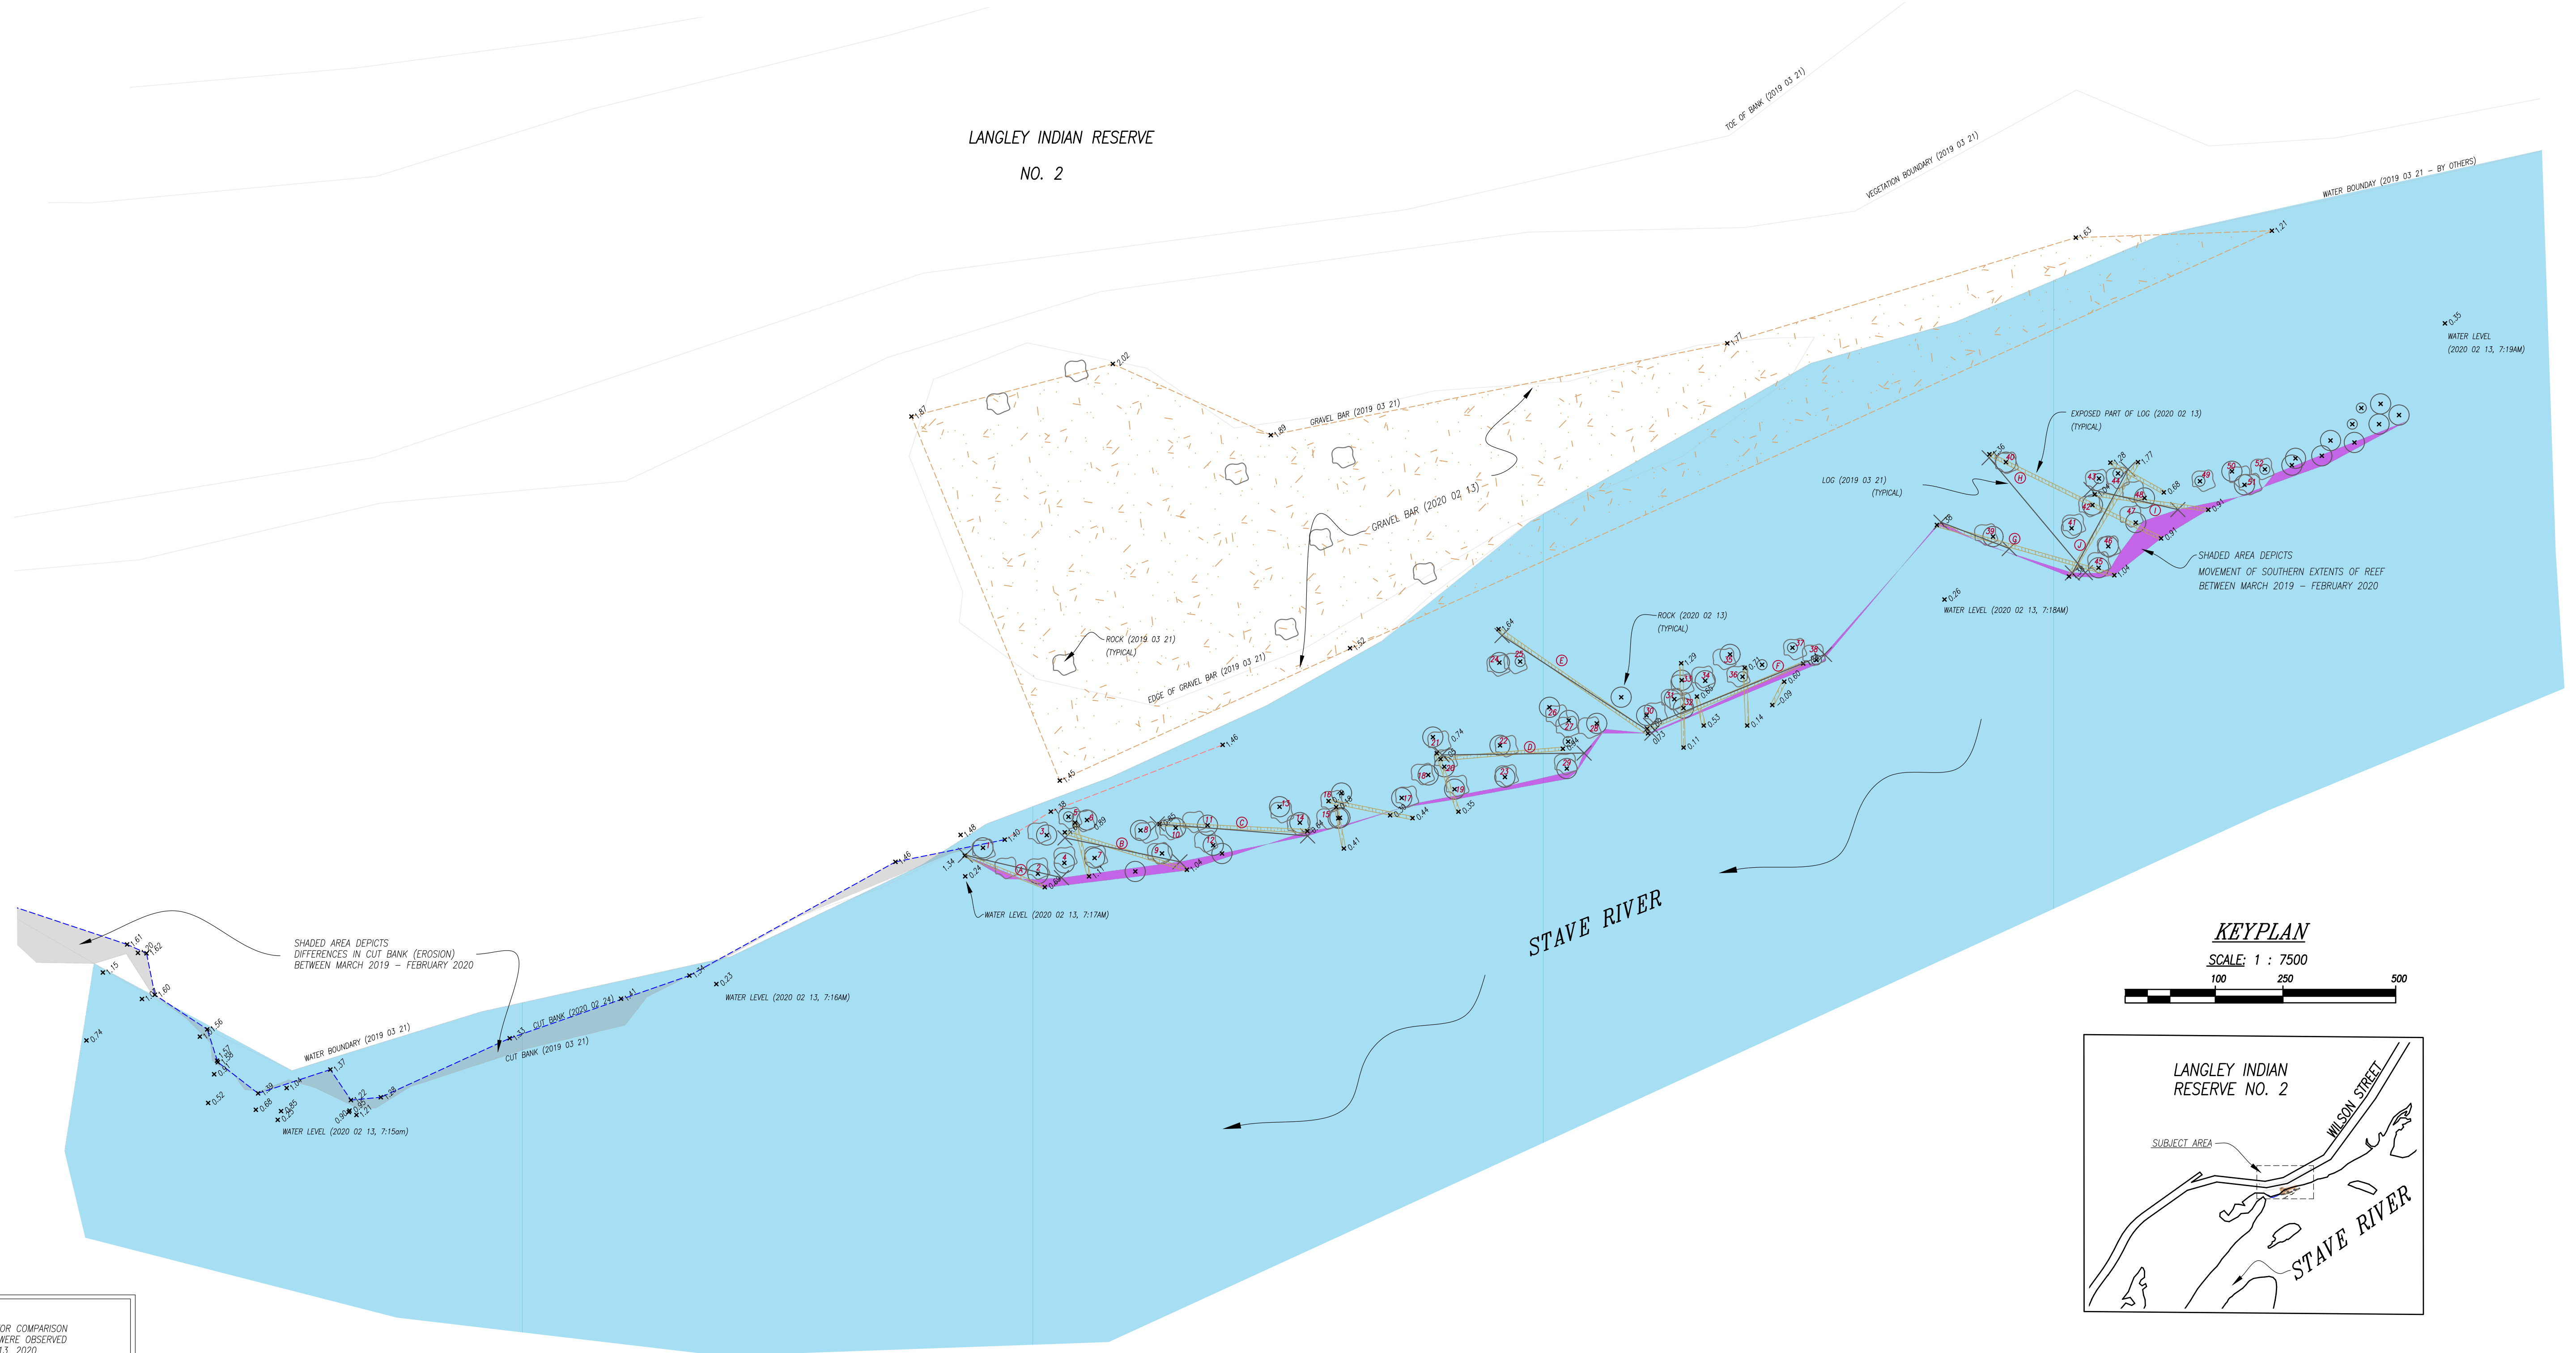
With an empirical movement threshold between 0.1m-0.5m of shifting, the surveyors compared the as-built surveying drawings and re-surveyed the bank and reef structure. The findings indicate that there is some movement within the reef structure, almost all movement falls beneath the 0.1m threshold. On average the boulders “rocks” have moved an average of 0.21 m, the north end of the logs (bankside) have moved on average 0.17m and the south end (river-side) have moved on average 0.85m. Two logs G-G and H-H have slightly greater shift 3.2m and 2.5m change respectively. This shift may be due to the extent the south ends are within the river, movement being caused by hydrological push (river current).

Some erosion has occurred within and around the reef structure, represented as purple shading in the surveyed drawing, ranging from 0.3m to 1.04m. Particularly, it is occurring at the uppermost section where the mainstem flows intercept the right bank. Further downstream there is minimal erosion until nearing the end of the reef where some erosion action is still observed.

Further downstream where no reef structure was installed, the surveyors measured the banks between March 2019 and February 2020, shaded as light grey in the surveyed drawing. Downstream erosion of the cut-bank ranges from 0.25m to 1.61m of active erosion. Just Upstream of boulder 52, where no rootwads were installed active erosion has been surveyed and observed.
