WATERSHED ASSESSMENTS (CWAPs) FOR
CRANBY CREEK AND BALLPARK CREEK, TEXADA ISLAND, BC

FINAL REPORT

Project No. 0801-00-81528

October, 2000

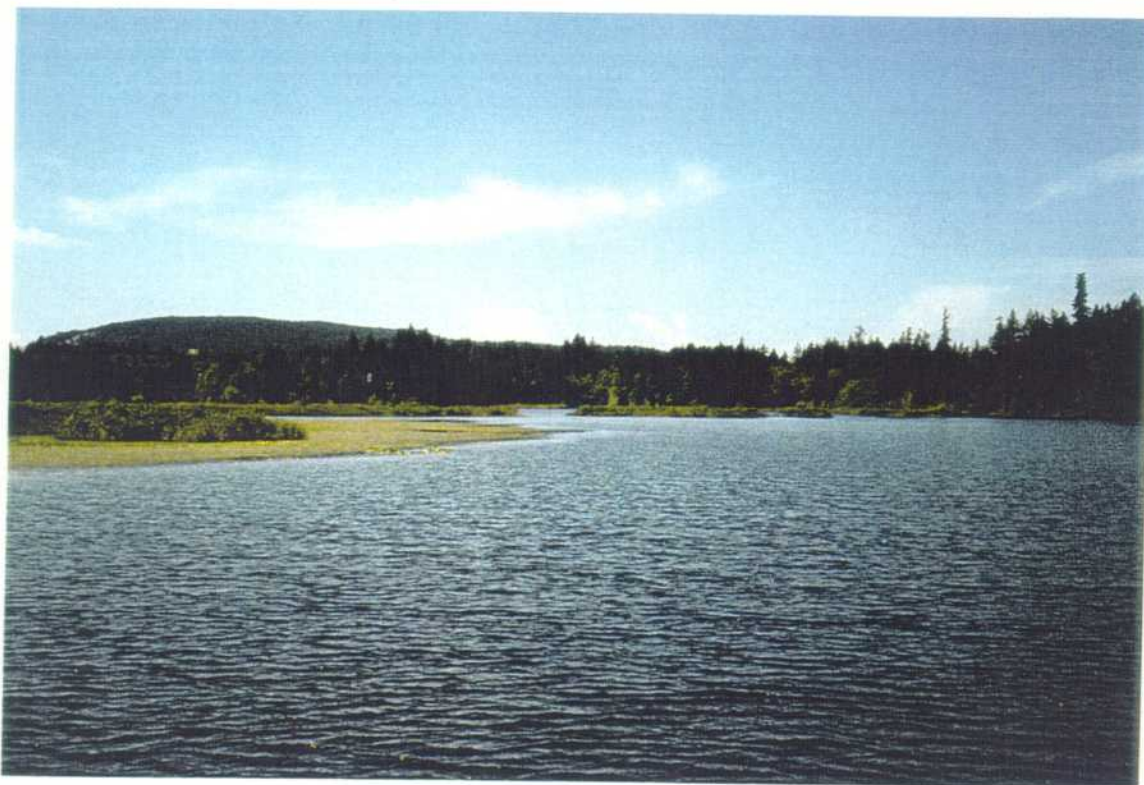
Photo 1 – Cranby Lake, view from dam (June, 2000)

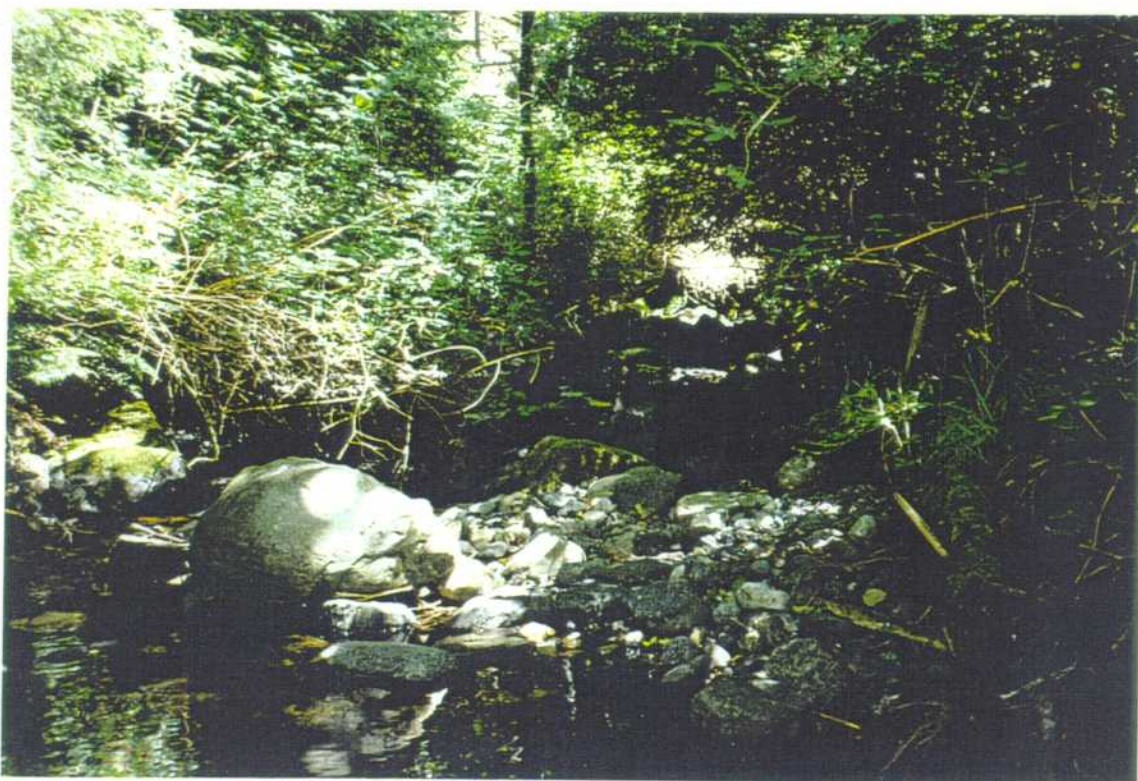
Photo 2 – Lower Ballpark Creek (June, 2000)

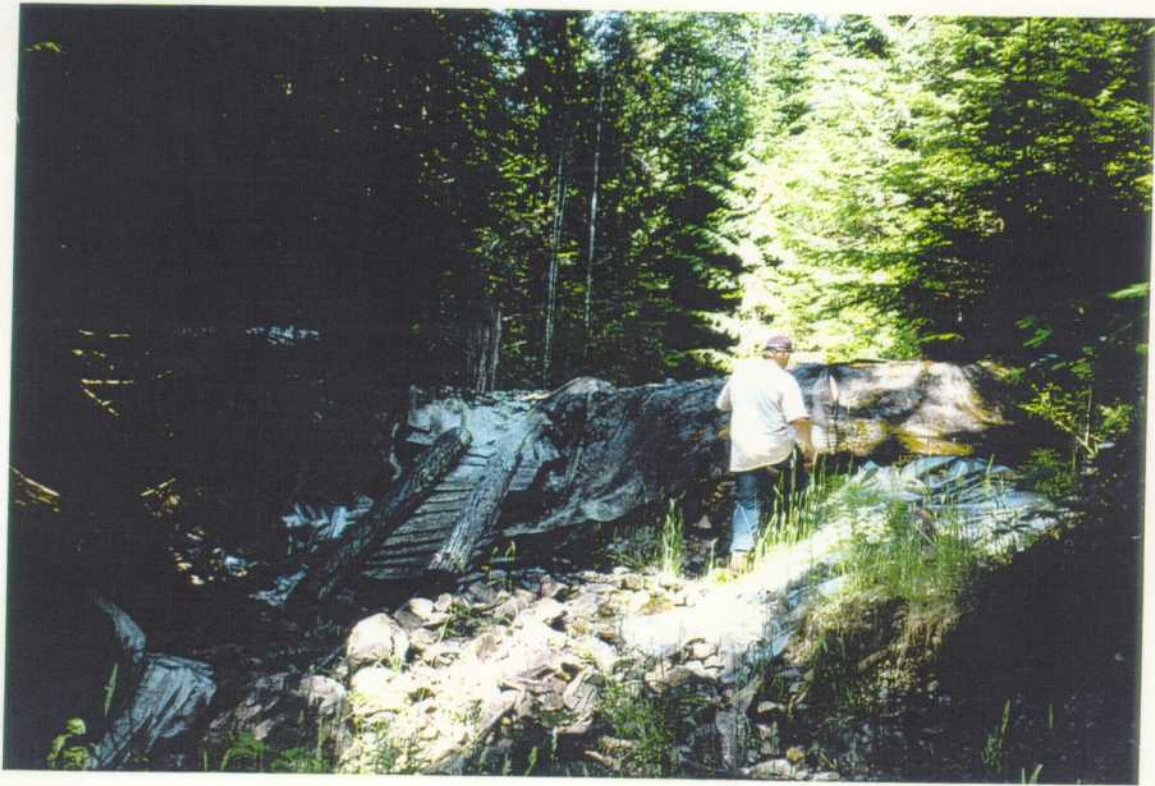
Channel disturbance on upstream sections of Halley Creek (Reach 1-3) was observed. There is evidence of washout originating from an unauthorized water detention pond (see Photo 3). Diversion of the stream channel onto a constructed road/trail has caused extensive surface erosion along road cutslopes and along the road itself. However, the extent of the disturbance is limited to a short (approx. 100 m) section above a gently sloped wetland area that is not known to be fish-bearing. The Halley Creek tributary also lies outside of the Cranby Lake watershed, the location of the community water supply intake.

Photo 3 – Washed out water diversion structure on Halley Creek (June, 2000)

- as noted by the terrain mapping report, with the presence of extensive limestone deposits on Texada Island, there is the potential for the existence and development of karst and cave features (sinkholes, caves and underground drainage) that may pose safety risks and other problems during forest development. Underground cavities and channels may transport sediment directly into creeks. It is recommended that, if any karst or cave features be identified during construction, the extent of any sinkholes and potential road building and safety concerns be assessed.
- should development occur in the upper Halley Creek tributary basin, an abandoned water retention structure and washed out section of road should be rehabilitated.

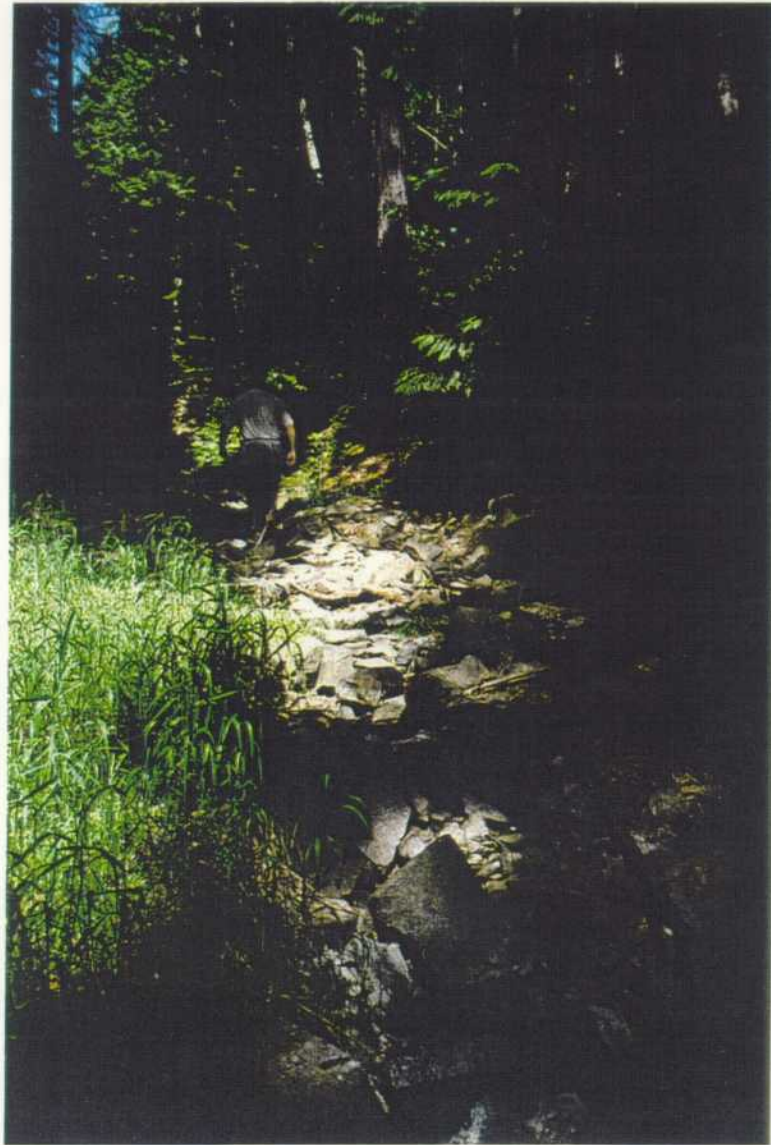
Photo 4 – Halley Creek, washed out section of road downstream from water diversion structure (June, 2000)
