FINAL REPORT

**UPPER BONAPARTE RIVER
WATERSHED – CHANNEL, RIPARIAN
AND SEDIMENT SOURCE
ASSESSMENT**

VOLUME 1: TEXT AND APPENDICES

Project #754

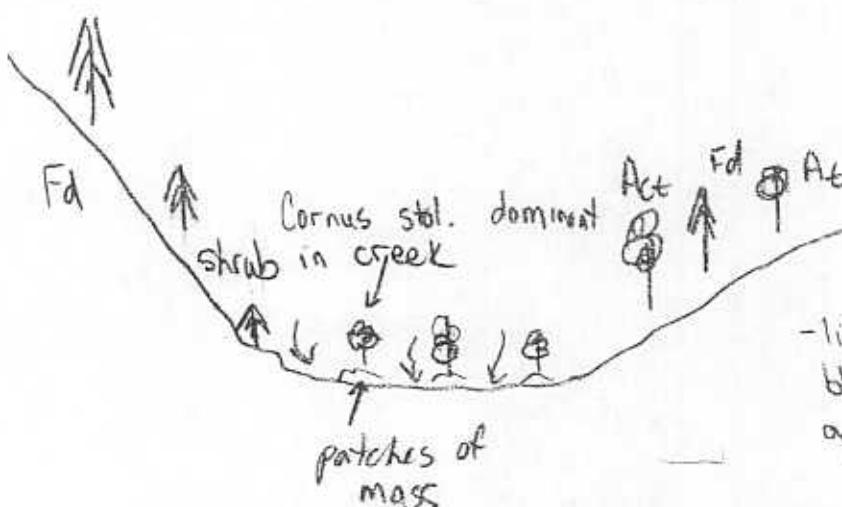
- gravel is fine
- bank% approx.
- no exposed banks
- banks essentially topsoil

-likely als of site
blocked creating
degrading environment

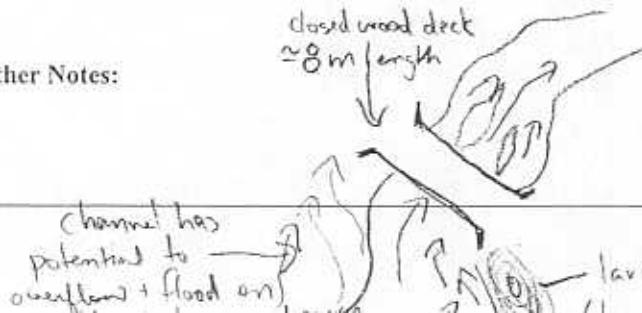
- Note: Sourcing has caused gradient to decrease - probably heavy log jams d/s - H sensitivity here - good found for CCPA
- ie. remove SWD + clean debris off of here.

- fire in past possibly creates source for SWD.

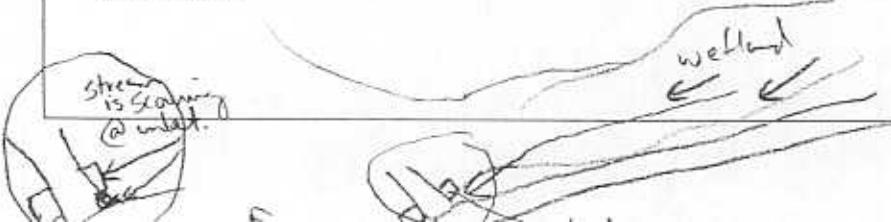
- currently the channel is beginning to degrade the road and around the culvert (see diagram). Simple fix - cheap. Hwy return.
- minimal excavation of the road to properly place rock.

- Bank material is fines with some angular cobble + gravel from the road

- Bank material is 70% fines 30% gravel + cobble.
