# **KETTLE RIVER RAINBOW TROUT ASSESSMENT AND HABITAT RESTORATION 2008**

Greg Andrusak, BSc., R.P.Bio.  
*Redfish Consulting Ltd.*  
Nelson, BC

December 2008

Prepared for the  
Ministry of Environment

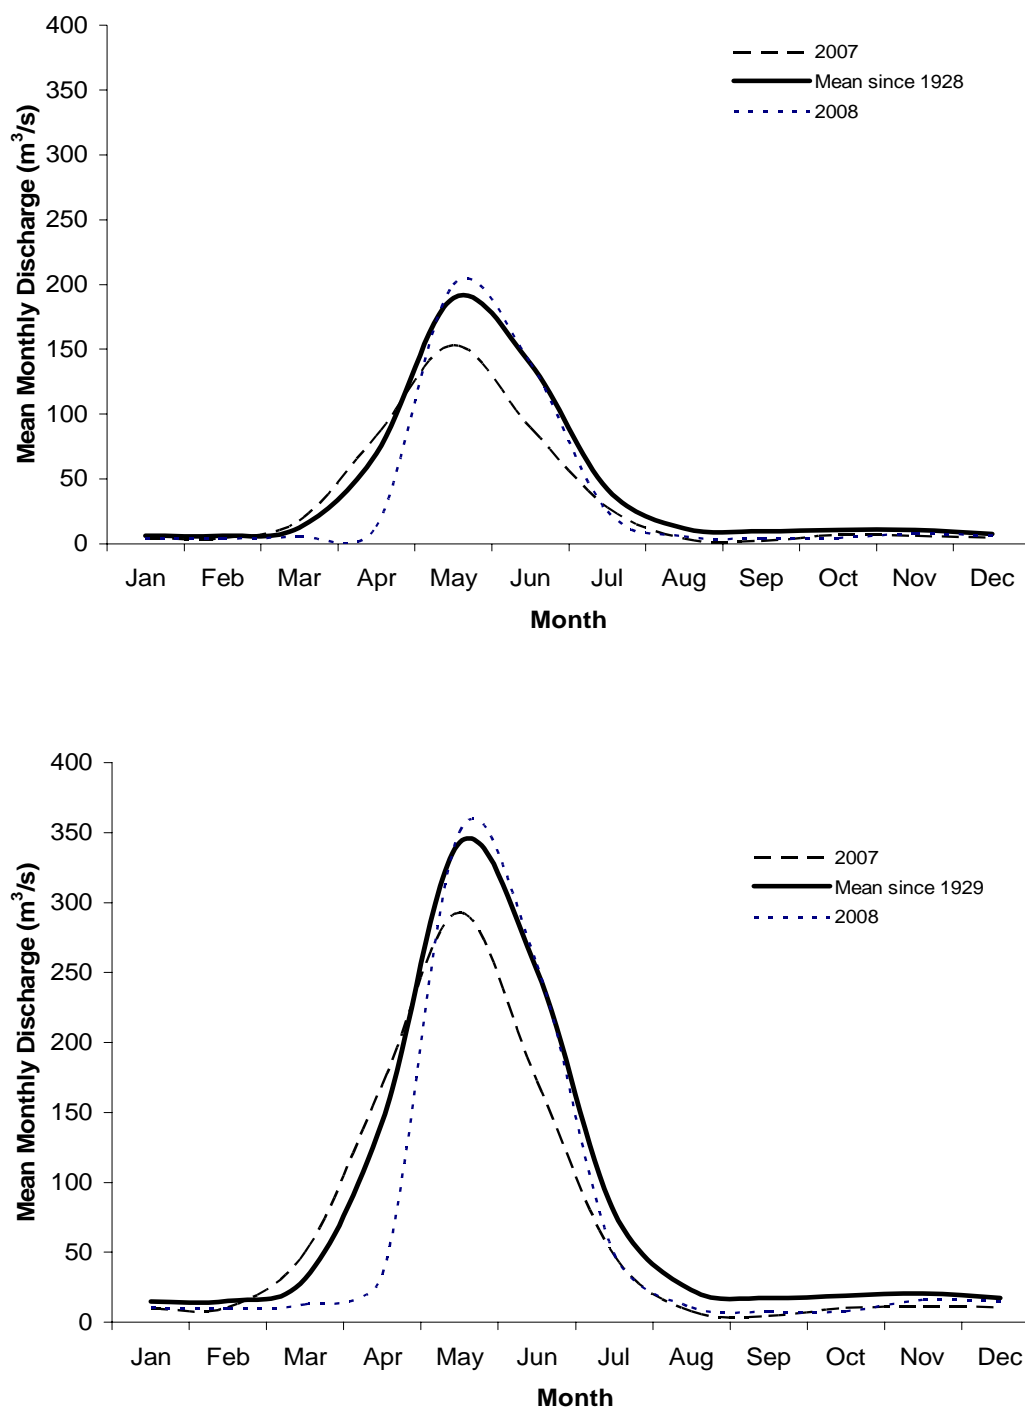
**Figure 3.** Mean monthly discharge ( $\text{m}^3/\text{s}$ ) for 2007 and 2008 for Ferry (upper) and Laurier (lower), WA, recorded since 1928-29. The Ferry station represents flows in the upper Kettle River near Midway BC, while Laurier represents flows in the lower portion of the river near Grand Forks BC.

Monthly flow data from the USGS Water Resources survey stations at Ferry and Laurier, WA indicated that Kettle River peak flows occurred in late May to early June, 2008, well above levels observed in 2007 (Figs. 3). However, mean monthly summer flows in 2008 (July-October), starting in July, were well below the mean value for 79 years of data collected at both stations, similar to 2007 (Fig. 4). The 2008 summer flows were well below the normal flow regime; slightly above the 20% percentile of for both the middle and lower Kettle River.

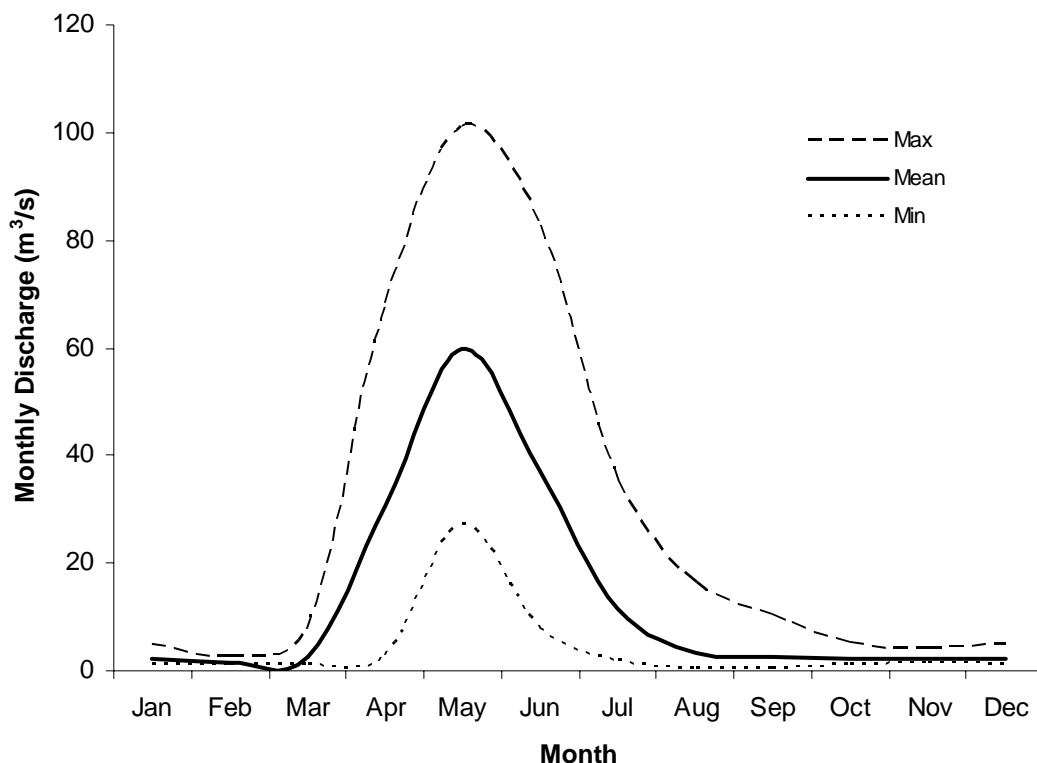
**Figure 5.** Mean, maximum and minimum monthly discharge ( $\text{m}^3/\text{s}$ ) for the West Kettle River at Westbridge BC, recorded since 1914 to 2006.

Although not current, monthly flow data recorded from 1914 to 2006 on the West Kettle River provides some insight into an average flow year and the range of variability. Similar to the Kettle River, historic (1914-2006) monthly flow data from the Environment Canada water survey stations at Westbridge, BC illustrates that the West Kettle River typically peaks during a period between May to June (Fig. 5). Importantly, the historical discharge recorded on the West Kettle River indicates an annual mean of  $\sim 14 \text{ m}^3/\text{s}$ , almost 3 times less than the upper Kettle River.

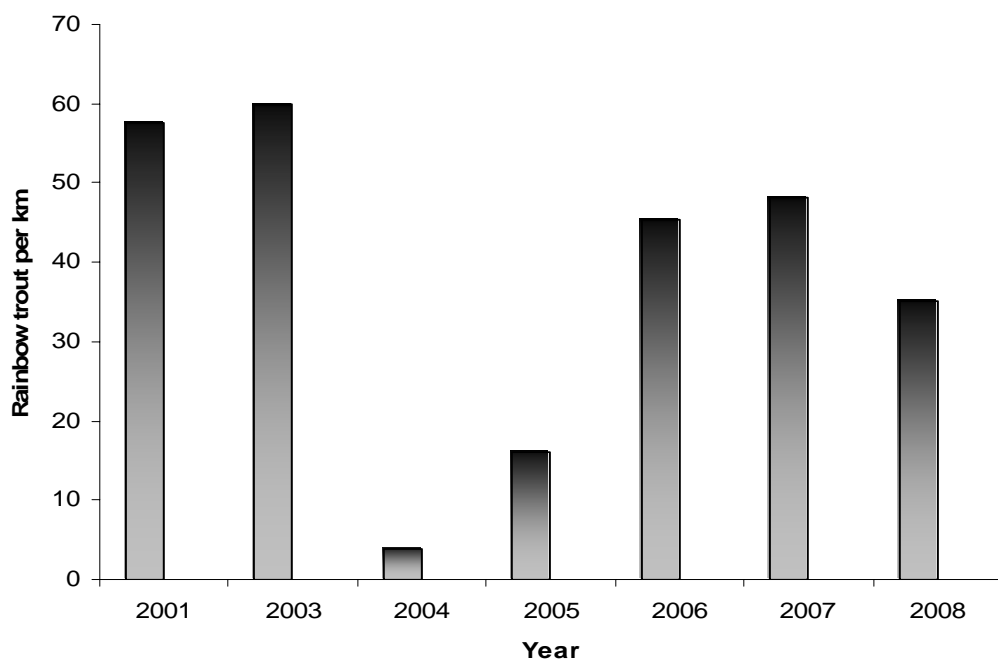
**Figure 6.** Mean rainbow trout per kilometre for mainstem Kettle River sites (KR1-KR8) from 2001 to 2008.

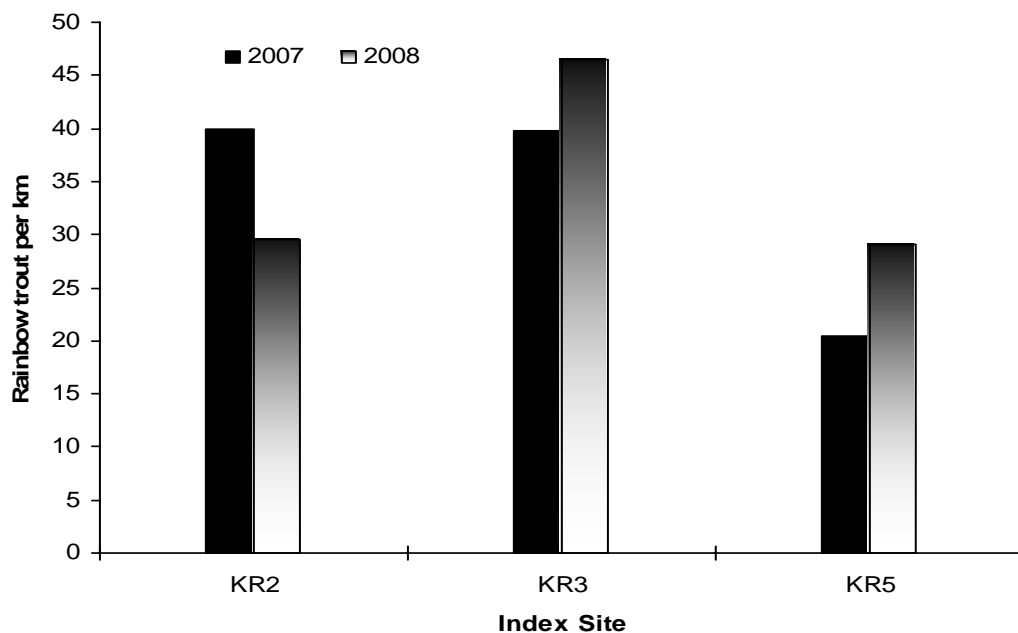
**Figure 7.** Mean rainbow trout per kilometre at index sites under the catch and release (KR2), catch and harvest (KR3) regulations and restoration initiatives (KR5) from 2007-2008.

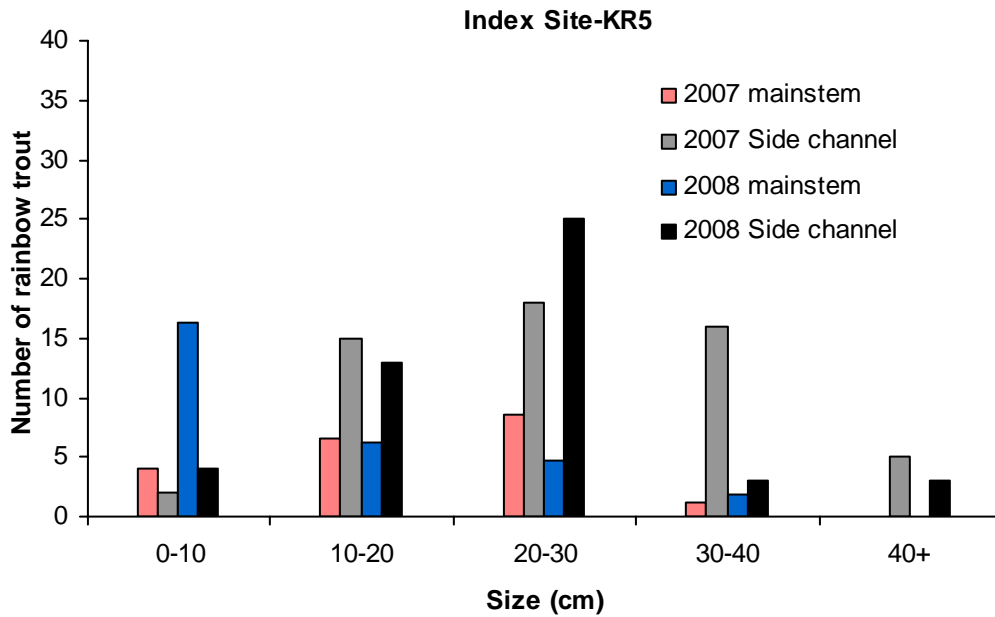
**Figure 9.** Rainbow trout abundance from 2007 to 2008 in the restoration site (KR5), including a sub-site that contains a 600 m highly complex side channel

At the restoration site (KR5), densities in the mainstem river section increased from 20 trout per km in 2007 to 29 trout per km in 2008 (Fig. 9; Table 1). However, these densities were relatively low compared to other mainstem sites on the Kettle River. As well, the ~600 m site side channel within KR5 was comprised of highly complex habitat (LWD and deep pool) also indicated a slight decline in 2008 compared to 2007. Although there was an overall decline in numbers in the side channel, densities were ~2.5 times higher than its mainstem counterpart in 2008 (Table 1). The 2008 survey conducted at KR5 provides the necessary background data on fish abundances prior to installation of habitat structures.

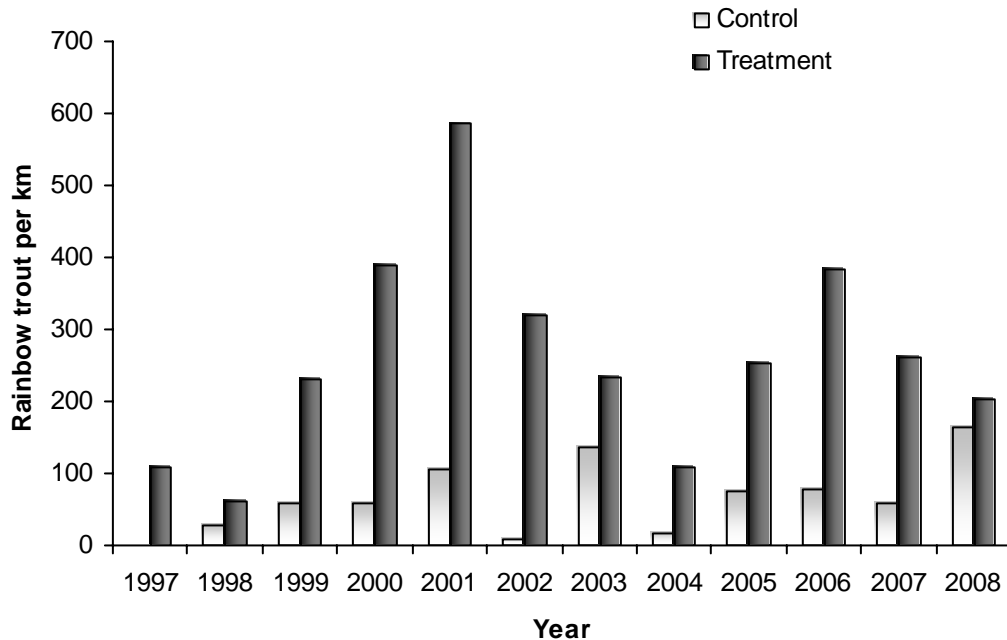
**Figure 10.** Rainbow trout per km in response to in-stream restoration (treatment section) on the West Kettle River, 1997 to 2008.

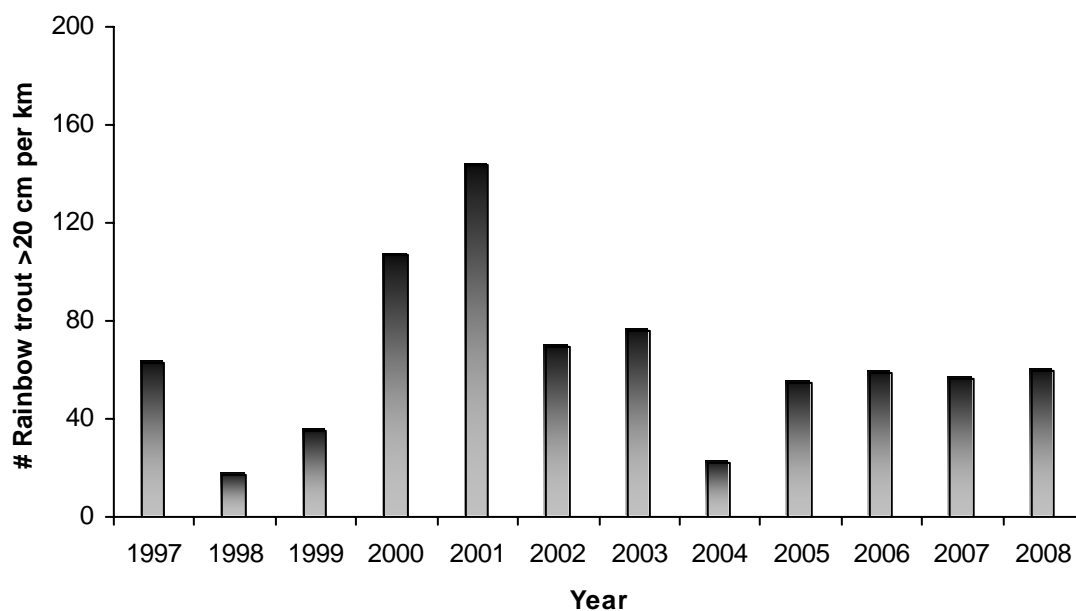
**Figure 11.** Catchable (> 20 cm) rainbow trout per km in response to in-stream restoration (treatment section) on the West Kettle River, 1997 to 2008.

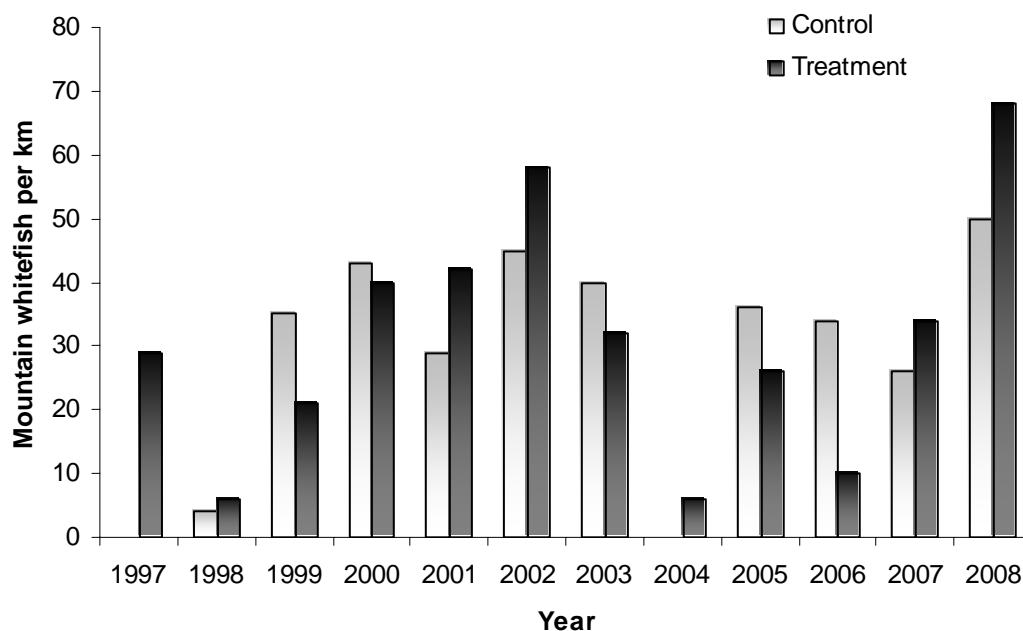
**Figure 12.** Whitefish per km in response to in-stream restoration (treatment section) on the West Kettle River, 1997 to 2008.

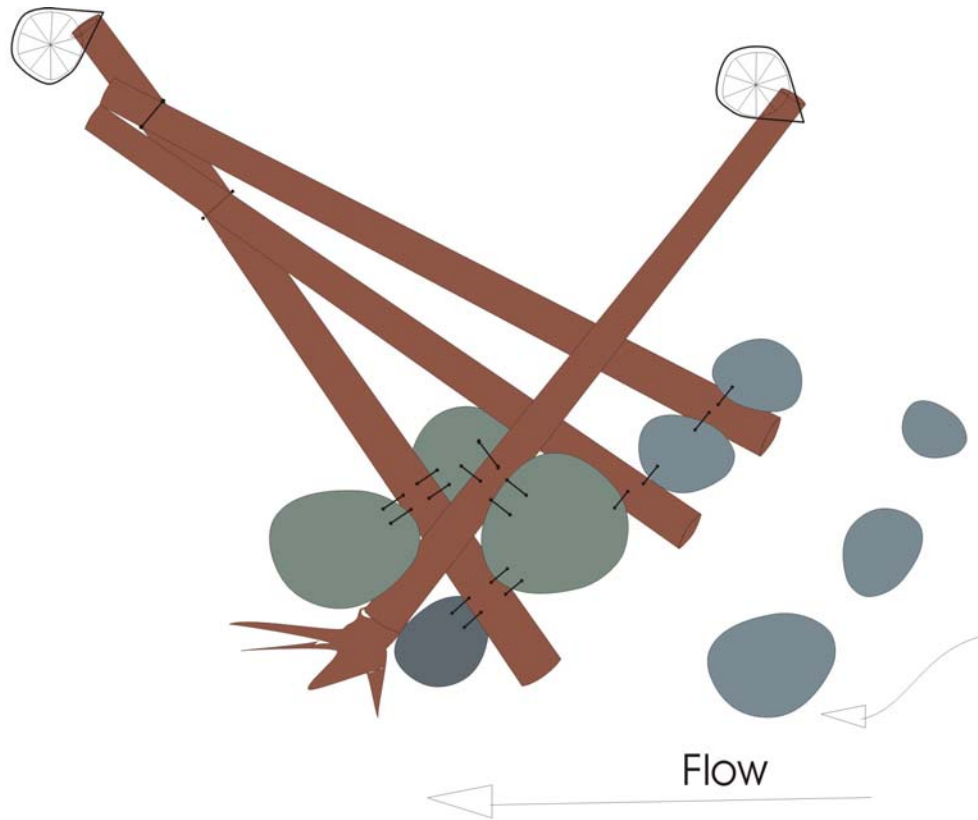
**Notes: Fish Habitat Structure Modifications for Navigable Waters:**

1. Large wood habitat structures are secured close to the streambank to ensure adequate thalweg water for navigation;
2. Frontal upstream facing logs are installed without rootwads;
3. Rear log with rootwad has upper roots cut off; 1-2 rootwads are alternatively positioned inside the structure (as shown) near shore to provide fish over-wintering refuge habitat;
4. 3-4 large boulders are set as a deflector cluster directly upstream of the large wood habitat structure; these also provide juvenile salmonid rearing habitat;
5. Boulder ballasting cables are very short, pass through the logs surfaces, and are set to ensure no hazard to navigation;
6. Ballasting at 1.5-2 times log buoyancy ensures no movement of large wood at low and high flows;
7. Signage is provided to advise water navigators of log structures.

**Figure 13.** Navigable waters design concept: triangular ramp-log structure designed to restore trout habitat and to trap driftwood and, if needed, to protect/stabilize stream banks. (Large buried ballast boulders are required at the top of the bank where riparian trees are likely small, or <30 cm in basal diameter.)

At each site, wood structures were ballasted with boulders using the epoxy attachment technique (Slaney and Zaldokas 1997 and Melville 1997). Boulders were drilled using  $\frac{9}{16}$  inch bits to accommodate  $\frac{1}{2}$  inch galvanized cable. Boulder ballasting requirements were calculated using methods provided by D'Aoust and Millar (2000).

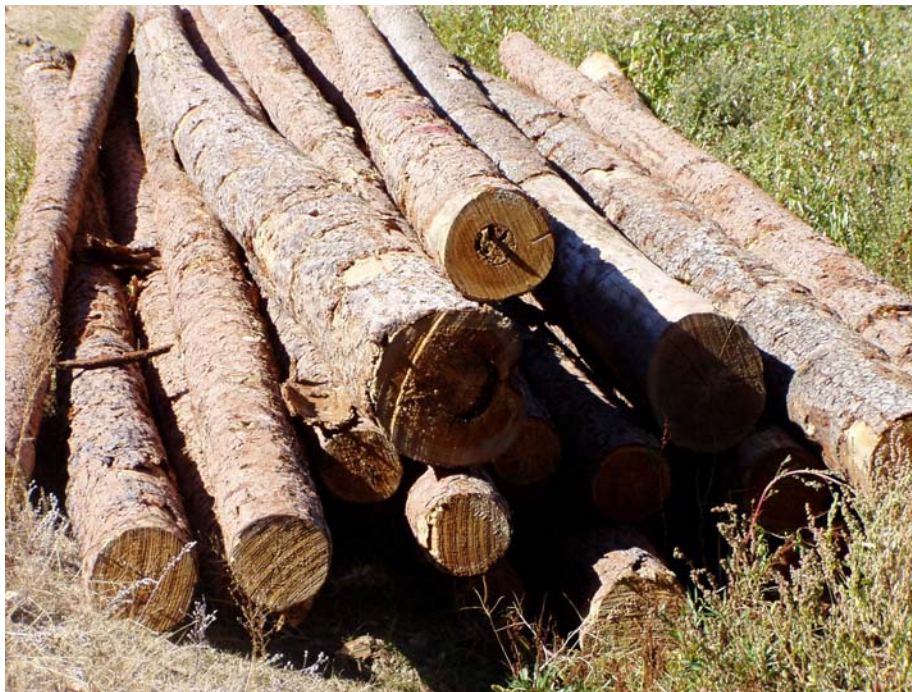
**Photo A 2.** Logs (15 m length x 0.5 m diameter) used in constructing triangular ramp-log structure on the Kettle River in 2008.

The 2008 project required a total of ~40 large logs, consisting of larch and fir, and ~100 large boulders to construct 9 LWD habitat structures. Of this total, the logs ranged from 14-15 m in length and from 0.5m -1.0m in diameter, which were delivered by Pope and Talbot near Midway, BC. Boulders were delivered from a MoT quarry located ~80 km away from the construction site at Trapping Creek. Boulders ranged in size from 0.25m – 0.6 m in diameter.

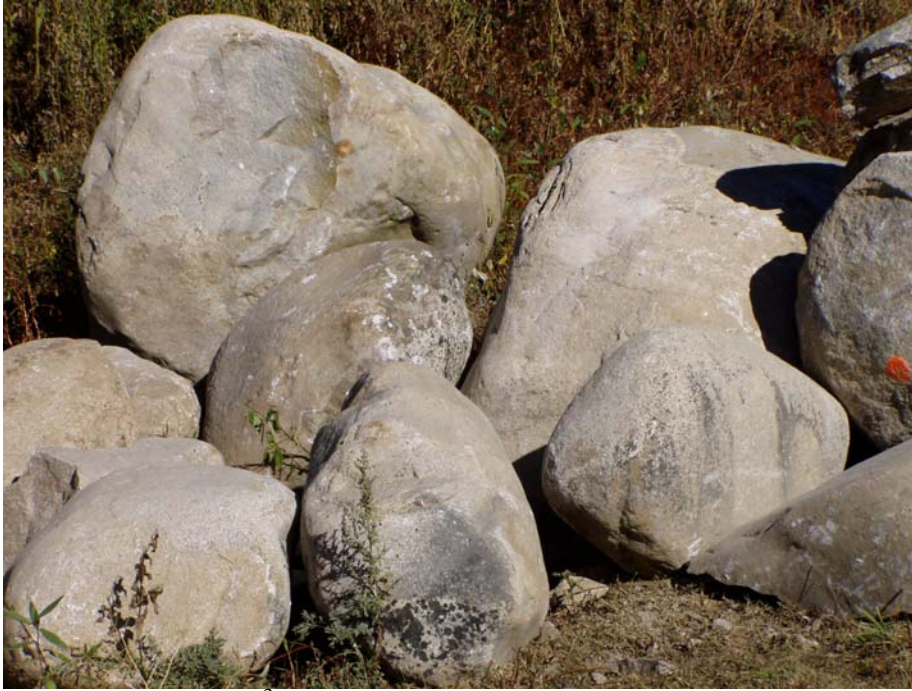
**Photo A 3.** Boulders ( $\sim 0.3 \text{ m}^3$  diameter) used in construction of triangular ramp-log structure on the Kettle River in 2008.

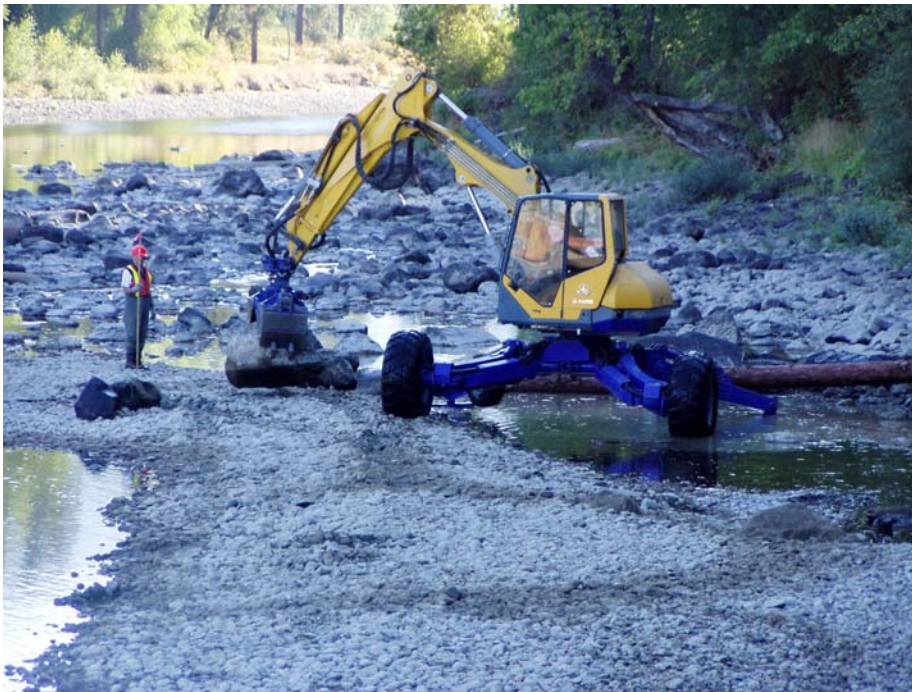
**Photo A 4.** Spyder-hoe excavator used in constructing triangular ramp-log structure on the Kettle River in 2008.

All instream machine work was conducted with “spyder” excavator (Cat E120B) that was serviced with biodegradable hydraulic oil. The barren flood plain also allowed easy access for the excavator to deliver boulders and large LWD directly to the restoration sites from the staging area. As well, a small excavator (Cat E120B) was used to load materials into 2 dump trucks at the MoT quarry near Trapping Creek.

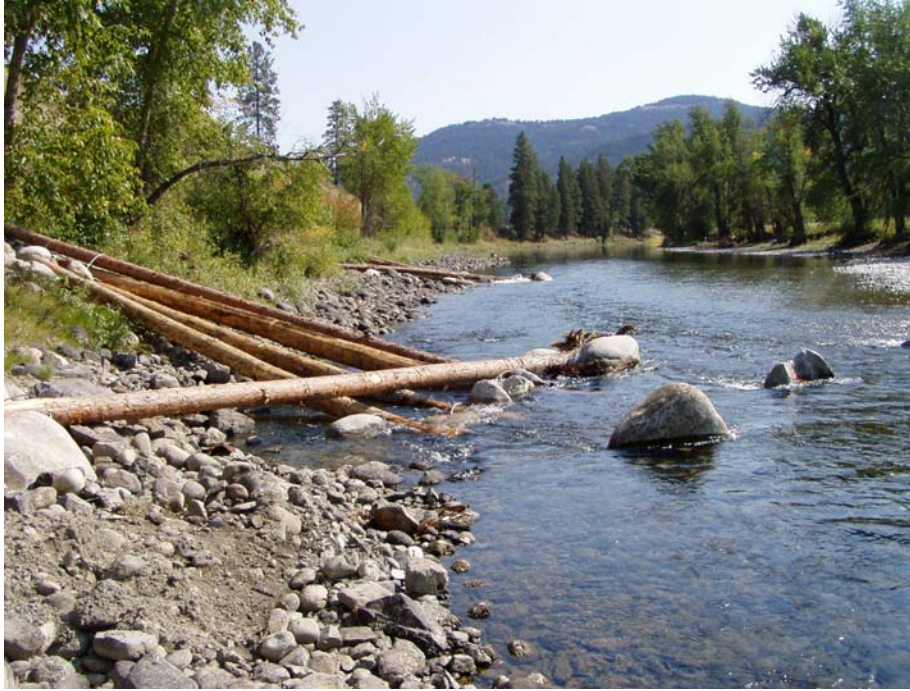
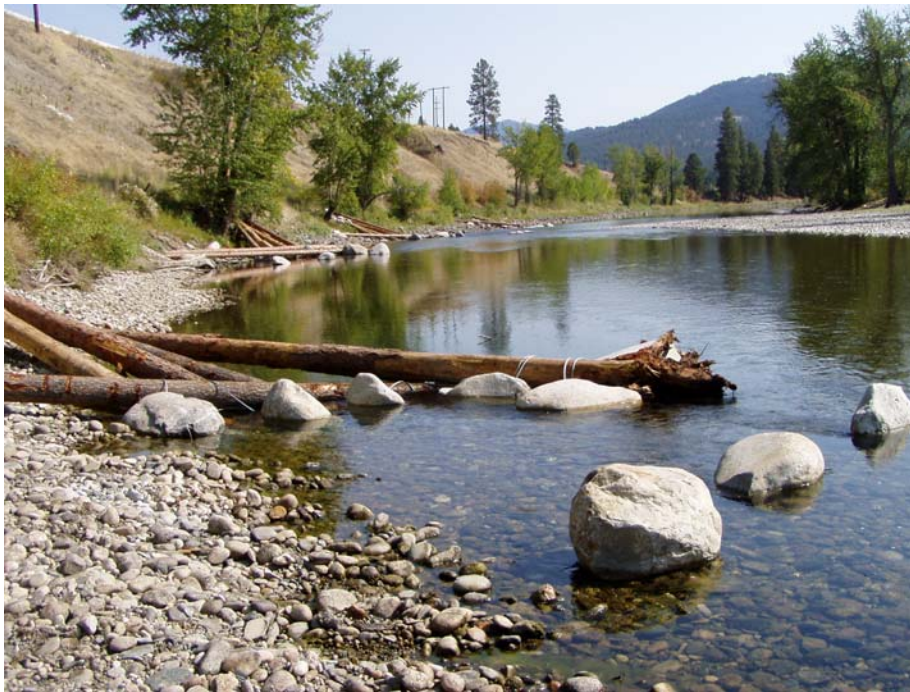
**Photo A 5.** Site after completion of habitat structure placement adjacent to John Bick property in 2008.

**Photo A 6.** Site after completion of habitat structure placement adjacent to John Bick property in 2008.
