Analysis of Sedimentation and Sediment Mitigation Strategies for Mission Creek

Prepared for:

City of Kelowna Environment Division
1435 Water Street
Kelowna, BC V1Y 1J4

March 2009

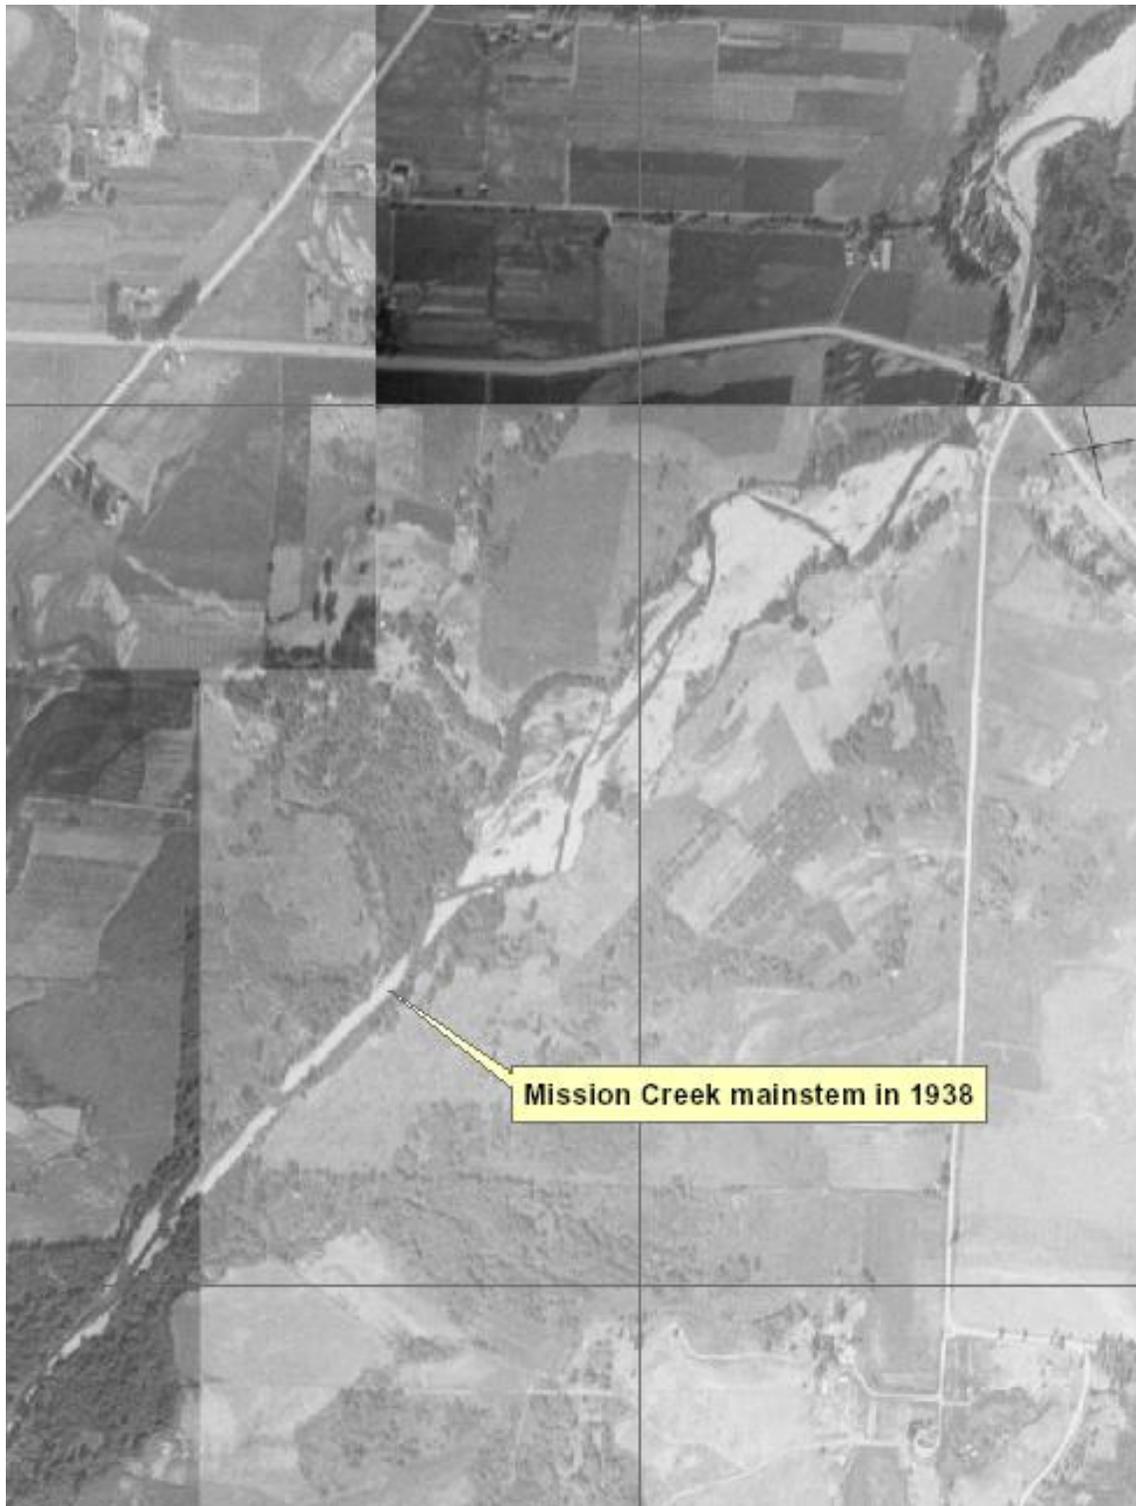
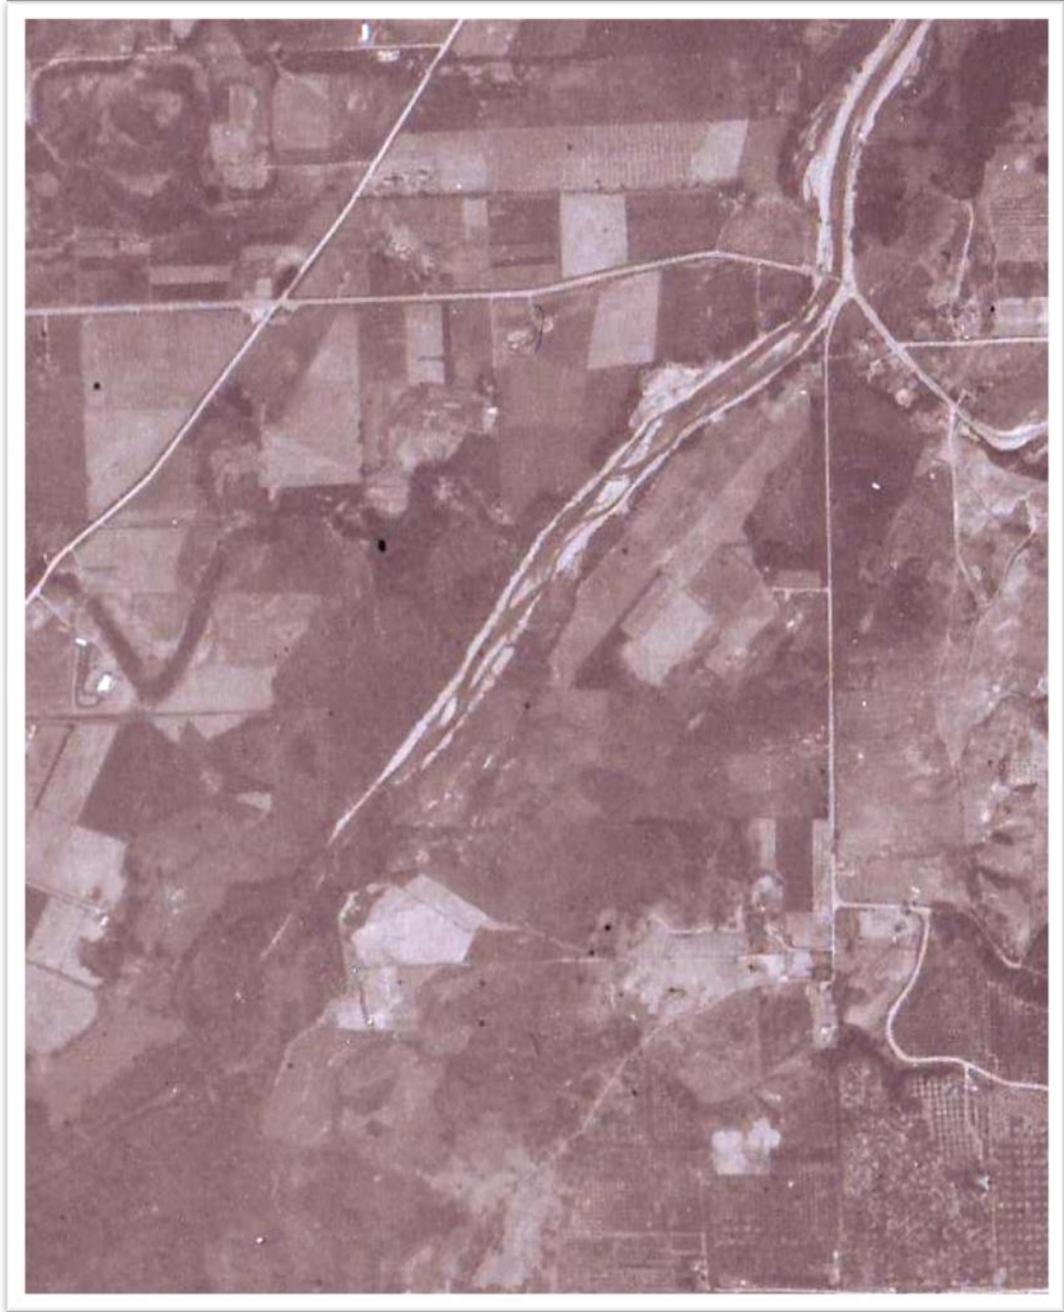
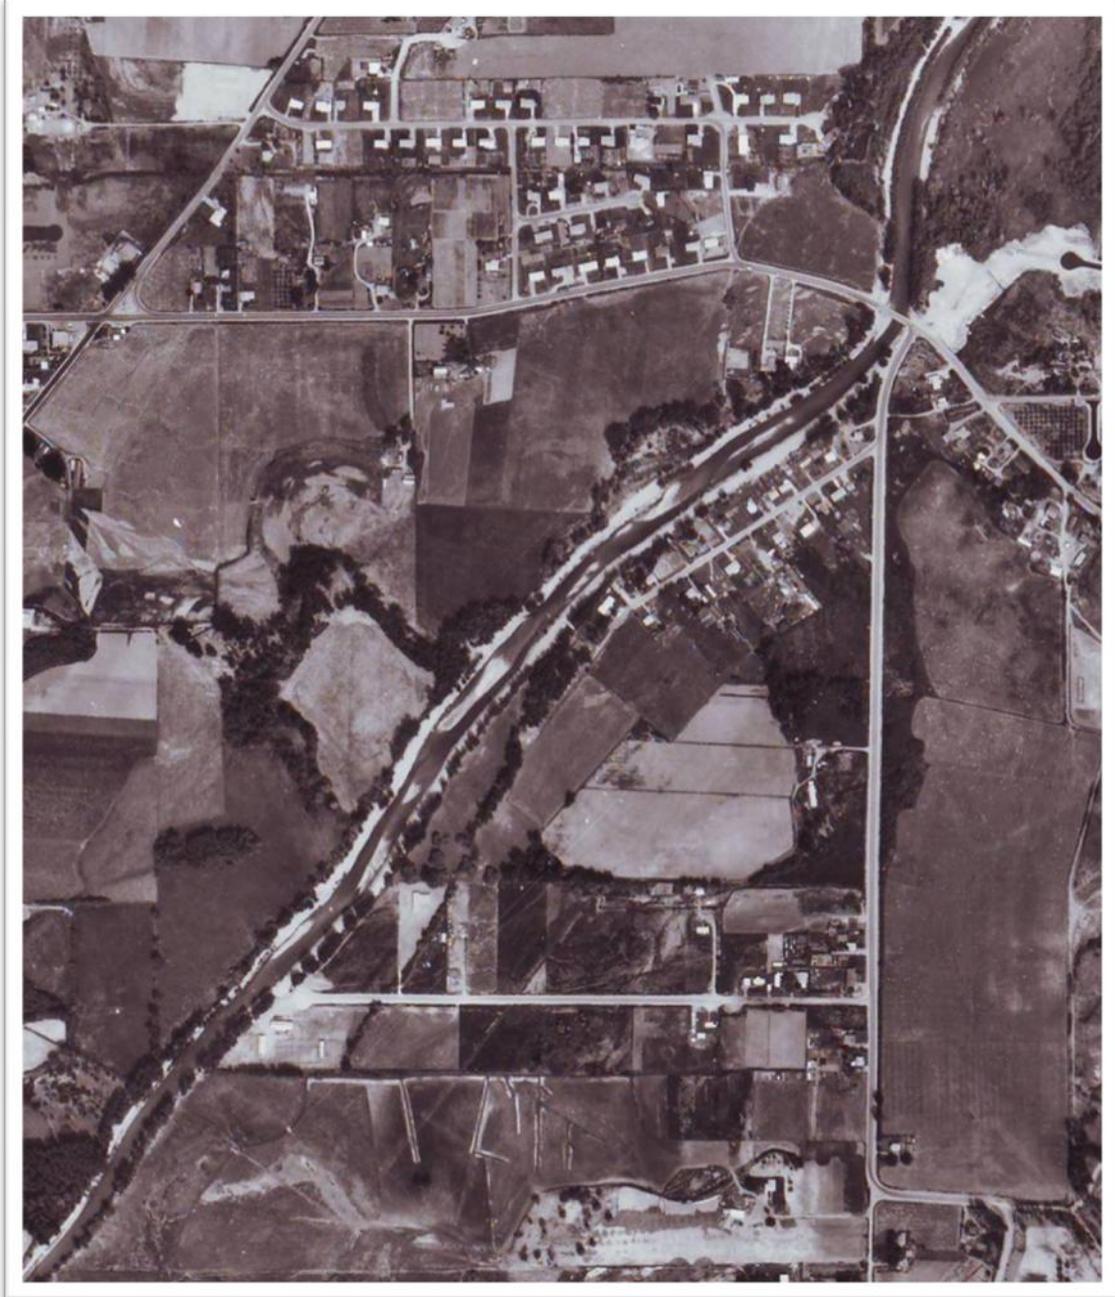
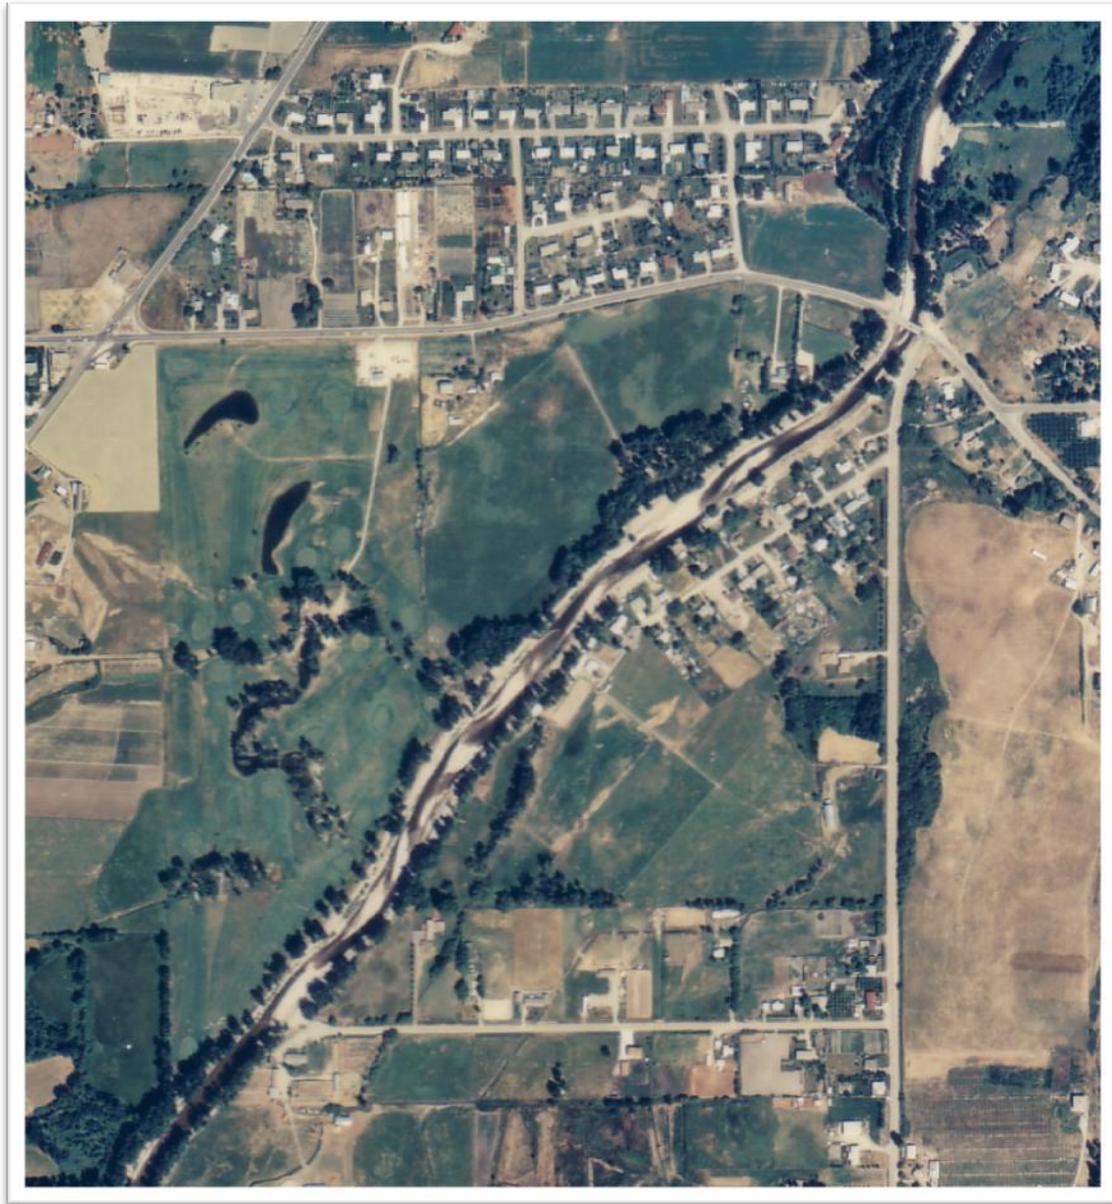
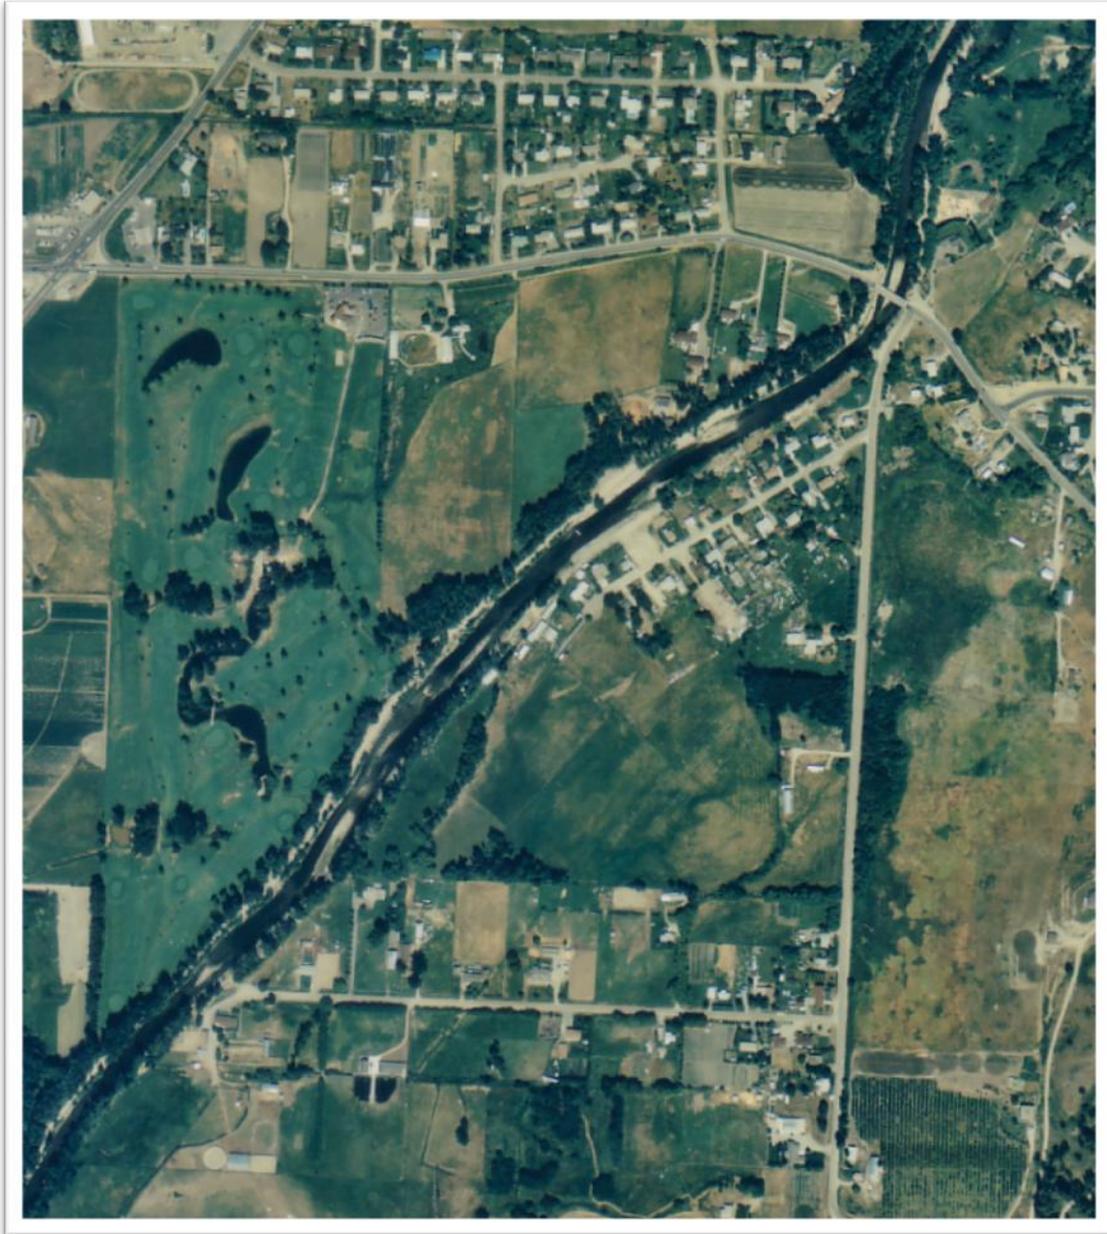
Figure 2-6. Aerial photographs of reaches number 14 and 15 for (A) 1938, (B) 1951, (C) 1963, (D) 1973, (E) 1986, (F) 1996, and (G) 2006.

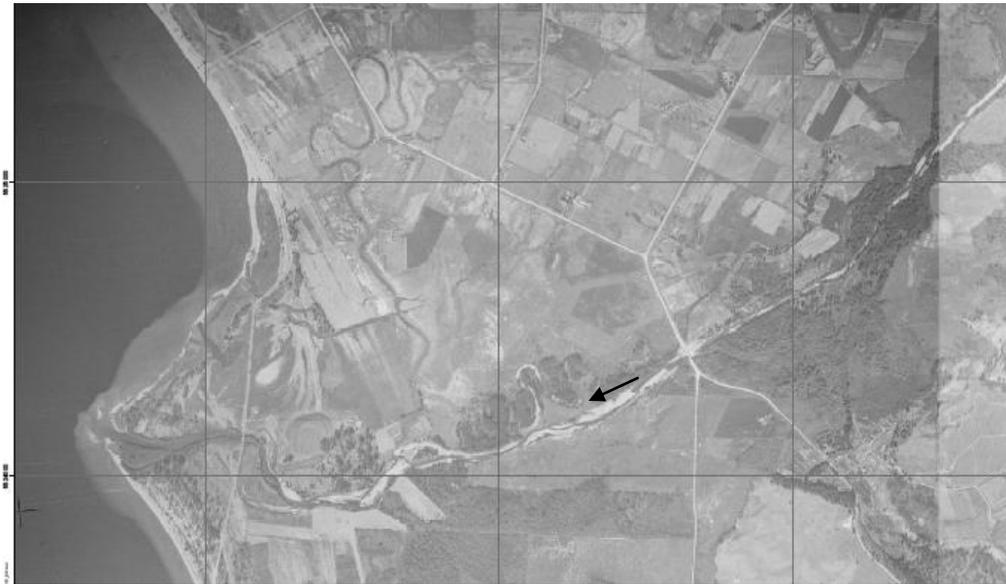
Figure 2-7. 1938 Mission Creek channel displaying the abandoned channels on the floodplain near KLO road. Arrows indicated flow direction.

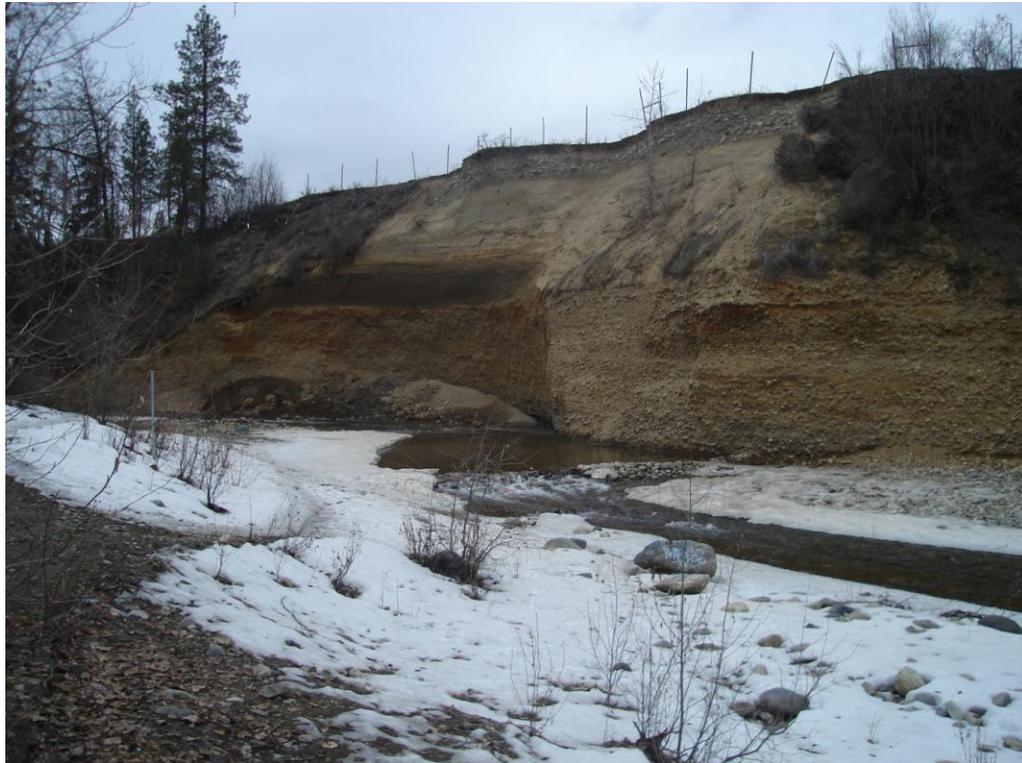
A.

Figure 5-1. Erosion sites in Mission Creek. (A) Erosion site in reach 5. (B and C) Erosion sites occurring in reach 6.

during the restoration of Mission Creek. One such site occurs in reach 5 (Figure 5-1A) and two additional sites occur within reach 6 (Figure 5-1BC). It should be noted that these sites are not the cause of the sedimentation downstream. However, decreasing the amount of sediment input should decrease the sedimentation a proportional amount. Note that decreasing the input of sediment could exacerbate vertical down-cutting if it is occurring. Recall that down-cutting occurs when the sediment discharge in is less than the sediment discharge out of a reach. Decreasing the sediment discharge in further in a degrading reach will cause increased down-cutting.

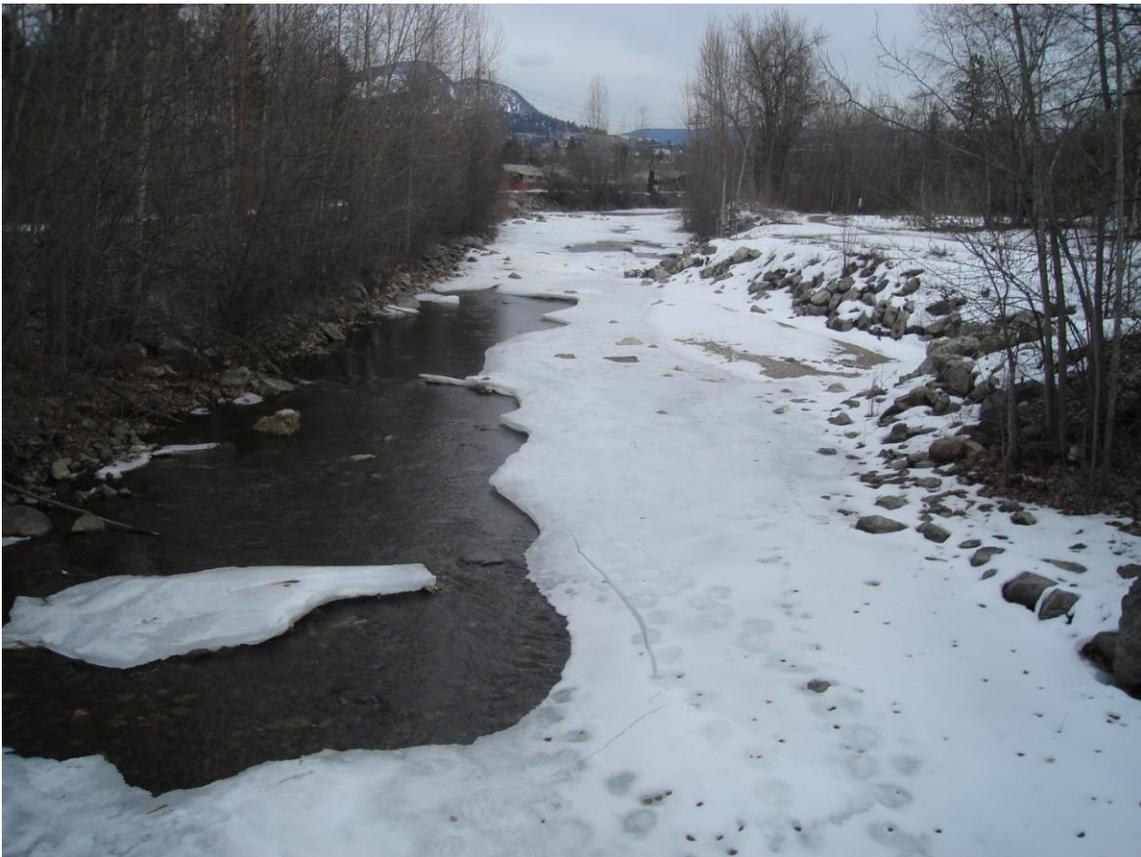
Figure 5-2. Mission Creek channel looking upstream at the demonstration riffle.

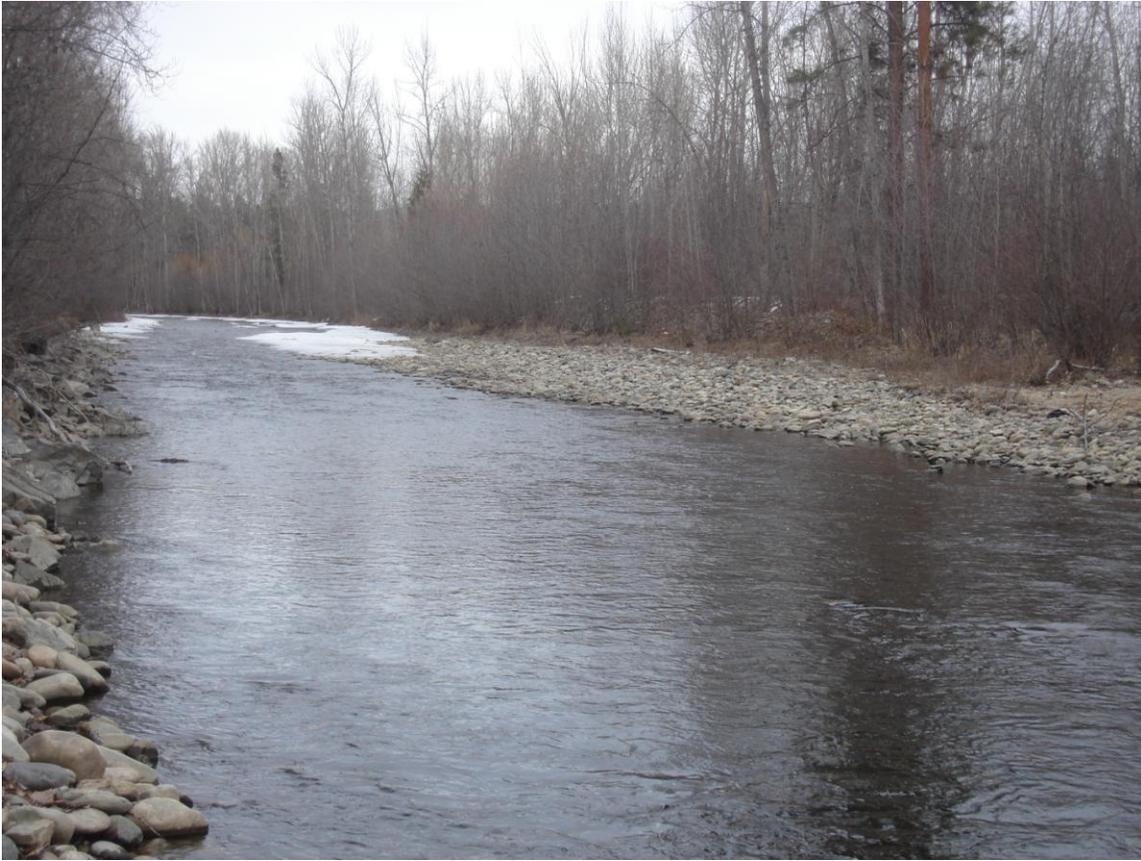
Figure 5-3. Mission Creek channel looking upstream in reach 13.

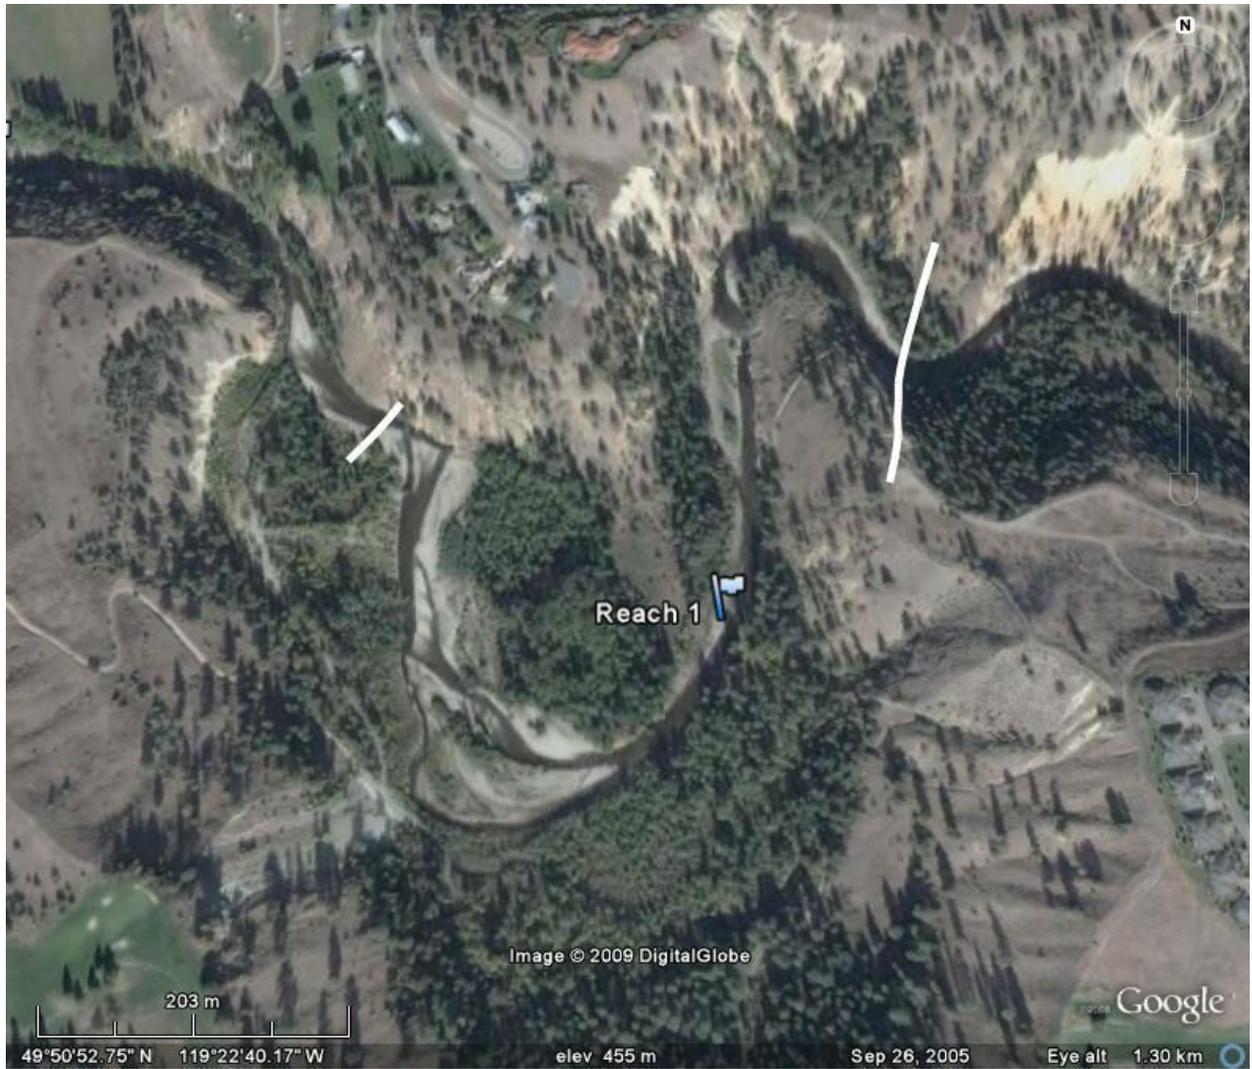
Reach #	1	<i>Length (m)</i>	1044.7
<i>Start (m)</i>	0	<i>End (m)</i>	1044.7
<i>Reach type</i>	Wandering	<i>Avg. width (m)</i>	36.3
<i>Slope (m/m)</i>	0.0144	<i>Avg. depth (m)</i>	0.67
<i>D16 (mm)</i>	67	<i>Width/Depth</i>	54.5
<i>D50 (mm)</i>	137	<i>Avg. R</i>	0.67
<i>D84 (mm)</i>	239	<i>Avg. Velocity (m/s)</i>	2.52
<i>Avg. % Sand (<2mm)</i>	0	<i>Shear stress (Pa)</i>	94.2
<i>Avg. % Gravel (2-62mm)</i>	15	<i>Mobility Ratio</i>	0.69
<i>Avg % Cobbles (64-128 mm)</i>	72	<i>Specific stream power (W/m²)</i>	198
<i>Avg. % Boulders (>128mm)</i>	13	<i>Avg. Fr</i>	0.99

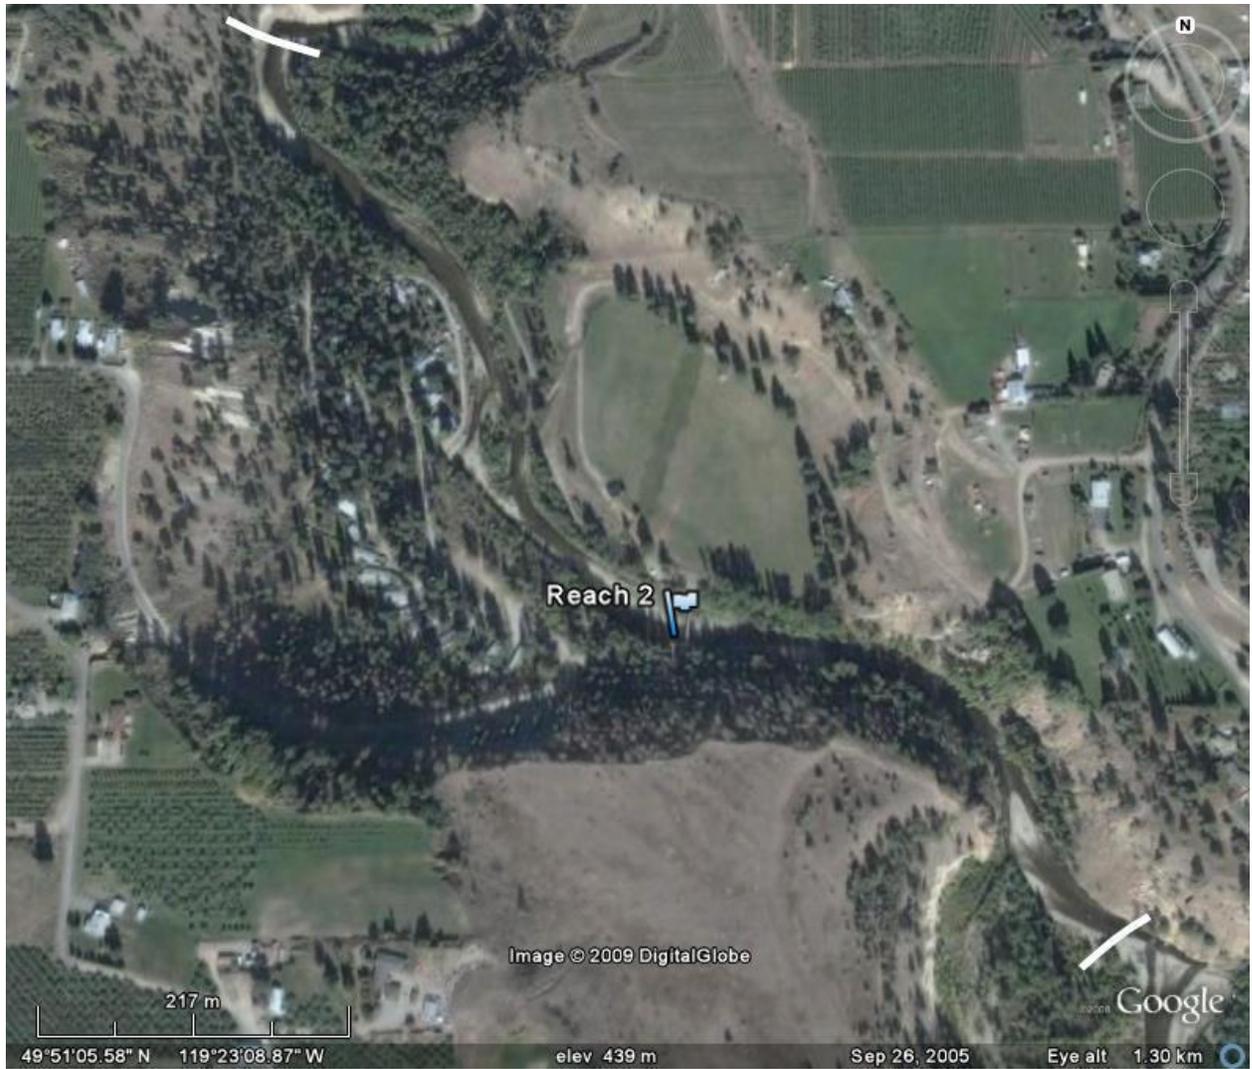
Reach #	2	Length (m)	1055.1
Start (m)	1044.7	End (m)	2099.8
Reach type	Wandering	Avg. width (m)	41.0
Slope (m/m)	0.0089	Avg. depth (m)	0.71
D16 (mm)	63	Width/Depth	58.0
D50 (mm)	115	Avg. R	0.72
D84 (mm)	195	Avg. Velocity (m/s)	1.86
Avg. % Sand (<2mm)	0	Shear stress (Pa)	62.5
Avg. % Gravel (2-62mm)	18	Mobility Ratio	0.54
Avg % Cobbles (64-128 mm)	76	Specific stream power (W/m²)	109
Avg. % Boulders (>128mm)	5	Avg. Fr	0.71

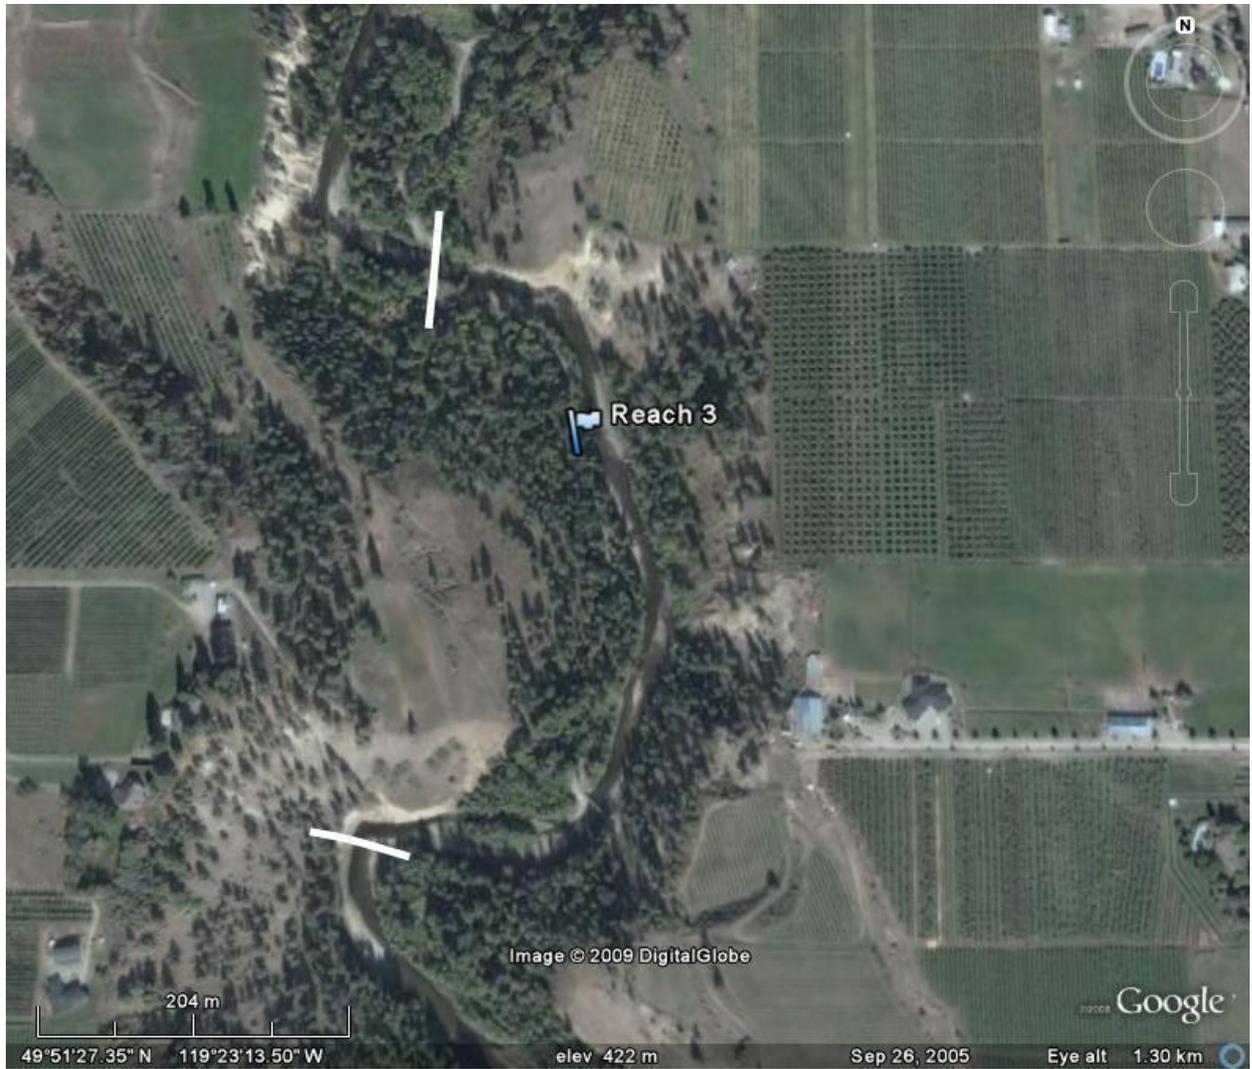
Reach #	3	Length (m)	764.6
Start (m)	2099.8	End (m)	2864.4
Reach type	Wandering	Avg. width (m)	30.5
Slope (m/m)	0.0094	Avg. depth (m)	0.87
D16 (mm)	58	Width/Depth	34.8
D50 (mm)	100	Avg. R	0.86
D84 (mm)	177	Avg. Velocity (m/s)	2.03
Avg. % Sand (<2mm)	0	Shear stress (Pa)	79.4
Avg. % Gravel (2-62mm)	22	Mobility Ratio	0.79
Avg % Cobbles (64-128 mm)	74	Specific stream power (W/m²)	154
Avg. % Boulders (>128mm)	4	Avg. Fr	0.69

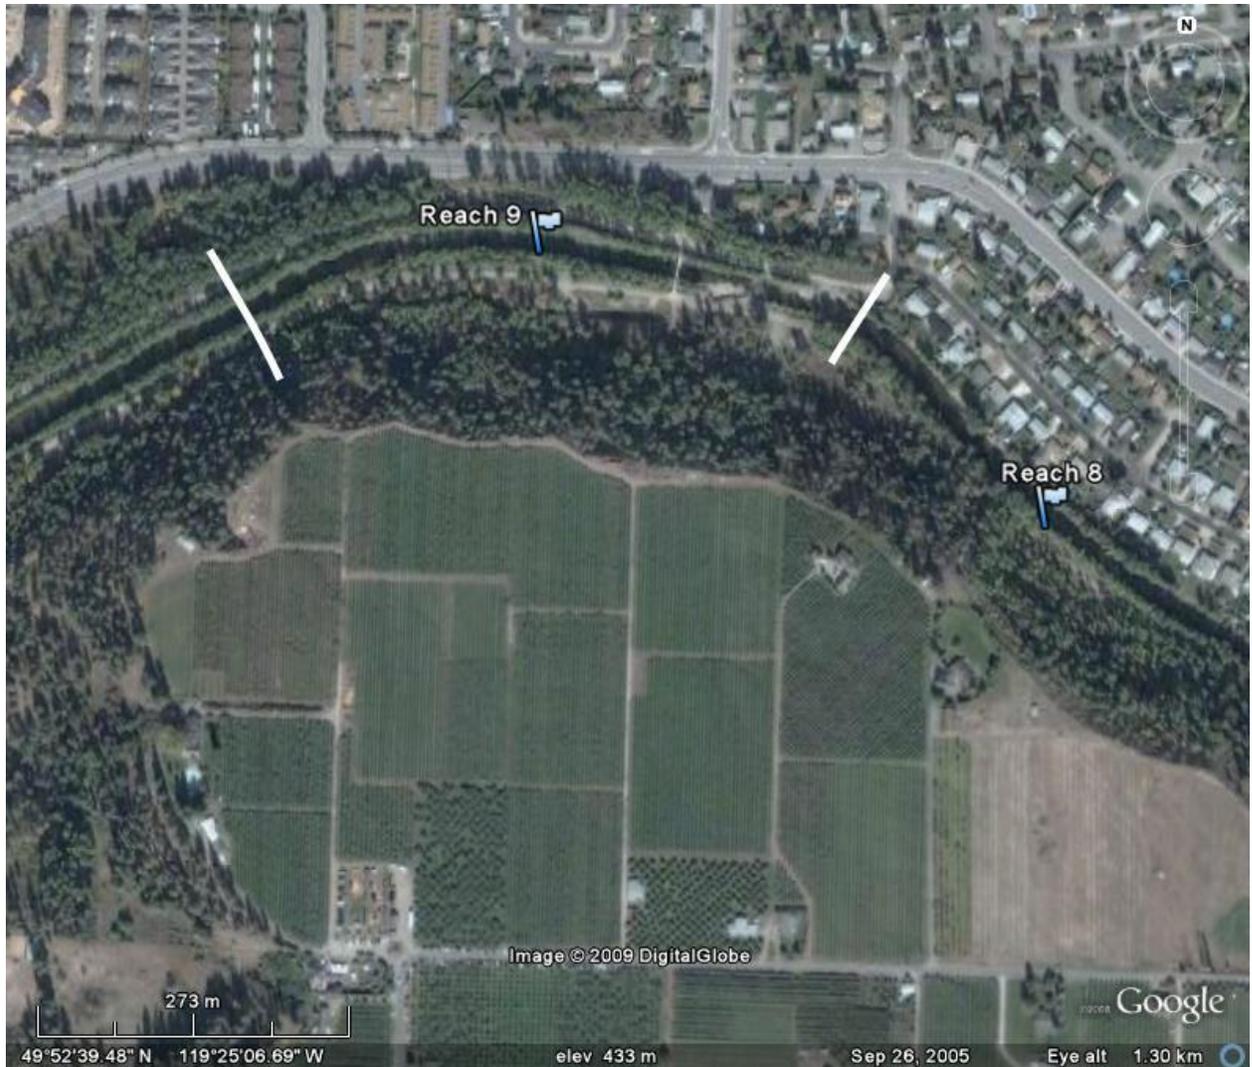
Reach #	9	Length (m)	562.5
Start (m)	6338.5	End (m)	6901
Reach type	Channelized/engineered riffle	Avg. width (m)	22.9
Slope (m/m)	0.011	Avg. depth (m)	0.60
D16 (mm)	37	Width/Depth	38.1
D50 (mm)	87	Avg. R	0.59
D84 (mm)	183	Avg. Velocity (m/s)	4.02
Avg. % Sand (<2mm)	2	Shear stress (Pa)	64.0
Avg. % Gravel (2-62mm)	34	Mobility Ratio	0.74
Avg % Cobbles (64-128 mm)	59	Specific stream power (W/m²)	240
Avg. % Boulders (>128mm)	7	Avg. Fr	1.66

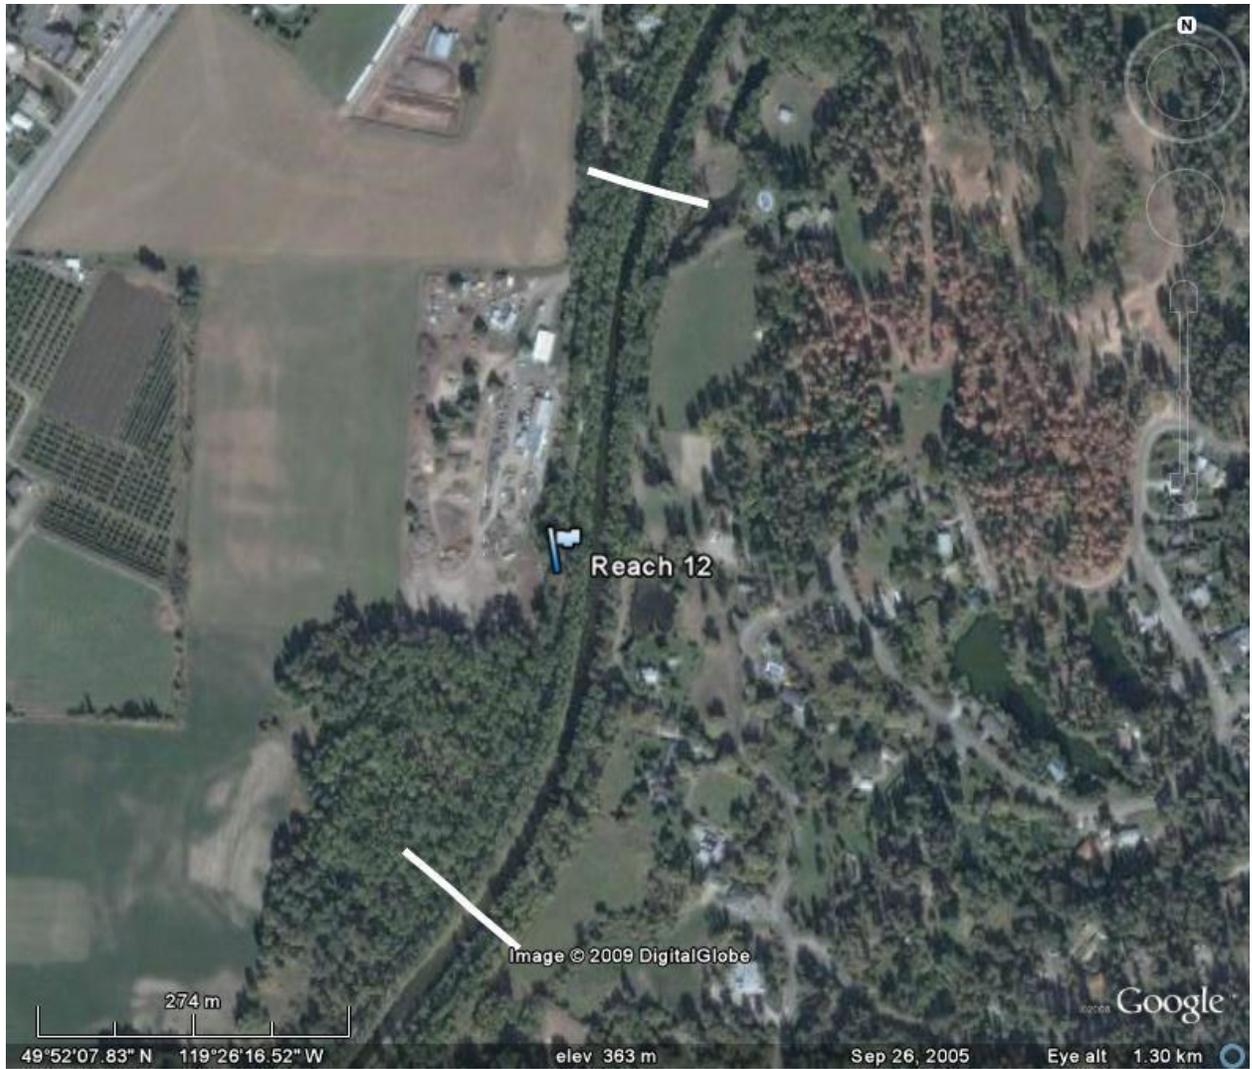
Reach #	12	<i>Length (m)</i>	681.9
<i>Start (m)</i>	8304.5	<i>End (m)</i>	8986.4
<i>Reach type</i>	Channelized	<i>Avg. width (m)</i>	23.5
<i>Slope (m/m)</i>	0.0068	<i>Avg. depth (m)</i>	0.94
<i>D16 (mm)</i>	37	<i>Width/Depth</i>	25.0
<i>D50 (mm)</i>	73	<i>Avg. R</i>	0.87
<i>D84 (mm)</i>	135	<i>Avg. Velocity (m/s)</i>	2.35
<i>Avg. % Sand (<2mm)</i>	0	<i>Shear stress (Pa)</i>	57.7
<i>Avg. % Gravel (2-62mm)</i>	45	<i>Mobility Ratio</i>	0.79
<i>Avg. % Cobbles (64-128 mm)</i>	54	<i>Specific stream power (W/m²)</i>	145
<i>Avg. % Boulders (>128mm)</i>	1	<i>Avg. Fr</i>	0.77

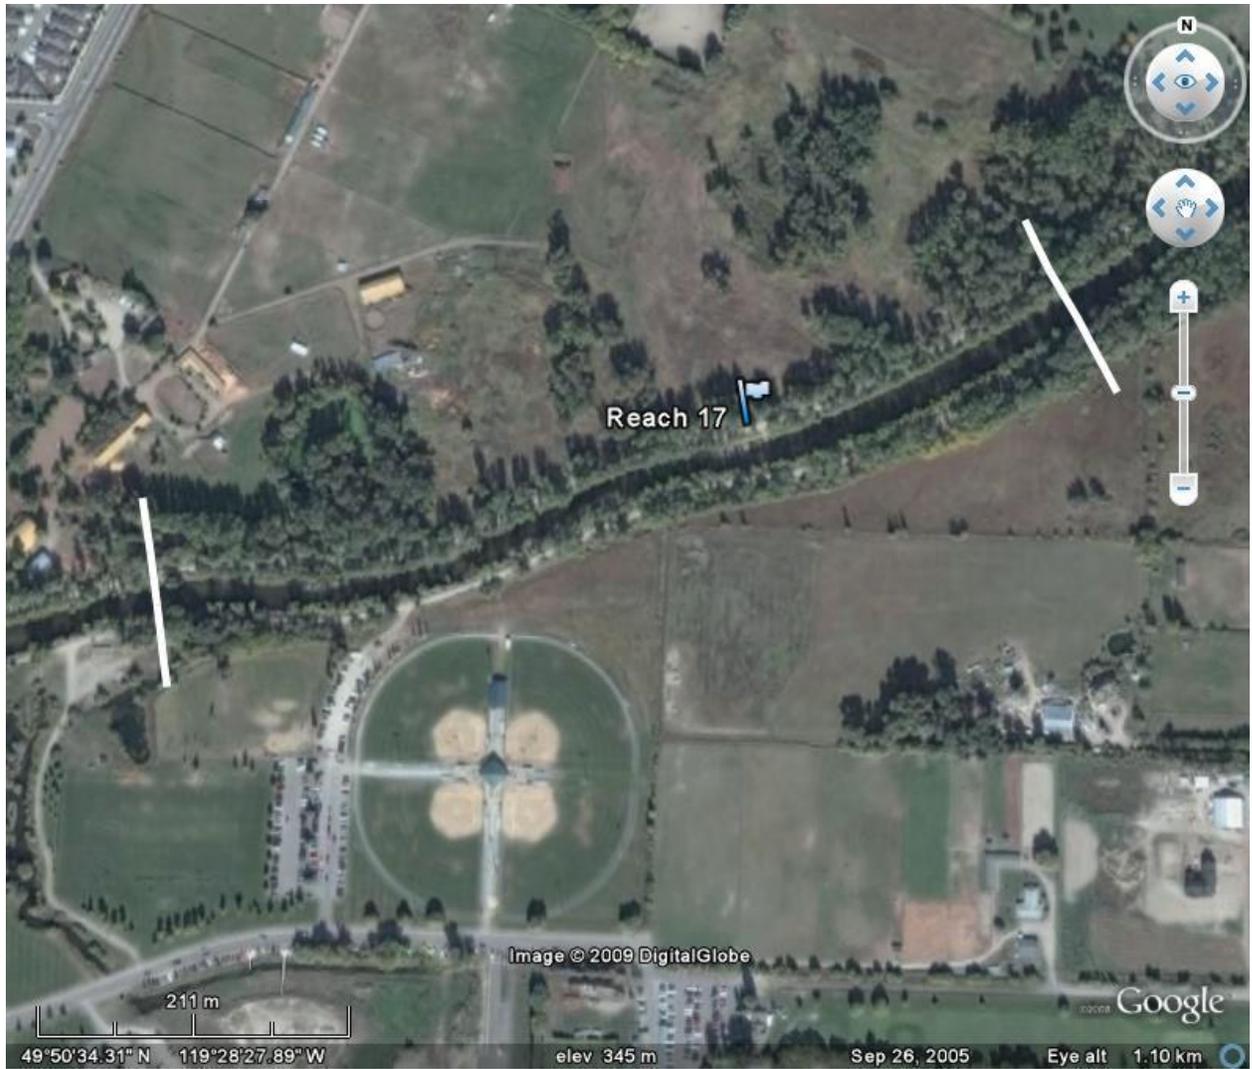
Reach #	17	<i>Length (m)</i>	968.7
<i>Start (m)</i>	12339.1	<i>End (m)</i>	13307.8
<i>Reach type</i>	Channelized	<i>Avg. width (m)</i>	23.2
<i>Slope (m/m)</i>	0.0024	<i>Avg. depth (m)</i>	1.16
<i>D16 (mm)</i>	30	<i>Width/Depth</i>	20.0
<i>D50 (mm)</i>	54	<i>Avg. R</i>	1.13
<i>D84 (mm)</i>	83	<i>Avg. Velocity (m/s)</i>	1.92
<i>Avg. % Sand (<2mm)</i>	5	<i>Shear stress (Pa)</i>	26.6
<i>Avg. % Gravel (2-62mm)</i>	58	<i>Mobility Ratio</i>	0.50
<i>Avg. % Cobbles (64-128 mm)</i>	37	<i>Specific stream power (W/m²)</i>	52
<i>Avg. % Boulders (>128mm)</i>	0	<i>Avg. Fr</i>	0.57
