Trout Creek Hydrological Risk Assessment

BC Ministry of Environment

**Grainger and Associates Consulting Ltd.
Salmon Arm, BC**

April, 2009

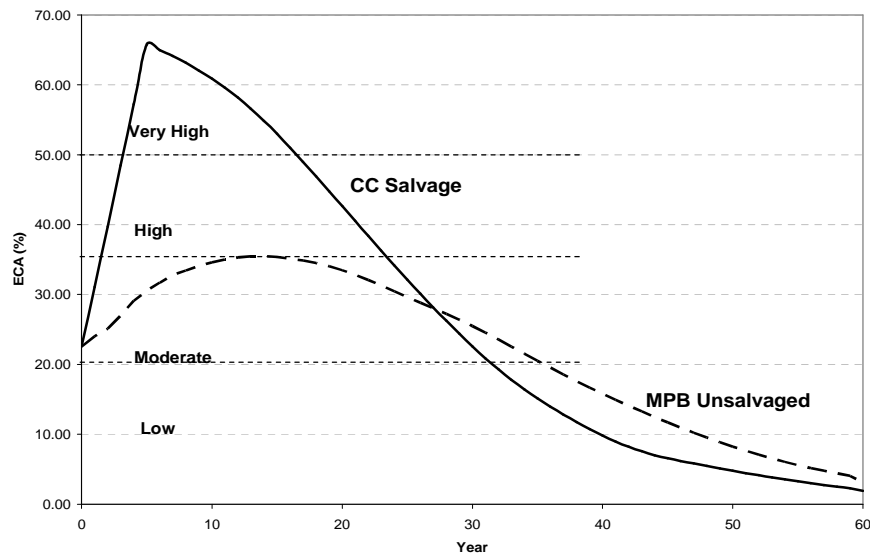
Figure 1. ECA Progressions in Trout Creek above H₅₀ for two management scenarios.

For these two scenarios, stand ECA data was rolled up into watershed or sub-basin ECA’s for Trout Creek watershed and 11 sub-basins. For Trout Creek Watershed at the DoS intake, the ECA progression over time for the two scenarios is shown in Figure 1. For the MPB/unharvested scenario there is as a moderate incremental ECA hazard lasting about 25 years; and for the full salvage harvest scenario there is a high incremental ECA hazard lasting about 20 years.

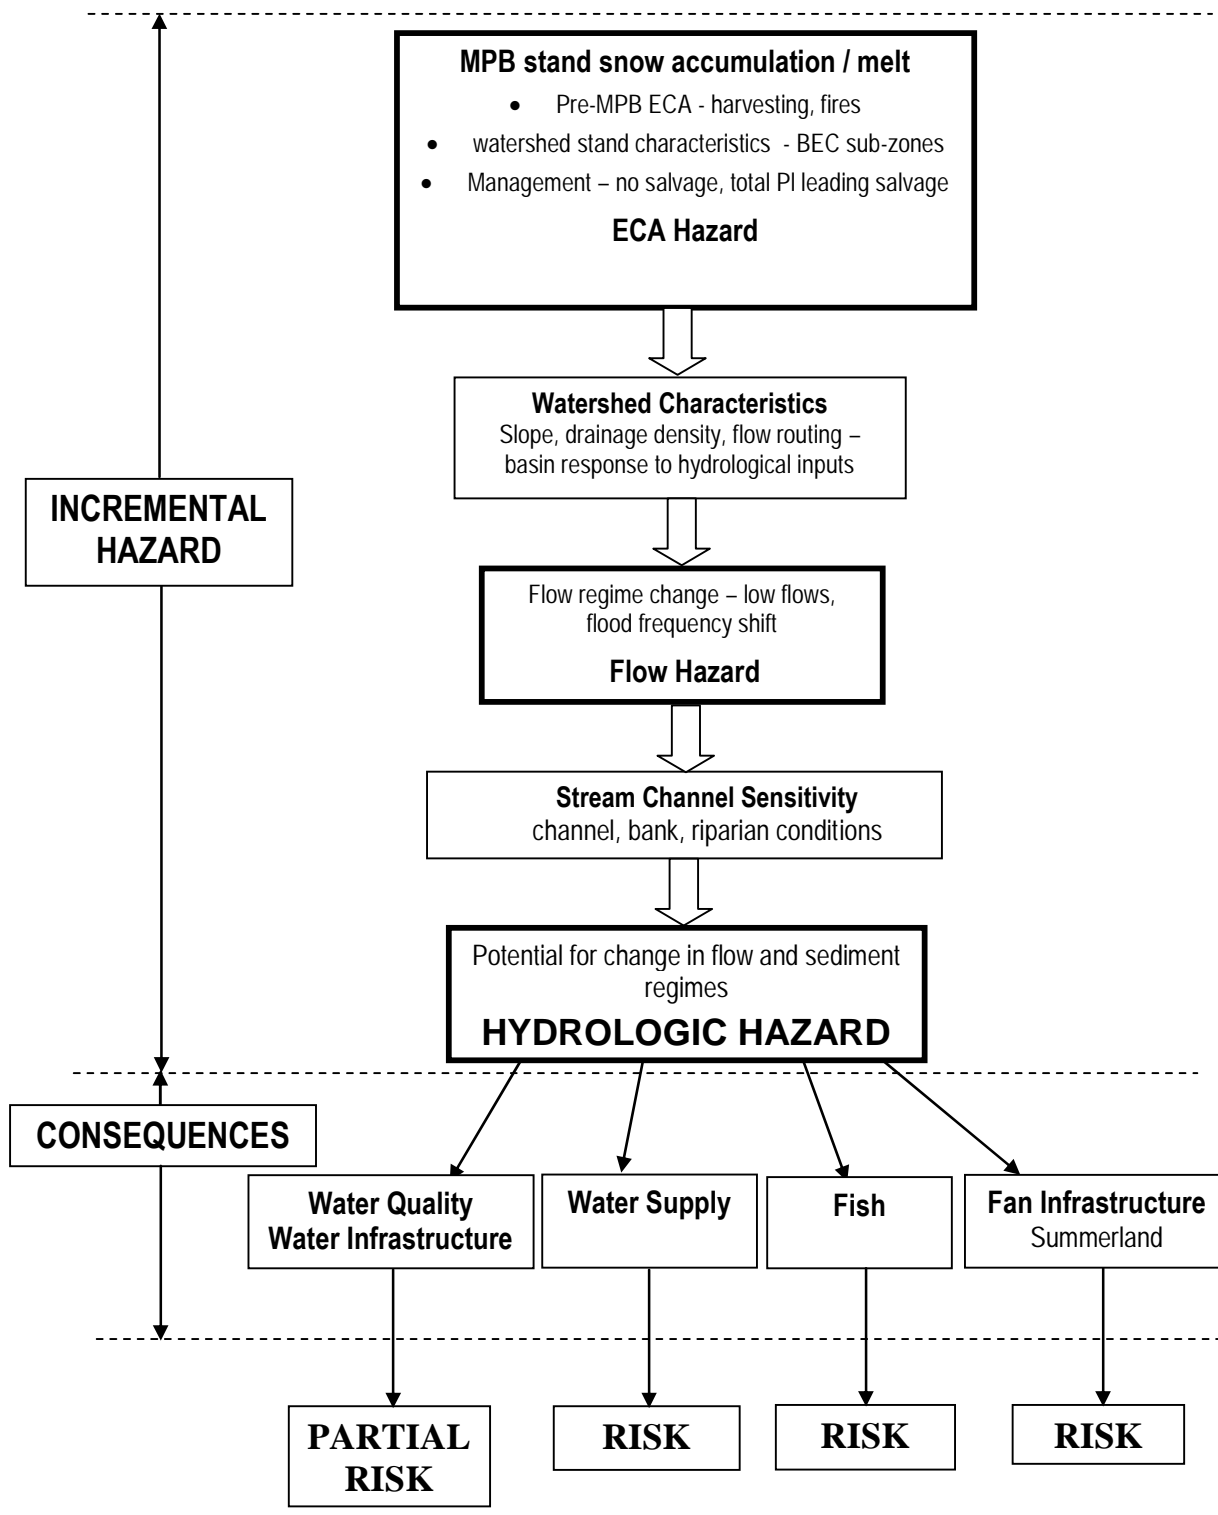
Figure 2. Risk Assessment Flow Chart

Figure 1 shows the risk assessment procedure used in this investigation. The incremental hydrologic hazard starts with changes in the forest canopy, snow accumulation and snow melt. This is expressed as an Equivalent Clearcut Area hazard (ECA). Watershed characteristics – drainage density, slope and routing factors (reservoirs, lakes and swamps) determine how the watershed will respond to changes in watershed ECA. A change in the flow regime is expressed as the flow hazard. How the flow hazard will affect stream channels depends on the existing channel conditions, and how sensitive or robust the channel is to changes stream flows. This is determined from field observations and previously published channel assessments. The channel sensitivity and flow hazard are combined to form the overall Hydrologic Hazard.

Once channel sensitivity has been determined, it is combined with the Peak Flow Hazard to give a Hydrologic Hazard for the drainage area (Figure 2). The Hydrologic Hazard therefore includes

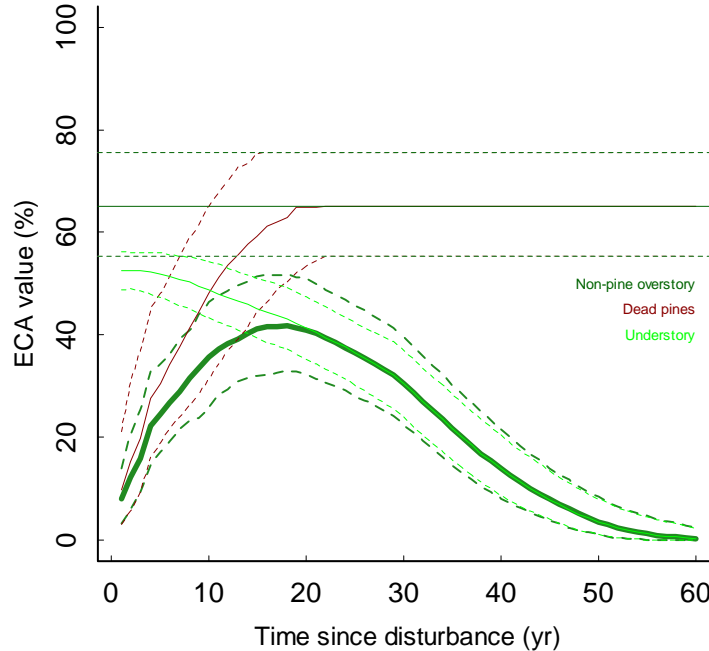
Figure 3. ECA projection (heavy green line) for unsalvaged older Montane Spruce BEC variant (MSdm, >110yr) showing the contributions over time of non-pine canopy (black line, showing a constant 35% ECA reduction over time) the dead pine (red line, showing decreasing ECA reduction as dead pines fall down over about 20 years) and understory (light green line). Dashed lines are 95% confidence intervals.

Huggard and Lewis (2008) also conducted sensitivity analyses on many of the critical input parameters, including percent mortality of natural understory, understory species composition, TIPSYP vs. VDYP regrowth modeling, different regeneration stocking delays, and other modeling components/assumptions. Generally the salvage vs. non-salvage ECA curves are most sensitive to the percentage of non-pine overstory, as shown in Figure 3.

It should be noted that the solid lines in Figure 3 are average values of the many different individual site conditions one would encounter in actual stands of a particular BEC variant. For instance, in high pine component stands there will be sites with very little understory, and other sites with a well-stocked understory.

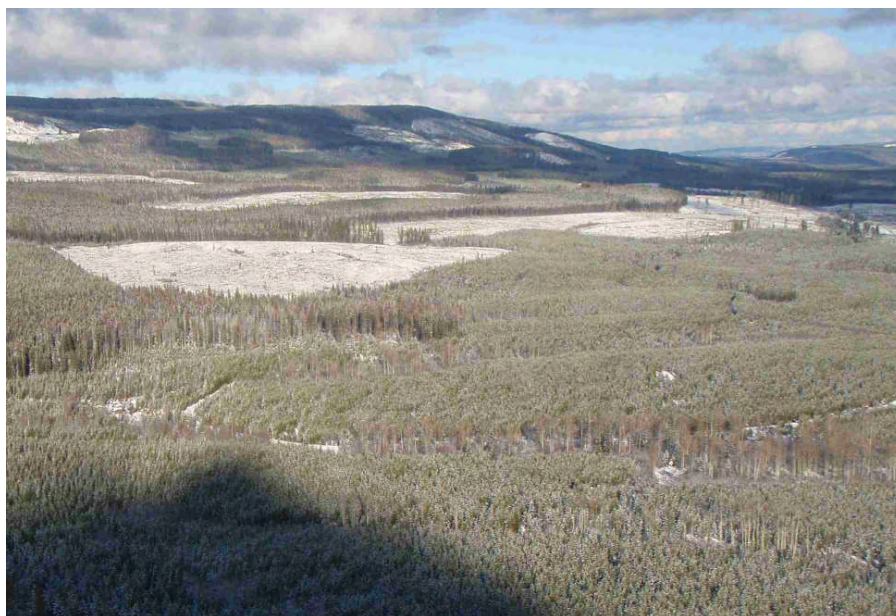
Photo 1. Broad gently sloping upland plateau area of Trout Creek.

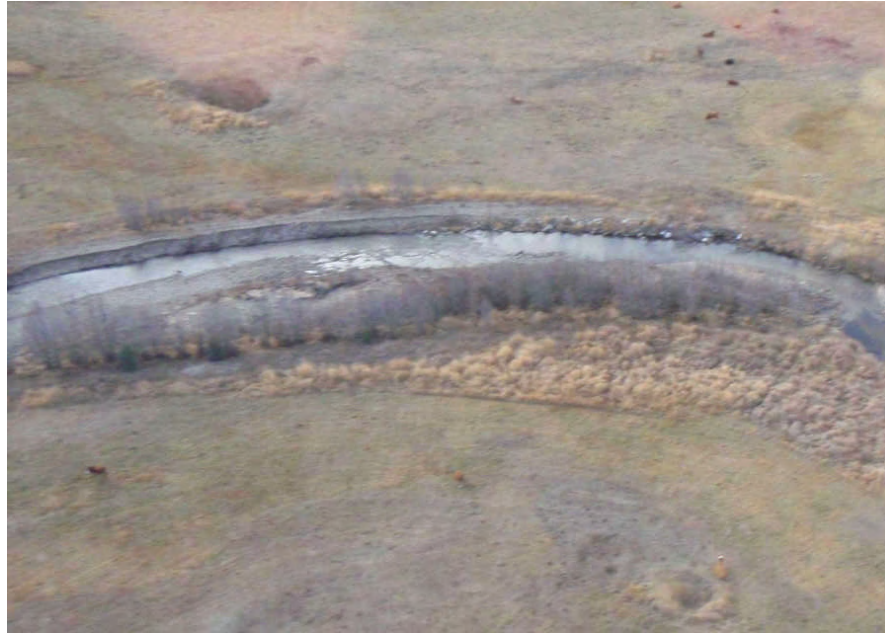
Photo 2. Cleared glaciofluvial/fluvial floodplain in Lower Trout Residual (Reach 9).
Note long eroding unprotected bank.

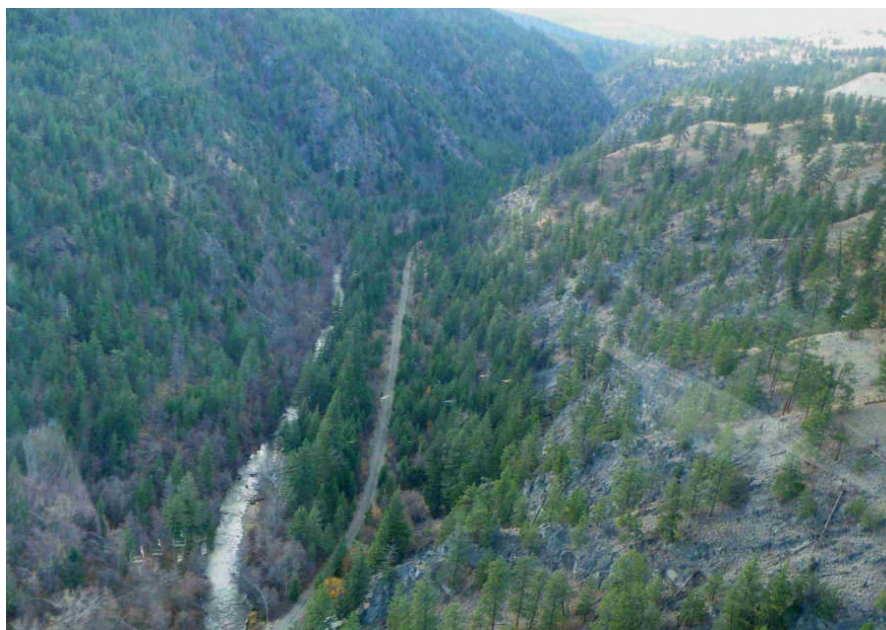
Photo 3. Typical lower Trout Creek above DoS water intake (Reach 3).

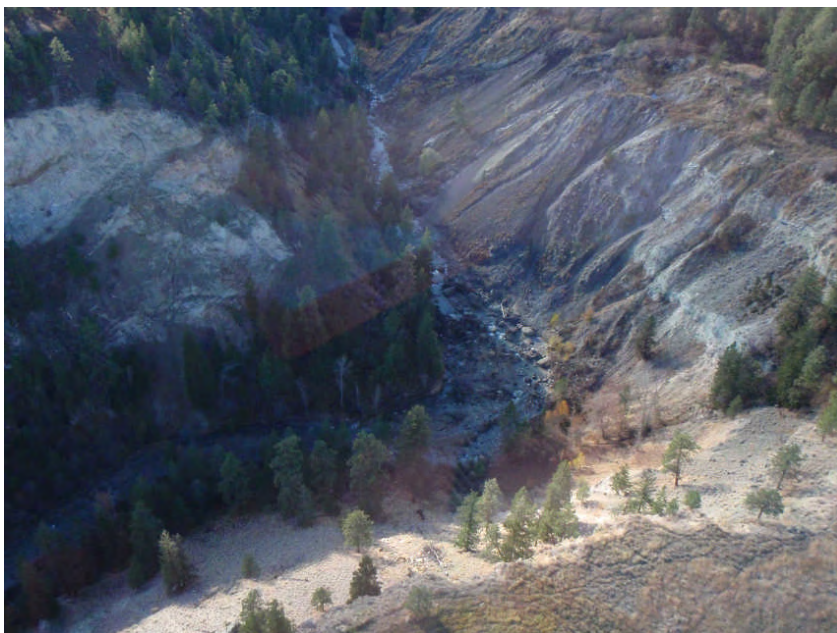
Photo 4. Steep eroding canyon below District of Summerland water intake (Reach 1B).

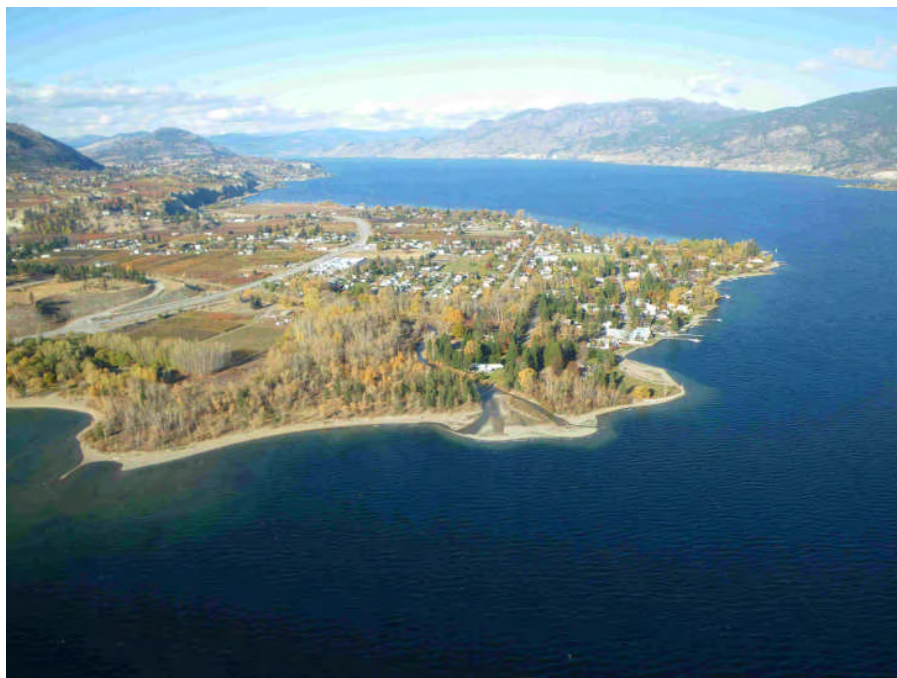
Photo 5. Trout Creek fan and stream outlet on Okanagan Lake (Reach 1A).

Trout Creek has a large alluvial fan at the mouth where it enters Okanagan Lake. While much of the fan volume is probably due to periglacial processes (formed during deglaciation), the lack of channel incision suggests some level of fan forming processes are still active. The channel on the fan has been straightened and dyked to protect adjacent agricultural and residential areas from flooding.

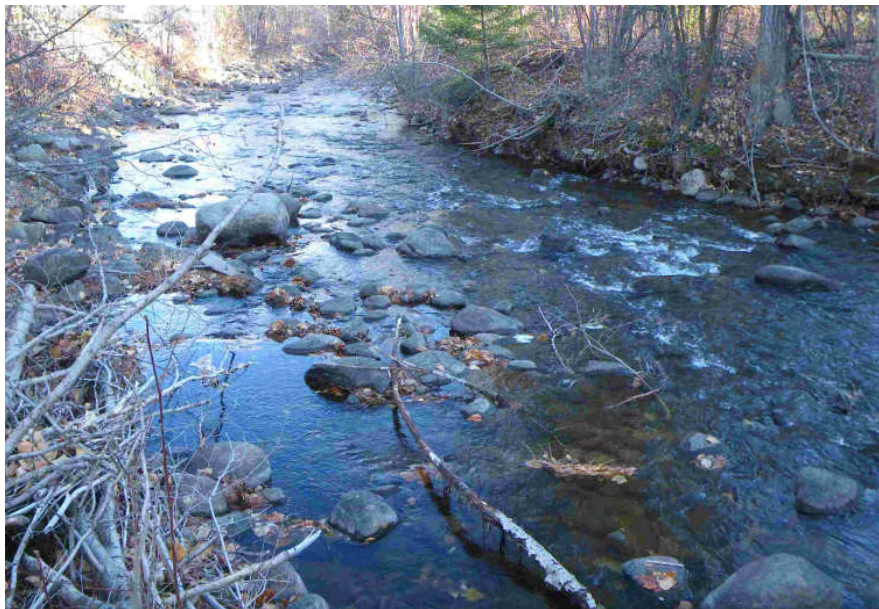
Photo 6. Stable Trout Creek channel with lag boulders and cobble bed.

Most channels in Trout Creek watershed appear to be stable and robust. Channel types are predominantly Cascade/Pool with cobble or boulder substrates (Photo 6). Riffle/Pool channel types with gravel substrates are found in lower gradient sections. Banks are typically composed of relatively coarse glacio-fluvial and/or colluvial deposits and are relatively resistant to erosion especially when vegetated with mature trees. Some lower gradient sections have developed floodplains and/or flow through finer sediments deposited during deglaciation (glacial outwash, glacial-fluvial and/or till deposits). Along incised mainstem channel sections, and in the lower reaches of tributary streams, bedrock is frequently exposed in the bed and banks.

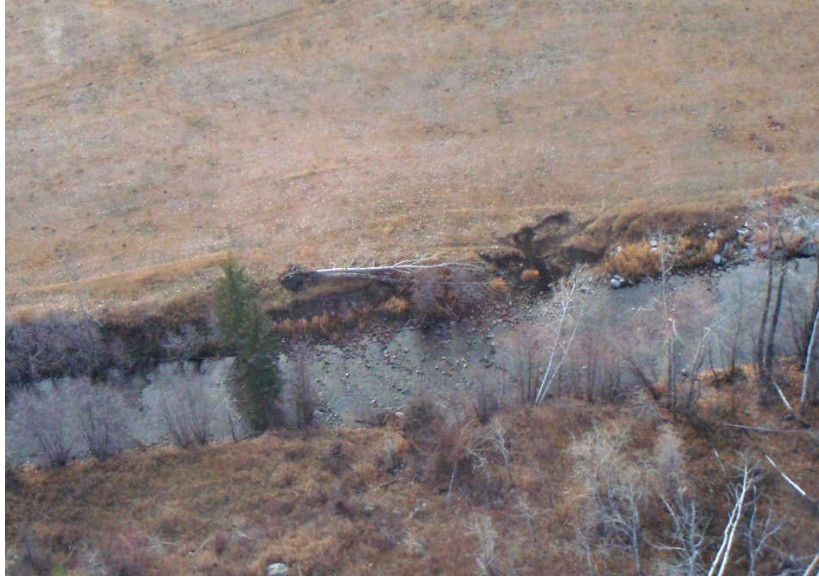
Photo 7. Lower Trout Residual Reach 9 through cleared agricultural land with eroding banks.

Disturbed reaches occur in Camp Creek and in Reaches 8-12 on the Trout Creek mainstem downstream of the Thirsk Reservoir. Disturbance in Camp Creek may be related to elevated peak flows and/or associated with forest harvesting (Dobson 2006). Reaches 8 through 12 on Trout Creek pass through private land cleared for agriculture. The reaches are low gradient with erodible banks and reduced riparian vegetation (Photos 2 and 7). Bank scour and aggradation is evident and channel avulsions have occurred in the past in this area.

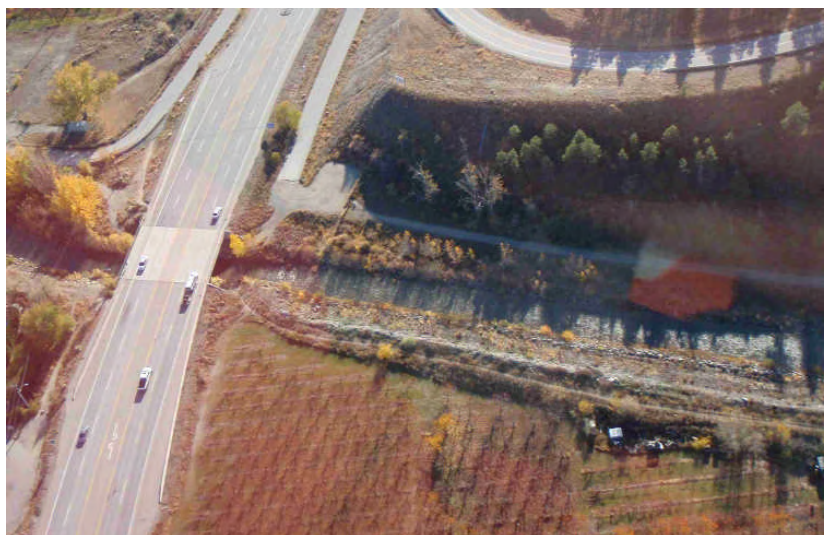
Photo 8. Trout Creek fan and Highway 97 crossing.

Trout Creek has a large alluvial fan at the stream mouth where it enters Okanagan Lake. The channel on the fan has been straightened and dyked to protect adjacent agricultural and residential areas from flooding. Some aggradation in the channel on the fan has occurred during past flood events.

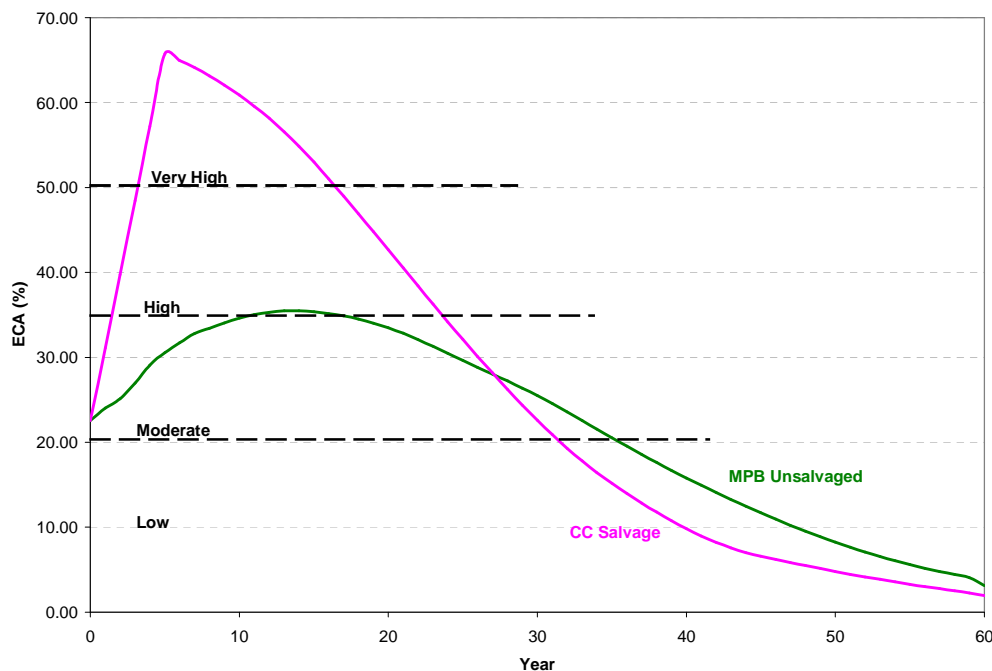
Figure 9. ECA and ECA hazard projections for Trout Creek Watershed above H₅₀ elevation, assuming full pine mortality from MPB infestation and full understory survival for MPB and no harvest scenario (green) and full salvage harvest of all pine-leading stands scenario (purple).

In Figure 9, we interpret the sustained ECA effect for the MPB/unharvested scenario as approximately the centre of the area under the curve above the low hazard level. Therefore, there is a moderate ECA hazard for approximately 25 years. The sustained ECA effect of the total clearcut salvage scenario is a high hazard for approximately 20 years. That is, with the overstory and understory survival assumptions made, the ECA effects of MPB mortality (and no further harvesting) may or may not be noticeable, and if there are noticeable effects they are not expected to be large. Similarly, the centre of the area under the ECA curve for the hypothetical full pine-leading stand salvage scenario suggests a high ECA hazard for 20 years. Within this time period significant ECA effects are considered likely.

This is the estimated shift in flood frequency resulting from the sustained 50% ECA expected with the total salvage harvesting scenario in Trout Creek (see Figure 9). Given the level of uncertainty whether the “moderate” peak flow effects associated with the MPB/unharvested scenario will be noticeable, it is not possible or meaningful to extrapolate a flood frequency shift for that scenario.

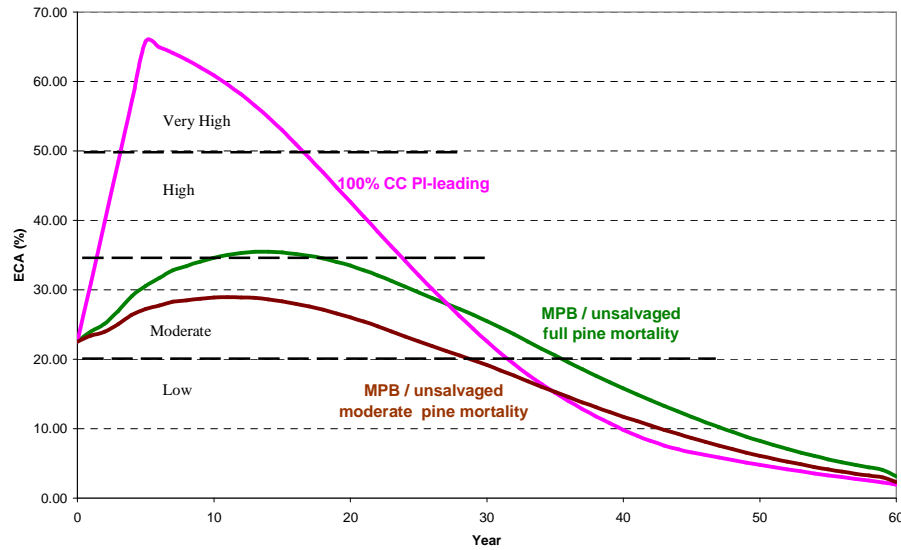
Figure 10. Trout Creek ECA progression for total salvage of pine-leading stands (purple); and MPB/ unharvested with full understory survival and two pine mortality scenarios - with 100% pine mortality (green) and with moderate pine mortality (brown) – see text for details.

The moderate pine mortality scenario assumes MPB attacks all canopy pine trees in 50% of ESSF pine-leading stands (many of which actually appear to be dominated by non-pine), 65% of MS stands <110 years old and 80% of MS stands >110 years. Remaining pine-leading stands are not affected. In the moderate MPB attack scenario maximum ECA is reduced from about 35% to approximately 30% and the watershed ECA recovers (to less than 20%) about 5 years earlier, slightly earlier than the total salvage and replant scenario recovery.

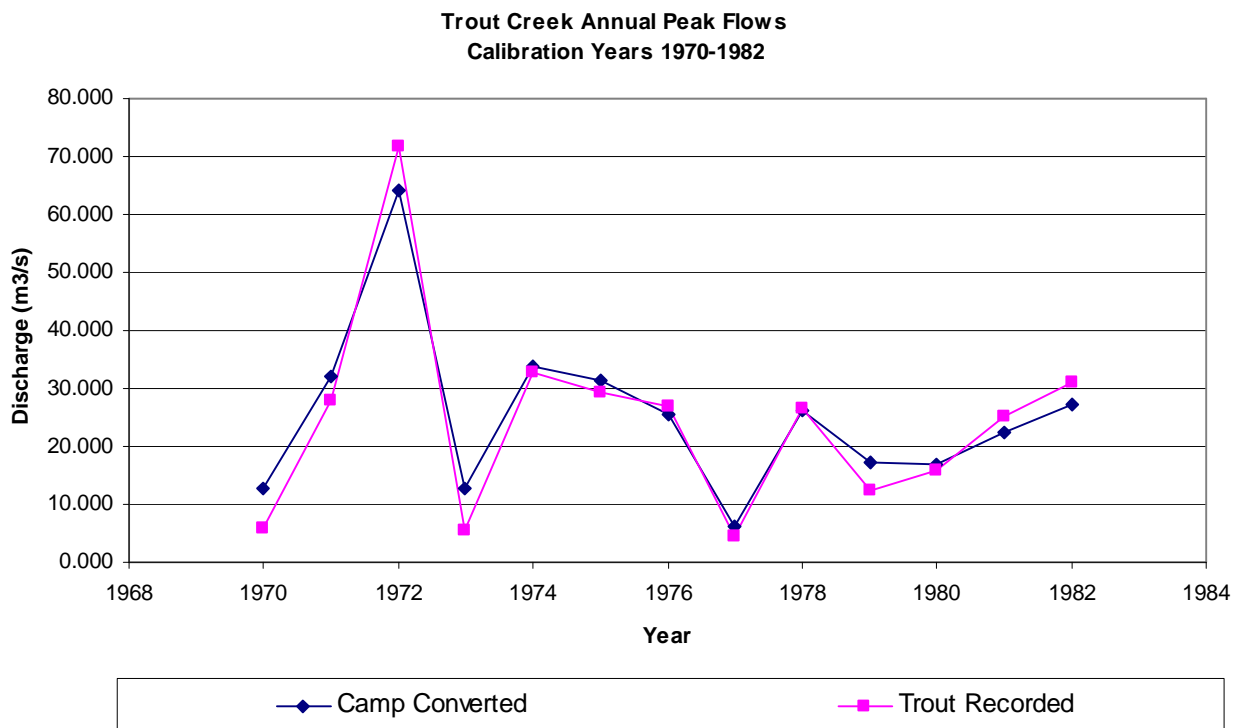
Figure 12. Comparison of Trout Creek annual peak flows and converted Camp Creek annual peaks (adjusted for sub-basin area) for the years both gauges were in operation simultaneously.

The value of 'n' was determined through calibration using the overlapping gauge records available from WSC. A value of n=0.94 generated the best fit for the corresponding flood peaks through the range of data. Annual peak flows converted from Camp Creek records using the above formula (with n=0.94) for the period 1970 to 1982 are plotted along with recorded Trout Creek peaks in Figure 12.

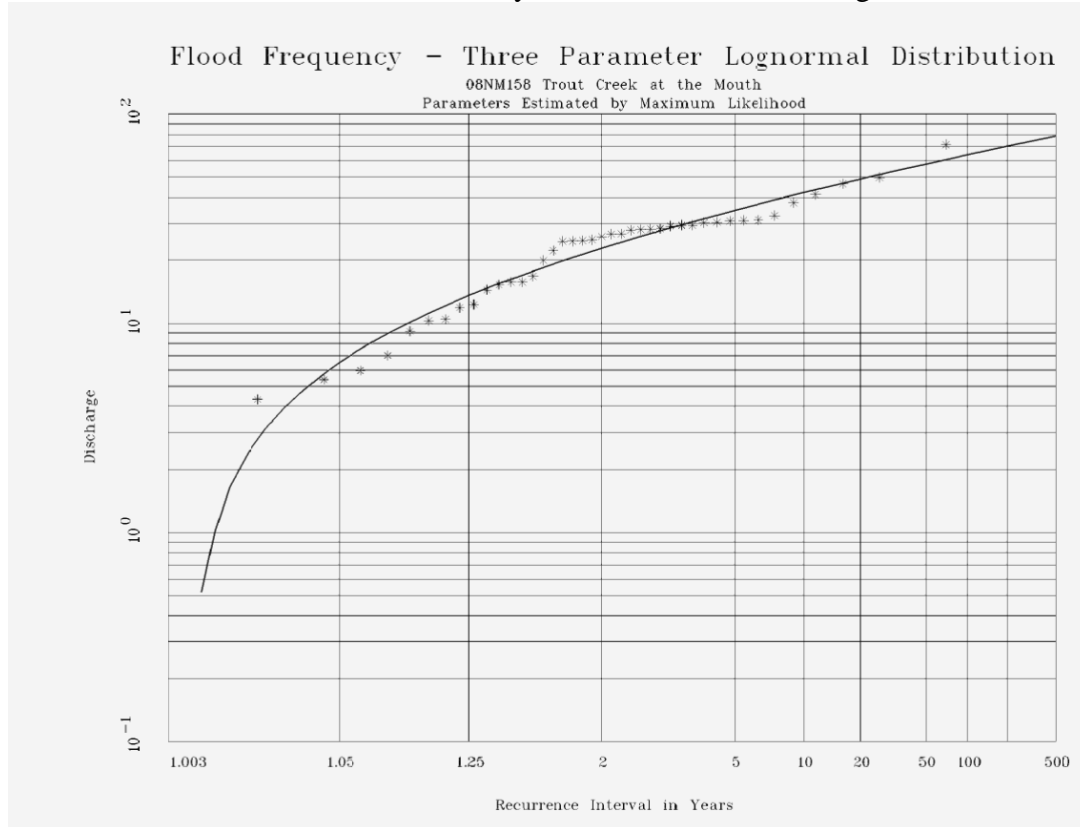
Figure 13. Trout Creek flood frequency curve.

Frequency Analysis (CFA) software. A three parameter Log-Normal distribution was found to best fit the data. The results of the analysis are shown below in Figure 13.

Table 5 lists peak discharge values for flood frequencies, as derived from the above flood frequency curve:

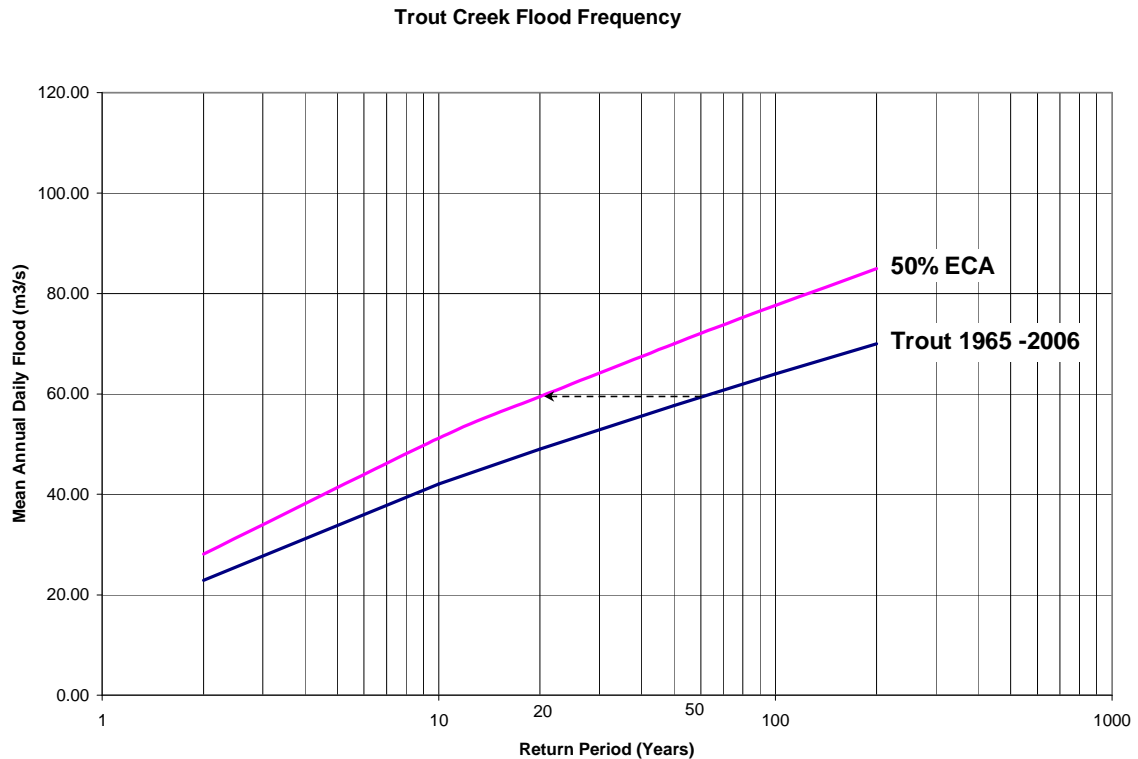
Figure 14. Estimated flood frequency shift for Trout Creek expected for the two decade period of sustained 50% ECA associated with the total clearcut salvage scenario.

There are a great many assumptions and different watershed conditions in the modelled watersheds, and therefore a significant degree of uncertainty in the modelling results that this flood frequency shift is extrapolated from. Nonetheless we would expect a shift of approximately this magnitude in Trout Creek if all pine-leading stands are harvested. For approximately the 20 year period shown in Figure 9, what had been the 50 year return period flood would be expected to occur, on average 2 to 3 times more frequently, or about once every 20 years.

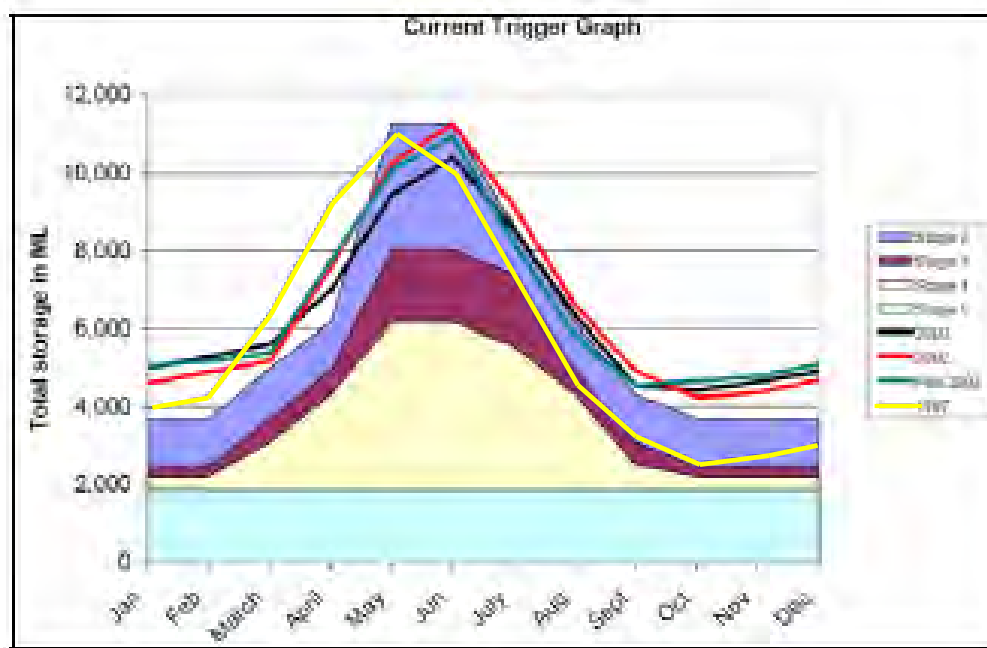
Figure 15. Trout Creek annual storage hydrograph for sample years, with water use management stages. Stages are storage scenarios prior to raising Thirsk Dam, which trigger increasing water use restrictions from Stage 2 through Stage 5. The coloured curves show water storage over time for various years, under an water user Operating Agreement governing water consumption rates. (From Aqua Consulting Inc., 2008).

In 1987 (yellow line, Figure 15), even though maximum reservoir storage was realized, the reservoir drawdown began approximately 30 days earlier than normal, presumably because of an earlier freshet peak due to natural variability in climatic conditions. As Figure 15 shows, this resulted in decreased reservoir storage availability in August and September. Any additional advancement of freshet runoff due to MPB and salvage-related effects could add to the natural climatic variation in freshet timing, and result in an earlier freshet, earlier reservoir use and decreased storage availability later in the growing season.
