**CANFOR - FORT ST. JOHN
1998
RECONNAISSANCE LAKE INVENTORY
OF
ROD LAKE***

WSC: 235-304300-30300

Prepared for:
**Canadian Forest Products Ltd.
Fort St. John/Taylor Division
RR#1, Comp 2, Site 13
Fort St. John, B.C.
V1J 4M6**

MARCH 1999

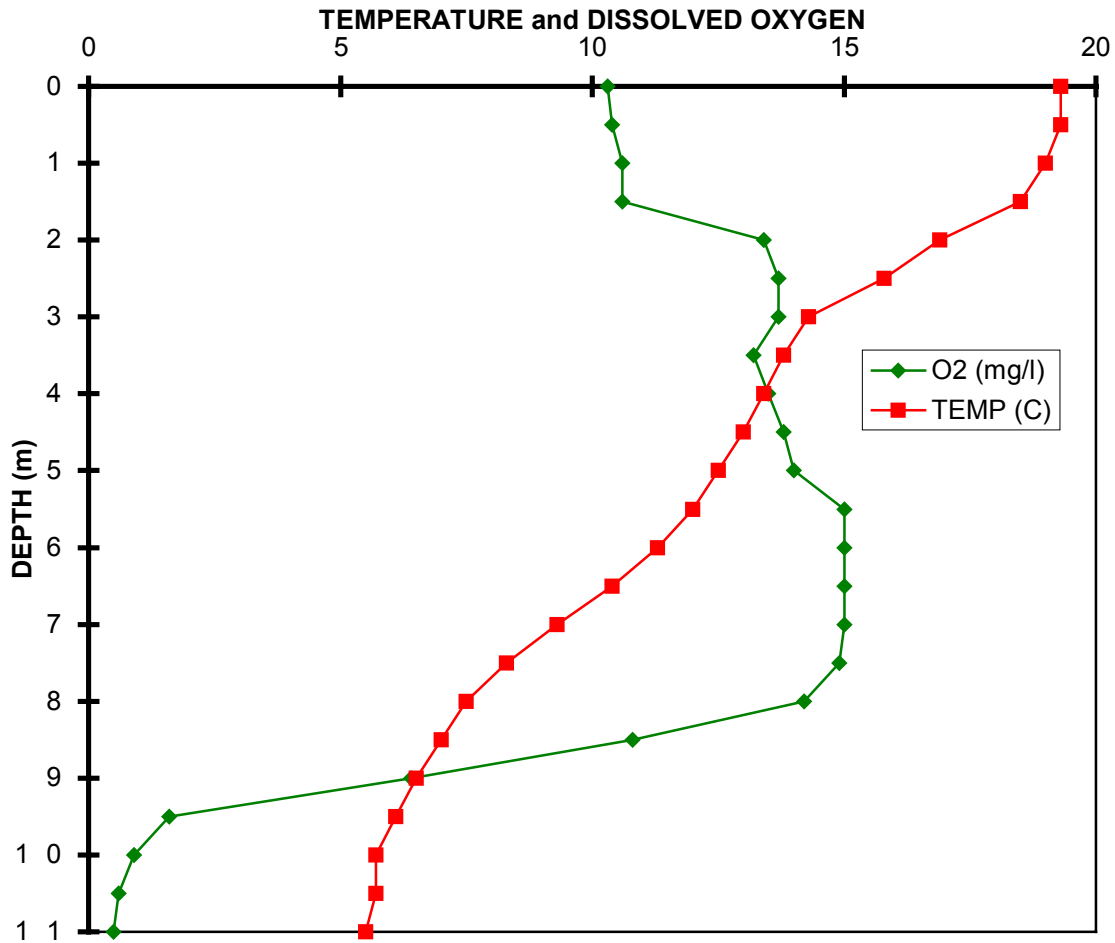
Figure 5: Temperature and dissolved oxygen profiles for Rod Lake* on July 30, 1998

A summary of the limnology station sampling conditions and results appear in Table 3. Dissolved oxygen and temperature profiles are represented in Figure 5. Tabular DO and temperature data is recorded in Appendix IV; values used in profiles are an average of descending and ascending readings.

There was no sharply defined thermal stratification of the lake at the time of the survey, although a weak thermocline is indicated at 2 to 3 metres depth. Dissolved oxygen readings suggest that the lower two metres of the water column is relatively oxygen-poor, with the remainder of the lake volume appearing capable of over-summering fish. Anoxic conditions evident below approximately 9 metres accounted for 9.4% of the lake volume.

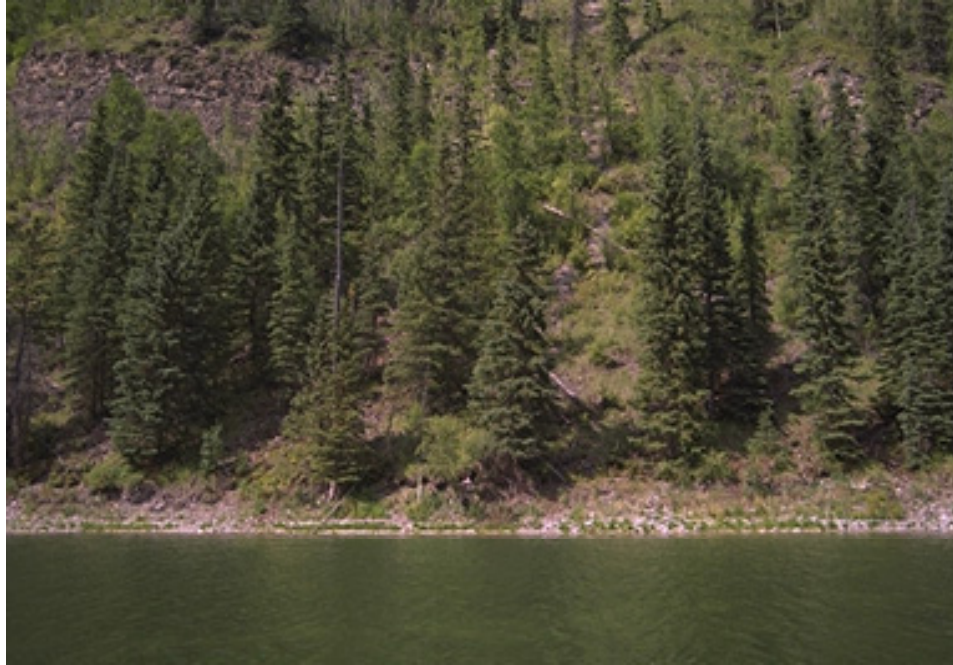
Plate 1: View of benchmark from center of lake. (Roll 12/Frame 20)

The lake level benchmark was established on the north side of the lake, 120 metres from the east end (Plate 1). A length of 10mm rebar, painted red, was driven in at the base of a 30cm dbh hybrid spruce just above the high-water mark (Plate 2). The base of the tree was de-limbed and a blaze was cut at an elevation matching the top of the rebar, from which point measurements were taken. Benchmark elevation was .81 metres above the recognizable high-water mark and 3.04 metres above the current lake level.

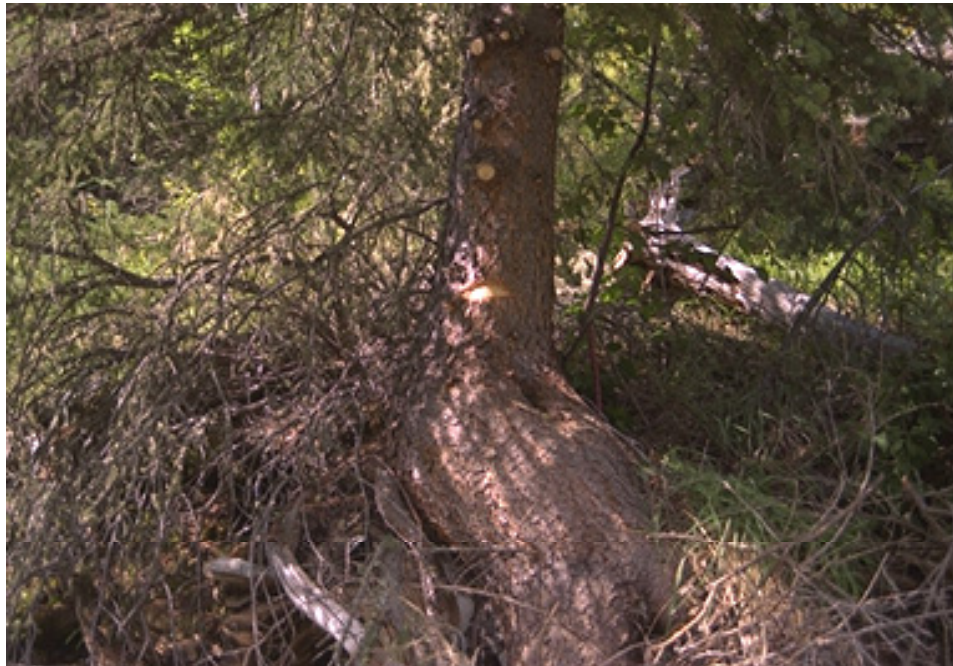
Plate 2: Close-up view of benchmark. Note the 10 mm rebar stake of the right of the blazed spruce. (Roll 12/Frame 19)

General and specific features were noted during an initial shoreline reconnaissance. The lake level benchmark was established by driving in a length of 10mm rebar at a recognizable location. The upper portion of the rebar stake was painted red to aid in future relocation.
