# **Penticton Creek Hydrological Risk Assessment**

**BC Ministry of Environment**

**Grainger and Associates Consulting Ltd.**

**November, 2010**

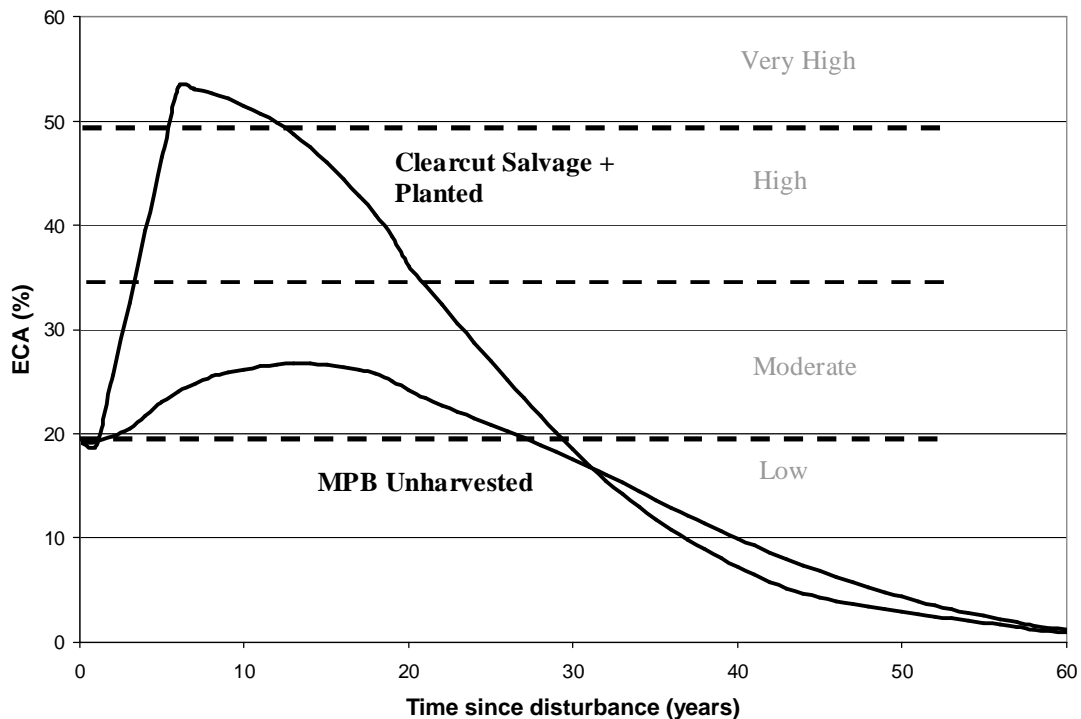
Figure 10. ECA hazard projections for Penticton Creek Watershed at CoP intake.

The current ECA for the Penticton Creek watershed is Low. Following full pine mortality and no harvesting there is a Moderate ECA hazard for approximately 25 years; and following the full salvage harvest scenario there is a sustained High incremental ECA hazard lasting about 20 years. It is clear there is a much greater change in forest canopy and thus watershed ECA following clearcut salvage harvesting than if MPB-attacked stands are left unharvested.

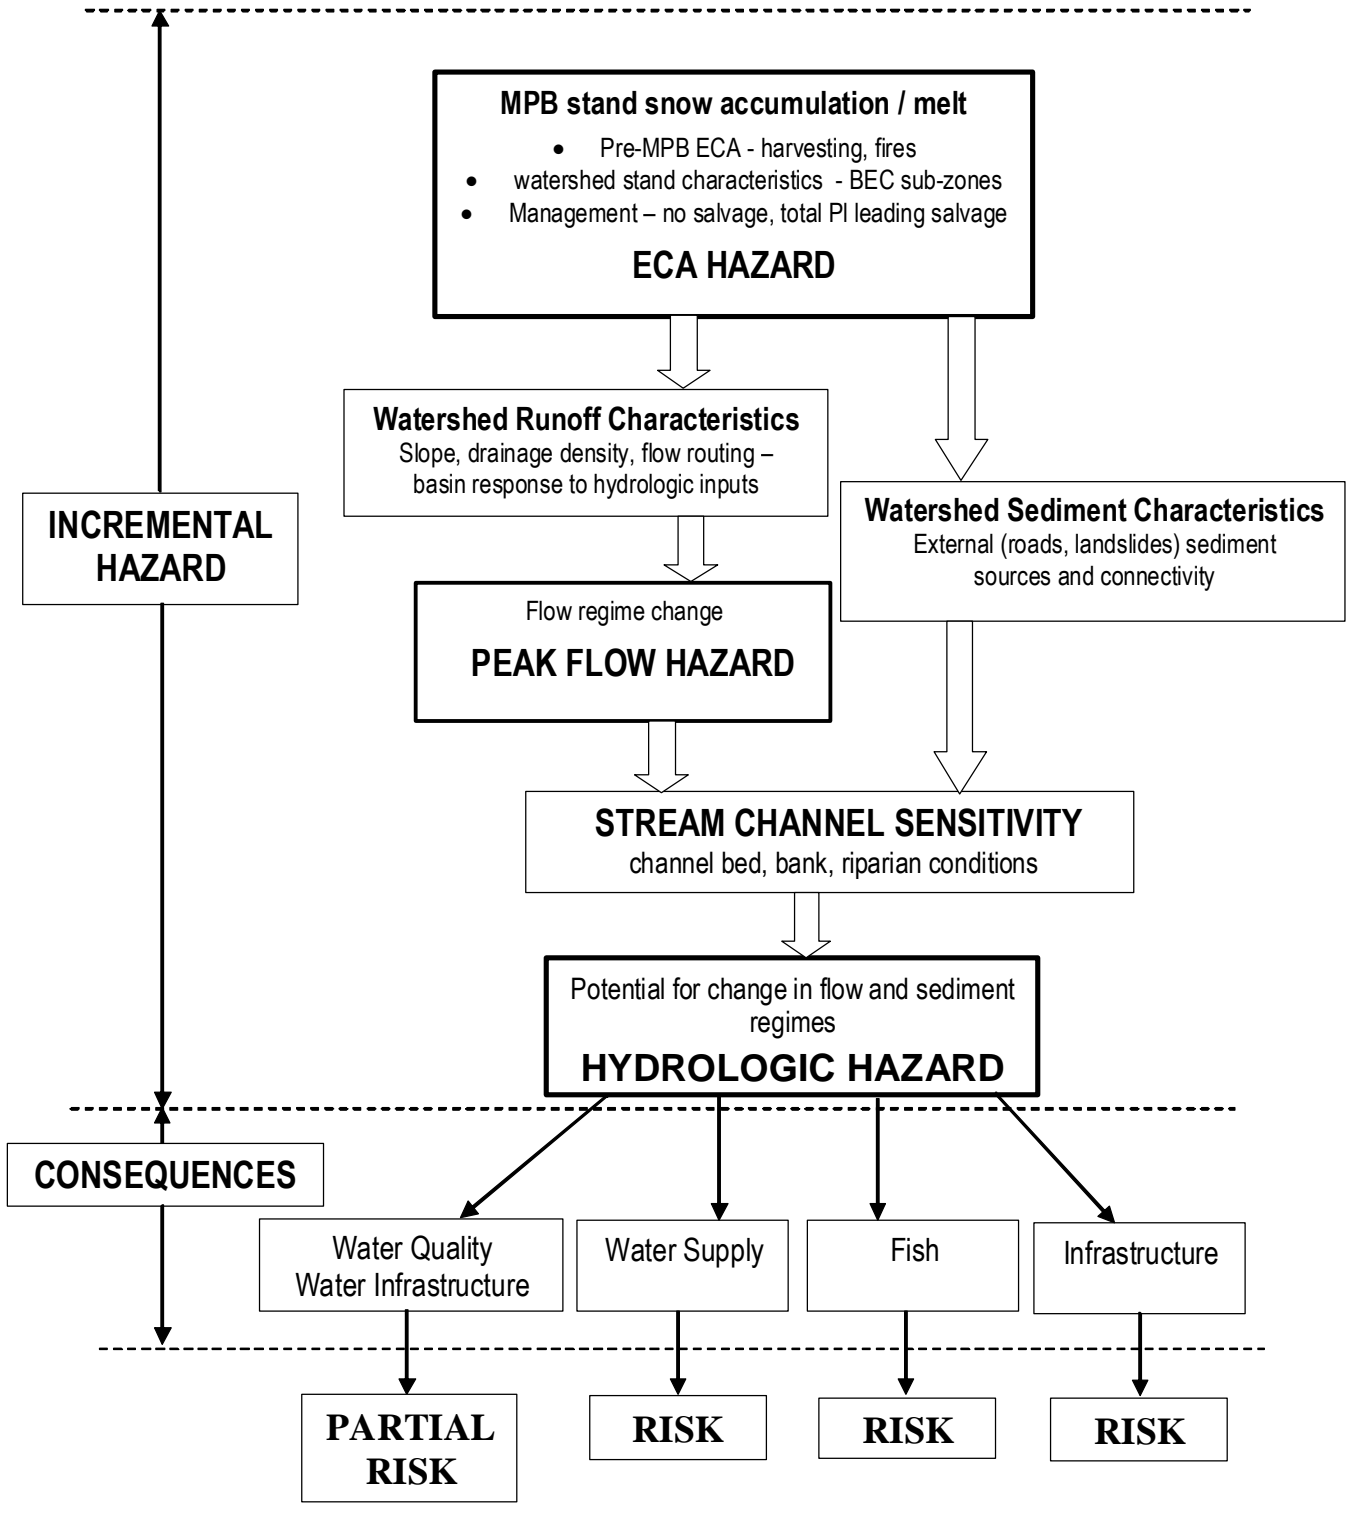
**Figure 2.** Risk Assessment Flow Chart

Figure 2 shows the risk assessment procedure used in this investigation. The incremental hydrologic hazard starts with changes in the forest canopy, snow accumulation and snow melt. This is expressed as an Equivalent Clearcut Area hazard (ECA). Watershed characteristics – drainage density, slope and routing factors (reservoirs, lakes and swamps) determine how the watershed will respond to changes in watershed ECA. A change in the flow regime is expressed as the flow hazard. How the flow hazard will affect stream channels depends on the existing channel conditions, and how sensitive or robust the channel is to changes in stream flows. This is determined from field observations and previously published channel assessments. The channel sensitivity and flow hazard are combined to form the overall Hydrologic Hazard.

Once channel sensitivity has been determined, it is combined with the Peak Flow Hazard to give a Hydrologic Hazard for the drainage area (Figure 2). The Hydrologic Hazard therefore includes forest cover ECA effects, sub-basin drainage characteristics and channel sensitivity rolled up into a single hazard reflecting the potential for channel change, and is an expression of expectations regarding peak flows and sediment delivery at the drainage outlet.

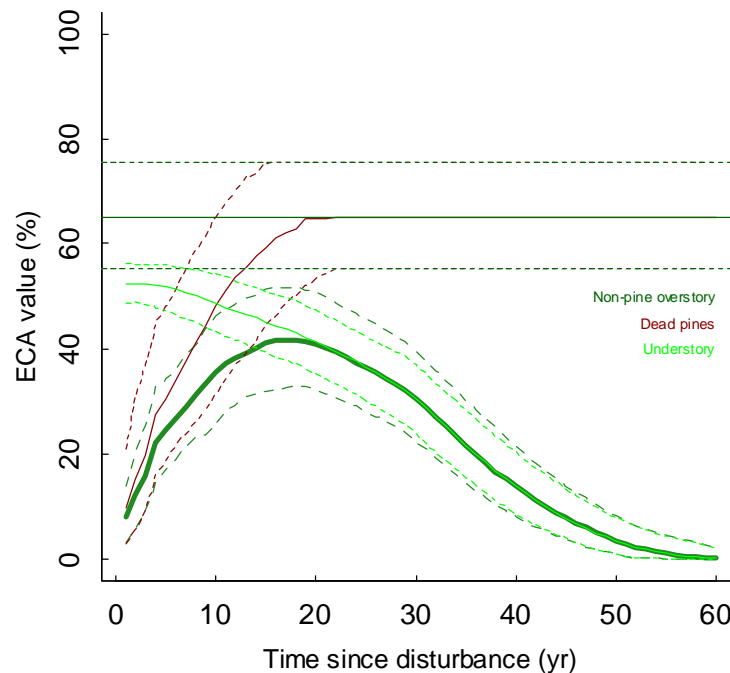
**Figure 3.** ECA projection (heavy green line) for unsalvaged older Montane Spruce BEC variant (MSdm, >110yr) showing the contributions over time of non-pine canopy (black line, showing a constant 35% ECA reduction over time) the dead pine (red line, showing decreasing ECA reduction as dead pines fall down over about 20 years) and understory (light green line). Dashed lines are 95% confidence intervals.

Huggard and Lewis (2008) also conducted sensitivity analyses on many of the critical input parameters, including percent mortality of natural understory, understory species composition, TIPSY vs. VDYP regrowth modeling, different regeneration stocking delays, and other modeling components/assumptions. Generally the salvage vs. non-salvage ECA curves were found to be most sensitive to the percentage of non-pine overstory, as shown in Figure 3.

It should be noted that the solid lines in Figure 3 are average values of the many different individual site conditions one would encounter in actual stands of a particular BEC variant. For instance, in high pine component stands there will be sites with very little understory, and other sites with a well-stocked understory.

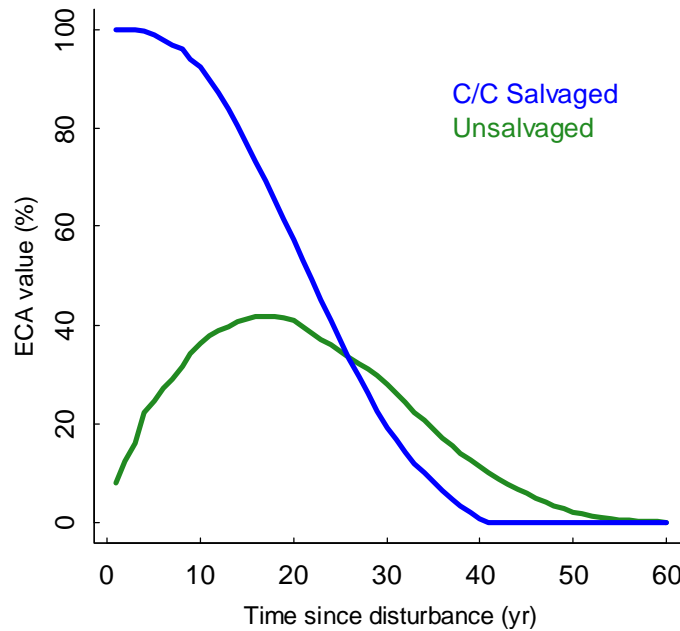
**Figure 4.** ECA projections for unsalvaged and clearcut salvaged and planted older MSdm, showing that ECA for unharvested MPB attacked stands never rises above about 40%. There is a 20 to 25 year period where the clearcut salvaged and replanted stand has a significantly higher ECA than the unharvested stand, after which the planted stand recovers slightly ahead of the unharvested stand.

ECA curves for clearcut harvested attacked stands were also developed, based on expected regrowth rates of planted stands. Figure 4 shows a comparison of the unharvested and harvested ECA progression over time, for the same stand type shown in Figure 3. Similar curves were developed for all major BEC zones or subzones in the hydrologically important upper portion of the watershed. The cumulative effect of the different ECA progressions in different BEC zones in the watershed is calculated, to arrive at a watershed ECA.

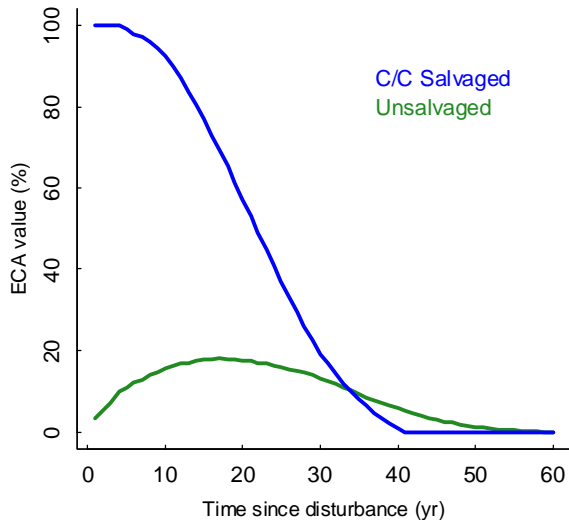
Figure 7. ECA progression in ESSF pine-leading stands.

ESSF ECA curves (Figure 7) are based on 56 plots in 7 ESSFdc stands. In stands labelled 100% pine or >80% pine, the actual measured overstory pine component averages 30.7%. The rest of the overstory was approximately equal amounts of spruce and balsam. The average understory has 1,000 well-spaced stems (>1.3m tall) per hectare (ha).

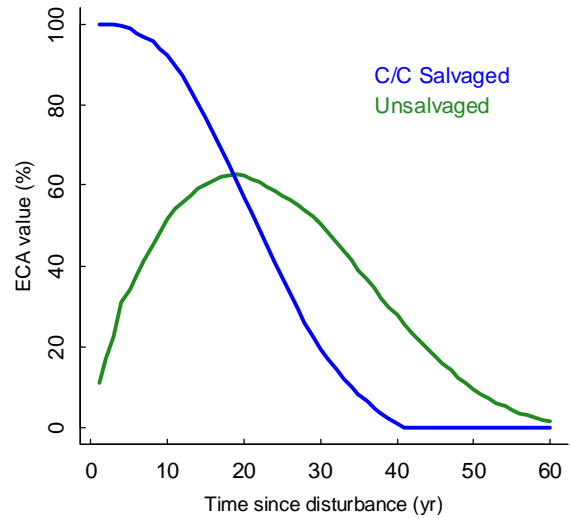
Figure 8. ECA progression in younger pine-leading MSdm stands (70 to 110 yr).

The younger MSdm ECA curves (Figure 8) are based on 64 plots in 8 pine-leading stands. The measured overstory pine component averages about 90%. Average understory is 280 well-spaced stems per ha (>1.3m tall) per ha. The older MSdm ECA curves (Figure 9) are based on 85 plots in 10 stands with an average overstory pine component of 74.0 % and an average understory of 560 well-spaced understory stems >1.3m tall per ha.

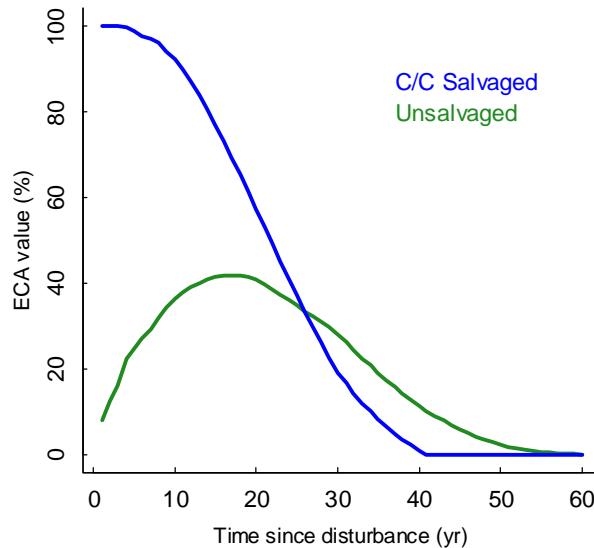
Figure 9. ECA progression in older pine-leading MSdm (> 110 yrs) stands.

As discussed in Section 2.2.2, the unsalvaged curves are based on field measurements taken for this project of secondary stand structure in Vegetation Resource Inventory (VRI) labelled pine-leading stands in seven South Okanagan watersheds (see Appendix B). The curves shown here assume full pine mortality, full understory survival and a site index (SI) of 15.

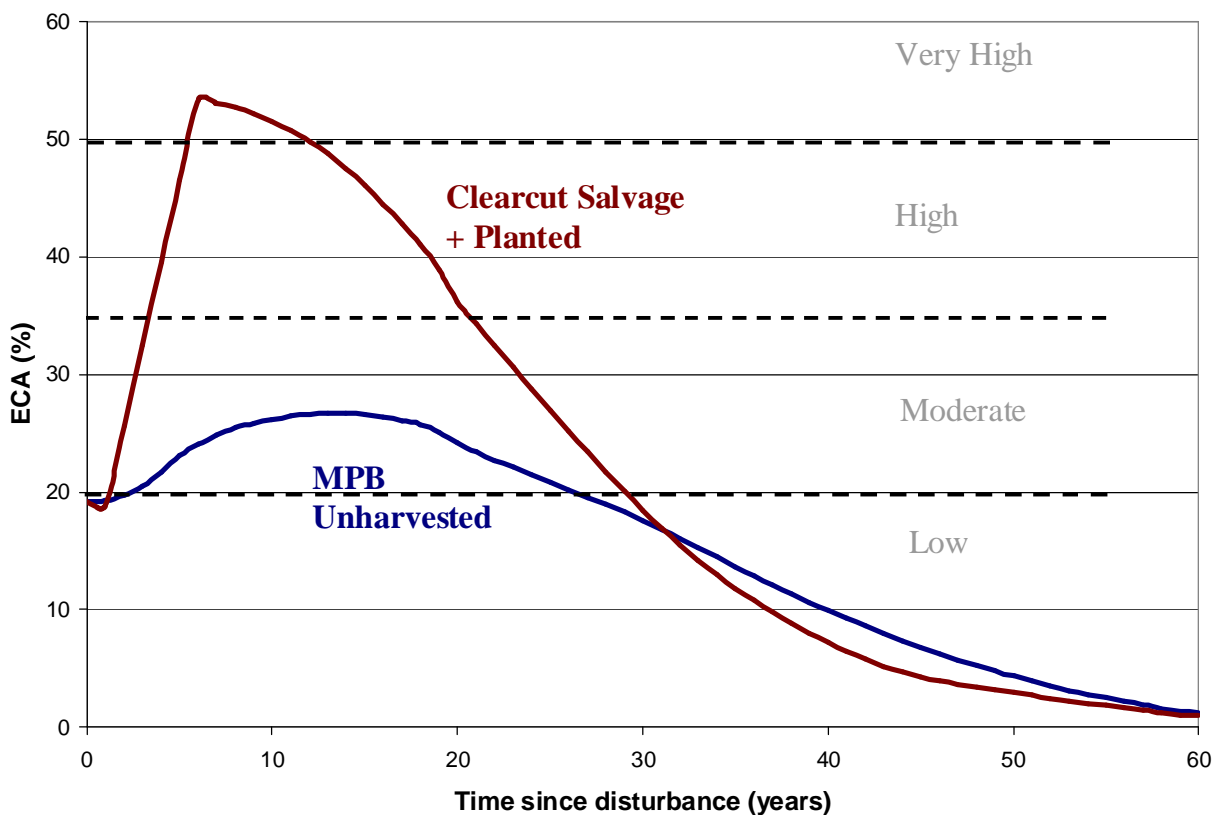
**Figure 10.** ECA hazard projections for Penticton Creek Watershed above H<sub>60</sub>elevation, assuming full pine mortality from MPB infestation, full understory survival for unharvested MPB and no further harvesting (blue) and full salvage harvest of all pine-leading stands (brown).

In the “unharvested MPB” scenario (blue line) all pine trees in pine-leading stands are assumed to be killed by MPB, no further forest harvesting activity takes place in the watershed and there is full survival of the measured understory. That is, all stands are retained and there is no salvage harvesting of pine-leading stands and no harvesting of non-pine green wood. In the “clearcut salvage” scenario (brown line) all pine-leading stands are clearcut harvested, with the exception of riparian zones, old growth management areas, unstable terrain and other areas designated as long-term reserves, as contained in GIS layers supplied by forest licensees. These areas are preserved, however if they are pine-leading it is presumed that the pine dies.

In watershed ECA modelling, MPB attack was phased in over 5 years, and salvage harvesting followed 1 year behind the MPB attack. Two management scenarios were modelled as shown in Figure 10.

To extrapolate to the expected flood frequency shift in Penticton Creek with the total salvage scenario, which has an extended High ECA Hazard (see Figure 10), all the modelled results would have to be scaled down (the amount of flood frequency shift reduced); because either the amount of clearcutting and the corresponding ECA is higher in the modelled watersheds, or the watershed area is smaller than Penticton Creek. Smaller watersheds are generally more “flashy” than larger watersheds, and all else being equal, one could expect a smaller change in flood regime in larger watersheds. We also note the slight divergence between the control and treatment flood regimes, such that larger (longer return period) floods show somewhat larger increases in magnitude than smaller floods (Allila, *et al.* 2009)

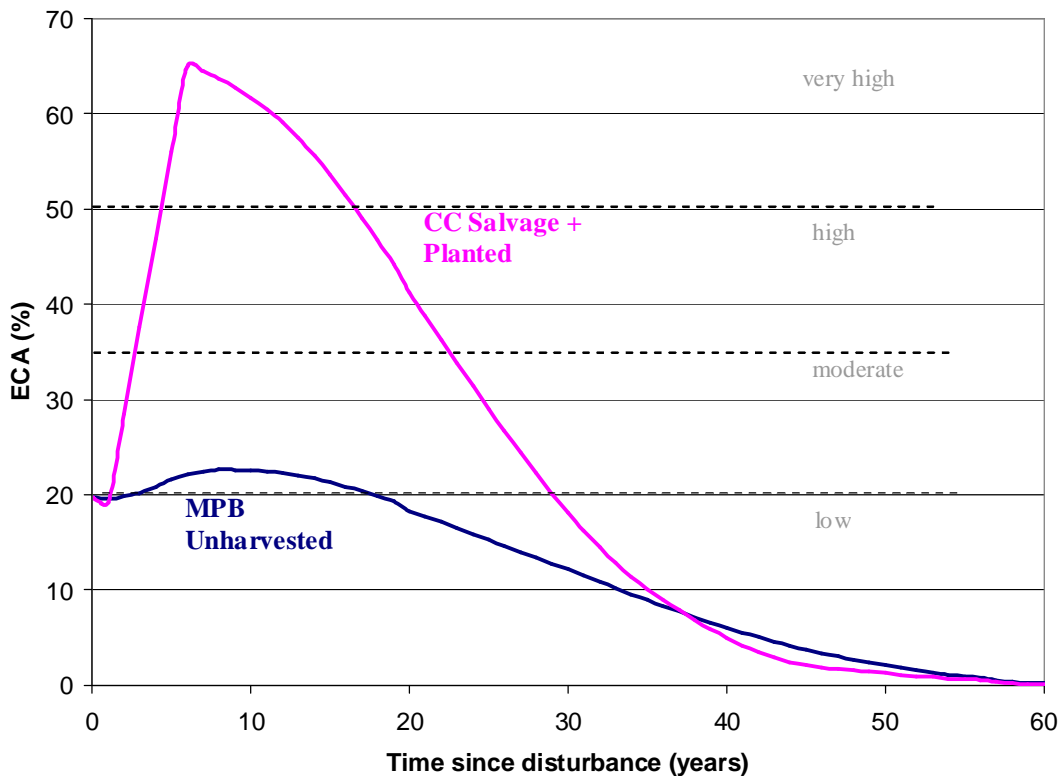
Figure 11. Greyback Lake sub-basin ECA. Post salvage ECA values are High to Very High for about 25 years. Post unharvested MPB attack ECA values remain predominantly Low.

The Greyback Lake sub-basin shows mainly lower ECA values following the unharvested MPB scenario, but a longer period of High to Very High ECA values following the full salvage scenario (Figure 11). This is because there is a lot of unharvested ESSF type stands in Greyback sub-basin, which field plots showed have a lot of non-pine overstory in supposed pine-leading stands (see Figure 7), and a lot of post-MPB hydrologic function which will be removed when salvage harvested. This results in a low ECA following MPB attack of what pine there is, and a much higher ECA following salvage of the entire mixed pine and non-pine stands. The sustained ECA following the unharvested MPB scenario

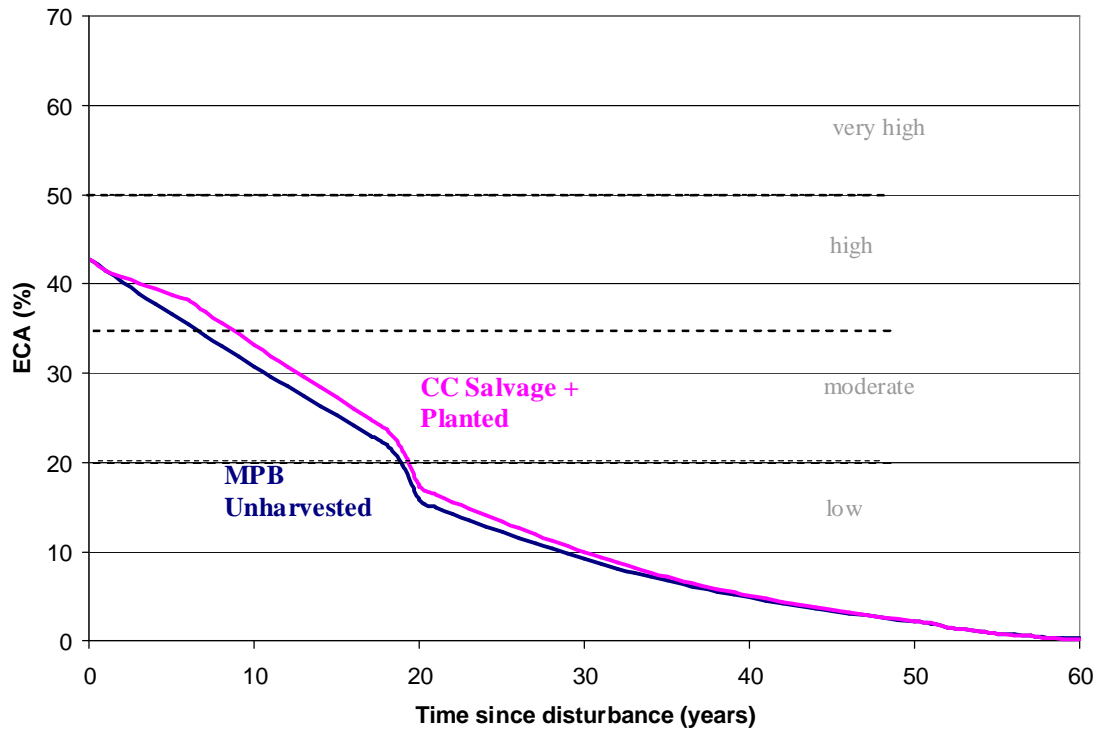
Figure 12. Dennis Creek sub-basin ECA. Current ECA values are High and in both management scenarios. ECA values continually decrease to Low in about 20 years. Due to past harvesting there is very little pine leading forest left to harvested in this sub-basin.

In Dennis Creek (Figure 12), almost all the pine-leading stands in the basin have been harvested; much in the mid to late 1990's and some in the lower watershed around 1980. There is virtually nothing left to salvage, so the ECA for both the unharvested and harvested scenarios are almost identical. Although the current ECA is high, having at least two harvesting entries has allowed some stands to begin to recover before the next entry. This has kept the ECA in Dennis Creek from reaching the Very High levels that result if a lot of pine-leading stands are harvested at once, as is the case in the hypothetical full salvage scenario in Greyback Lake sub-basin (Figure 11). Now in Dennis Creek sub-basin all stands are recovering and ECA continually decreases from its current High level to a Low ECA in about 20 years. The sustained ECA in Dennis Creek is predominantly Moderate for about 20 years, for both scenarios.

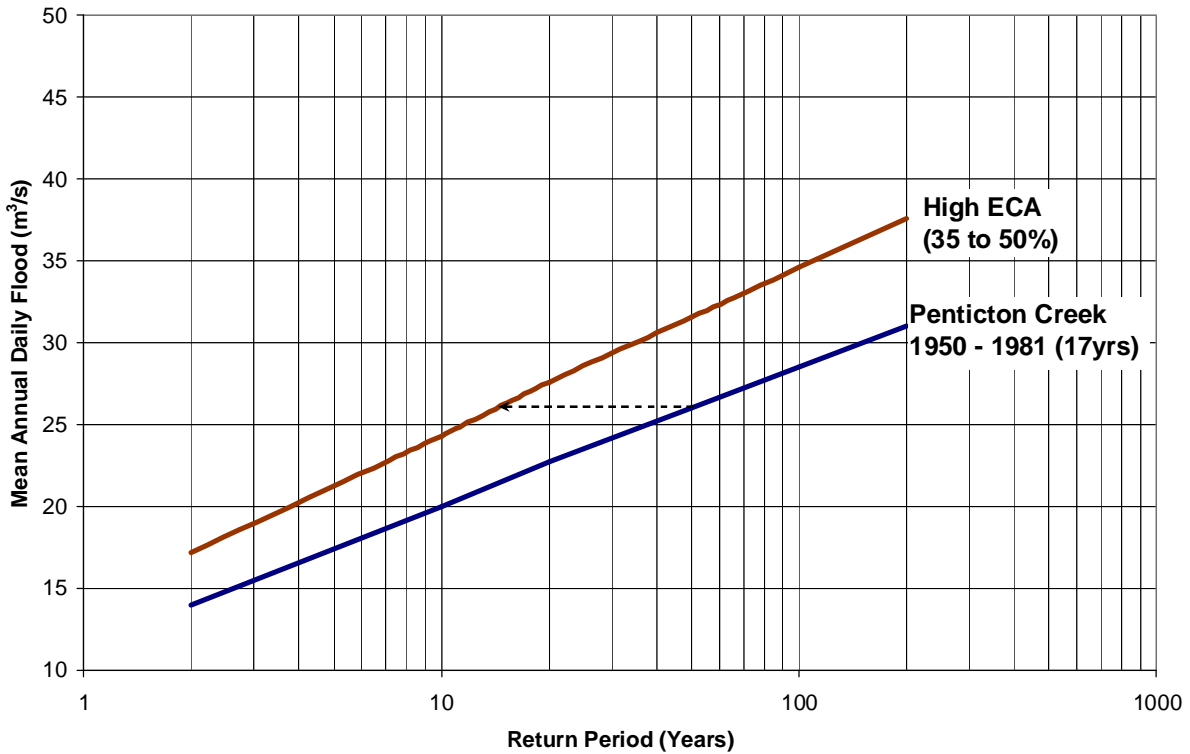
**Figure 13.** Estimated flood frequency shift (for hypothetical uncontrolled flood) in Penticton Creek with a sustained High ECA for 15 to 20 years following the complete harvest of pine-leading stands, based on the expected response of an average, uncontrolled mid-sized Okanagan Watershed.

Figure 13 shows that following the full salvage harvesting scenario the historic 50 year flood is expected to occur approximately every 15 years; and all other magnitude floods would similarly be expected to occur more frequently. This also means that if there is full salvage harvest of pine-leading stands, floods larger than have been experienced in recent times are more likely to occur. This flood frequency shift is expected to last for about 15 to 20 years. With a moderate ECA, such as that expected to last about 25 years after total MPB pine mortality and no further harvest, some increase in flood frequency, and shift in the flood frequency curve, may occur, but a significant flood frequency shift is not expected.

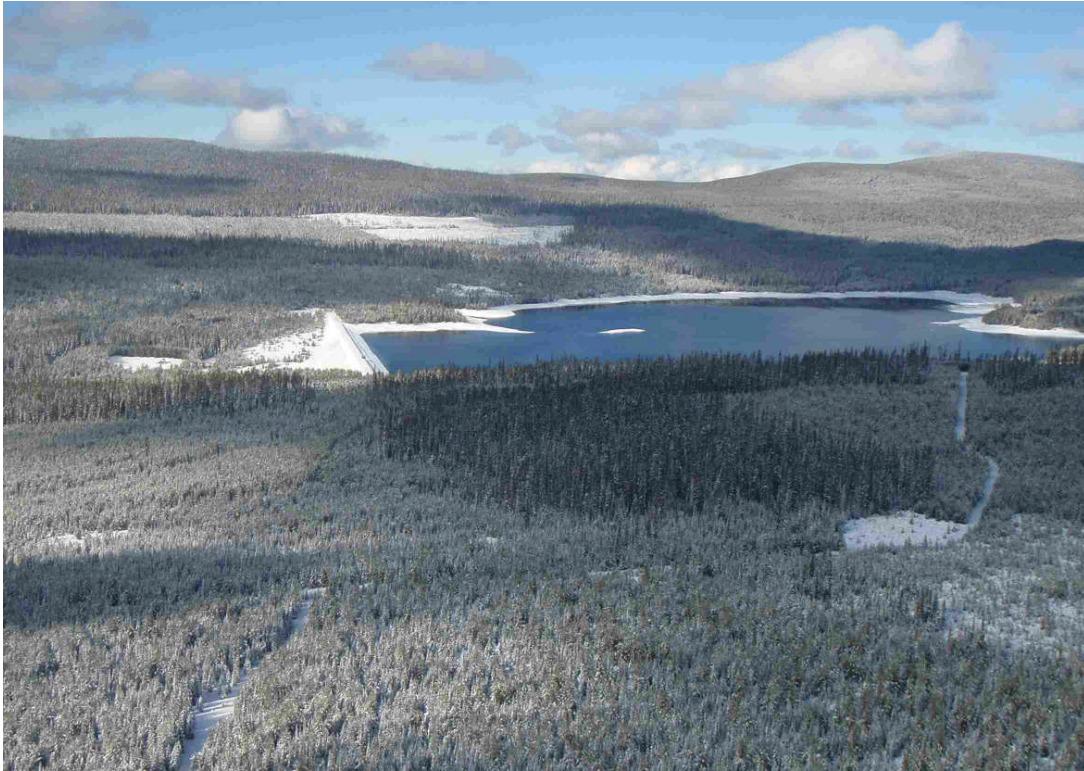
**Photo 1.** Broad gently sloping upland plateau of Penticton Creek with Greyback Lake Reservoir.

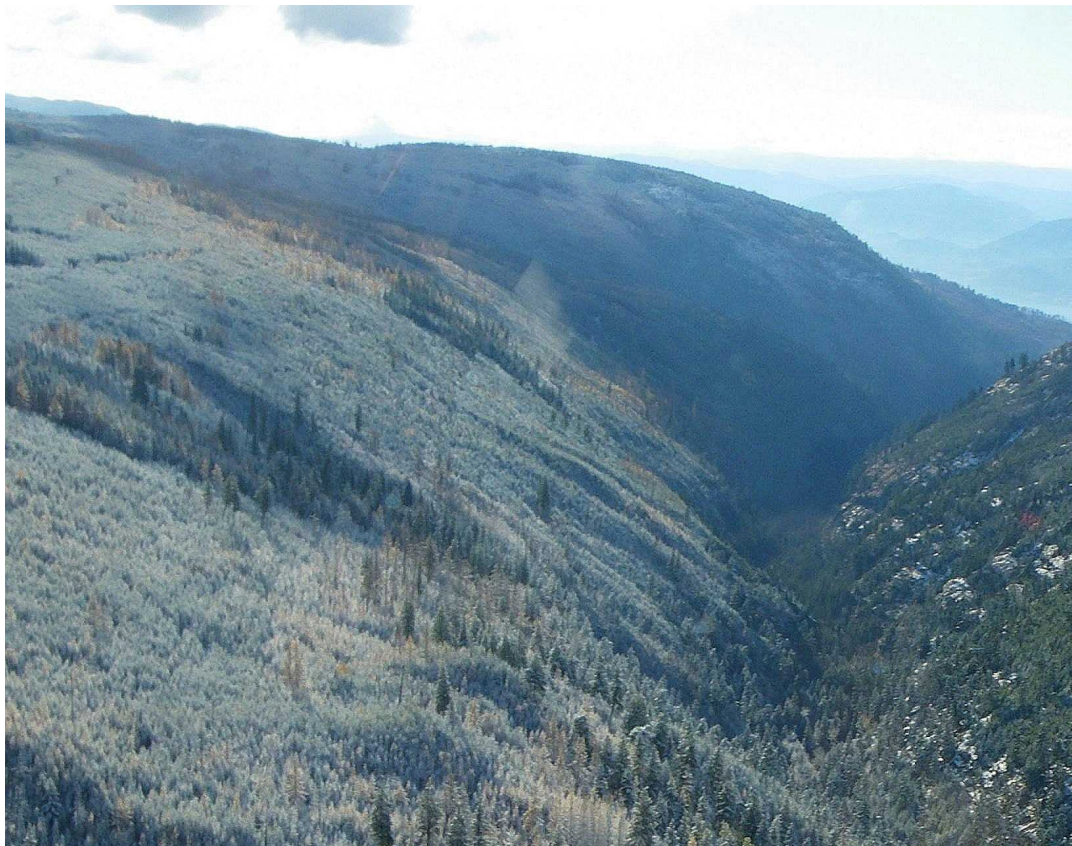
**Photo 2.** Incision of Penticton Creek mainstem into upland plateau, with moderately steep to steep escarpment slopes.

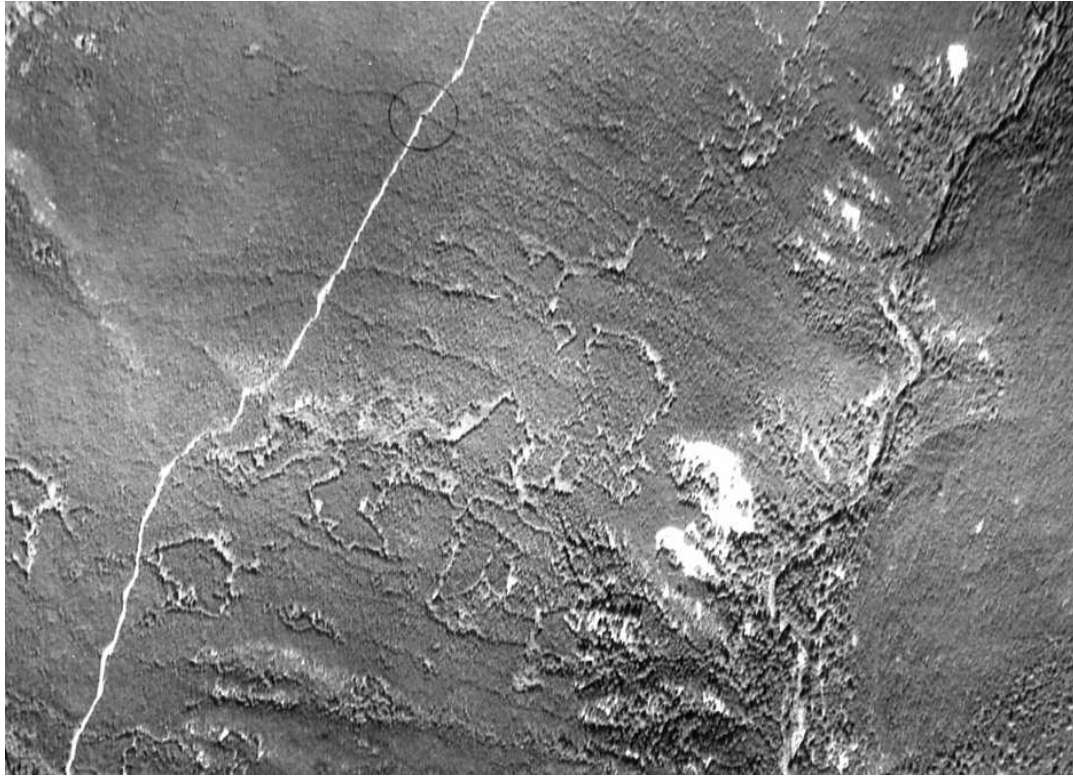
**Photo 3.** Group of slope failures forming Landslide 1 on west Penticton Creek escarpment, between Reed and Municipal Creek in 1938 air photo (BC106:81). Note several smaller slope failures upstream, and aggraded (bright) mainstem starting just downstream of those landslides.

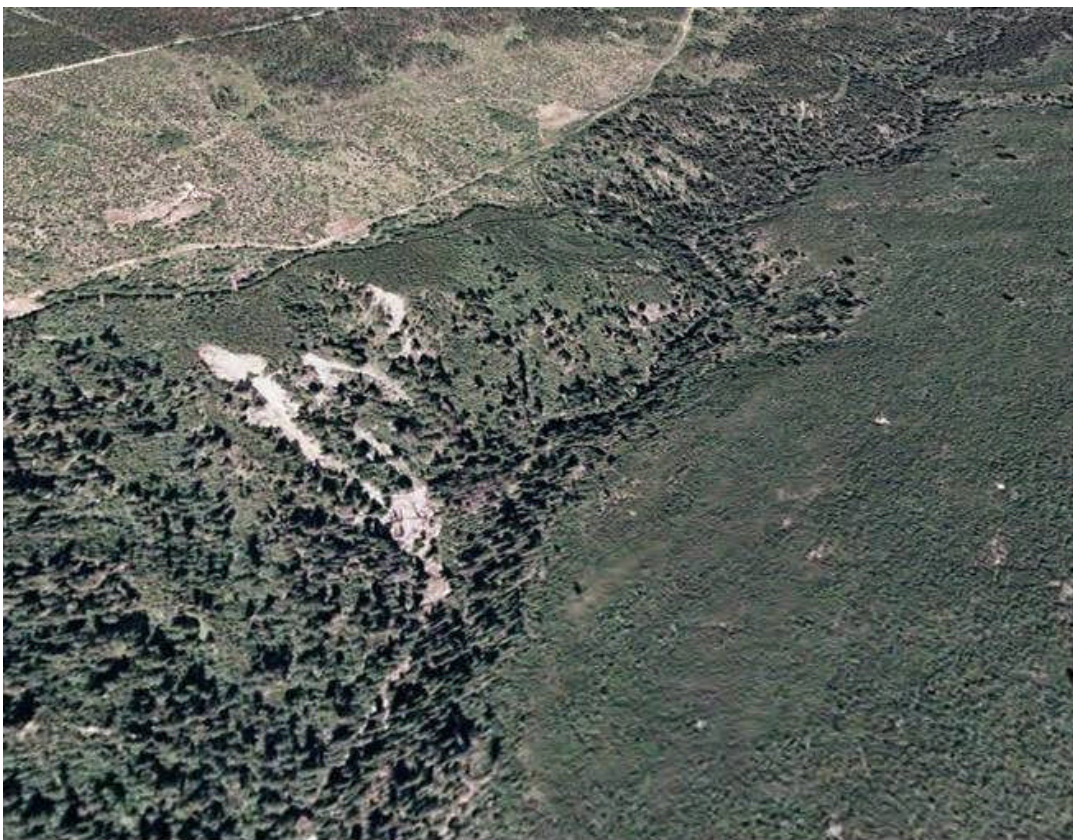
**Photo 4.** Google image of Landslide 1 from 2004 photography; still contributing some sediment to Penticton Creek mainstem. Smaller upstream slides are largely revegetated.

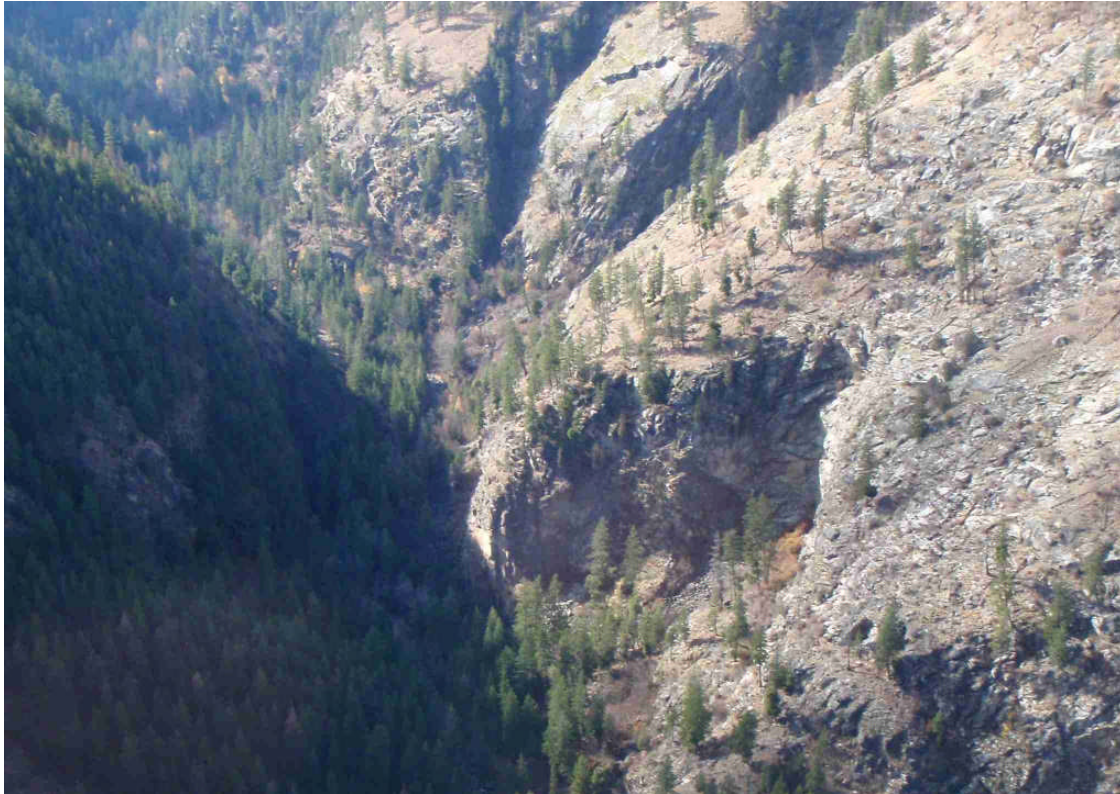
**Photo 5.** Eroding bedrock escarpment in lower Penticton Creek.

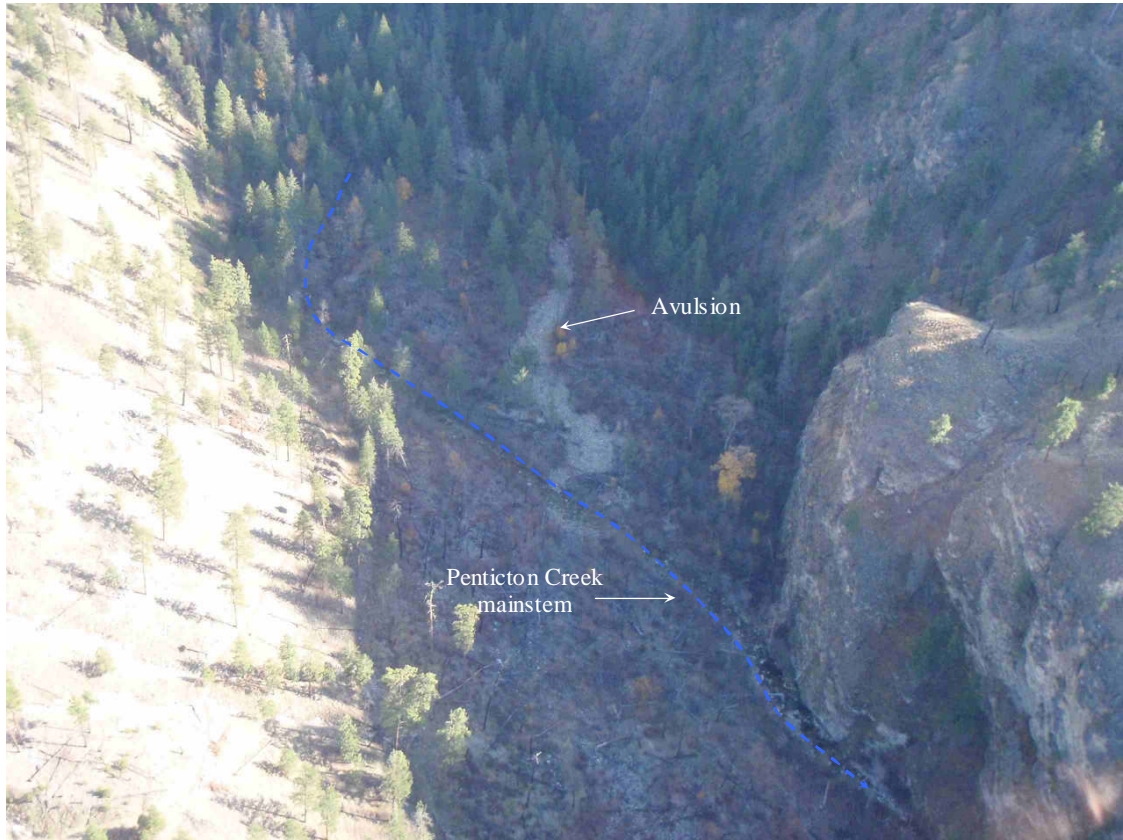
**Photo 6.** Penticton Creek channel avulsion on narrow floodplain in deeply incised reach upstream of Campbell Mountain Irrigation diversion reservoir. Note bedrock control on left bank.

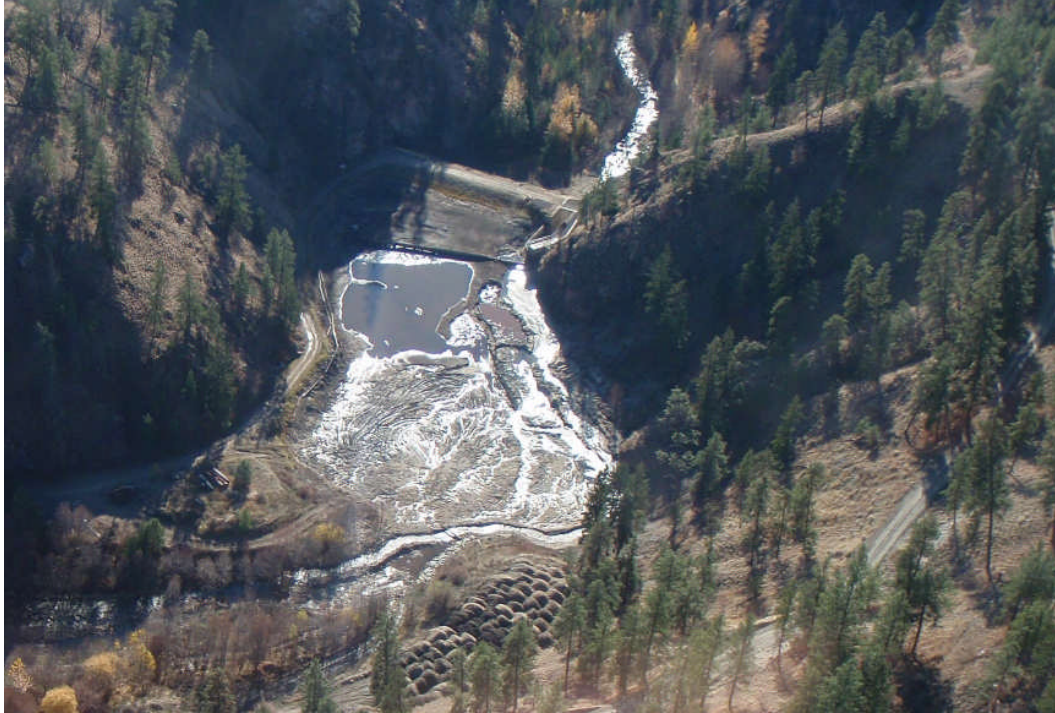
**Photo 7.** Intake reservoir for Campbell Mtn. irrigation diversion on Penticton Creek mainstem, largely emptied for maintenance and likely for removal of accumulated sediment from behind dam, which is stored to right of stream.

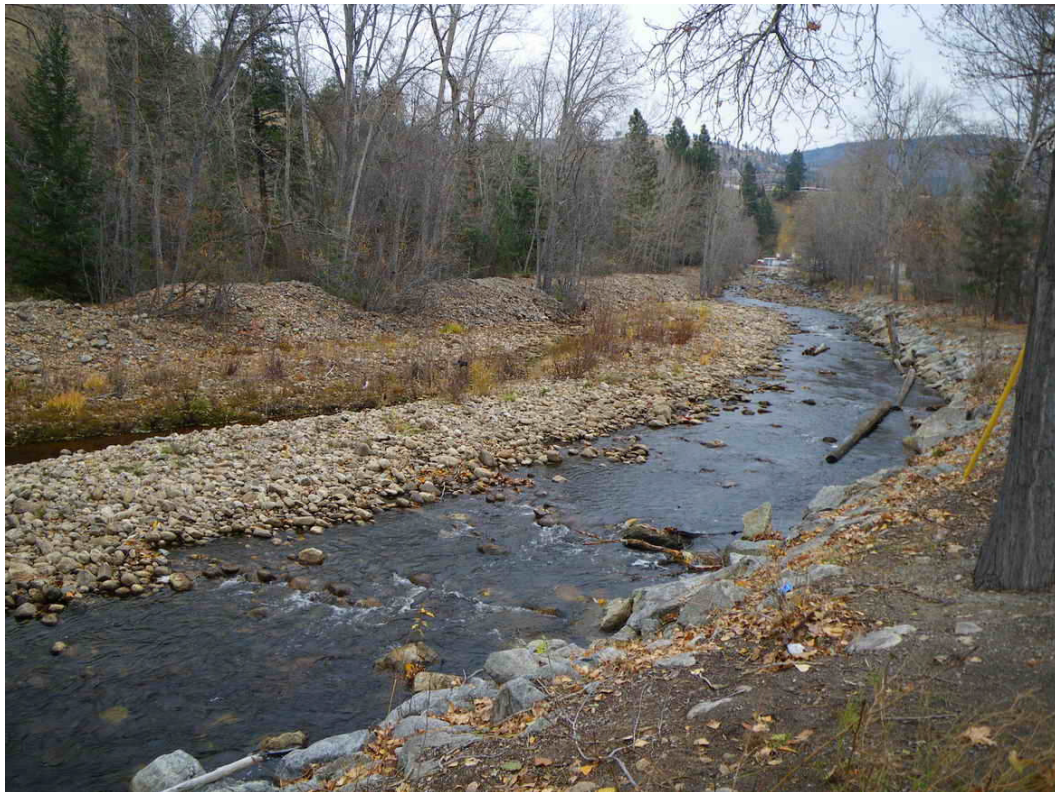
**Photo 8.** Channelized Penticton Creek on fan. Note dredged sediment stored on left bank.

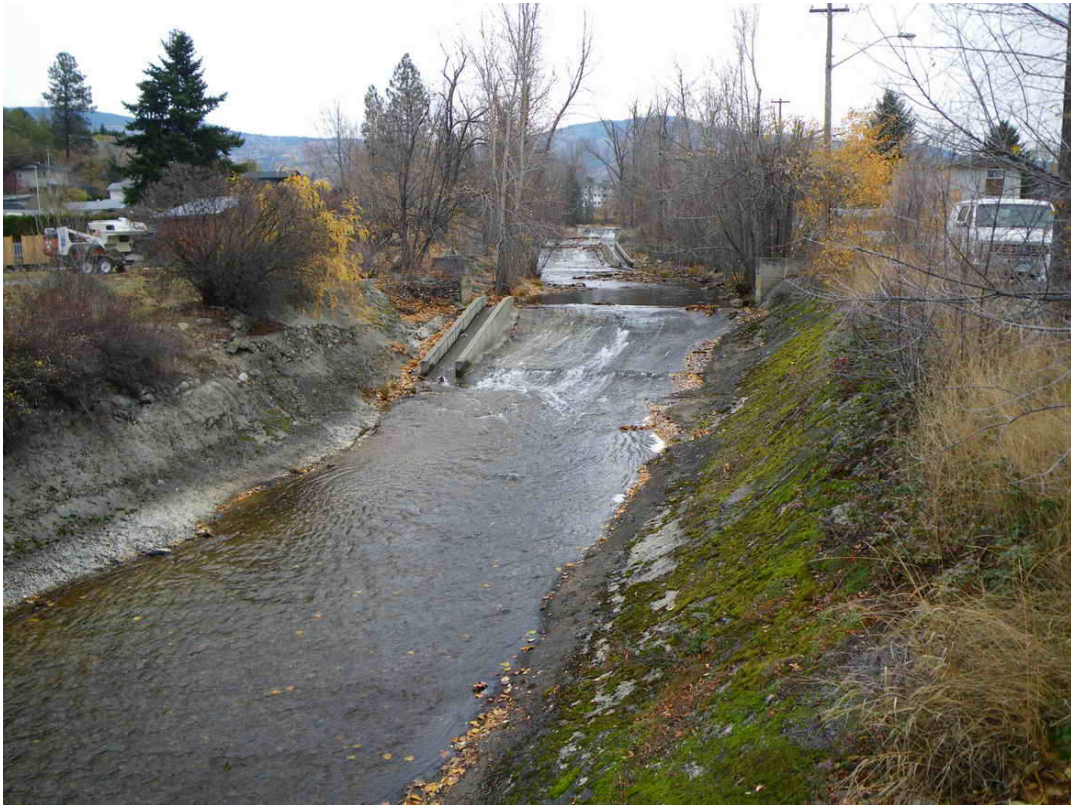
**Photo 9.** Concrete grade controls and channelization on the Penticton Creek fan.

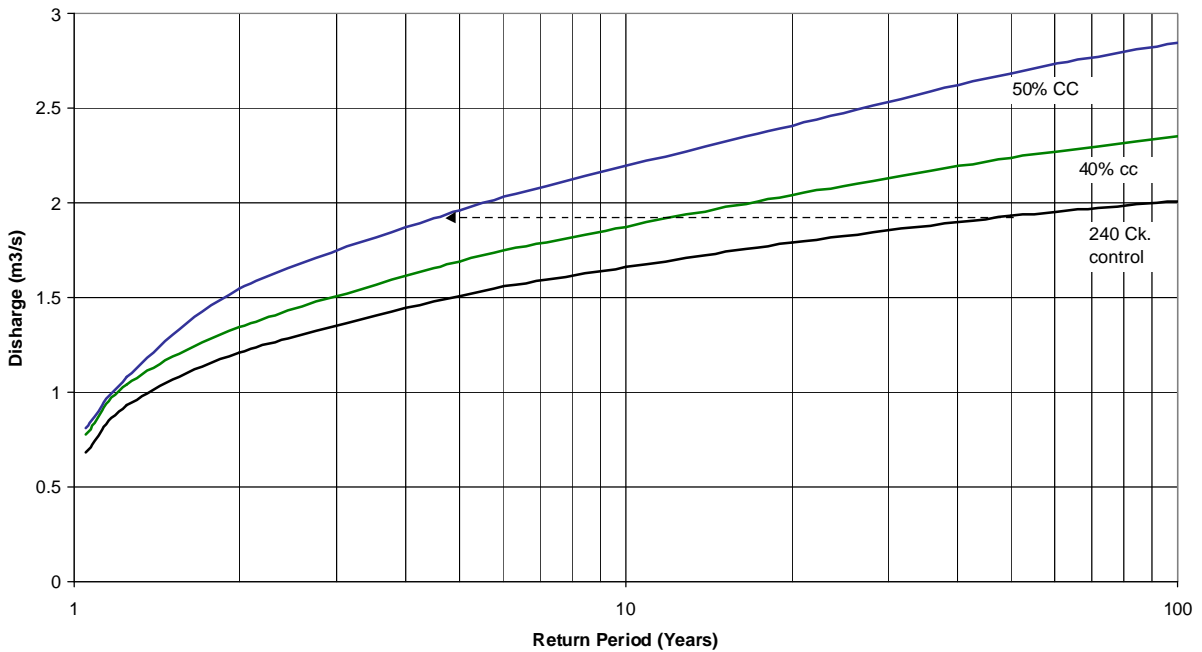
Figure C-1. Modelled flood frequency for 240 Creek, a 5km<sup>2</sup> tributary of Penticton Creek, with 40% and 50% clearcutting of upper watershed. With 50% clearcutting the 50 year flood would be expected to occur on average every 5 years. Data from Schnorbus *et al.* 2004.

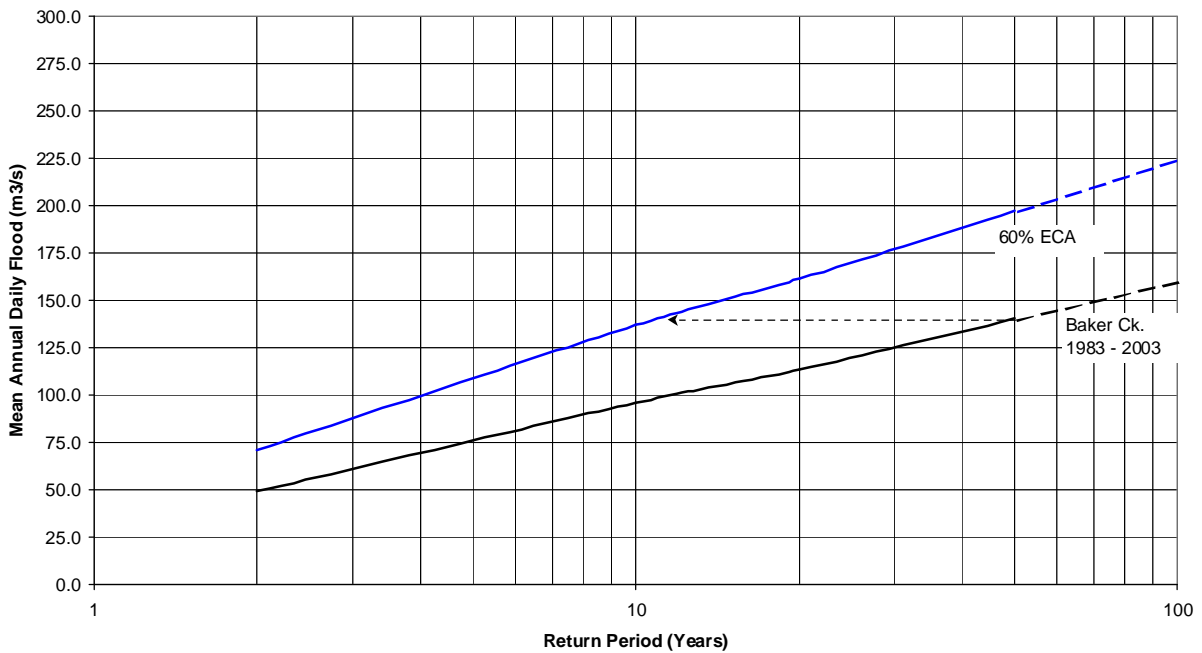
Figure C-2: Modelled flood frequency shift for Baker Creek (1570km<sup>2</sup>) with approximately 60% ECA, from clearcutting and MPB pine mortality. The 50 year flood becomes about the post-treatment 11 year flood. Data from FPB 2007.

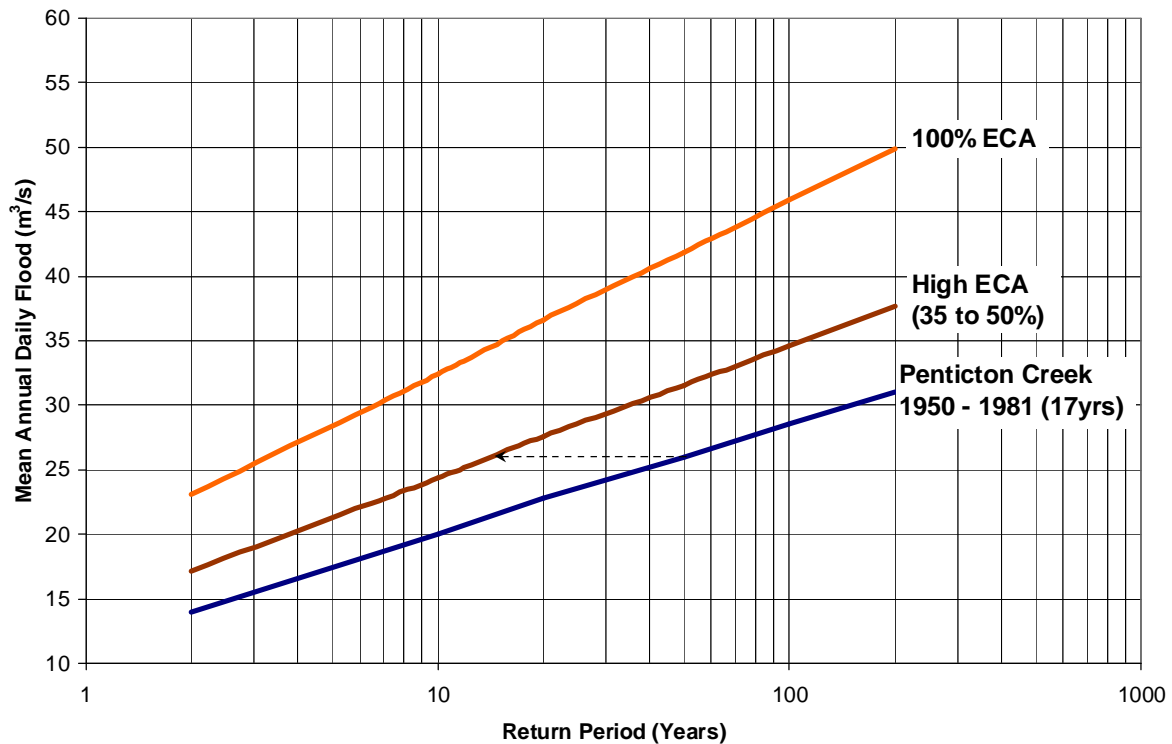
Figure C-3. Modelled flood frequency shift for Penticton Creek (uncontrolled), extrapolating from a “typical” Okanagan watershed (Allila et al., 2007) with a high (35 to 50%) ECA. The historic 50 year flood becomes the 15 year post-treatment flood for the 15 to 20 year period of sustained high ECA
