**Re: Preliminary Sediment Management Review – Stoltz Slide and Block 51**

The following is our report on the project titled ‘Cowichan Sediment Source Inventory and Restoration Prescriptions’ under BCCF Contract No. N111531-4. This report was prepared by LGL Limited environmental consultants and Kerr Wood Leidal Associates Ltd., consulting engineers. The purpose of the project was to evaluate critical erosion sites on the Cowichan River, to review and comment on previous conceptual restoration designs that were developed for Stoltz Slide, to recommend an action plan for quantifying the relative contributions of sediment from each of the significant sources, and to recommend a potential stabilization strategy for the Stoltz Slide including a preliminary implementation budget. The work program for this project included office reviews and assessments of previous reports and aerial photographs, field reviews of three main sediment source areas (two at Block 51 and Stoltz Slide), and development of a rehabilitation design concept for Stoltz Slide.

## Overview Memorandum

**RE:** **COWICHAN RIVER**  
**Stoltz Slide Stabilization**  
**Preliminary Findings**  
**Our File 2211-001**

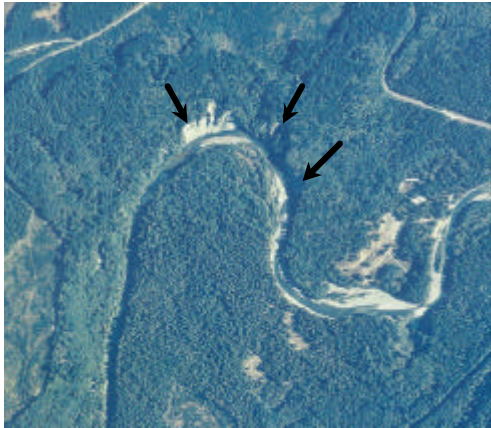
The Stoltz Slide is located on the left bank of the Cowichan River about 15 km west of Duncan, BC. The area of concern is the outside edge of a meander bend where a 30 to 40 m high deposit of glacial sediment is actively eroding. Seepage and overland runoff draining down the cutbank combined with erosion at the toe of the deposit has resulted in significant inputs of fine and coarse sediment to the Cowichan River. The cutbank appears to have gone through a cycle of activity and stabilization in the past half century. Upstream of the tight meander bend and eroding cutbank, the Cowichan River passes through Marie Canyon where it is incised into bedrock.

**Figure 1**  
1998 air photograph of Stoltz Slide area. Flow is from left to right. The arrows point to areas of active bank erosion.

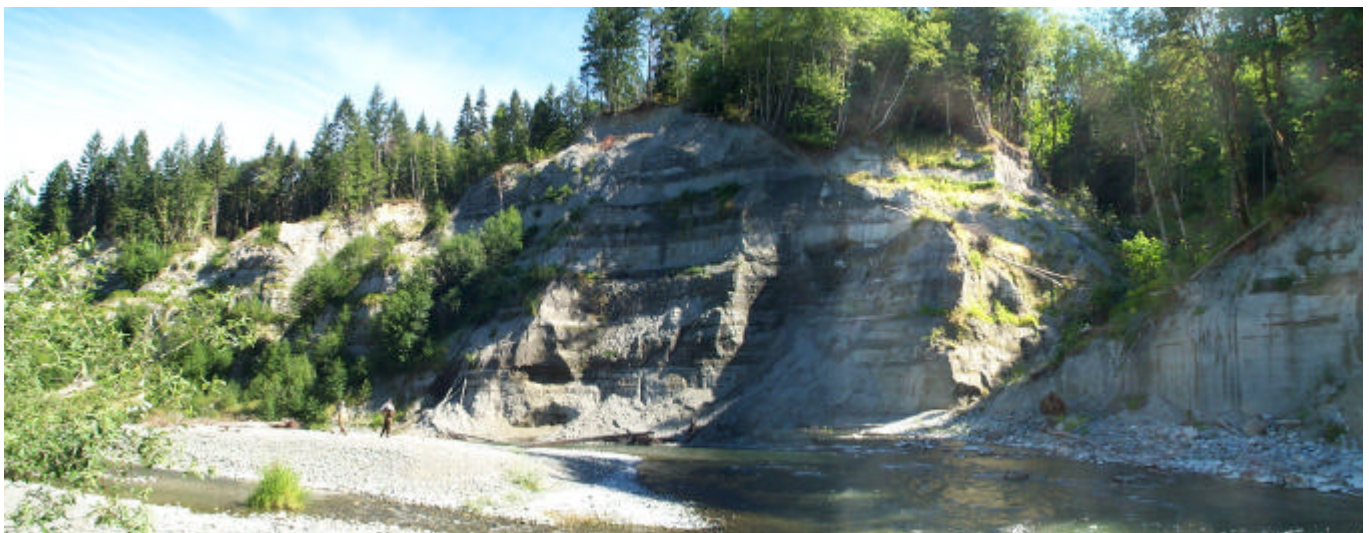
The air photograph review and site visit results indicate that the Stoltz Slide originates in a complex sequence of glacial fluvial and glacial lacustrine materials with visible thicknesses of up to 40 m. The bank stratigraphy consists of multiple layers of glaciolacustrine sediments (fine sand, silt and clay) interbedded with layers of fine sand as well as layers of coarser outwash material (sand, or sand and gravel). The slope has an average gradient of 70 to 80%. Erosion is occurring along a 600 m long section of the river. The average channel gradient through the site is approximately 0.35%.

**Figure 2.** Cutbank erosion at Stoltz Slide area. Flow is from left to right. Note the person on the gravel bar for scale. July 2004.

There is probably no large-size, deep-seated instability that extends back into the forest from the crest of the slope. Rather the process is a gradual retreat of an oversteepened erosional scar, with the slope instability a result of two main factors:

Slope failures appear to originate in the uppermost and thickest layer of glaciolacustrine material, which comprises the majority of the top 20 m of the slope. Failures and subsequent erosion of the soil debris have resulted in amphitheatre-shaped bowls along the crest of the slope. The observed bowls may originate from slumping, possibly rotational sliding, within the lacustrine sequence. These failures could be due to high pore pressures, possibly static liquefaction or even seismic induced liquefaction within loose, saturated sand lenses in the slope. Eroded material is delivered to the base of the slope where it is entrained by the river.

3. **Constructed Terrace with Bank Protection:** With a portion of the flow directed into the backchannel, the toe of the main cutbank area (about a 250 m length) is more easily stabilized. We recommend widening the channel in this location and that the excavated gravels and cobbles be placed at the toe of the cutbank to create a 2 to 3 m high terrace. The terrace could then be planted with willows to promote stability. The terrace could be 15 to 25 m wide and protected with riprap and large woody debris. The riprap could be buried with native sediment to provide self-revealing bank protection.

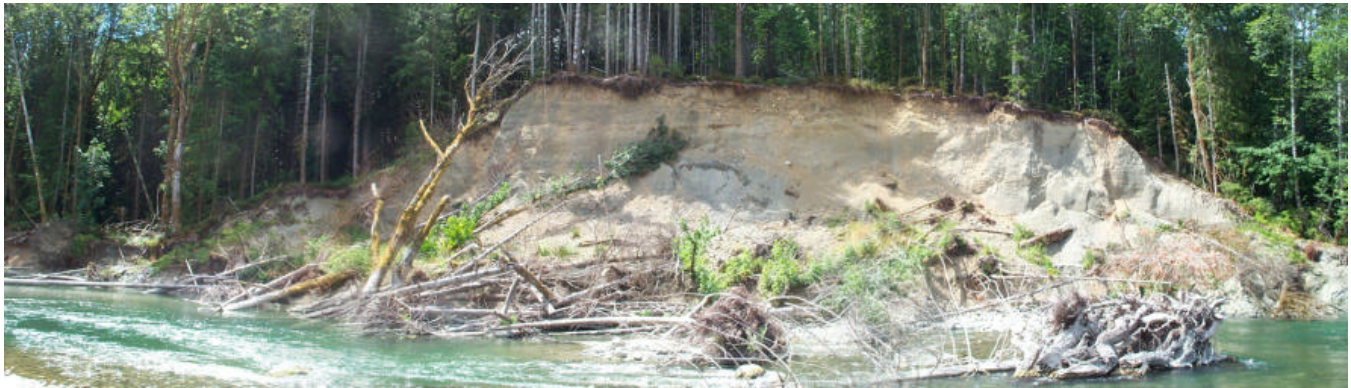
right bank of the river, a number of 15 to 20 m high cutbanks are being eroded. The lengths of the cutbanks vary from about 80 to 150 m.

**Figure 2.** Cutbank erosion at Block 51 area. July 2004.

Cutbank soils consists of layers of sand, and sand mixed with gravel and cobble that overlie 5 to 7 m of glaciolacustrine sediment (fine sand, silt and clay). Erosion from the coarser deposits at the top of the banks provide a source of bed material to the river, and coarse material tends to accumulate along the base of the slope where it is easily entrained into the river. Although the fine sand, silt and clay materials are exposed along the length of the cut-bank, erosion is often limited to the upstream-most section of the cutbank, where back-eddies tend to form.

If the sediment analysis indicates that stabilizing the cutbanks in Block 51 is feasible, then a phased approach is also recommended. After detailed investigation, banks in Block 51 could be stabilized using a pilot project approach so that success of techniques can be observed and adjustments made. Preliminary costs for a typical 4 m high bank 50 m long could be in the \$50,000-75,000 range.
