San Juan River Watershed: Fish Passage Assessments - January 2011

Funding Source: Land Based Investment Program
Project No. 4031504

Citation: Musial, B., S. Hamilton and M. C. Wright. 2011. San Juan River Watershed: Fish Passage Assessments. FIA Project No. 4031504. Unpublished consultant's report prepared for BC Timber Sales Strait of Georgia Business Area

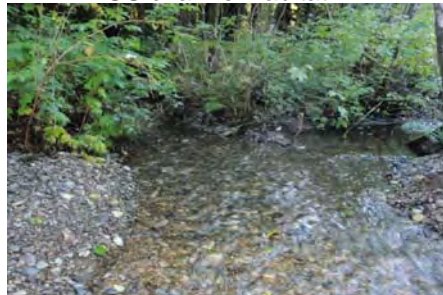
US channel habitat

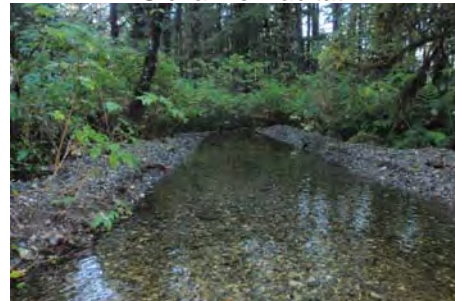
DS channel habitat

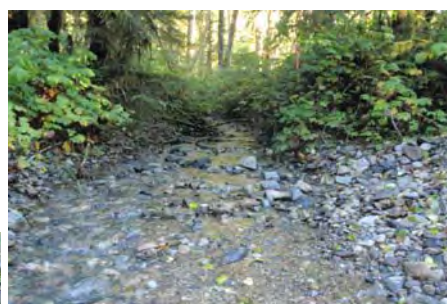
US channel habitat

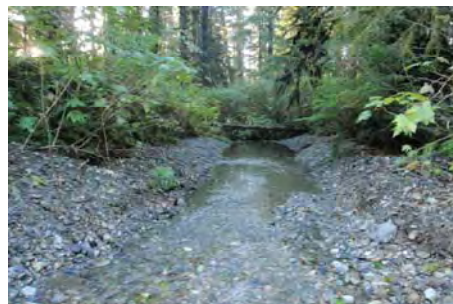
DS channel habitat

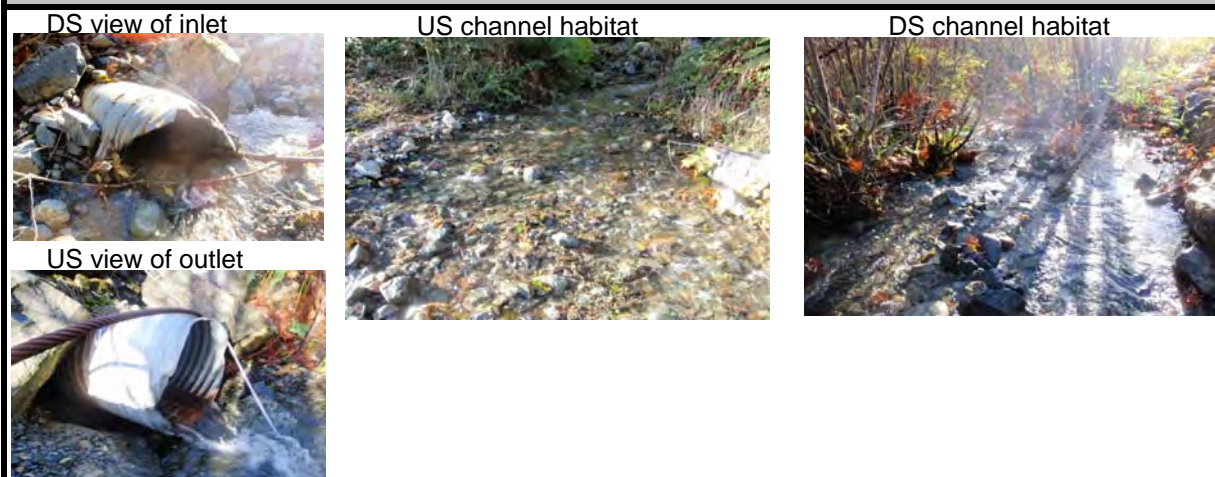
Photo Plates

Upstream Habitat Notes:	Downstream Habitat Notes:
Suitable spawning substrate, not a lot of flow so it may dry up during dry periods.	Good spawning substrate, braided channel.
Banks under developed.	Channel drains into Harris Creek.
Culvert is too small for channel.	A thorough assessment downstream should be conducted prior to replacement. DS barriers and/or gradient may act as fish barrier.
Assessment of US habitat quality strongly recommended prior to replacement or removal.

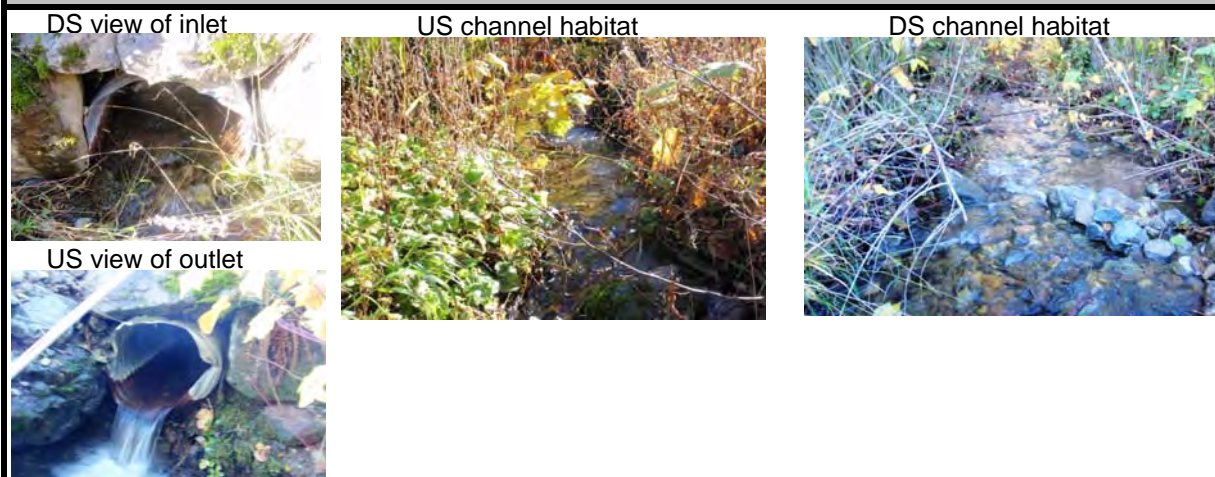
Photo Plates

Upstream Habitat Notes:	Downstream Habitat Notes:
Narrow channel with good spawning substrate.	Nice spawning substrate with large cobble, narrow channel may become quite dry during low flows.
Small cascade visible.	Downstream crossings all bridges in good working order. HGI could be higher.
Assessment of US habitat quality strongly recommended prior to replacement or removal.	A thorough assessment downstream should be conducted prior to replacement. DS barriers and/or gradient may act as fish barrier.

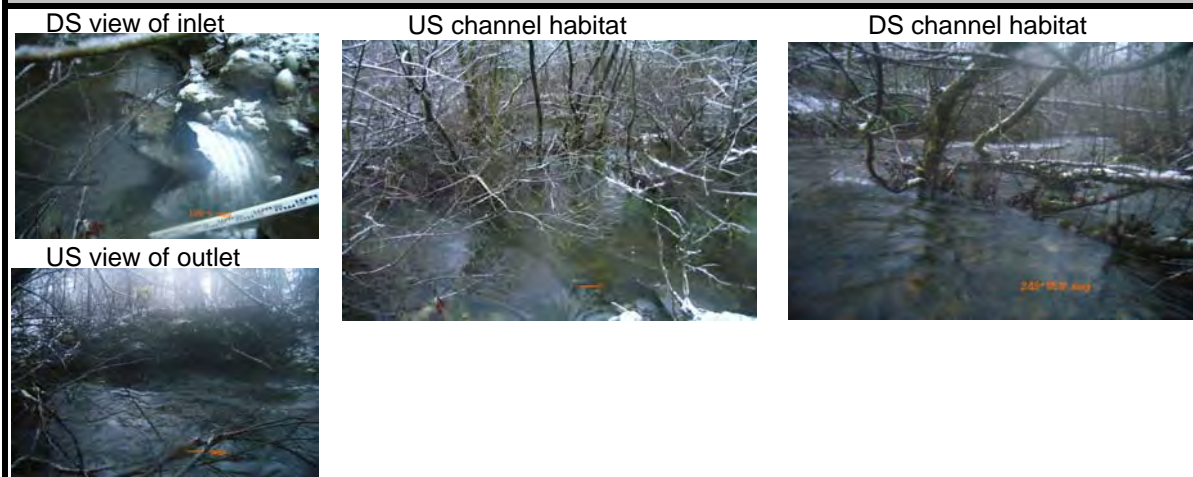
Photo Plates

Upstream Habitat Notes:	Downstream Habitat Notes:
No defined channel. Undefined source.	Well defined cutbanks
Looks to be a flooded area due to high flow.	Good gravel and cobble substrate for spawning.
Assessment of US habitat quality strongly recommended prior to replacement or removal.	A thorough assessment should be done before considering removal or replacement; DS barriers and/or gradient may act as a fish barrier.

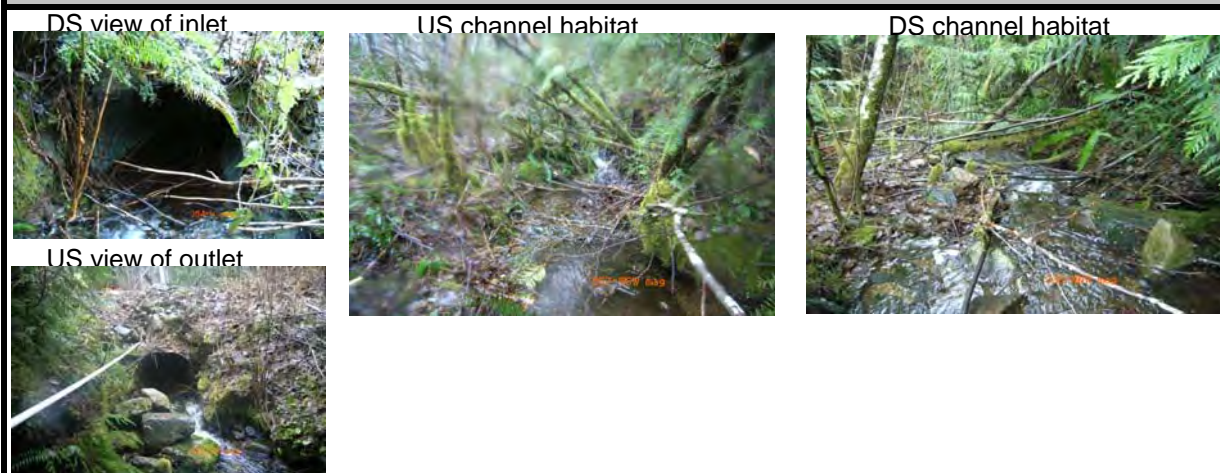
Photo Plates

Upstream Habitat Notes:	Downstream Habitat Notes:
Lots of woody debris jams impeding flow. Could get really low in summer.	Good mix of boulder and gravel substrate.
Lots of bedrock showing.	Almost 100% overhanging vegetation.
No real channel definition.	A thorough assessment should be done before considering removal or replacement; DS barriers and/or gradient may act as a fish barrier.
Assessment of US habitat quality strongly recommended prior to replacement or removal.

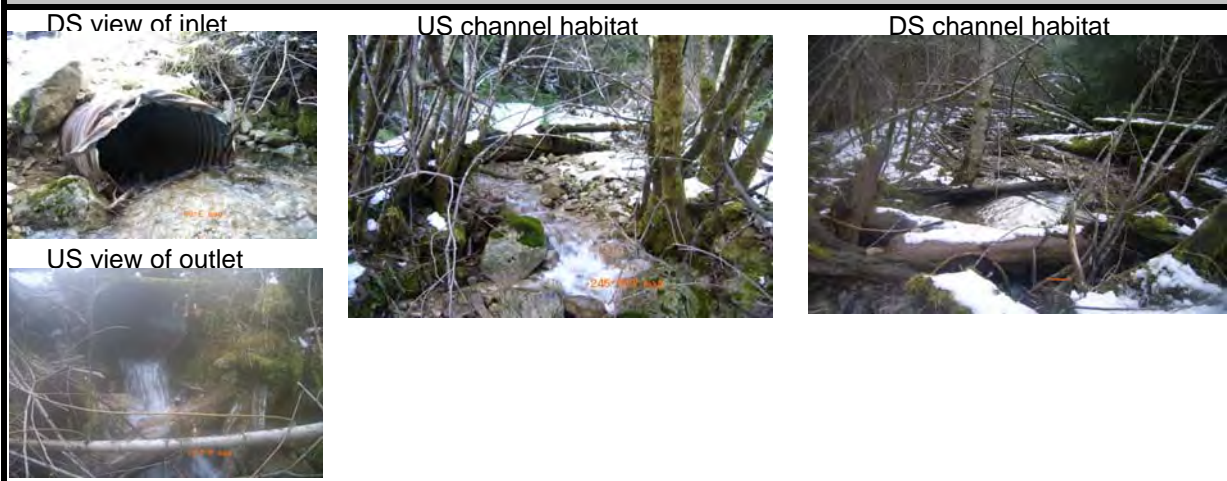
Photo Plates

Upstream Habitat Notes:	Downstream Habitat Notes:
Narrow and shallow channel.	Pool leading to a riffle.
Approximately 15% gradient, increasing upstream.	Larger cobble dominating substrate. Some LWD and over hanging vegetation.
LWD and overhanging vegetation present.	A thorough assessment should be done before considering removal or replacement; DS barriers and/or gradient may act as a fish barrier.
Assessment of US habitat quality strongly recommended prior to replacement or removal.

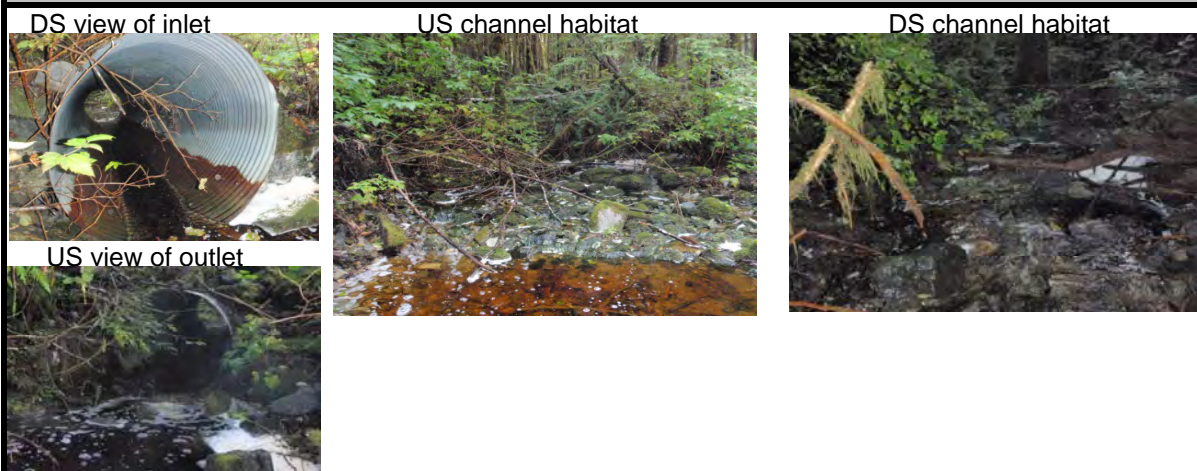
Photo Plates

Upstream Habitat Notes:	Downstream Habitat Notes:
Steep cascades-likely gets steeper further uphill.	Bedrock exposed throughout channel.
	Channel is a fish-inferred tributary to a fish-observed main branch.
Assessment of US habitat quality strongly recommended prior to replacement or removal.	A thorough assessment downstream should be conducted prior to replacement. DS barriers and/or gradient may act as fish barrier.
