***CHEAKAMUS RIVER  
Cheakamus Off-River Channel Development: "Dave's Pond Extension"***

Cheakamus River Off-Channel Rehabilitation 2001-2002

BCH 01.LM.17

Victor Elderton  
North Vancouver Outdoor School  
School District 44, British Columbia  
October, 2001

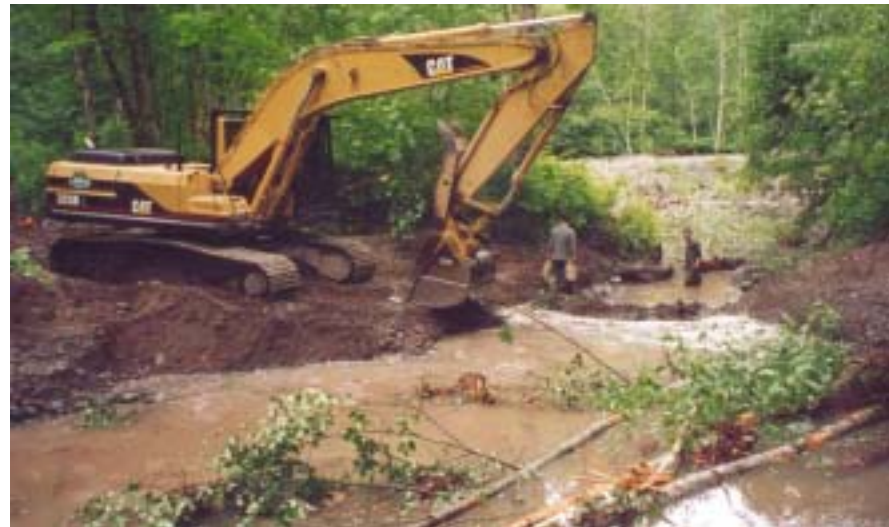
2

**Figure 2.**  
*Moving an isolation barrier between new work (foreground) and existing habitat; and changing from earthworks to sandbags*

The equipment operators excavated habitat isolated from existing habitat by leaving the connecting excavations while completing new pond grading and sloping for the expansions. In the few instances where expansion occurred in the existing pond, the pond system was isolated from the Cheakamus River system.

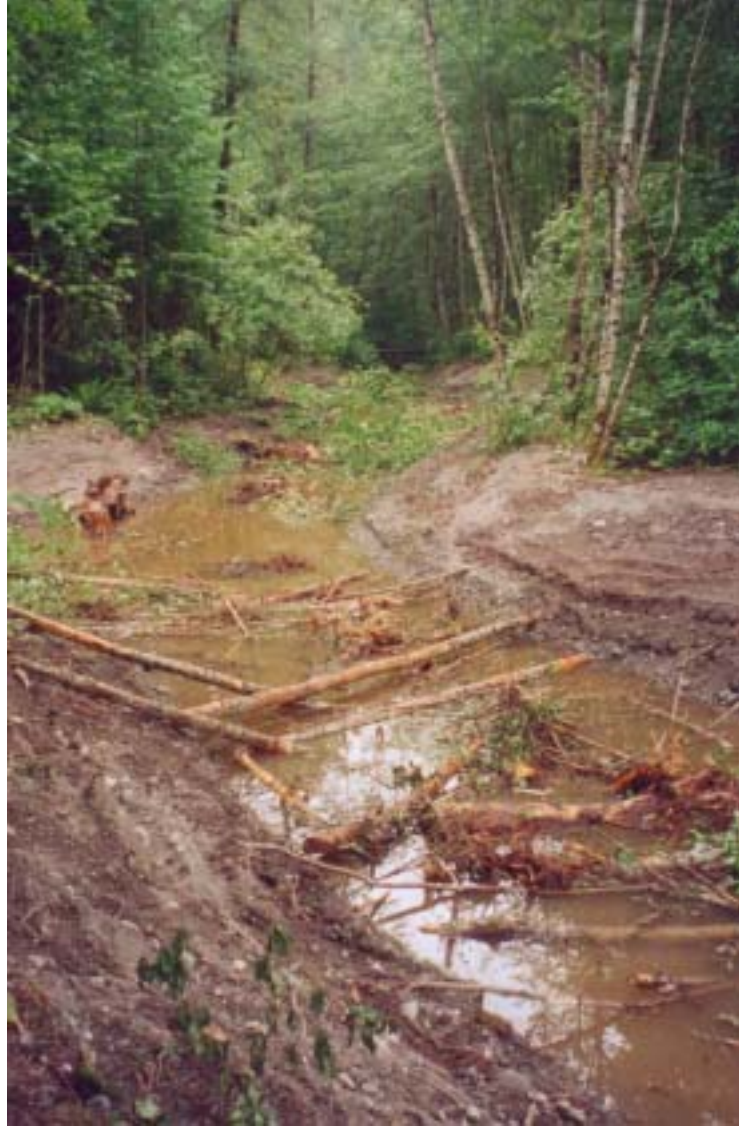
3

**Figure 3.**  
*Recently  
completed  
habitat*

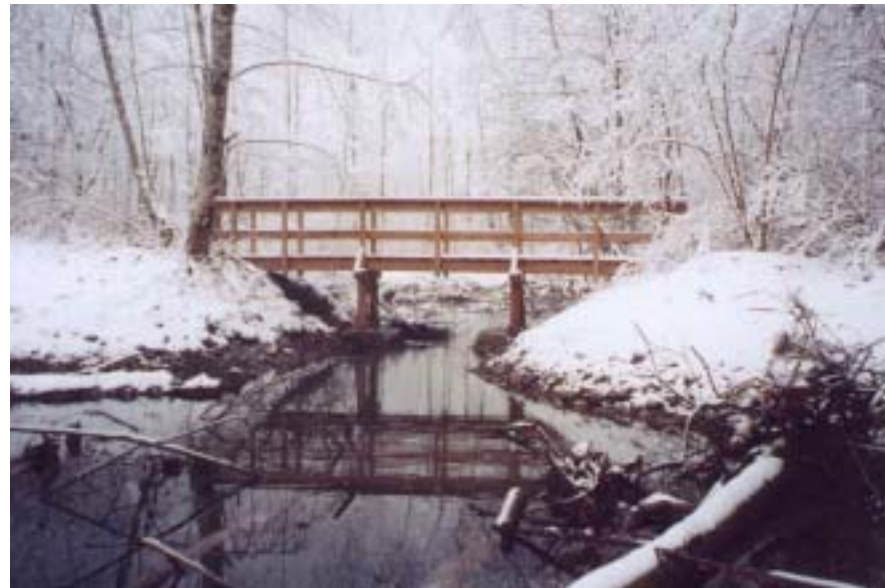
5

**Figure 5.**  
Bridge close-up

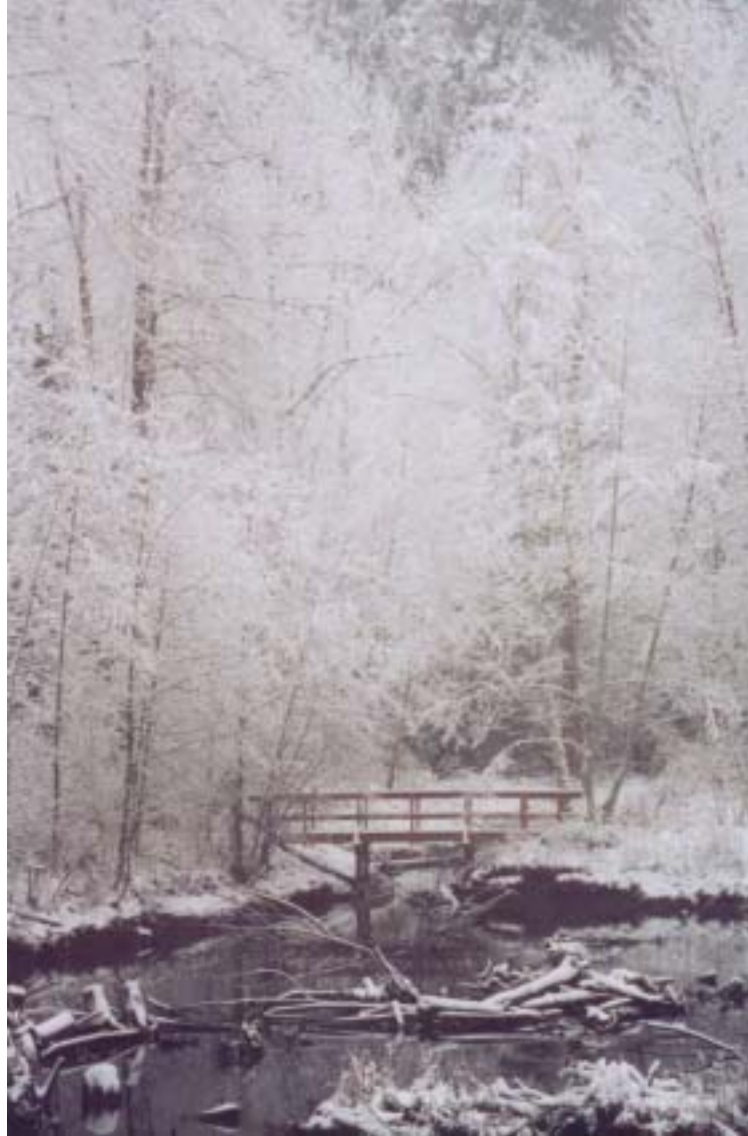
6

**Figure 6.**  
*Bridge in  
service*
