ALOUETTE RIVER - HABITAT RESTORATION EFFECTIVENESS MONITORING

2009 PROJECT FINAL REPORT

BCRP Project # 09.ALU.03

BCCF Project Report # 03-2009

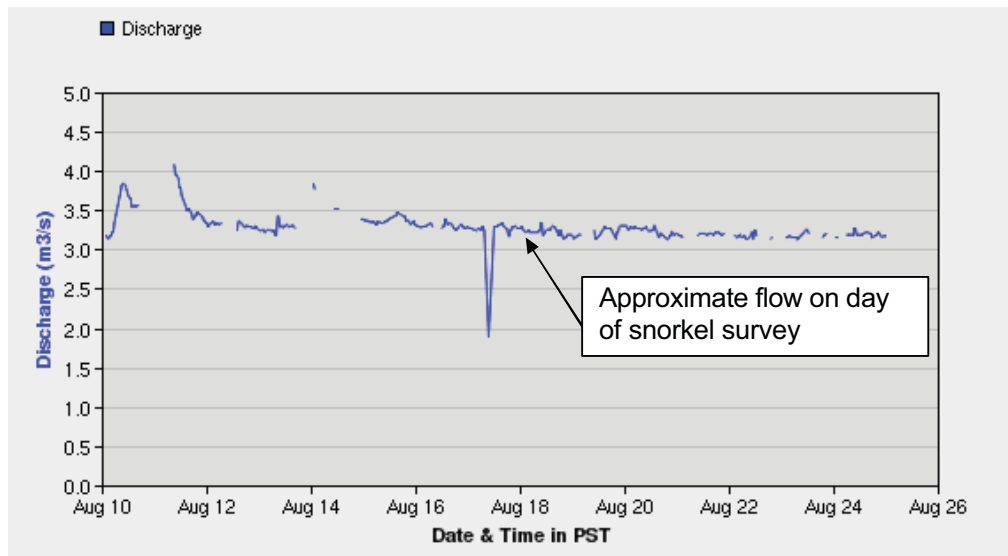
Figure 5. *Water Survey of Canada* water discharge reading for Alouette River – near Haney, BC (station 08MH005). The x-axis range encompasses the period when the summer snorkel survey was conducted (August 18, 2009).

A water discharge graph is provided to illustrate flows that were experienced during the summer and winter swims (figure 5 and 6). Water discharge data has been acquired from the *Water Survey of Canada* website; http://www.wateroffice.ec.gc.ca/graph/graph_e.html?stn=08MH005 (Alouette River near Haney (08MH005)), data has not yet been calibrated by Environment Canada.

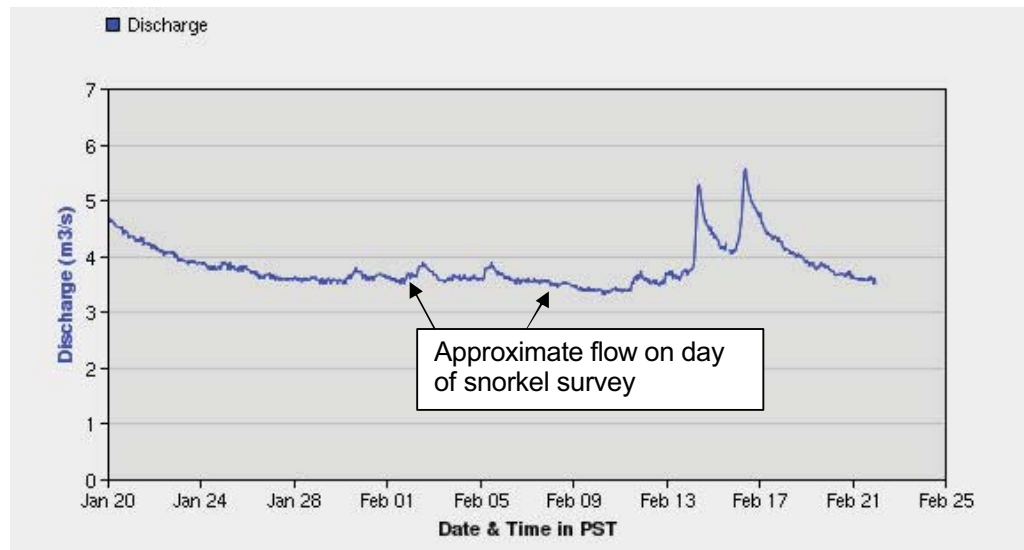
Figure 6. *Water Survey of Canada* water discharge reading for Alouette River – near Haney, BC (station 08MH005). The x-axis range encompasses the period when the winter snorkel survey was conducted (February 02 and 08, 2010).

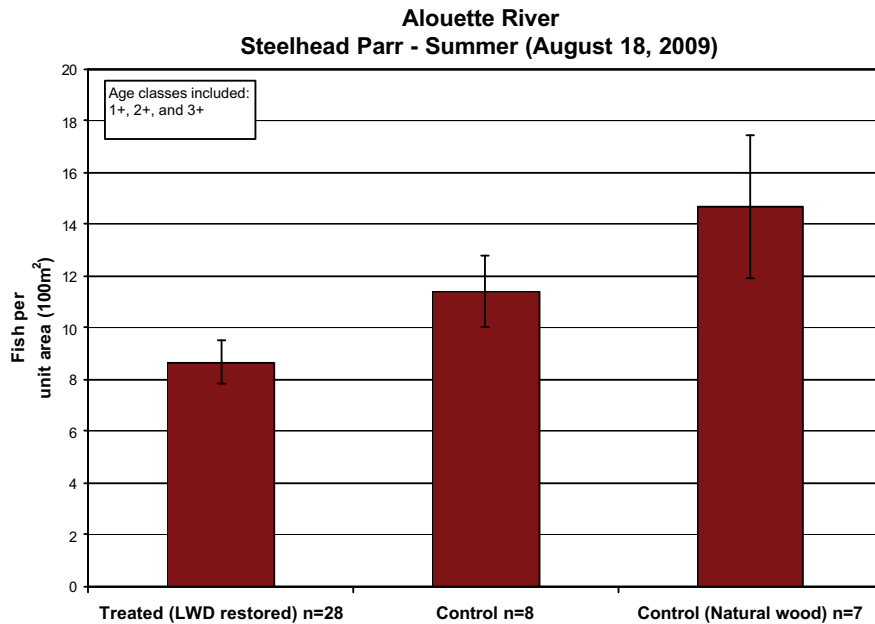
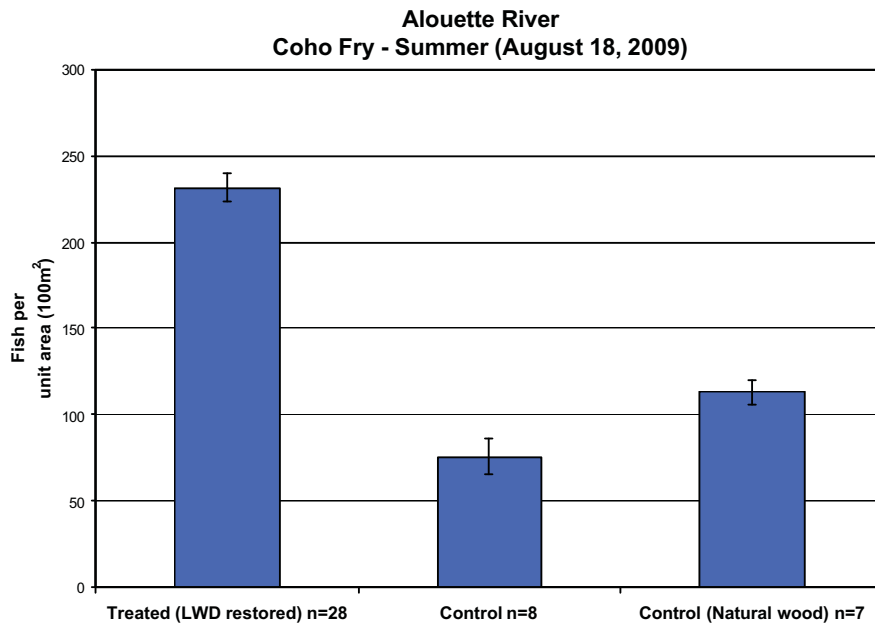
Figure 7 and Figure 8. Summer day time snorkel survey fish abundance estimates (August 2009). Steelhead parr include all 1+, 2+, and 3+ age class. Results are presented per 100m² unit area. Error bars represent "1" standard error.

In the summer, approximately 73% of juvenile salmonid abundance was associated with LWD treated sites relative to the control sites (not including natural wood control). The majority of this abundance was due to high coho fry abundance. The combined coho fry and steelhead parr abundance was 240/100m² in LWD sites, compared to 87/100m² in control sites.

A significant difference was experienced between study types of wood restored and both control study types (control and natural wood). Steelhead parr abundance, in the summer months showed a significant difference between the natural wood control, and the wood treated and control sites (table 1 and 2, and figure 7). This indicates a greater preference of natural wood to that of the wood treated and control sites. A significant difference was also experienced with coho preferring wood treated sites to that of the control and natural wood control (table 1 and 2, and figure 8).

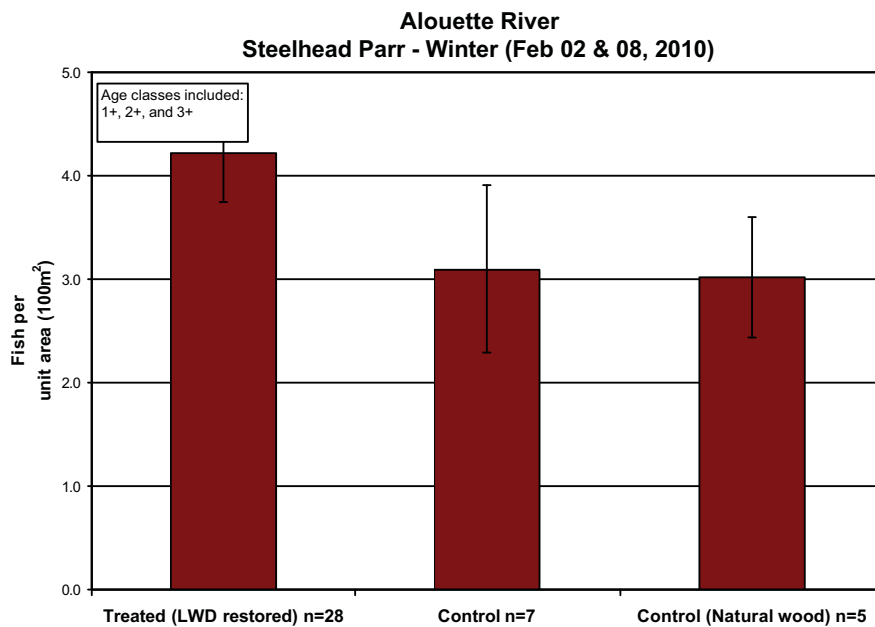
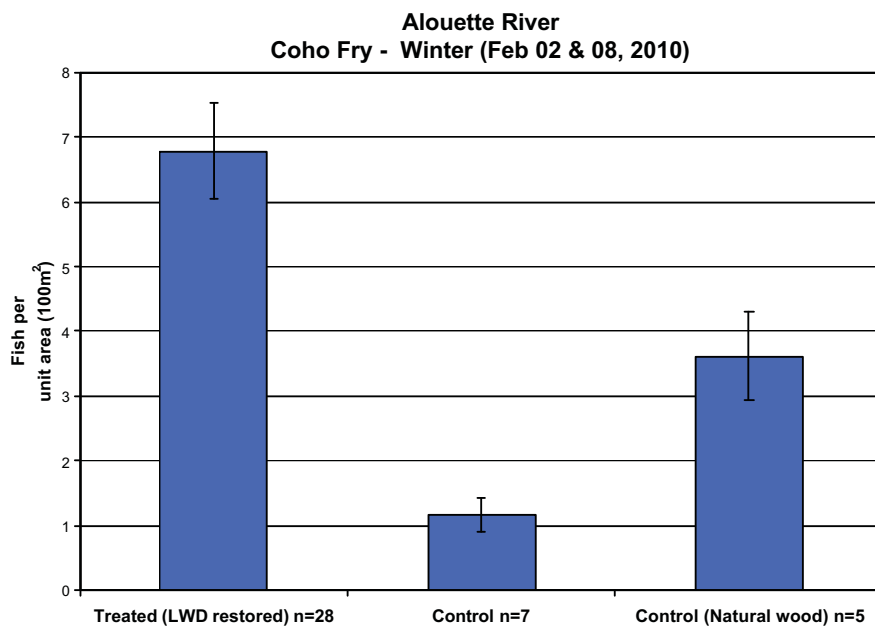
Figure 9 and Figure 10. Winter night-time snorkel survey fish abundance estimates (February 2010). Steelhead parr include all 1+, 2+, and 3+ age class. Results are presented per 100m² unit area. Error bars represent "1" standard error.

Identically, in the winter, 73% of juvenile salmonid abundance was associated with LWD treated sites relative to the control (not including natural wood control). The combined coho and steelhead abundance was 11/100m² in LWD sites, compared to 4/100m² in control sites for the winter survey.

The abundance results from the winter survey do not indicate any significant difference amongst the study types for steelhead parr (table 1 and 2, and figure 9). Coho fry production in the control site (winter) was significantly less than the fry inhabiting either the wood treated or the natural wood control site; indicating a significant difference (table 1 and 2, and figure 10).
