ASSESSMENT OF GRAVEL QUANTITY/QUALITY/STABILITY AND STRANDING RISKS IN REACH 1 OF THE JORDAN RIVER

FWCP SEED PROJECT 13.JOR.02

May 13, 2014

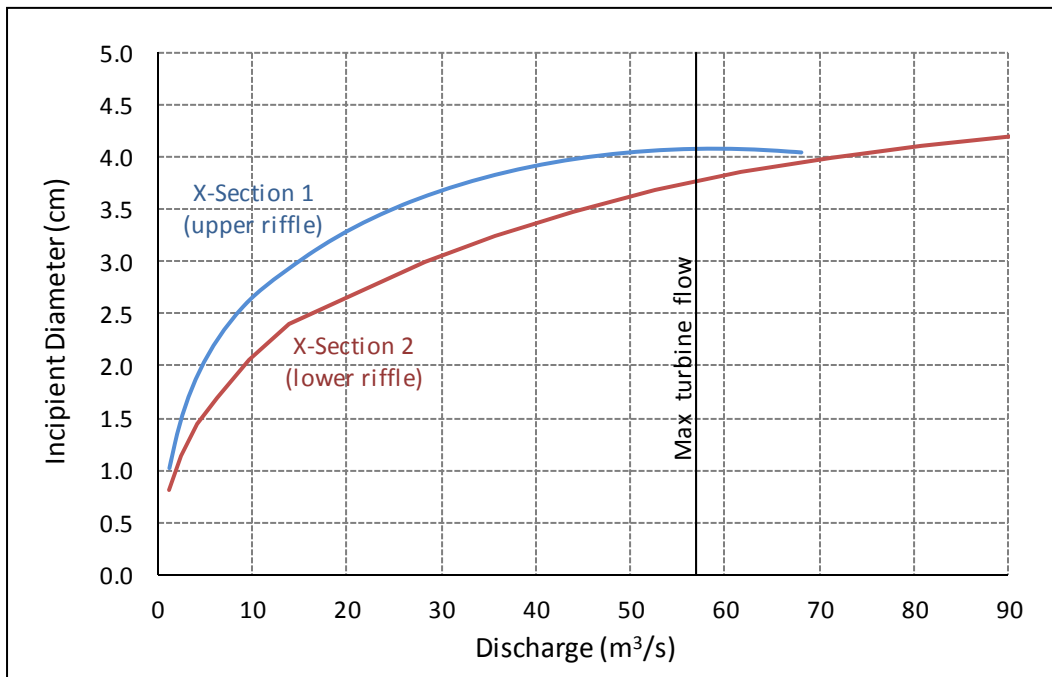
Figure 4. Incipient particle diameter as a function of discharge for Cross-Sections 1 (upper riffle) and 2 (lower riffle).

As mentioned above, gravel sized substrates appear to have been scoured from Reach 1 leaving an armoured layer of mostly cobbles and boulders. Given that habitats upstream of the tailrace have pockets of gravel and larger particles are not armoured, it is likely that the state of habitat in Reach 1 is due to the scour action of peaking flows from the Jordan River Generating Station. At full generation, these flows amount to 57 m³/s. Analysis of the cross-section data in WINXSPro suggests that the tractive force on the stream bed at this discharge is 4.1 kg/m² at XS1 and 3.9 kg/m² at XS2 (Appendix I). According to Newbury and Gaboury (1993), for non-cohesive bed materials greater than 1 cm in diameter, tractive force is equal to incipient diameter (the size in cm at which a particle is mobilized). Thus, a discharge of 57 m³/s is estimated to mobilize substrates ≤ 4.1 cm as XS1 and ≤ 3.9 cm at XS2. Figure 4 shows incipient diameter as a function of discharge for each cross-section (based on data from Appendix I). Visual observations suggest that these incipient diameters may be an underestimation of particle sizes mobilized by generation flows. Possible explanations for this are the repeating nature of generation flows, or perhaps a surge effect from the sudden release of a large amount of water.

The presence of a 918 m² bed of gravel with a relatively high percentage of particle sizes less than 4.1 cm is likely due to its location on the inside of curvature of the turbine outflows. The behaviour of these outflows is to shoot across to the opposite bank at a slight downstream angle. The opposite bank then redirects the flows downstream. This configuration leaves an inside semicircle that does not experience the full forces of the turbine flows.

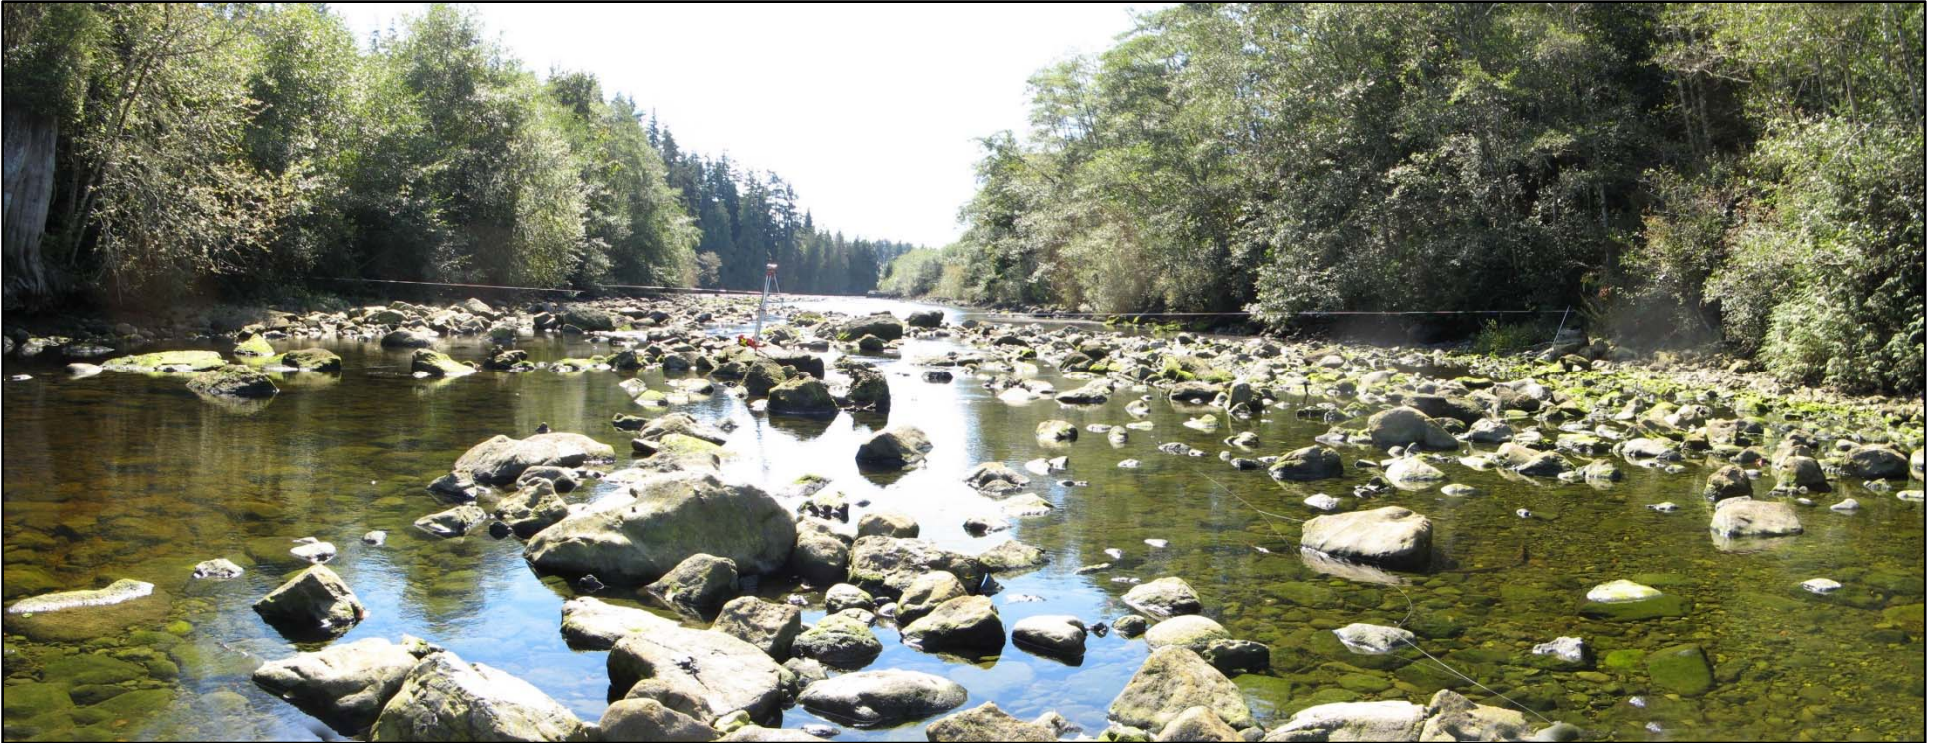
Photo 1. View looking downstream at Cross-Section 1 (upper riffle) (September 9, 2013, discharge 0.37 m³/s). The only location with any significant quantity of gravel in Reach 1 can be seen in the lower right of the photo. This section of gravel begins at the transect line and extends along the right side of the channel upstream for 60 m.

The third row in Table 1 shows the substrate composition of the one location in Reach 1 where a continuous patch of gravel was found. Composition of this site is unique with 50% of materials composed of small and large gravel. The site begins 80 m downstream of the tailrace, extends downstream by roughly 60 m, and has a width ranging from 12 – 21 m (Figure 2). The site was subdivided into a section with continuous gravel located along the right side, and a section where the gravel was patchier, located on the thalweg side. GIS computation indicated an area of 495 m² for the continuous gravel portion, and 423 m² for the patchy portion, for a combined area of 918 m². Quality of the gravel was judged to be only fair due to shallowness of the layer, and a moderate level of compaction as a result of intrusion of fines (15%). Nevertheless, generating station staff have observed spawning and salmon eggs at this site in previous years (Dwayne Walsh, Jordan River Generating Station, pers. comm.). Photos of the area and its gravel are included in Appendix II (Photos 1, 3, and 4).

Field surveys included a level and rod survey of one cross-section profile on each riffle, and a longitudinal thalweg profile from the top to the bottom of the study area. Locations of these profiles are shown in Figure 2, while results are illustrated in Figure 3. Channel geometry statistics generated using survey data and WINXSPRO software are provided in Appendix I. Photos of upper and lower transects are given in Appendix II (Photos 1 and 2).

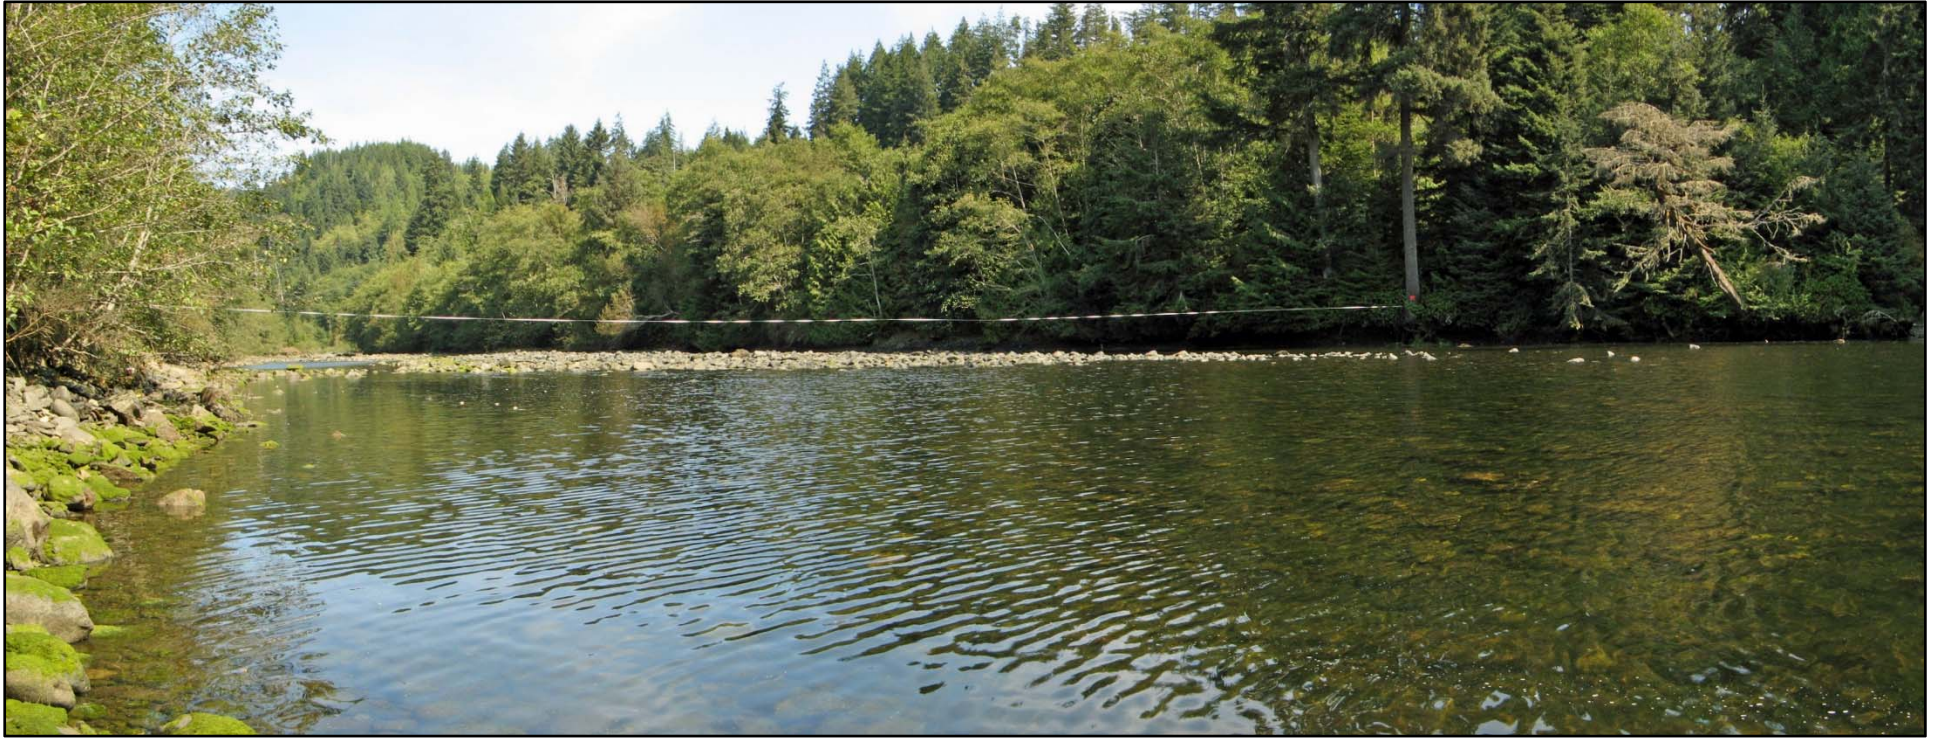
Photo 2. View looking upstream at Cross-Section 2 (lower riffle) (August 14, 2013). Unfortunately, an incoming tide had inundated the riffle by the time the photos were taken.

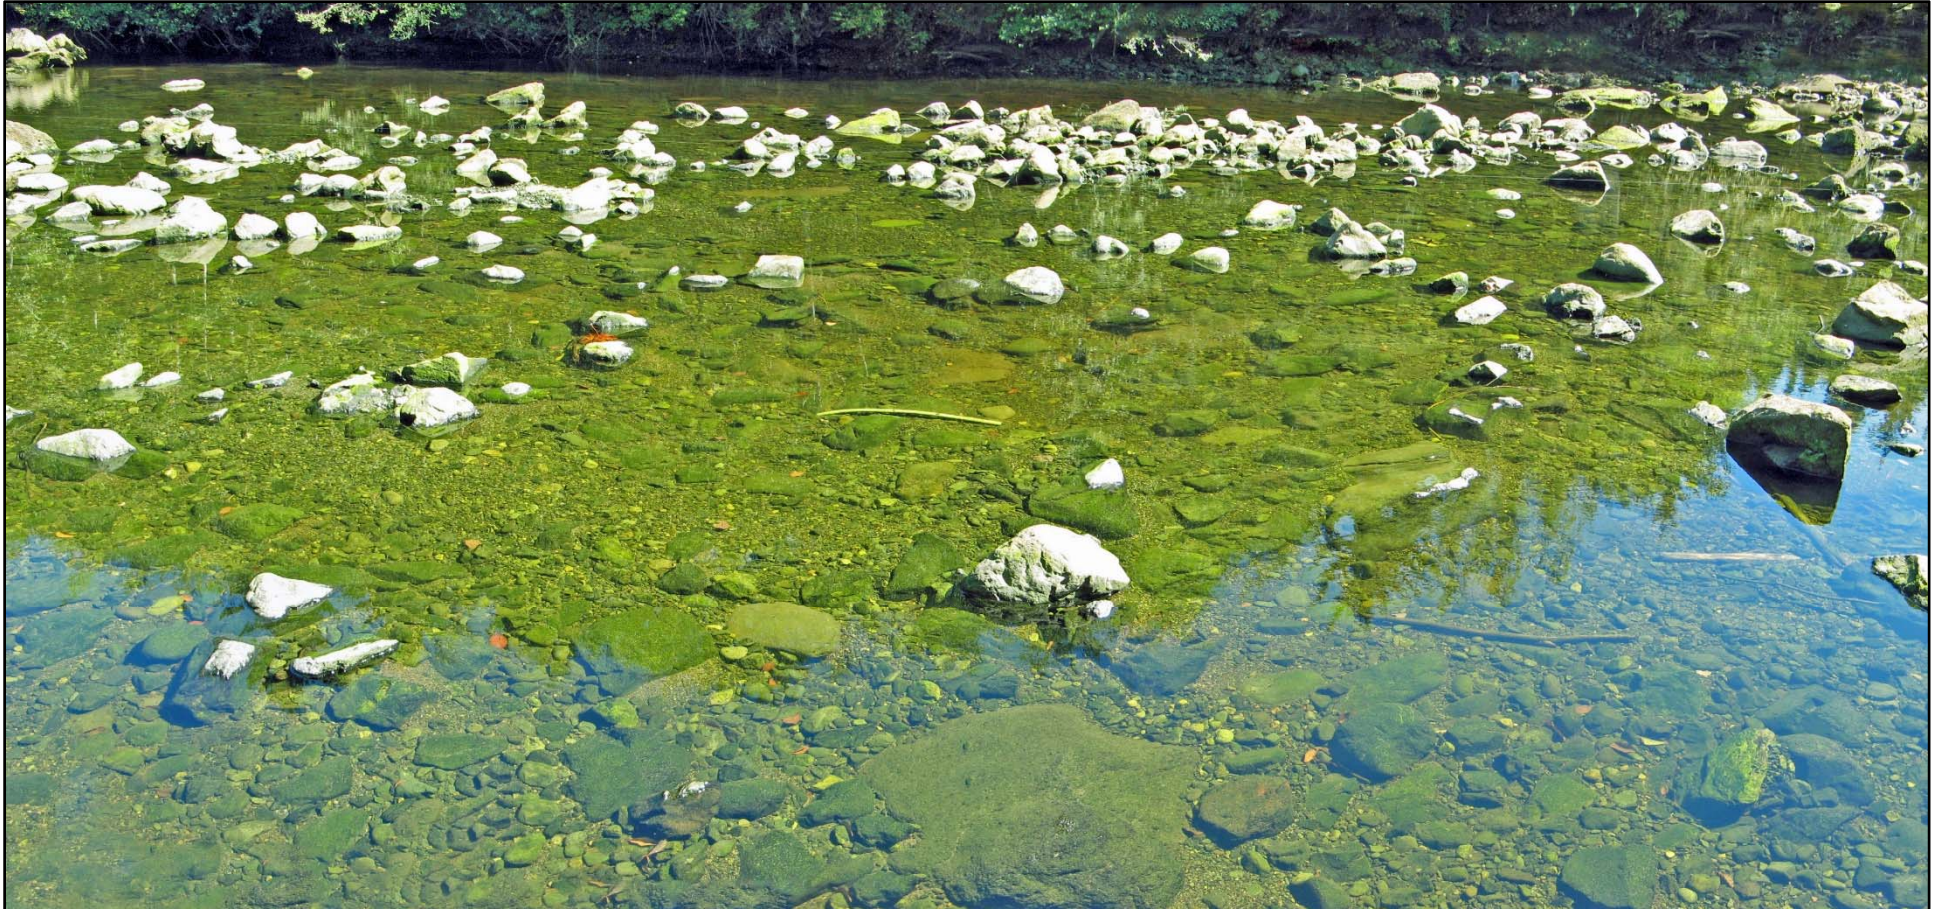
Photo 3. View of the section of continuous gravel from mid channel looking toward the right bank (September 9, 2013). Some spawning has been observed in this gravel in past years by the generating station staff.

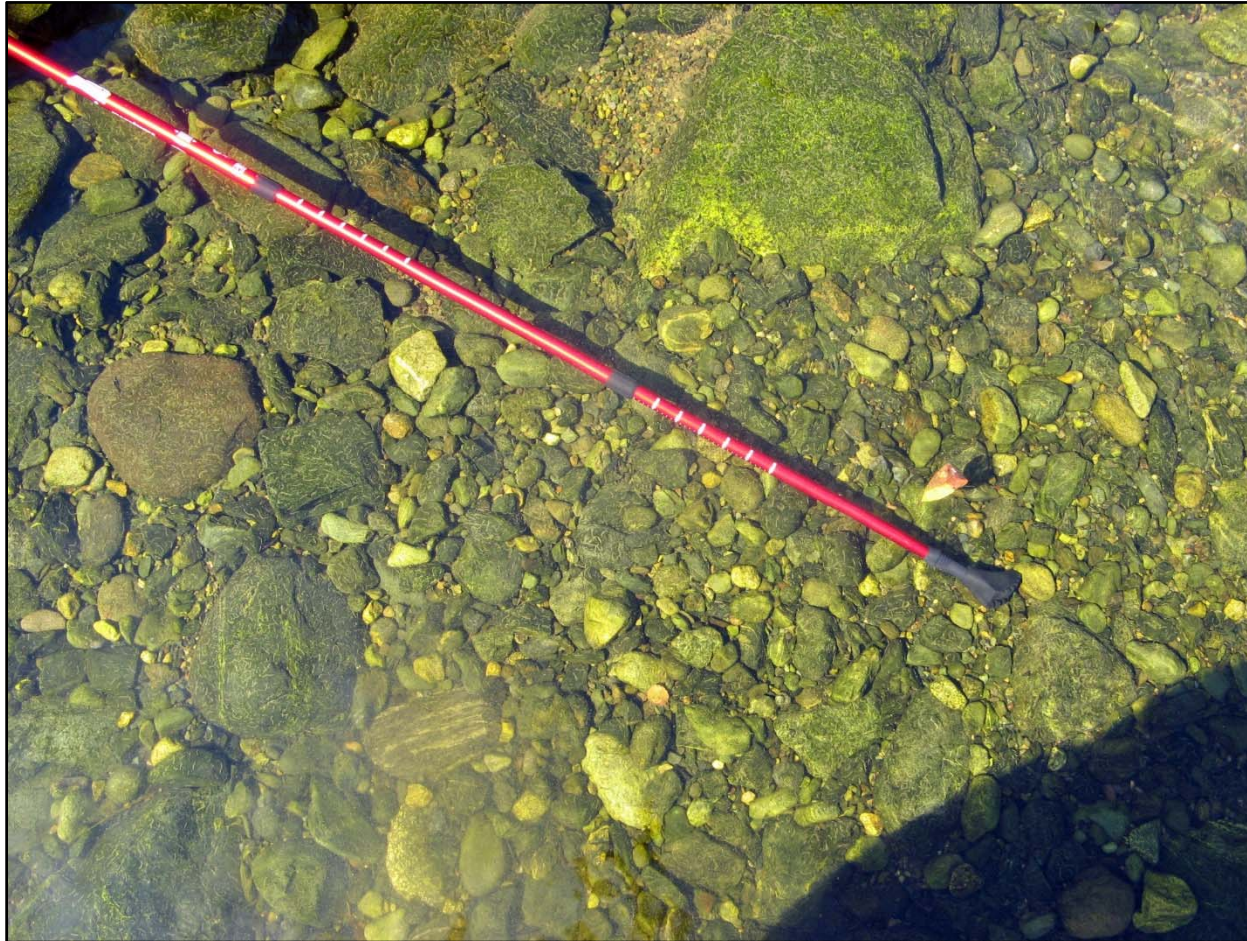
Photo 4. Close-up view of gravel composition of the continuous gravel pad (September 9, 2013). White bands on the walking stick are 2.5 cm.

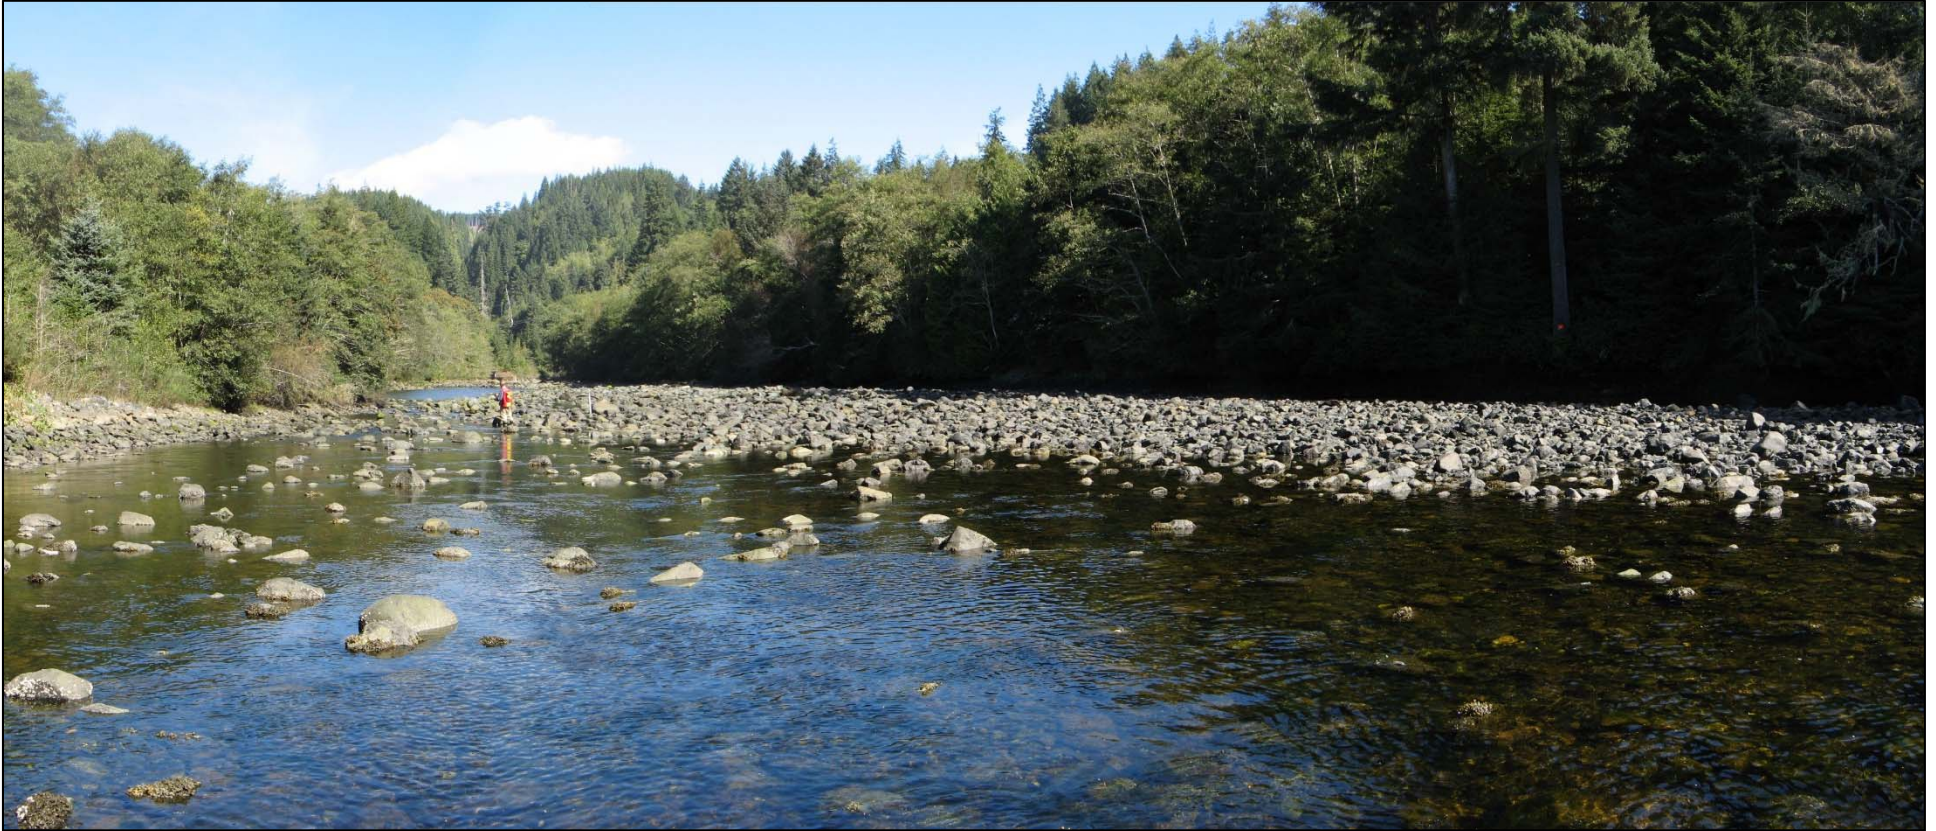
Photo 5. View looking upstream at the lower riffle on an incoming tide (September 9, 2013). On the east side of the channel (river left facing downstream) is a cobble/boulder bar that may pose stranding issues when the Jordan turbine is turned off and flows drop (if fish are in the river and if the tide is less than 2 m).

It is the impression of the author that the new base flows alleviate stranding concerns for eggs and alevins in the substrate. However, there are still likely to be stranding risks for rearing or downstream migrant juveniles that are swept onto higher elevation portions of bars when generation is turned on, and potentially left there when generation is turned off. The primary location of concern for this scenario is the cobble/boulder bar on the left (east) side of the lower riffle. This risk would only occur when tide heights are below the elevation of potential stranding sites. Field observations suggest that stranding would only be an issue at tidal heights of roughly ≤ 2 m. Adult stages are less likely to become stranded as they can more readily move to deeper habitats as flow recede. Photo 5 in Appendix II provides a view of the lower riffle bar area.

If in the future, stranding is deemed to be an issue, there are various means of minimizing impacts. Examples include: 1) introducing a ramp-down rate for the Jordan River generator, 2) timing the cessation of generation with higher tides, and 3) at the cessation of generation, maintain a small load so as to supply sufficient water until high tide.

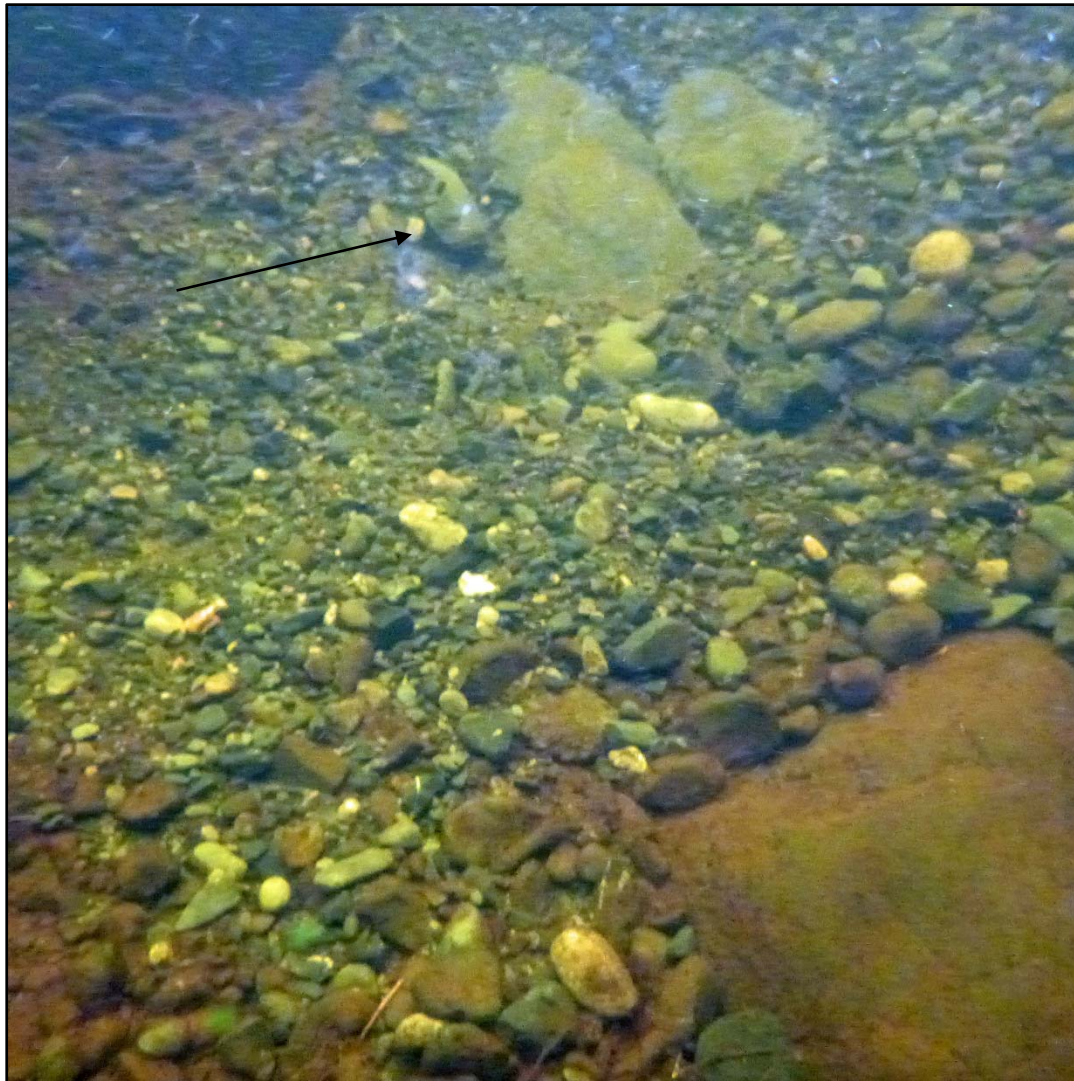
Photo 6. View of adult coho holding over an area of digging in Reach 2 (November 9, 2013 snorkel survey).

gauging station above the generating station was 0.497 m³/s. A total of 6 adult coho and 1 dead jack coho were observed, and signs of redd digging were observed at 3 locations. All 6 live coho were found in Reach 2, four of which were observed in association with some large LWD on the right bank opposite Unnamed Creek 3. The dead jack coho was found in the pool at the tailrace outflow (Reach 1). Photo 6 shows an adult coho holding over an area of digging while Photo 7 shows an adult holding among the rocks (Appendix II).

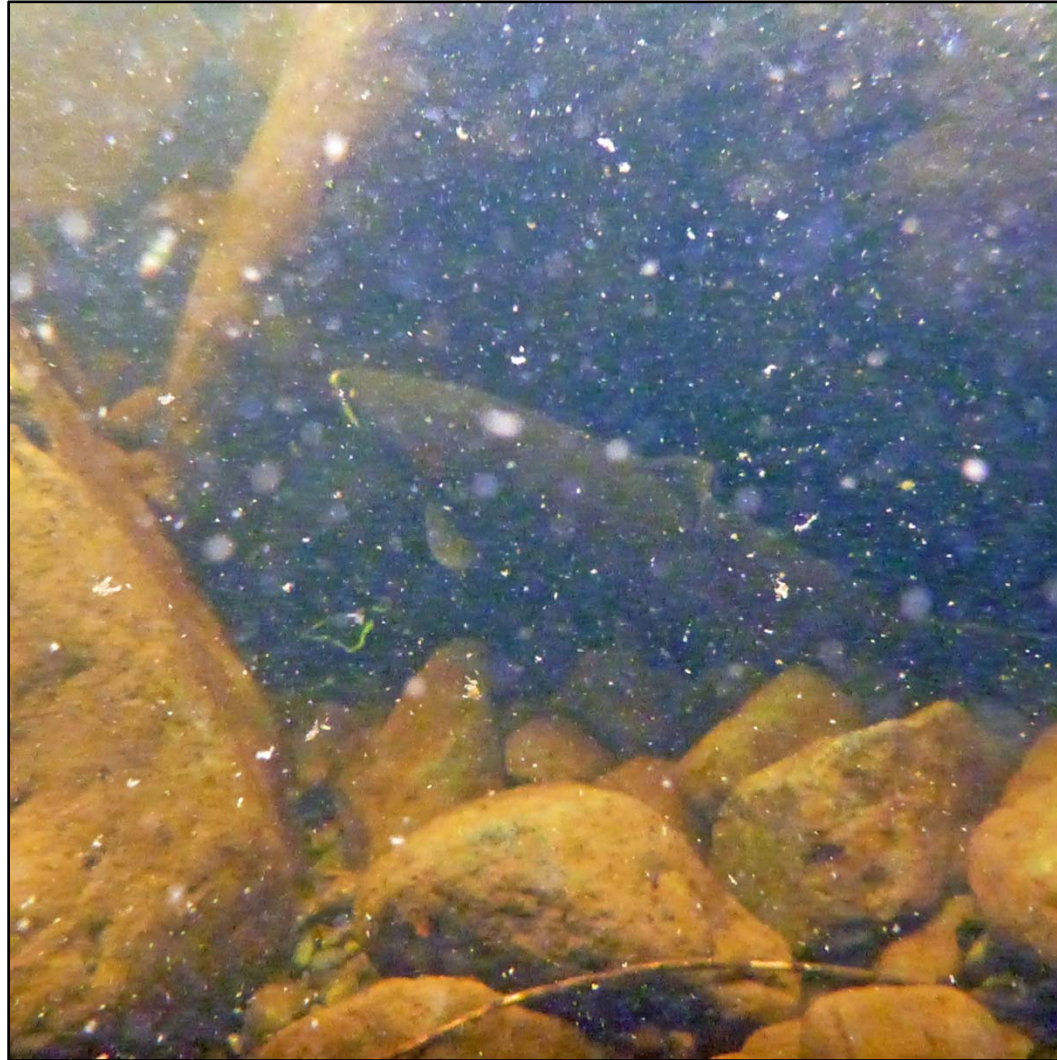
Photo 7. Adult coho holding among rocks in reach 2 (November 9, 2013 snorkel survey).
