# East Kootenay Integrated Lake Management Partnership

## Koocanusa Reservoir Sensitive Habitat Inventory Mapping – Phase 2 Final Report

UKE-F17-F-1403

December 15, 2017

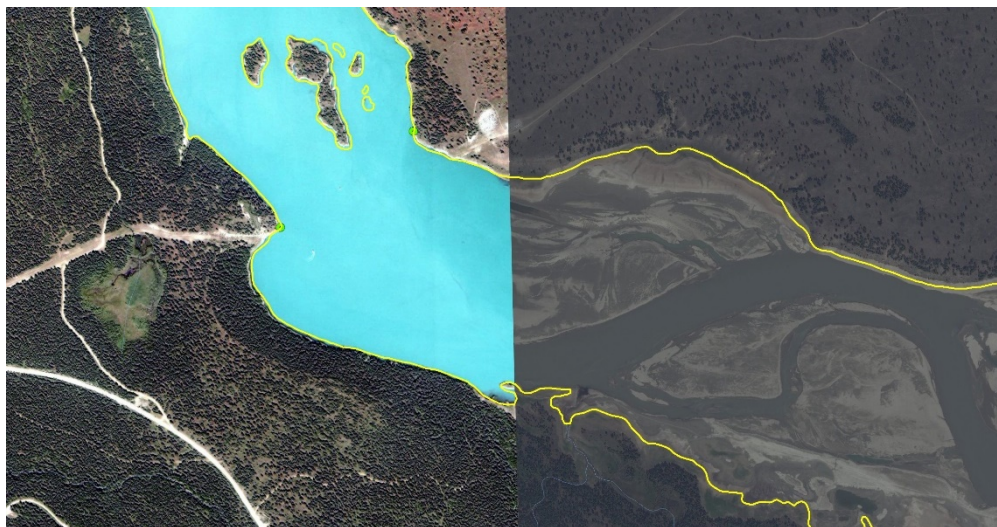
**Figure 1. Orthophoto view of Lake Koocanusa, showing full-pool (left) and low-pool (right). The BC Freshwater Atlas shoreline is shown in yellow.**

Lake Koocanusa operates on a flood management strategy referred to as the VarQ. It was implemented to improve the reservoir and river operations at the Libby Dam (Wade and Weatherly, 2012). Similar to standard flood management, VarQ uses forecasted inflow, except in years that have a lower risk of flooding, it allows for greater flexibility to regulate the amount of water and the time at which water needs to be released from the reservoir (Wade and Weatherly, 2012). The maximum and minimum operating levels for Lake Koocanusa are 749.5 metres (2,459 feet) and 697.1 metres (2,287 feet), respectively as shown in Figure 1. For the purpose of this study, EKILMP defines full-pool as 744.9 to 749.5 m (2444 - 2459 feet) and the 30 meter zone of adjacent upland, while low-pool is when reservoir elevations are between 730.9 and 744.9 m (2398 - 2444 feet). In general, full-pool occurs from July through September, while low-pool occurs from January through April. It is the full-pool shoreline and associated foreshore that is the focus of this study.

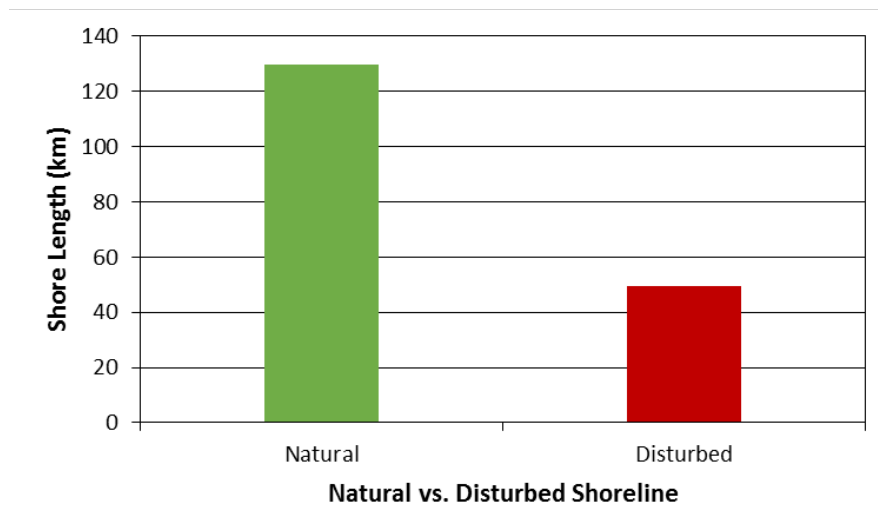
**Figure 3. Extent of Natural and Disturbed shoreline along Lake Koocanusa.**

Results of the FIM study show that approximately 72% (130 km) of the shoreline of Lake Koocanusa is in natural condition and 28% (50 km) is disturbed. AHI results show that the majority of the shoreline has High (41%) or Very High (23%) ecological value. Shoreline segments with Very High and High ecological value generally included a Zone of Sensitivity

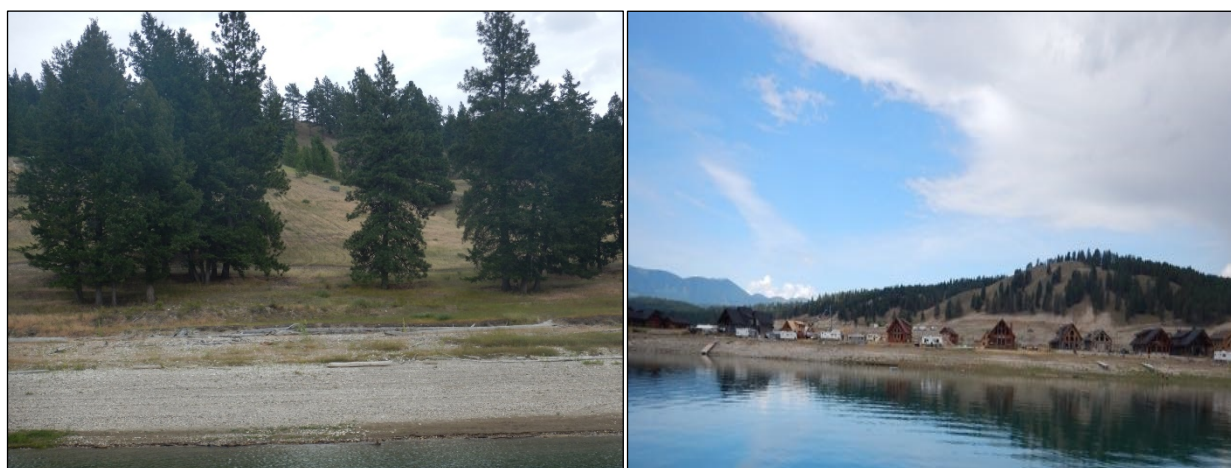
**Figure 4. An example of a natural shoreline (left photo) and disturbed shoreline (right photo). Photos by Heather Leschied (EKILMP), July 2015.**

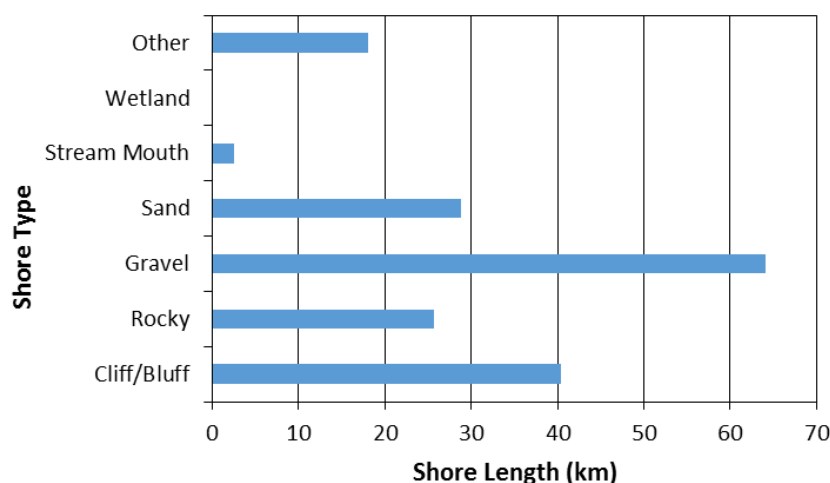
Figure 5. Total length of each Shore Type along Lake Koocanusa.

The foreshore of Lake Koocanusa is diverse consisting of cliff/bluff, rocky, gravel, sand, stream mouth, and other shore types. A breakdown of the lengths of each of these foreshore types along the perimeter of the lake is provided in Figure 5. The foreshore is primarily Gravel Beach Shore Type (64 km or 36% of the shoreline). Cliff/bluff and Sand Shore Types also make up substantial lengths of the shore (22% and 16% respectively), while Stream Mouth Shore Type makes up the smallest extent of foreshore (1%). Wetlands are not present along the foreshore. Figure 6 depicts the two dominant shorelines along Lake Koocanusa.

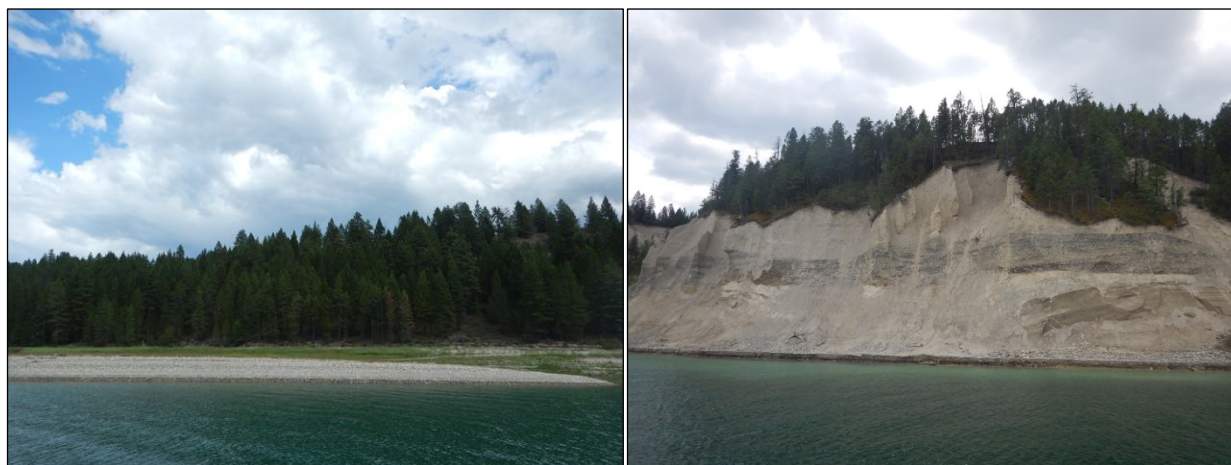
Figure 6. Gravel beach shore type (left photo) and Cliff/Bluff shore type (right photo). Photos taken by Heather Leschied (EKILMP), July 2015.

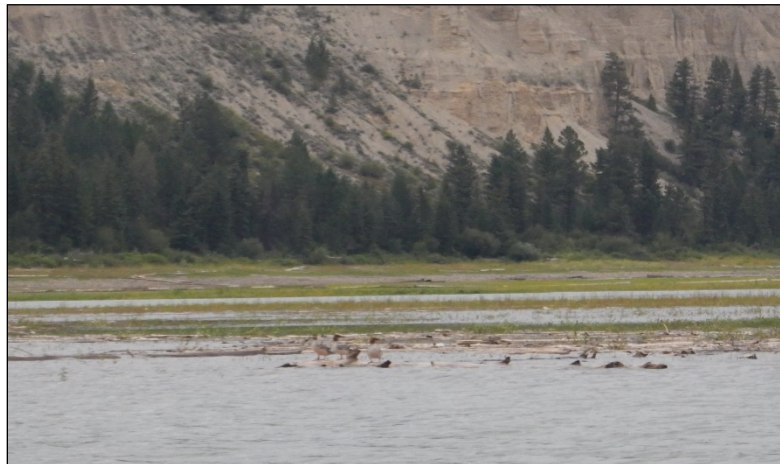
**Figure 9. Emergent vegetation along the shoreline of Segment 47. Photo by Heather Leschied (EKILMP), July 2015.**

Aquatic vegetation describes the portion of the shoreline that comprises emergent, submergent, or floating vegetation (Schleppe and Mason, 2009). The dominant type of aquatic vegetation observed along the lake is emergent vegetation, comprising about 4.0% of the total shoreline (Figure 8). Submergent vegetation is less abundant representing only 0.2% of the shoreline. Floating vegetation was not observed along the shoreline. Figure 9 is an example of a segment that has emergent vegetation.

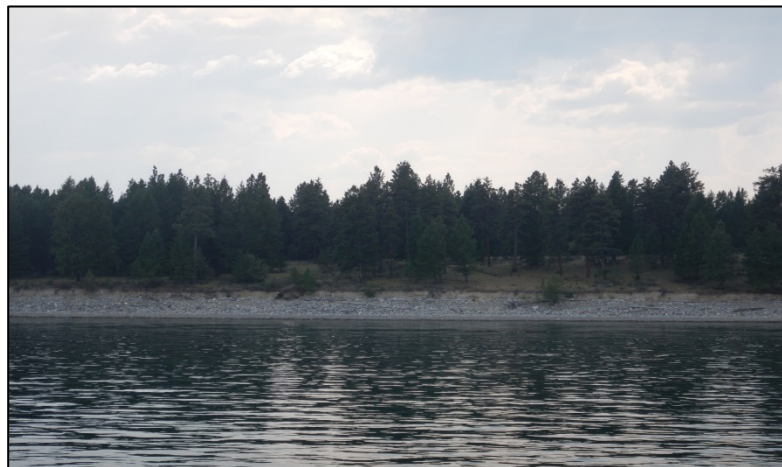
Figure 11. Coniferous forest vegetation along Segment 5. Photo by Heather Leschied (EKILMP), July 2015.

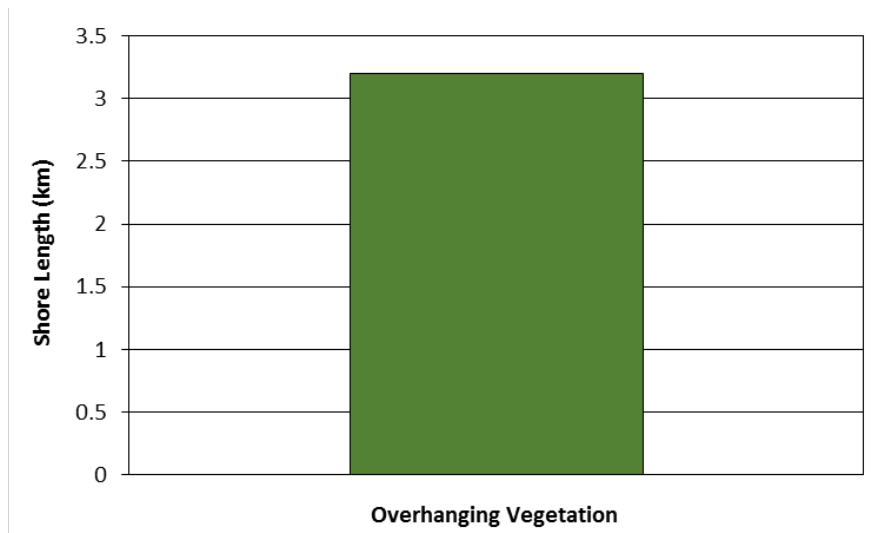
Figure 12. Total overhanging vegetation along Lake Koocanusa.

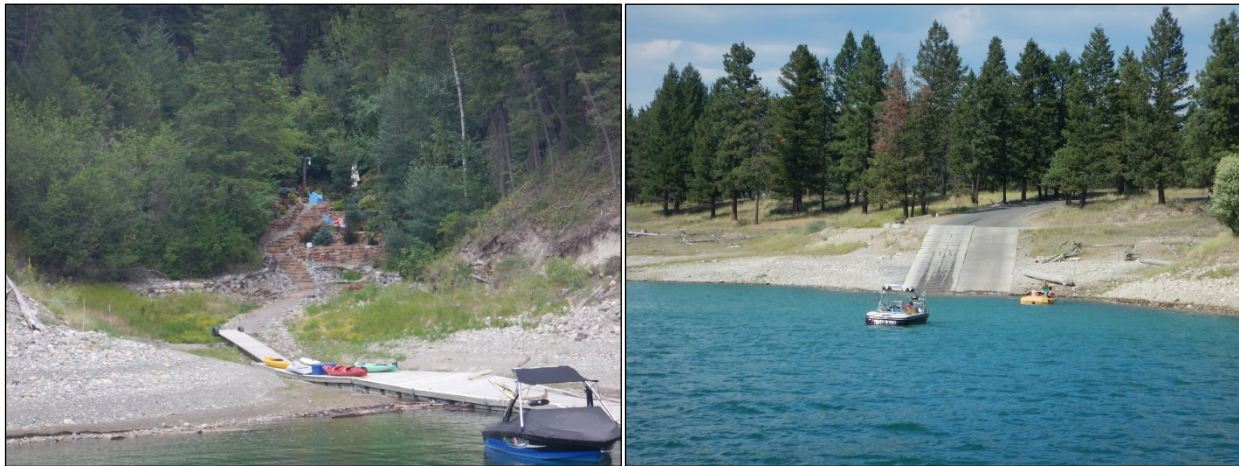
Figure 14. Shoreline Modifications: a dock along Segment 44 (left photo) and a boat launch along Segment 38 (right photo). Photos by Heather Leschied (EKILMP), July 2015.

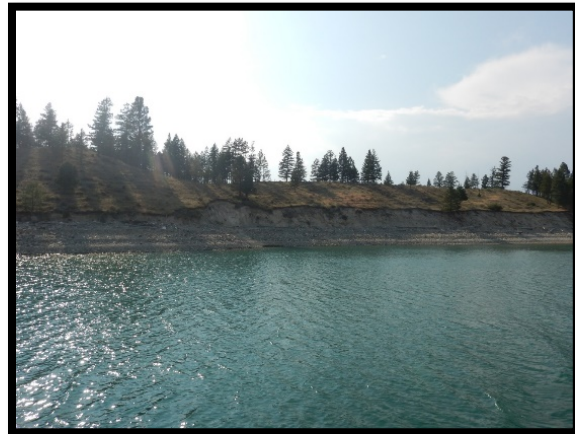
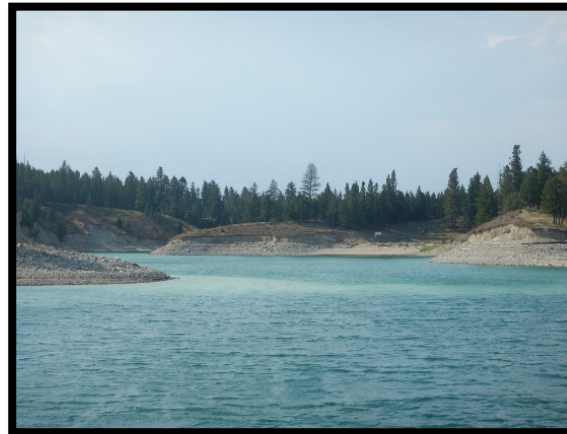
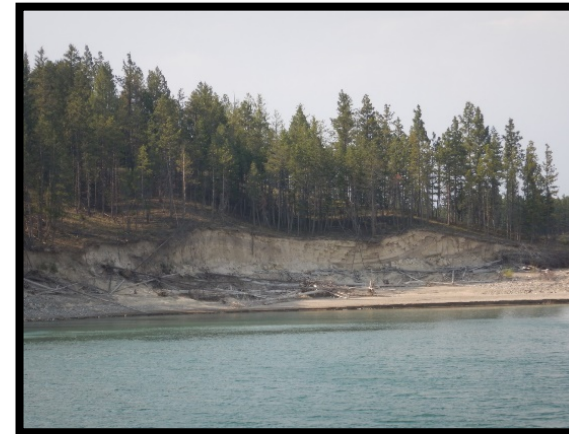
## Lake Koocanusa Segment No. 1

Segment Length (km)	Shore Type	Shore Type Mod.	Slope	Land Use	Level of Impact	Livestock Access	Disturbed	Natural
2.8	Cliff/Bluff	None	Very Steep (60+)	Forestry	Low (<10%)	Yes	10	90
Comments:

Retain Walls	% Ret. Wall	Ret. Wall Material	Docks	Docks per km	Boat Launch	% Rail Modifier	% Road Modifier	Marinas	Substrate Mod.	% Substrate Mod.
0	0	0	0	0	2	0	1	0	No	0
Comments: 23 mooring buoys, 14 boats

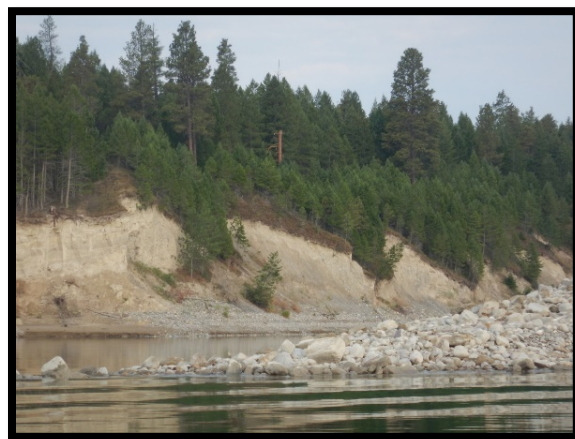
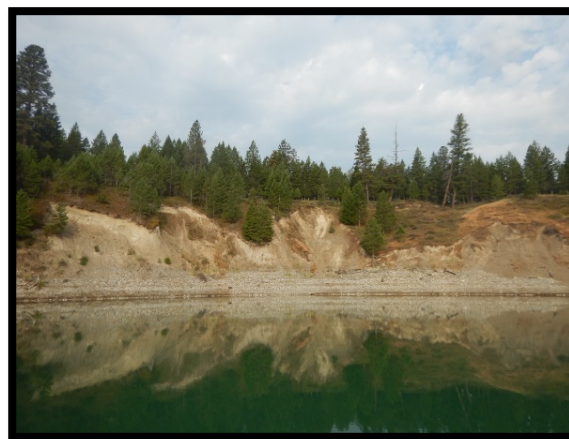
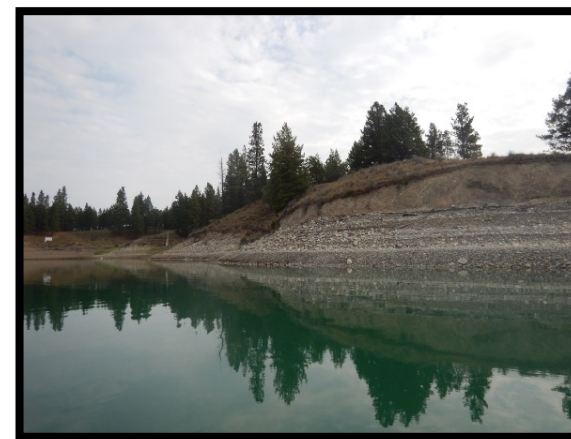
## Lake Koocanusa Segment No. 2

Segment Length (km)	Shore Type	Shore Type Mod.	Slope	Land Use	Level of Impact	Livestock Access	Disturbed	Natural
3	Stream Mouth	Other	Steep (20-60)	Forestry	Low (<10%)	Yes	5	95
Comments:		some low gradient areas, grassy, 1 private home, fields at top of bank

Retain Walls	% Ret. Wall	Ret. Wall Material	Docks	Docks per km	Boat Launch	% Rail Modifier	% Road Modifier	Marinas	Substrate Mod.	% Substrate Mod.
0	0	0	0	0	0	0	0	0	No	0
Comments:		1 moored boat

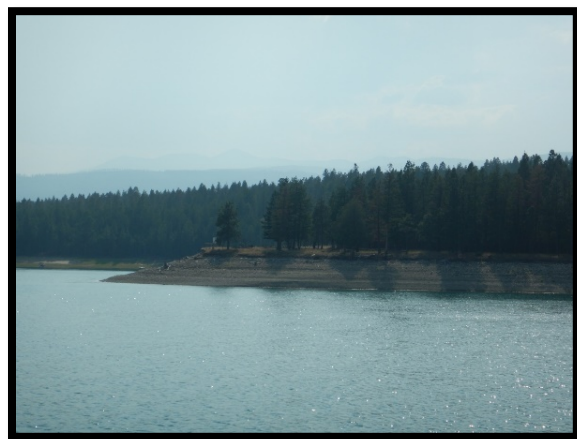
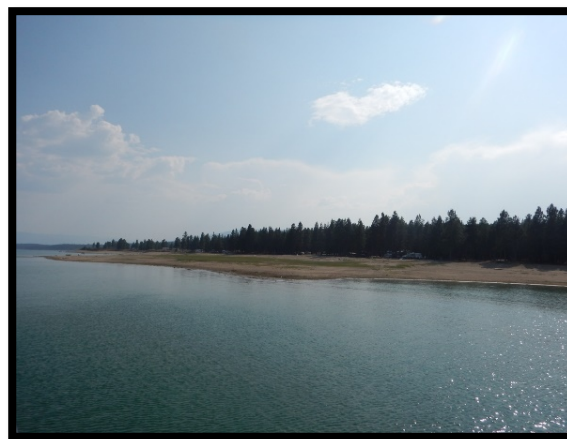
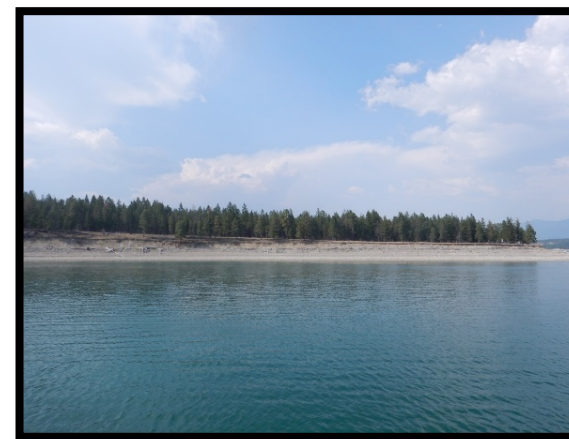
## Lake Koocanusa Segment No. 3

Segment Length (km)	Shore Type	Shore Type Mod.	Slope	Land Use	Level of Impact	Livestock Access	Disturbed	Natural
4.2	Sand	None	Low (0-5)	Recreation	High (>40%)	Yes	80	20
Comments:		sandy shores campground

Retain Walls	% Ret. Wall	Ret. Wall Material	Docks	Docks per km	Boat Launch	% Rail Modifier	% Road Modifier	Marinas	Substrate Mod.	% Substrate Mod.
0	0	0	0	0	2	0	10	0	No	0
Comments:		gravel boat launches

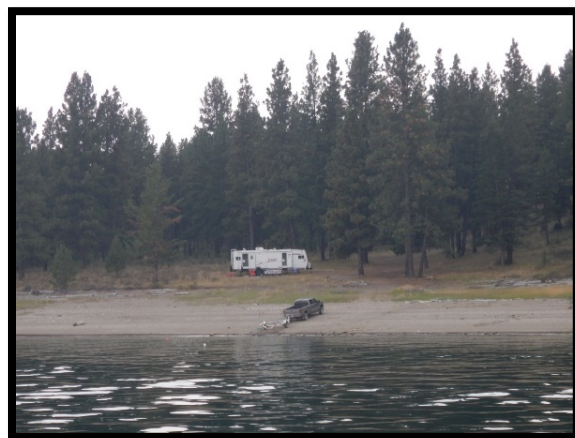
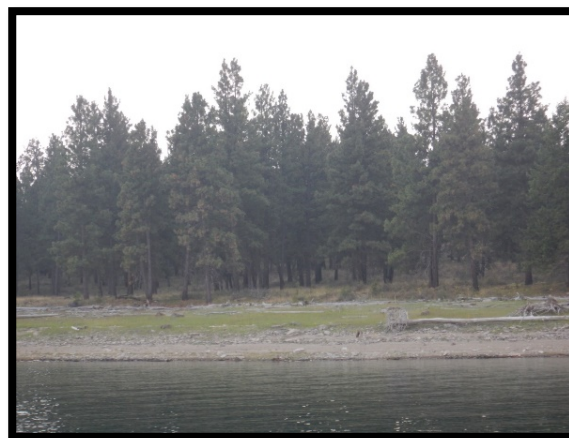
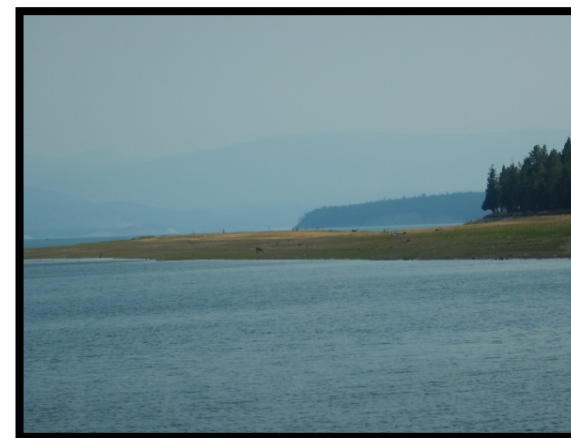
## Lake Koocanusa Segment No. 4

Segment Length (km)	Shore Type	Shore Type Mod.	Slope	Land Use	Level of Impact	Livestock Access	Disturbed	Natural
1.6	Gravel	None	Low (0-5)	Natural Area	Low (<10%)	Yes	1	99
Comments:		camping, boat access

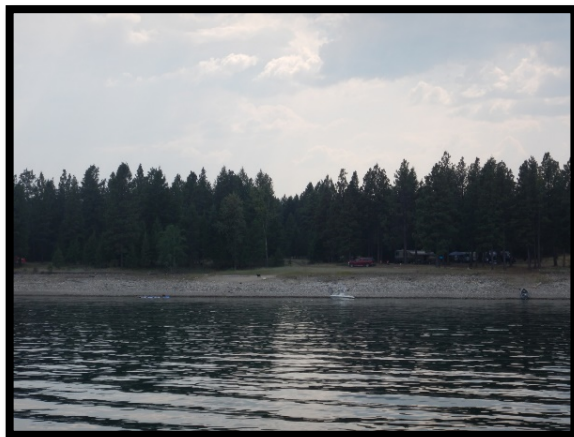
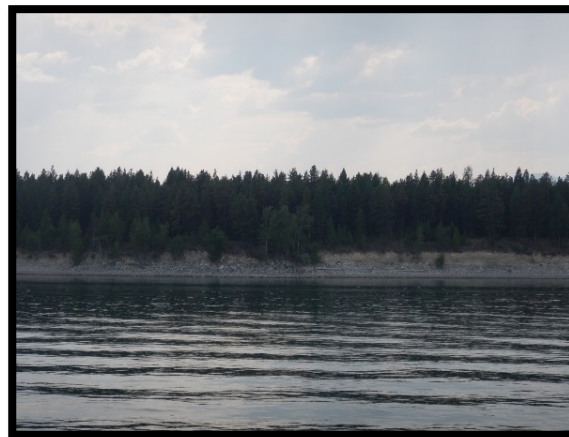
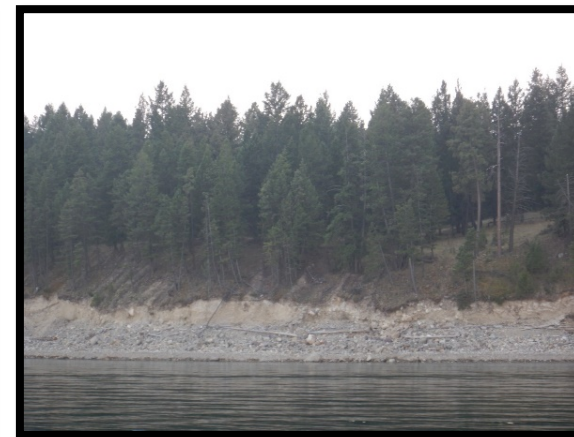
## Lake Koocanusa Segment No. 5

Segment Length (km)	Shore Type	Shore Type Mod.	Slope	Land Use	Level of Impact	Livestock Access	Disturbed	Natural
2.5	Rocky Shore	Other	Steep (20-60)	Forestry	Low (<10%)	Yes	5	95
Comments:		camping, boat access

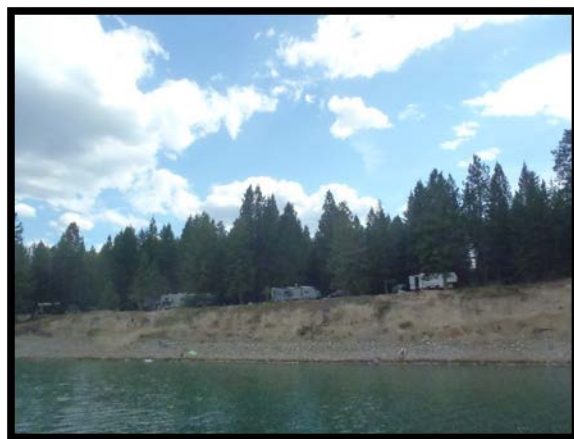
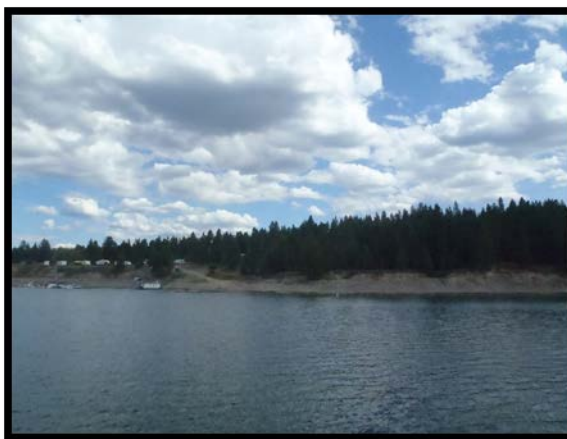
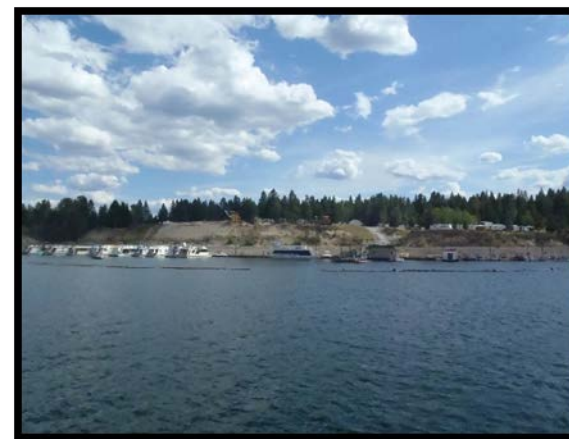
## Lake Koocanusa Segment No. 6

Segment Length (km)	Shore Type	Shore Type Mod.	Slope	Land Use	Level of Impact	Livestock Access	Disturbed	Natural
3.7	Cliff/Bluff	Marina large (20+)	Very Steep (60+)	Single Family	High (>40%)	Yes	40	60
Comments:		private/commercial/recreation

Retain Walls	% Ret. Wall	Ret. Wall Material	Docks	Docks per km	Boat Launch	% Rail Modifier	% Road Modifier	Marinas	Substrate Mod.	% Substrate Mod.
2	1	Concrete	1	0	0	0	10	1	No	0
Comments: 250 m floating breakwater, cattle fence

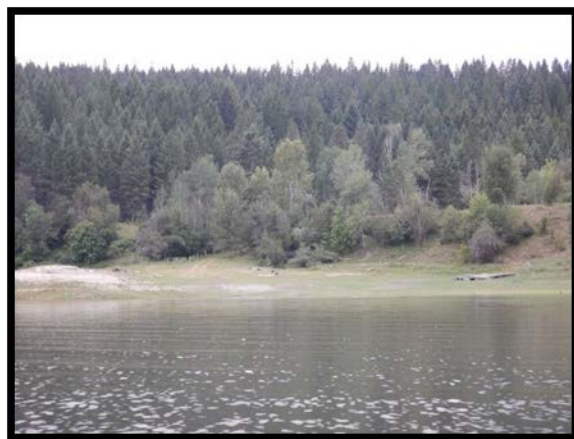
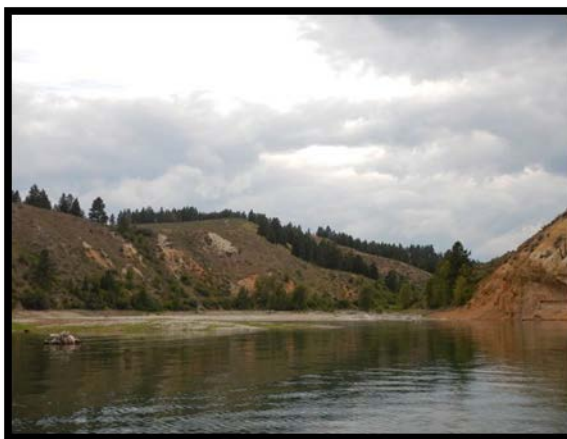
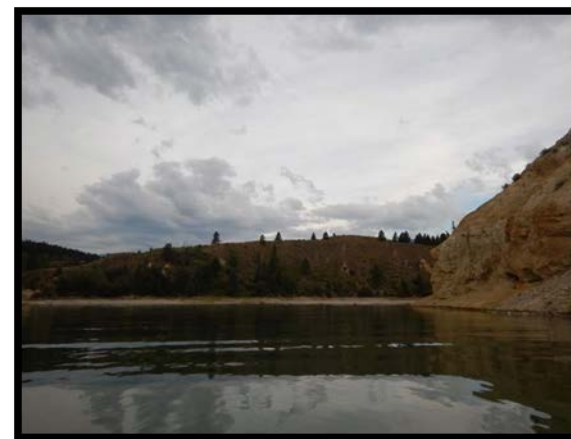
## Lake Koocanusa Segment No. 7

Segment Length (km)	Shore Type	Shore Type Mod.	Slope	Land Use	Level of Impact	Livestock Access	Disturbed	Natural
1.4	Stream Mouth	Road	Low (0-5)	Natural Area	Low (<10%)	Yes	10	90
Comments: gold cr fan /outlet shallow bay

Retain Walls	% Ret. Wall	Ret. Wall Material	Docks	Docks per km	Boat Launch	% Rail Modifier	% Road Modifier	Marinas	Substrate Mod.	% Substrate Mod.
0	0	0	1	1	1	0	35	0	No	0
Comments: orv access/truck access

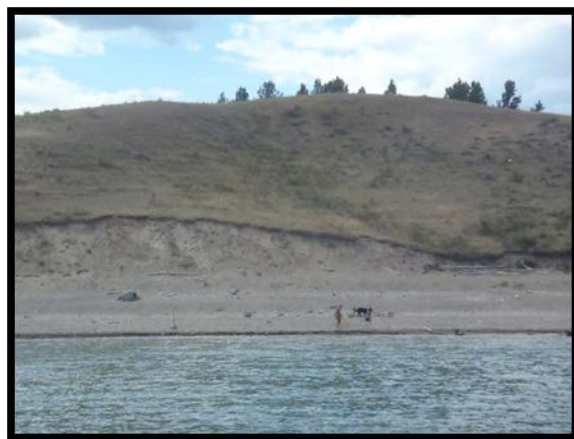
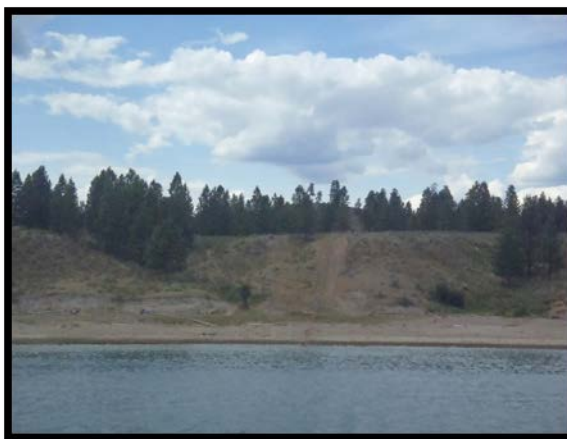
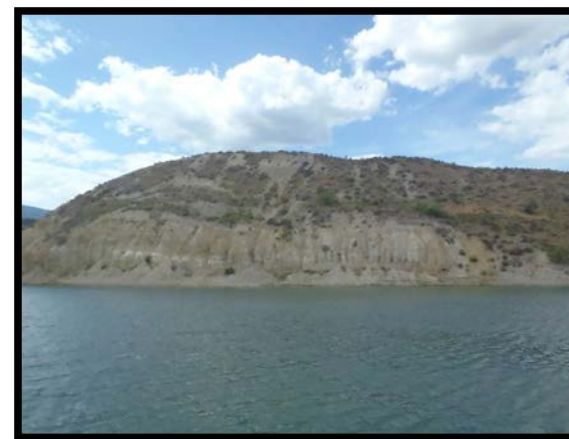
## Lake Koocanusa Segment No. 8

Segment Length (km)	Shore Type	Shore Type Mod.	Slope	Land Use	Level of Impact	Livestock Access	Disturbed	Natural
2.1	Cliff/Bluff	None	Very Steep (60+)	Natural Area	Low (<10%)	Yes	10	90
Comments:	hoodoos

Retain Walls	% Ret. Wall	Ret. Wall Material	Docks	Docks per km	Boat Launch	% Rail Modifier	% Road Modifier	Marinas	Substrate Mod.	% Substrate Mod.
0	0	Other	0	0	0	0	0	0	No	0
Comments:	2 sailboats, cattle fence

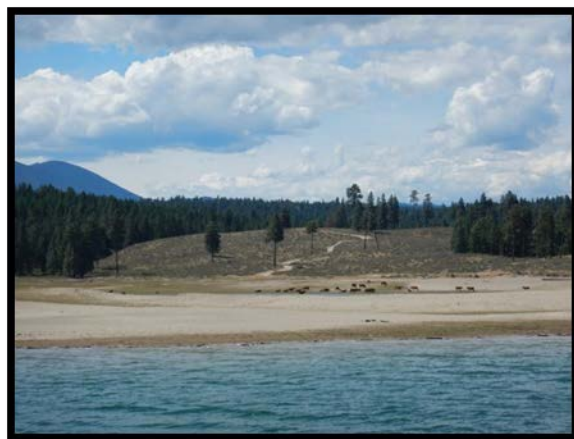
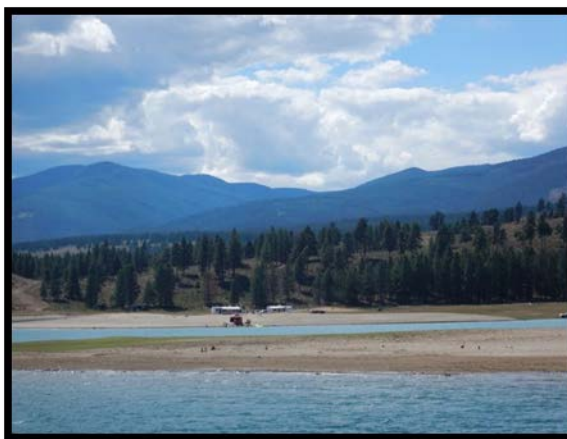
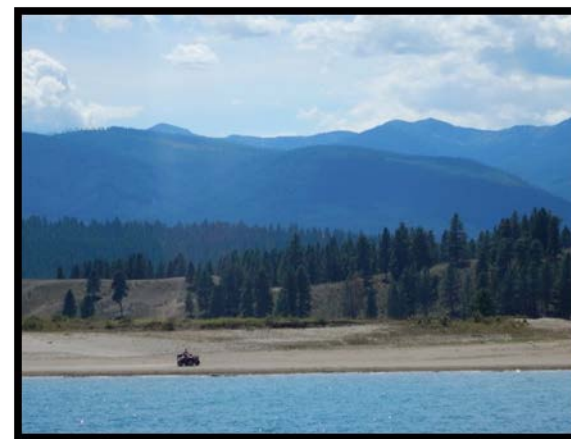
## Lake Koocanusa Segment No. 9

Segment Length (km)	Shore Type	Shore Type Mod.	Slope	Land Use	Level of Impact	Livestock Access	Disturbed	Natural
2	Sand	Road	Moderate (5-20)	Natural Area	High (>40%)	Yes	80	20
Comments:		sandy beach

Retain Walls	% Ret. Wall	Ret. Wall Material	Docks	Docks per km	Boat Launch	% Rail Modifier	% Road Modifier	Marinas	Substrate Mod.	% Substrate Mod.
0	0	Other	0	0	0	0	10	0	No	0
Comments:		25 cattle, 3 trailers, 8 boats, 2 house boats , 1 tent, dogs

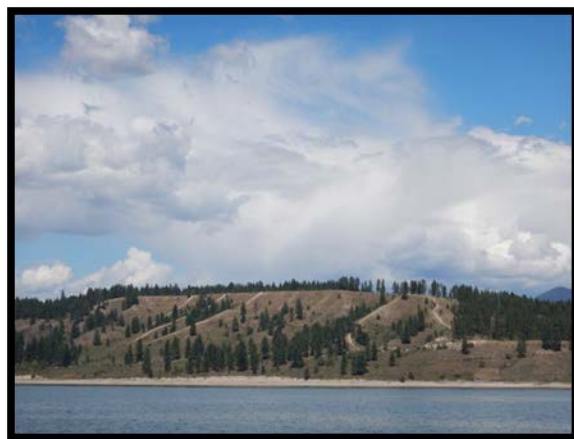
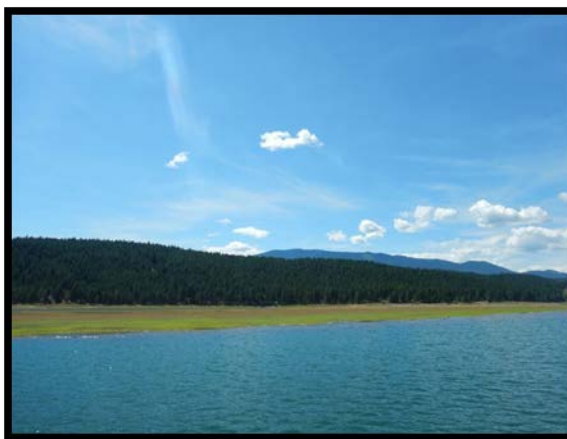
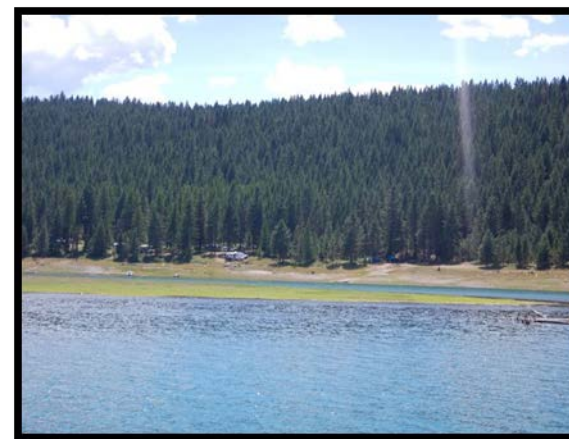
## Lake Koocanusa Segment No. 10

Segment Length (km)	Shore Type	Shore Type Mod.	Slope	Land Use	Level of Impact	Livestock Access	Disturbed	Natural
7.4	Rocky Shore	Road	Very Steep (60+)	Forestry	Medium (10-40%)	Yes	25	75
Comments:

Retain Walls	% Ret. Wall	Ret. Wall Material	Docks	Docks per km	Boat Launch	% Rail Modifier	% Road Modifier	Marinas	Substrate Mod.	% Substrate Mod.
0	0	Other	0	0	2	0	0	0	No	0
Comments: 1 cattle fence, 4 docks, camping, roads/trails, 2 pocket beaches, swim platform

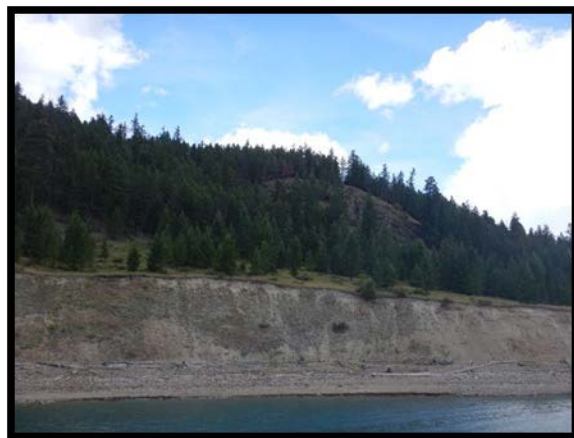
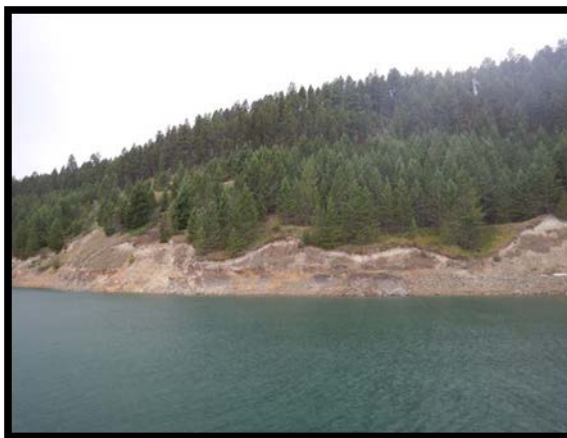
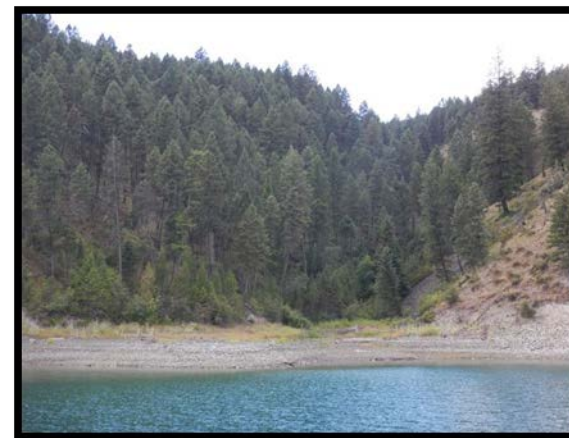
## Lake Koocanusa Segment No. 11

Segment Length (km)	Shore Type	Shore Type Mod.	Slope	Land Use	Level of Impact	Livestock Access	Disturbed	Natural
3.7	Cliff/Bluff	None	Very Steep (60+)	Forestry	Low (<10%)	Yes	0	100
Comments:		wisa - wha

Retain Walls	% Ret. Wall	Ret. Wall Material	Docks	Docks per km	Boat Launch	% Rail Modifier	% Road Modifier	Marinas	Substrate Mod.	% Substrate Mod.
0	0	Other	0	0	0	0	0	0	No	0
Comments:		1 cattle fence, old skid road/forry road

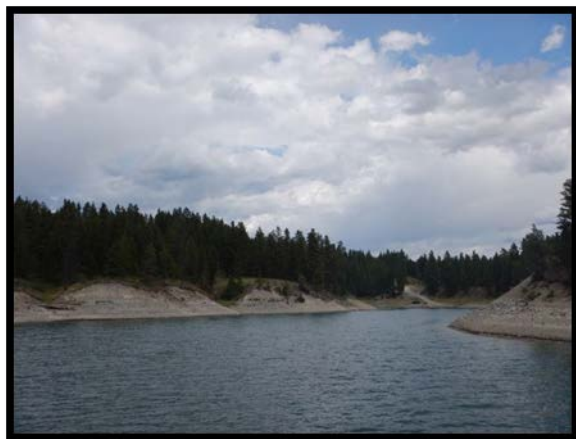
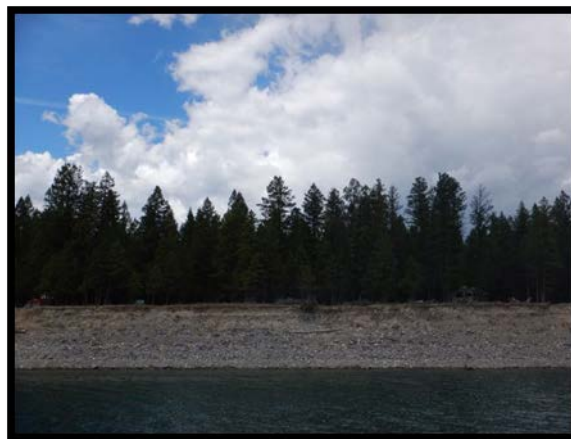
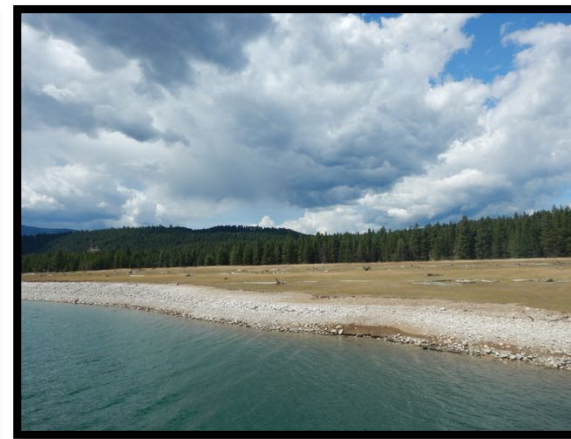
## Lake Koocanusa Segment No. 12

Segment Length (km)	Shore Type	Shore Type Mod.	Slope	Land Use	Level of Impact	Livestock Access	Disturbed	Natural
2	Rocky Shore	Other	Steep (20-60)	Recreation	Medium (10-40%)	No	40	60
Comments:		steep gravel/boulder banks

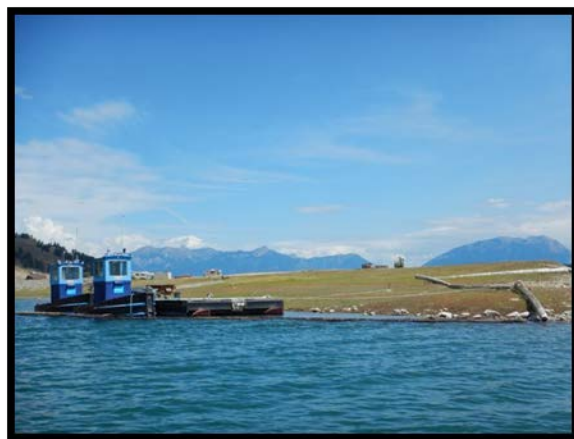
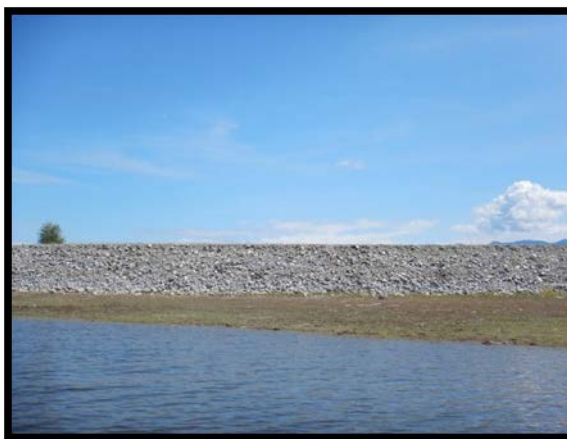
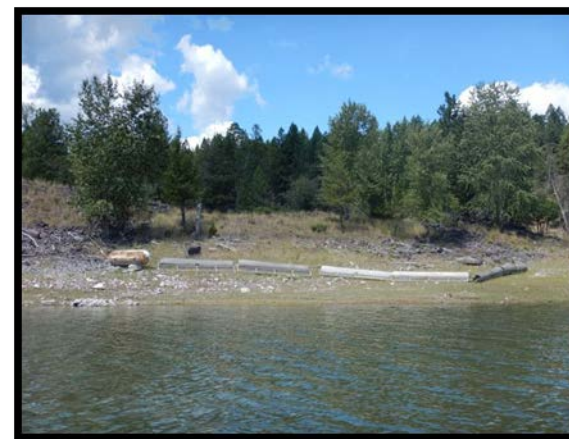
## Lake Koocanusa Segment No. 13

Segment Length (km)	Shore Type	Shore Type Mod.	Slope	Land Use	Level of Impact	Livestock Access	Disturbed	Natural
1	Rocky Shore	Other	Moderate (5-20)	Industrial	Medium (10-40%)	Yes	50	50
Comments: shallow mud/grass bay adjacent Sweetwater s breakwater

Retain Walls	% Ret. Wall	Ret. Wall Material	Docks	Docks per km	Boat Launch	% Rail Modifier	% Road Modifier	Marinas	Substrate Mod.	% Substrate Mod.
0	0	Other	1	1	0	0	30	0	No	0
Comments: 5 marker buoys, 2 log breakwater, 1 propane tank, 2 tugs

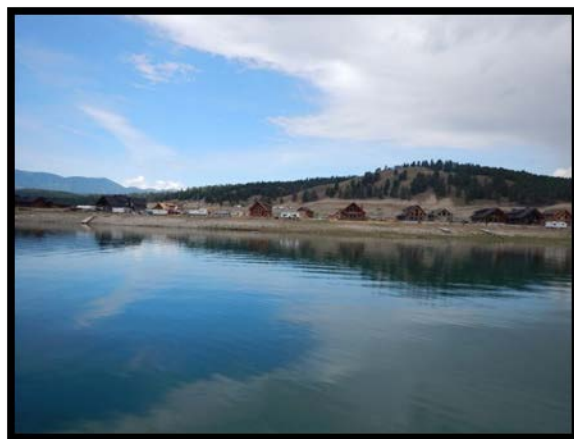
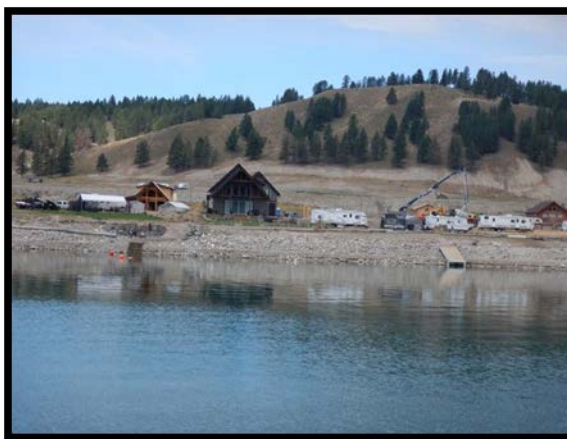
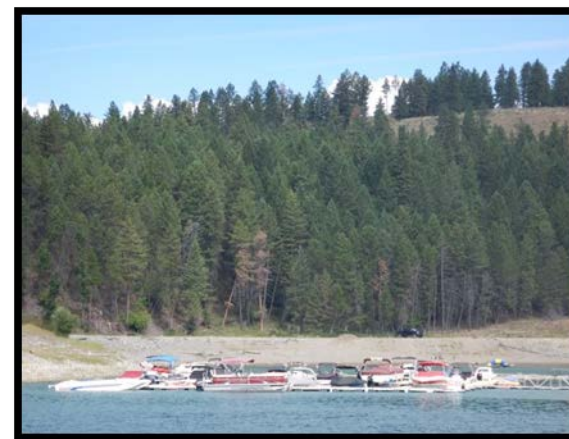
## Lake Koocanusa Segment No. 14

Segment Length (km)	Shore Type	Shore Type Mod.	Slope	Land Use	Level of Impact	Livestock Access	Disturbed	Natural
2.7	Gravel	Marina large (20+)	Bench	Single Family	High (>40%)	No	100	0
Comments:		Sweetwater

Veteran Trees		Snags
No	No	
Flora Comments:		landscaped/exposed soil - construction
Fauna Comments:		1 swallow

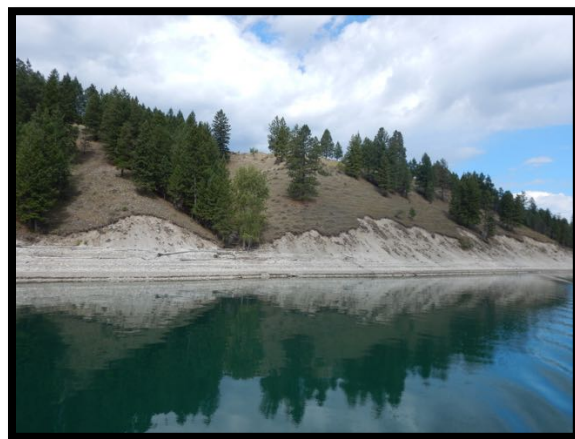
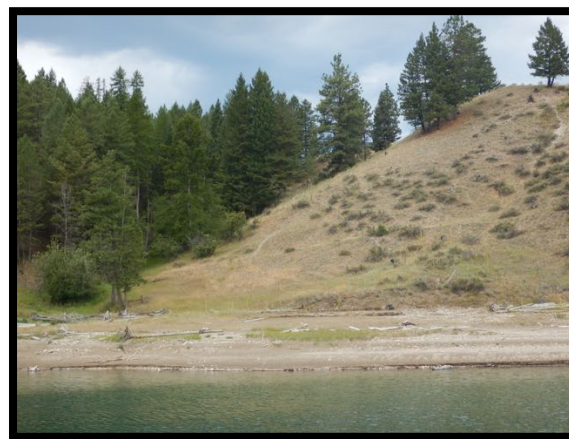
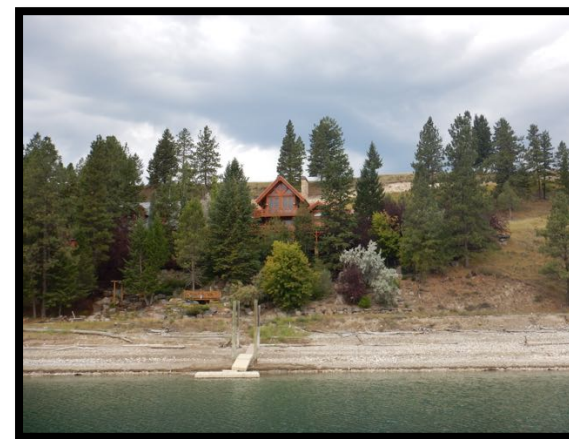
## Lake Koocanusa Segment No. 15

Segment Length (km)	Shore Type	Shore Type Mod.	Slope	Land Use	Level of Impact	Livestock Access	Disturbed	Natural
1.3	Cliff/Bluff	Road	Very Steep (60+)	Forestry	Low (<10%)	Yes	5	95
Comments: 1 private home with landscaping, active bank erosion

Retain Walls	% Ret. Wall	Ret. Wall Material	Docks	Docks per km	Boat Launch	% Rail Modifier	% Road Modifier	Marinas	Substrate Mod.	% Substrate Mod.
1	1	Stonework	1	1	0	0	10	0	No	0
Comments: 4 pilings, 1 mooring buoy

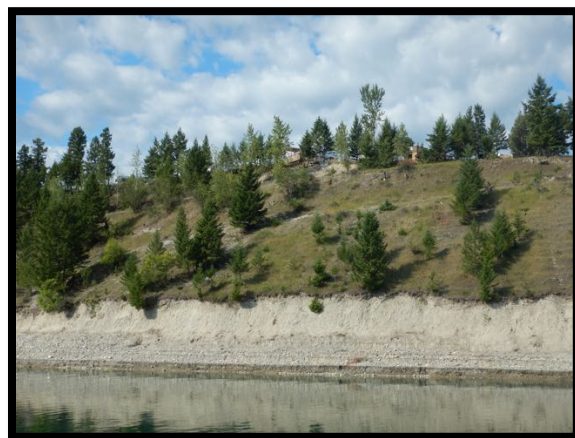
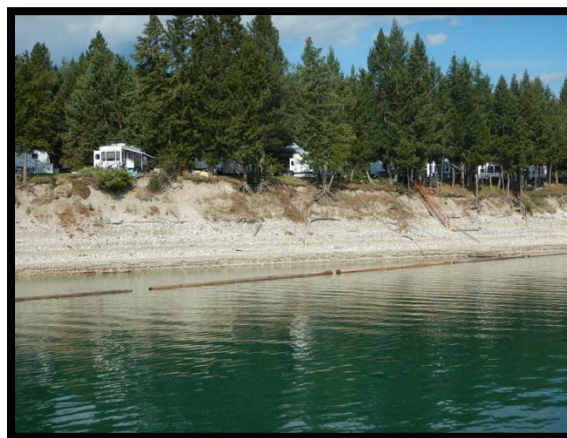
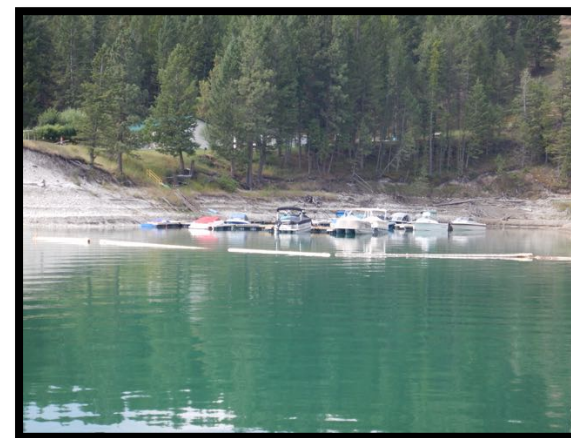
## Lake Koocanusa Segment No. 16

Segment Length (km)	Shore Type	Shore Type Mod.	Slope	Land Use	Level of Impact	Livestock Access	Disturbed	Natural
1.8	Cliff/Bluff	Marina large (20+)	Very Steep (60+)	Commercial	High (>40%)	No	100	0
<b>Comments:</b> extensive development on steep banks/bluffs

Retain Walls	% Ret. Wall	Ret. Wall Material	Docks	Docks per km	Boat Launch	% Rail Modifier	% Road Modifier	Marinas	Substrate Mod.	% Substrate Mod.
0	0	0	2	2	1	0	100	3	Yes	5
<b>Comments:</b> 1 concrete boat launch, 8 stairs, 2 trails, 4 swimming platform platforms, 2 mooring buoys, fences

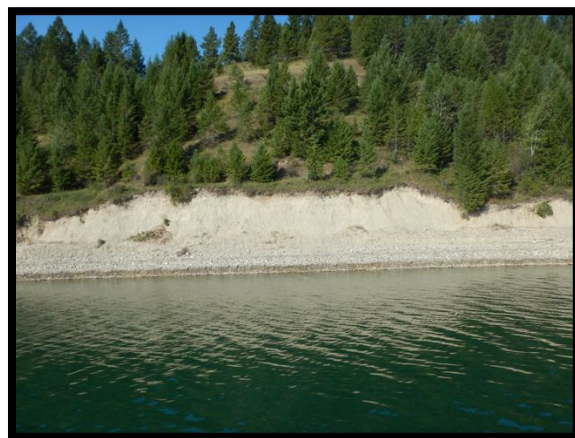
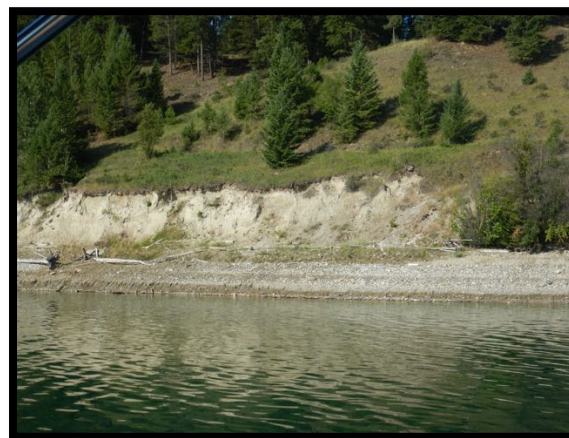
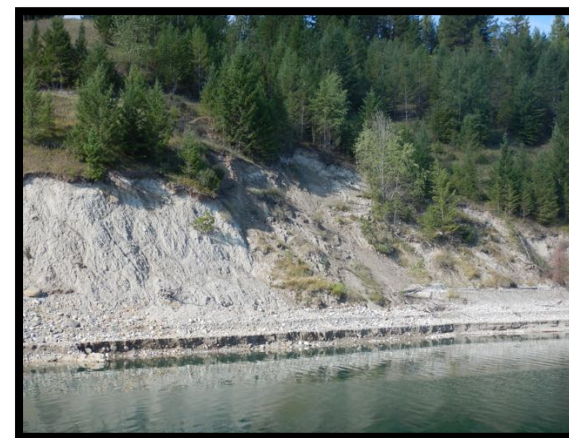
## Lake Koocanusa Segment No. 17

Segment Length (km)	Shore Type	Shore Type Mod.	Slope	Land Use	Level of Impact	Livestock Access	Disturbed	Natural
2.4	Cliff/Bluff	None	Very Steep (60+)	Forestry	Low (<10%)	Yes	5	95
Comments:		significant steep eroding clay/sand bluffs

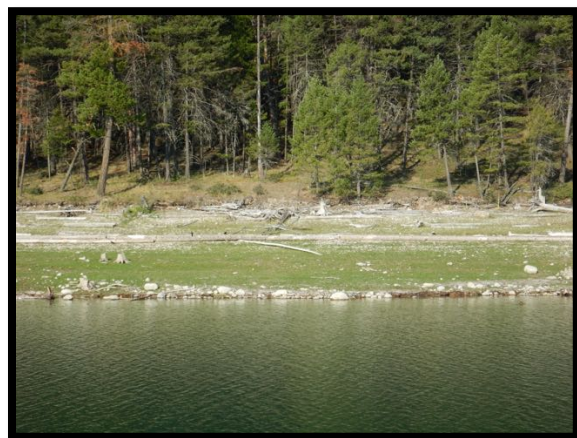
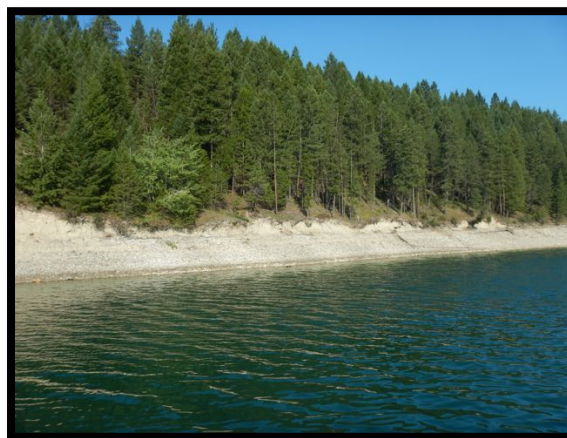
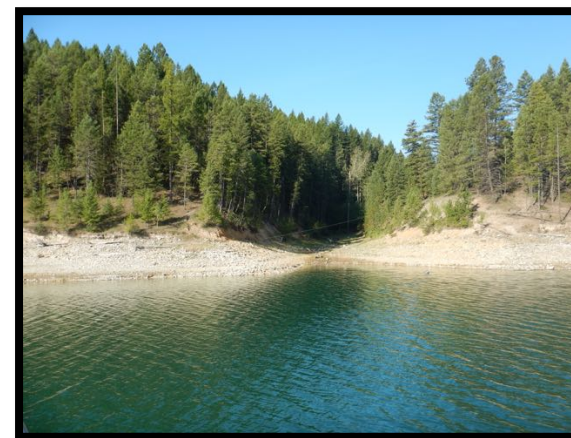
## Lake Koocanusa Segment No. 18

Segment Length (km)	Shore Type	Shore Type Mod.	Slope	Land Use	Level of Impact	Livestock Access	Disturbed	Natural
3.7	Gravel	None	Steep (20-60)	Forestry	Low (<10%)	Yes	0	100
Comments:

Retain Walls	% Ret. Wall	Ret. Wall Material	Docks	Docks per km	Boat Launch	% Rail Modifier	% Road Modifier	Marinas	Substrate Mod.	% Substrate Mod.
0	0	0	0	0	0	0	0	0	No	0
Comments: 1 mooring buoy, 500m log boom/breakwater at north end, 1 rope swing

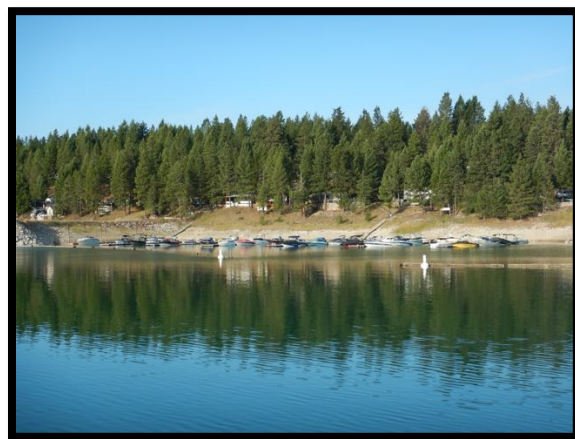
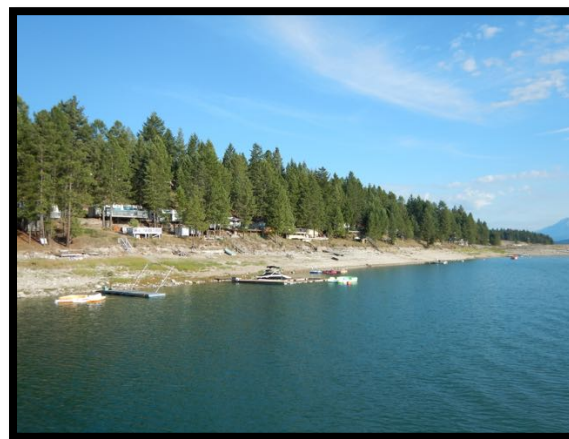
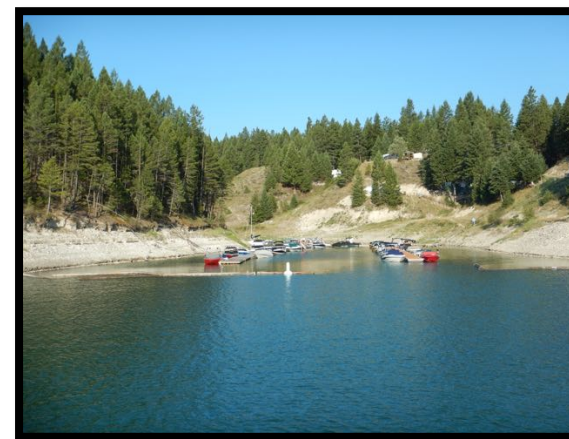
## Lake Koocanusa Segment No. 19

Segment Length (km)	Shore Type	Shore Type Mod.	Slope	Land Use	Level of Impact	Livestock Access	Disturbed	Natural
0.9	Sand	Marina large (20+)	Moderate (5-20)	Commercial	High (>40%)	No	100	0
Comments:		Cutts marinas and rv park

Retain Walls	% Ret. Wall	Ret. Wall Material	Docks	Docks per km	Boat Launch	% Rail Modifier	% Road Modifier	Marinas	Substrate Mod.	% Substrate Mod.
6	6	Wood	10	10	1	0	100	2	Yes	100
Comments:		beach grooming, 4 breakwater 500m total, 8 mooring buoys, 6 pilings, 10 stairs, 1 swimming platform

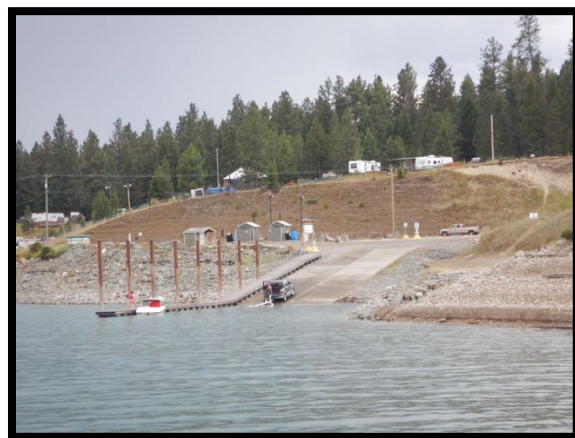
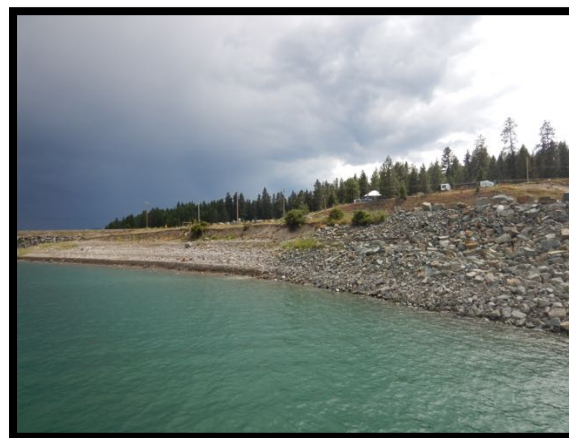
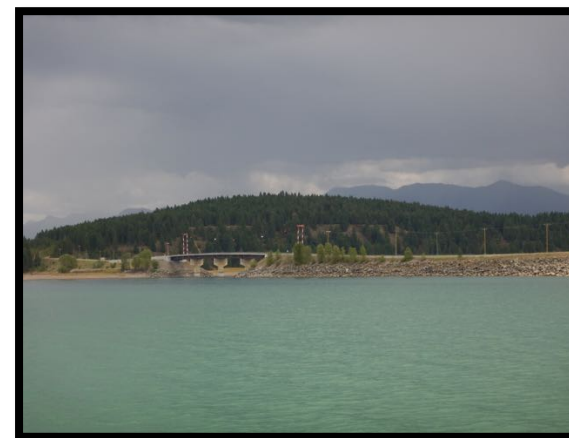
## Lake Koocanusa Segment No. 20

Segment Length (km)	Shore Type	Shore Type Mod.	Slope	Land Use	Level of Impact	Livestock Access	Disturbed	Natural
1.6	Other	Road	Steep (20-60)	Industrial	High (>40%)	No	98	2
Comments: large boat launch/riprap causeway /highway

Retain Walls	% Ret. Wall	Ret. Wall Material	Docks	Docks per km	Boat Launch	% Rail Modifier	% Road Modifier	Marinas	Substrate Mod.	% Substrate Mod.
0	0	0	0	0	0	0	5	0	No	0
Comments: orphan dock and breakwater
