# East Kootenay Integrated Lake Management Partnership

## Koocanusa Reservoir Sensitive Habitat Inventory Mapping – Phase 2 Final Report

UKE-F17-F-1403

December 15, 2017

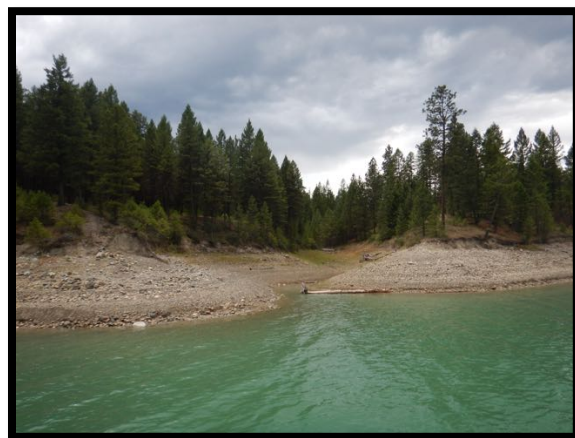
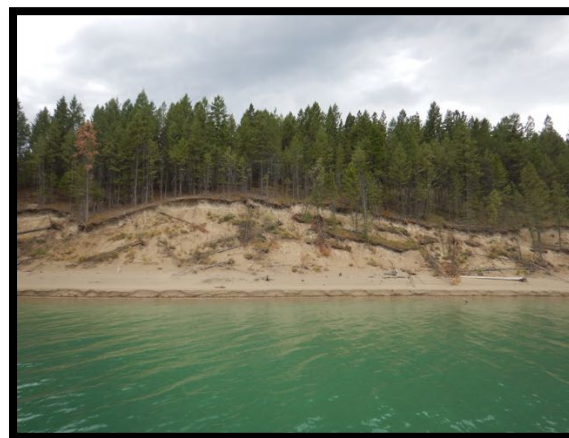
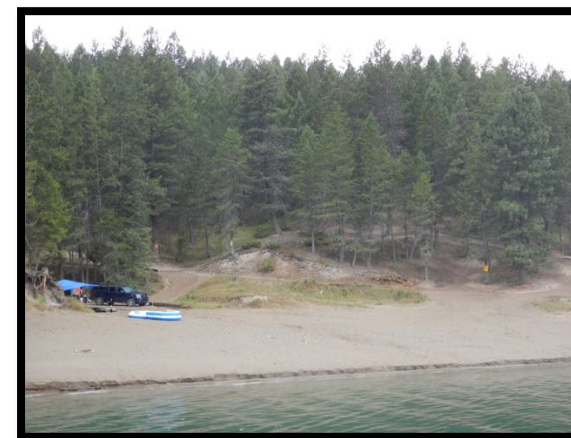
## Lake Koocanusa Segment No. 21

Segment Length (km)	Shore Type	Shore Type Mod.	Slope	Land Use	Level of Impact	Livestock Access	Disturbed	Natural
3.5	Gravel	Road	Low (0-5)	Forestry	Low (<10%)	Yes	2	98
Comments:		In end gravel/rocky s end eroding sandy cliffs

Retain Walls	% Ret. Wall	Ret. Wall Material	Docks	Docks per km	Boat Launch	% Rail Modifier	% Road Modifier	Marinas	Substrate Mod.	% Substrate Mod.
0	0	0	0	0	0	0	5	0	No	0
Comments:		orv use/camping

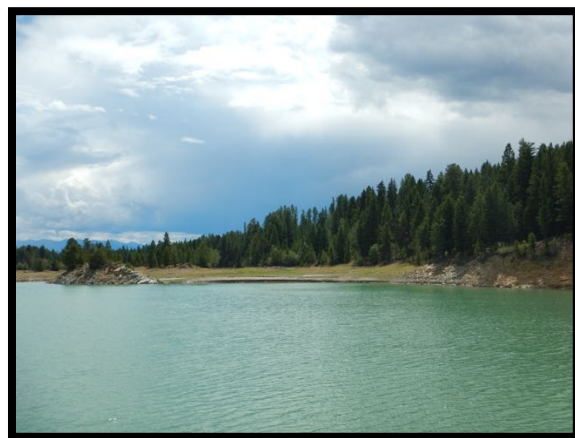
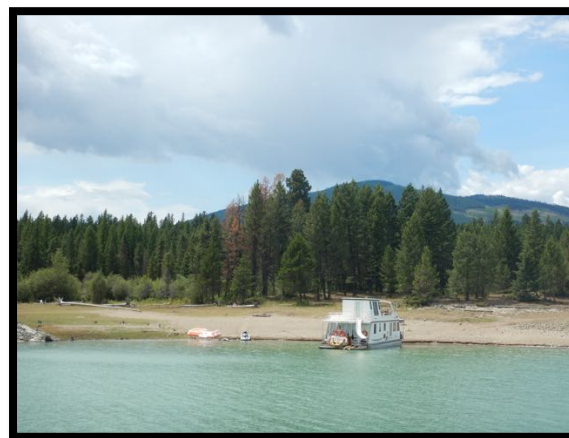
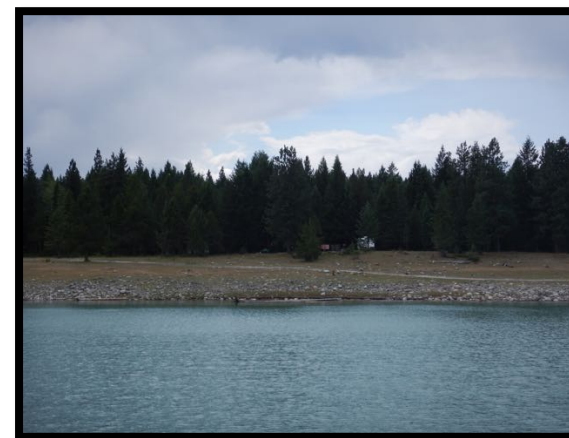
## Lake Koocanusa Segment No. 22

Segment Length (km)	Shore Type	Shore Type Mod.	Slope	Land Use	Level of Impact	Livestock Access	Disturbed	Natural
5	Rocky Shore	Road	Moderate (5-20)	Forestry	High (>40%)	Yes	50	50
Comments: bedrock/rubble/boulder/sand-gravel, steep at start 600 m then low bench

Mud	Organics	Fine	Sand	Gravel	Cobble	Boulder	Bedrock
0	0	5	10	20	5	20	40
Comments: broken bedrock common

Veteran Trees	Snags
>25	>25
Flora Comments:	
Fauna Comments: 1 jv eagle, 3 eagles, 3 tv, swallows, sandpipers - pot curlew habitat degraded by cows

Retain Walls	% Ret. Wall	Ret. Wall Material	Docks	Docks per km	Boat Launch	% Rail Modifier	% Road Modifier	Marinas	Substrate Mod.	% Substrate Mod.
0	0	0	0	0	0	0	50	0	No	0
Comments: unorganized camping, orv access, 4 pocket beaches, improvised boat launches

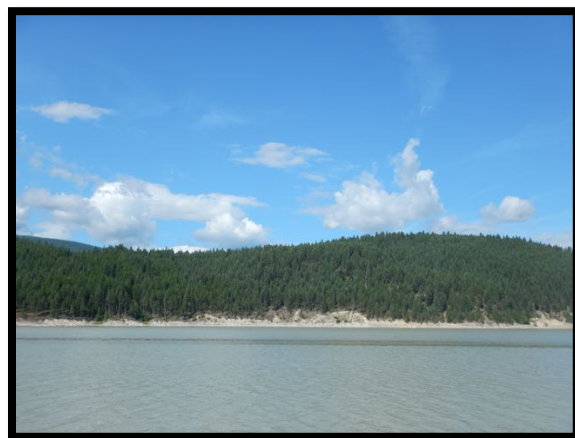
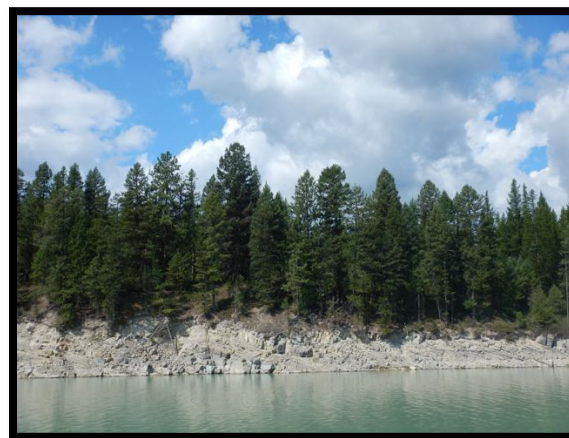
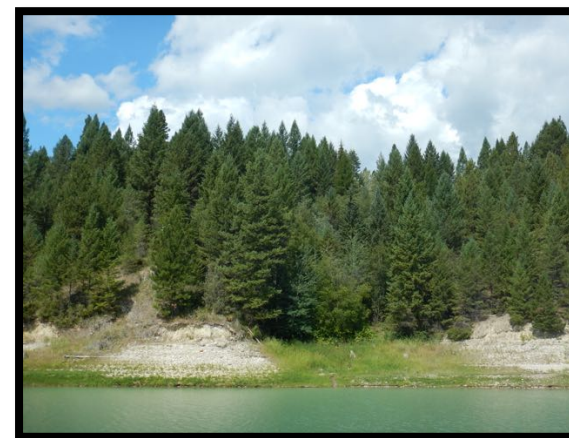
## Lake Koocanusa Segment No. 23

Segment Length (km)	Shore Type	Shore Type Mod.	Slope	Land Use	Level of Impact	Livestock Access	Disturbed	Natural
11.5	Rocky Shore	Road	Steep (20-60)	Forestry	Low (<10%)	Yes	5	95
Comments: bedrock much more prevalent than east shore

Veteran Trees	Snags
>25	>25
Flora Comments:	
Fauna Comments: ht hawk, swallows/nests, 3 jv eagles, 2 eagles, 3 tv, crow, squirrel, chip, sandpipers,

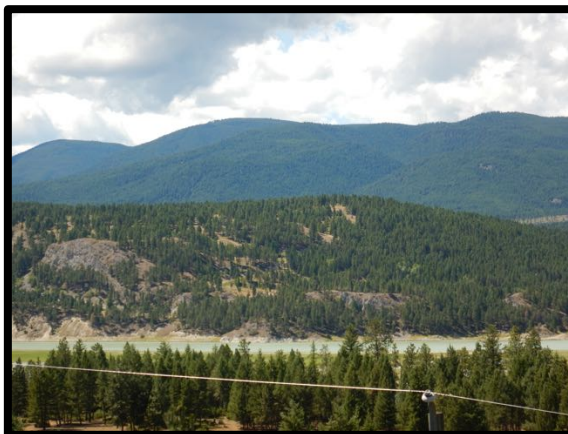
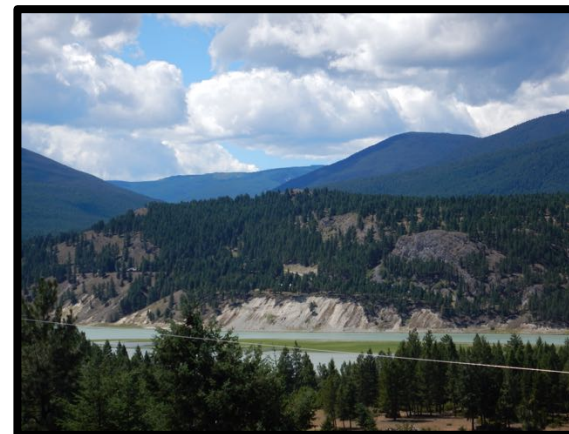
## Lake Koocanusa Segment No. 24

Segment Length (km)	Shore Type	Shore Type Mod.	Slope	Land Use	Level of Impact	Livestock Access	Disturbed	Natural
2.5	Cliff/Bluff	Road	Very Steep (60+)	Natural Area	Low (<10%)	No	1	99
Comments: south of wardner town site-osprey landing

Retain Walls	% Ret. Wall	Ret. Wall Material	Docks	Docks per km	Boat Launch	% Rail Modifier	% Road Modifier	Marinas	Substrate Mod.	% Substrate Mod.
0	0	0	0	0	1	0	1	0	No	0
Comments: 2 road access points

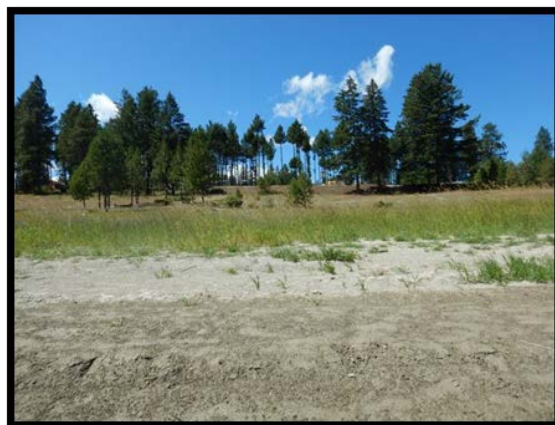
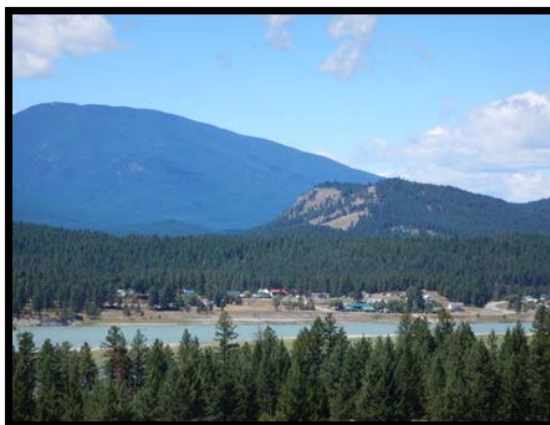
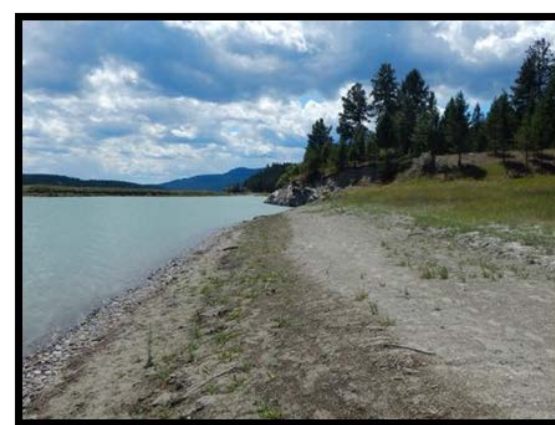
## Lake Koocanusa Segment No. 25

Segment Length (km)	Shore Type	Shore Type Mod.	Slope	Land Use	Level of Impact	Livestock Access	Disturbed	Natural
3.7	Gravel	Road	Moderate (5-20)	Single Family	High (>40%)	No	90	10
Comments:		wardner town site

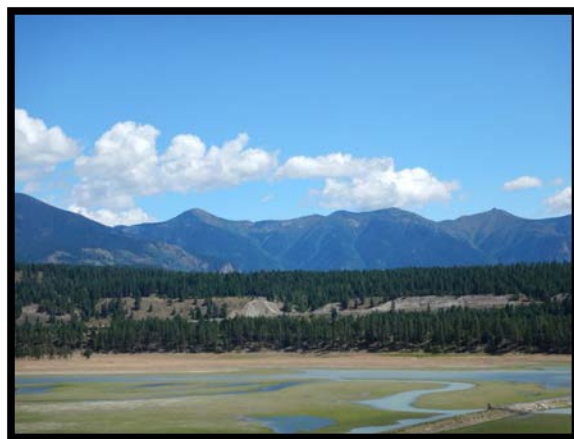
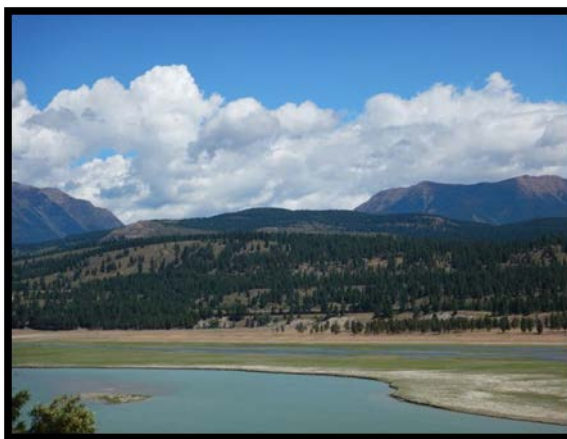
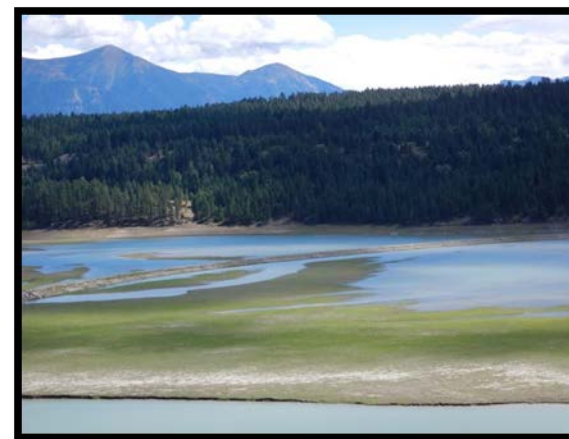
## Lake Koocanusa Segment No. 26

Segment Length (km)	Shore Type	Shore Type Mod.	Slope	Land Use	Level of Impact	Livestock Access	Disturbed	Natural
6.5	Other	Road	Low (0-5)	Agriculture	High (>40%)	Yes	50	50
Comments:		grazing fields

Retain Walls	% Ret. Wall	Ret. Wall Material	Docks	Docks per km	Boat Launch	% Rail Modifier	% Road Modifier	Marinas	Substrate Mod.	% Substrate Mod.
0	0	0	0	0	0	0	5	0	No	0
Comments:		road access

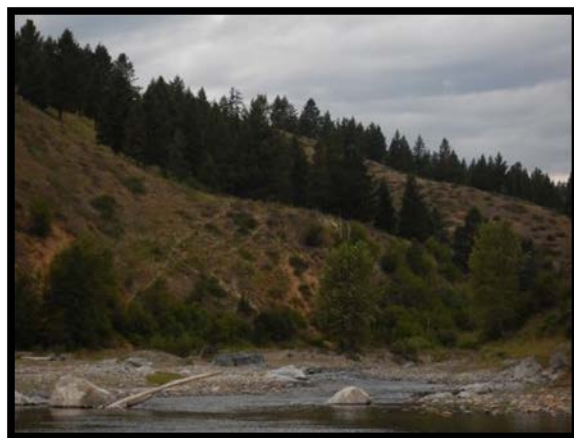
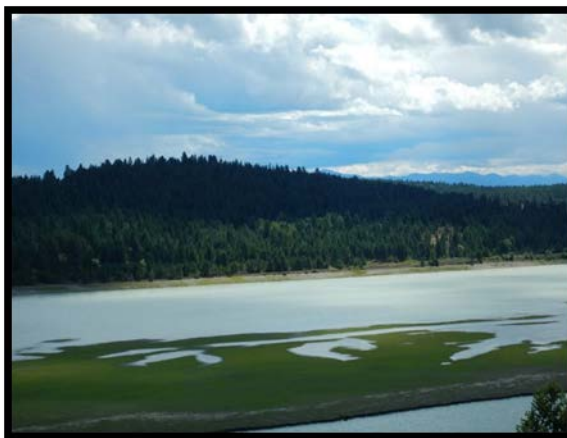
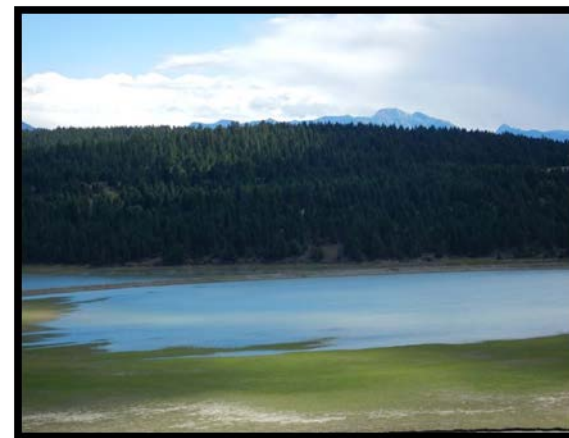
## Lake Koocanusa Segment No. 27

Segment Length (km)	Shore Type	Shore Type Mod.	Slope	Land Use	Level of Impact	Livestock Access	Disturbed	Natural
3.4	Gravel	Road	Moderate (5-20)	Rural	None	Yes	20	80
Comments:	frontage old rail line

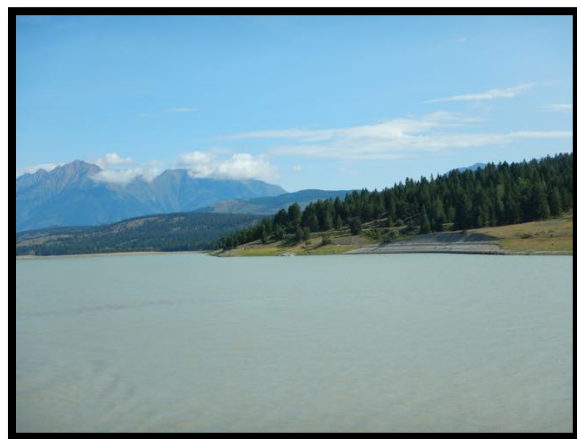
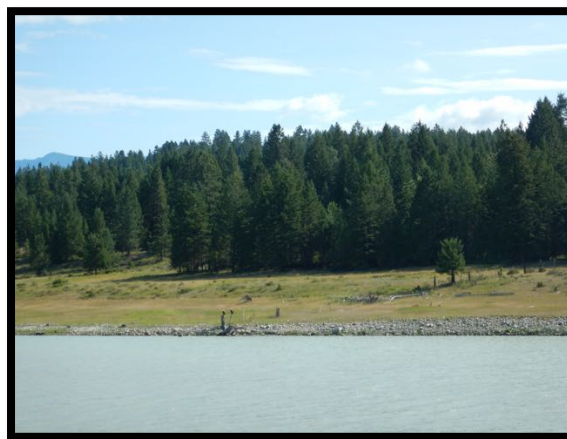
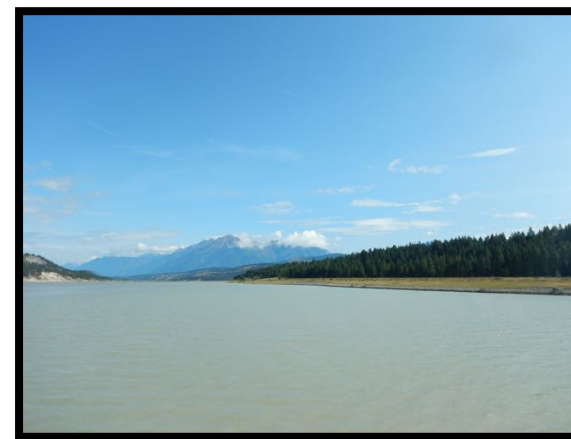
## Lake Koocanusa Segment No. 28

Segment Length (km)	Shore Type	Shore Type Mod.	Slope	Land Use	Level of Impact	Livestock Access	Disturbed	Natural
1.2	Gravel	Railway	Moderate (5-20)	Agriculture	Medium (10-40%)	Yes	50	50
<b>Comments:</b> 90 percent low grassy bench, stopped short 200m of end of segment water too shallow

Retain Walls	% Ret. Wall	Ret. Wall Material	Docks	Docks per km	Boat Launch	% Rail Modifier	% Road Modifier	Marinas	Substrate Mod.	% Substrate Mod.
0	0	0	0	0	0	0	0	0	No	0
<b>Comments:</b> 1 cattle fence

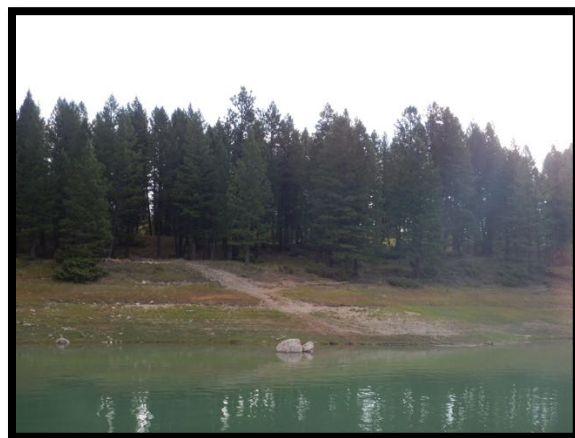
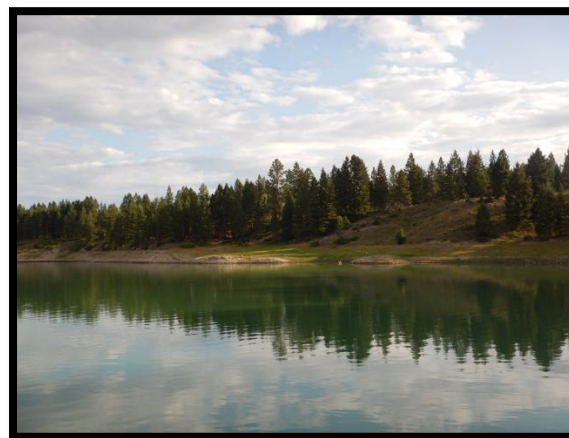
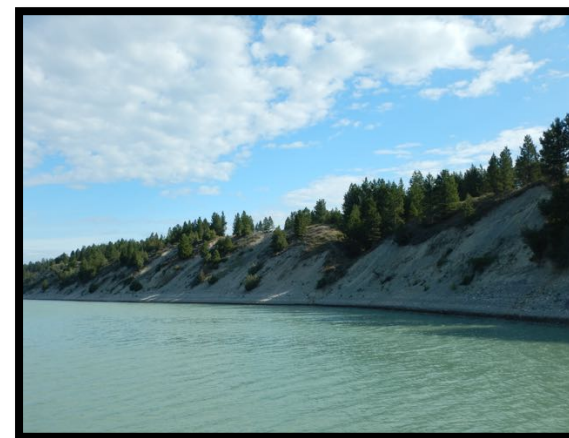
## Lake Koocanusa Segment No. 29

Segment Length (km)	Shore Type	Shore Type Mod.	Slope	Land Use	Level of Impact	Livestock Access	Disturbed	Natural
11	Gravel	Road	Very Steep (60+)	Forestry	Low (<10%)	Yes	5	95
<b>Comments:</b> predominantly steep, 1 short section 800-1,000m of low and moderate gradient,

Retain Walls	% Ret. Wall	Ret. Wall Material	Docks	Docks per km	Boat Launch	% Rail Modifier	% Road Modifier	Marinas	Substrate Mod.	% Substrate Mod.
0	0	0	0	0	1	0	10	0	No	0
<b>Comments:</b> 2 mooring buoys, 2 boats, 1 cattle fence

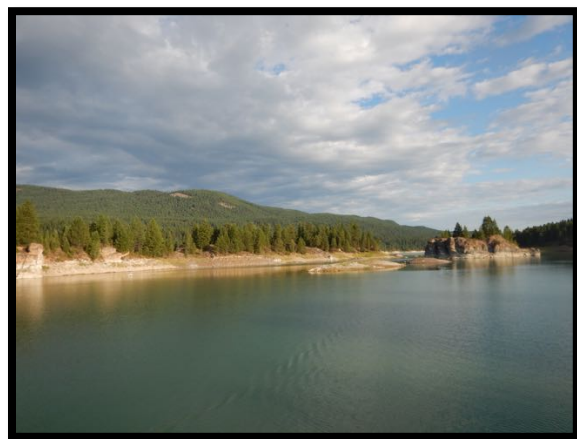
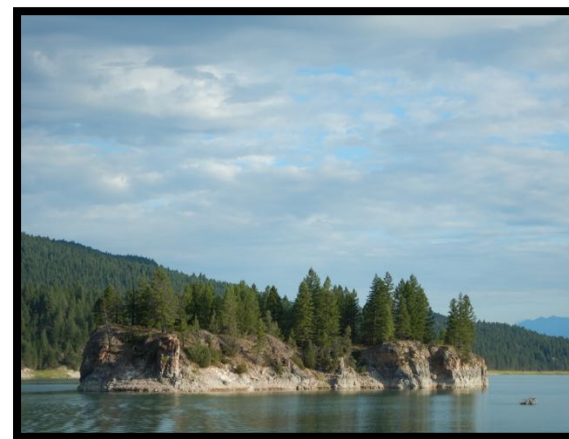
## Lake Koocanusa Segment No. 30

Segment Length (km)	Shore Type	Shore Type Mod.	Slope	Land Use	Level of Impact	Livestock Access	Disturbed	Natural
2	Cliff/Bluff	None	Very Steep (60+)	Forestry	Low (<10%)	No	1	99
Comments: bedrock/broken bedrock /rubble piles- islands 3 large, several small

Mud	Organics	Fine	Sand	Gravel	Cobble	Boulder	Bedrock
0	0	10	0	10	0	20	60
Comments: angular broken rock

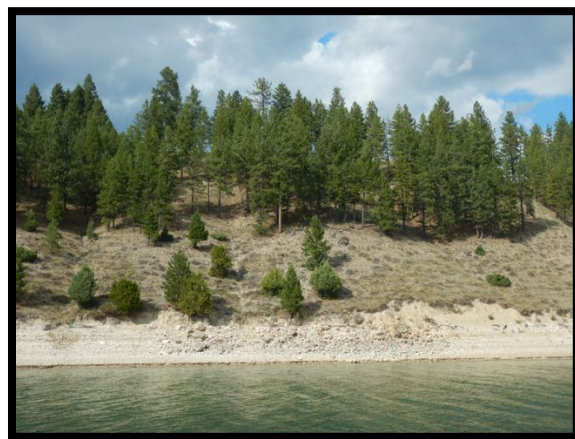
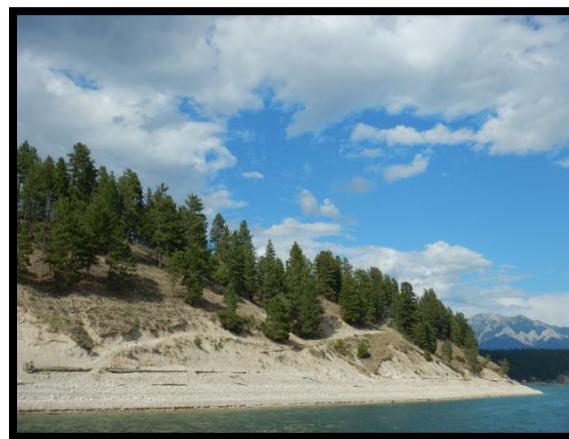
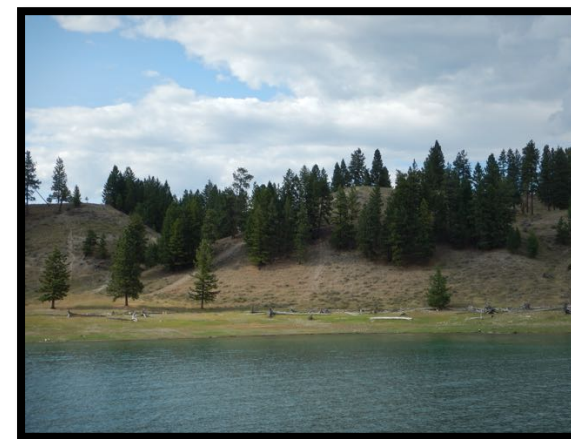
## Lake Koocanusa Segment No. 31

Segment Length (km)	Shore Type	Shore Type Mod.	Slope	Land Use	Level of Impact	Livestock Access	Disturbed	Natural
4.1	Gravel	None	Very Steep (60+)	Forestry	Low (<10%)	Yes	5	95
Comments:	cliff bluffs

Retain Walls	% Ret. Wall	Ret. Wall Material	Docks	Docks per km	Boat Launch	% Rail Modifier	% Road Modifier	Marinas	Substrate Mod.	% Substrate Mod.
0	0	0	0	0	0	0	0	0	No	0
Comments:	Orv use, localized

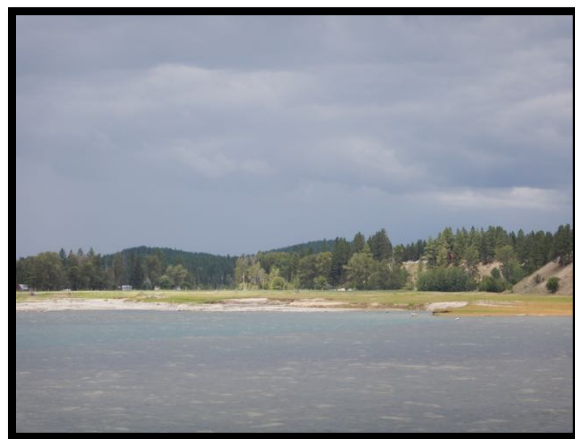
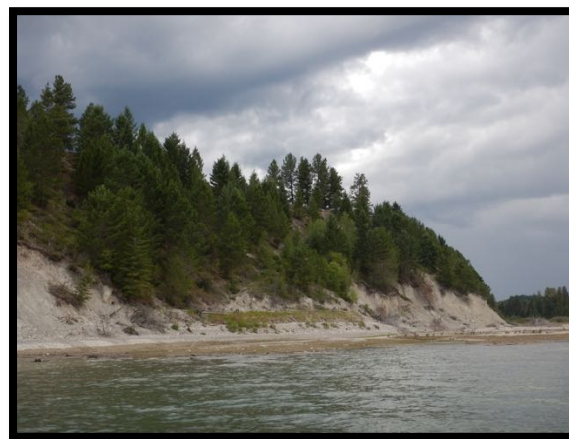
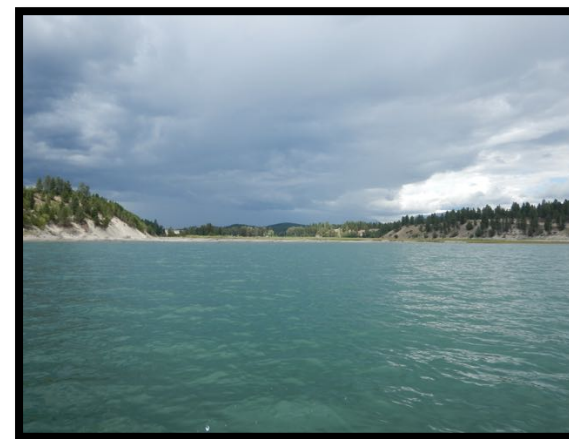
## Lake Koocanusa Segment No. 32

Segment Length (km)	Shore Type	Shore Type Mod.	Slope	Land Use	Level of Impact	Livestock Access	Disturbed	Natural
1.8	Stream Mouth	None	Low (0-5)	Natural Area	Low (<10%)	Yes	10	90
Comments:		sand creek outlet fan/braided channels

Retain Walls	% Ret. Wall	Ret. Wall Material	Docks	Docks per km	Boat Launch	% Rail Modifier	% Road Modifier	Marinas	Substrate Mod.	% Substrate Mod.
0	0	0	0	0	0	0	0	0	No	0
Comments:		orv use

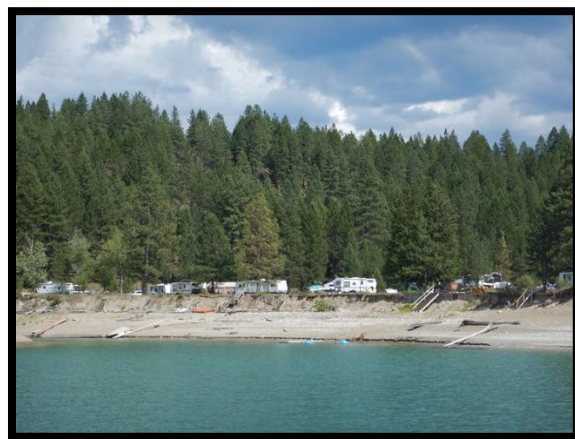
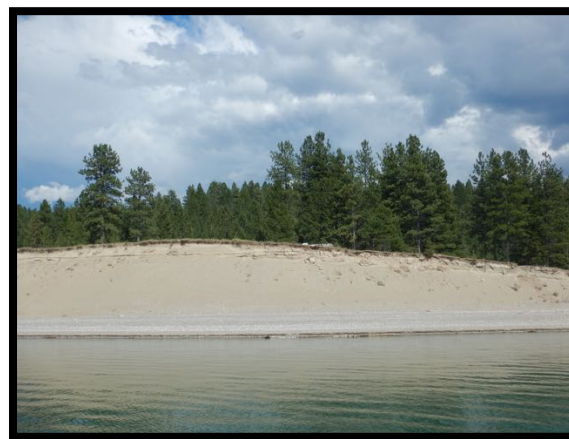
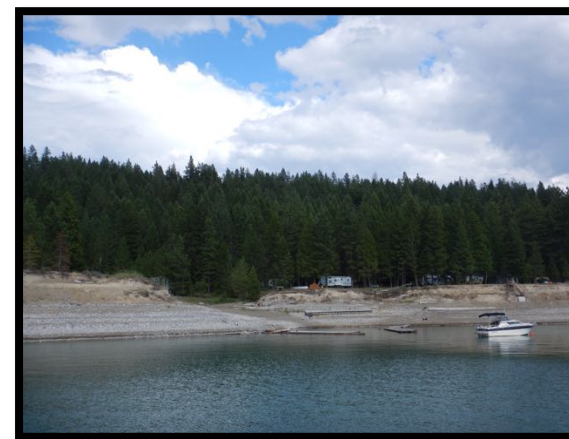
## Lake Koocanusa Segment No. 33

Segment Length (km)	Shore Type	Shore Type Mod.	Slope	Land Use	Level of Impact	Livestock Access	Disturbed	Natural
3.9	Gravel	Road	Steep (20-60)	Recreation	High (>40%)	No	80	20
Comments:		gravel, some sand banks

Retain Walls	% Ret. Wall	Ret. Wall Material	Docks	Docks per km	Boat Launch	% Rail Modifier	% Road Modifier	Marinas	Substrate Mod.	% Substrate Mod.
9	8	Mixed	36	8	7	0	90	0	No	0
Comments:		61 mooring buoys, 22 swimming platform, 29 stairs, 20 pilings, 5 floating breakwater, 1 fence, boats

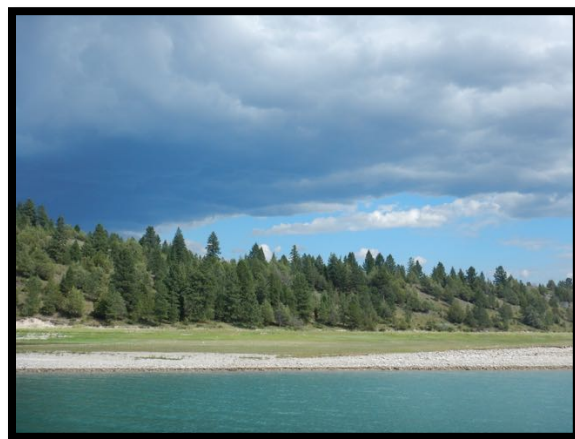
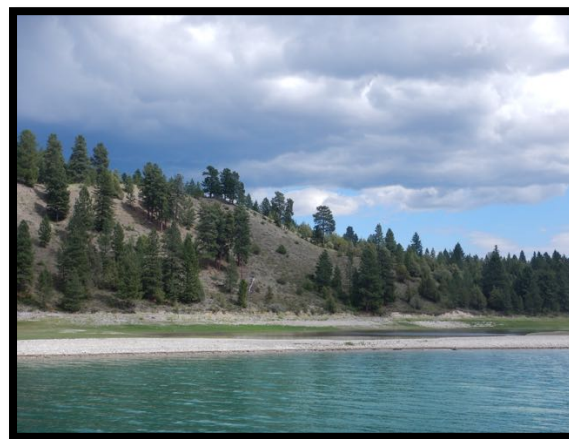
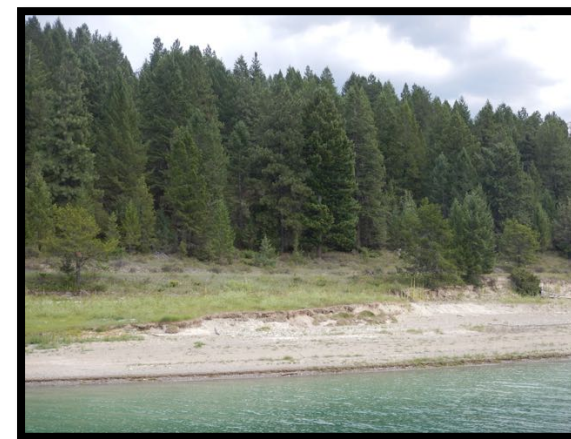
## Lake Koocanusa Segment No. 34

Segment Length (km)	Shore Type	Shore Type Mod.	Slope	Land Use	Level of Impact	Livestock Access	Disturbed	Natural
3.1	Gravel	Road	Steep (20-60)	Forestry	High (>40%)	Yes	50	50
Comments: gravel shoreline with variable width 20 - 100 m grassy benches below full pool

Retain Walls	% Ret. Wall	Ret. Wall Material	Docks	Docks per km	Boat Launch	% Rail Modifier	% Road Modifier	Marinas	Substrate Mod.	% Substrate Mod.
0	0	0	0	0	0	0	50	0	No	0
Comments: orv trails to water

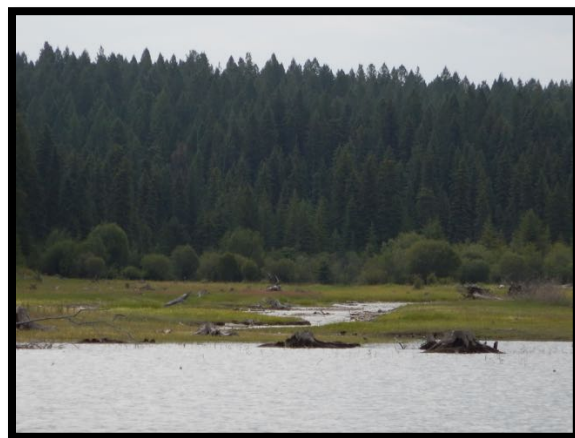
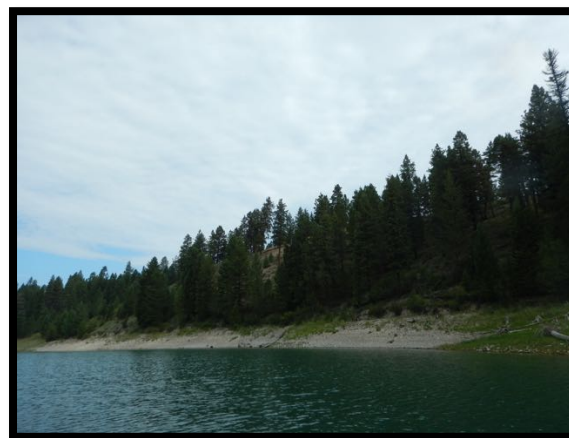
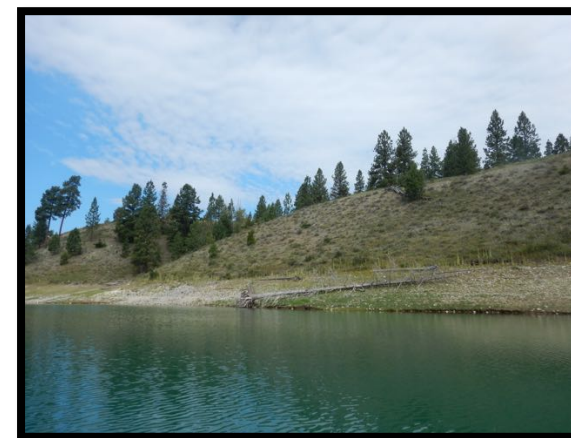
## Lake Koocanusa Segment No. 35

Segment Length (km)	Shore Type	Shore Type Mod.	Slope	Land Use	Level of Impact	Livestock Access	Disturbed	Natural
2.2	Gravel	Road	Steep (20-60)	Forestry	Low (<10%)	Yes	2	98
Comments:		Kikomun inlet road at western entrance

Retain Walls	% Ret. Wall	Ret. Wall Material	Docks	Docks per km	Boat Launch	% Rail Modifier	% Road Modifier	Marinas	Substrate Mod.	% Substrate Mod.
0	0	0	0	0	0	0	0	0	No	0
Comments:		2 orv trails to water

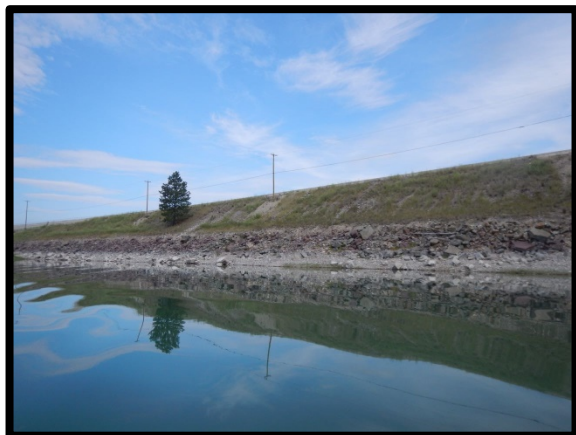
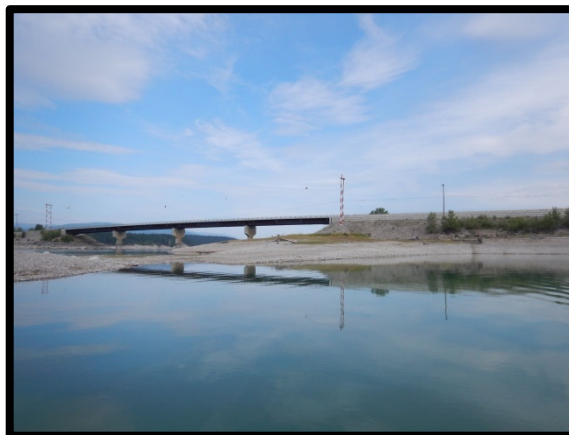
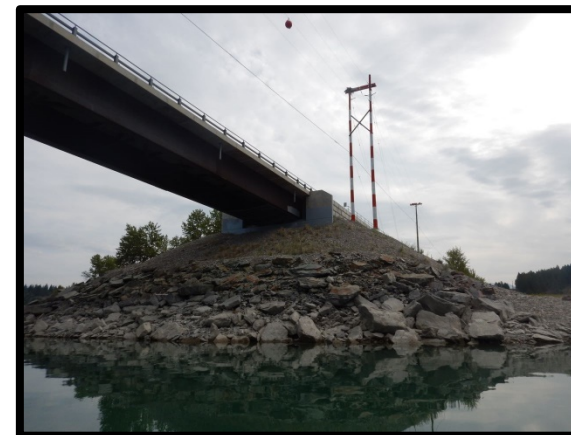
## Lake Koocanusa Segment No. 36

Segment Length (km)	Shore Type	Shore Type Mod.	Slope	Land Use	Level of Impact	Livestock Access	Disturbed	Natural
1.4	Other	Road	Steep (20-60)	Industrial	High (>40%)	No	70	30
Comments:		east side Kikomun crossing causeway

Agriculture	Commercial	Forestry	Industrial	Natural Area	Park	Recreation	Rural	Single Family
0	0	0	70	30	0	0	0	0
Comments:		causeway overlaying natural gravel deposit

Class	Stage	Shrub Cover	Tree Cover	Distribution	Bandwidth (m)
Exposed soil	Sparse	None	None	Patchy	10
Comments:		grasses/shrub/trees on gravel deposit under causeway and spreading out both sides n and s at bridge

Retain Walls	% Ret. Wall	Ret. Wall Material	Docks	Docks per km	Boat Launch	% Rail Modifier	% Road Modifier	Marinas	Substrate Mod.	% Substrate Mod.
0	0	0	0	0	1	0	0	0	No	0
Comments:		1 orphan dock, low water boat launch

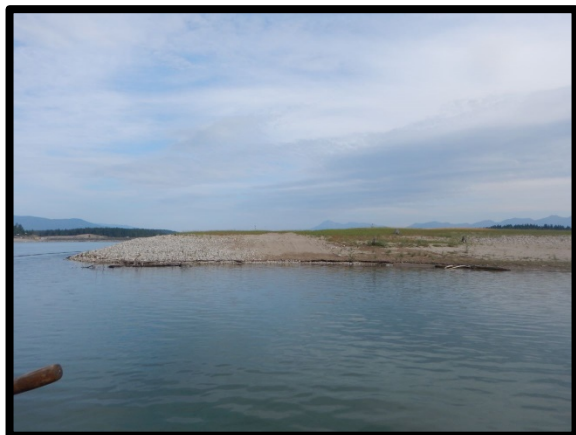
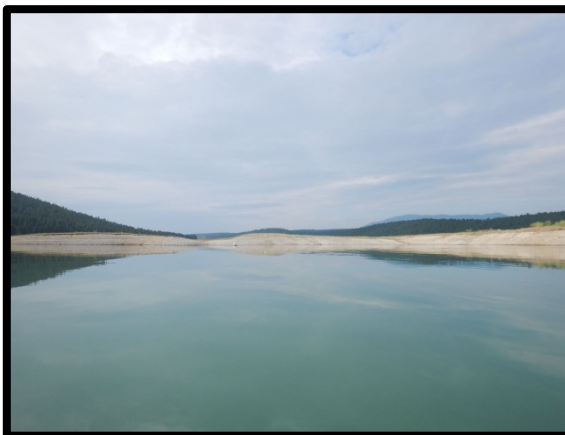
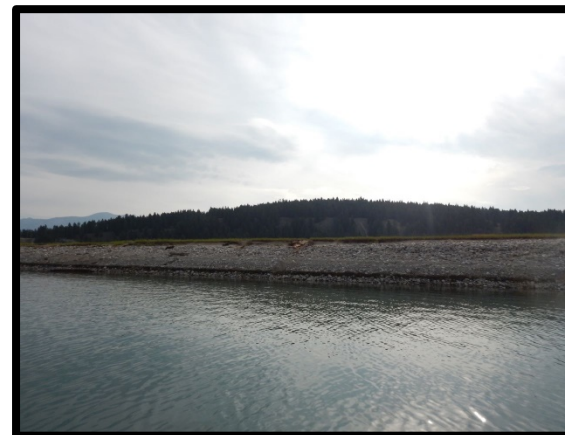
## Lake Koocanusa Segment No. 37

Segment Length (km)	Shore Type	Shore Type Mod.	Slope	Land Use	Level of Impact	Livestock Access	Disturbed	Natural
1.9	Gravel	None	Moderate (5-20)	Natural Area	Low (<10%)	No	5	95
Comments:		island at south Kikomun crossing

Retain Walls	% Ret. Wall	Ret. Wall Material	Docks	Docks per km	Boat Launch	% Rail Modifier	% Road Modifier	Marinas	Substrate Mod.	% Substrate Mod.
0	0	0	0	0	1	0	0	0	No	0
Comments:		numerous gravel boat launches depending on water level

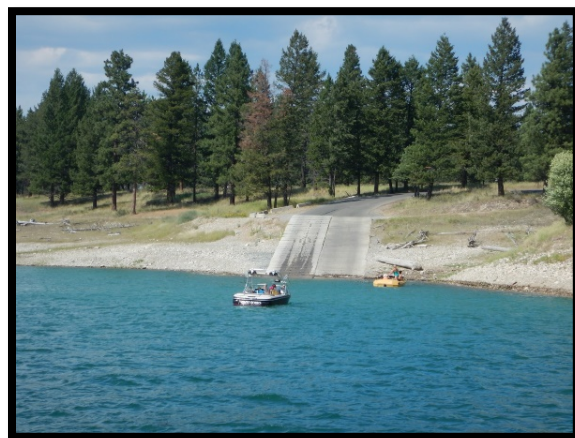
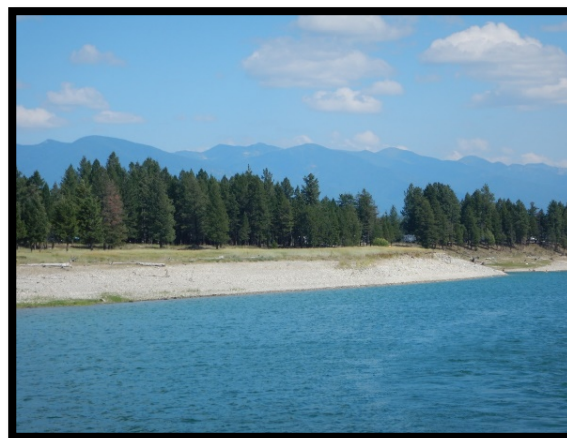
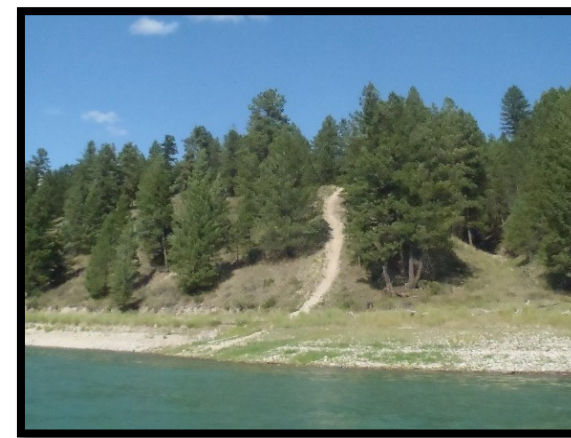
## Lake Koocanusa Segment No. 38

Segment Length (km)	Shore Type	Shore Type Mod.	Slope	Land Use	Level of Impact	Livestock Access	Disturbed	Natural
5.9	Gravel	Other	Moderate (5-20)	Park	Medium (10-40%)	No	40	60
Comments:		Kikomun park

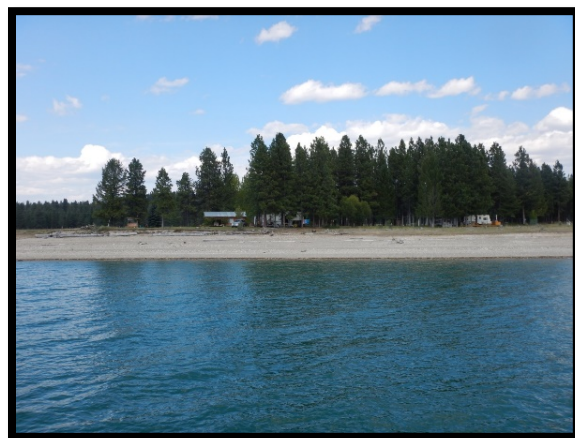
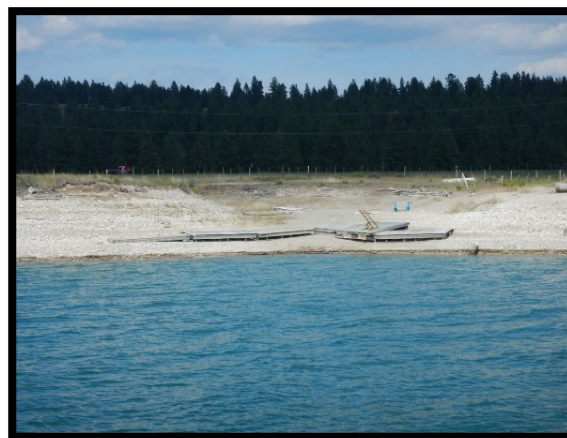
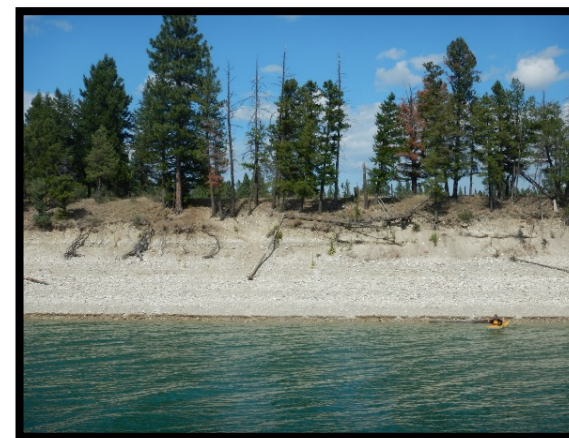
## Lake Koocanusa Segment No. 39

Segment Length (km)	Shore Type	Shore Type Mod.	Slope	Land Use	Level of Impact	Livestock Access	Disturbed	Natural
0.7	Gravel	Road	Steep (20-60)	Single Family	High (>40%)	Yes	60	40
Comments:

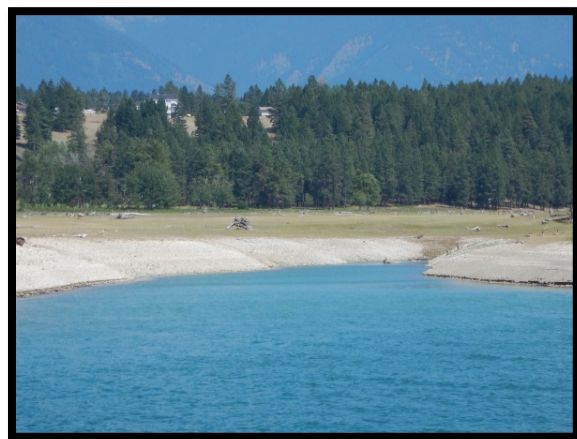
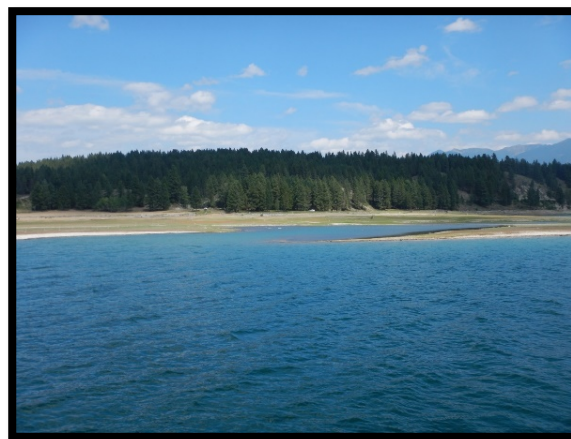
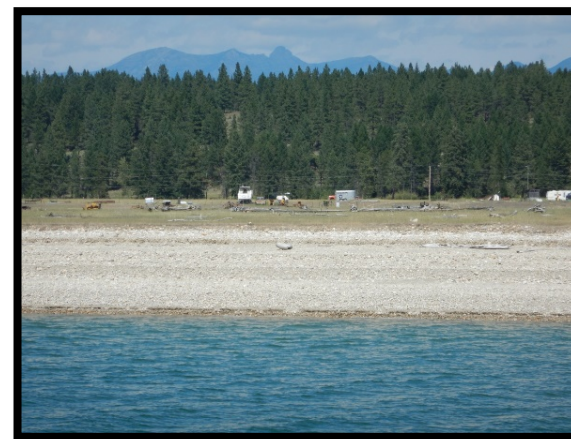
## Segment No. 40

Segment Length (km)	Shore Type	Shore Type Mod.	Slope	Land Use	Level of Impact	Livestock Access	Disturbed	Natural
3.2	Other	Road	Low (0-5)	Agriculture	High (>40%)	Yes	75	25
Comments: north end agriculture, south end natural with road

Retain Walls	% Ret. Wall	Ret. Wall Material	Docks	Docks per km	Boat Launch	% Rail Modifier	% Road Modifier	Marinas	Substrate Mod.	% Substrate Mod.
0	0	0	0	0	0	0	0	0	No	0
Comments: temporary electric fence

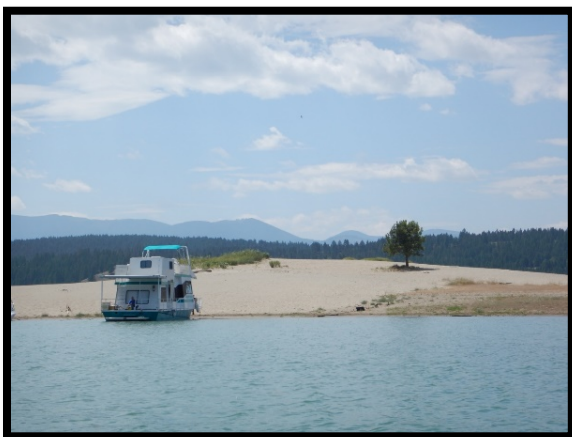
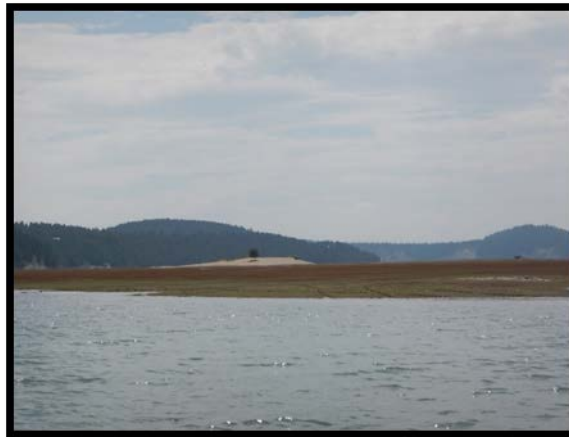
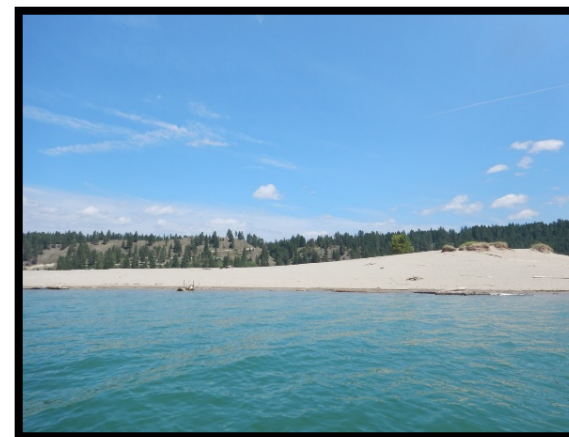
## Lake Koocanusa Segment No. 41

Segment Length (km)	Shore Type	Shore Type Mod.	Slope	Land Use	Level of Impact	Livestock Access	Disturbed	Natural
1.9	Sand	None	Low (0-5)	Natural Area	Medium (10-40%)	Yes	10	90
<b>Comments:</b> area mostly inundated at full pool except sand beach island at s end

Retain Walls	% Ret. Wall	Ret. Wall Material	Docks	Docks per km	Boat Launch	% Rail Modifier	% Road Modifier	Marinas	Substrate Mod.	% Substrate Mod.
0	0	0	0	0	0	0	0	0	No	0
<b>Comments:</b> extensive orv, house boats, motor boats, pets, human use

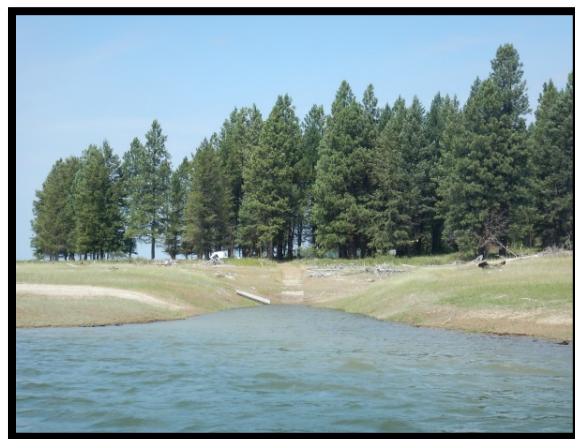
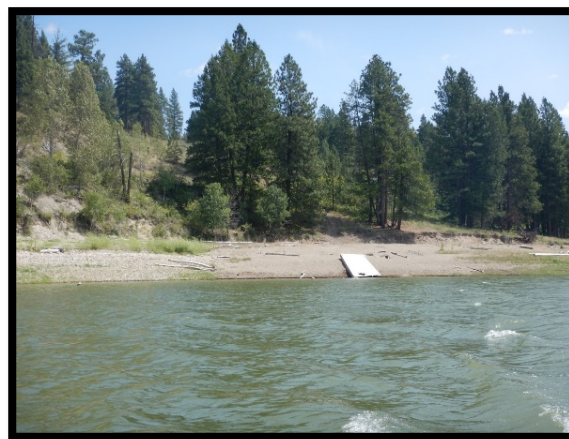
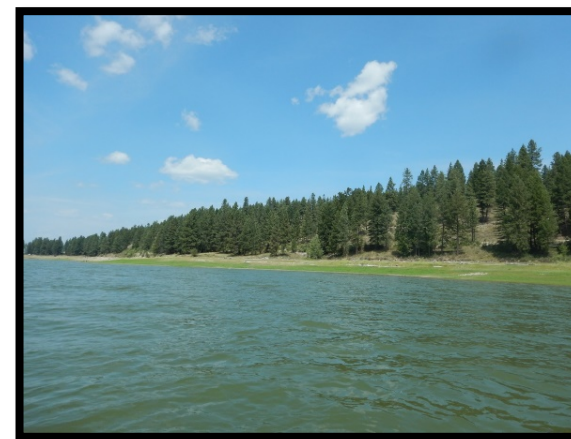
## Lake Koocanusa Segment No. 42

Segment Length (km)	Shore Type	Shore Type Mod.	Slope	Land Use	Level of Impact	Livestock Access	Disturbed	Natural
0.9	Gravel	Road	Moderate (5-20)	Natural Area	High (>40%)	Yes	60	40
Comments:		natural area with road through 95 percent of segment

Retain Walls	% Ret. Wall	Ret. Wall Material	Docks	Docks per km	Boat Launch	% Rail Modifier	% Road Modifier	Marinas	Substrate Mod.	% Substrate Mod.
0	0	0	3	3	1	0	90	0	No	0
Comments:		1 concrete boat launch

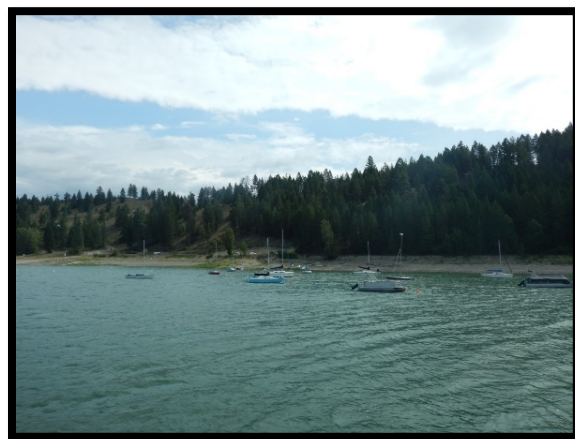
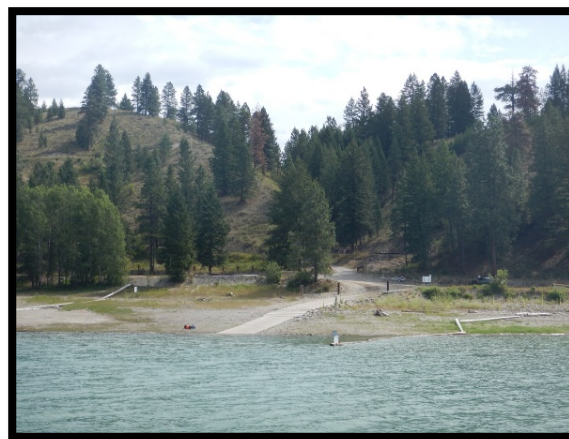
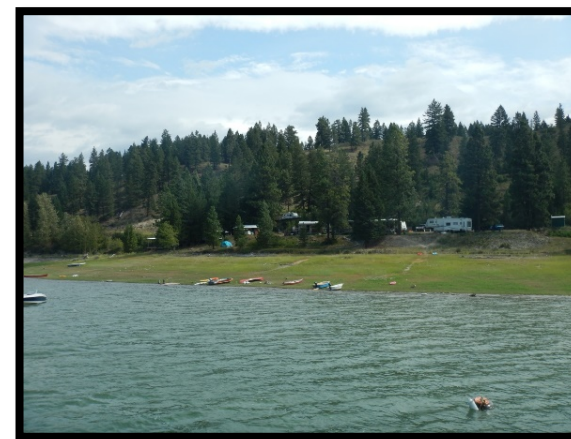
## Lake Koocanusa Segment No. 43

Segment Length (km)	Shore Type	Shore Type Mod.	Slope	Land Use	Level of Impact	Livestock Access	Disturbed	Natural
1.9	Gravel	Road	Moderate (5-20)	Recreation	Medium (10-40%)	No	40	60
Comments: F.O.L.K.S campground, mooring, boat launch, pocket beach

Retain Walls	% Ret. Wall	Ret. Wall Material	Docks	Docks per km	Boat Launch	% Rail Modifier	% Road Modifier	Marinas	Substrate Mod.	% Substrate Mod.
0	0	0	1	1	1	0	35	0	Yes	8
Comments: 1 concrete launch, 29 mooring buoys, 51 boats, 2 platforms, 4 houseboats, 3 log booms1 pocket beach

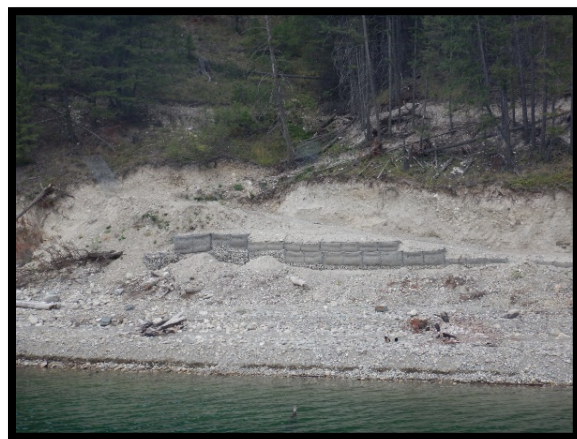
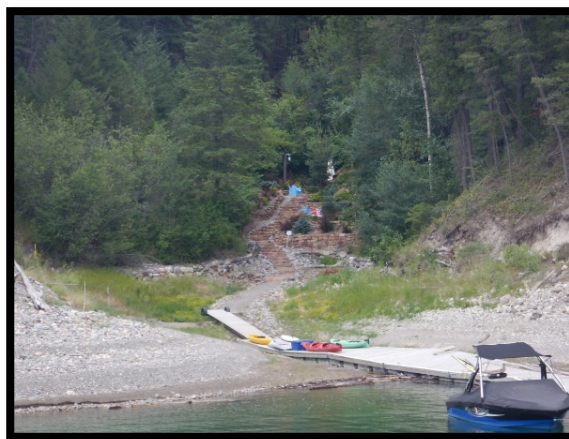
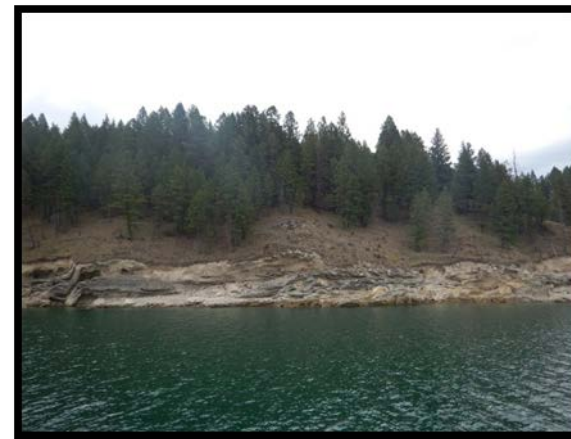
## Lake Koocanusa Segment No. 44

Segment Length (km)	Shore Type	Shore Type Mod.	Slope	Land Use	Level of Impact	Livestock Access	Disturbed	Natural
1.2	Cliff/Bluff	None	Steep (20-60)	Natural Area	Low (<10%)	No	2	98
Comments: 30 percent crown, 70 percent natural, 2 obvious developments

Retain Walls	% Ret. Wall	Ret. Wall Material	Docks	Docks per km	Boat Launch	% Rail Modifier	% Road Modifier	Marinas	Substrate Mod.	% Substrate Mod.
1	1	Stonework	1	1	0	0	1	0	Yes	1
Comments: 1 swimming platform, 2 mooring buoys, 2 stair access, 1 log boom 150 m, atv trail to gabions

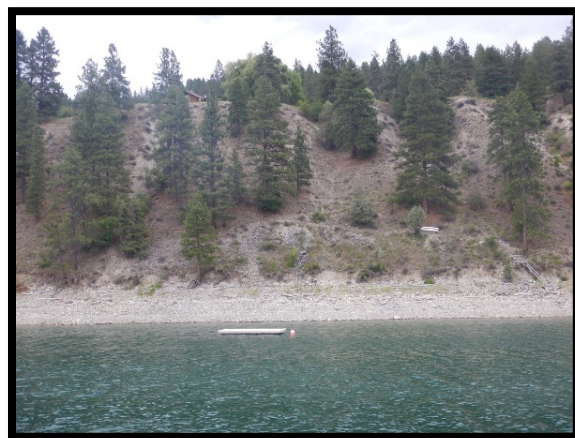
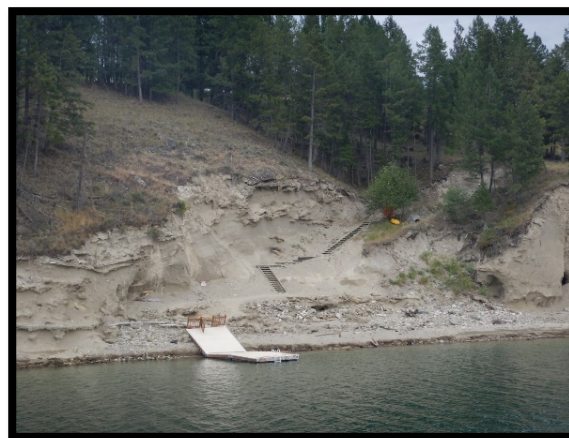
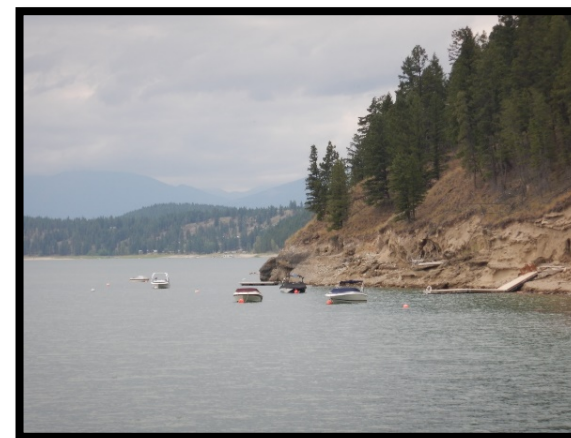
## Lake Koocanusa Segment No. 45

Segment Length (km)	Shore Type	Shore Type Mod.	Slope	Land Use	Level of Impact	Livestock Access	Disturbed	Natural
0.7	Cliff/Bluff	Road	Steep (20-60)	Single Family	Medium (10-40%)	No	20	80
Comments: developed on flat at top of cliff, access to foreshore by steep trails, roads

Retain Walls	% Ret. Wall	Ret. Wall Material	Docks	Docks per km	Boat Launch	% Rail Modifier	% Road Modifier	Marinas	Substrate Mod.	% Substrate Mod.
0	0	0	2	2	1	0	2	0	No	0
Comments: 19 mooring buoys, 4 stairs, 4 swim platforms, 1 log breakwater - 100 m, 6 boats

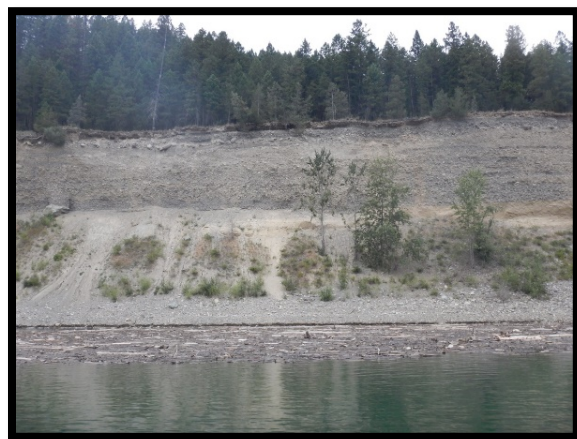
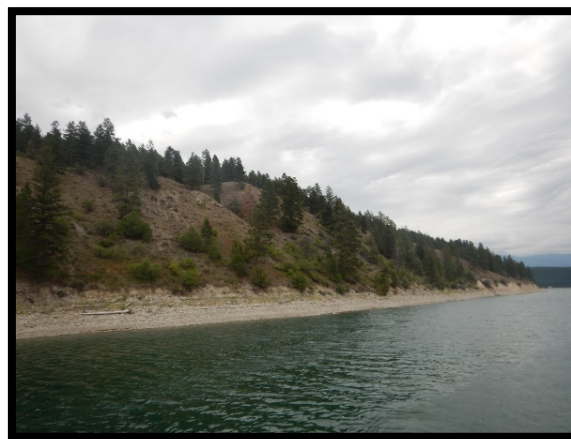
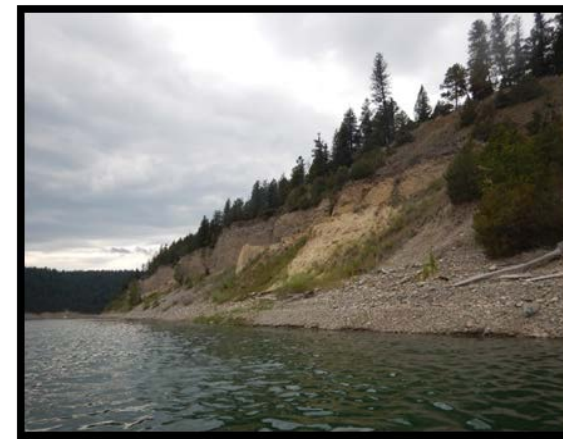
## Lake Koocanusa Segment No. 46

Segment Length (km)	Shore Type	Shore Type Mod.	Slope	Land Use	Level of Impact	Livestock Access	Disturbed	Natural
3.3	Cliff/Bluff	None	Steep (20-60)	Forestry	None	Yes	0	100
Comments:		some eroding clay banks/some gravel/sand slopes
