# East Kootenay Integrated Lake Management Partnership

## Koocanusa Reservoir Sensitive Habitat Inventory Mapping – Phase 2 Final Report

UKE-F17-F-1403

December 15, 2017

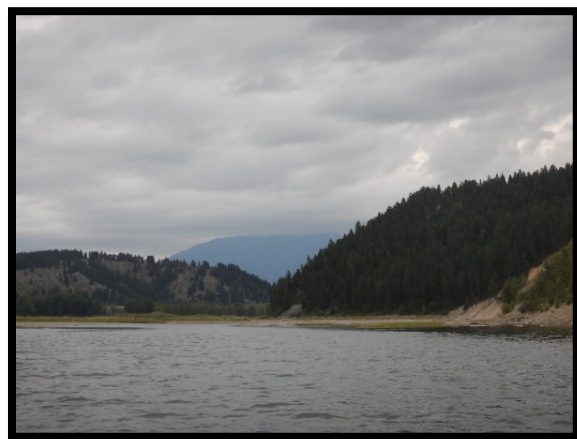
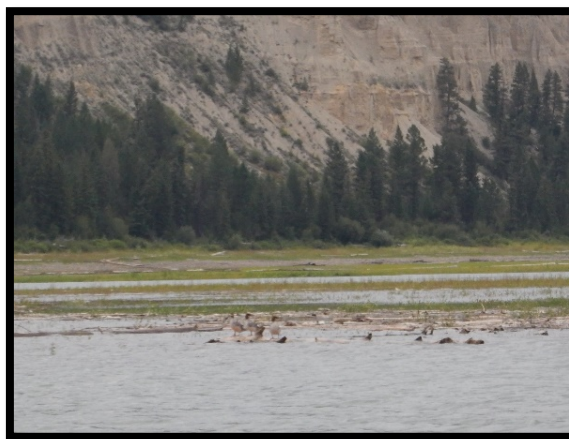
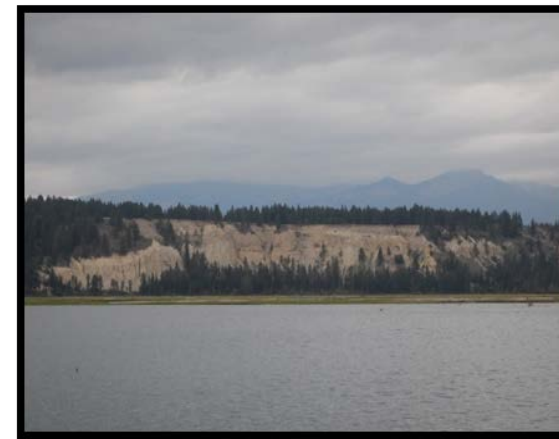
## Lake Koocanusa Segment No. 47

Segment Length (km)	Shore Type	Shore Type Mod.	Slope	Land Use	Level of Impact	Livestock Access	Disturbed	Natural
5.9	Stream Mouth	None	Steep (20-60)	Natural Area	Low (<10%)	Yes	1	99
Comments:		elk river wetland/outlet

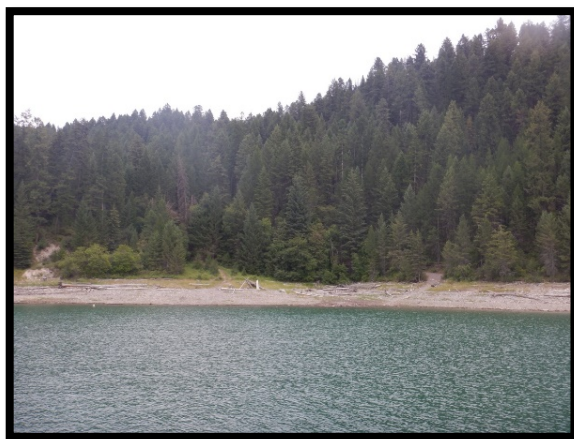
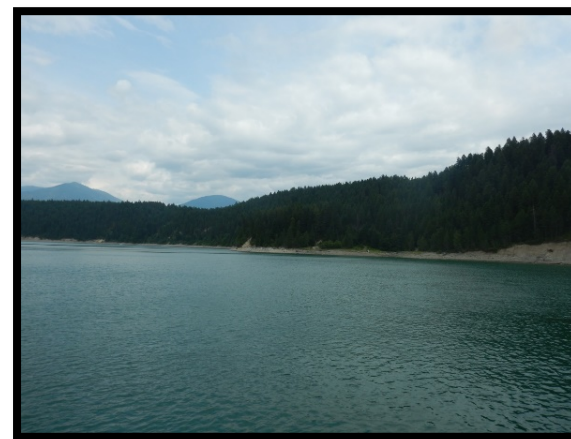
## Lake Koocanusa Segment No. 48

Segment Length (km)	Shore Type	Shore Type Mod.	Slope	Land Use	Level of Impact	Livestock Access	Disturbed	Natural
1.5	Rocky Shore	None	Steep (20-60)	Forestry	Low (<10%)	No	1	99
Comments:

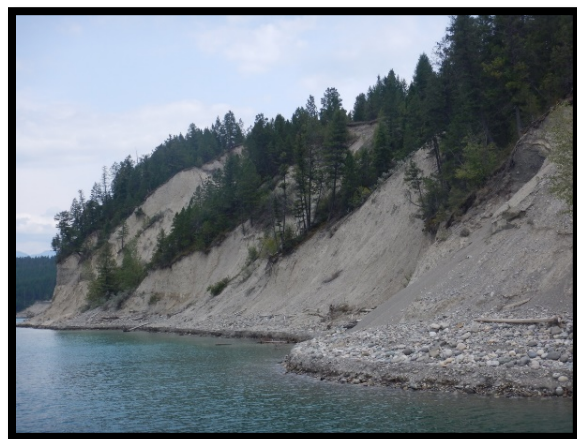
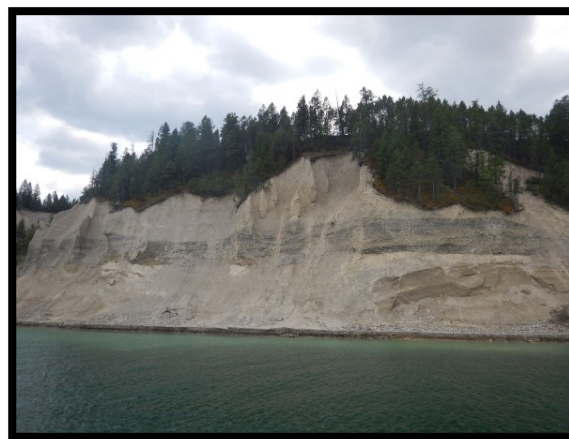
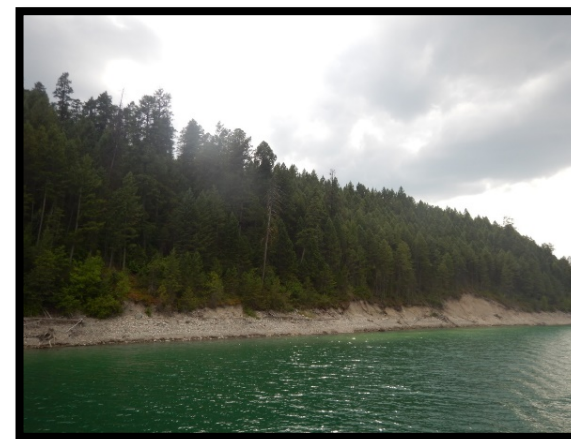
## Lake Koocanusa Segment No. 49

Segment Length (km)	Shore Type	Shore Type Mod.	Slope	Land Use	Level of Impact	Livestock Access	Disturbed	Natural
3.3	Cliff/Bluff	None	Very Steep (60+)	Forestry	Low (<10%)	No	1	99
Comments:		steep unstable cliffs

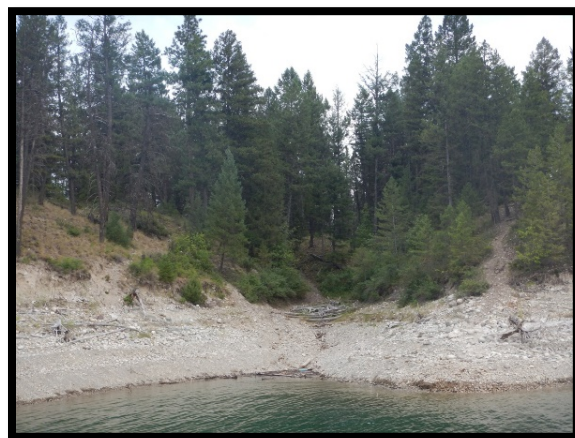
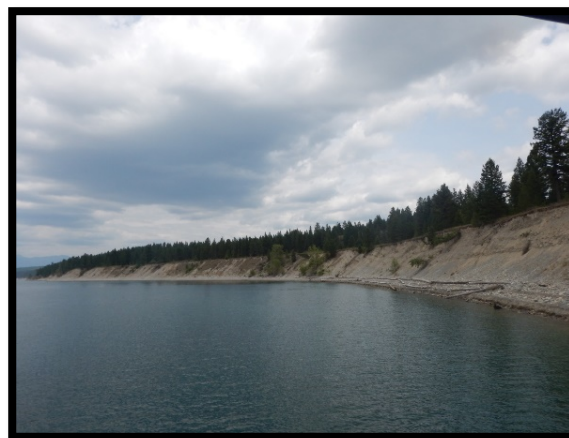
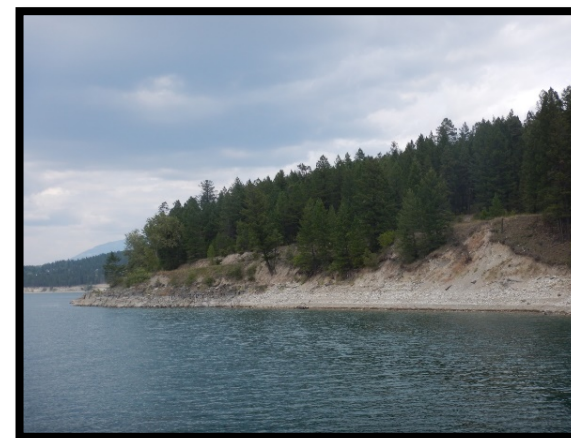
## Lake Koocanusa Segment No. 50

Segment Length (km)	Shore Type	Shore Type Mod.	Slope	Land Use	Level of Impact	Livestock Access	Disturbed	Natural
2.5	Gravel	Road	Steep (20-60)	Forestry	Low (<10%)	Yes	1	99
Comments:	10 m steep gravel banks

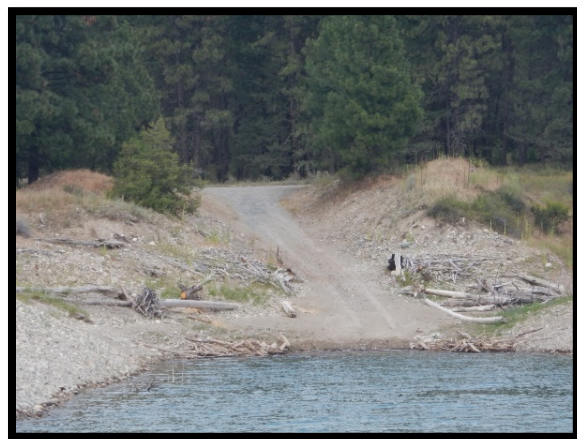
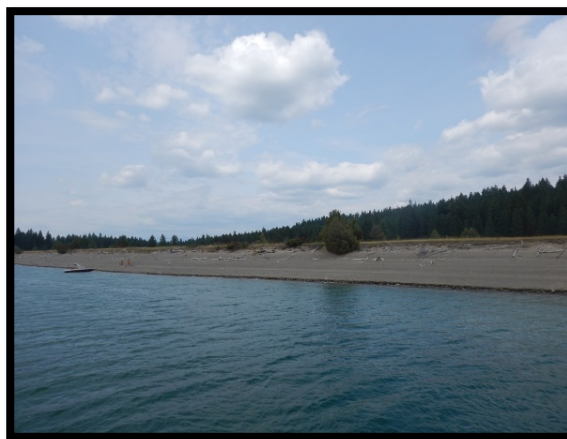
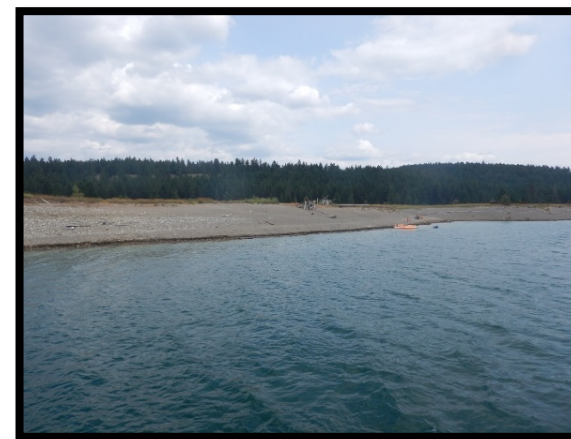
## Lake Koocanusa Segment No. 51

Segment Length (km)	Shore Type	Shore Type Mod.	Slope	Land Use	Level of Impact	Livestock Access	Disturbed	Natural
2.4	Gravel	Road	Bench	Forestry	Low (<10%)	Yes	30	70
Comments: sand beach, organized camping, Dorr, grassy fields

Agriculture	Commercial	Forestry	Industrial	Natural Area	Park	Recreation	Rural	Single Family
0	0	95	0	0	0	5	0	0
Comments: extensive upland and foreshore use, 5 unorganized campsites, heavy orv use with serious damage

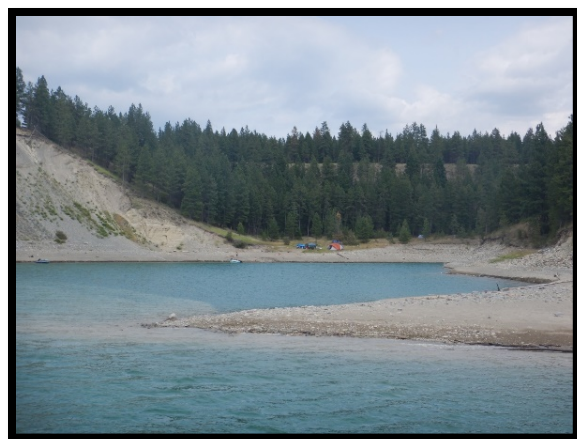
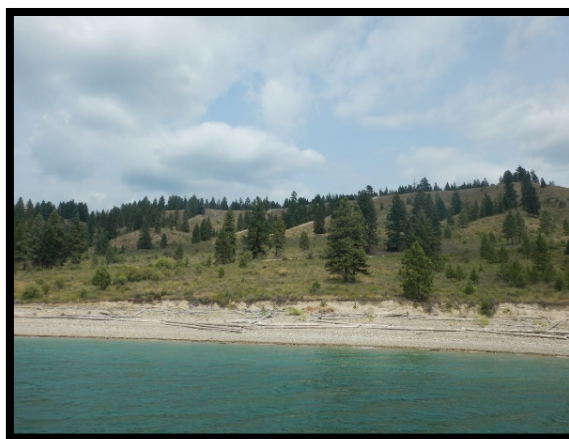
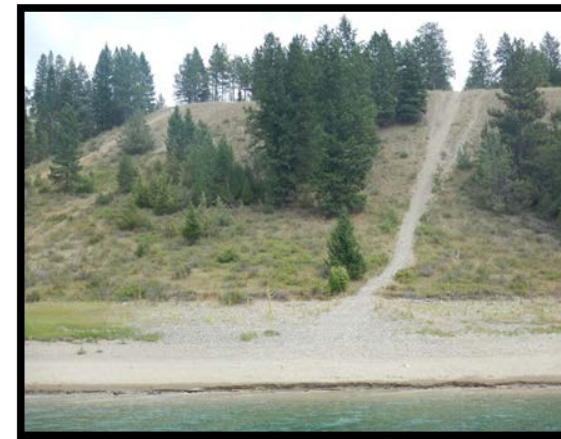
## Lake Koocanusa Segment No. 52

Segment Length (km)	Shore Type	Shore Type Mod.	Slope	Land Use	Level of Impact	Livestock Access	Disturbed	Natural
5.2	Gravel	Road	Moderate (5-20)	Forestry	High (>40%)	Yes	50	50
Comments: good public access, 3 sand beaches

Retain Walls	% Ret. Wall	Ret. Wall Material	Docks	Docks per km	Boat House	% Rail Modifier	% Road Modifier	Marinas	Substrate Mod.	% Substrate Mod.
0	0	0	1	0	0	0	95	0	No	0
Comments: informal boat launches, 2 mooring buoys, 10 boats

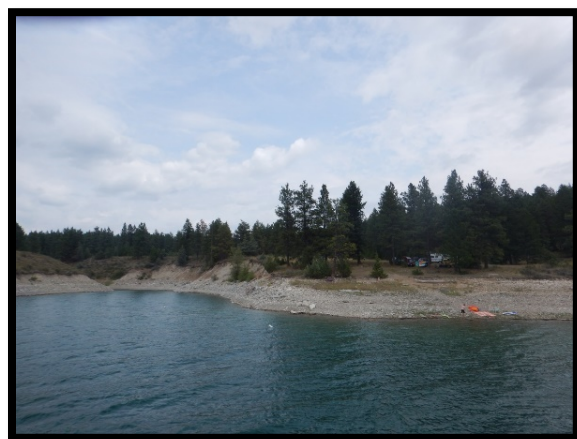
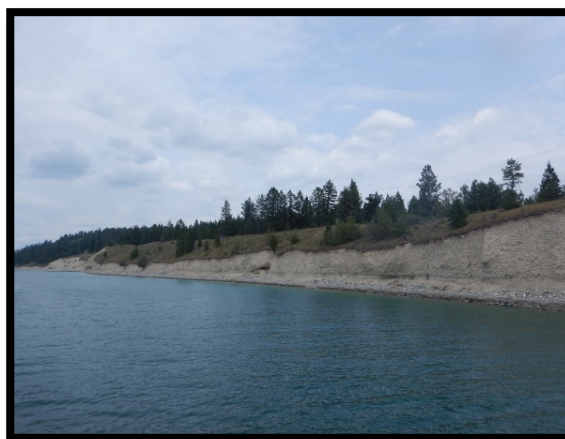
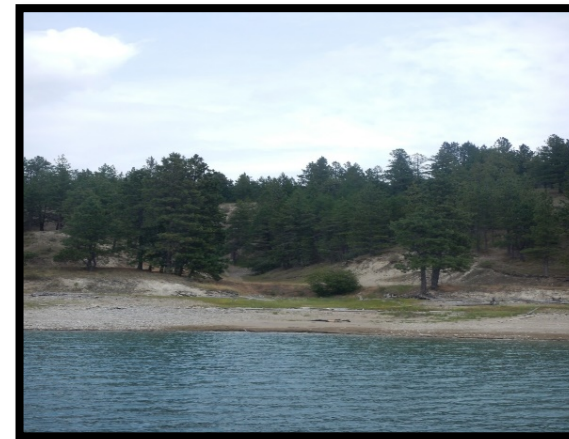
# Lake Koocanusa Segment No. 53

Segment Length (km)	Shore Type	Shore Type Mod.	Slope	Land Use	Level of Impact	Livestock Access	Disturbed	Natural
4.4	Cliff/Bluff	None	Very Steep (60+)	Forestry	Low (<10%)	Yes	0	100
Comments: a few calcium formations, a few shale outcrops/ledges

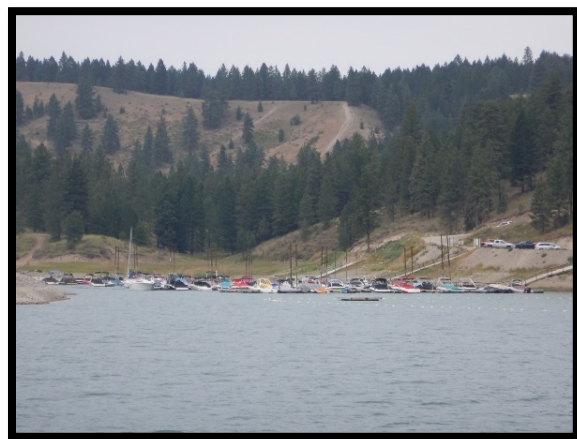
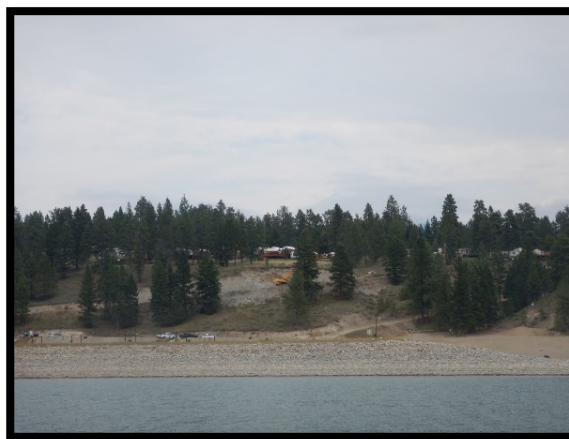
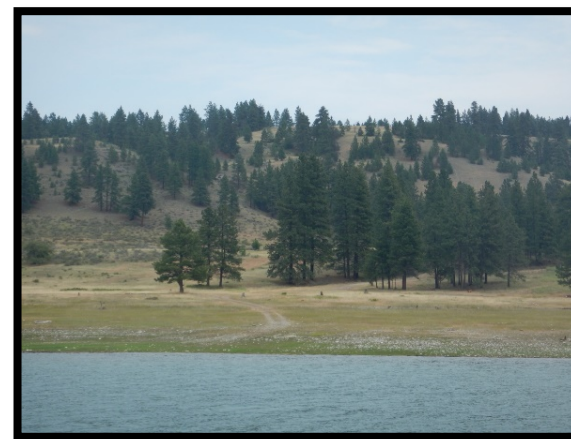
## Lake Koocanusa Segment No. 54

Segment Length (km)	Shore Type	Shore Type Mod.	Slope	Land Use	Level of Impact	Livestock Access	Disturbed	Natural
3.1	Rocky Shore	Road	Low (0-5)	Forestry	Medium (10-40%)	Yes	40	60
Comments:		unorganized recreation/marina

Retain Walls	% Ret. Wall	Ret. Wall Material	Docks	Docks per km	Boat Launch	% Rail Modifier	% Road Modifier	Marinas	Substrate Mod.	% Substrate Mod.
0	0	0	1	0	0	0	40	1	No	0
Comments:		1 large marina, unorganized road network

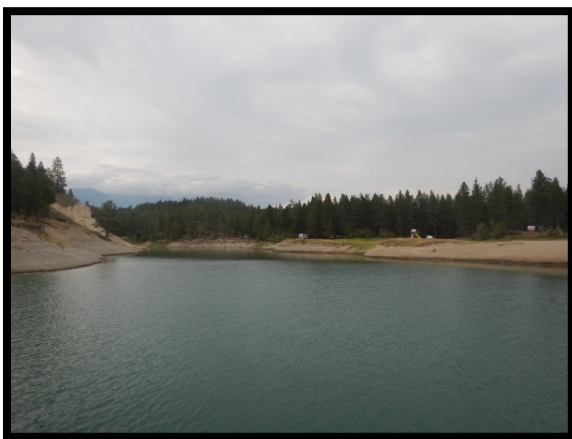
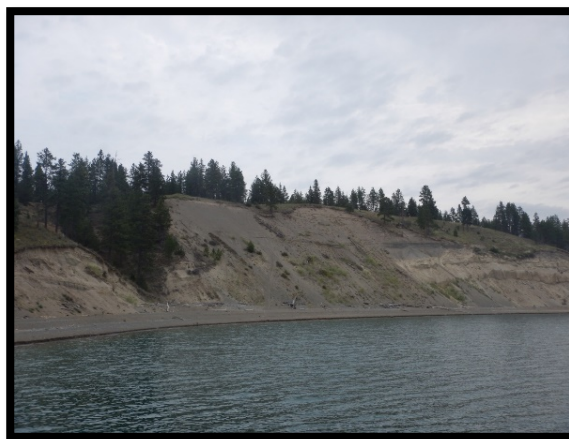
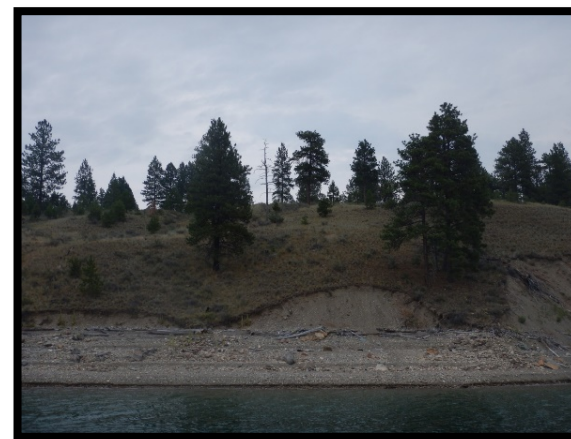
## Lake Koocanusa Segment No. 55

Segment Length (km)	Shore Type	Shore Type Mod.	Slope	Land Use	Level of Impact	Livestock Access	Disturbed	Natural
1.1	Cliff/Bluff	None	Very Steep (60+)	Rural	Low (<10%)	Yes	5	95
Comments:		private no buildings /check ownership

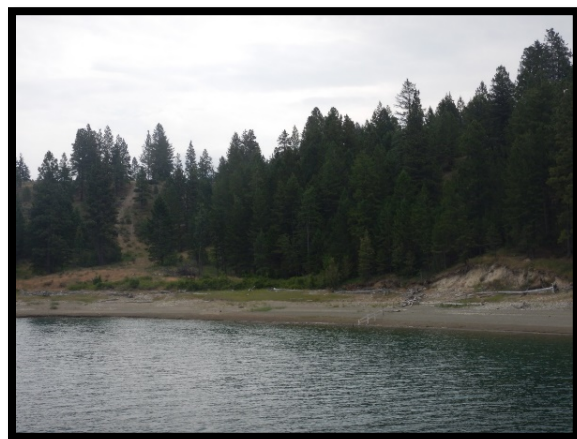
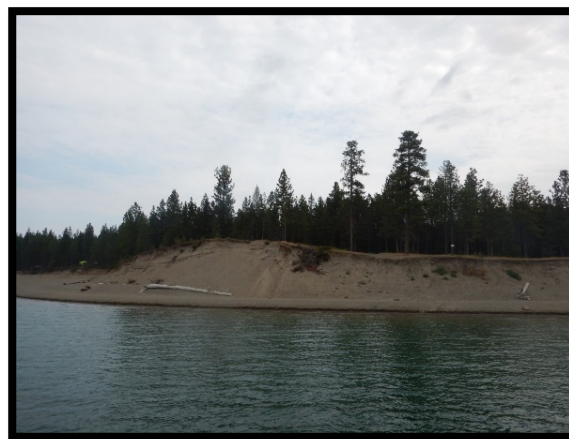
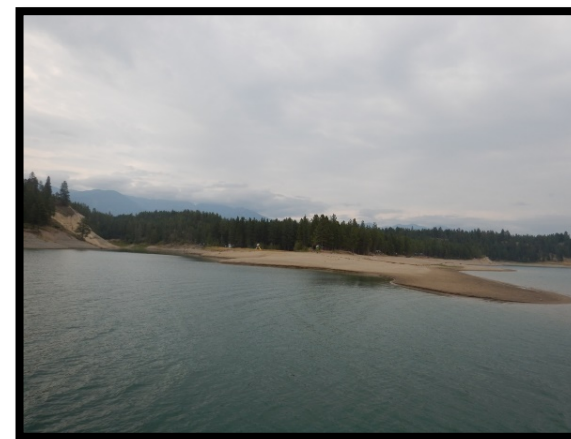
## Lake Koocanusa Segment No. 56

Segment Length (km)	Shore Type	Shore Type Mod.	Slope	Land Use	Level of Impact	Livestock Access	Disturbed	Natural
3	Sand	Other	Low (0-5)	Recreation	Low (<10%)	Yes	70	30
Comments:		big springs campground

Retain Walls	% Ret. Wall	Ret. Wall Material	Docks	Docks per km	Boat Launch	% Rail Modifier	% Road Modifier	Marinas	Substrate Mod.	% Substrate Mod.
0	0	0	0	0	2	0	0	0	No	0
Comments: log swim breakwater

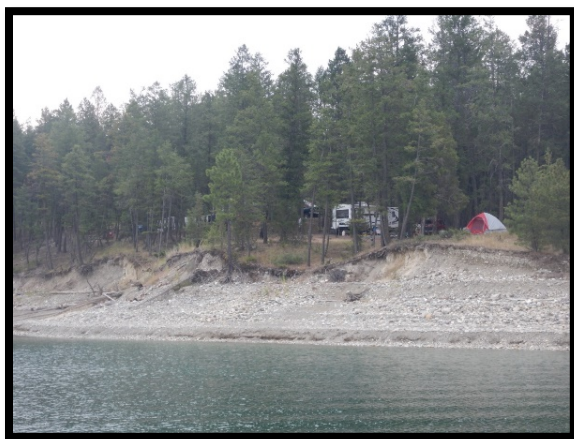
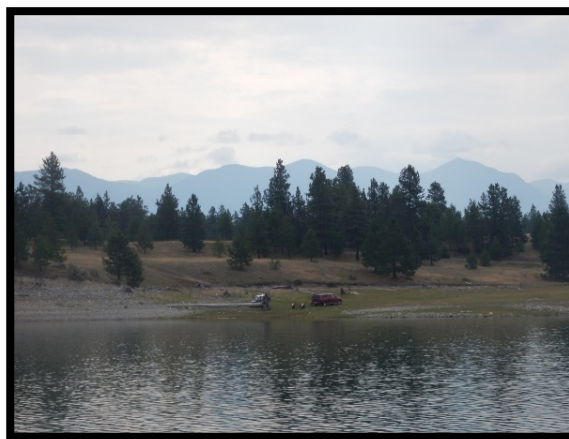
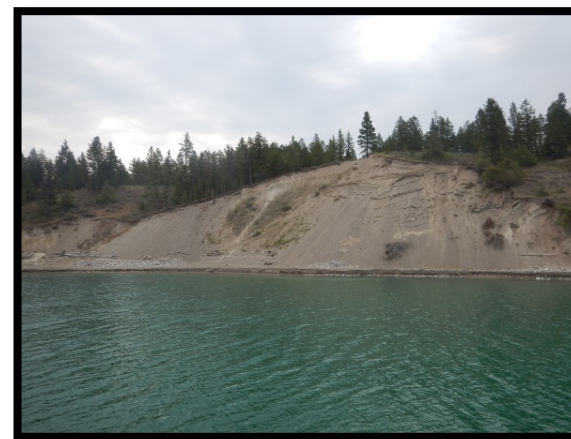
## Lake Koocanusa Segment No. 57

Segment Length (km)	Shore Type	Shore Type Mod.	Slope	Land Use	Level of Impact	Livestock Access	Disturbed	Natural
6.8	Rocky Shore	None	Steep (20-60)	Forestry	Low (<10%)	Yes	5	95
Comments: orv use, camping, grazing
