INDIAN CREEK RIPARIAN RESTORATION PHASE 3
FWCP PROJECT COL-F19-W-2696

Masse Environmental Consultants Ltd

30-Mar-2019

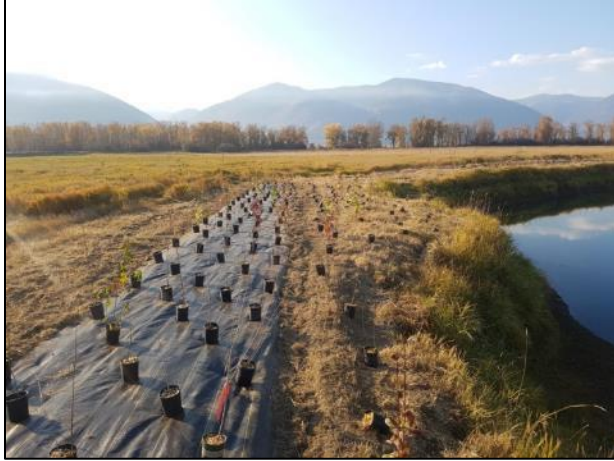
Photo 1. Habitat Island 4 solarization plot. Plants laid out at 1 m spacing on landscape fabric, and 1.5 m spacing on exposed ground.

Two solarization treatment plots were installed to treat reed canary grass in Habitat Island 4 and improve the competitive advantage of the plantings (Table 5). The solarization plots consisted of two patches of landscape fabric installed along the top of bank. The north patch covered an area of approximately 150 m² and the east patch covered an area of approximately 130 m². The fabric was secured in place with 15 cm steel landscape staples, and the edges were keyed in to the soil at depths of ≥20 cm. Additional staples were used to secure the edges of the fabric to the bottom of the trench. Holes of 15 cm in diameter were hand cut in the fabric at 1 m spacing in preparation for planting. In addition to reducing

competition with surrounding agronomic grasses by suppressing light availability, the landscape fabric should also deplete the seedbank within the treatment area by increasing soil temperature (Johnson 2005 and Geum 2009).

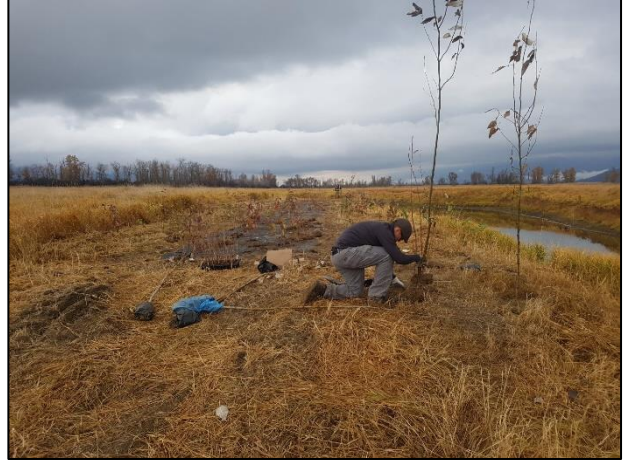
Photo 2. Lower Kootenay Band staff planting tall rooted spike cuttings in Habitat Island 4.

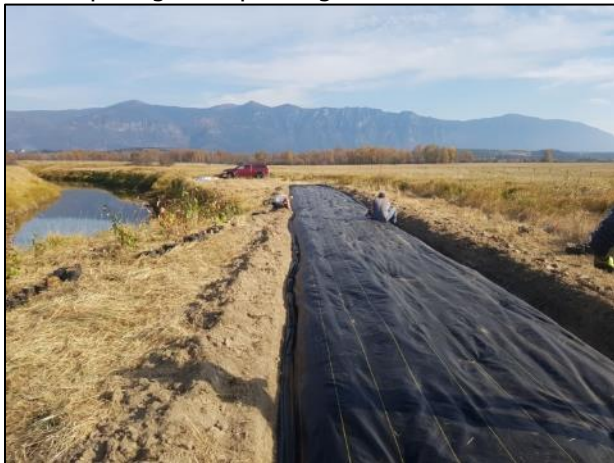
Photo 3. Keying in landscape fabric, Habitat Island 4 solarization plot.

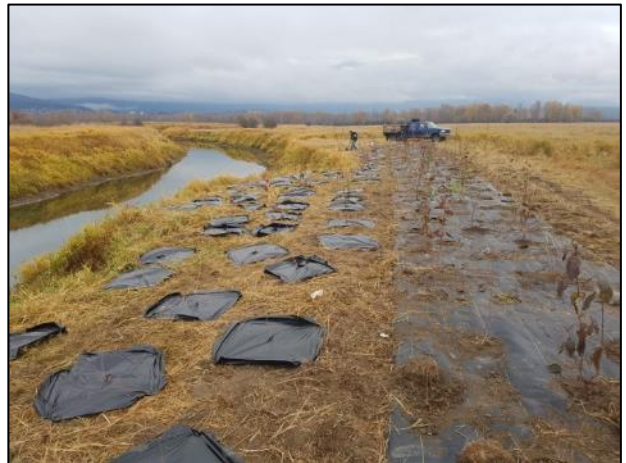
Photo 4. Plants protected with brush blankets (left) and solarization plot (right), Habitat Island 4.

The remaining plants were planted at 1.5 m spacing and protected from competition with brush blankets. The brush blankets were also secured with 15 cm steel landscape staples. A summary of 2018 restoration activities is outlined in Table 3.

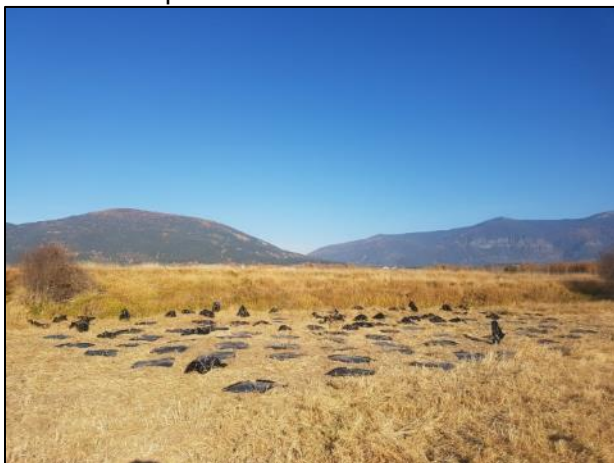
Photo 5. Plants installed in Habitat Island 5i.

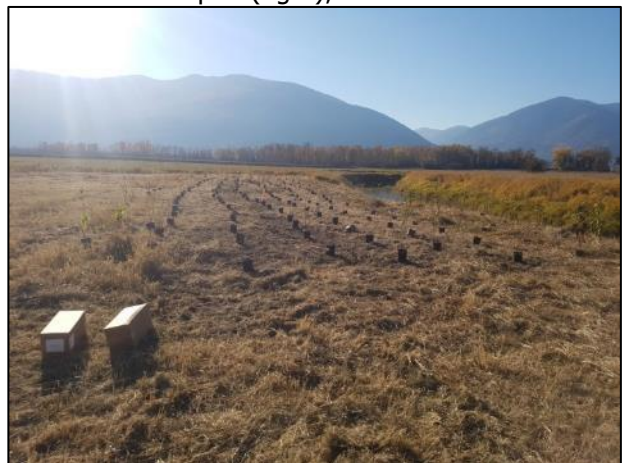
Photo 6. Plants laid out in Habitat Island 5ii.

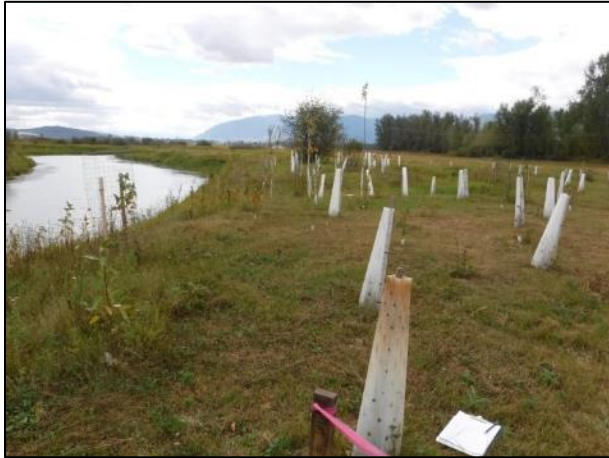
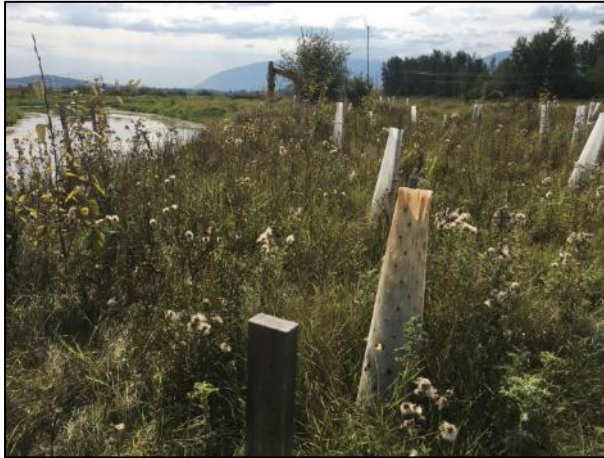
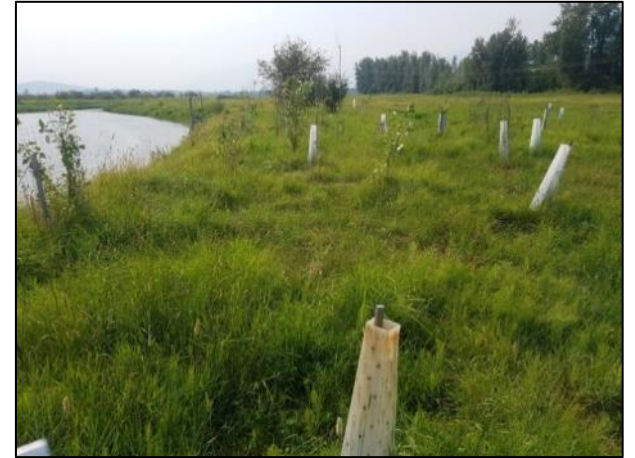
PP3a. September 2, 2016.

Photo point monitoring was conducted on August 3, 2018. Photo monitoring results are presented in Appendix 1. Photos pp3a and pp3b show a distinct reduction in Canada thistle cover between September 2017 and August 2018.

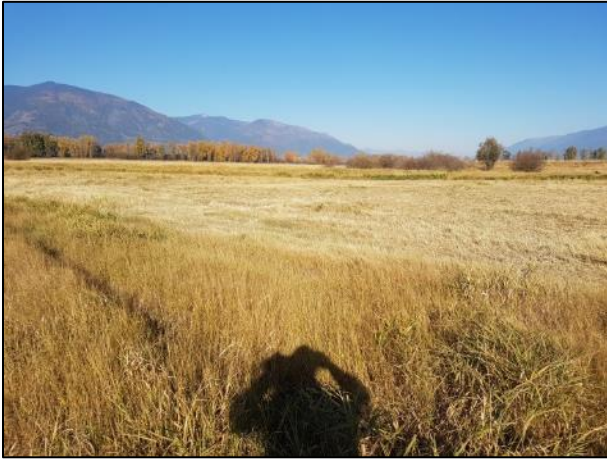
PP6a. October 15, 2018. Baseline image of Habitat Island 5ii.

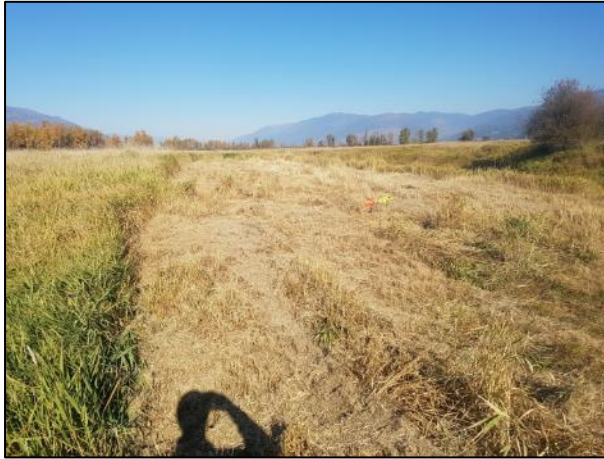
PP7a. October 15, 2018. Baseline image of north end of Habitat Island 4.

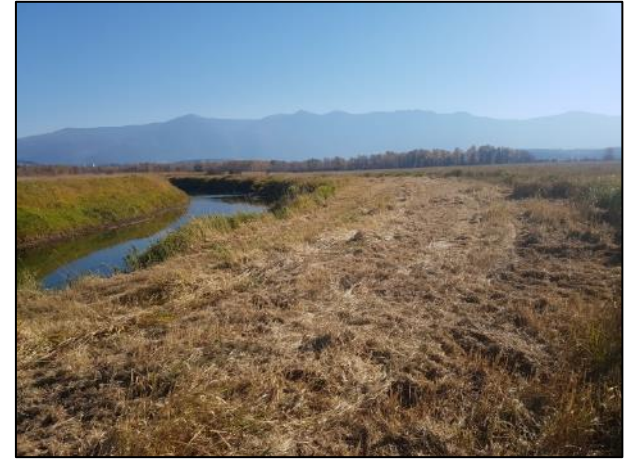
PP7b. October 15, 2018. Baseline image of east part of Habitat Island 4.

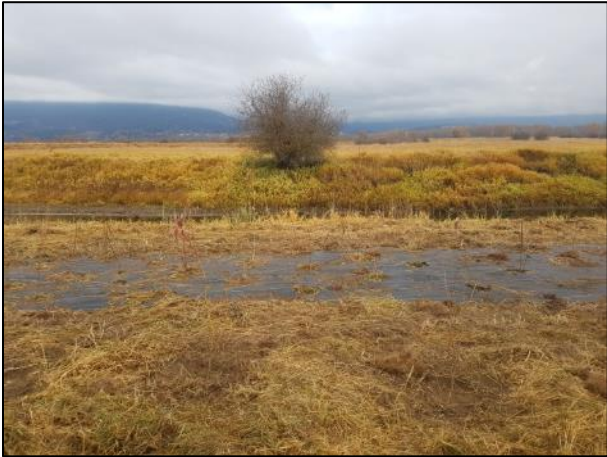
PP8a. October 26, 2018. Initial image of Habitat Island 4 in detail.

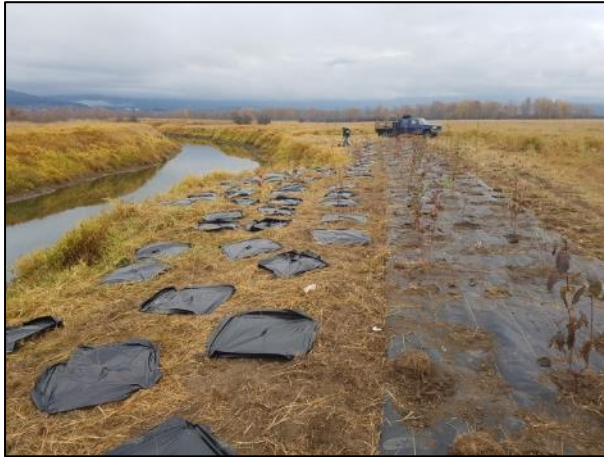
PP9a. October 26, 2018. Initial image of Habitat Island 4 in detail.

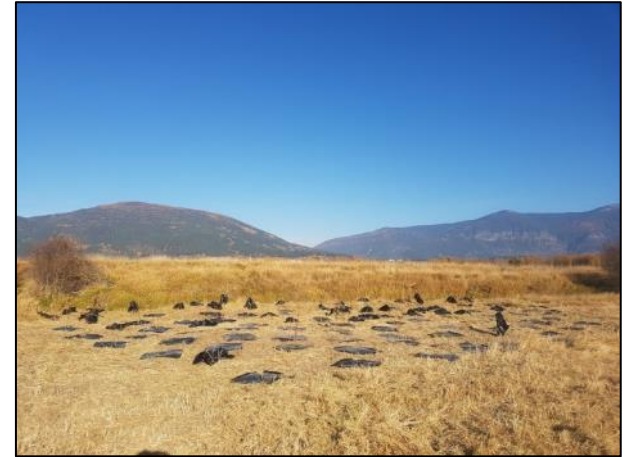
PP10a. October 22, 2018. Initial image of Habitat Island 5ii.
