# THE CORPORATION OF THE DISTRICT OF SUMMERLAND

## Interior Watershed Assessment

## TROUT CREEK WATERSHED

*July 1996*

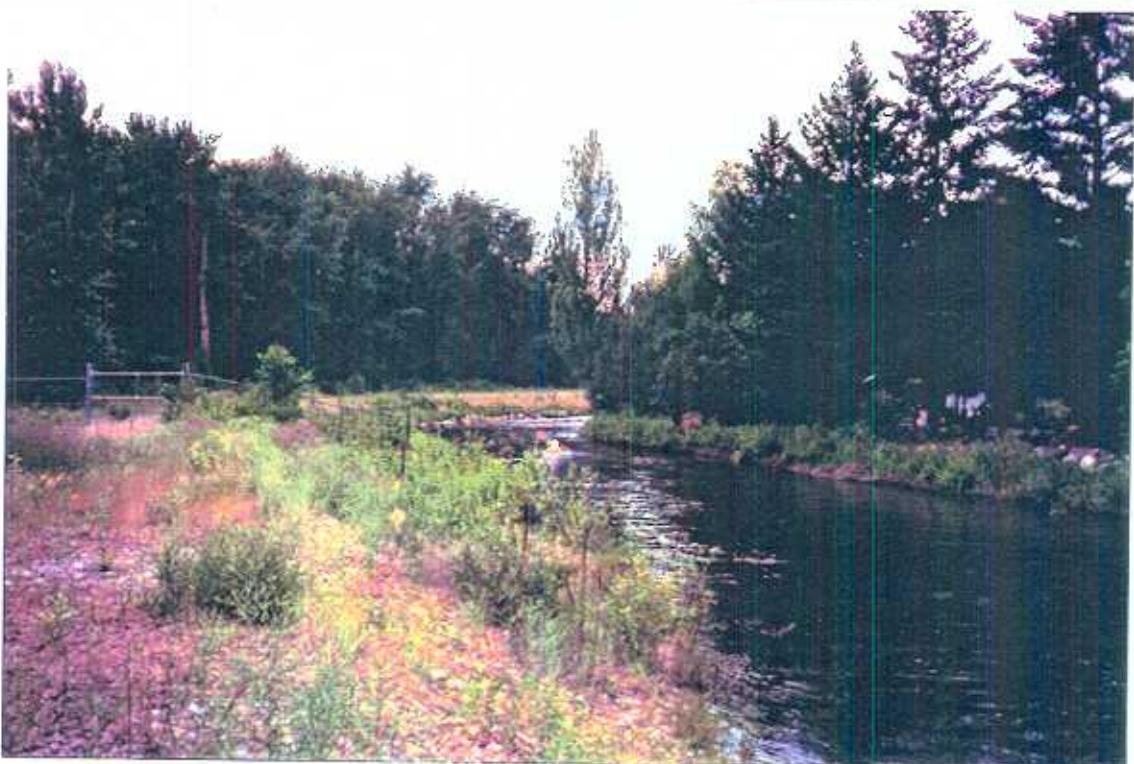
**PHOTO 1.** Trout Creek at Okanagan Lake. (*July 1996 - ID# 6-11*)

Forest development impacts were not assessed in the field in this residual unit due to the amount of rural and urban development. Development other than forest development is beyond the scope of the IWAP. Therefore, hazard rating values may not reflect the actual impacts that have occurred in this portion of the watershed (i.e. agricultural development, urban development and channelization of Trout Creek adjacent to Okanagan Lake) [Photograph 1].

Several old roads are present in this portion of the watershed on Crown land. These roads should be reviewed to determine requirements for road deactivation in order to reduce potential surface erosion problems and potential hazards that may exist to human life.

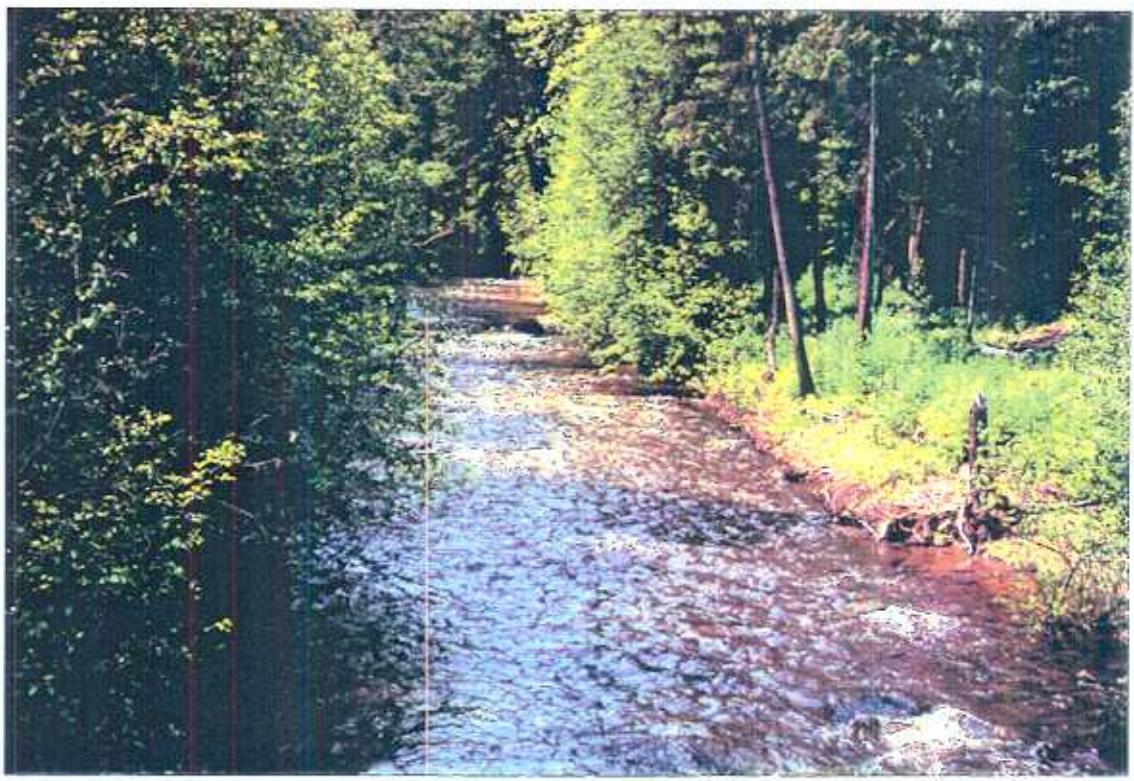
**PHOTO 2.** Lower Trout Creek in the Residual above Intake 1. (*June 1996- ID# 6-9*)

The field inspection confirmed the low peak flow hazard rating. Channels inspected were found to be stable with very little evidence of impacts from past forest development [Photograph 2].

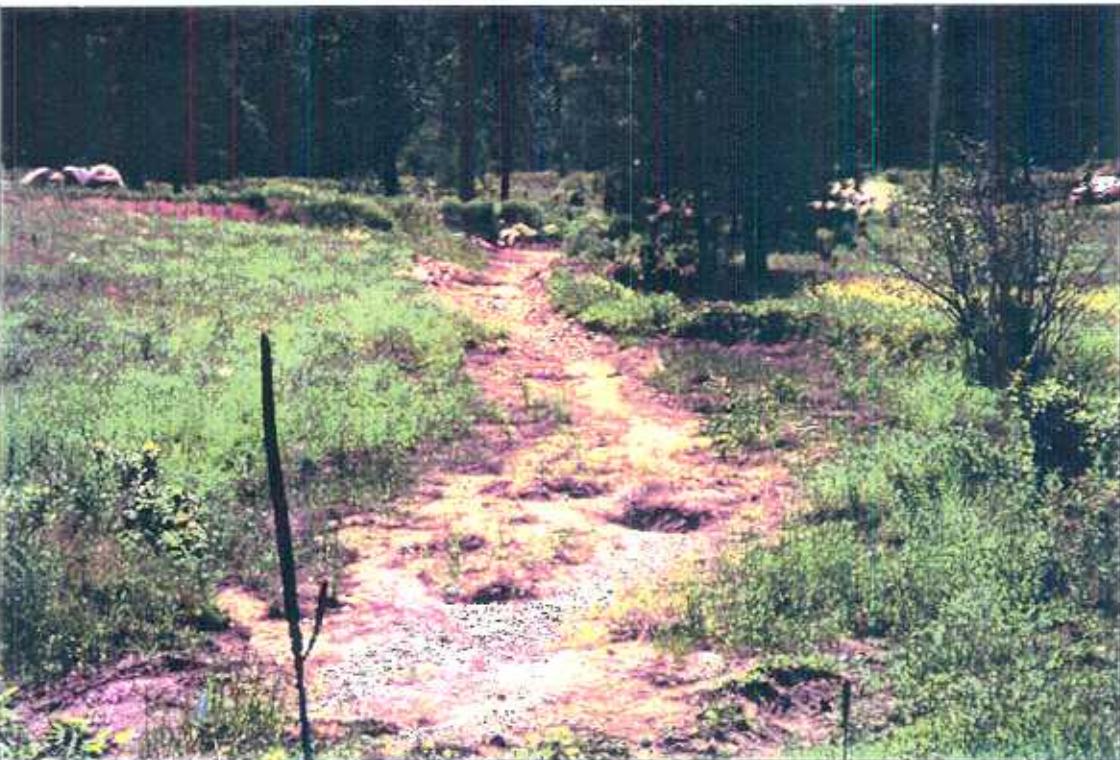
**PHOTO 3.** Lower Darke Creek approximately 100 m from Trout Creek.  
(June 1996 - ID# 6-8)

Based on the field observations, the surface erosion hazard rating should be maintained at high. Darke Creek flows sub-surface in the lower reaches of the watershed, limiting the impact of surface erosion on Trout Creek [*Photograph 3*].

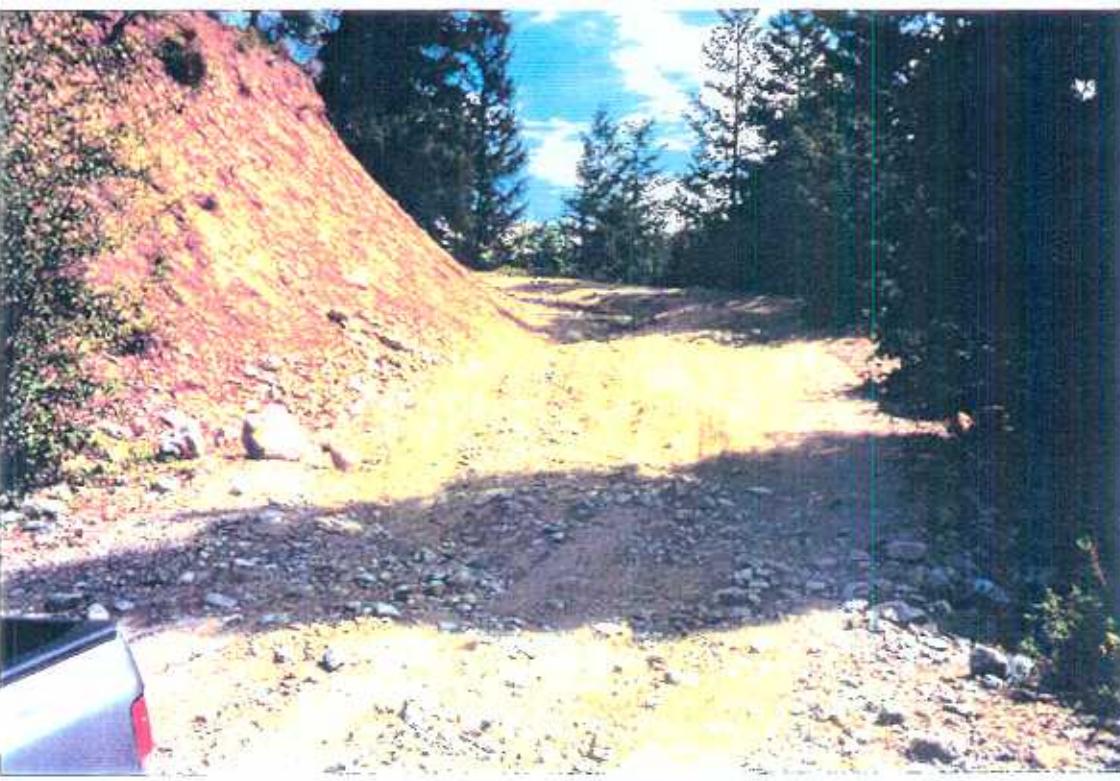
**PHOTO 4.** Road surface erosion directly above Darke Lake in the Darke Lake Park.  
(June 1996 - ID# 6-5)

However, roads throughout the Darke Lake Park (in the upper sub-basin) had extensive surface erosion and should be deactivated [*Photograph 4*]. Surface erosion from these roads is entering Darke Creek and could impact resident fish in both the creek and Darke Lake. Proper deactivation of roads should reduce the surface erosion hazard rating.

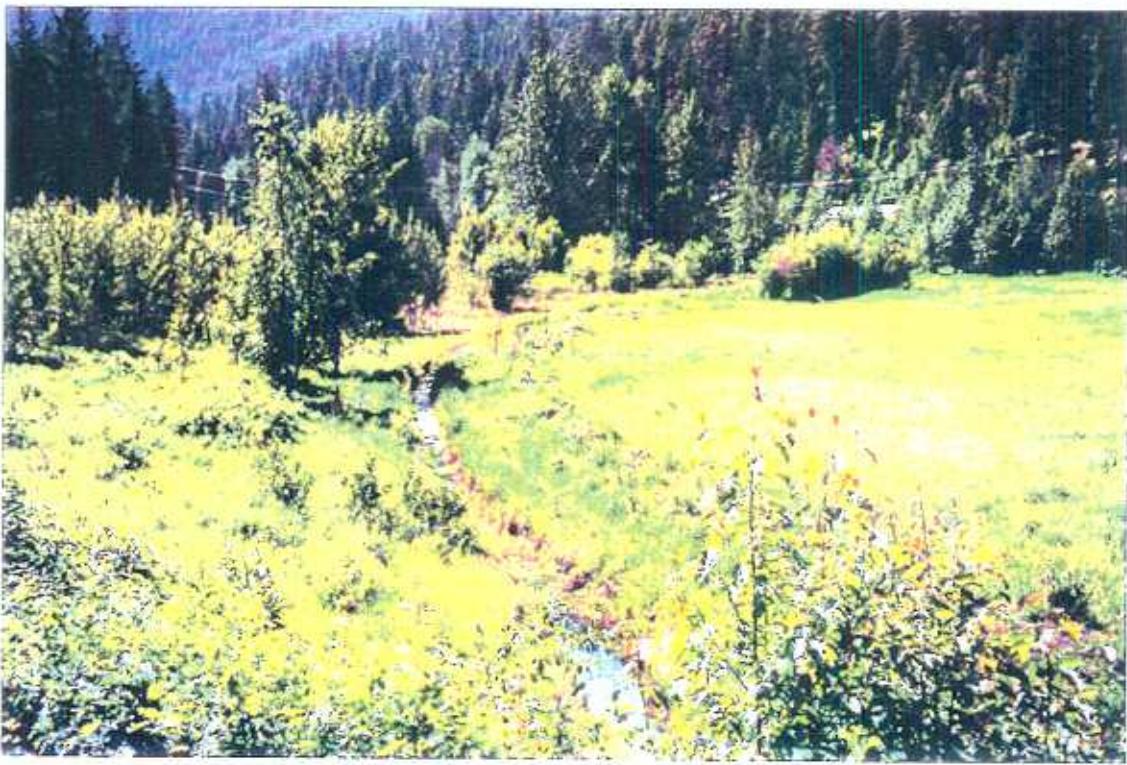
**PHOTO 5.** Middle reaches of Darke Creek flowing through agricultural land.  
(June 1996 - ID# 6-7)

Riparian buffers on private land - through the middle and lower reaches of the sub-basin, - have been impacted by agricultural activities [*Photograph 5*]. These impacts are considered to be beyond the scope of this report, therefore, the low riparian buffer hazard rating has been maintained.

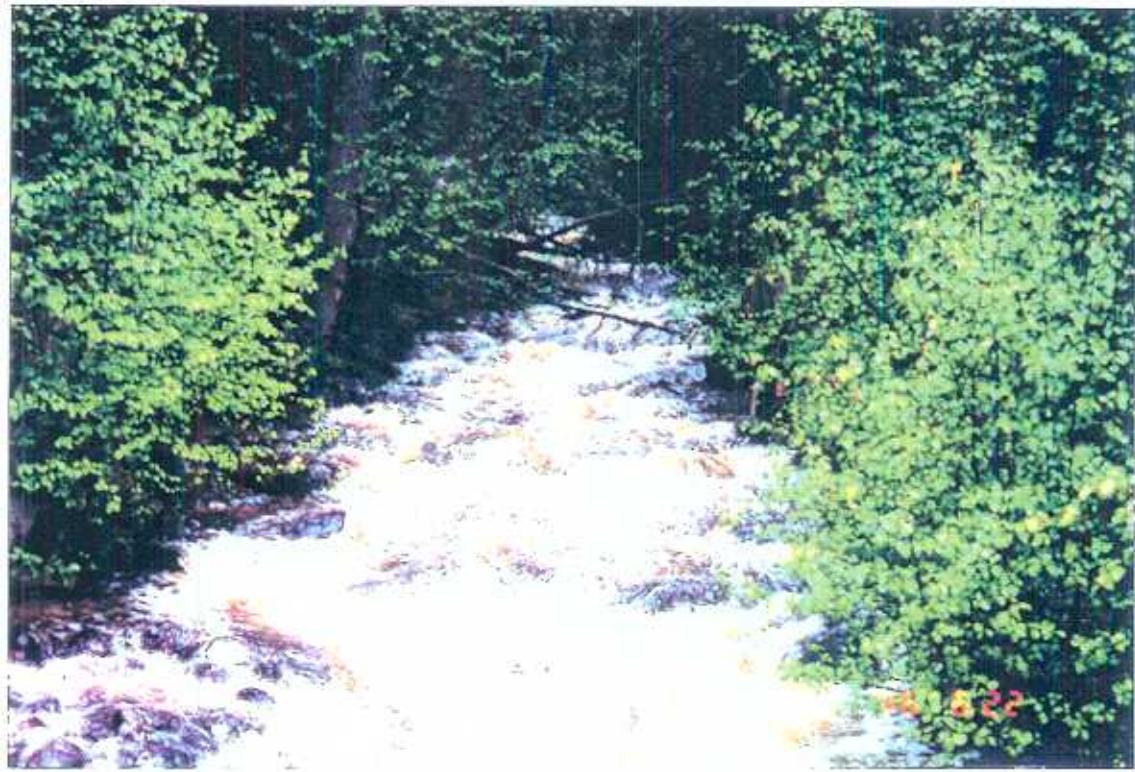
**PHOTO 6.** Isintok Creek directly above Isintok Main. (June 1996 - ID# 5-10)

Evidence of impacts from increased peak flows were not observed in the field [*Photograph 6*]. Isintok Lake has an outlet control structure, therefore, peak flow increases above the lake will be buffered by the lake.

The moderate hazard rating may be reduced to low after proper deactivation of roads to restore natural drainage patterns.

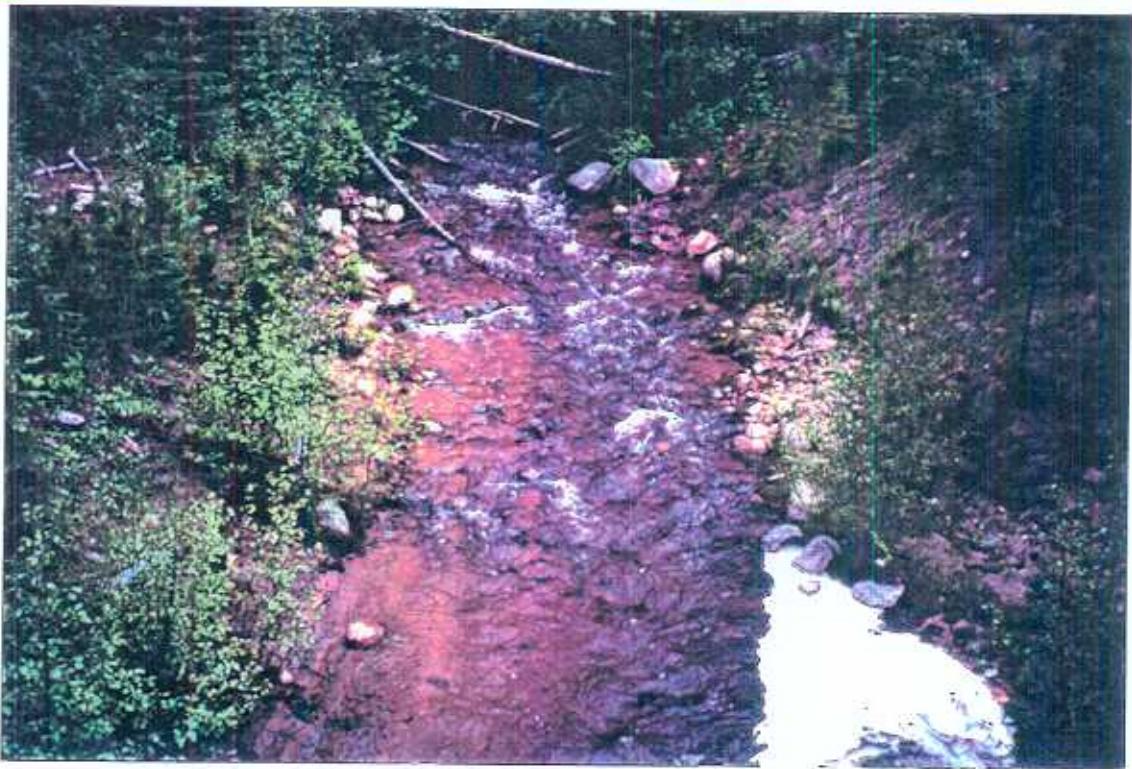
**PHOTO 7.** Bull Creek directly above the mainline into the Bull Creek sub-basin.  
*(June 1996 - ID# 5-9)*

The field inspection confirmed the low peak flow hazard rating. Channels inspected were found to be stable with very little evidence of impacts from past forest development [*Photograph 7*].

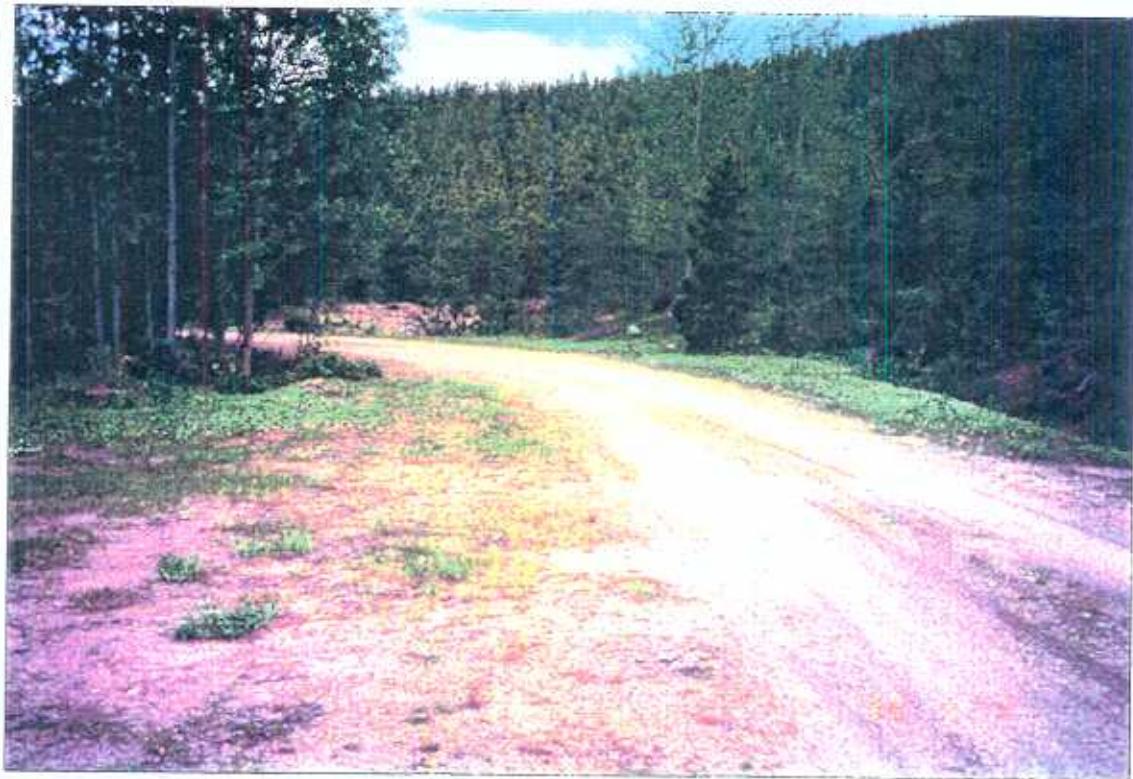
**PHOTO 8.** Typical road surfaces in the Bull Creek sub-basin. *(June 1996 - ID# 5-8)*

Throughout the Bull Creek sub-basin, there was little evidence of extensive surface erosion [*Photograph 8*]. Based on the field observations, the surface erosion hazard rating has been maintained at moderate.

The moderate hazard rating has been maintained due to very little evidence of road running surface rutting or rills, no apparent sediment deposition in ditchlines or streams and the lack of ditchline or cutbank erosion. Proper deactivation of roads should further reduce the moderate surface erosion hazard rating.

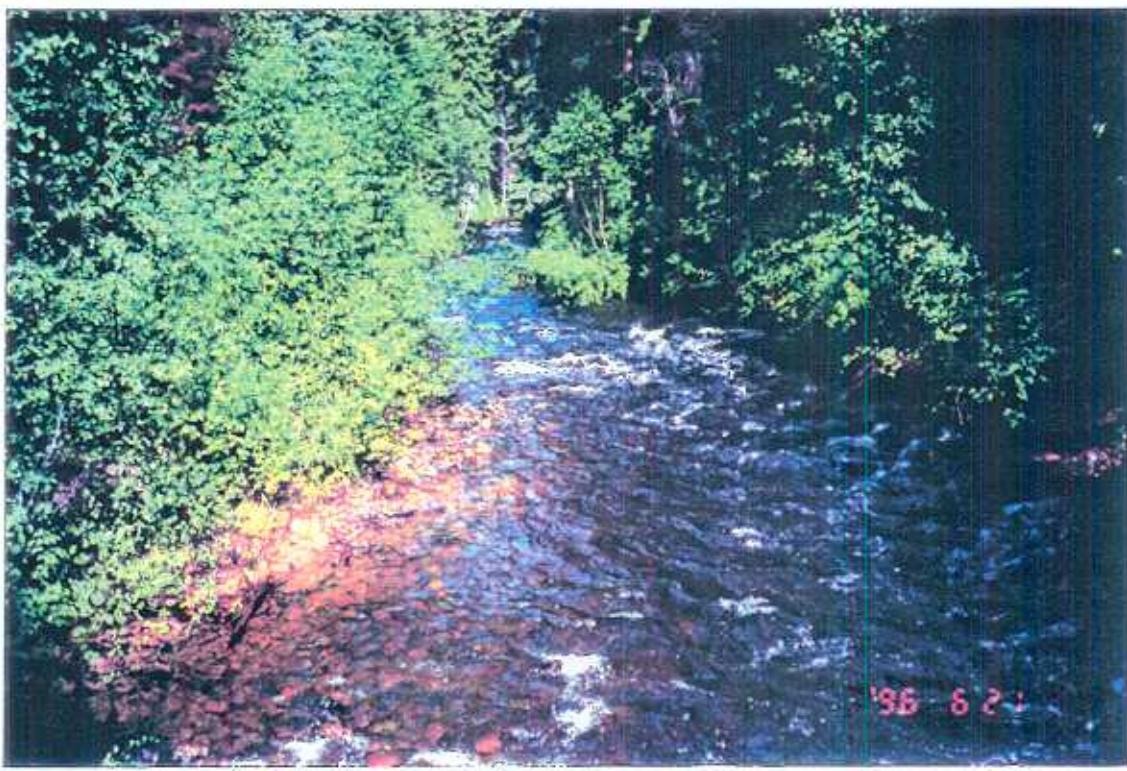
**PHOTO 9.** Trout Creek below the confluence of the Lost Chain Creek sub-basin.  
(June 1996 - ID# 4-14)

Based on the field observations, the peak flow hazard rating can be reduced to moderate in this residual unit [*Photograph 9*]. Stream channels appeared stable with no evidence of increased peak flows. Thirsk Lake - which is above this residual unit - will also buffer any potential peak flow impacts from the watershed above the lake.

The peak flow hazard rating could be reduced to low upon proper deactivation of inactive roads and restoration of natural drainage patterns.
