# STREAM CLASSIFICATION

## TUMBLEWATER CREEK

### BUCKLEY BAY

**ISLAND TIMBERLANDS LIMITED PARTNERSHIP**

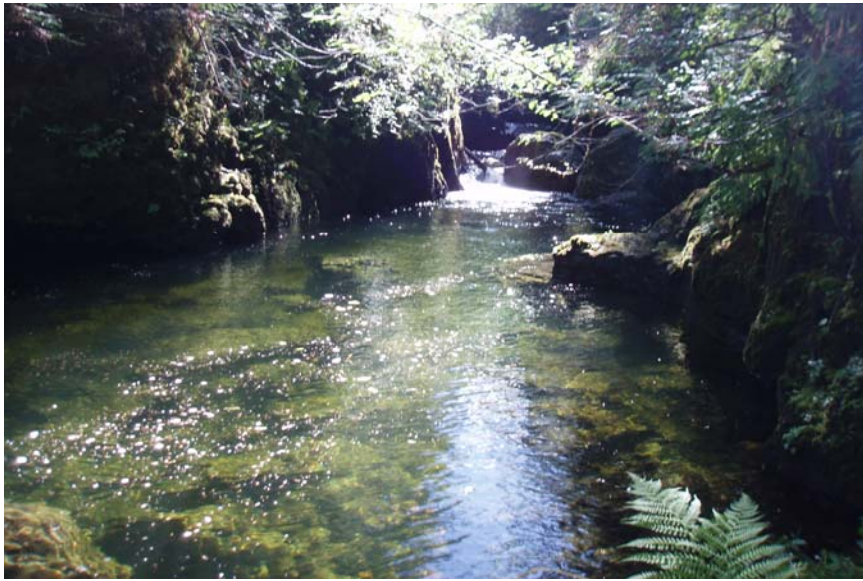
Photo 1 - Upstream 420m from the confluence with the Tsable River, the stream is within a canyon. Due to the steep canyon walls and the deep pools, the stream could not be walked upstream from this point.

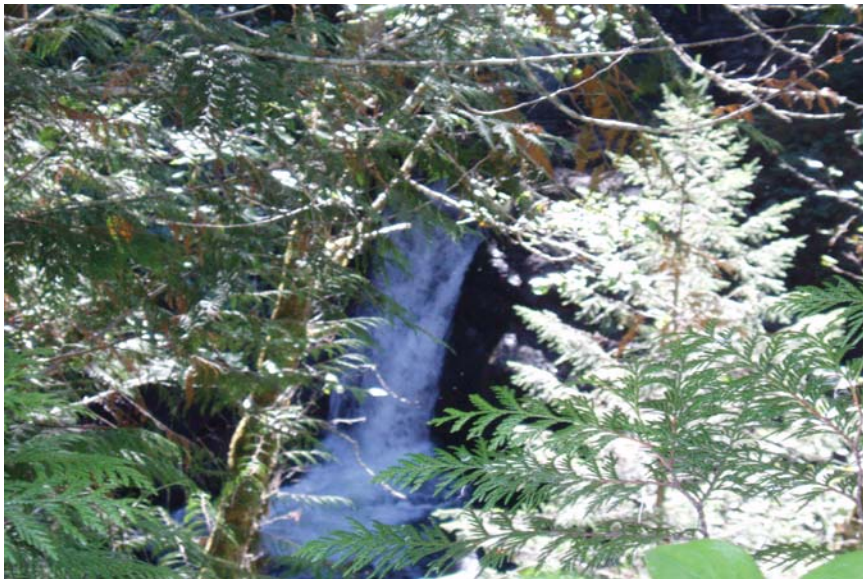
Photo 2 - Adjacent to a spur road off of Tsable Main, on the west side of Tumblewater Creek, +10m high falls were observed. These falls are a definable barrier to upstream fish passage.

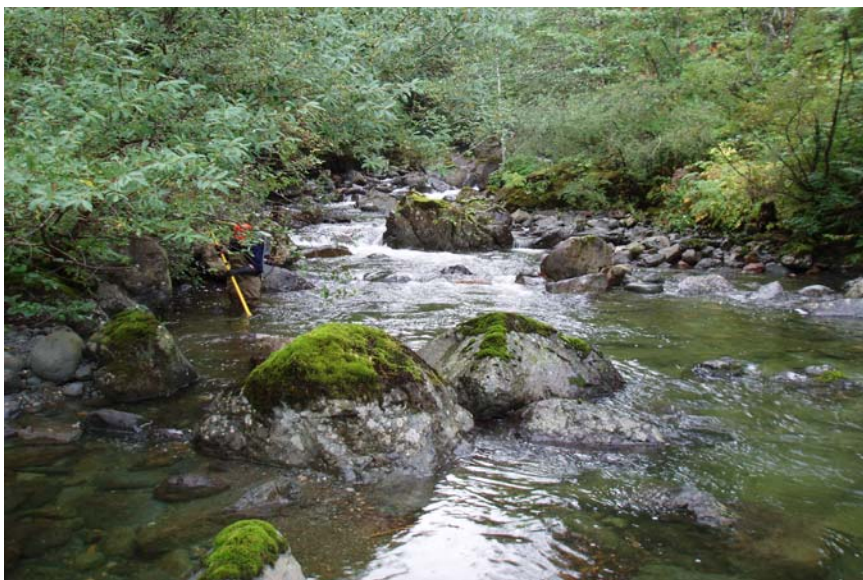
Photo 3 – Within the sampled reaches, Tumblewater Creek averages 20m wide with a cobble/boulder substrate. The stream is confined within steep side slopes.

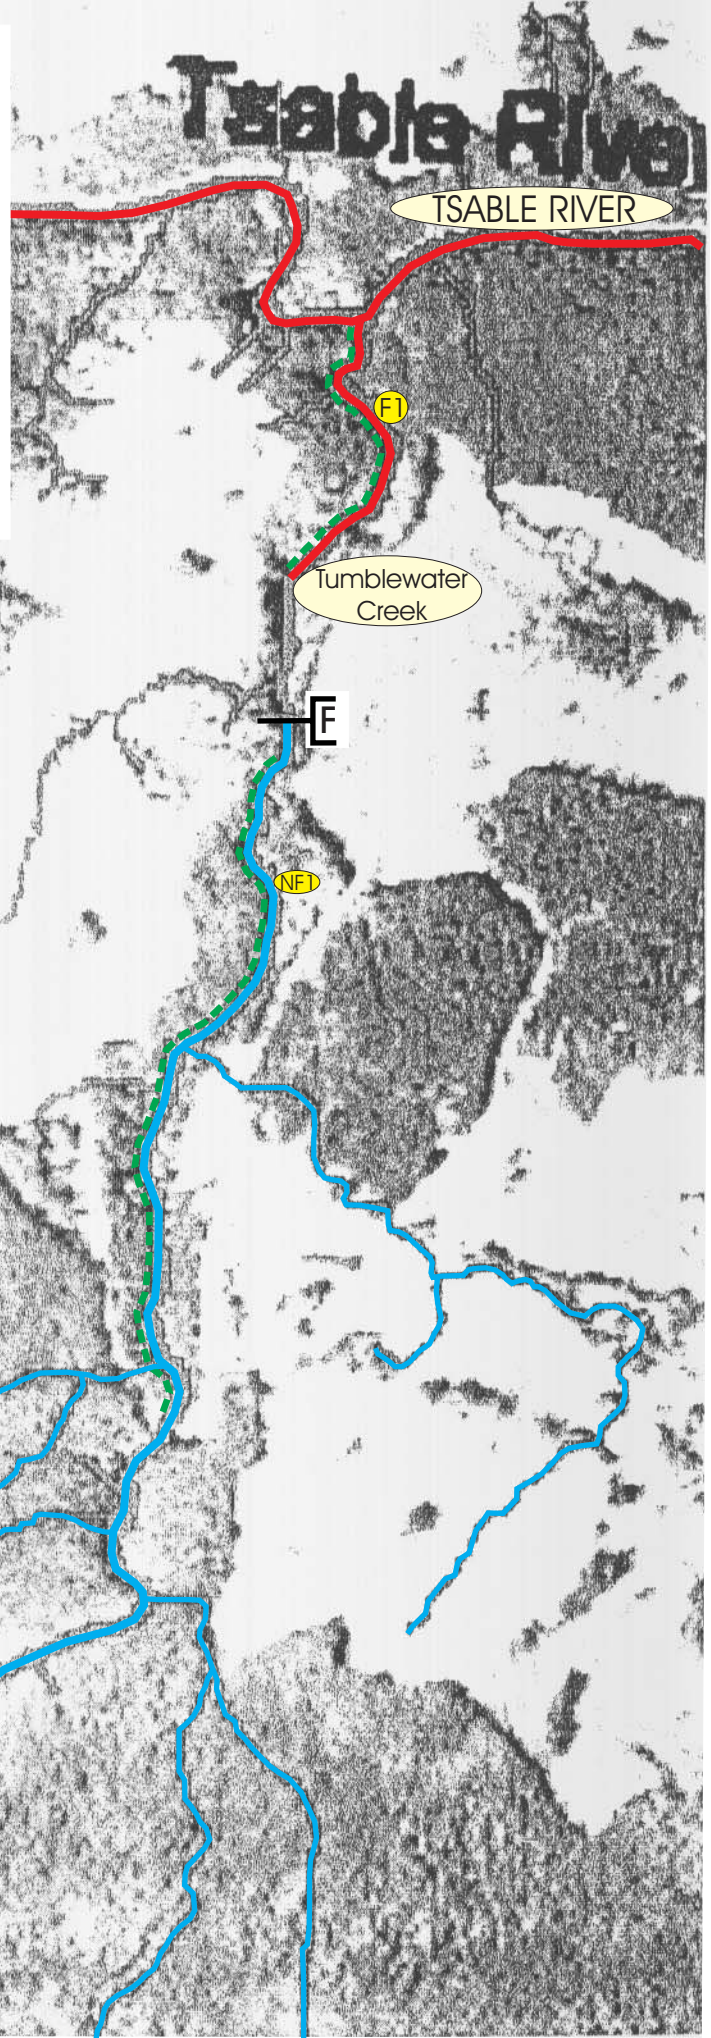
**Area:** Tumblewater Creek    **Scale:** 1:10,000    **Date:** September 2006  
**Drainage:** Tumblewater Creek within the Tsable River drainage.

STREAM NAME/#:	○	SAMPLE SITE:	— — — — —
CLASSIFICATION:	●	FALLS:	— E
F1-S3 (red):	—		
NF1-NF3 (blue):	—
