Photo Plates – Englishman River Storage Feasibility, Shelton Lake Option. June 2012.

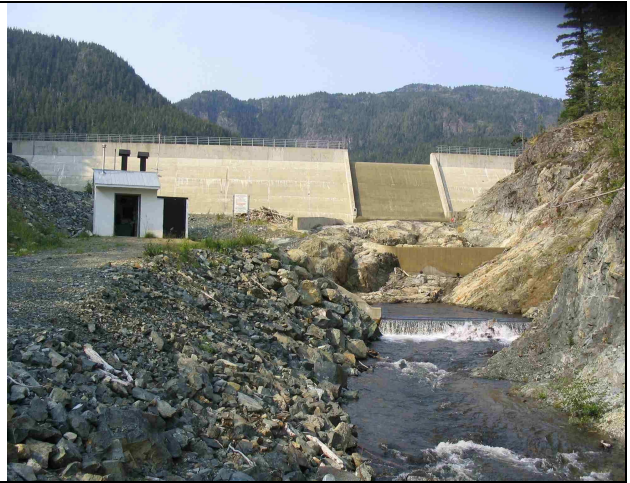
2. Arrowsmith Dam (July 2004)

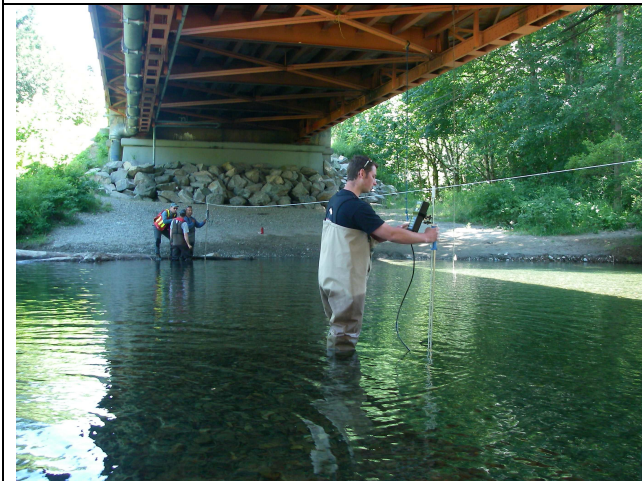
3. BCCF & WSC staff measuring discharge at WSC stn# o8HBo02 (Englishman R near Parksville; July 2010)

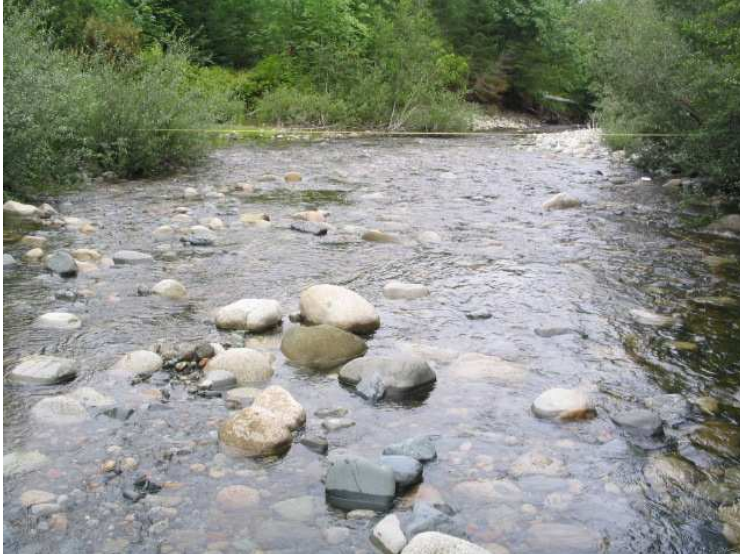
7. Looking downstream (north) on South Englishman River, from a point 165 m upstream of its confluence with the Englishman mainstem.

July 23, 2007.

Discharge is $0.550 \text{ m}^3 \cdot \text{s}^{-1}$, or about 19% of mean annual discharge.

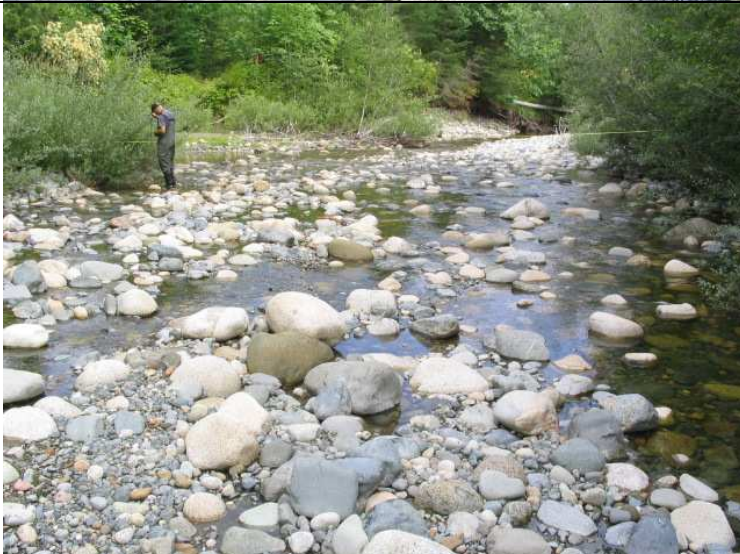
8. Looking downstream (north) on South Englishman River, from the same location as in Photo 7.

July 13, 2007.

Discharge is $0.068 \text{ m}^3 \cdot \text{s}^{-1}$, or 2.5% of mean annual discharge.

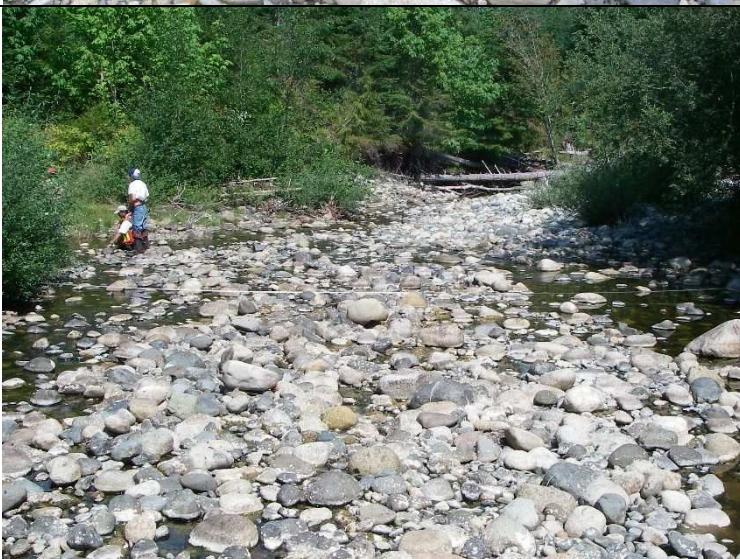
9. Looking downstream (north) on South Englishman River, from the same location as in Photo 7.

July 29, 2009.

Discharge is $0.018 \text{ m}^3 \cdot \text{s}^{-1}$, or 0.6% of mean annual discharge.

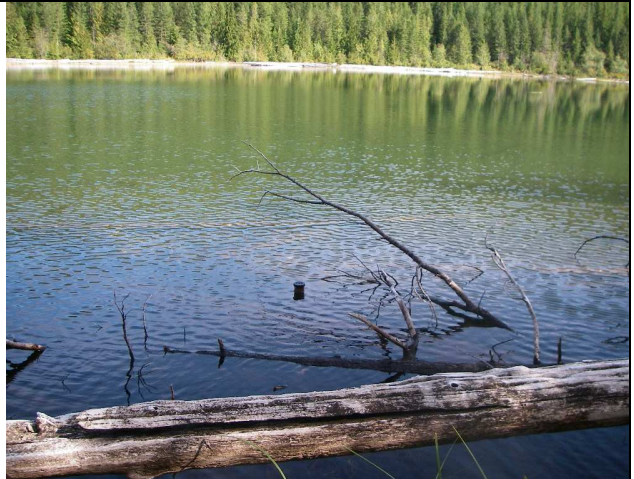
23. Lake level station on Shelton Lake.

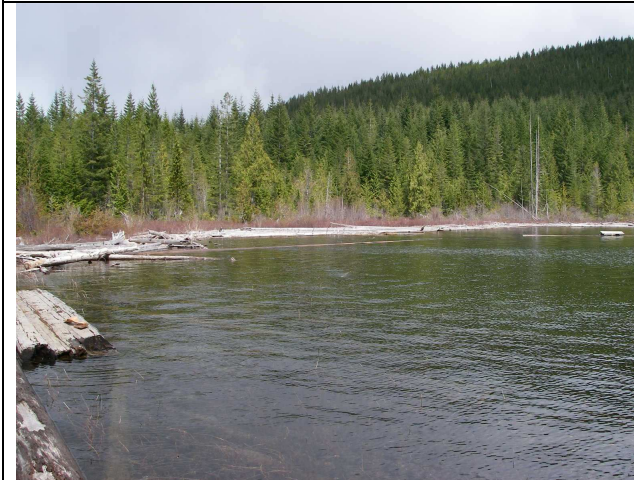
24. View looking NE of Shelton Lake outlet area. Photo taken May 4, 2007.

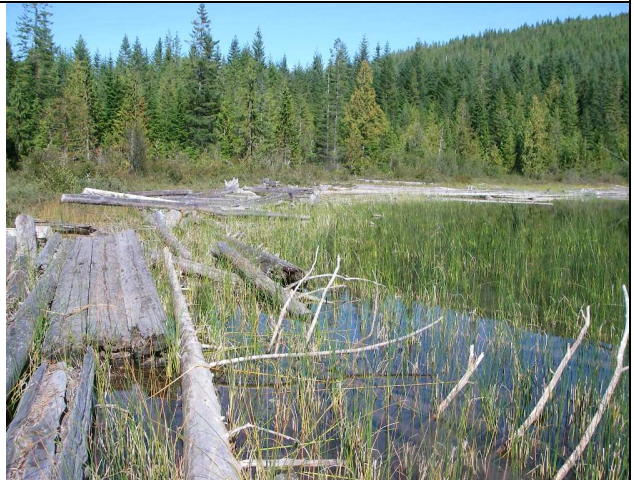
25. View looking NE of Shelton Lake outlet area (same view as photo 24). Photo taken September 21, 2009.

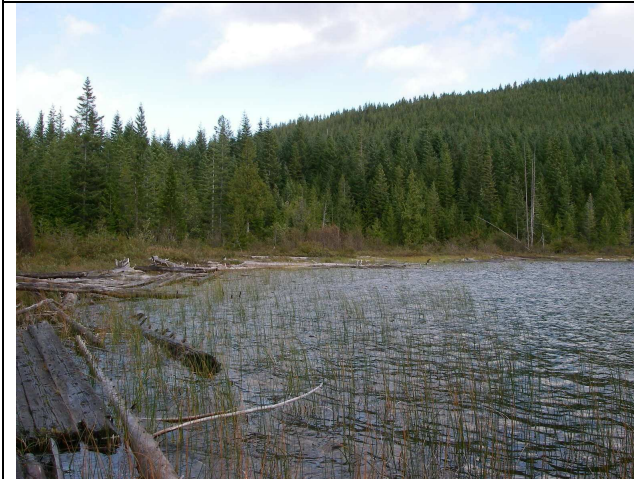
26. View looking NE of Shelton Lake outlet area (same view as photo 24). Photo taken October 7, 2008.

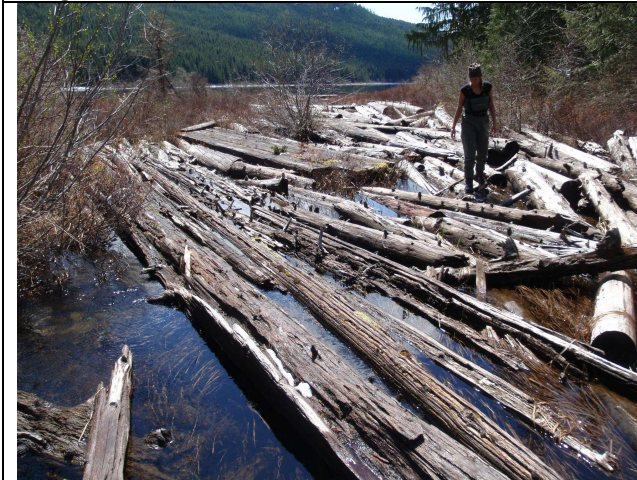
30. Upstream view of Shelton Lake outlet, with stable log jam in foreground, May 14, 2009.

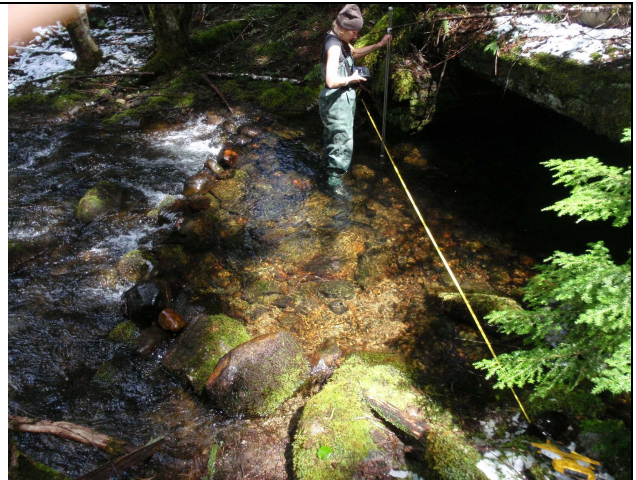
35. Measuring discharge in Shelton Creek, immediately downstream of Spur C-26 box culvert, May 14, 2009.

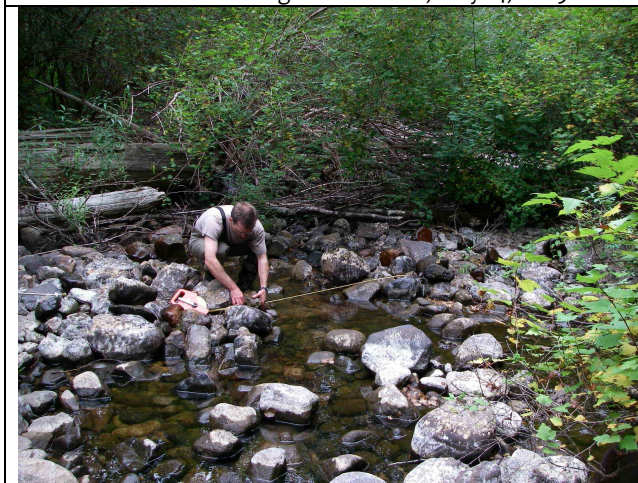
38. South Englishman River ~1.2 km downstream of Healy Lake, with 2 L/sec flow, September 23, 2008.
