# Effectiveness Monitoring of Fish Habitat Restoration/Enhancement Projects on Vancouver Island (2003-04)

**Habitat Conservation Trust Fund**  
Victoria, BC  
Project # 1-161 (WLAP Grant Funds)

**June 2004**

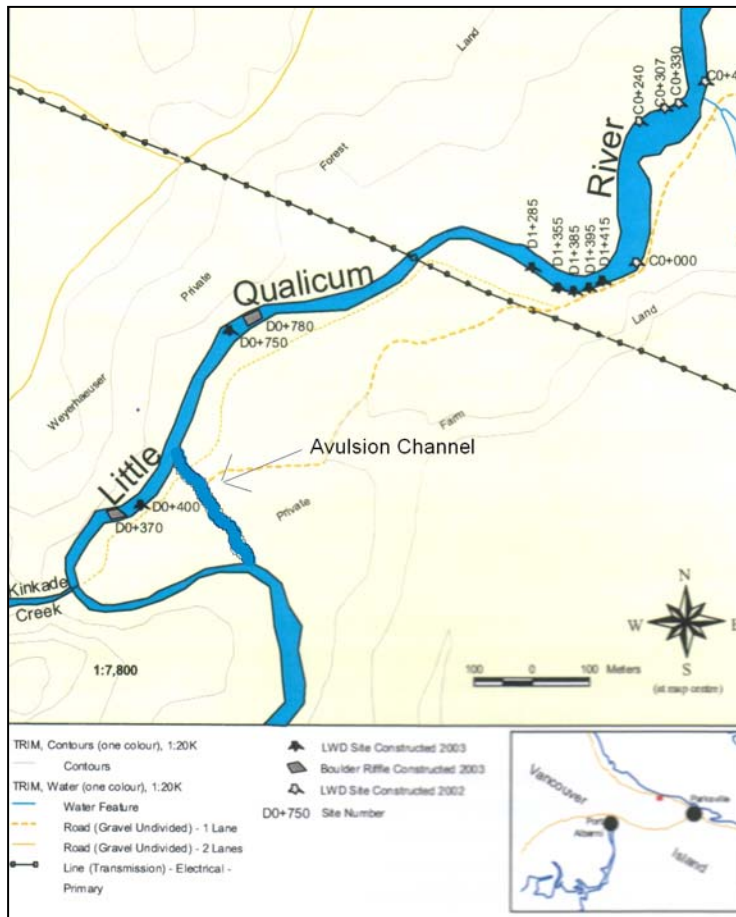
**Figure 4. Restoration sites constructed on the Little Qualicum River in 2003.**

In the third week of October 2003, a large rain on snow event in the upper watershed resulted in a significant channel avulsion (i.e., bypass or new channel formation) through a farm field immediately above most of the 2003 restoration sites (Craig 2004). An inspection five days after the avulsion event revealed the river had left its historic channel approximately 250 m upstream of the Kinkadee Creek confluence, and re-entered 250 m downstream of the confluence. As a result, two of nine sites were isolated from the mainstem and are now located in lower Kinkadee Creek (Craig 2004).

In 2002, BCCF constructed 20 LWD structures and four boulder riffle sites in the mainstem (Figure 3). In 2003, an additional seven mainstem LWD sites and two boulder riffle sites (Figure 4) were built (Craig 2004). Construction occurred from August 7-13, 2002 and from September 4-10, 2003. The prime area of restoration was focused from approximately 1.1 km upstream of the DFO hatchery fence to 400 m downstream of Kinkadee Creek confluence.

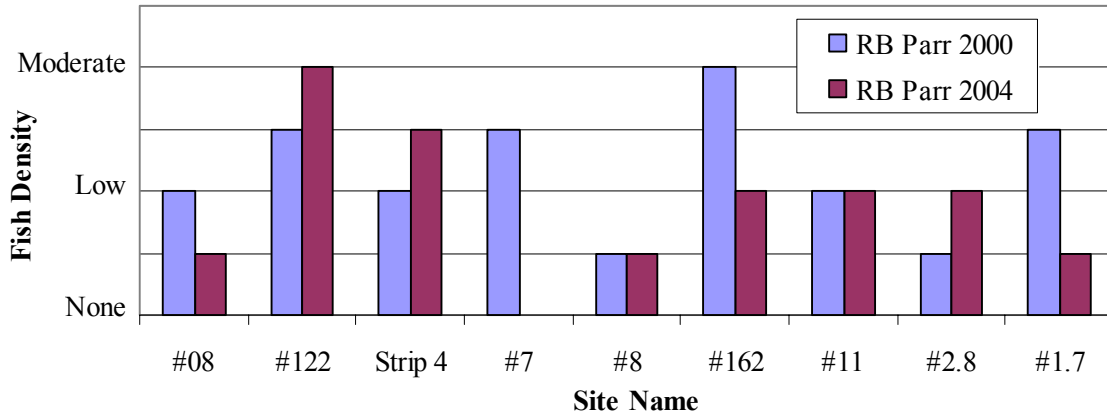
On October 7, 2003, BCCF fisheries technicians surveyed nine boulder-riffle sites in the Big Qualicum River. Weather conditions were 100% overcast and mild. Stream discharge was 2.55 m<sup>3</sup>/s (pers. comm., DFO hatchery staff) and water temperature was 10.0°C. Rainbow parr densities in 2004 were similar to those observed in 2000 (Figure 14, Appendix B.1.).

**Figure 14. Comparison of rainbow parr densities in nine constructed boulder-riffle sites in the Big Qualicum River, fall 2000 and 2004.**

Several reasons may account for the differences observed in rainbow parr and fry densities observed in 2000 versus 2004. The increased presence of large adult chinook and chum salmon may have caused some displacement of juvenile rainbow trout in the 2004 observations. Adult salmon were observed at sites # 8, #162, #11, and #1.7. Additionally, structural changes and infilling in sites #08 and #7 have reduced the quality of rearing habitat.

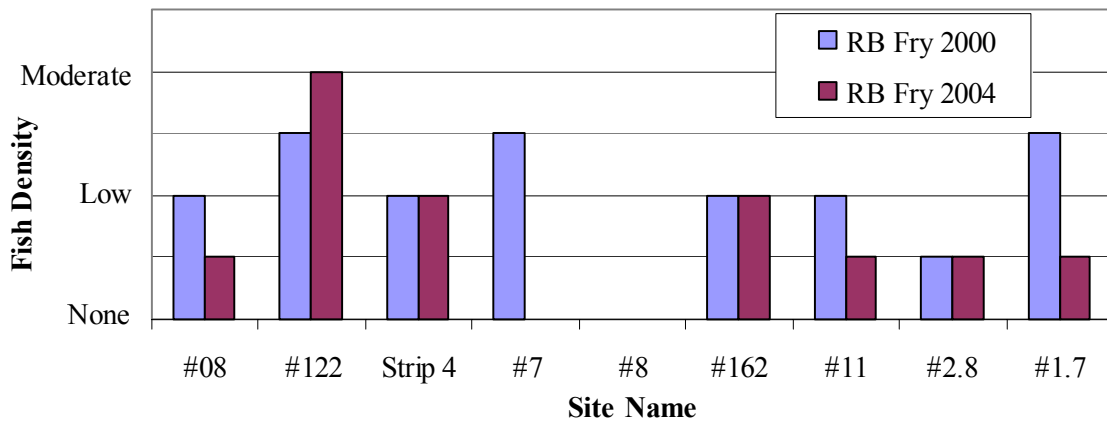
Rainbow fry densities in 2004 equal to or lower than densities documented in the 2000 results (Figure 15). Coho fry densities changed very little when comparing the 2000 and 2004 monitoring results (Appendix B.1.).

**Figure 15. Comparison of rainbow trout fry densities in nine constructed boulder-riffle sites in the Big Qualicum River, fall 2000 and 2004.**

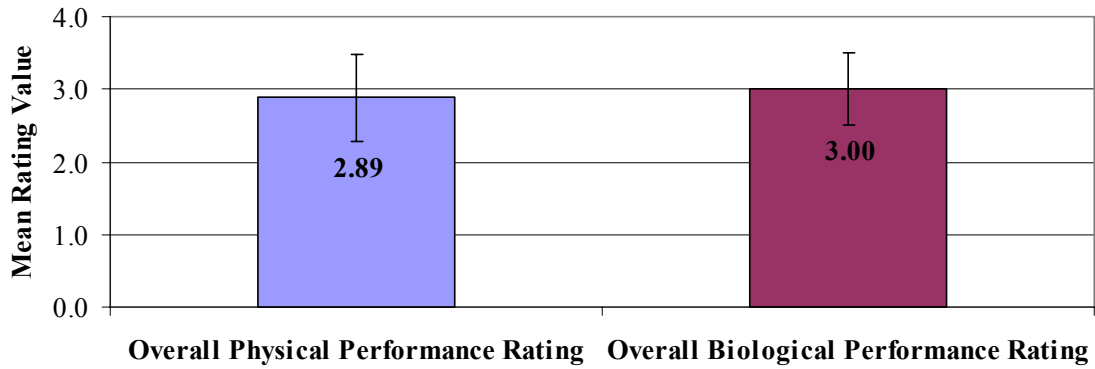
Overall, physical and biological performance evaluations on June 15, 2004 (Appendix B.2) show that site conditions are meeting expectations and objectives (Figure 16). Sites #08 and #7 have experienced shifting and infilling of boulders, resulting in reduced habitat quality and a decrease in the physical and biological ranking.

**Figure 16. Summary of physical and biological performance ratings of nine boulder riffle sites constructed in 2000 in the Big Qualicum River (95% C.I.).**

Site #8 appears to be functioning poorly, as very low densities of fish were observed both in 2000 and 2004. Recommendations include lowering the riffle crest to reduce the overall gradient through the structure and creating more “pockets” with sufficient depth and size for fish rearing. It is also recommended that site #08 be repaired as several boulders have shifted out of position, reducing the quality of the available habitat.

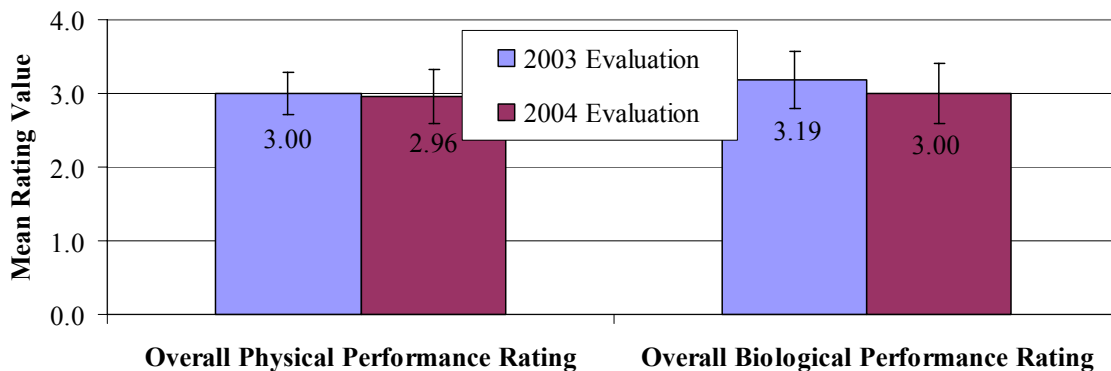
The overall physical and biological performance of 2002 sites was considered good during both evaluations with site conditions generally meeting design expectations (Figure 17). Some scour and additional accumulation of natural LWD and SWD at several sites has further improved rearing conditions for juvenile salmonids.

**Figure 17. Summary of physical and biological performance ratings for structures built in the Little Qualicum River in 2002 (95% C.I.).**

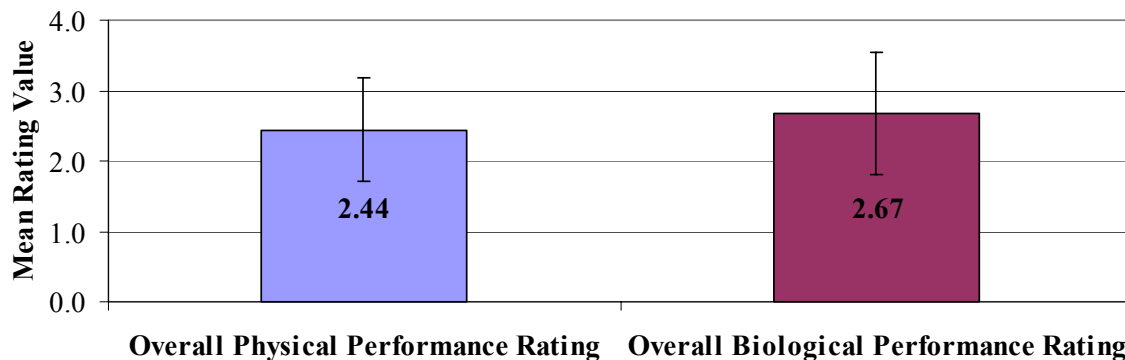
This year's monitoring results of the nine restoration sites constructed in 2003 were poorer than for the sites constructed in 2002 (Figure 17 and 18).

**Figure 18. Summary of physical and biological performance ratings for structures built in the Little Qualicum River in 2003 (95% C.I.).**

Plans to return the Little Qualicum River to its historic channel are being developed by MWLAP, DFO, BCCF and the local property owner. This will likely entail extensive work around sites built in 2003 and may provide an opportunity to fix infilled and/or damaged structures<sup>5</sup>.

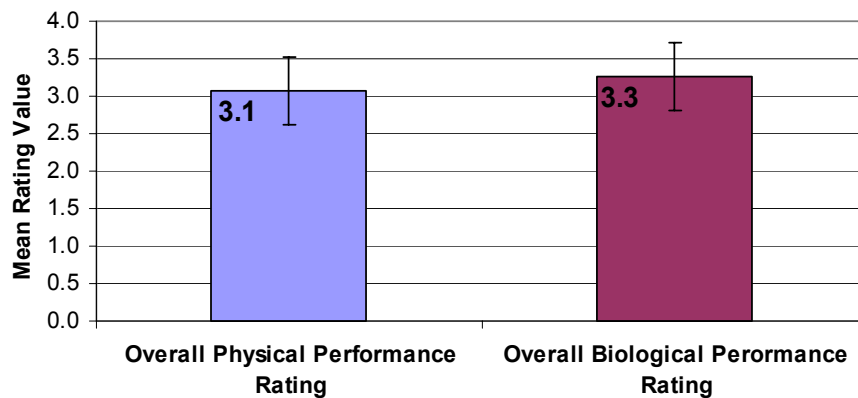
Monitoring of structures built in the Englishman River in 2003 was conducted on June 4, 2004 (Appendix B.6). Fourteen of 15 sites constructed had performance ratings that are meeting or exceeding expectations and objectives, with overall physical and biological performance ratings of 3.1 and 3.3, respectively (Figure 16).

**Figure 19. Summary of physical and biological performance ratings for structures built in the Englishman River in 2003 (95% C.I.).**

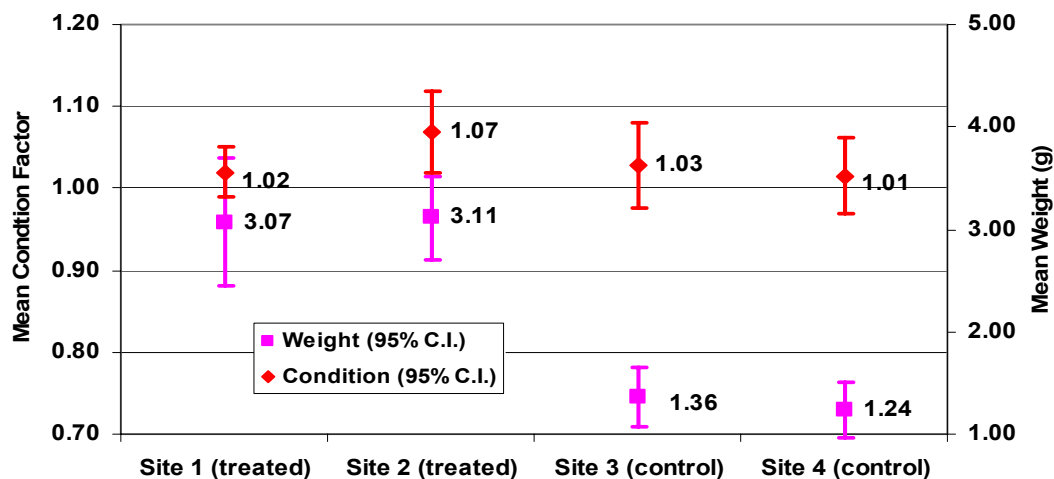
Juvenile sampling occurred at the lower two sites (treated) September 19 and at the upper two sites (control) on September 23 (Appendix D.2). Sites 1 and 2 (treated) were located 2.0 km and 1.5 km downstream of the uppermost fertilizer sites. Sites 3 and 4 (control) were located 350 m and 400 m upstream of the uppermost fertilizer site. Figure 20 compares mean weights and condition factors of fish sampled in treated and untreated sites. Mean weights were two times greater in treated sites than untreated sites, and condition factors were roughly equal.

**Figure 20. Mean weight and condition factor of rainbow/steelhead trout fry in control and treated sites in Harris Creek, September 19 and 23, 2003.**

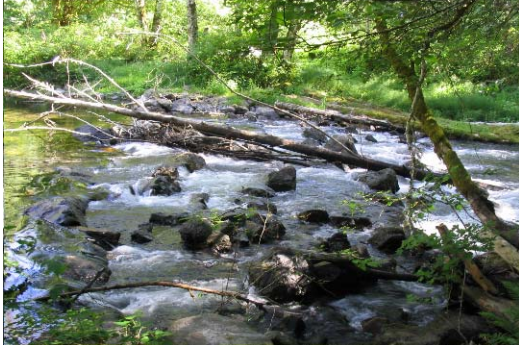
Photo 1. Big Qualicum River boulder-riffle at site #8 looking cross-stream from R/B.

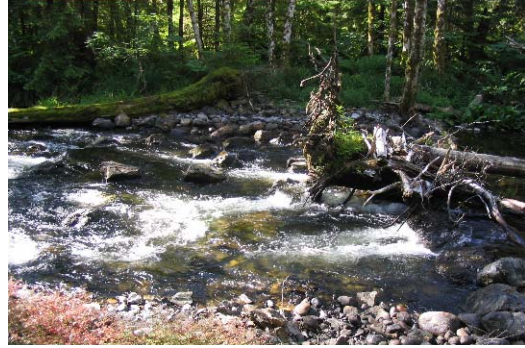
Photo 2. Big Qualicum River boulder-riffle at site Strip 4 looking cross-stream from L/B.

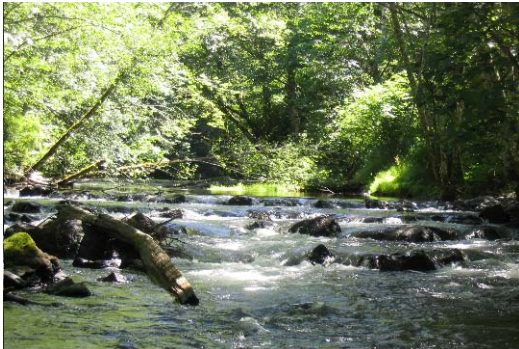
Photo 3. Big Qualicum River boulder-riffle at site #1.7 km looking U/S.

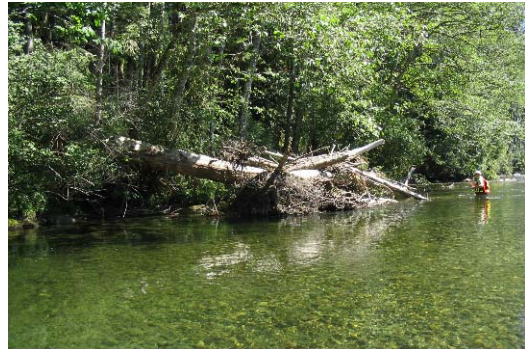
Photo 4. Little Qualicum River LWD structure at site D0+750 looking D/S.

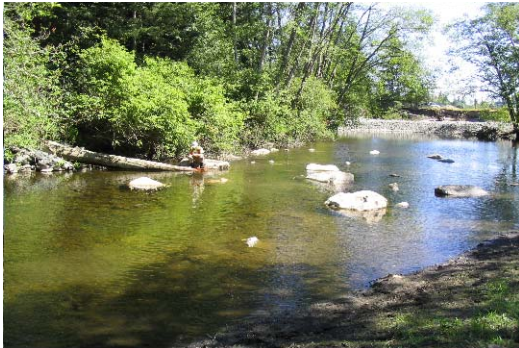
Photo 5. Little Qualicum River boulder-riffle at site D0+370 looking D/S. Note avulsion effects.

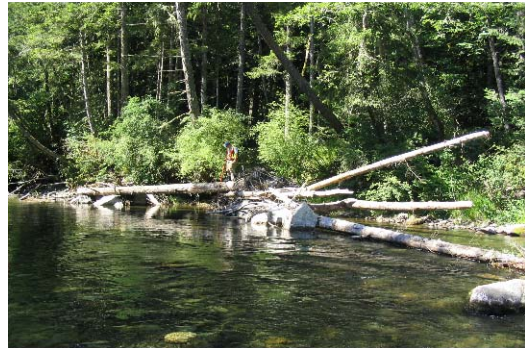
The flood event also likely contributed to the failure of one LWD restoration site (C0+757). The structure had shifted onto a bedrock shelf on the bank and was providing minimal fish habitat. Several sites showed additional bank erosion resulting from installed restoration structures. Repair of these sites is recommended during instream construction planned for 2004.

Photo 6. Little Qualicum River LWD failed structure at site C0+757 looking U/S.

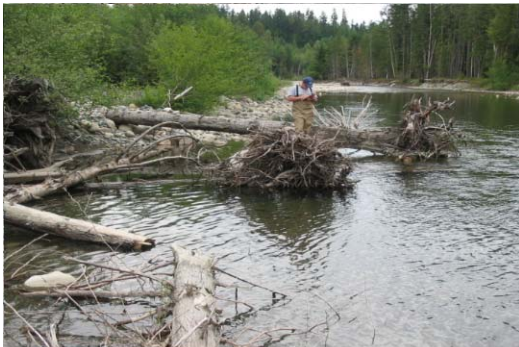
Photo 7. Englishman River LWD structure at site 5+900 looking D/S.

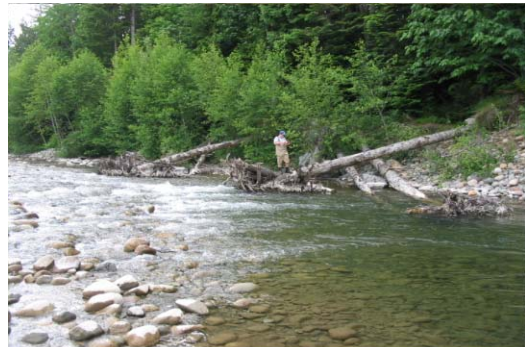
Photo 8. Englishman River LWD structure at site 5+600 looking U/S.

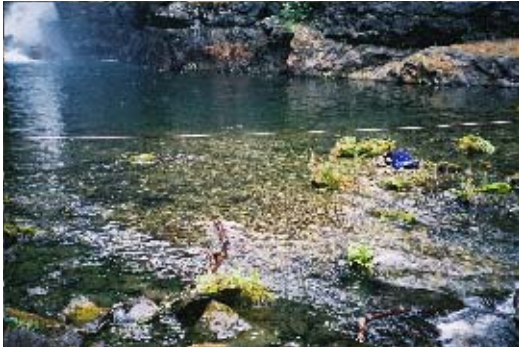
Photo 1. Campbell River gravel monitoring looking at Elk Falls pool tailout, Aug. 8, 2003.

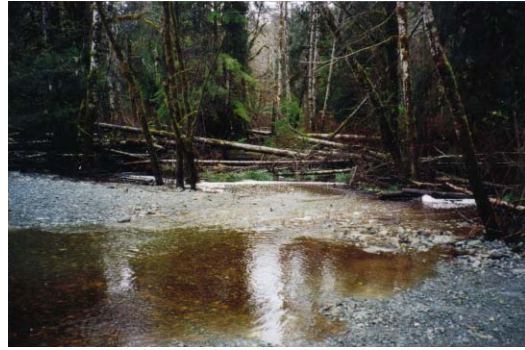
Monitoring of gravel placed in the Lens Creek side-channel in the summer of 2002 was conducted on December 12, 2003. Spawning coho adults were noted throughout the side-channel, with coho redds observed at four of five gravel placement sites. Physical measurements to document gravel pad size, depth and distribution were not made, given the spawning activity. General comments on gravel pad size and condition as well as spawning activity is summarized in Table 4.

Photo 2. Lens Creek gravel monitoring looking at side-channel, Dec. 12, 2003.

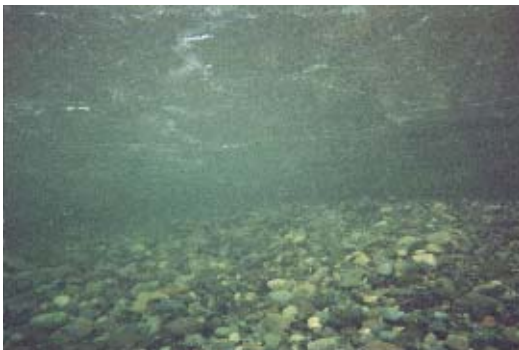
Site 1 appeared more stable as approximately 70 % of the original platform remained intact. Site 1 benefits from the protection of an old log weir immediately upstream of the site, which reduces flow and lessens scour. No signs of spawning activity were noted at site 1.

Photo 3. South Nanaimo gravel monitoring looking at site 1, March 10, 2004.

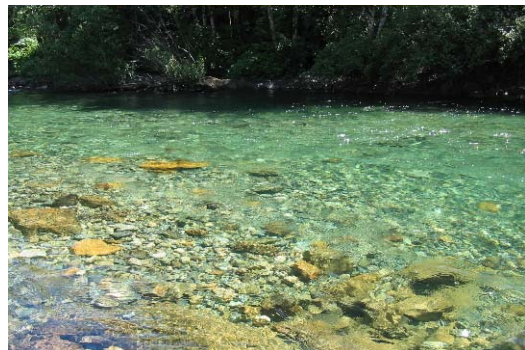
Monitoring at the outlet of Sproat Lake occurred on June 27, 2003. Snorkel observations revealed that some displacement of gravel had occurred, with downstream accumulations noted in three separate locations. The majority of the primary gravel pad constructed in 2002 appeared to be intact and extended to 54 m past the low head weir. The remaining pad equalled 448 m<sup>2</sup> and had a mean gravel depth of 0.45 m. This pad accounted for approximately 202 m<sup>3</sup> (72.5 %) of the original 278 m<sup>3</sup> of placed material (Table 6).

Photo 4. Sproat Lake gravel monitoring looking at primary gravel pad, June 27, 2003.

Monitoring of gravel conditions at the outlet of Sproat Lake is recommended on a regular basis. Further gravel additions to this location should be undertaken on an “as required basis”, to maintain optimal spawning conditions.

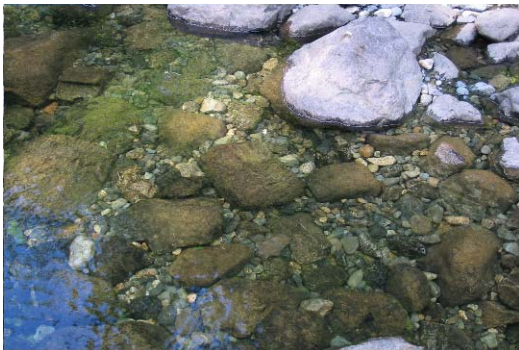
Photo 5. Toquart Lake gravel monitoring, boulder infilling with gravel, June 26, 2003.

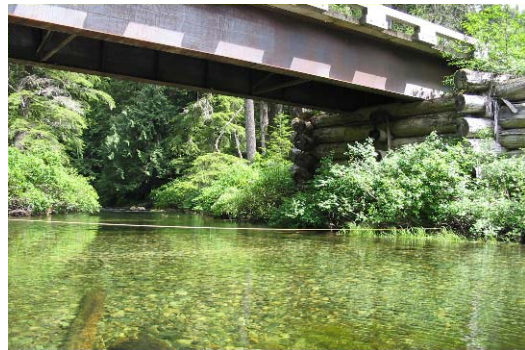
Photo 6. Stewart Lake gravel monitoring looking D/S at gravel pad, July 1, 2003.

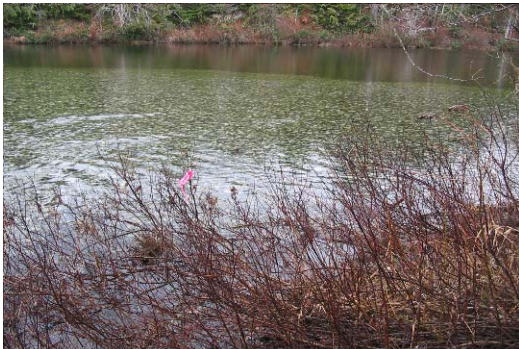
Photo 7. Dickson Lake gravel monitoring looking at north pad, March 23, 2004.

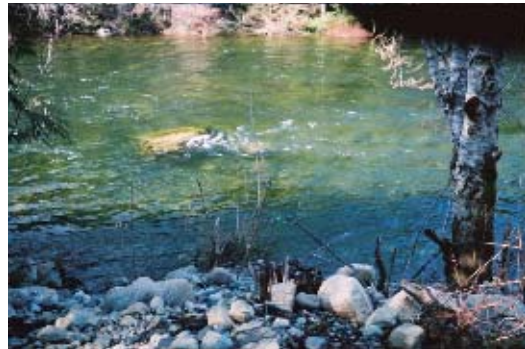
Photo 8. Nanaimo Lake gravel monitoring looking at pad, March 10, 2004.

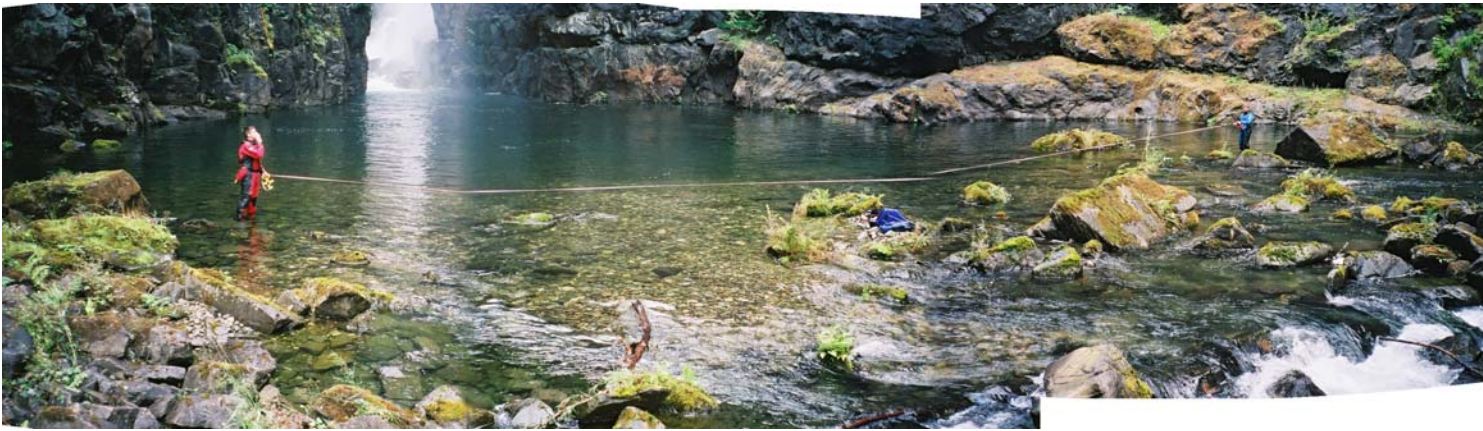
Photo Pan 1. Looking upstream at the tailout of the Elk Falls plunge pool. Significant opportunity still exists to increase the quantity of spawning gravel at this location.

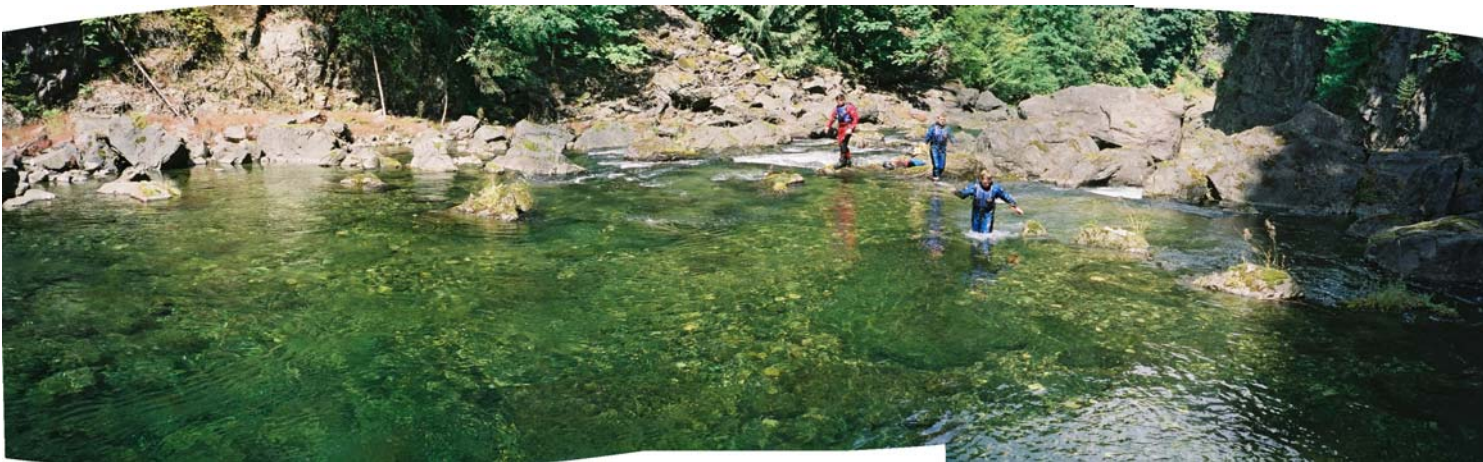
Photo Pan 2. Looking downstream at the secondary gravel placement site in 2002. An opportunity exists to place more spawning material at this location.

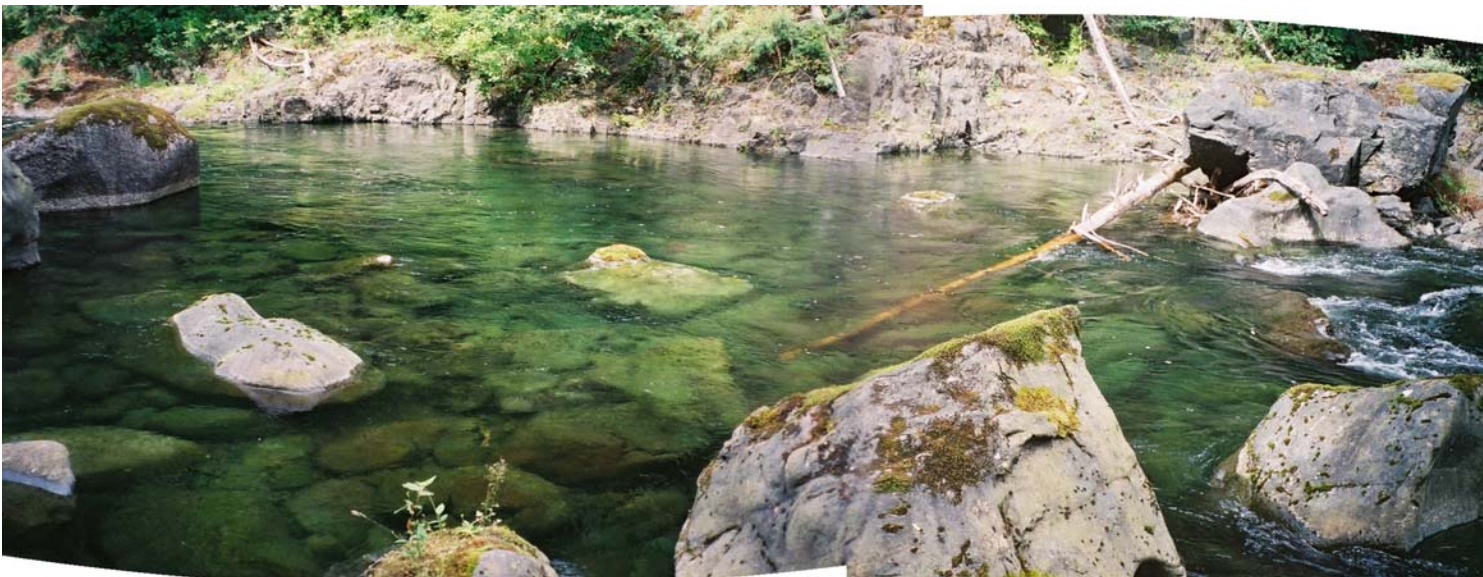
Photo Pan 3. Looking across-stream at a tail-out identified as a candidate for future gravel enhancement. This location was approximately 1.2 km downstream of Elk Falls.

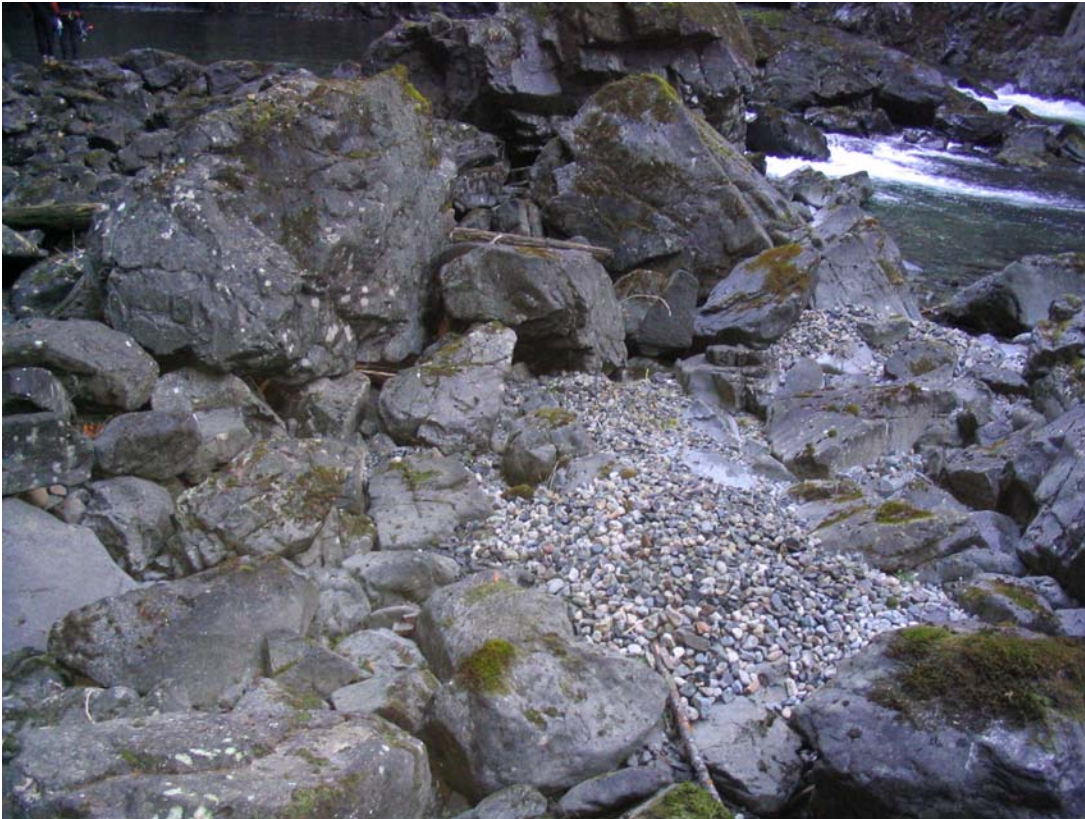
Photo 1. Introduced gravel from the falls pool tailout that has been distributed downstream ~40 m to a right bank location.

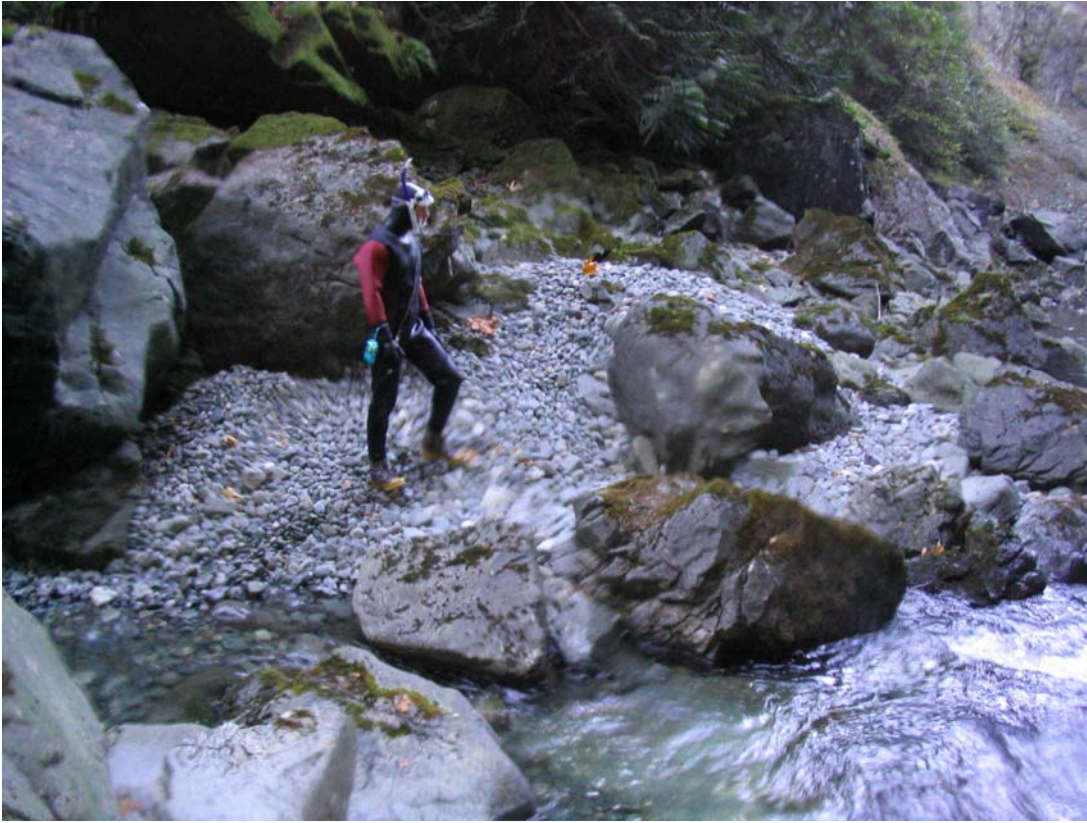
Photo 2. Gravel from the falls pool tailout that has been distributed ~80 m downstream on the left bank.

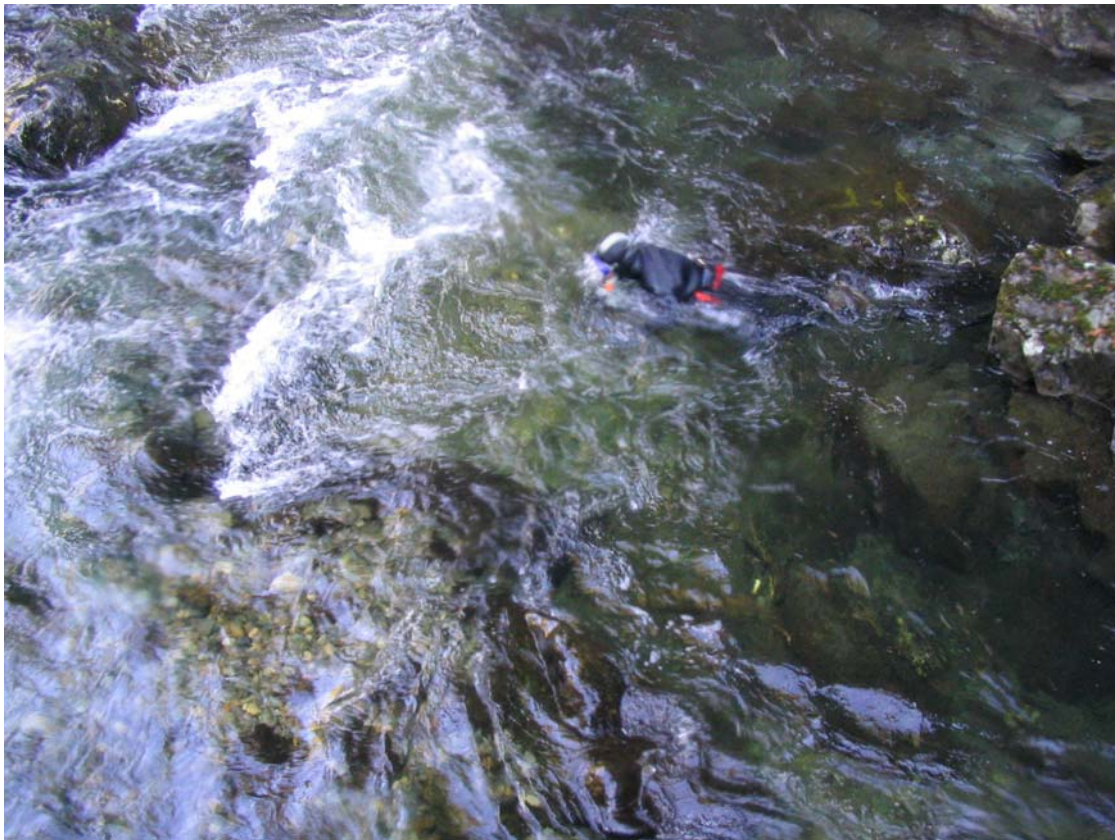
Photo 3. Functioning gravel that has accumulated downstream of the lower installation site.

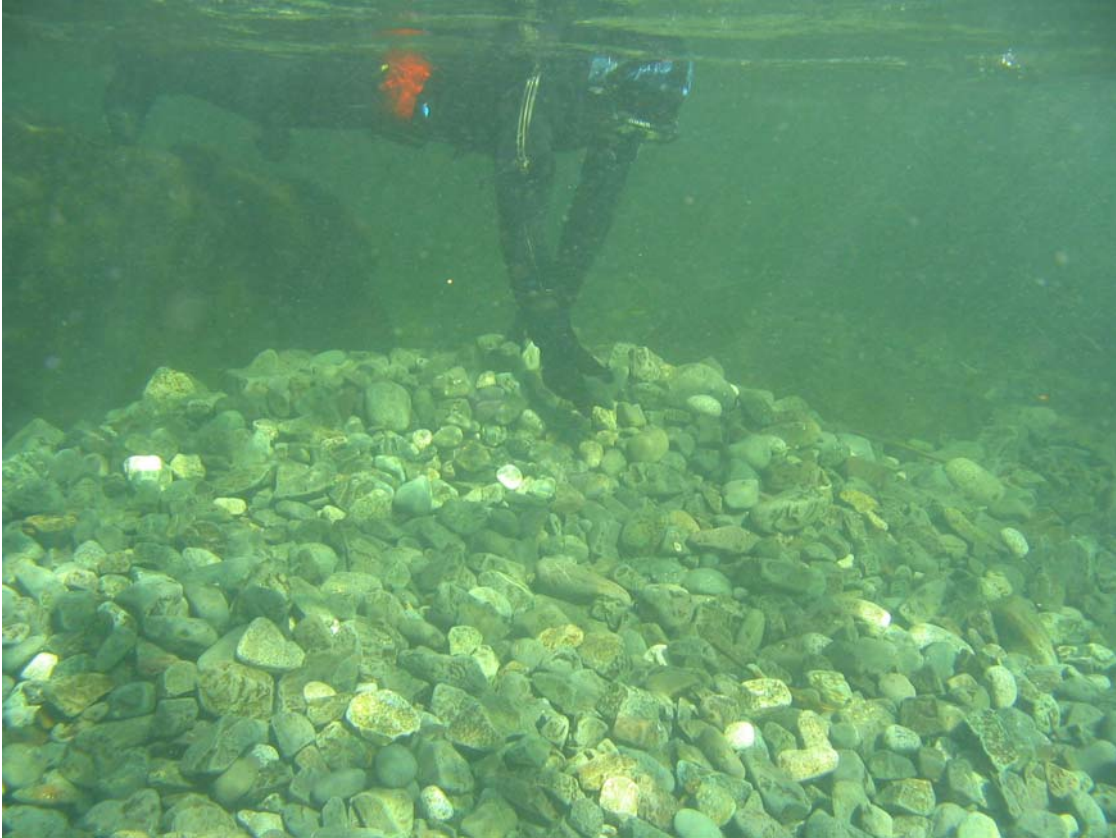
Photo 4. New gravel accumulation downstream of the lower installation site.
