Identifying Wetlands For Restoration Opportunities: Year 1 Progress Report

PEA-F20-W-2966

1 September 2020

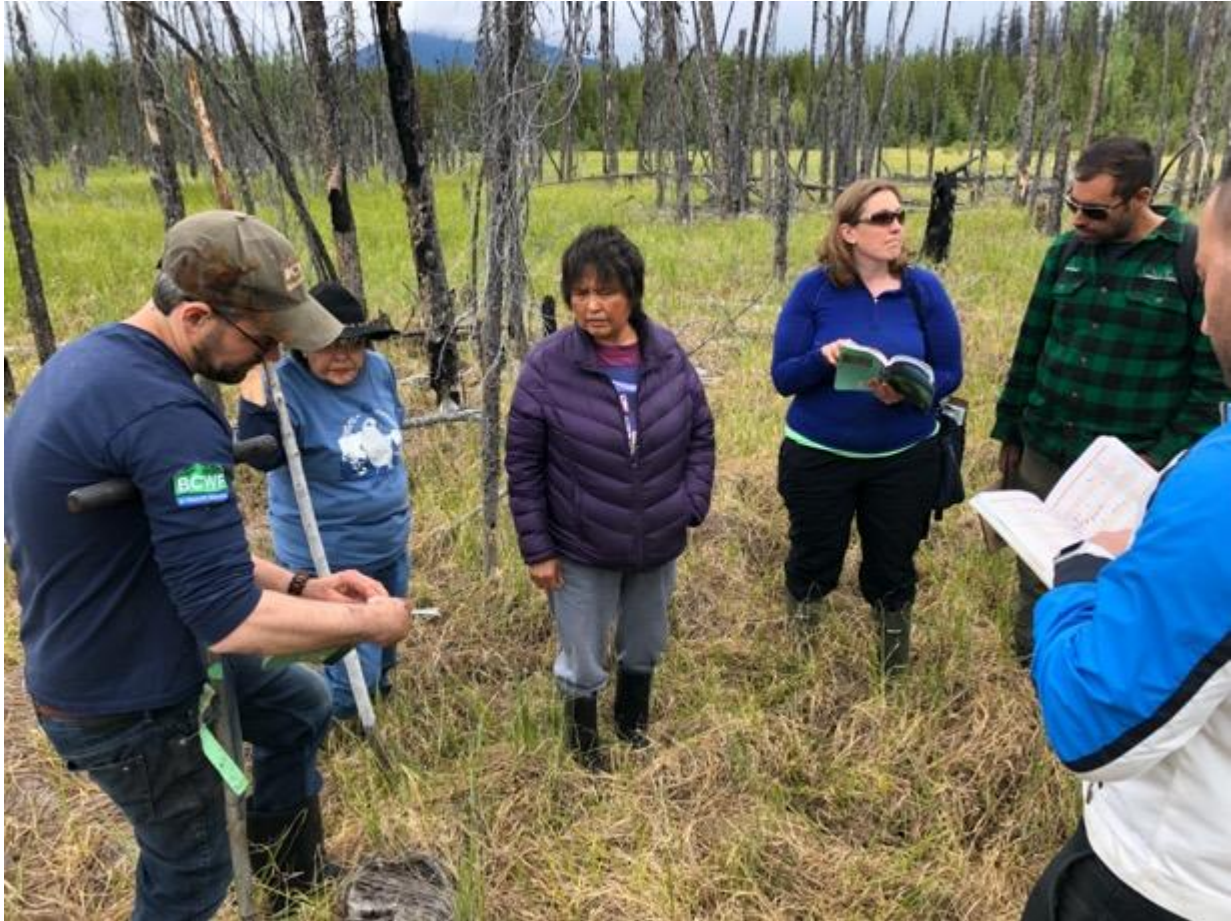
Figure 3. Field component of the wetland health assessment training workshop in Tsay Keh Dene, June 2019.

Figure 2 shows participants learning about wetland health in the classroom, and Figure 3 shows workshop participants learning how to conduct rapid wetland health assessments in the field

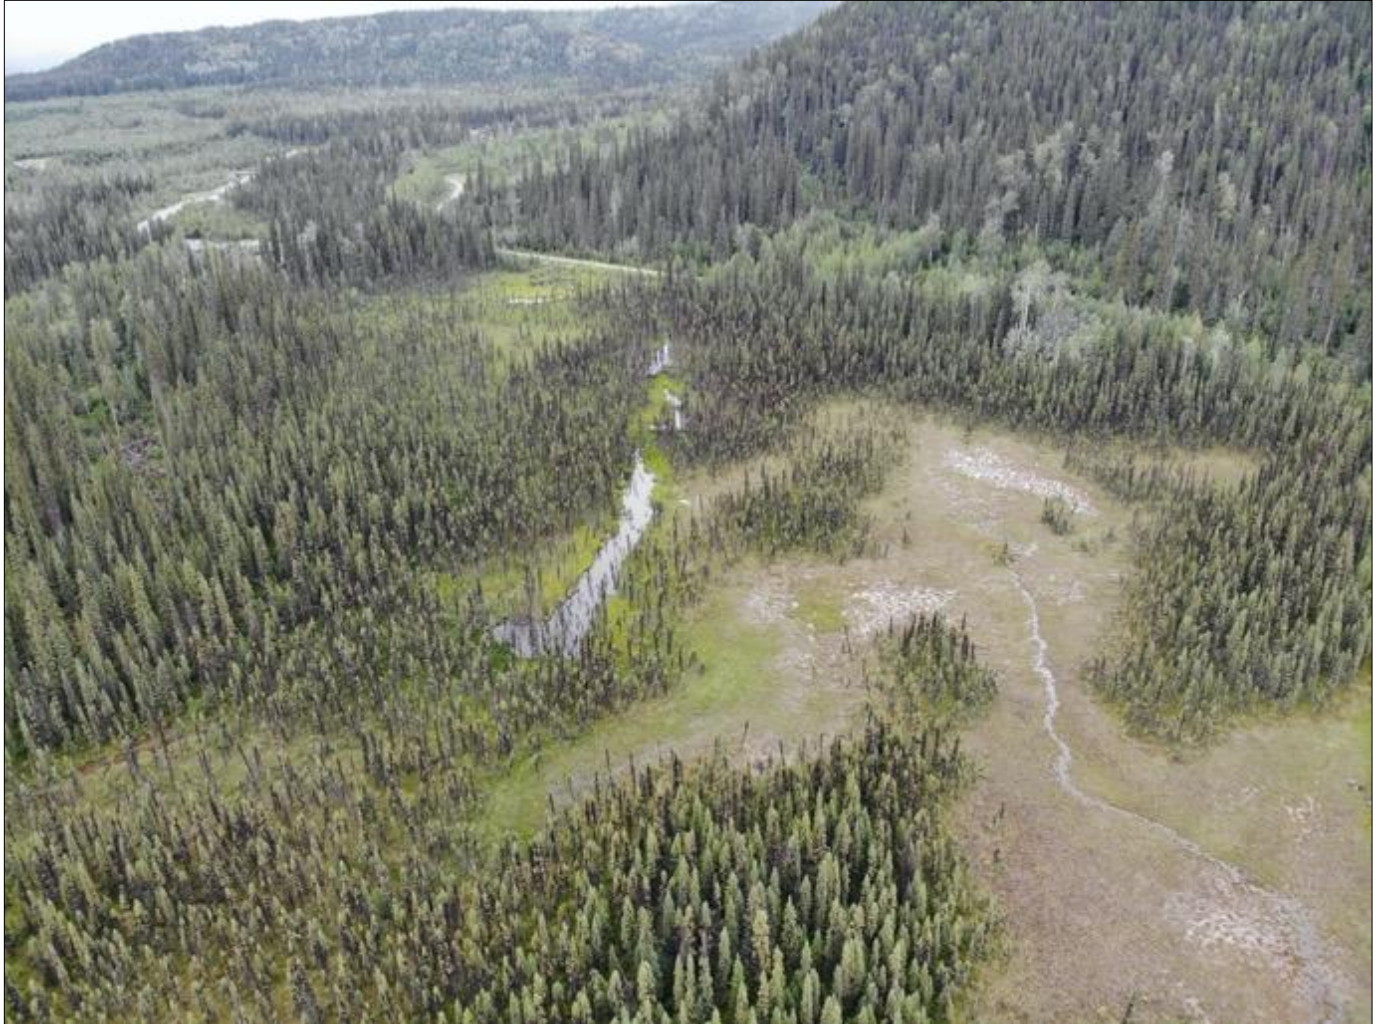
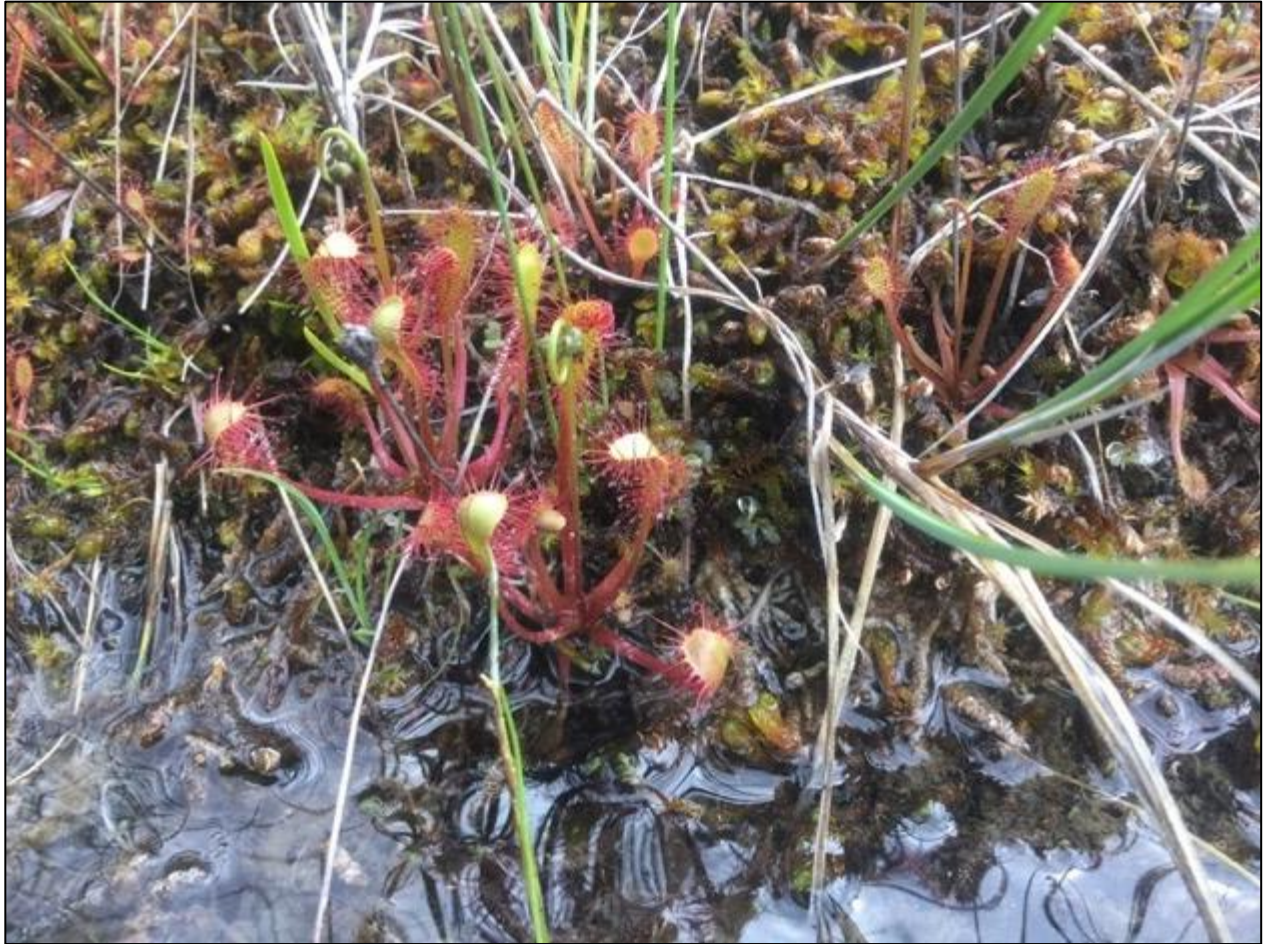
Figure 5. Aerial view of assessment site W1

Site comments: The site was observed to have black spruce (*Picea mariana*) interspersed with wet inundated areas and a small channel of running water. Common sundew (*Drosera rotundifolia*), a carnivorous wetland plant was abundant. (Figure 6). Other plant species observed were Labrador tea (*Rhododendron groenlandicum*), horsetails (*Equisetum* sp.), and willow (*Salix* sp.). Very little emergent vegetation was present. A blocked culvert, likely due to improper road maintenance and ditch cleaning was also present at the road (Figure 7). A wading bird believed to belong to the family Scolopacidae (sandpipers) was observed at this site. Very little emergent vegetation was observed at this site. In areas without standing water present, the ground was observed to be very wet indicating the presence of water in the soils.

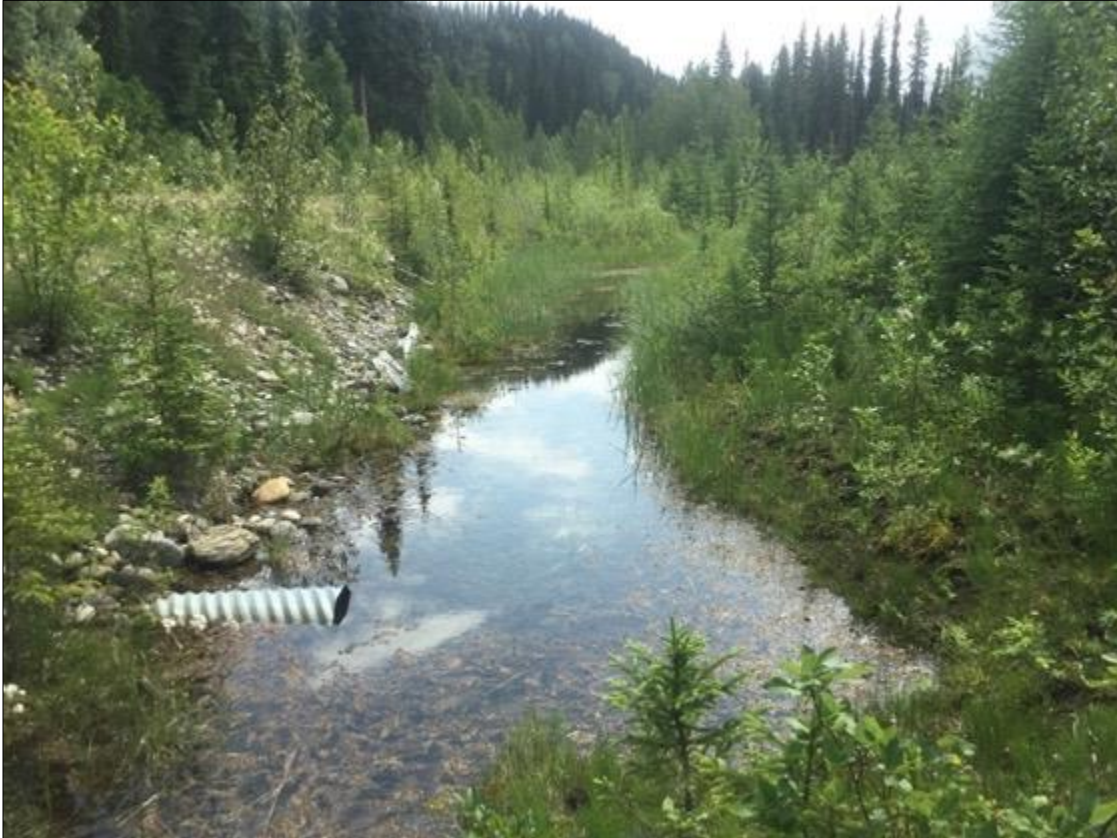
Figure 7. Blocked culvert at site W1

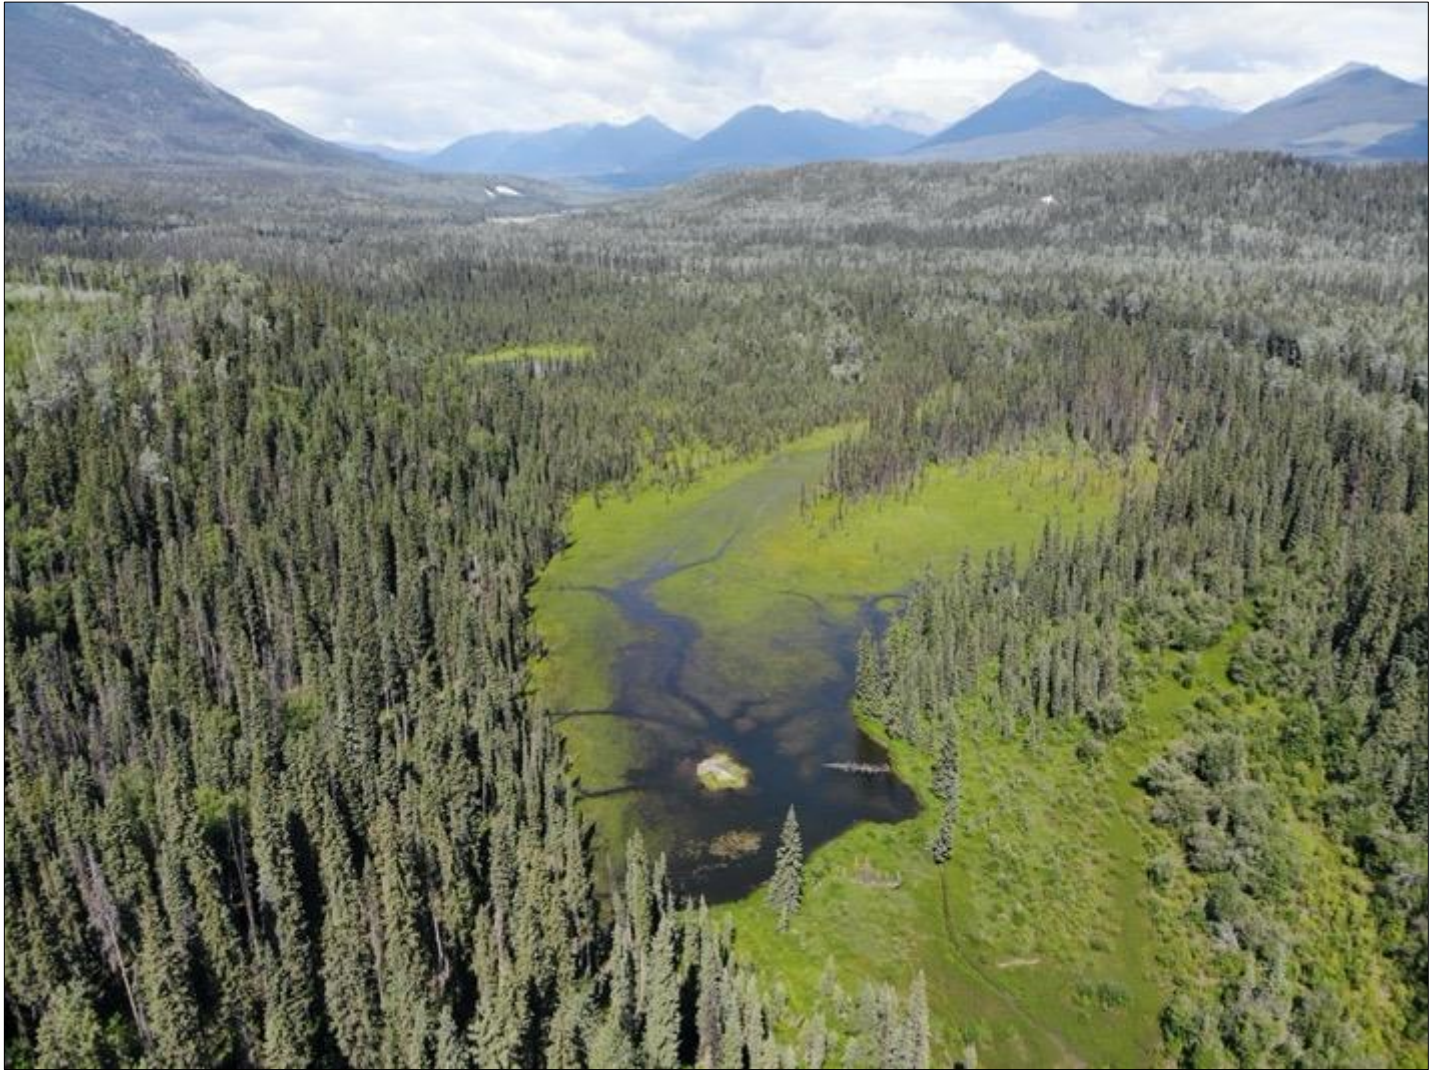
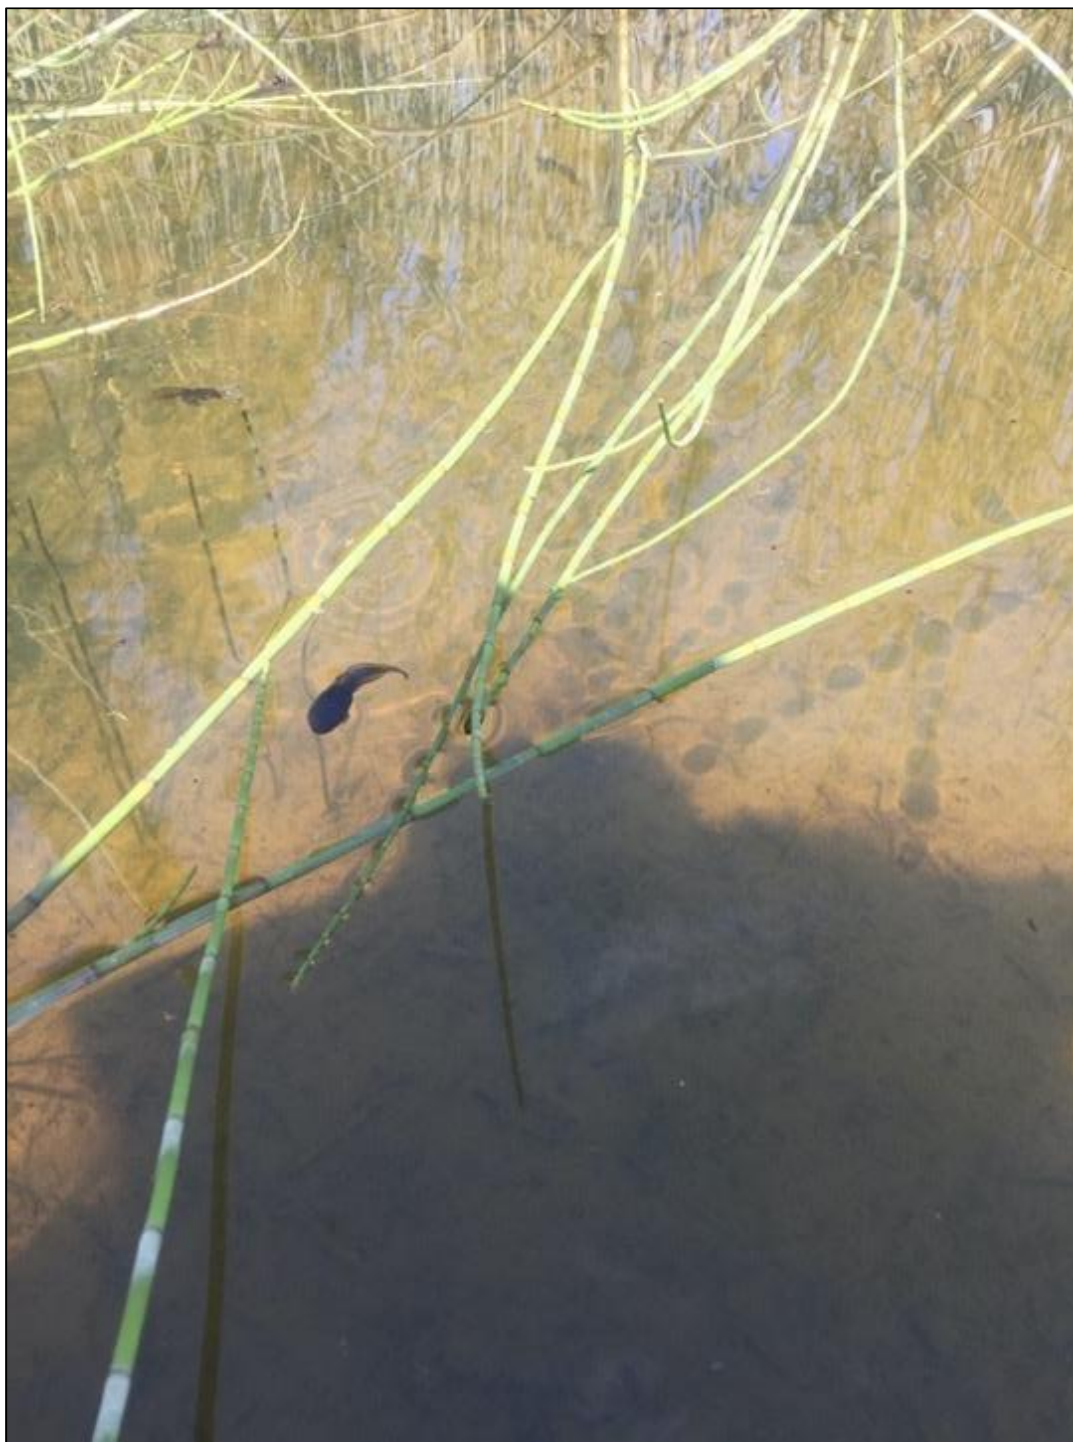
Figure 8. Aerial view of site W2 near Discovery Camp

Site comments: This site is located a short walk from Discovery Camp, an outdoor camp for TKD youth. A beaver dam was present as well as a beaver lodge. Numerous tadpoles of an unidentified species were observed in the water (Figure 9). Moose (*Alces alces*) tracks were present along with signs of browsing. Numerous damselflies were observed, and the development of damselfly larva is dependent on wetland habitat. A yellow-rumped warbler (*Setophaga coronata*) was also observed. Sedges were the dominant emergent vegetation present. Willow (*Salix* sp.) along the wetland borders showed signs of browsing.

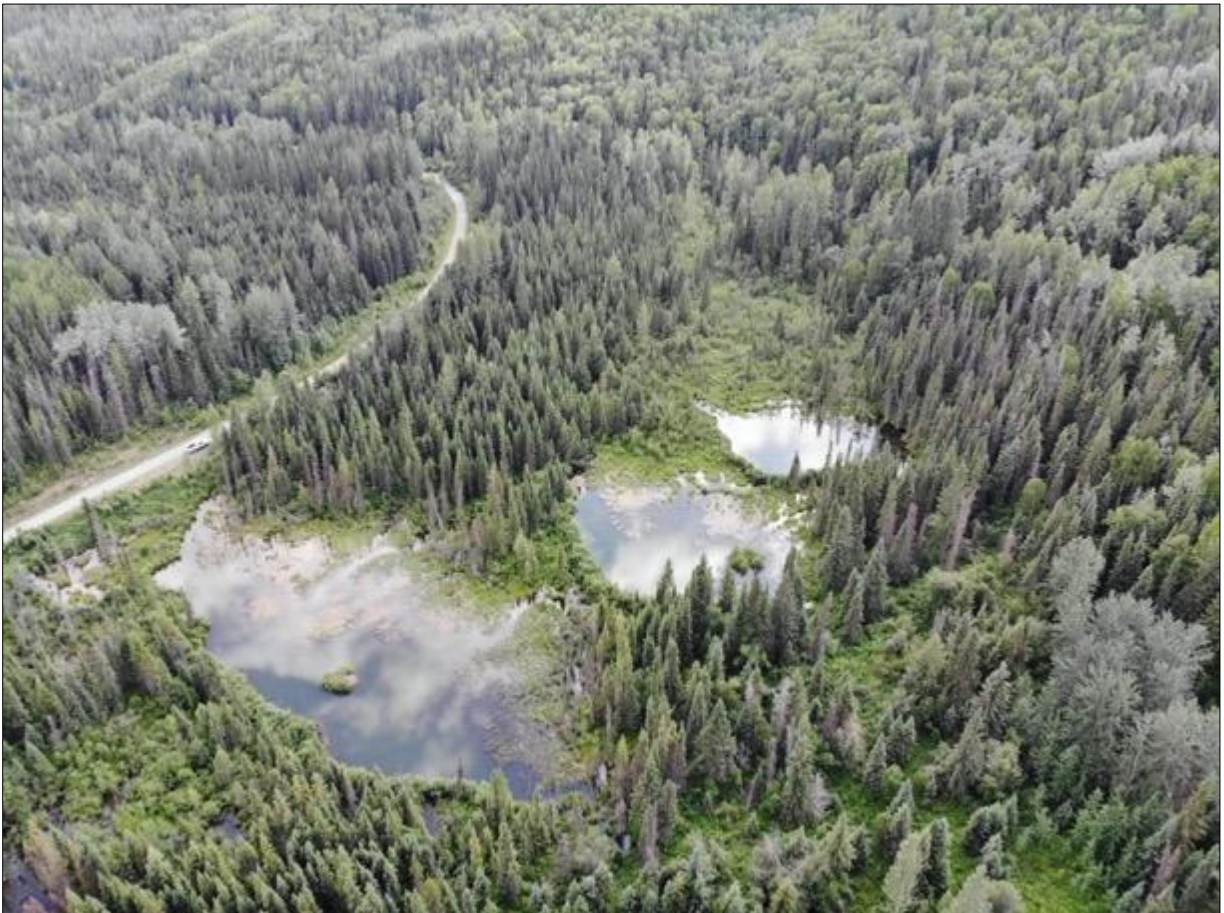
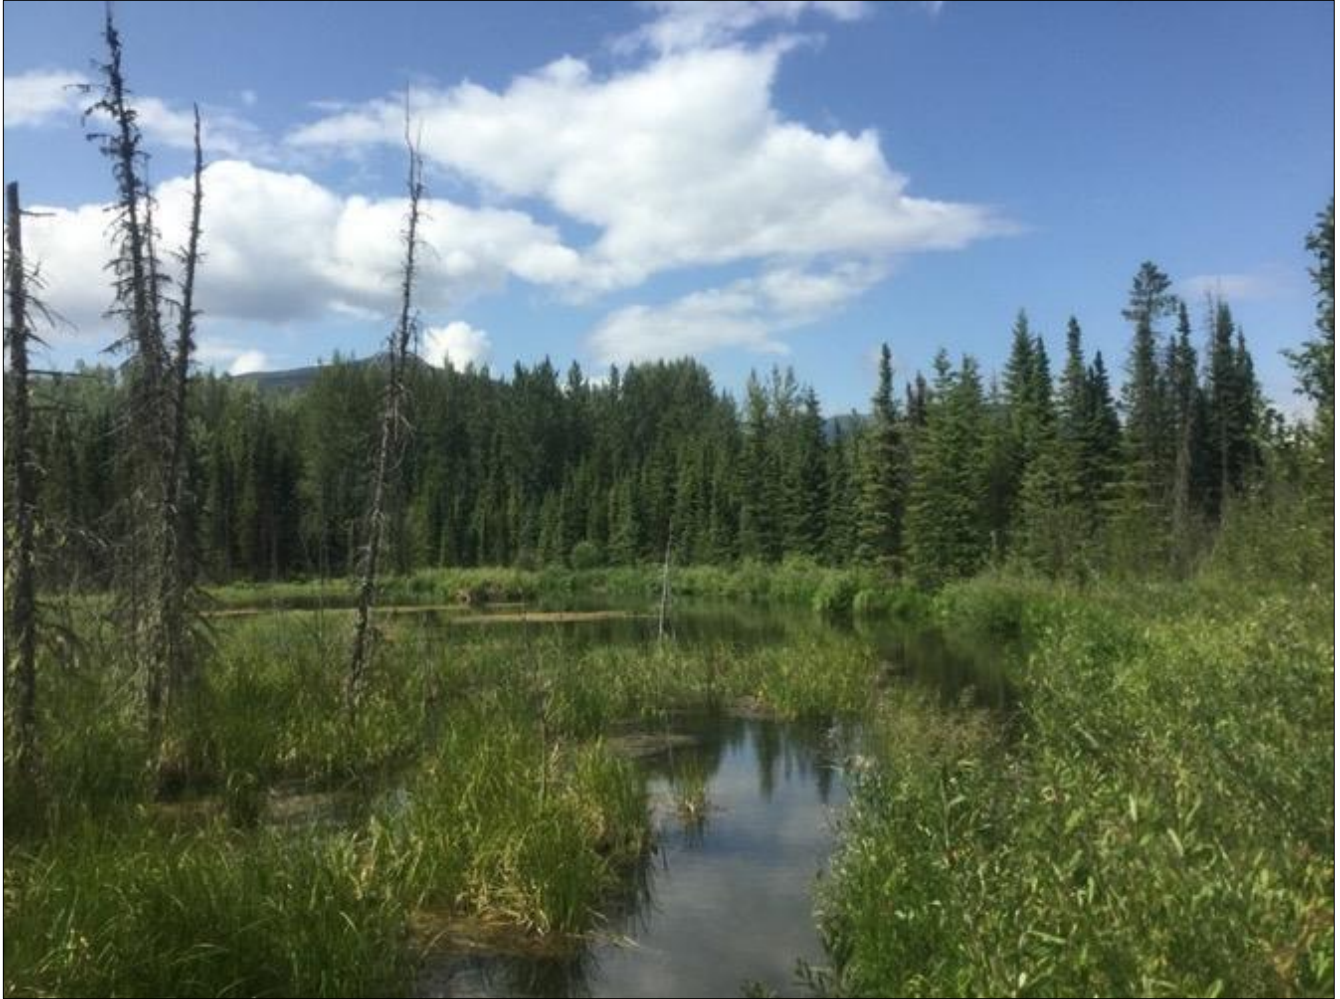
Figure 10. Aerial view of site W3

Site Comments: This site is a small wetland on the west side of the Ospika FSR. Dead spruce (*Picea* sp.) were observed. Sedges were the dominant emergent vegetation present. Other vegetation observed included willow (*Salix* sp.) A beaver lodge was present but appeared to be old and not in use.

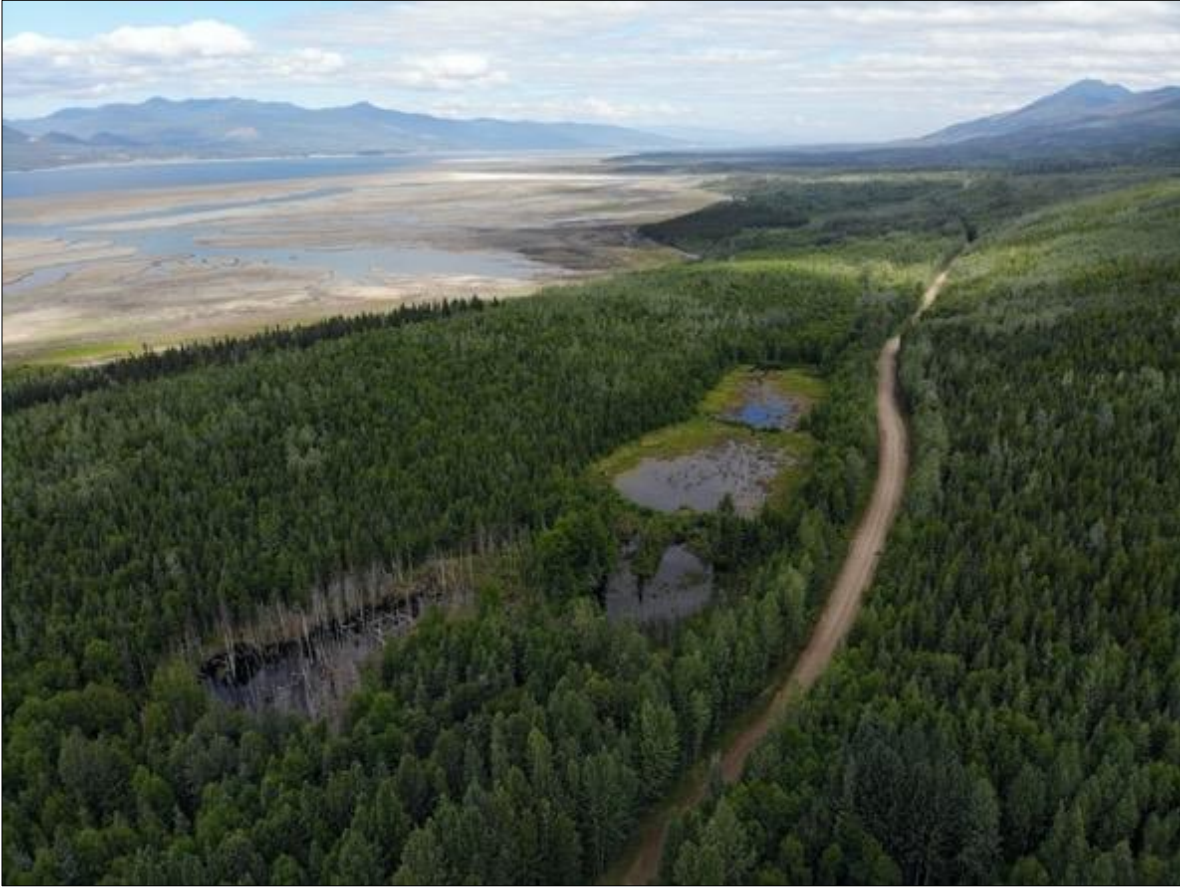
Site Comments: This site along the Davis FSR appears to have been inundated due to a beaver dam. Dead trees were observed standing in the inundated area. Browsed willow (*Salix* sp.) and moose droppings were observed. Dragonflies were present. Creeping buttercup (*Ranunculus repens*), an invasive species was also noted at this site. Other plant species observed were raspberry (*Rubus* sp.) and red currant (*Ribes* sp.), both of which are edible.

Figure 12. Aerial view of site W4 beside the Davis FSR, with Williston Reservoir in the background

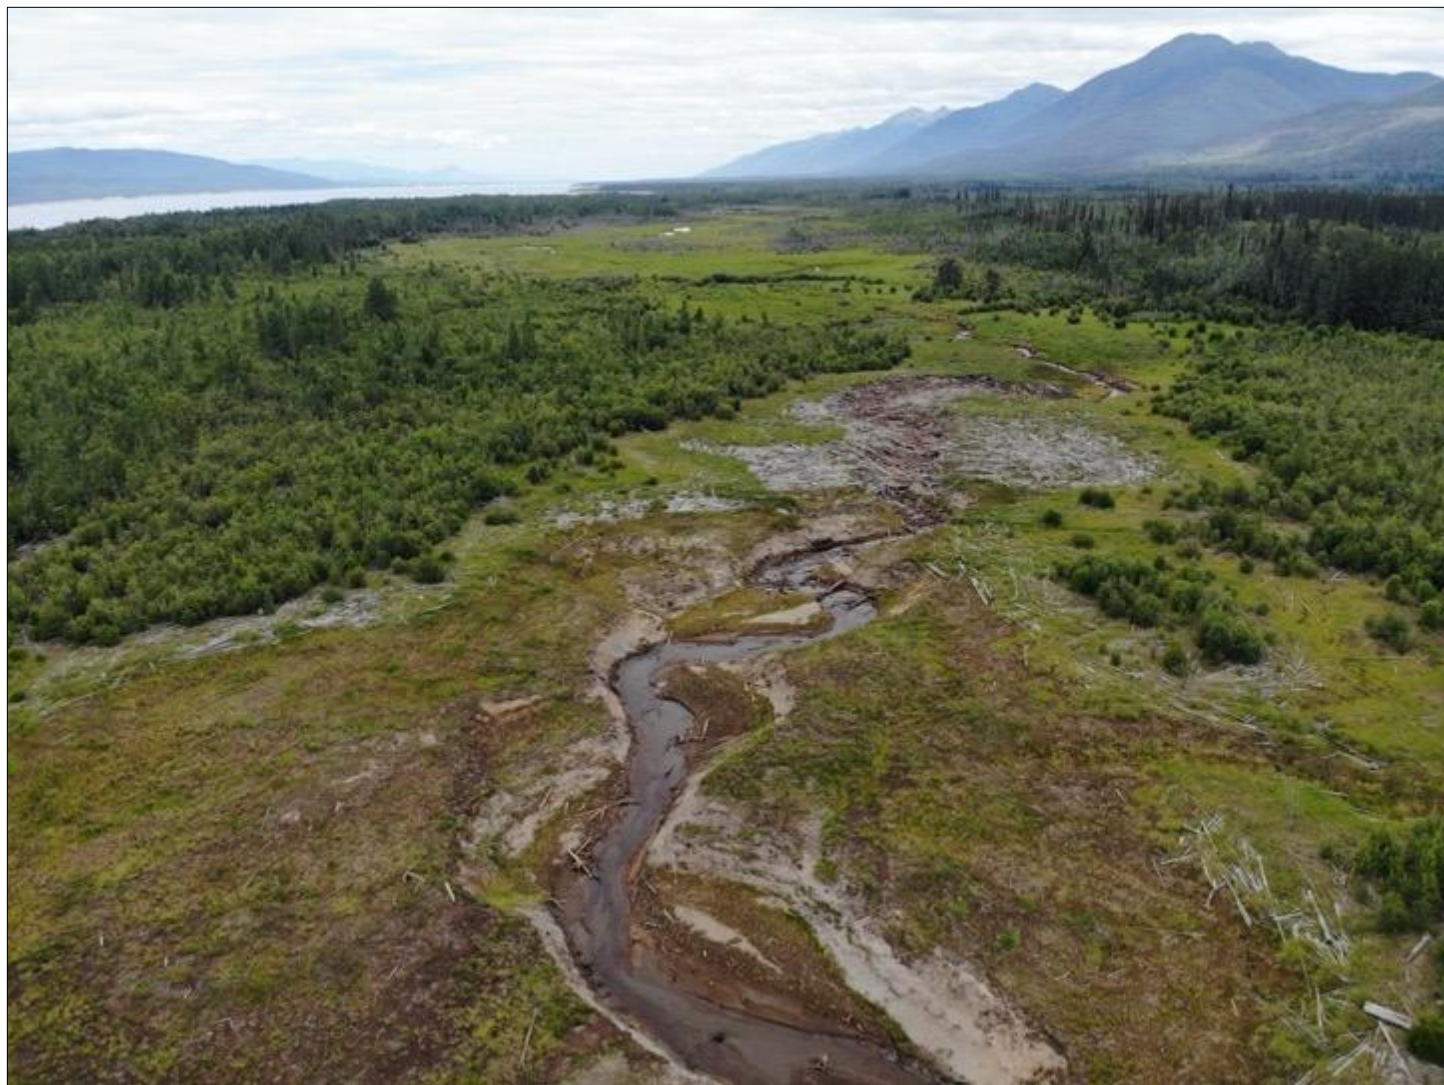
Site Comments: This site shows major degradation, where the creek has headcut, causing the wetland to dry out. A headcut is an erosional feature caused by a sudden drop in the streambed. Headcuts can move upstream, as in the case of this site, and cause a channel incision, which is the overall lowering of channel bed, which in turn leads to the stream falling below its floodplain, and the subsequent drying of associated wetlands.

Figure 13. Aerial view of the degraded wetland at Middle Creek showing channel incision

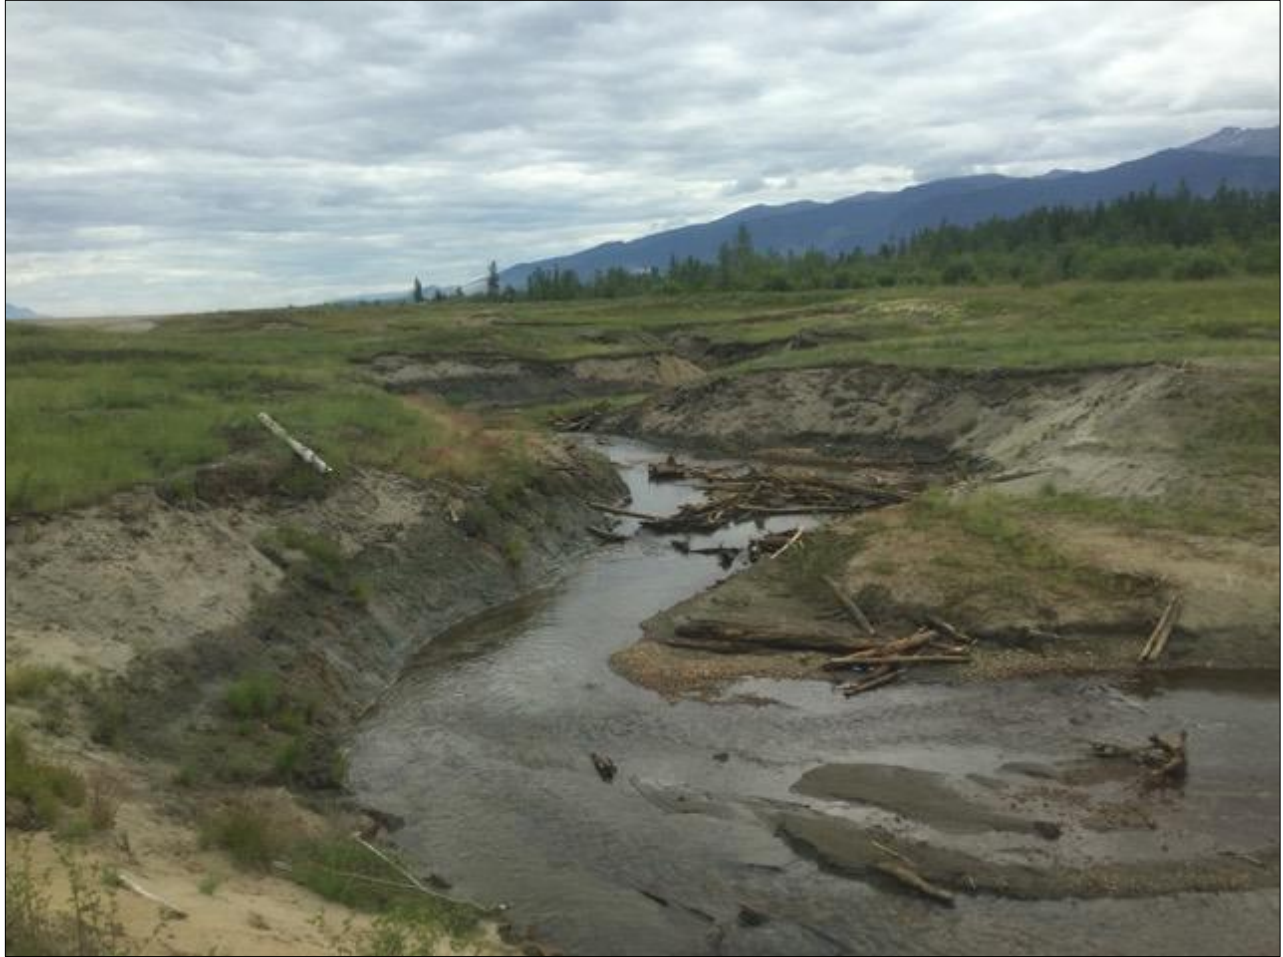
Invasive creeping buttercup (*Ranunculus repens*), and disturbance indicator foxtail barley (*Hordeum jubatum*) were observed at this site. Wood frogs (*Lithobates sylvaticus*) were seen during the assessment, as well as grizzly bear (*Ursus arctos horribilis*) tracks. There was no standing water or emergent vegetation present, due to the channel incision.

Figure 14. Deep channel created by the headcut at Middle Creek leading to drying of the wetland

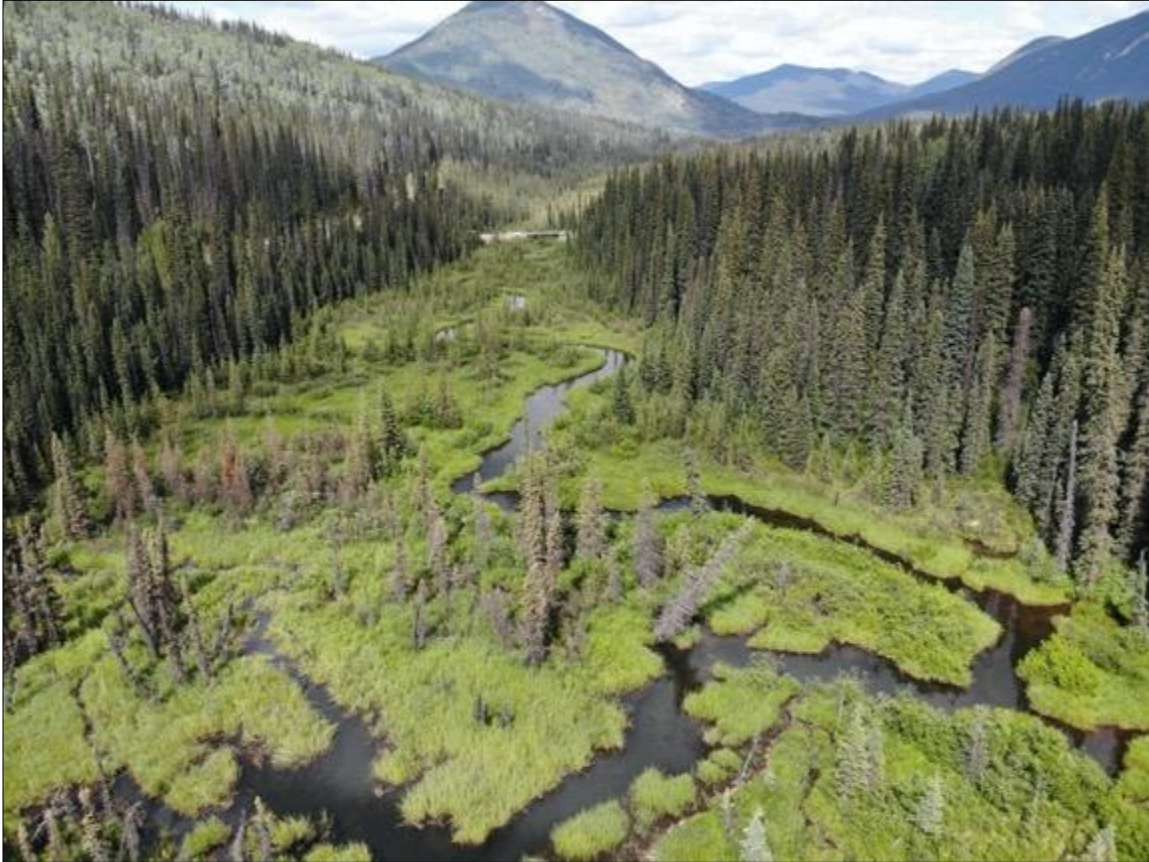
Figure 15. Aerial view of the wetland north of the Akie mainline

Site Comments: This wetland was observed to have a mix of lentic (still) and lotic (flowing) systems. Sedges and horsetails (*Equisetum* sp.) were the dominant emergent vegetation present. Willow (*Salix* sp.) was present but no browsing indicators were observed. Creeping buttercup (*Ranunculus repens*), an invasive species was present. One unidentified fish was observed by the crew. This wetland was later found to be outside TKD Nation territory, and will not be considered as having restoration potential for the purpose of this project.

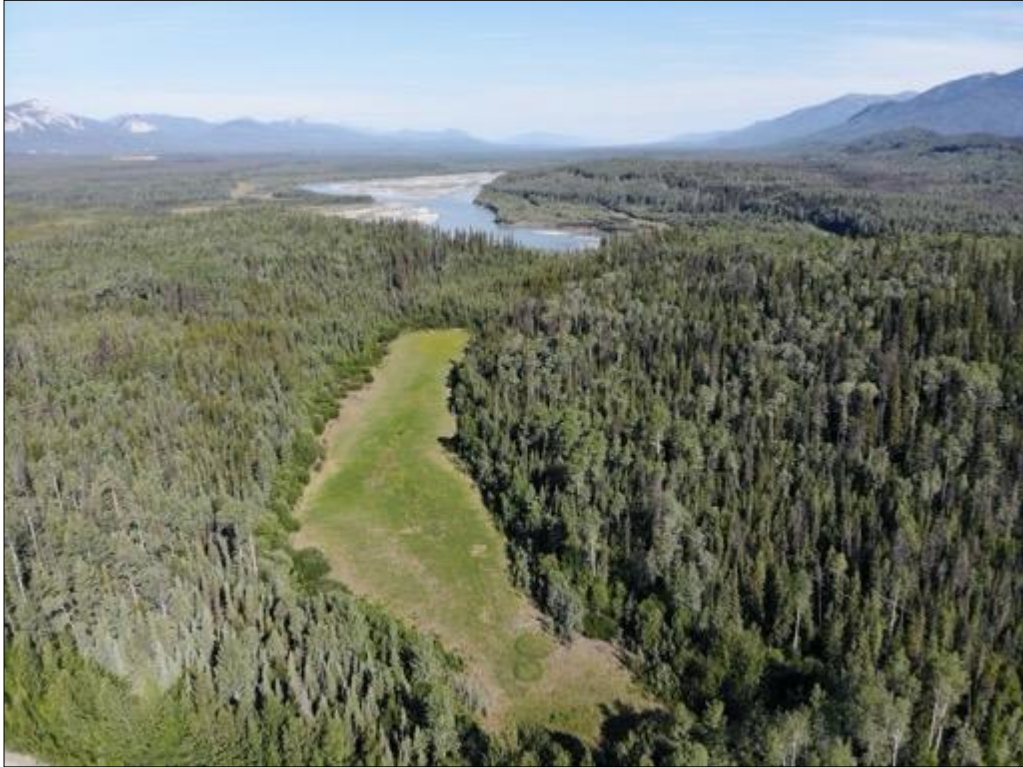
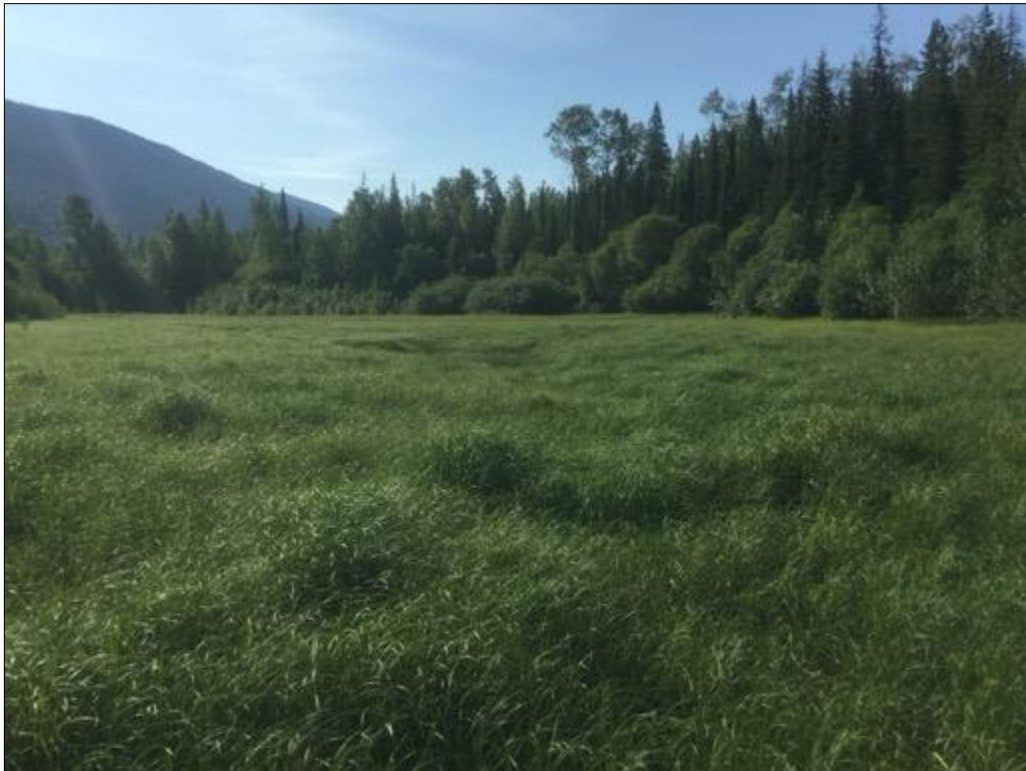
Figure 16. Aerial view of site W7 near the bridge at Deserters Canyon

Site Comments: This site was entirely dry and covered by grasses, except for a few small microsites with bare soil and limited vegetation cover. The boundary of the site was well established with willow (*Salix* sp.), alder (*Alnus rubra*), spruce (*Picea* sp.), and aspen (*Populus tremuloides*). Numerous wood frogs (*Lithobates sylvaticus*) were observed, as well as unidentified ungulate droppings and bear scat. Songbirds were heard but not identified.

According to local knowledge this area used to be wet in the past but has been dry for a number of years.

Figure 17. Grasses are the dominant vegetation at site W7

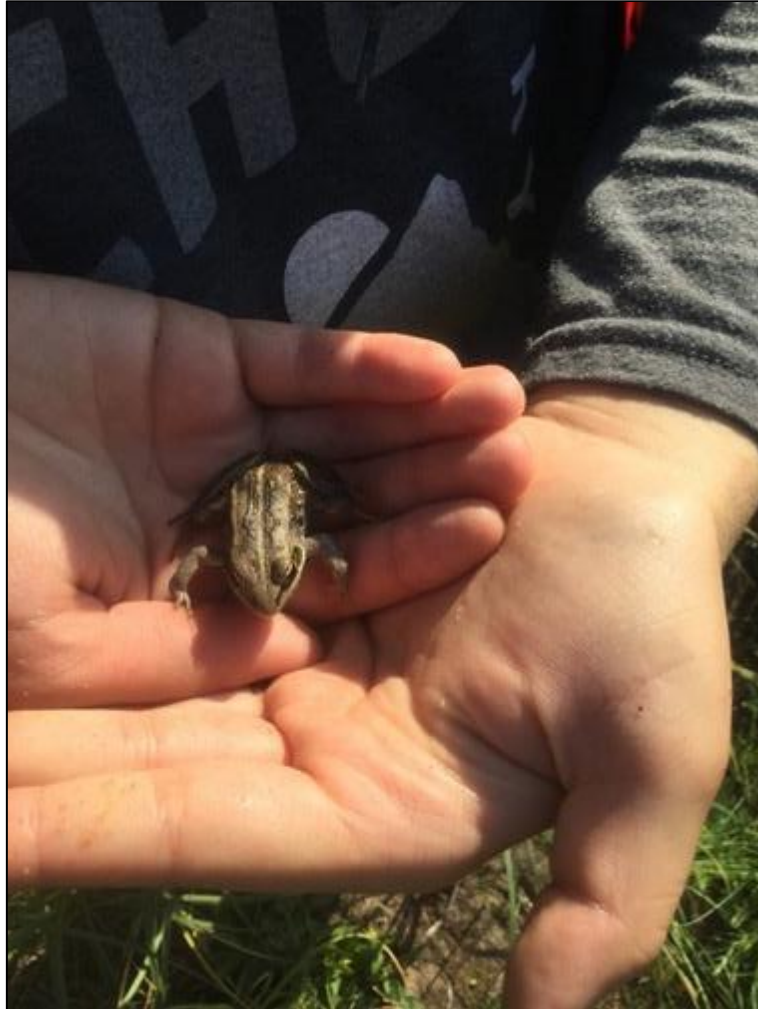
Figure 18. Wood frog (*Lithobates sylvaticus*) at site W7

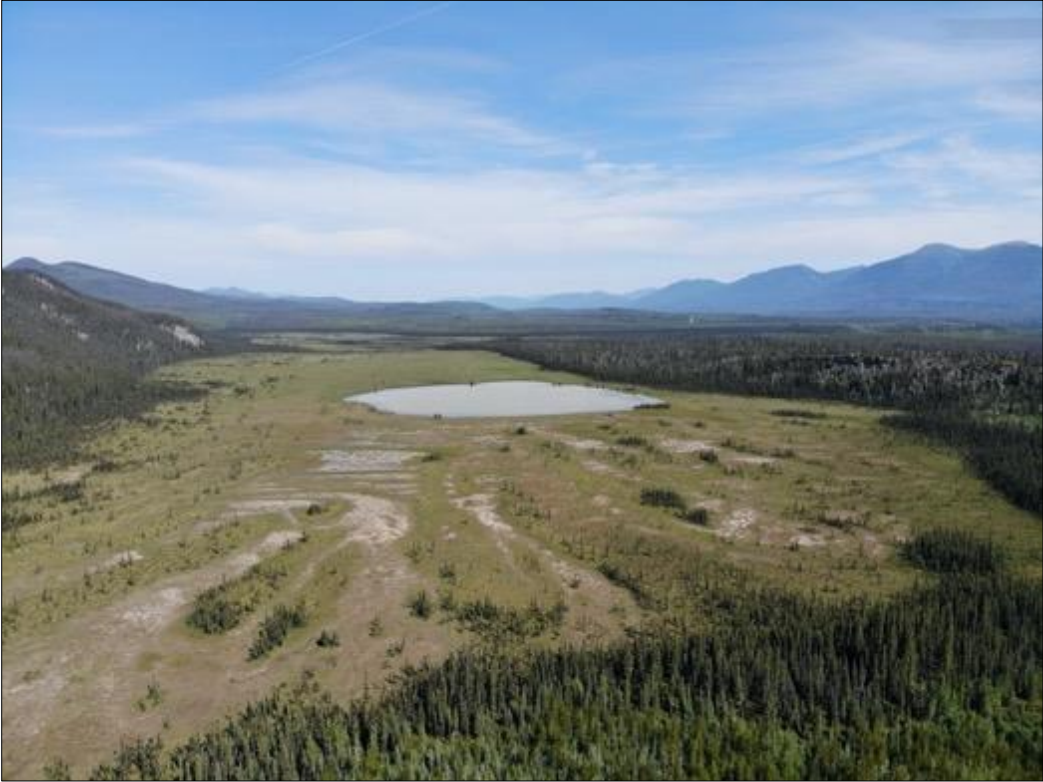
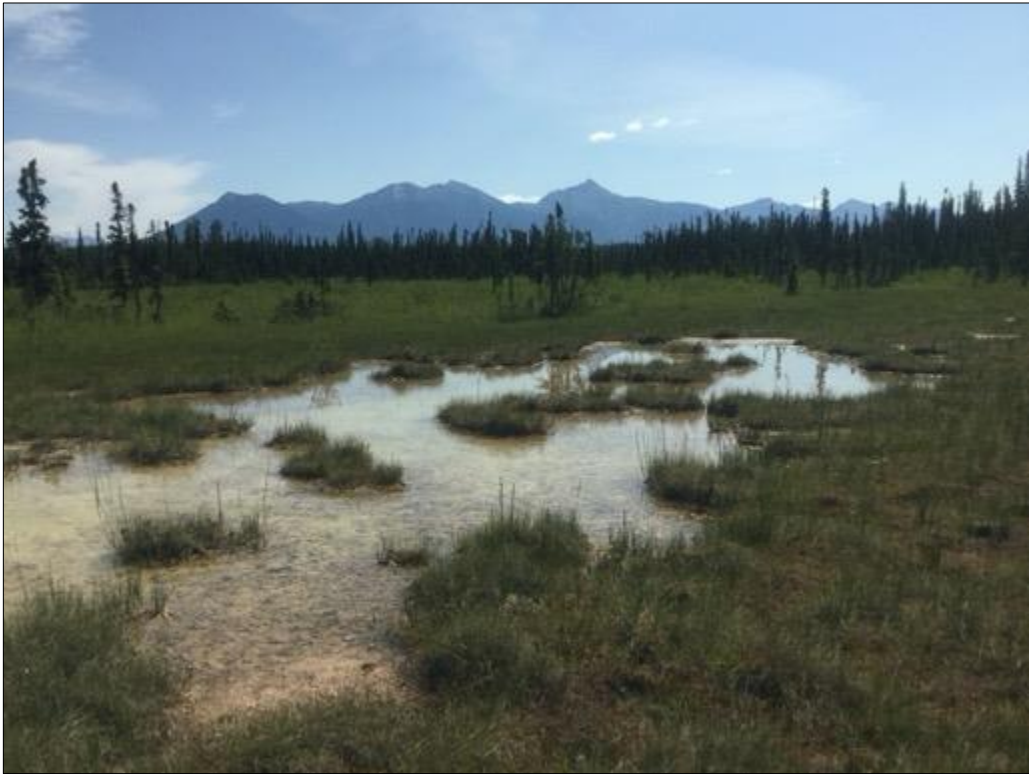
Figure 19. Aerial view of site W8

Site comments: This site was accessed by an old trail through a plantation on the north side of site W9 on the 10,000 Rd, which is accessed via the Russell FSR at 10km. Wood frogs (*Lithobates sylvaticus*) and numerous unidentified butterflies were observed. The site was wet throughout; even in areas appearing dry the soil was inundated. Black spruce (*Picea mariana*), alder (*Alnus rubra*), and willow (*Salix* sp.) were present at this site. No invasive species were observed.

Figure 20. Inundated area in site W8

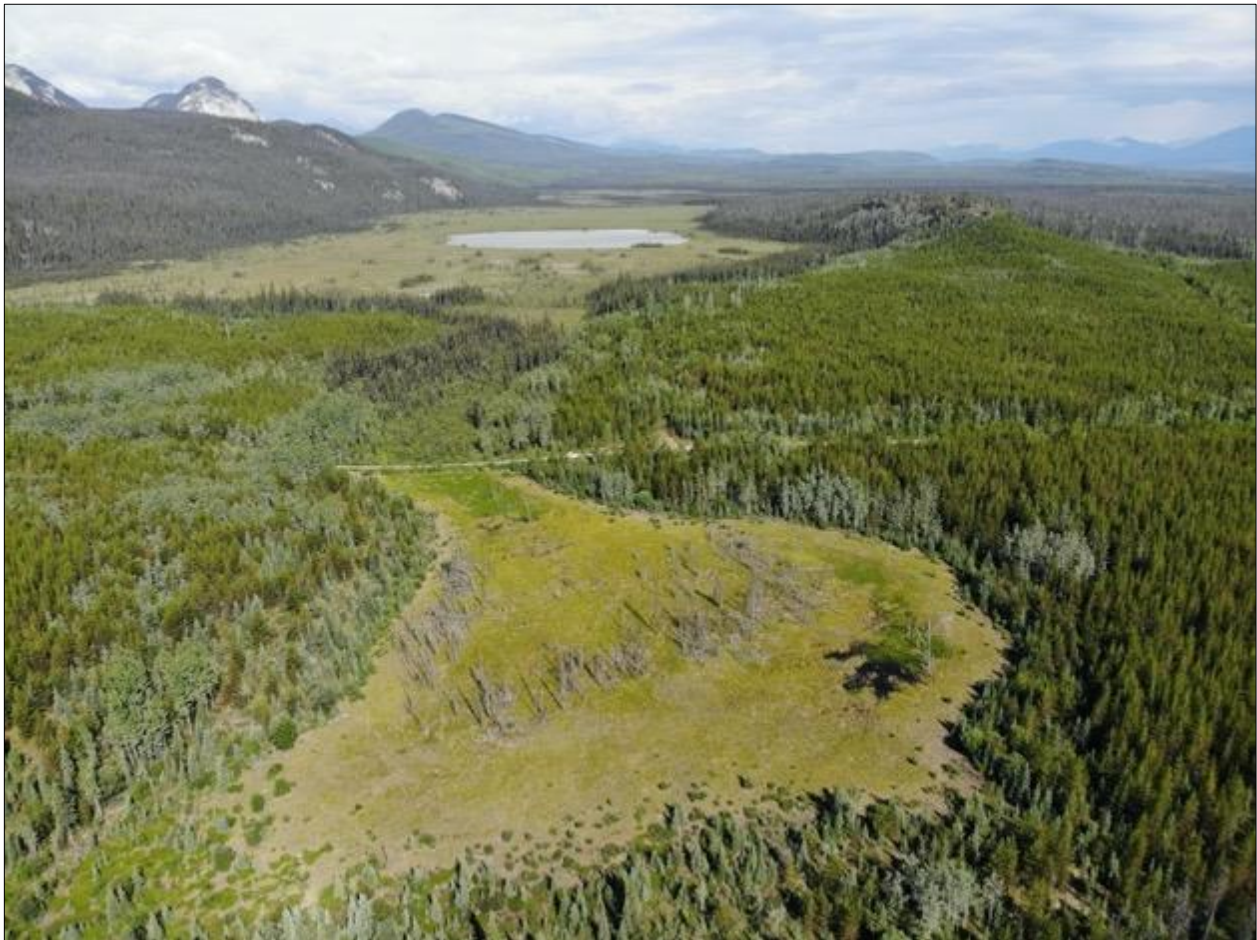
Figure 21. Aerial view of side W9 (foreground) and W9 (background)

Site Comments: This site appears to have been inundated at one time but was dry at the time of the health assessment. Two culverts were observed at the road, one was mostly buried and the other was perched. Very little water or emergent vegetation was present, and was confined to the area near the culverts. Sedges were the dominant emergent vegetation observed. Some of the dead standing trees showed evidence of past fire. Across the road was a damp area with an abundance of black spruce (*Picea mariana*), which prefers wet sites. It was theorized that improper culvert placement could be responsible for the lack of water and emergent vegetation at this site.
