Identifying Wetlands For Restoration Opportunities: Year 1 Progress Report

PEA-F20-W-2966

1 September 2020

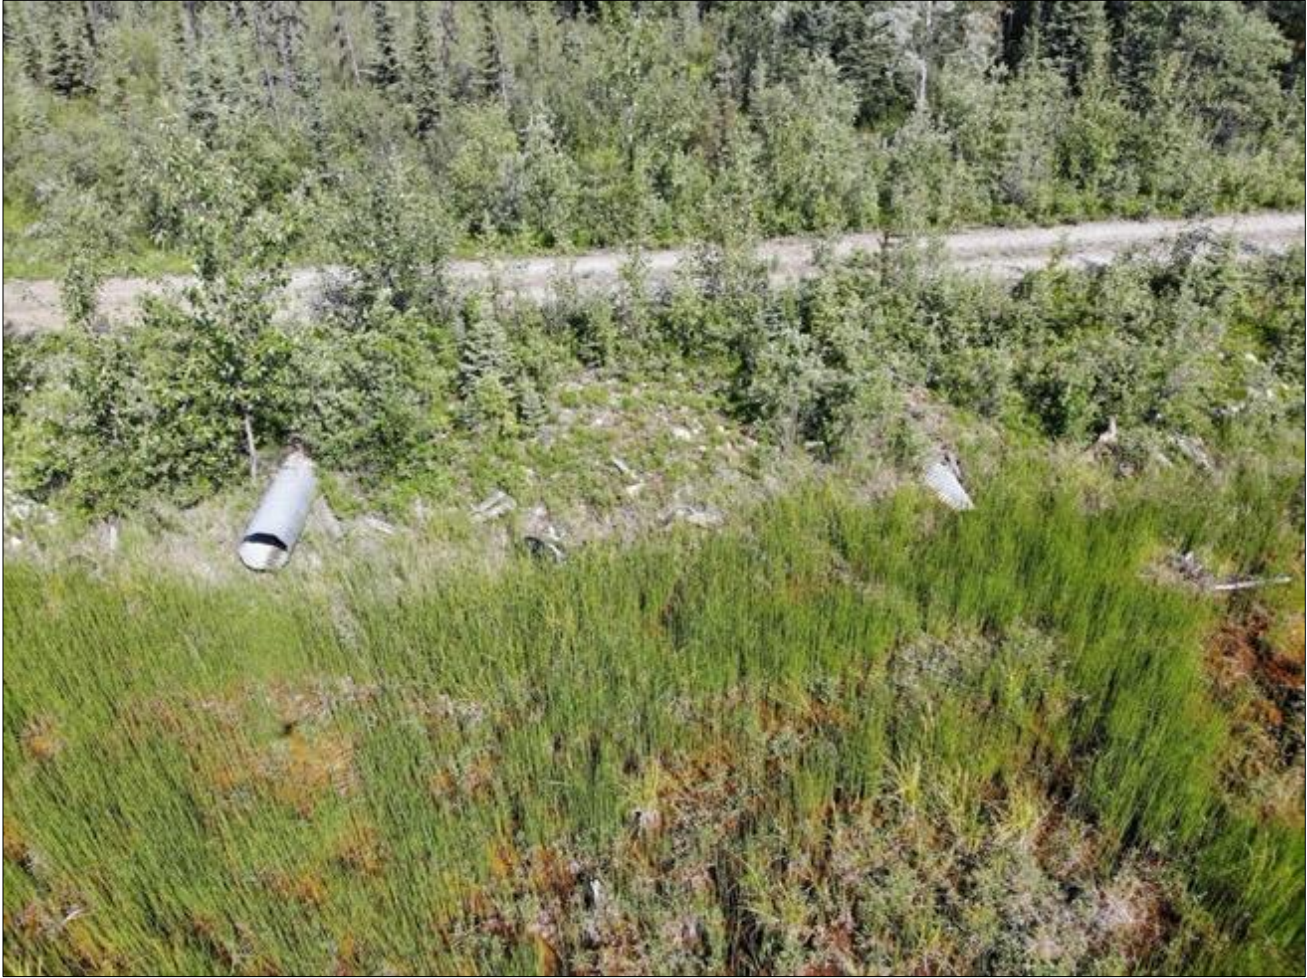
Site Comments: This site appears to have been inundated at one time but was dry at the time of the health assessment. Two culverts were observed at the road, one was mostly buried and the other was perched. Very little water or emergent vegetation was present, and was confined to the area near the culverts. Sedges were the dominant emergent vegetation observed. Some of the dead standing trees showed evidence of past fire. Across the road was a damp area with an abundance of black spruce (*Picea mariana*), which prefers wet sites. It was theorized that improper culvert placement could be responsible for the lack of water and emergent vegetation at this site.

Figure 22. Culverts at site W9. Left culvert is perched high, right culvert is buried

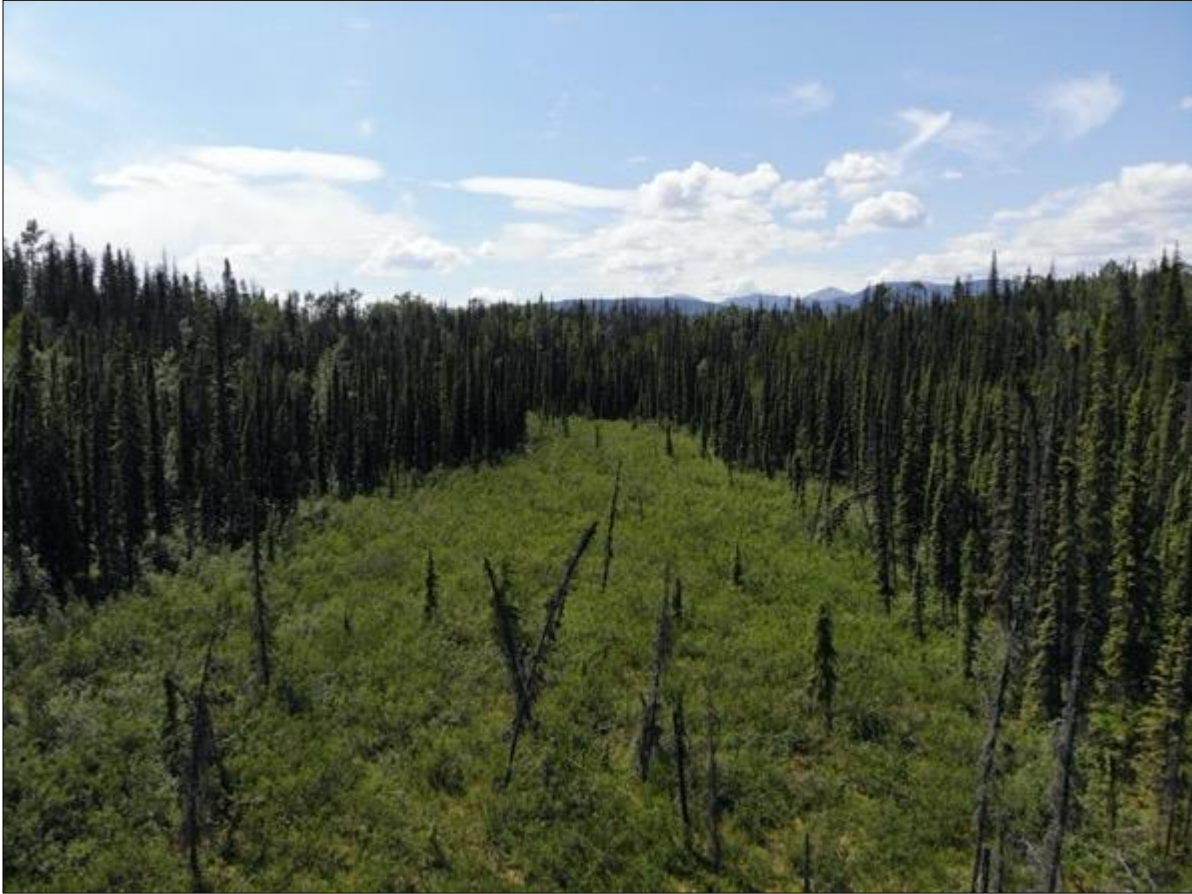
Site Comments: This site appeared dry and mossy but was actually wet, and in areas fairly deep, with a moss layer covering the water. Emergent vegetation (sedges) was plentiful, along with black spruce (*Picea mariana*) and alder (*Alnus rubra*). Dominant shrub cover was observed.

Figure 23. Site W10 appears dry, however the site is wet

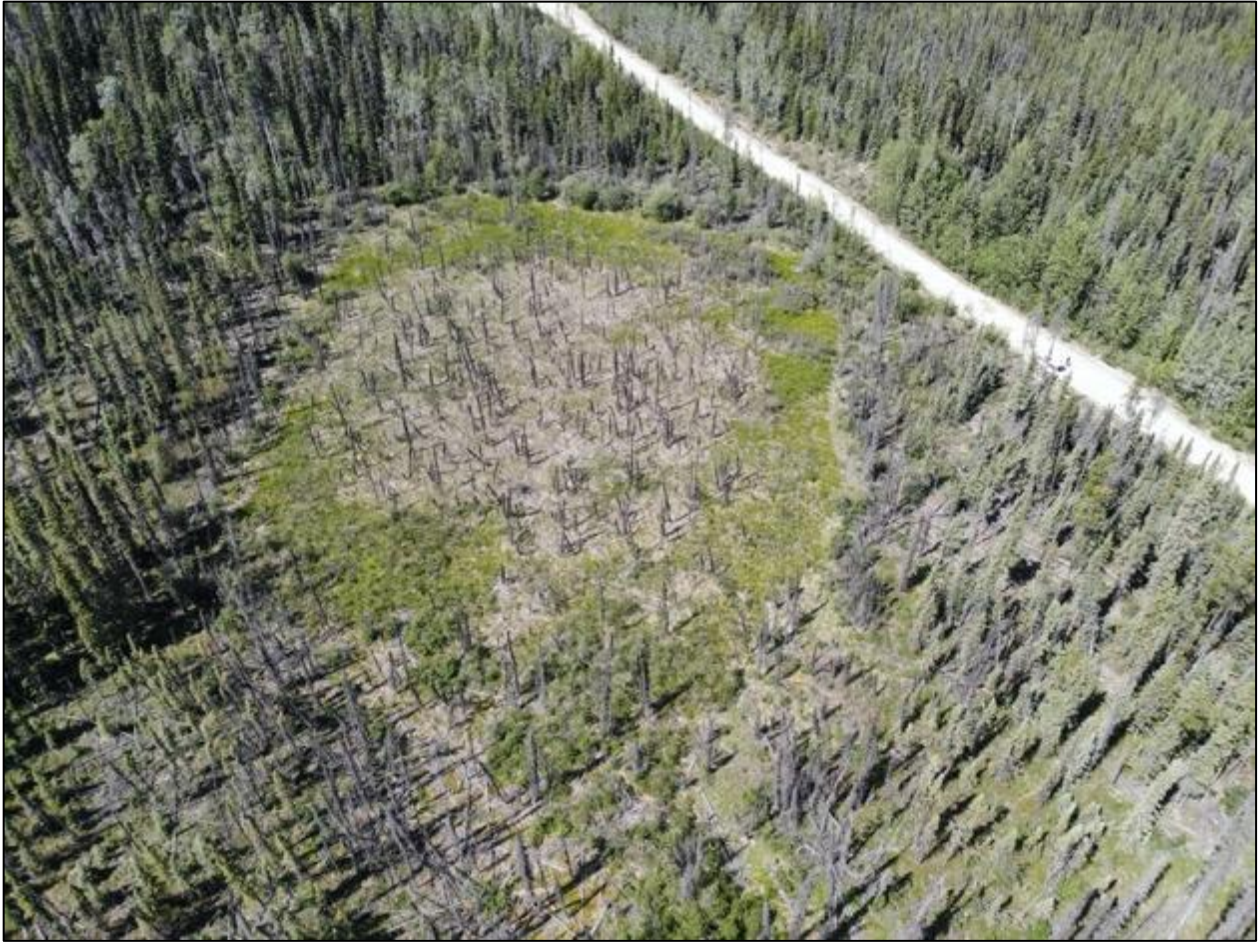
Figure 24. Aerial view of site W11 on the Pelly FSR

Site Comments: This site on the west side of the Pelly FSR has a low amount of water and dead trees scattered throughout. Emergent vegetation is mainly grass and rushes. The presence of dried brown grasses suggests the site once had more water but has dried out. Soapberry (*Shepherdia canadensis*) was observed at this site.

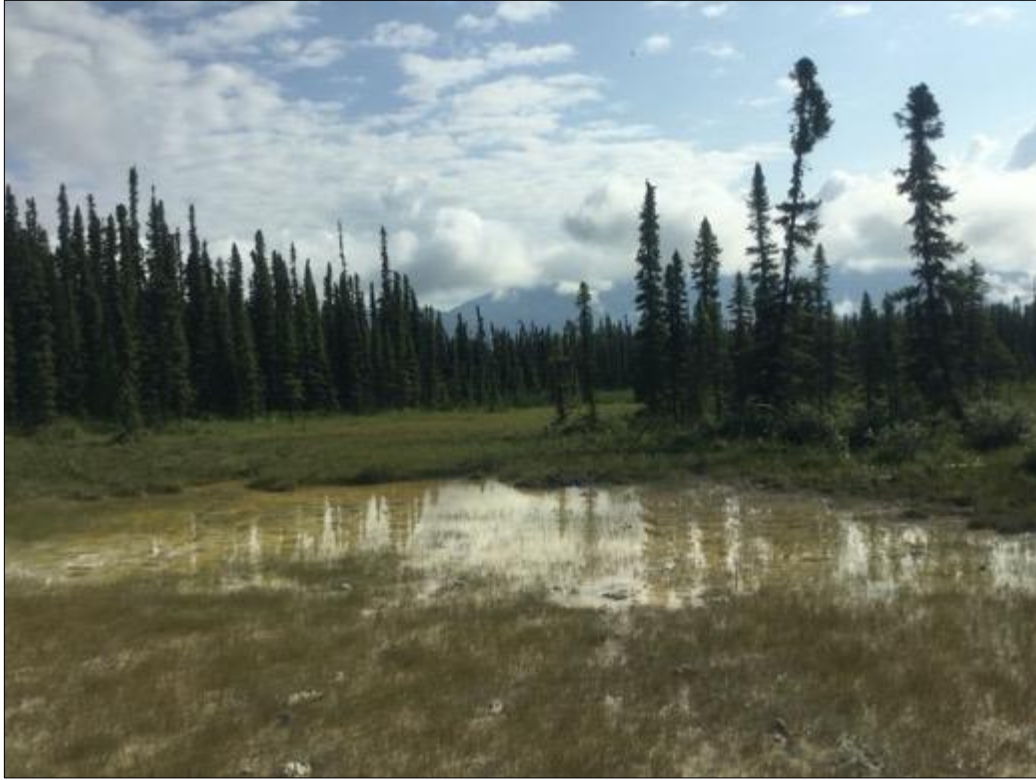
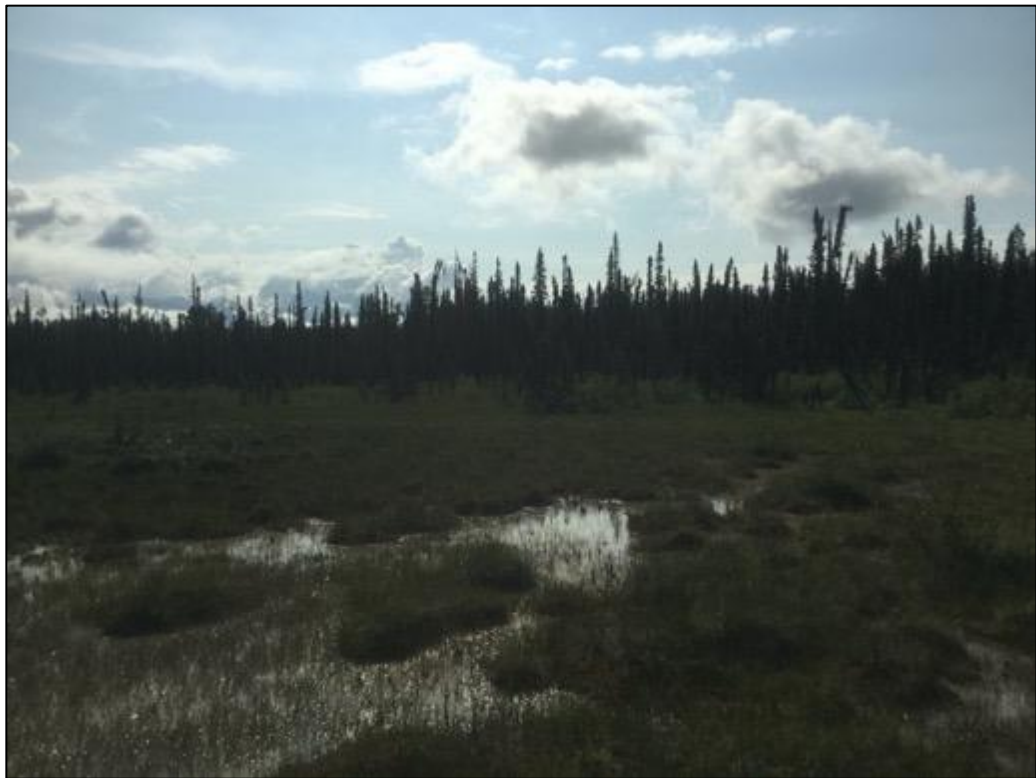
Figure 25. View of site W12

Site Comments: This site was wet at the time of assessment, and fringed with black spruce (*Picea mariana*). Small stunted spruce was also observed growing on raised microsites. Vegetation observed was willow (*Salix* sp.), soapberry (*Shepherdia canadensis*) and trappers tea (*Rhododendron groenlandicum*). Moose (*Alces alces*) tracks were observed and wood frogs (*Lithobates sylvaticus*) were present at this site during the assessment.

Figure 26. Emergent vegetation at site W12

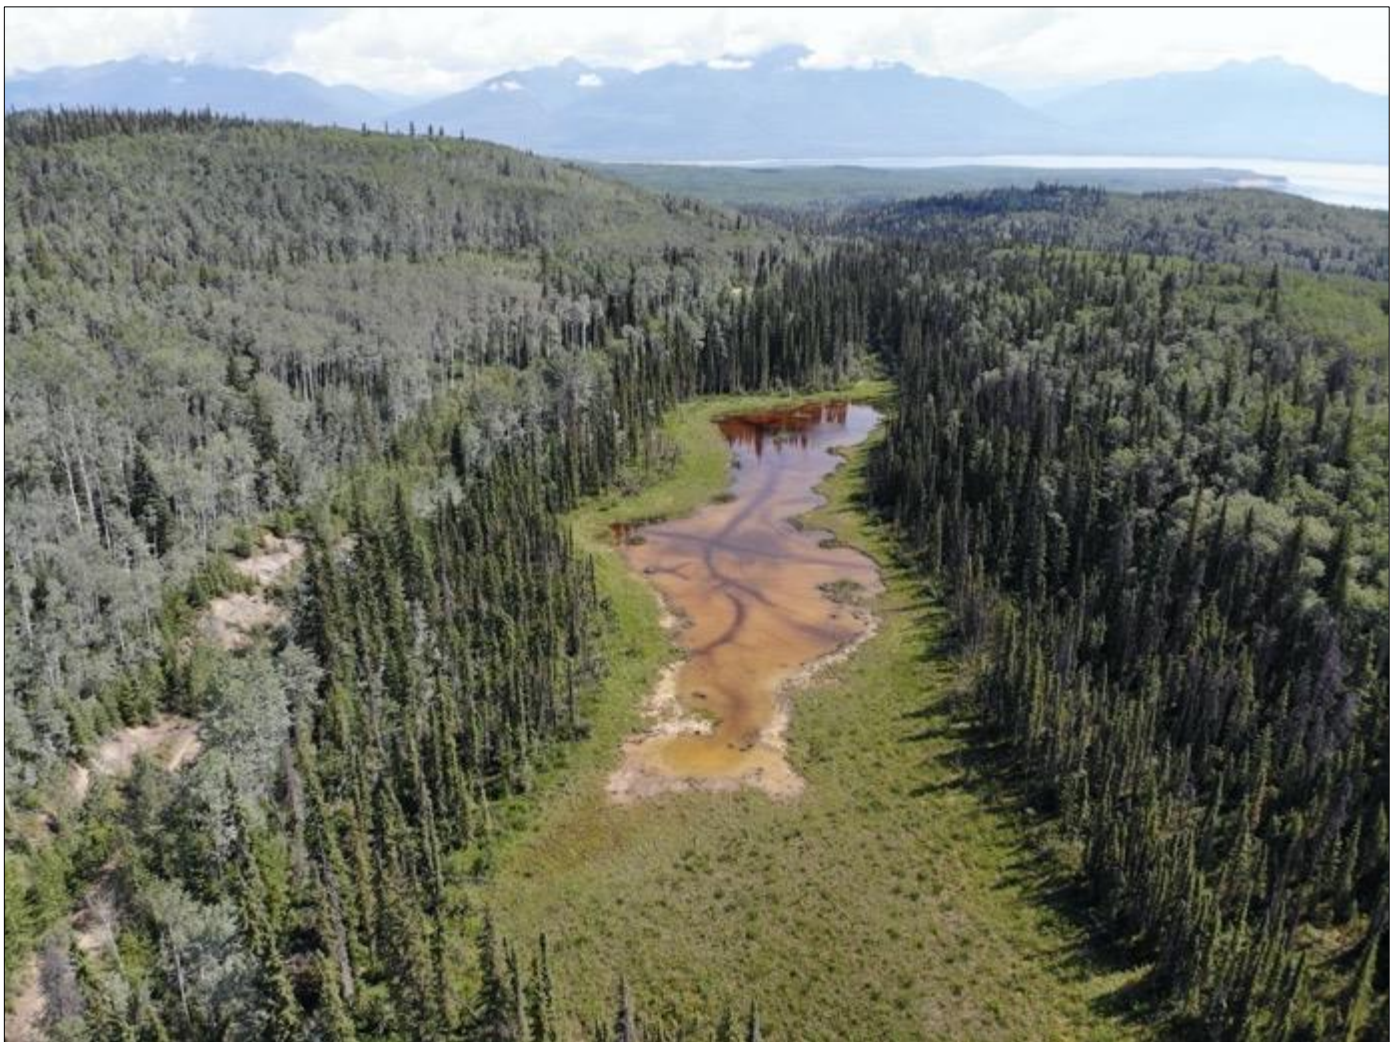
Figure 27. Aerial view of site W13 beside the Isola FSR

Site Comments: This site is on the south side of the Isola FSR. Sedges were the dominant emergent vegetation. Black spruce (*Picea mariana*) and alder (*Alnus rubra*) were present. Trappers tea (*Rhododendron groenlandicum*) and soapberry (*Shepherdia canadensis*) were observed. Unidentified waterfowl were present during the assessment, and dragonflies were also observed.

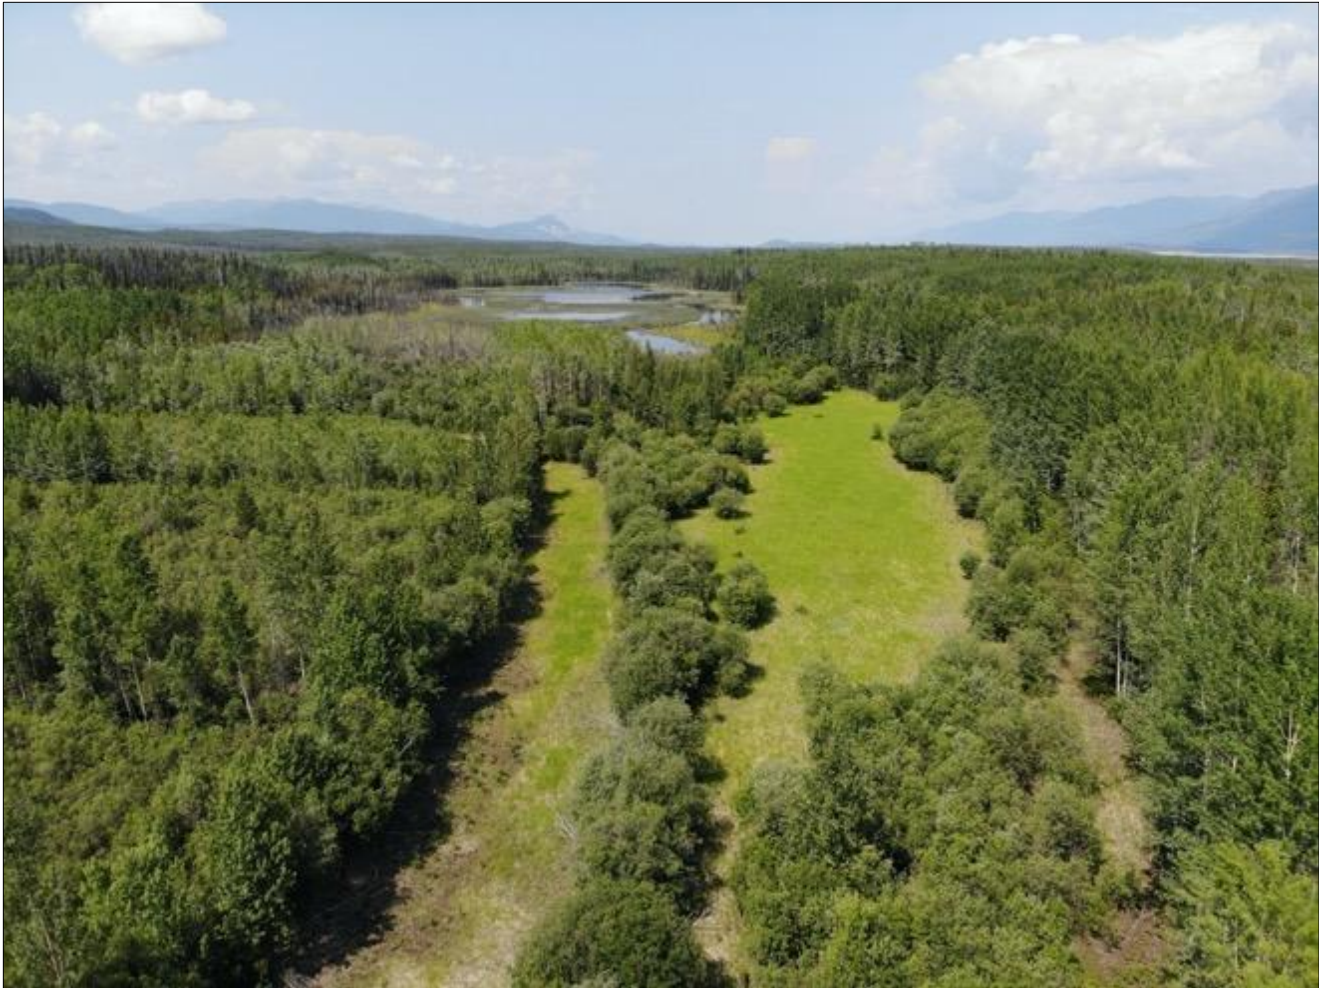
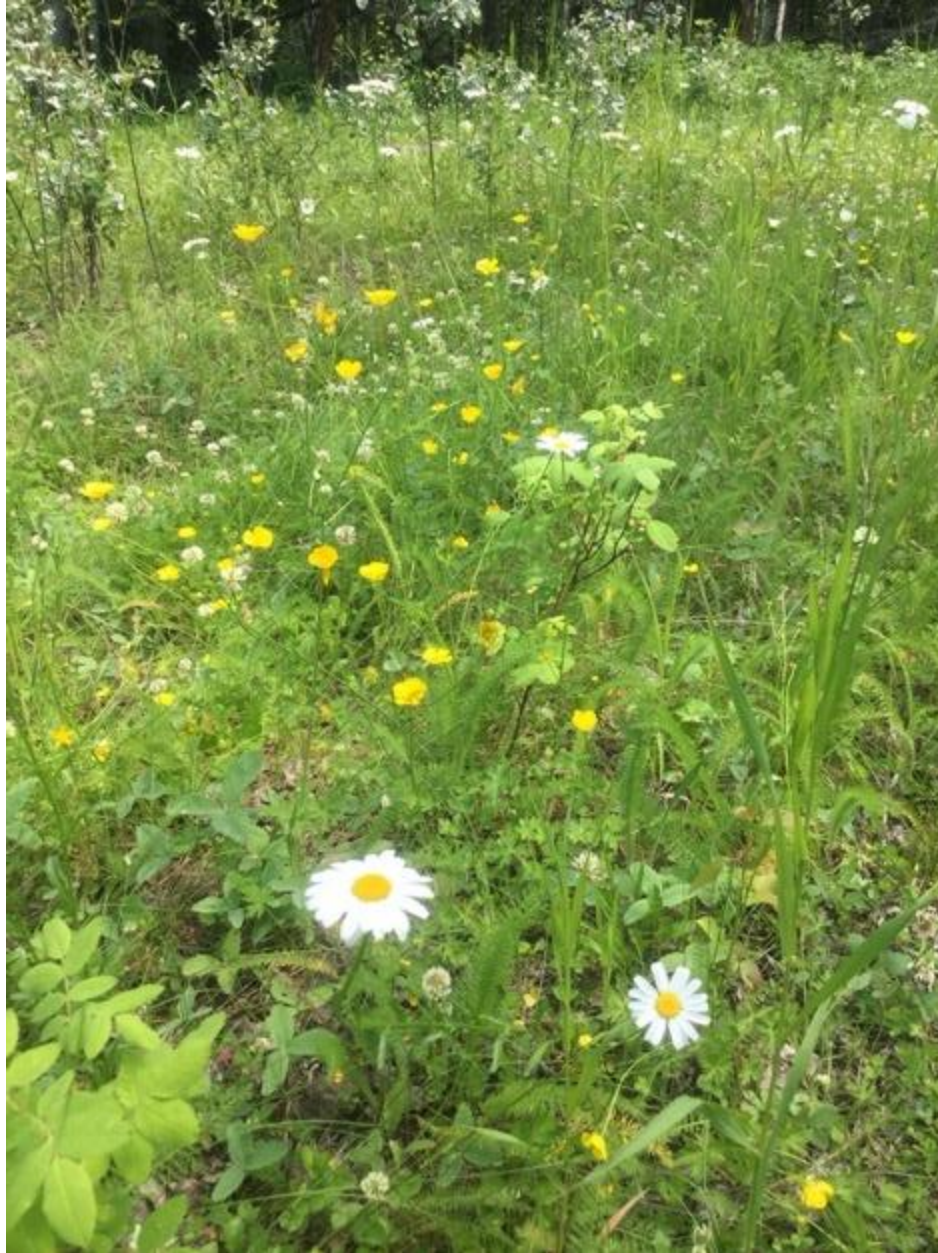
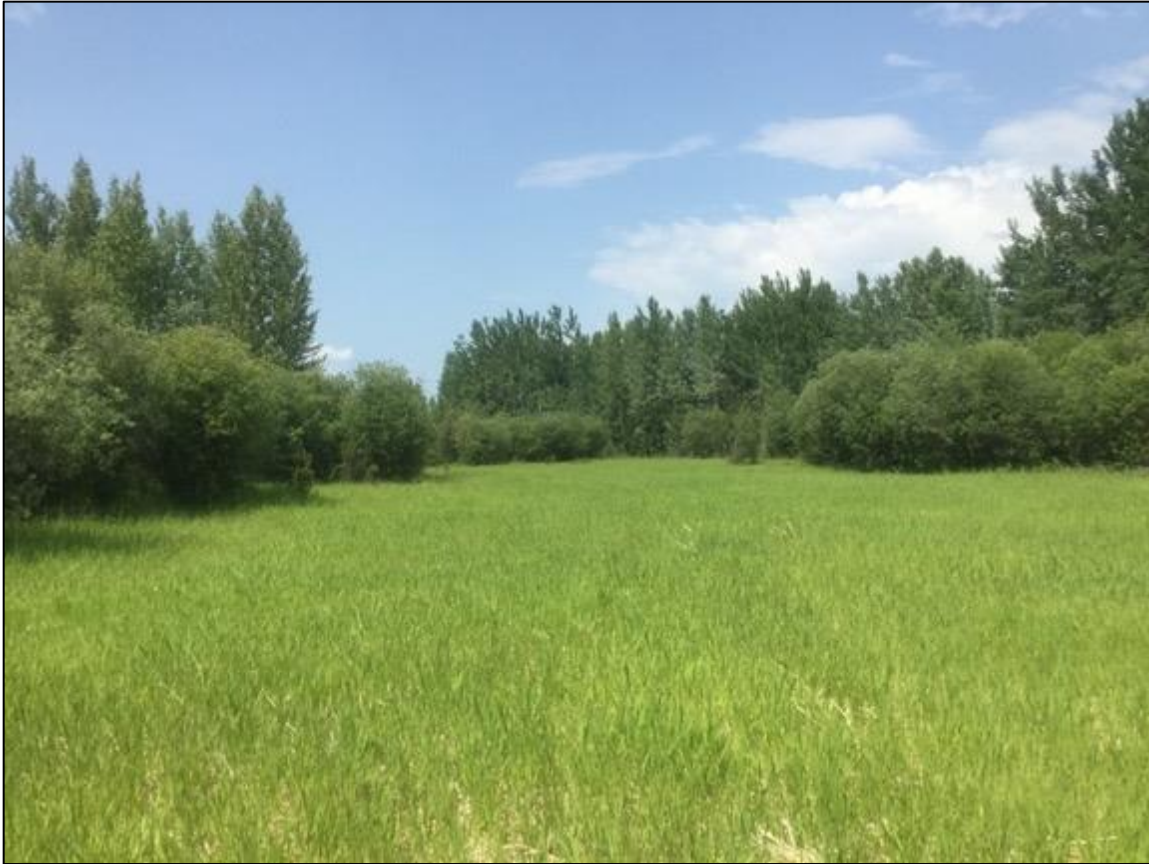
Figure 28. Aerial view of site W14 showing Rat Lake in the background

Site Comments: This site was once used as a horse pasture and reed canary grass (*Phalaris arundinacea*) was grown for forage. The site is no longer used as a pasture and the reed canary grass has dominated the area. It is considered an alien exotic species in British Columbia, i.e. a species which has moved outside its natural range often due to anthropogenic activity (Klinkenberg 2019). At this site it has dominated over other species to establish itself. Other invasive species observed were creeping buttercup (*Ranunculus repens*) and oxeye daisy (*Leucanthemum vulgare*).

Local knowledge has also indicated that in the past a ditch was dug from Rat Lake to bring water to Ingenika village. Wild mint (*Mentha arvensis*) was noted at the site during the assessment, and is collected by TKD citizens from this area. Older and newer beaver dams were present. Bear scat was observed along with moose (*Alces alces*) droppings and a cow moose was observed. Wood frogs (*Lithobates sylvaticus*) and western toads (*Anaxyrus boreas*) were observed during the assessment, as well as unidentified dragonflies and butterflies.

Figure 29. Oxeye daisy (*Leucanthemum vulgare*), creeping buttercup (*Ranunculus repens*) and reed canary grass (*Phalaris arundinacea*) at site W14

Figure 30. Old pasture dominated by reed canary grass (*Phalaris arundinacea*) at site W14

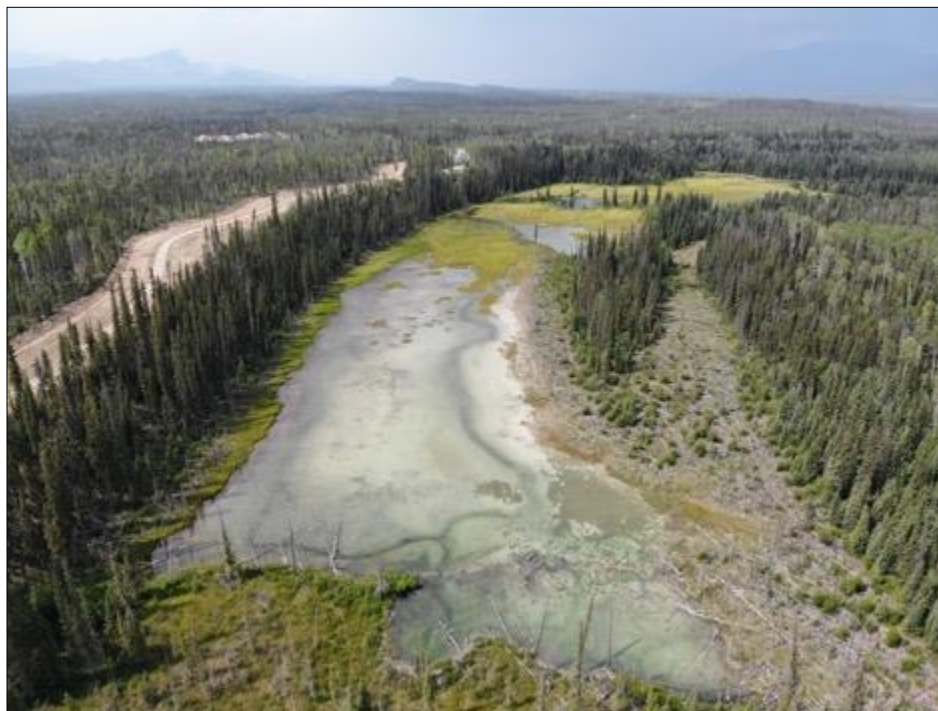
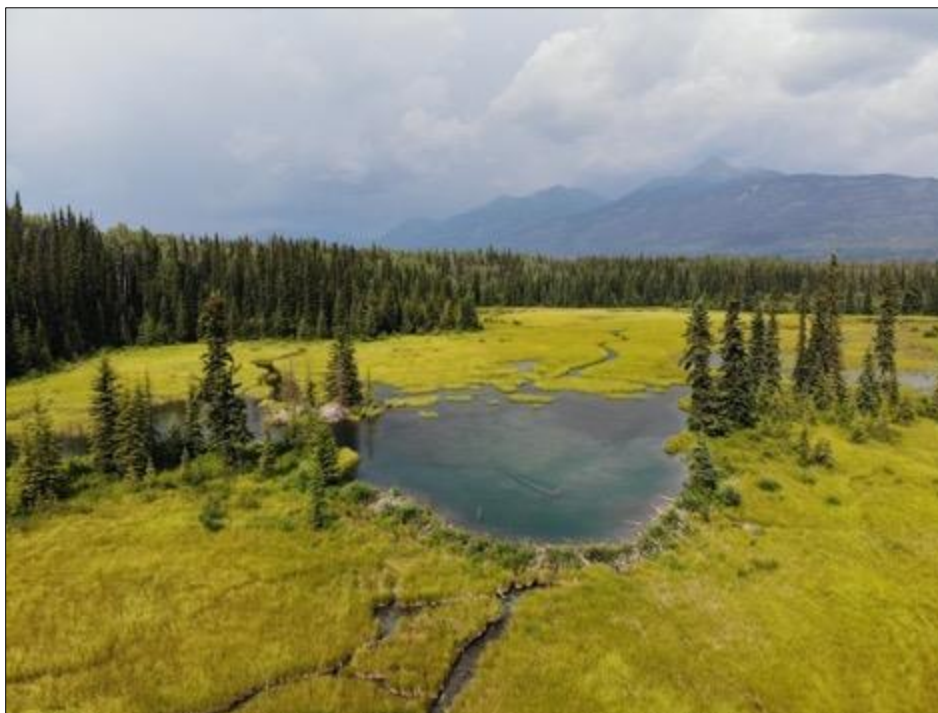
Figure 31. Aerial view of site W15

Site Comments: At site W15 a large wetland was observed along with a beaver dam and lodge. The creek flowing out of the wetland eventually flows into the Williston reservoir. Sedges were the dominant emergent vegetation observed. Black spruce (*Picea mariana*), alder (*Alnus rubra*), and willow (*Salix* sp.) were present on the wetland edge. Willow browse was not observed. Unidentified fish, waterfowl and dragonflies were observed during the assessment.

Figure 32. Beaver dam at site W15
