Chase Caribou Road Restoration Program

Year 1 (2023-2024) Summary Report

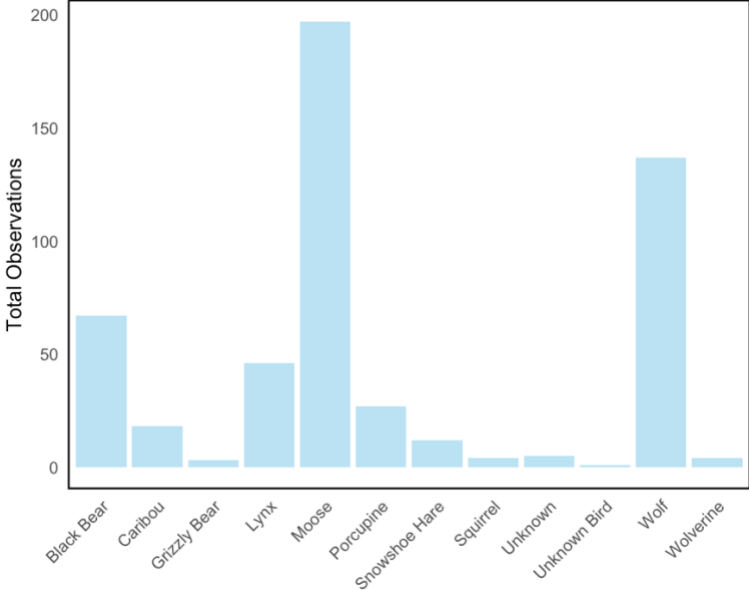
Figure 5. Summary of all independent wildlife detections on wildlife cameras deployed along the Swannell Mainline and associated spur roads, located within the Wędzih Yinè' IPCA.

We detected a total of 521 independent observations of wildlife during the deployment period, including 10 identified species, 1 unknown bird, and 1 unknown wildlife species (Figure 5). Moose (*Alces alces*) were the most frequently detected species, followed by gray wolf (*Canis lupus*; Figure 5; Table 4). Overall, predators accounted for 49.3% (257 independent observations) of all detections on the pre-treatment road. Predators were detected at a higher frequency than all ungulate species on all cameras except for RR79, located on a spur road off the Swannell Mainline (Figure 6). Caribou were detected at relatively low frequency, accounting for only 3.2% of detection (18 independent observations). Appendix 2 contains select wildlife camera images of detected species.

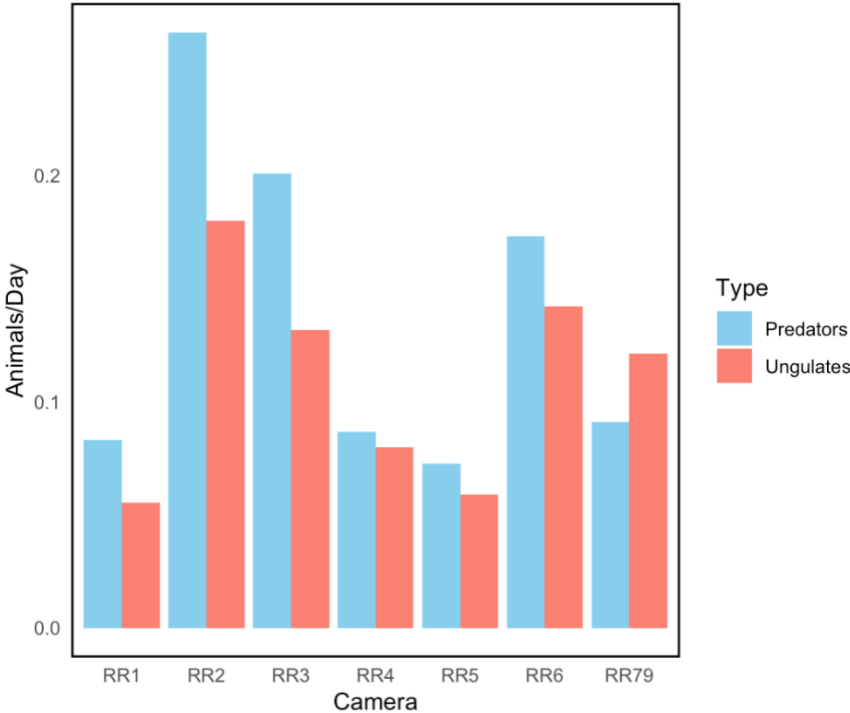
Figure 6. Summary of the average daily predator and ungulate detections at each camera location. Wildlife cameras were deployed along the Swannell Mainline or spur roads off the mainline, located within the Wędzih Yinè' IPCA.

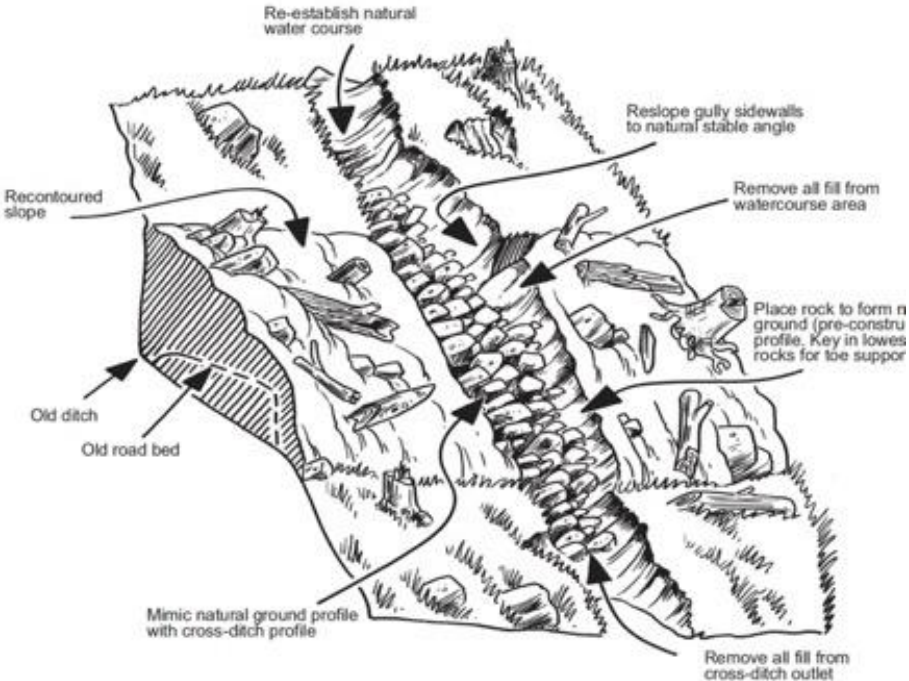
Figure 9. Deactivation with Culvert Removal from BC MFLNRORD (2019).

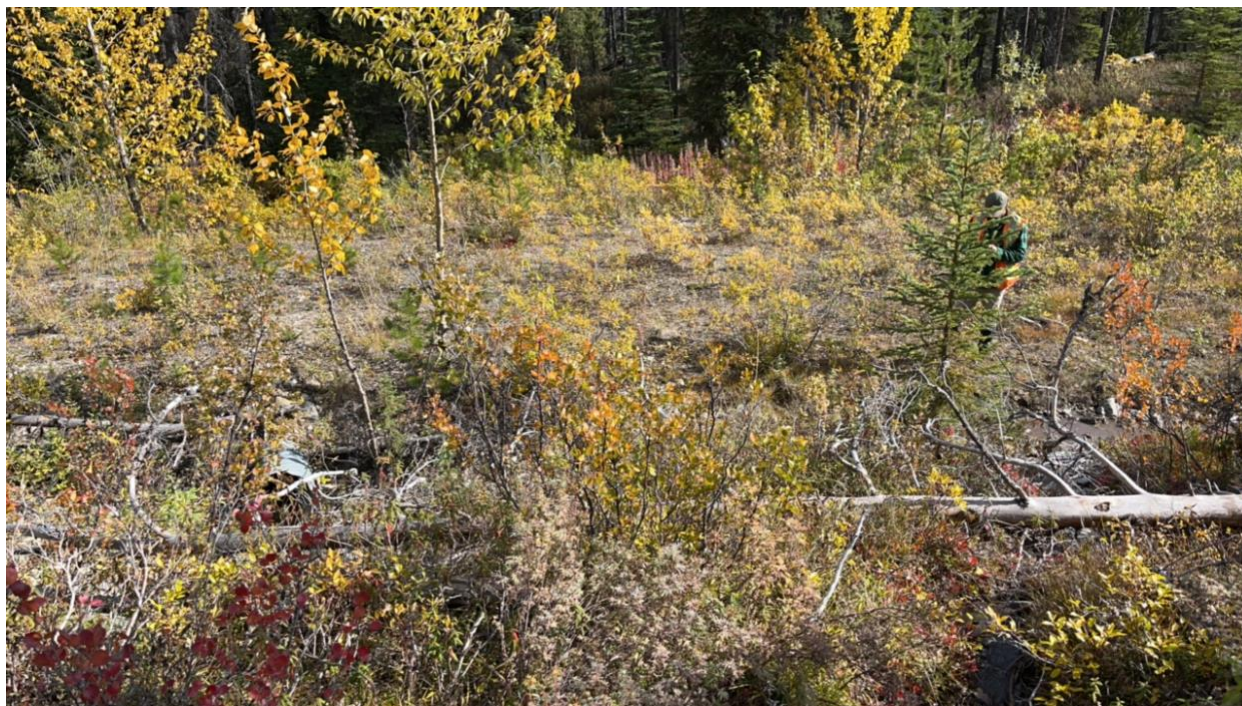
Figure 11. Photo of point location number 2.

Point 2	This location is downstream of Point 1. Remove the culvert re-contour the natural drainage path, to facilitate and establish natural drainage patterns and stabilize erosion prone areas. This culvert is currently non-functioning, and the road is re-directing water down the ditch line (Figure 11).
Point 3	Seepage area is located above the road. Maintain natural drainage across the road (Figure 12). This may include the establishment of Cross-Ditching (Figure 13) and Waterbars (Figure 14) to intercept water on the road and convey it across and below the road onto stable slopes.

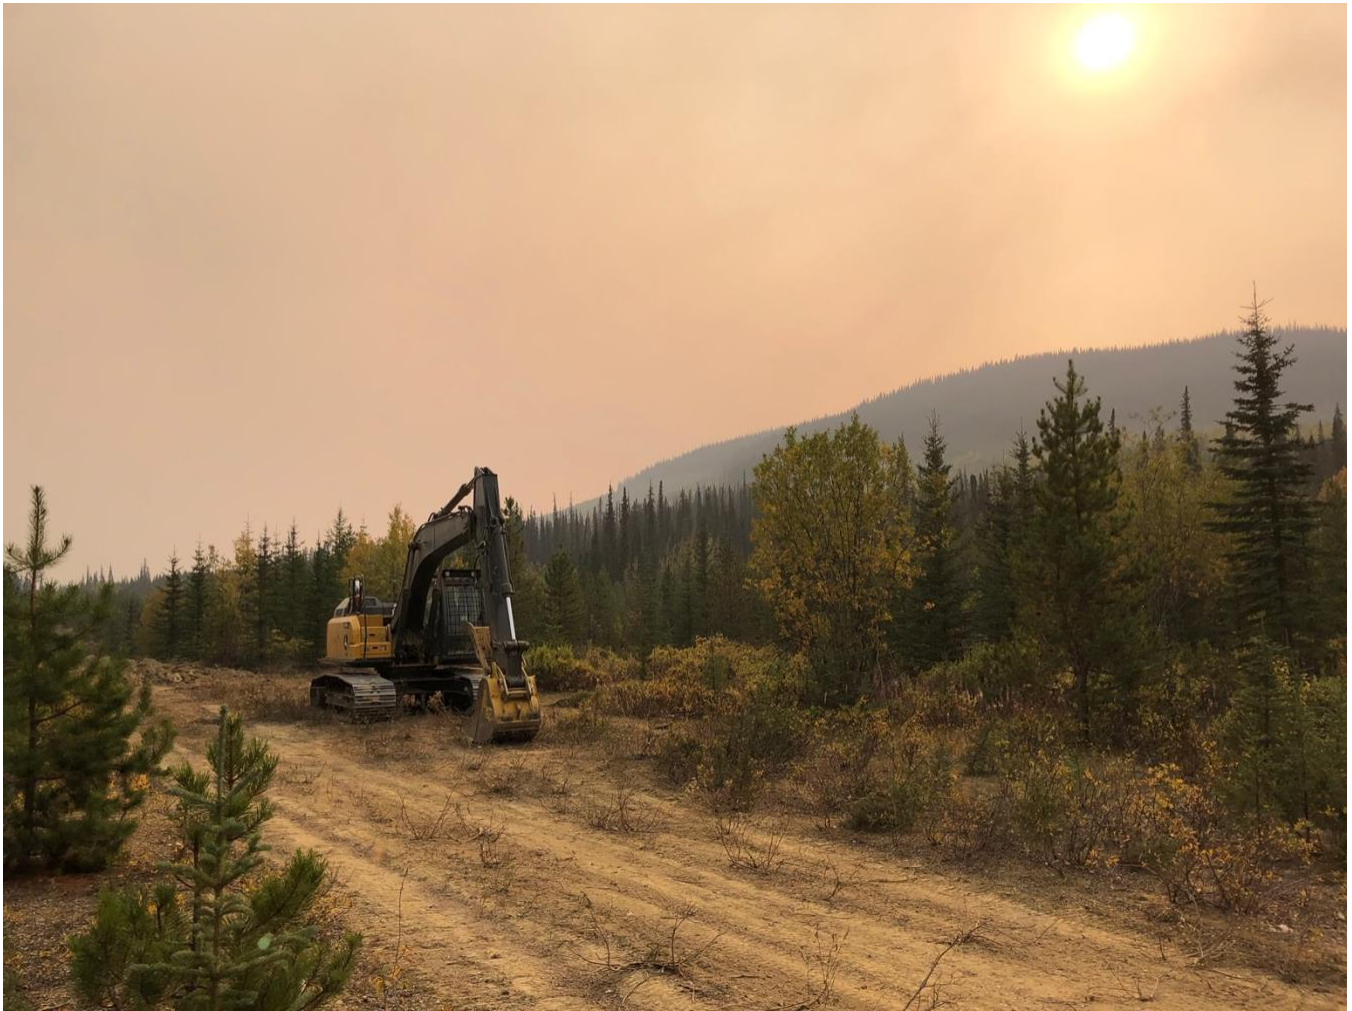
Figure 15. An excavator was used to implement ecological and functional restoration of the Chuyaza road. Pictured is the excavator at the end of a day, with treated road behind it and pre-treatment road in front of it.

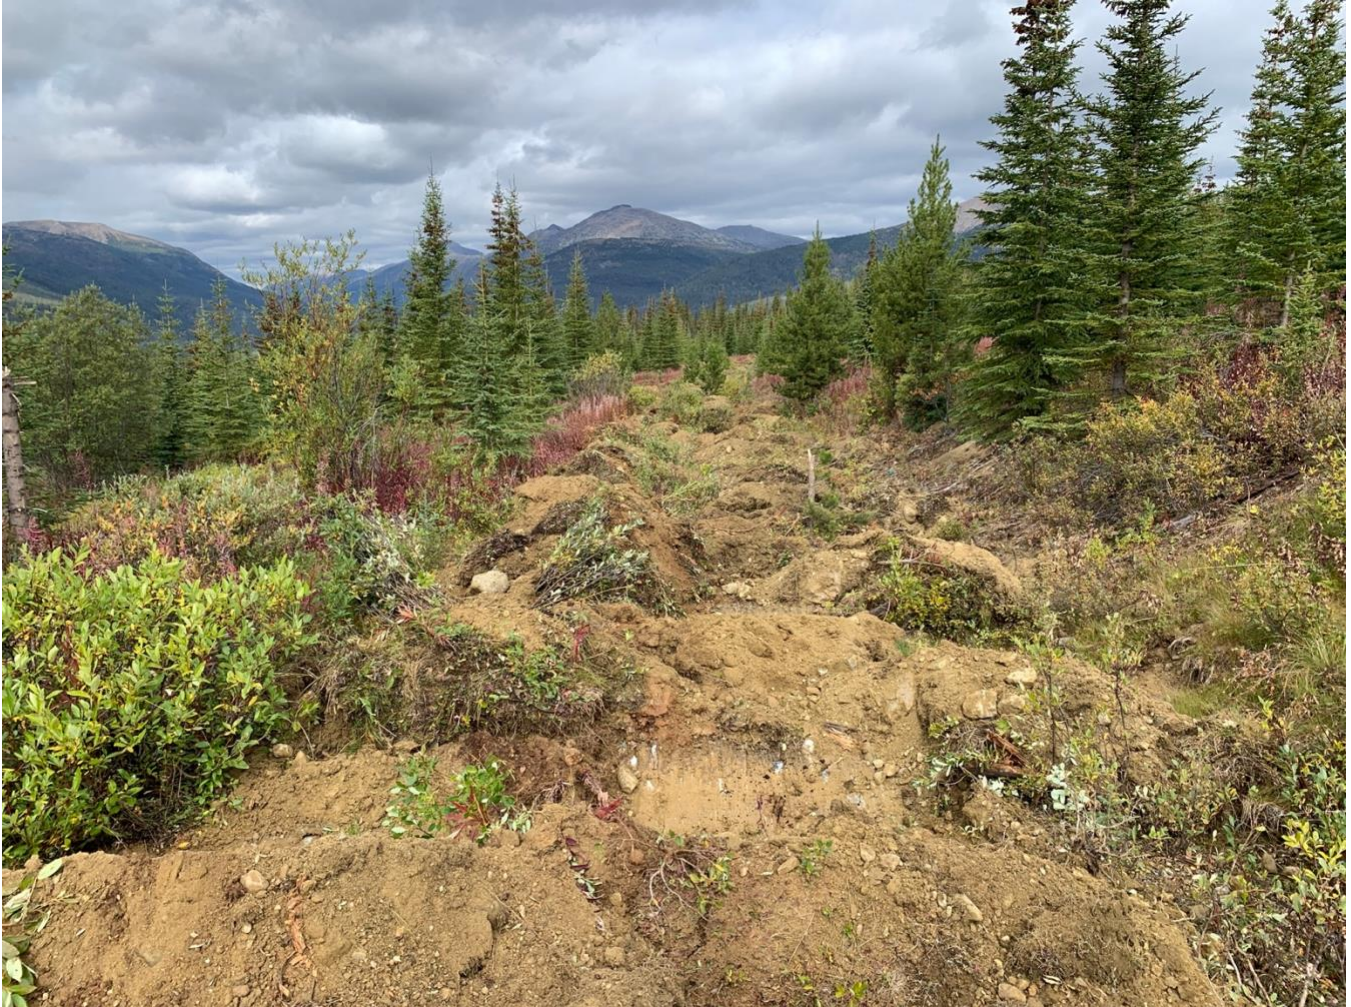
Figure 16. The excavator de-compacted the road surface and the digging bucket was used to create mounds and depressions (pictured above), as well as deep cross ditching and berms for access management. These Mechanical Site Treatments improve soil infiltration capacity, reduce soil bulk density, and create microsites where seeds and planted species can more easily establish.

- Road surface decompaction using an excavator and bucket.
- Machine screening and rough and loose soil mounding using an excavator with excavator bucket.
- Slash rollback using an excavator with excavator bucket.
- Access management using an excavator with excavator bucket.

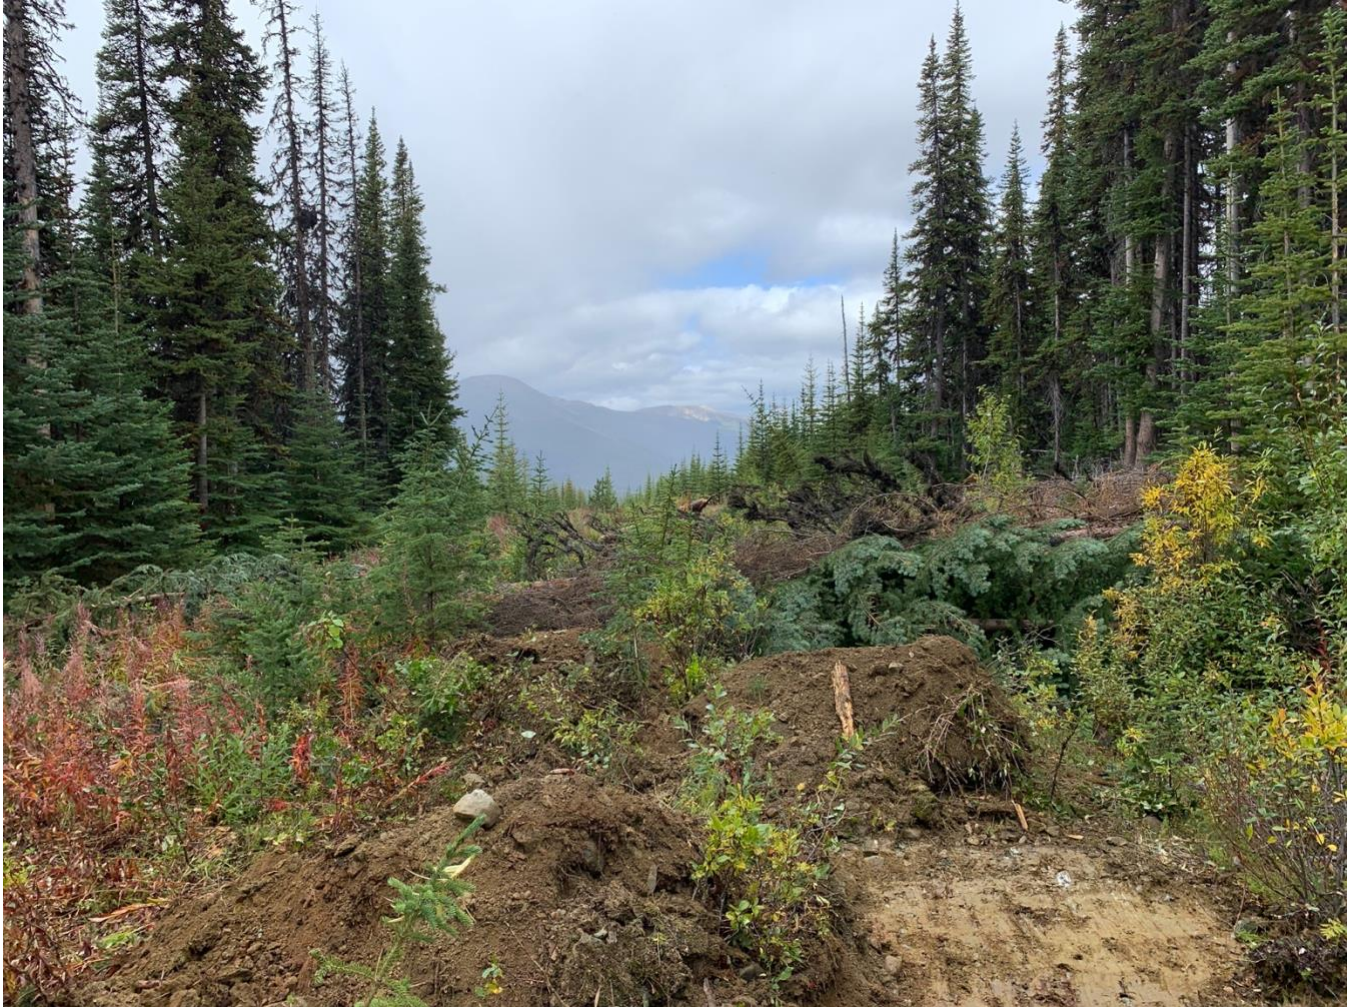
Figure 17. Another example of mounding, with some slash rollback picture towards the background of photo.
