Chase Caribou Road Restoration Program

Year 2 (2024-2025) Summary Report

FWCP Grant Number: PEA-F25-W-4049

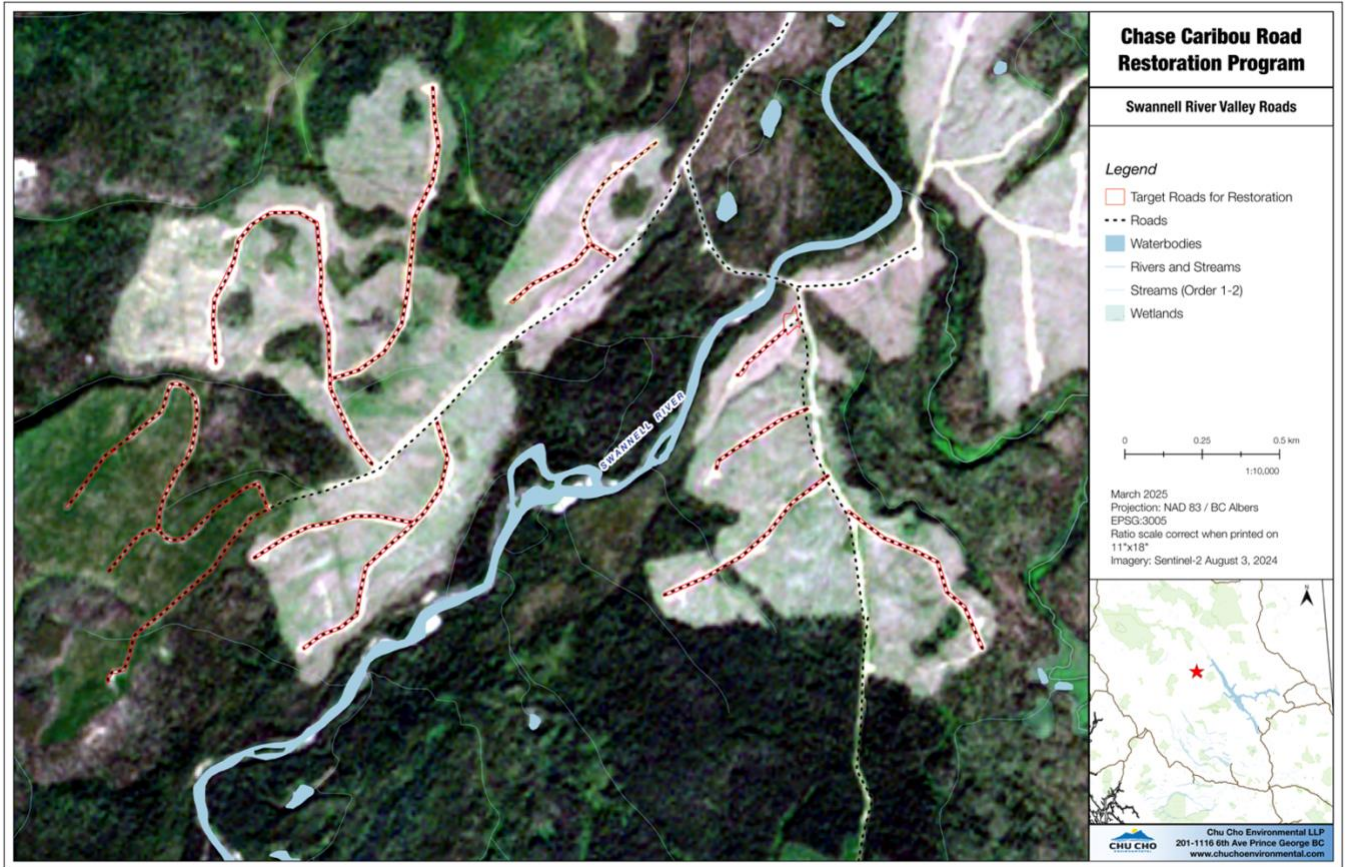
Figure 3.1. Restoration activities for the 2024-2025 Chase Caribou Road Restoration Program occurred within the Swannell River Valley, which falls entirely within the Wədzih Yinè' Indigenous Protected and Conserved Area and Chase Caribou low elevation core habitat.

The 2024-2025 CCRRP activities occurred within the Swannell River Valley, a low-elevation valley entirely within the Chase Caribou herd range boundary (Figure 3.1). The Swannell River Valley is located 55 km southeast of Tsay Keh Dene, BC, and 190 km northwest of Mackenzie, BC. The planned road segments are entirely in the Chase Caribou range and consist of several non-tenured road segments off the Swannell Mainline in identified Ungulate Winter Ranges (UWR, u-7-007 and u-7-025). Tenured road segments were not considered for 2024 due to Conifex Timber Inc. not being in a position in which the company could financially support restoration activities on road segments currently under their tenure.

Restoration work commenced on the most southerly spur road segments on the east side of the Swannell River, moving towards the Swannell River, and then shifting to the spur road segments on the west side, starting with the most northerly segments (Figure 3.1). No culverts were encountered along the 2.5 km of road that was restored in 2024. All target roads for restoration were in harvested areas, so there was no opportunity for hinging or falling trees, and the same treatment was applied to all roads.

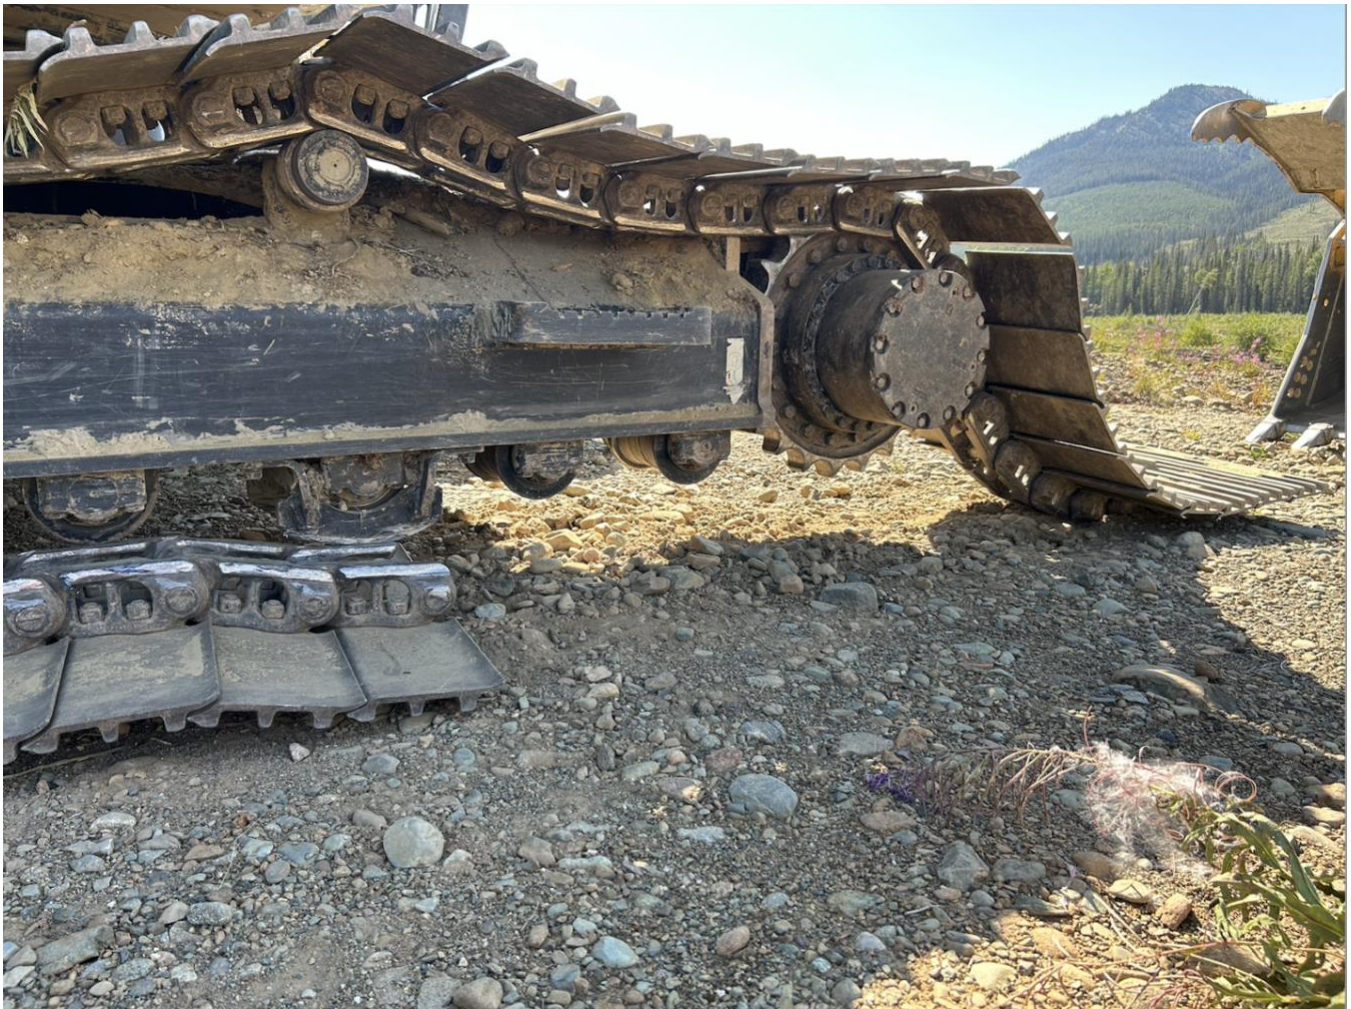
On August 17th, 2024, the John Deere 210G excavator broke, with one of the connection pins on the right track snapping, damaging the surrounding connection points, and breaking the track (Figure 4.1). No

Figure 4.1: Photo of the broken track link on the John Deere 210G excavator that was being used for restoration in 2024.

immediate fix was possible due to the remote worksite and the age of the track, so the excavator was unable to continue the work. Significant efforts over 2 days were put into finding both a replacement excavator, transportation for the excavator, and an operator. An additional operator was required because the original operator was engaged in the repair of their machine and obtaining parts from Prince George. Given the remote location, the lack of available excavators and experienced machine operators, and the cost of bringing a new excavator from Prince George to site, the decision was made to plant the road sections that had already been prepared by the excavator before it broke down, and to postpone work in the remaining 6.8 km of road sections until 2025. The crew had to make a difficult decision but chose to prioritize the long term success of the project and the resources provided by its funders. Continuing to search for an excavator, transportation, and an operator would have been a costly and inefficient use of funds.

- **Heavy Machinery:** Due to the excavator breakdown that occurred in 2024, further consideration should be made about having an actionable back up plan in case a similar mechanical failure occurs to the excavator being used for mechanical site preparation. Given the remote location and limited availability of excavators and operators on short notice, a definite back up plan may not be possible. However, having a tentative back up plan with Chu Cho Industries may allow for a mechanic to be available, or for a new machine and operator to be available in the future.

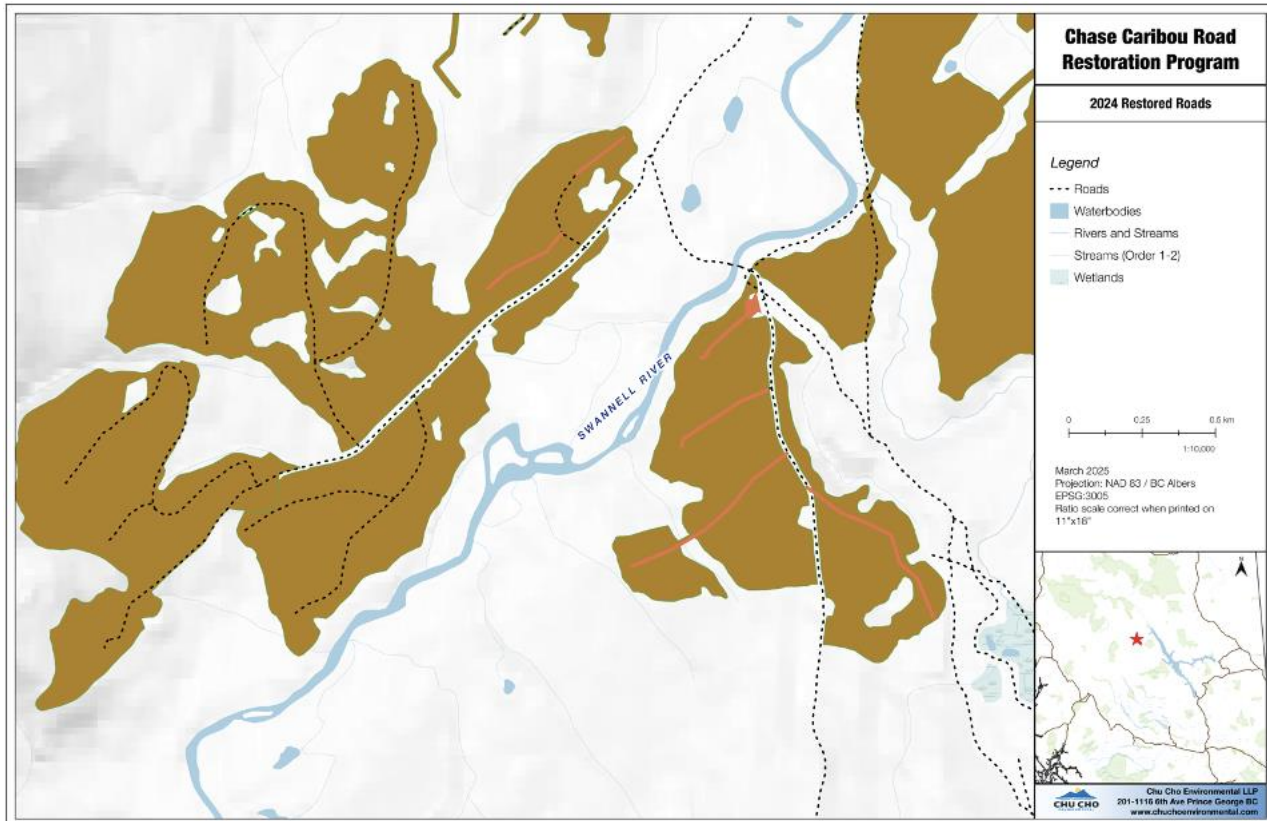
For 2024, ecological and functional restoration techniques were physically applied to 2.5 km of road (Figure 5.1). Assuming a 5 m average roadway width, 1.15 ha was physically treated with ecological and functional restoration treatments aimed at returning the road to the pre-disturbance state. Restoration of the 2.5 km of road proceeded according to the prescription until the right excavator track broke on August 17th, after which road preparation was no longer possible. Appendix 2: Supplemental Information contains select imagery of restoration treatments from the 2024 work.

Figure 5.1. In 2024, 2.5 km of roads were successfully restored and are indicated in red. Progress was halted when the excavator track broke during activities.

It is recommended that the 2025 CCRRP efforts focus on completing the 6.8 km of road segments that could not be completed in 2024 due to the broken excavator track, while also assessing the possibility of adding a few additional road segments that CCE developed restoration prescriptions for in 2024. This will continue to support TKDN's effort to reduce road density in the Wędzih Yinè' IPCA by removing road segments, including in block roads, and to make the habitat less suitable for predator travel and alternate prey species.

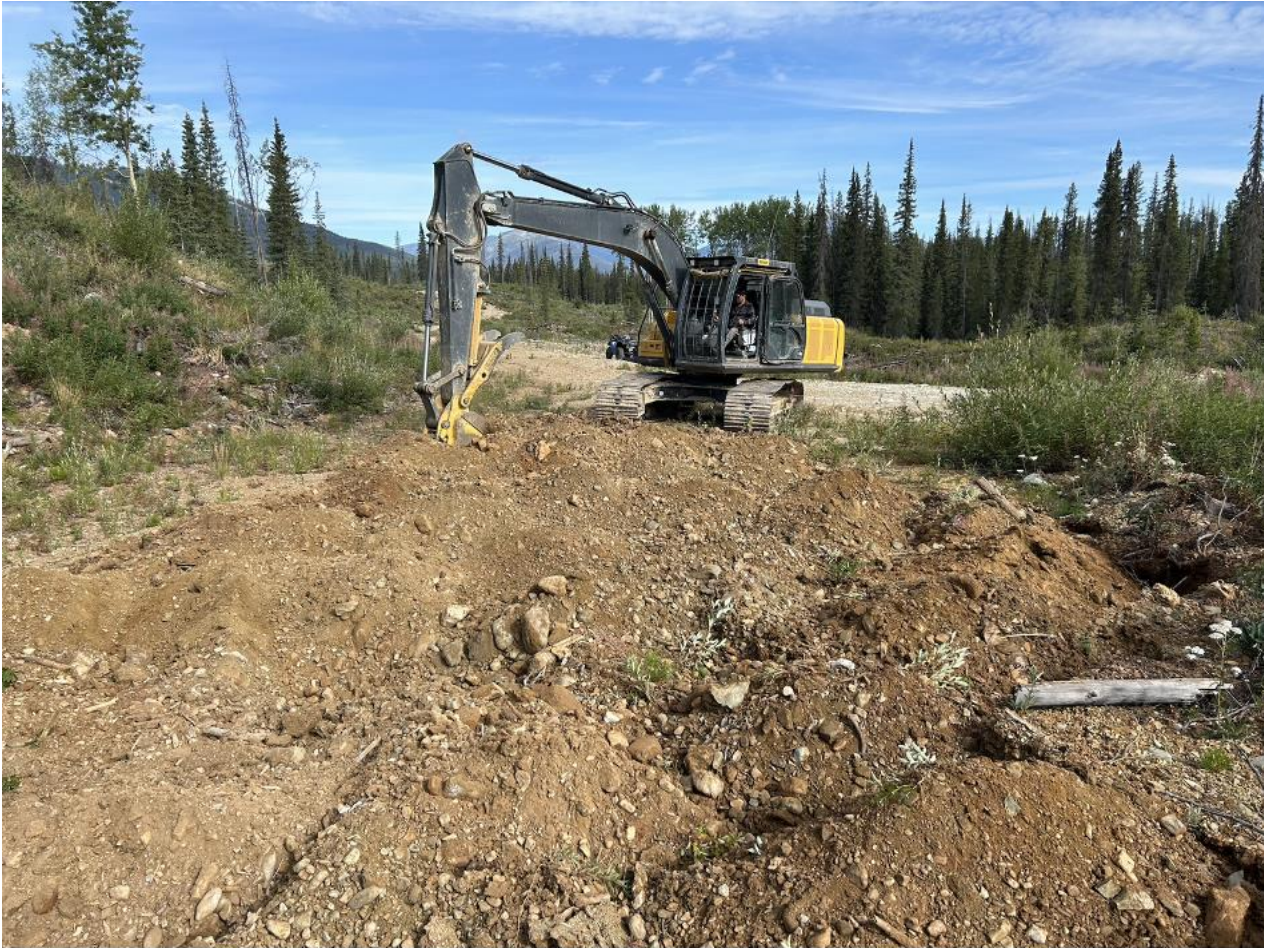
Road decompaction and preparation of the roadbed with a rough and loose treatment was done using the excavator equipped with a digging bucket. The operator would first decompact the road surface and excavate one or two buckets of soil, deposit that loosened soil beside the excavated depression, and then repeat this process adjacent to the first depression and mound (Figure 5.2). Available soil material would then be rolled back, and any available coarse woody debris would be added to the road to increase habitat complexity and provide visual screening. The operator started at the end of a road furthest away from the Swannell mainline and would walk the machine backwards, implementing the rough and loose treatment across the entire width of the road on the way back to the mainline. This prevented the operator from having to walk the excavator over the loosened road surface and allowed the operator to complete slash rollback and coarse woody debris placement on the road as part of the functional restoration treatment. The tree planter would follow behind the excavator, planting lodgepole pine (*Pinus contorta*) seedlings at the targeted 600 stems per hectare density in the sites deemed best for growth.

Figure 5.2: The John Deere 210G excavator completing road decompaction and recontouring on a section of road in 2024.

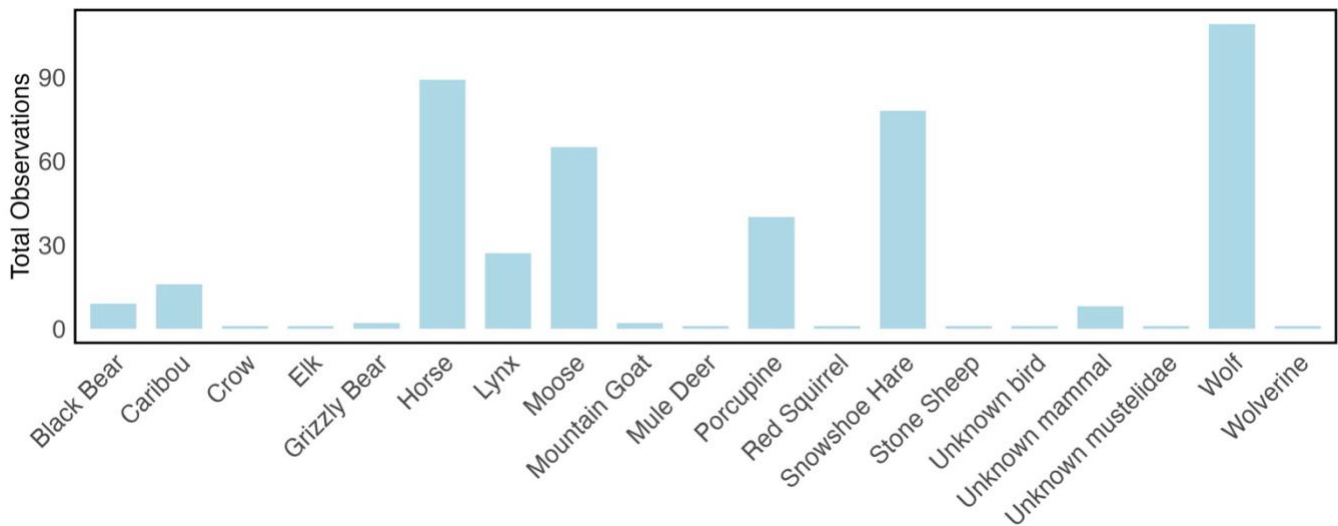
Figure 5.3. Summary of all independent wildlife detections on wildlife cameras (n = 4) deployed in the Swannell River Valley in 2023-2024, located within the Wədzih Yinè’ IPCA. Horses were the second most detected species overall, but are domestic and not wild horses.

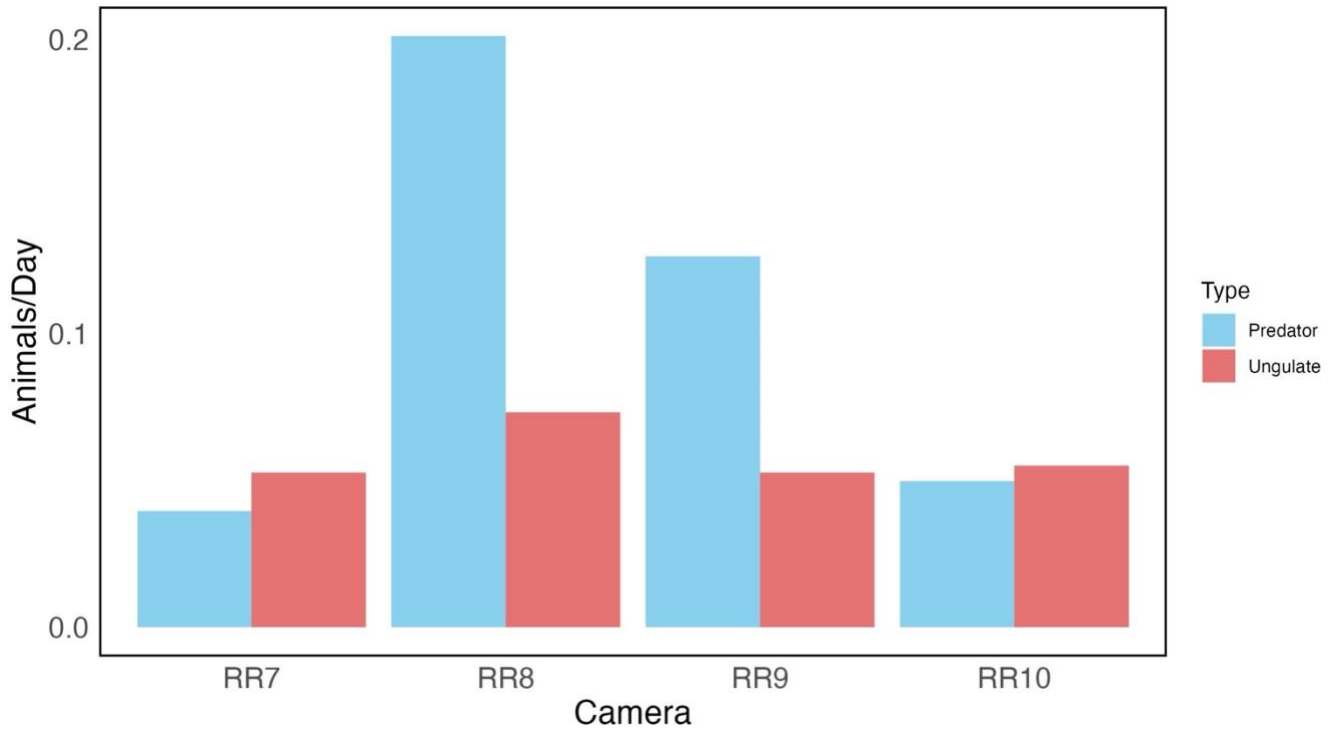
The average daily detection rate of predators was greater than ungulates on cameras RR 8 and RR 9, but slightly lower than ungulates on cameras RR7 and RR 10 (Figure 5.4). Most predator detections consisted of wolves, however grizzly bear (*Ursus arctos*) and wolverine (*Gulo gulo*) were also detected. Caribou were detected relatively infrequently, accounting for only 27 independent detections (5.9% of total detections; Table 3). Appendix 2 contains select wildlife camera images of detected species.

Figure 5.4. Summary of the average daily predator and ungulate detections at each camera location in 2023-2024. Predators included wolves, lynx, black bears, grizzly bears, and wolverines. Ungulates included caribou, elk, moose, deer, mountain goats, and Stone’s sheep.

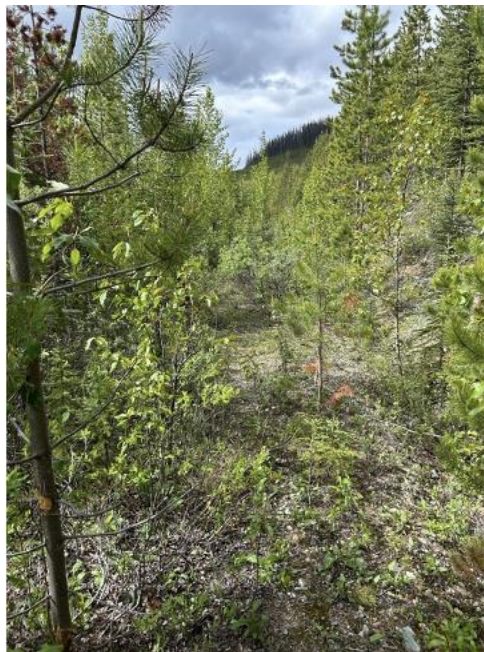
Figure 5.5. The road surface of the Flight 05 section of road was significantly overgrown with sapling pine and deciduous trees limiting potential predator line of sight. Due to the significant natural vegetation establishment on this road section, no further restoration treatment is required.

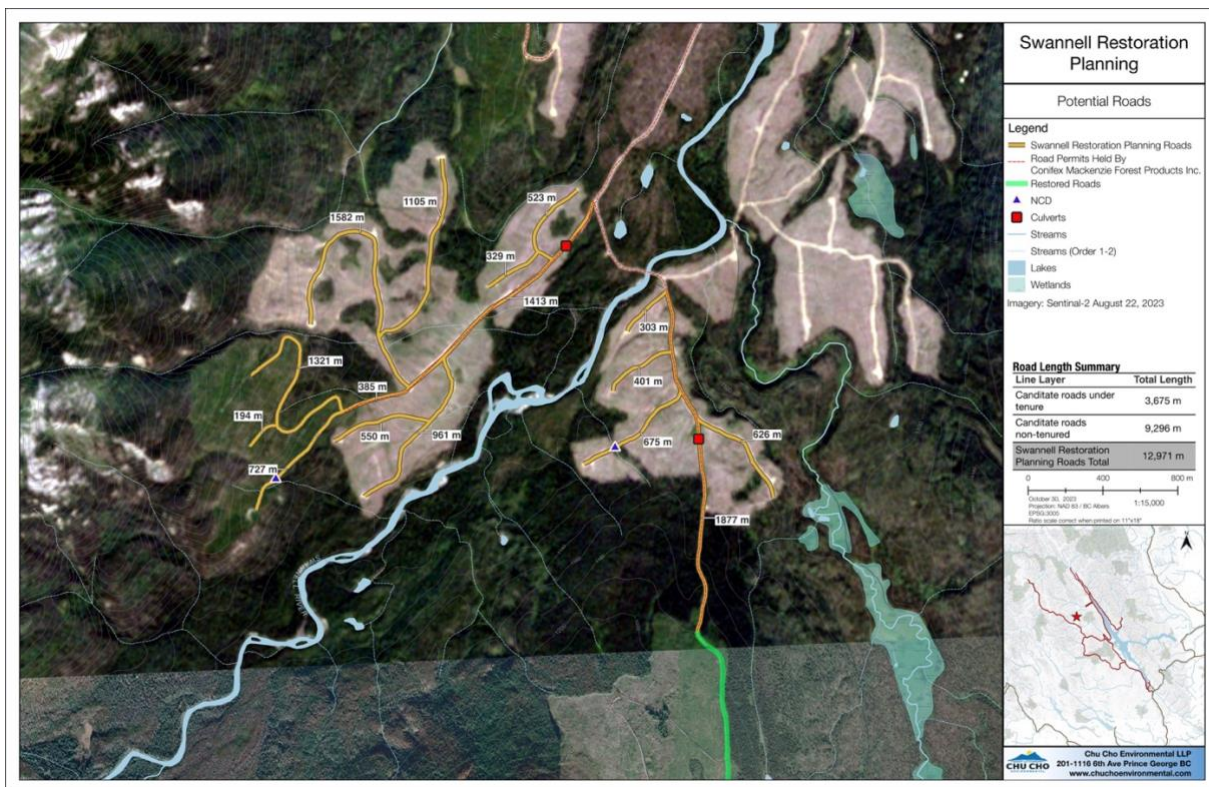
Figure 8.1. Road segments that made up the 2024 road restoration prescriptions.

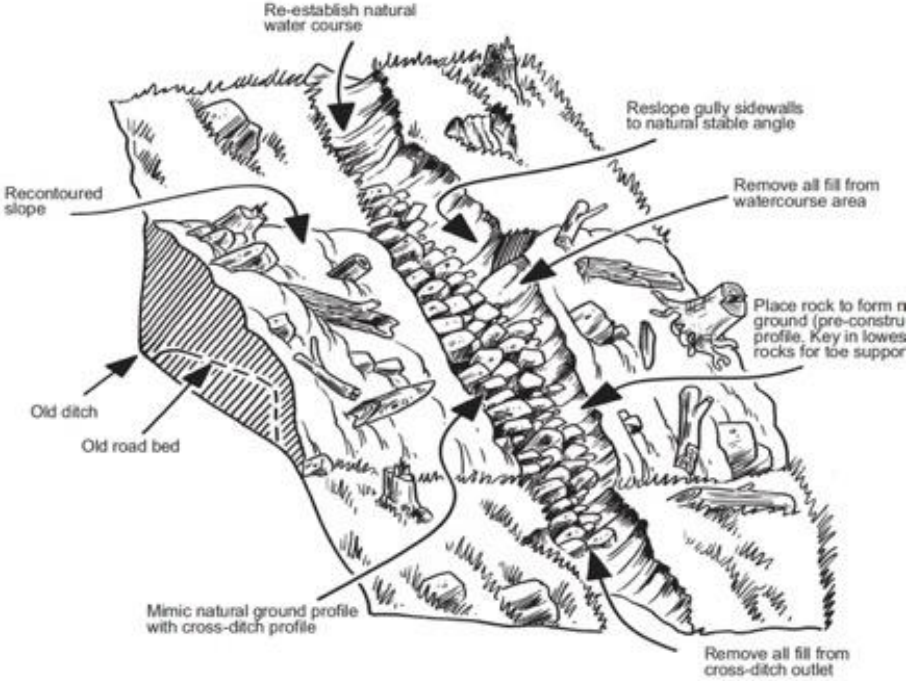
Figure 8.2. Deactivation with Culvert Removal from BC MFLNRORD (2019).

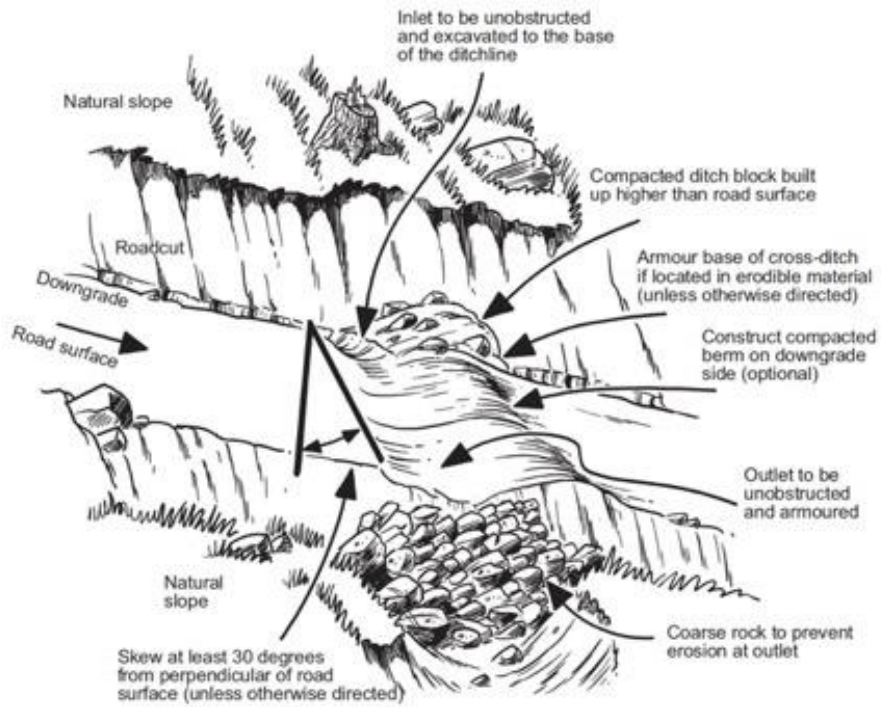
Figure 8.3. Deactivation with Cross-Ditching from BC MFLNRORD (2019).

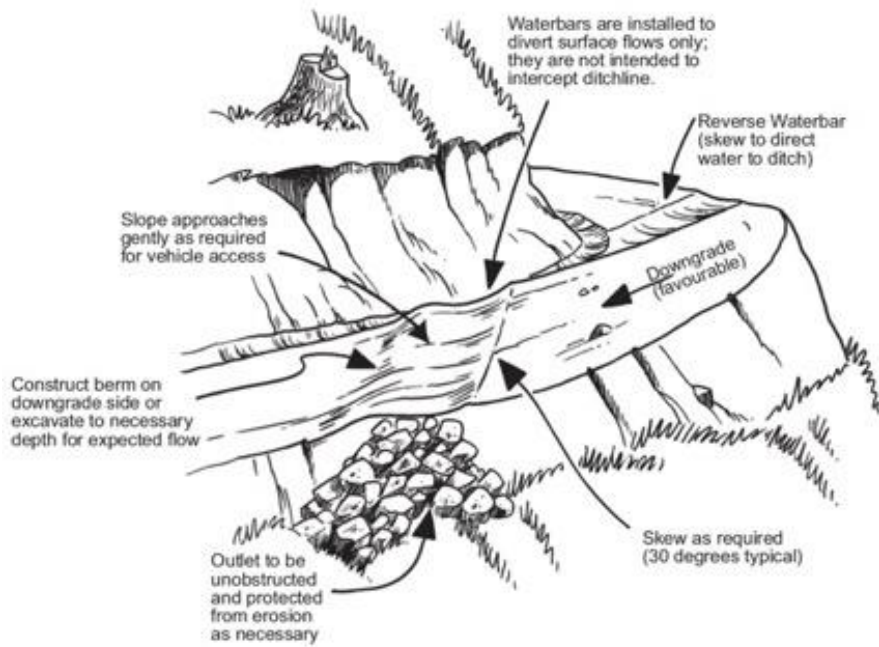
Figure 8.4. Deactivation with Waterbar from BC MFLNRORD (2019).

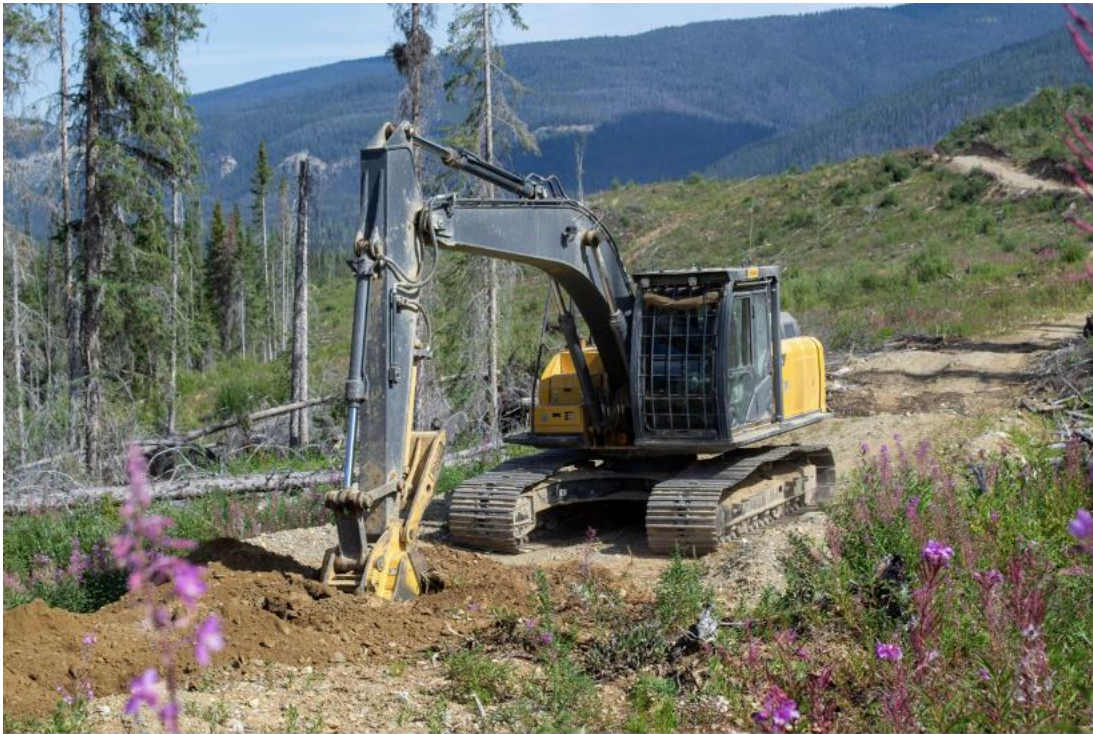
Figure 8.5. The 609 excavator used to implement ecological and functional restoration of the Chuyaza road section: part II. Pictured is the excavator de-compacting and mounding a section of road.

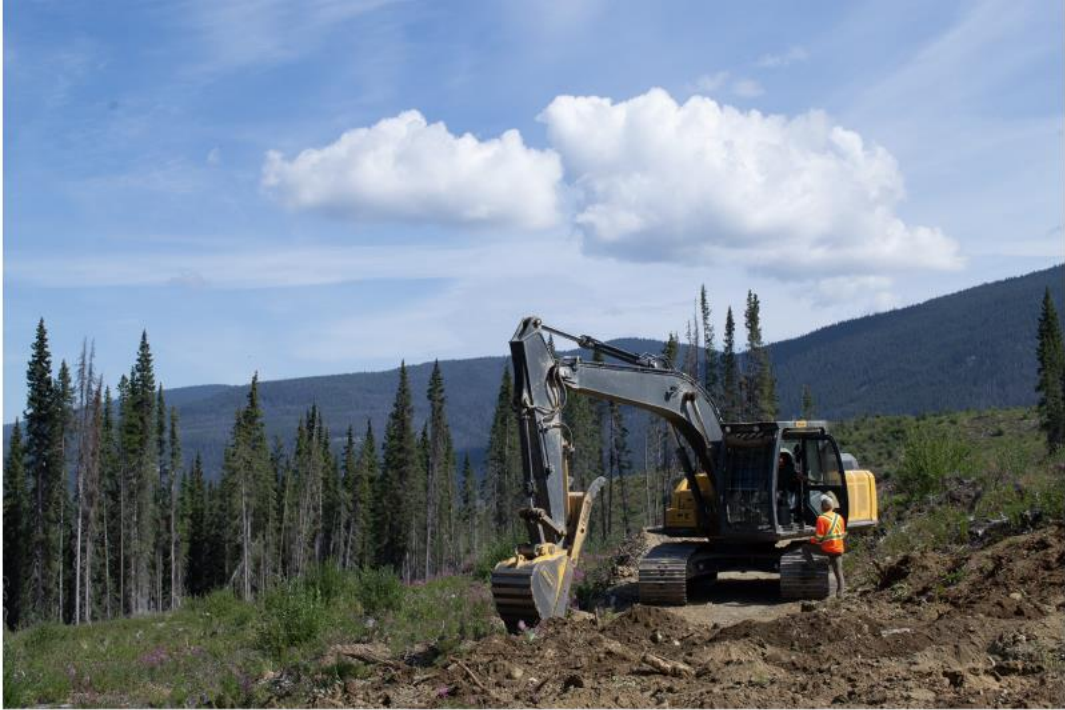
Figure 8.6. The CCE restoration supervisor speaking with the excavator operator about the strategy for the next road segment.

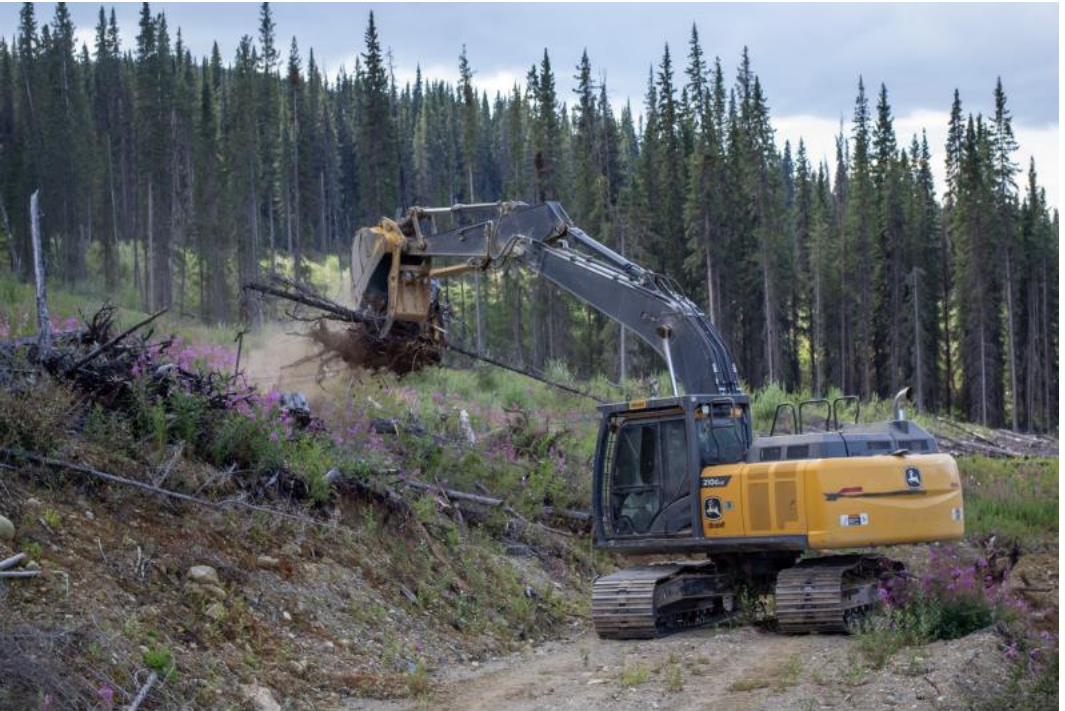
Figure 8.7. An example of the excavator completing slash rollback on a segment of road.

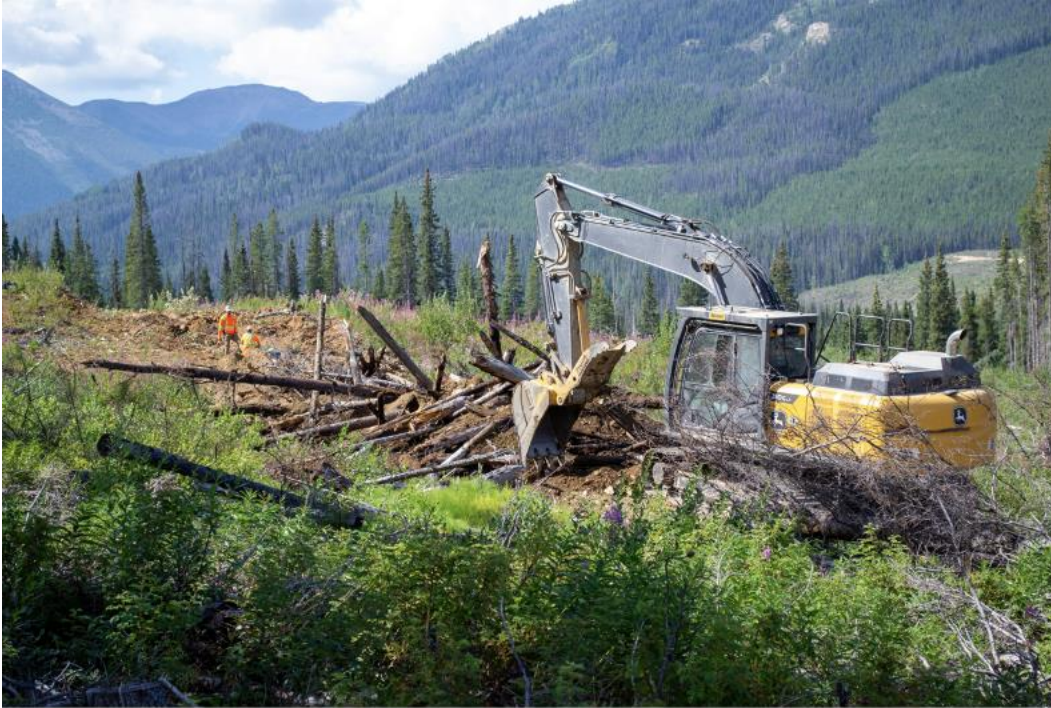
Figure 8.8. The excavator completing some functional restoration by creating a berm of soil and coarse woody debris to break up the sightline along a road segment.

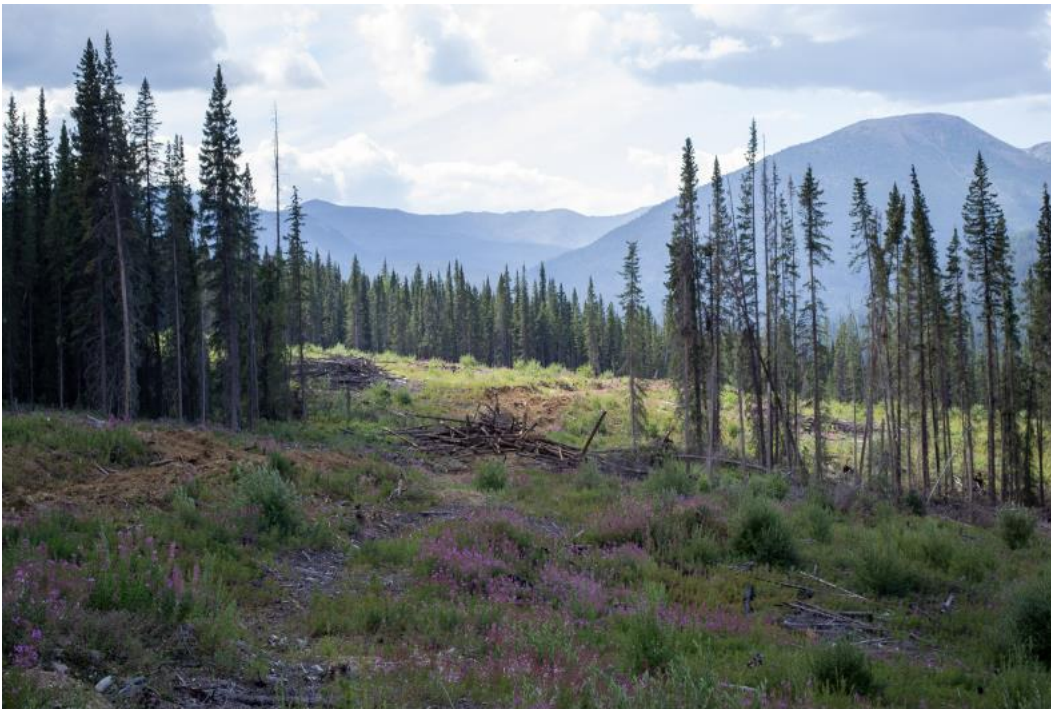
Figure 8.9. An example of functional and ecological restoration along a portion of road.

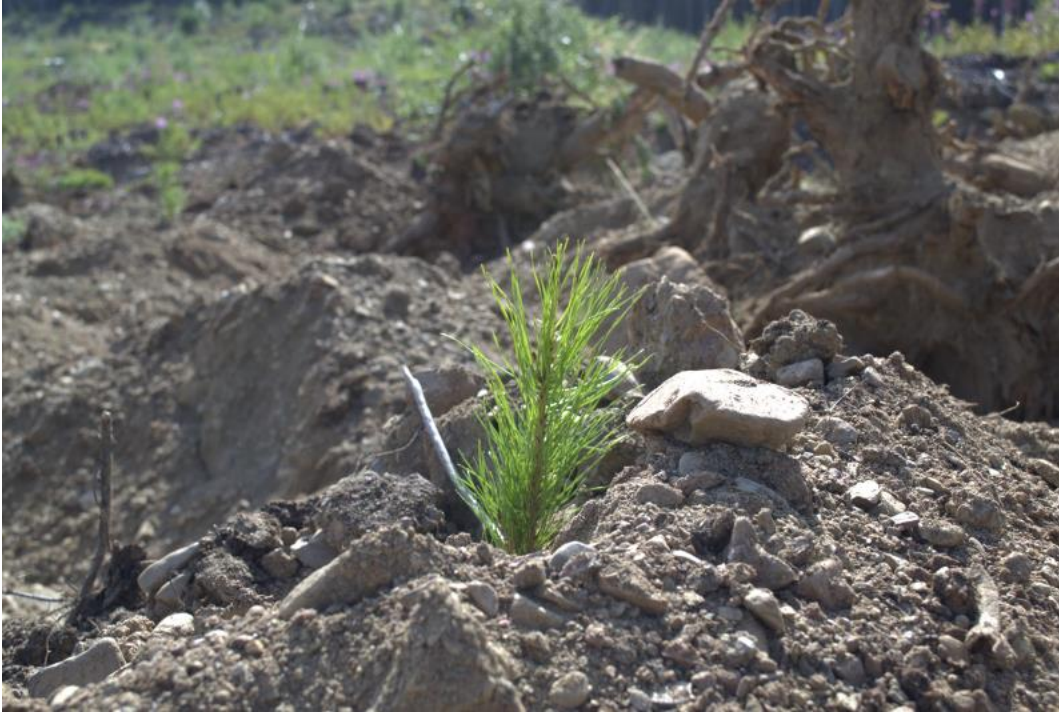
Figure 8.10. A planted lodgepole pine seedling in one of the mounds that was created by the excavator along a road segment in 2024.

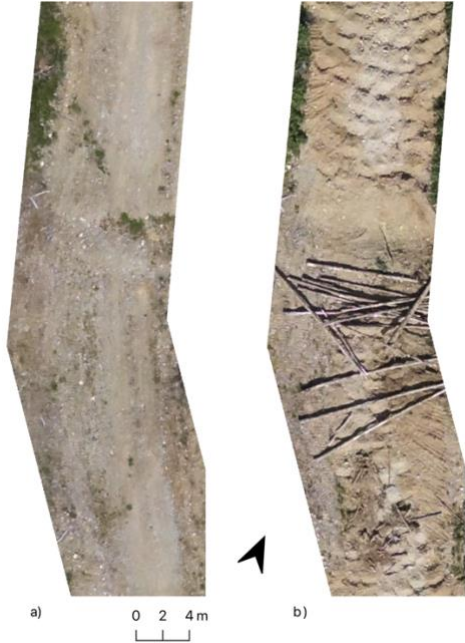
Figure 8.11. A comparison of part of the road surface of flight 04 a) before and b) after treatment. The road surface decompacted, coarse woody debris stacked across the road, and the access management ditch has been enlarged.

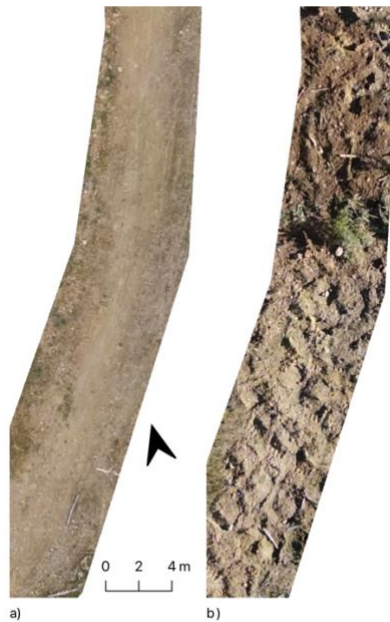
Figure 8.9. A comparison of the road surface of flight 03 a) before and b) after treatment, including decompaction of the road surface and transplanting trees from the road margin onto the decompacted road surface.
