COSENS BAY LAGOON STUDY

by
Bengt J. Kangasniemi
and
Patrick D. Warrington

Water Management Branch
April, 1983

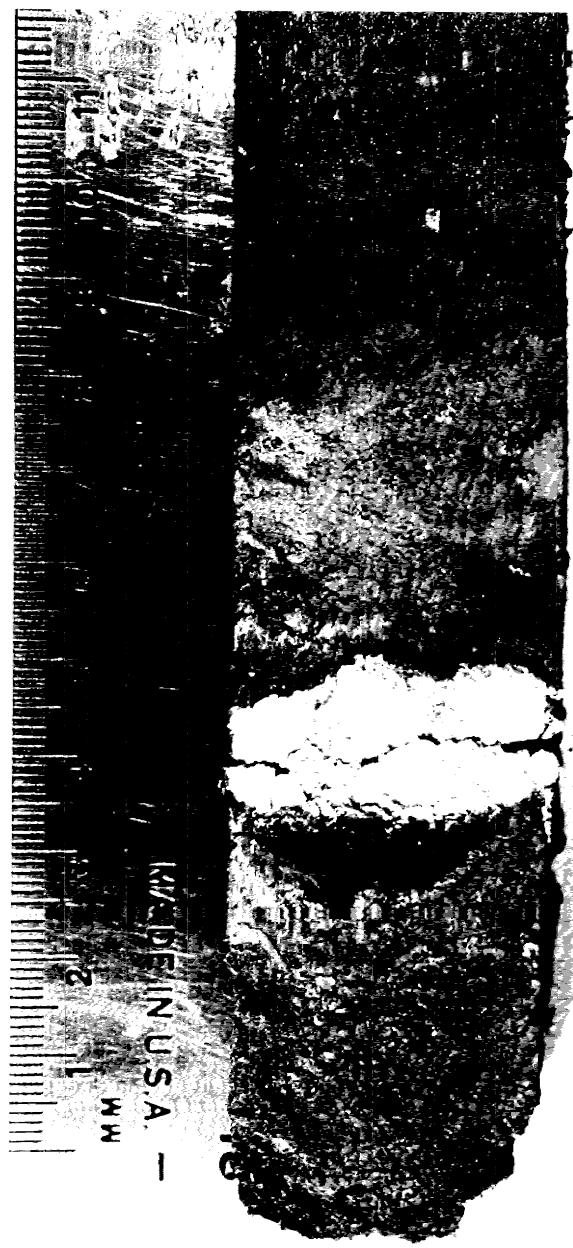
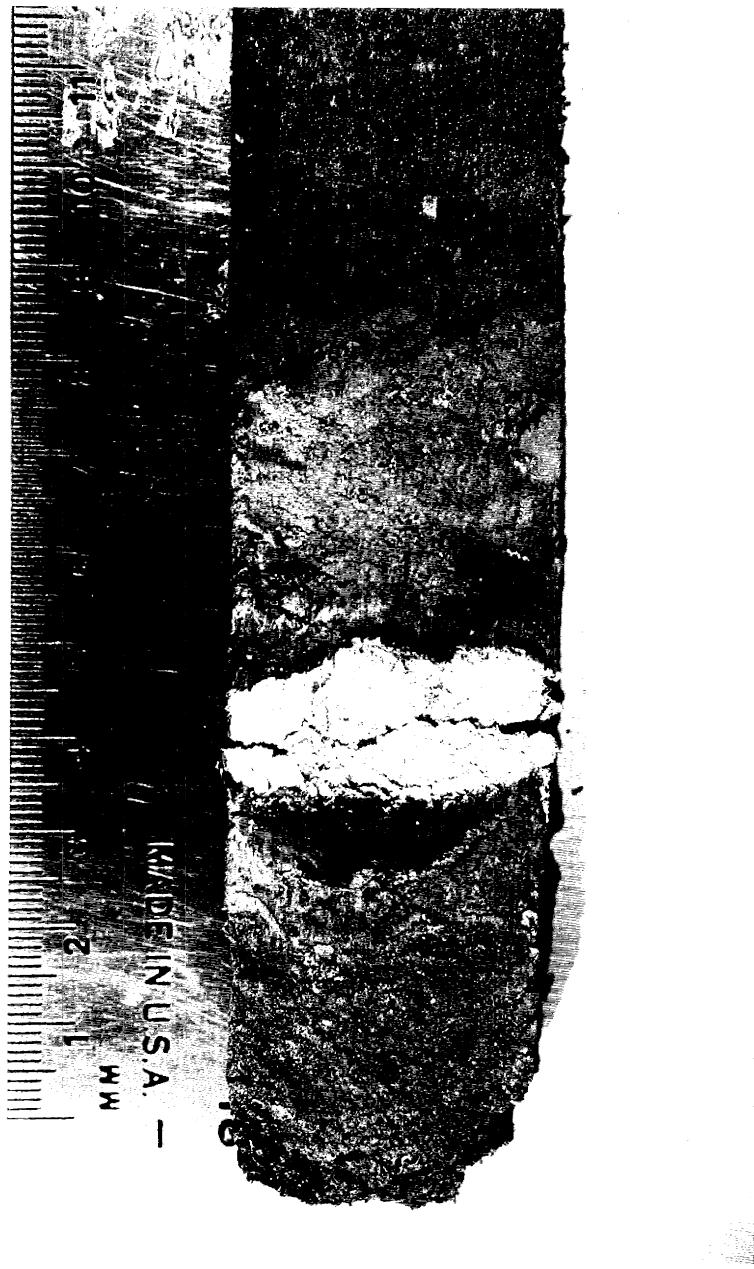
Photograph 3: Sediment core with Mount St. Helens ash layer from 3 200 years ago. Ash approximately 55 cm below sediment surface

Sediment core analysis indicated that the lagoon has remained intact at least 3200 years. A volcanic ash layer at a depth of about 55 centimetres (Figure 4) corresponds to an eruption of Mount St. Helens which occurred approximately 3200 years ago (Westgate et al., 1970; Westgate, personal communication, 1983). Such a distinct ash layer (Photograph 3) could only remain intact at an undisturbed site which was not subjected to the erosional activity associated with a lake shore, therefore, the bar formation must have been complete 3200 years ago. Based on the core depth of the ash and the date of the Mount St. Helens eruption, the sedimentation rate for the last 3200 years has been estimated as 0.17 mm per year. Chemical analysis of the sediment layers revealed that most of the sedimentation likely originated from decayed plant material, most probably aquatic plants.
