# **Reconnaissance Lake Inventory**

## **Stump Lake**

**Ministry of Environment, Lands and Parks  
Southern Interior Region**

March , 1999

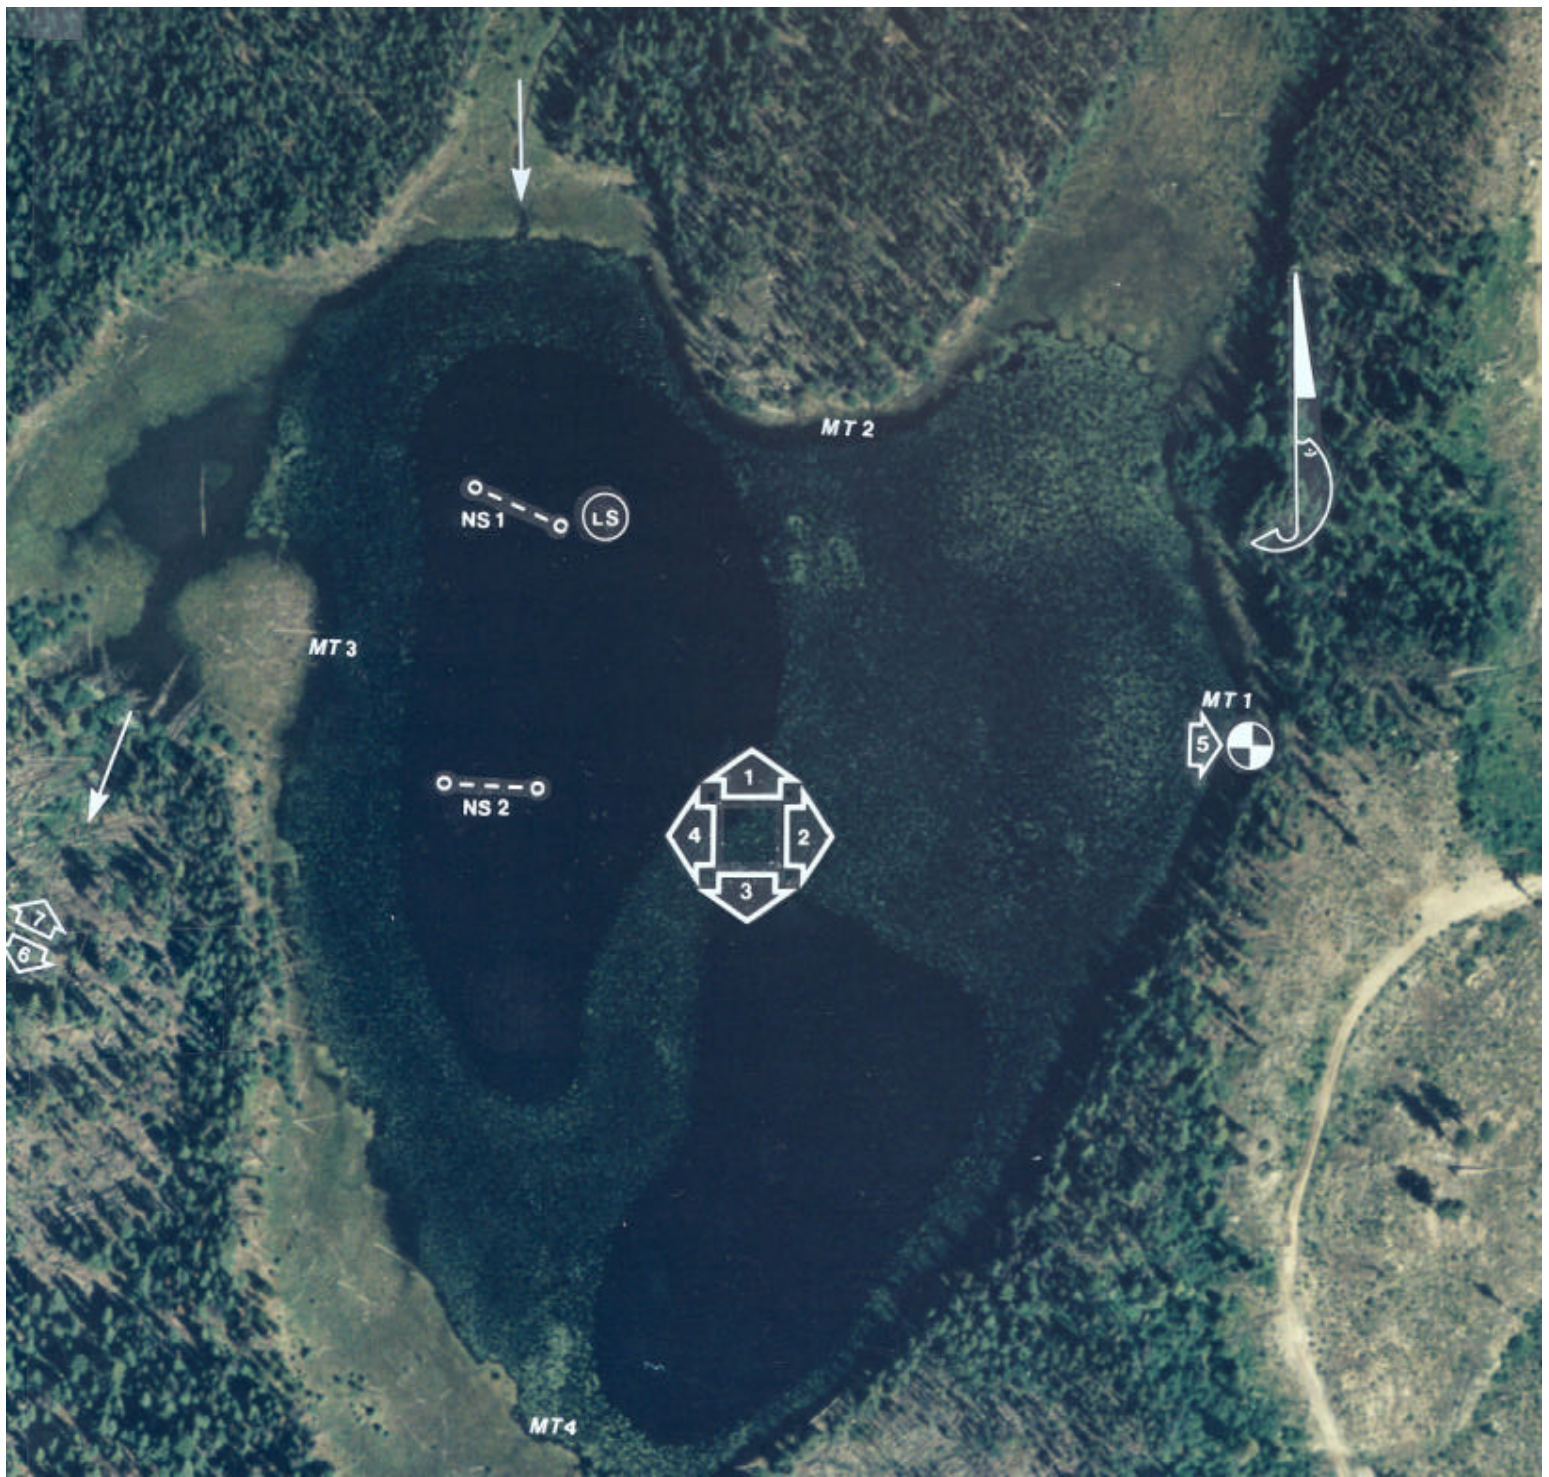
**Figure 2.** Annotated air photo of Stump Lake.  
 Airphoto Number: 30BCC96030 017  
 Scale: 1:1,500 (approx.)

A limnological sampling station was established near the deepest part of the lake. See annotated air photo on page 6 for sampling location. Measurements included pH, conductivity, dissolved oxygen and temperature profiles, as well as a laboratory analysis for general water chemistry parameters taken from a sample 0.5 m below the surface.

Two standard MOELP 300m six (6) panel variable mesh gill nets, one floating and one sinking were set in the lake to determine fish presence, and to obtain samples of the fish population. The mesh sizes of the nets and their order are 25, 76, 51, 89, 38 and 64 mm. The floating net was set for 5.6 hours and the sinking net was set for 5.4 hours. The net set locations are shown on the annotated air photo.

Four (4) Gee minnow traps were set in the lake to determine fish presence. The traps were set at an average depth of 0.5 m using canned cat food as bait. The minnow traps were set for an average of 5.6 hours. The minnow trap locations are shown on the annotated air photo.

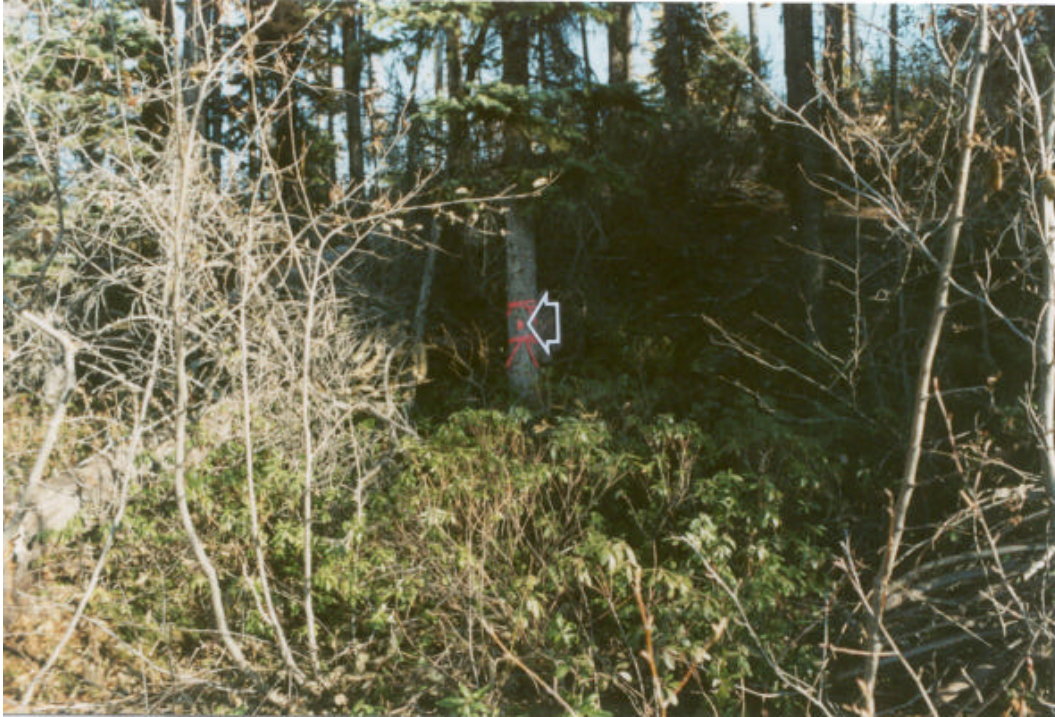
**Figure 9.** View of benchmark tree with arrow indicating location of spike (photo 5 on annotated air photo).

Type of Survey FL Littoral Area 96 % Method BT Max. Depth 6.9  
 Benchmark Height 2.4 Max Water Level 2.1  
 Benchmark Type/Location 6" spike with flagging tape in Spruce Tree near trail cut to lake  
 Comments

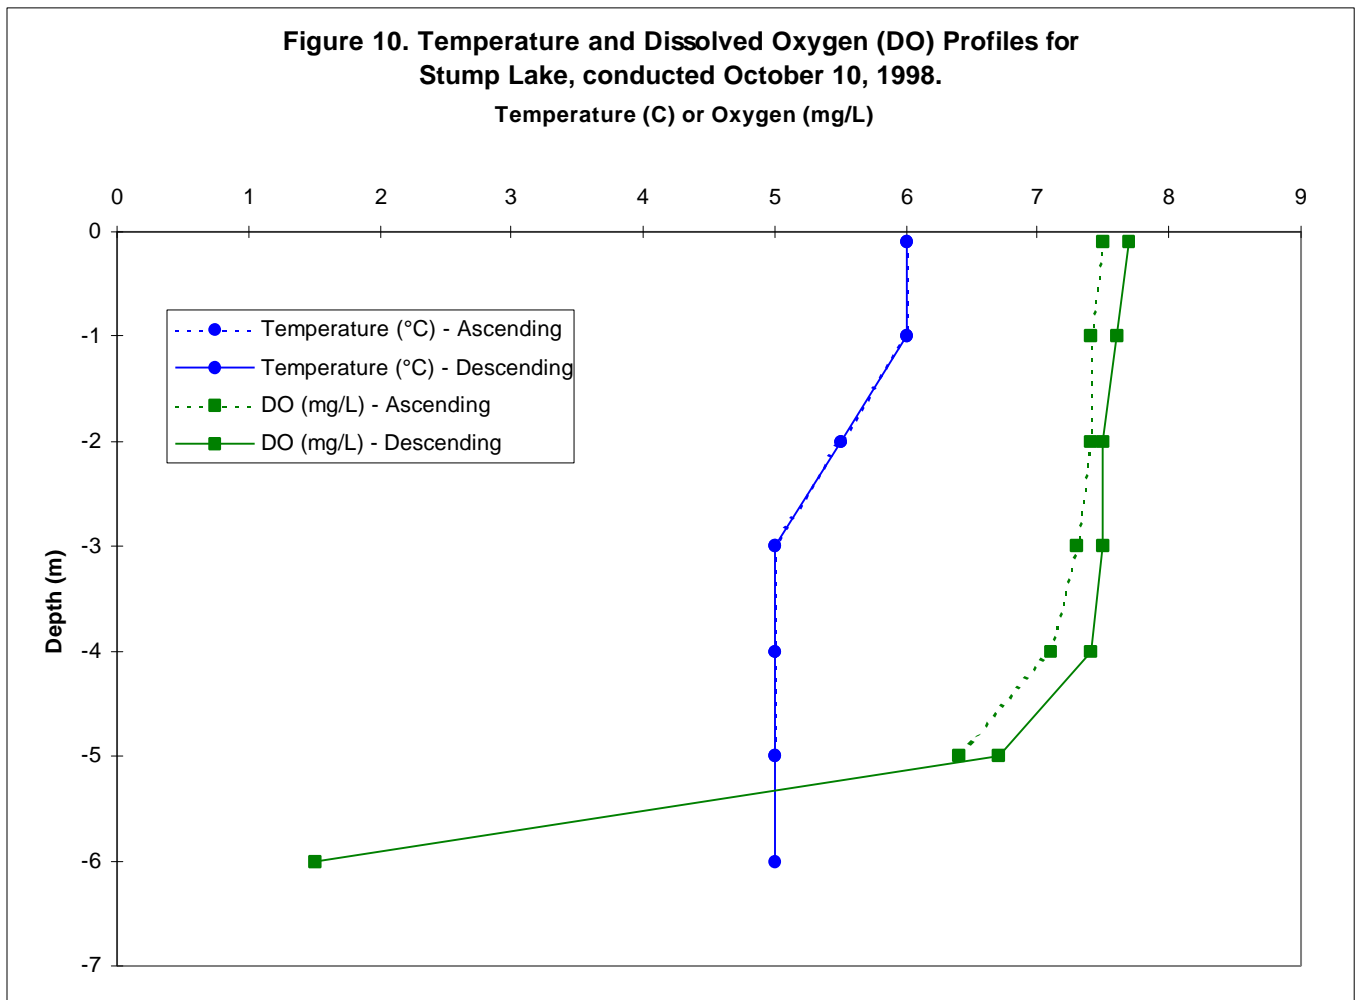
The laboratory analysis of the water sample taken at 0.5 m indicated a pH of 7.00, Specific Conductance of 52 uS/cm, and TDS (residue filterable) of 60 mg/l. The complete analysis results are listed in Appendix 2. A temperature/dissolved oxygen profile is shown in Figure 10.

A thermocline was located at a depth of 5 to 6 m. The water temperature and oxygen profile suggests that fish would be able to utilize depths above 5 m in the lake.

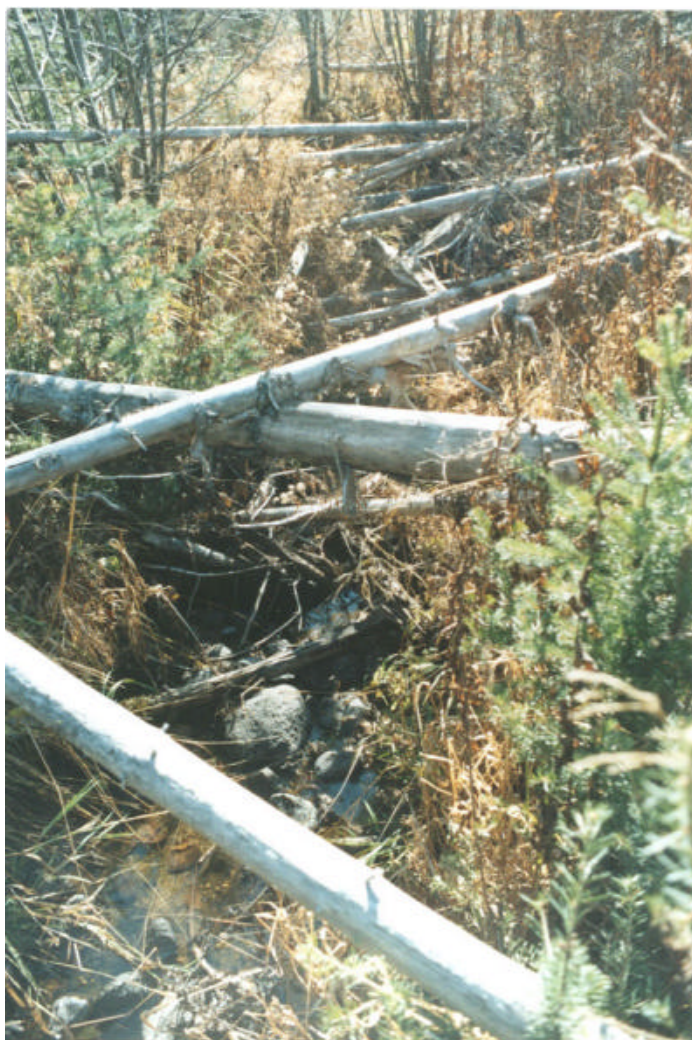
**Figure 11.** Site Card sample site on outlet stream approx. 100 m d/s of lake, d/s view (photo 6 on annotated air photo).

From this location a large area of blowdown has occurred making access to inspect this section of the outlet very difficult. Approximately 100 m d/s of the lake immediately below the area of blowdown a Site Card was completed (see Appendix 1 and Figures 11 & 12). The gradient here is approx. 1% with a good mix of pool and riffle habitat suitable for fish rearing. Although there was no flow occurring at the time of the survey there were standing pools of water in this section of the stream channel. Fish cover is abundant in the form of undercut banks, overhanging shrubs and large woody debris (LWD). The stream bed consisted of ample small gravels suitable for spawning habitat.

A further investigation should be conducted into whether the large spruce tree which has fallen across the mouth of the outlet stream may affect fish passage. The lack of a defined channel from the lake to the outlet stream should also be investigated to see if this would limit fish production if fish were reintroduced into the lake. Although Stump Lake has low productivity (60 PPM TDS), based on the inventory information collected, the ability for this lake to support fish production appears adequate if a stocking program is initiated and maintained. In the event that a lake stocking program is considered efforts should also be made to protect the outlet stream from any future logging activities. Angling pressure could also be regulated by not upgrading the existing road access or constructing vehicle access right to the lake. Leaving the existing short walk in access is recommended.
