Stream Classification and Mapping of Streams in Greensea Bay, Sonora Island.

Dave Freer
Ministry of Forests
Campbell River Forest District
Small Business Forest Enterprise Program
Campbell River, BC

February 1999

North Island Biological Consultants

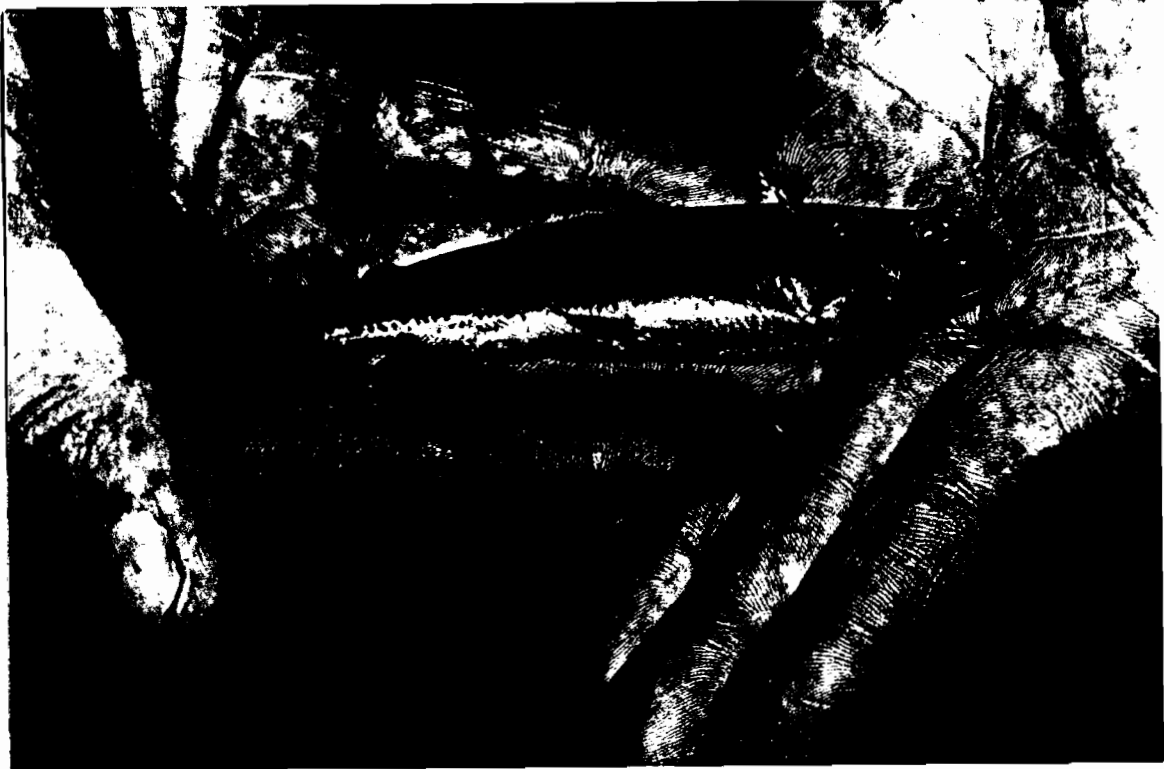
Cutthroat trout (*Oncorhynchus clarkii*) were detected in the first two reaches of Stream 1 (Figure 7). Based on fish presence and channel width, Reach 1 and 2 are classified as S4 and S3 respectively. At the beginning of Reach 3, gradient is high (35%+) and may prevent fish passage. No fish were found above this section. Therefore, Reach 3 is classified as S6. No fish were found in Tributary 1, although it does contain suitable fish habitat and connects to Stream 1 in a fish bearing reach. While the gradient is steep, the structure of the stream is such that it is possible that fish may be able to reach the flat area in reach 2. Based on this, both reaches of Tributary 1 are classified as S4.

Figure 7: Cutthroat trout found in Stream 1.
