23 March 2006
File: 2005-052

**MONTE CREEK – FISH PASSAGE IMPROVEMENT
7.5 KM OF PYTHON ROAD
Okanagan-Shuswap Forest District**

At your request, the author attended the above referenced site with Mr. Alan Bates, P.Eng. of Streamworks Unlimited on 15 November 2006. The purpose of the site visit was to assess the geotechnical and hydrological conditions at the existing crossing location with the goal of improving fish passage beneath the road. A visual assessment of the conditions, at and adjacent to, the subject stream crossing was undertaken. In addition, a sketch plan of the area was prepared along with a surveyed cross-section and profile of the stream channel at the subject site. Streamworks Unlimited undertook an office based hydrologic review of the watershed upstream of the crossing to estimate the Q_{100} design flows; evaluated hydrologic capacity of the existing culvert structure; and prepared a hydrologic mitigation plan to improve fish passage at this crossing. The following is a summary of the field and office assessments together with design details regarding construction of mitigation works to improve fish passage at this location.

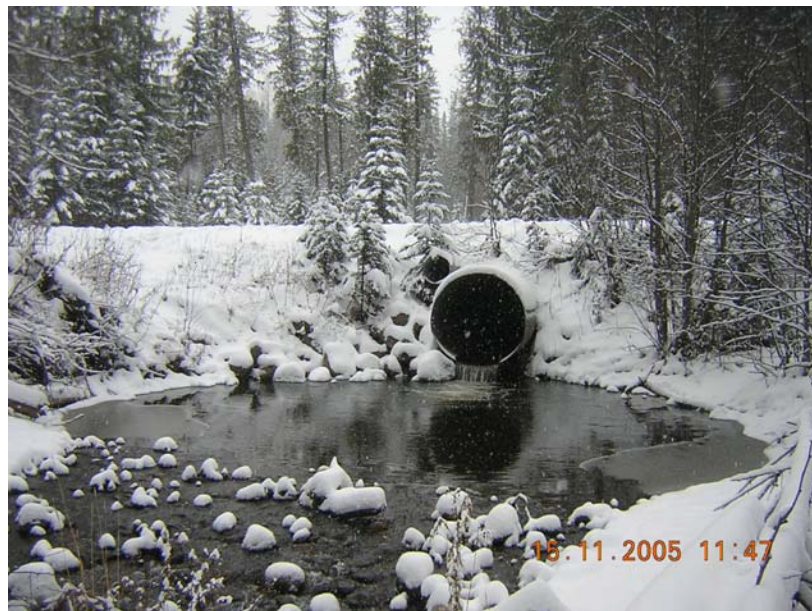
At the time of the field assessment the outlet flows from the existing 1.8 m diameter CSP culvert were dropping about 0.6 m to the water surface in the pool area (see Photo 1 on Plate 1 and Photo 7 on Plate 4). It is understood that this has been considered (by others) to represent a barrier to fish passage for some (small) fish. It is also understood that fish stocks from Stephen's Lakes could utilize stream habitat upstream of the subject crossing if it was accessible.

Photo 1 – View looking upstream at stream channel and culvert outlet. Existing rock riffle in foreground controls the elevation of the pool.

Removing and replacing the existing CSP culvert with either a bridge or other type of open bottom structure would provide the desired fish passage. Removing and replacing the existing structure, this would likely cost at least \$20,000. Alternatively, it is possible to re-establish the original pool water level elevation at the culvert outlet and thereby eliminate the vertical drop at the CSP outlet, by blocking the recently eroded channel and re-establishing stream flows within the abandoned channel. The attached 11 x 17 design drawing 2006-201 by Streamworks Unlimited, provides construction details for: 1) creating/reinforcing an elevation controlled rockfill riffle within the abandoned channel; and 2) blocking off the current, recently eroded channel.

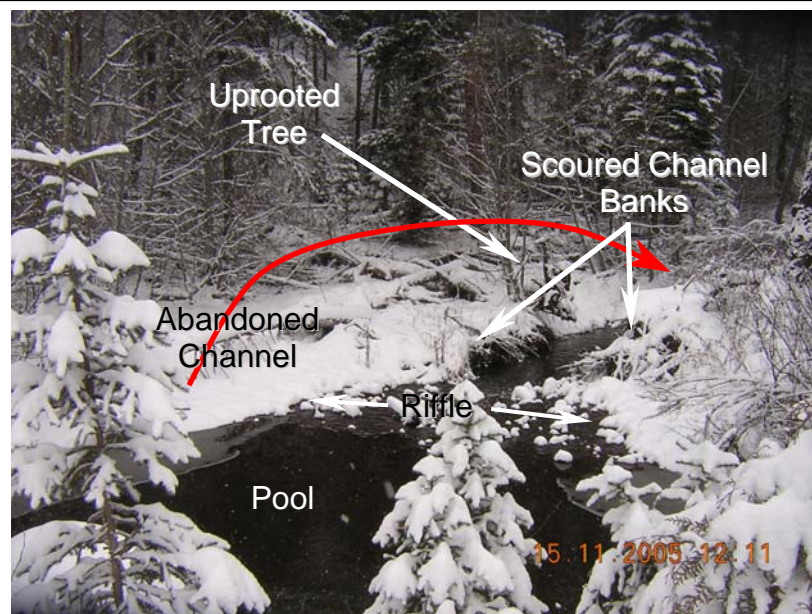
The current channel downstream of the culvert outlet consists of a large pool (about 8 m in diameter) and a wide rock riffle that controls the pool water elevation and directs the stream flows through a narrow (about 4 m wide) channel that appears to have been recently incised into the native soils (see Photo 2 on Plate 1 and Photo 8 on Plate 4). To the left (west) of this channel there is an abandoned stream channel consisting of a gravel and cobble streambed.

The uprooted tree shown on Photo 2 of Plate 1 and Photo 3 of Plate 2 appears to have both partially blocked the original stream channel, likely elevating water levels; and weakened the channel bank at the root wad location. This appears to have: 1) caused the stream to create the current channel by eroding through the rot wad area; 2) abandoned the original channel; and 3) dropped the elevation of the water level in the pool at the culvert outlet.

Photo 2 – View looking downstream at the pool, rock riffle, recently scoured new stream banks and abandoned channel.

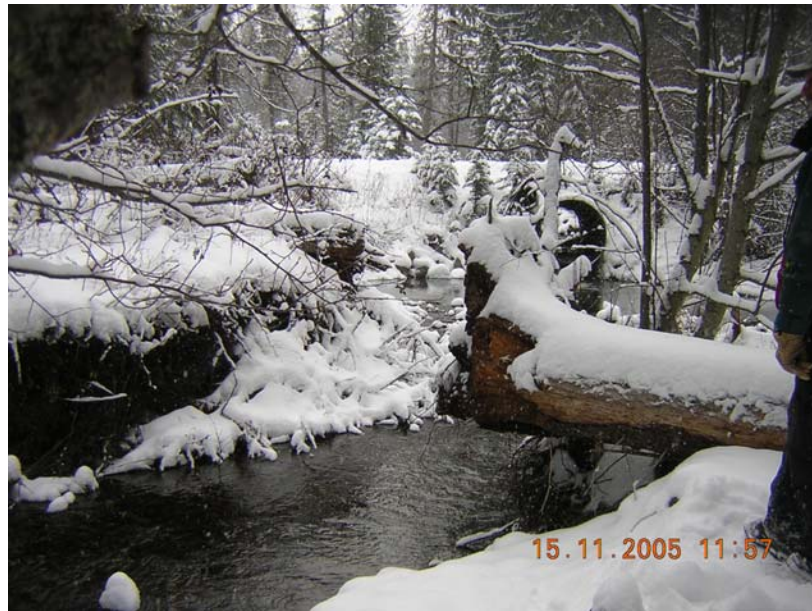
Plate 2

Photo 3 – View looking upstream at scoured channel, uprooted tree and culvert outlet.

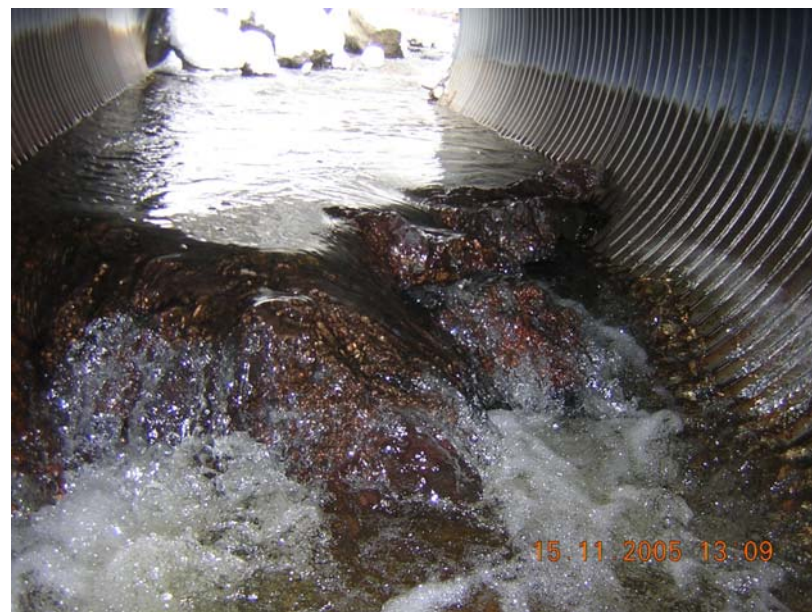
The culvert inlet is bevelled and armoured with large angular boulders in the order of 0.7 m in diameter (see Photo 5 on Plate 3). Two of the boulders from the rock armour are currently located within the culvert and have created riffles within the culvert (see Photo 4 on Plate 2).

Photo 4 – View looking upstream at riffle in culvert created by large angular boulder from rock-armoured inlet entering culvert.

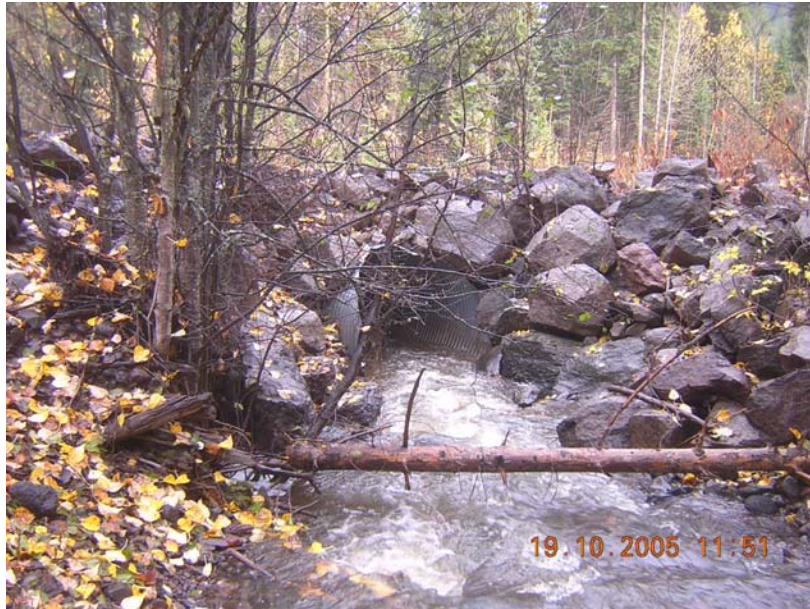
Plate 3

Photo 5 – View looking downstream at rock-armoured culvert inlet.

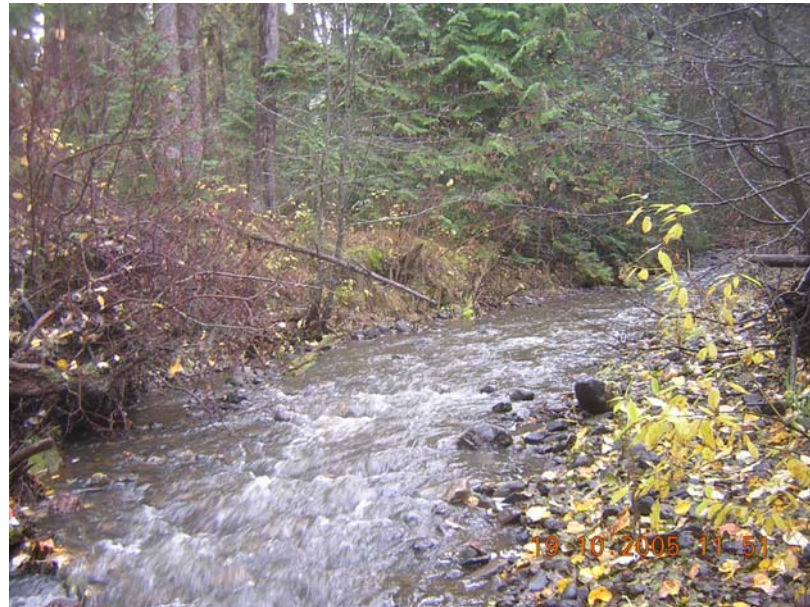
Upstream of the crossing the stream is in the order of four metres wide and has a channel bed consisting of gravel and cobbles with a maximum particle size of about 0.2 m in diameter (see Photo 6 on Plate 3).

Photo 6 – View looking upstream at the channel reach upstream of the culvert inlet.

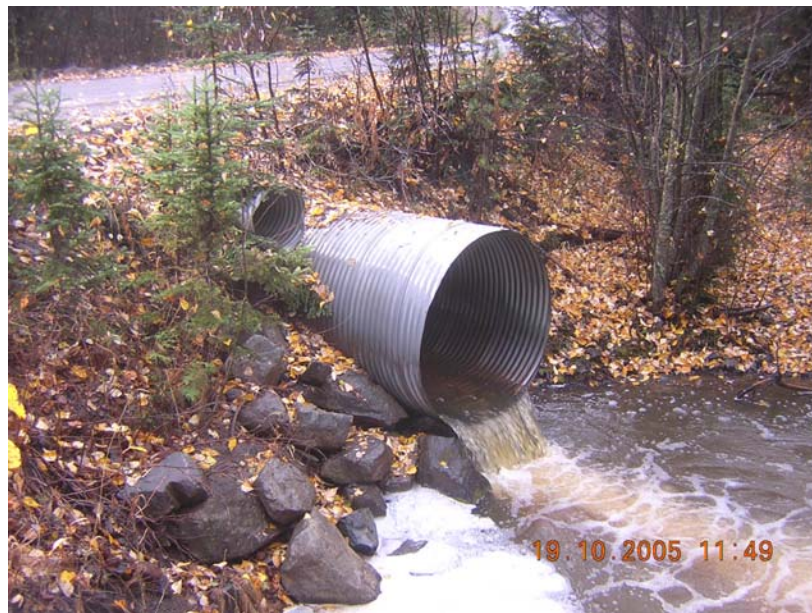
Plate 4

Photo 7 – View of perched culvert outlet and overflow culvert.

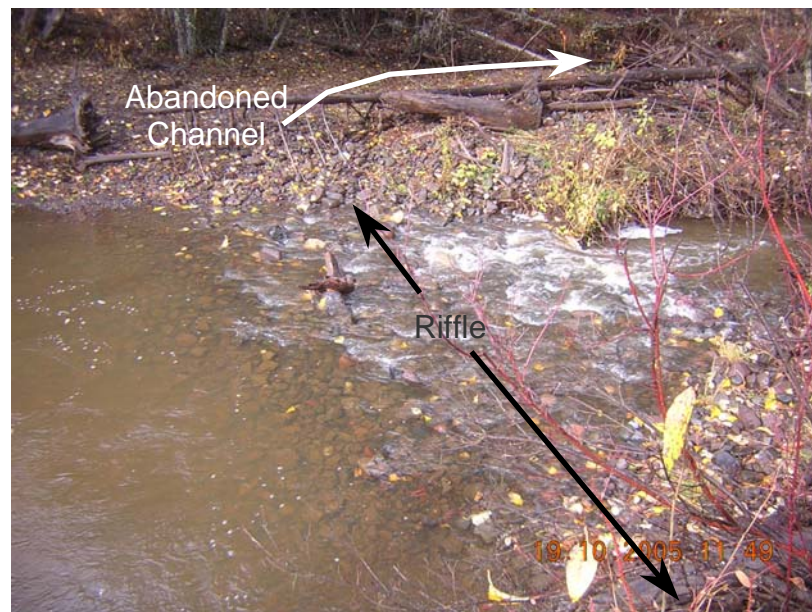
Photo 8 – Close up view of rock riffle and abandoned channel.

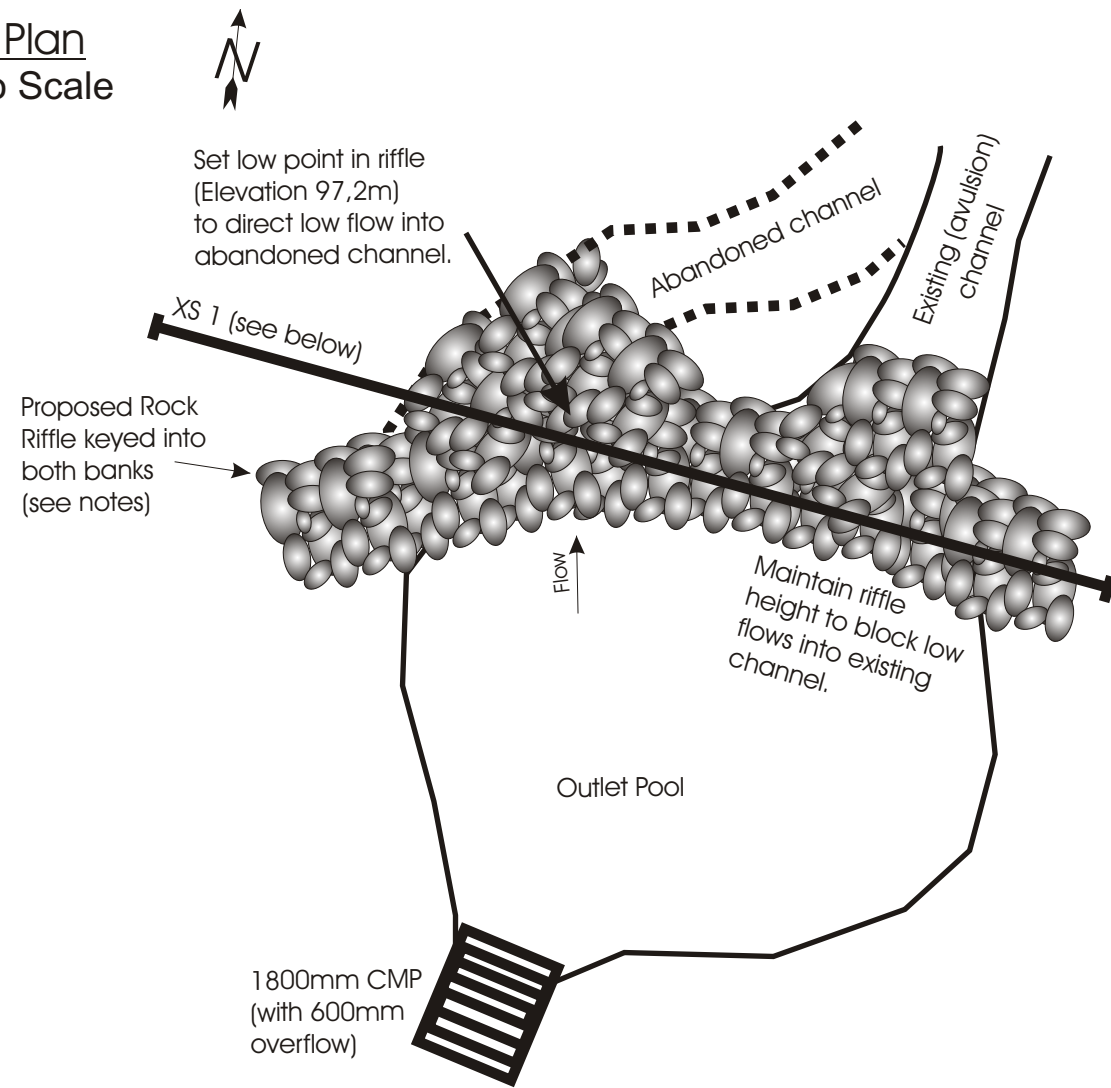
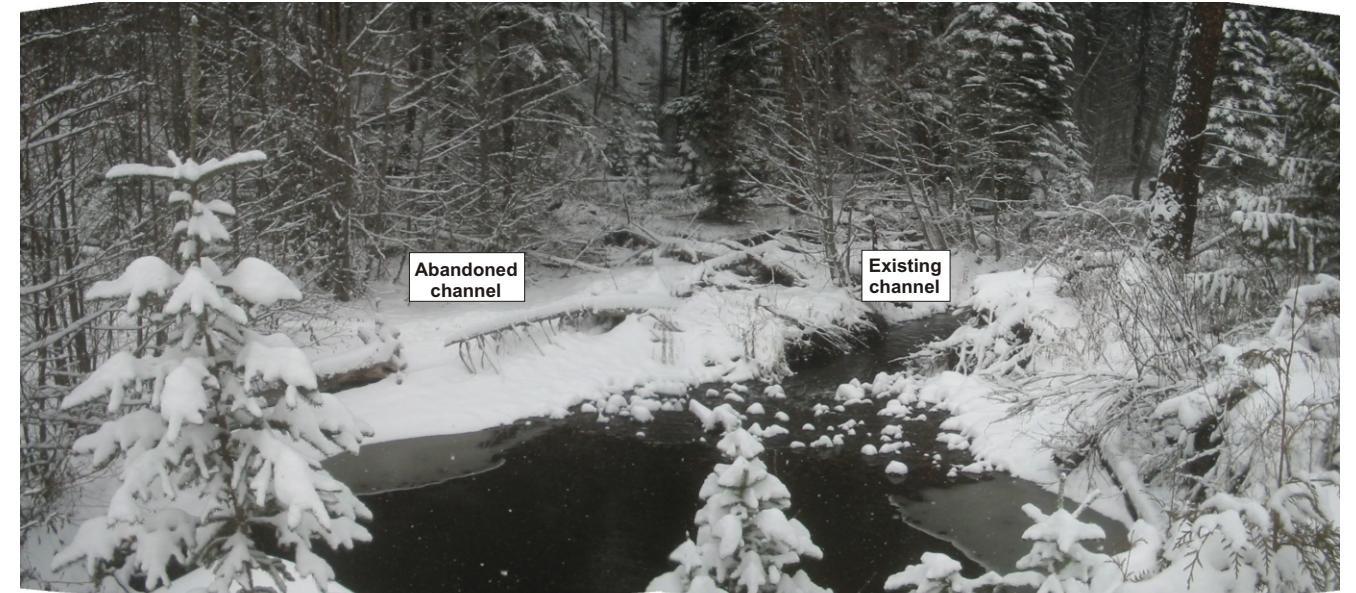
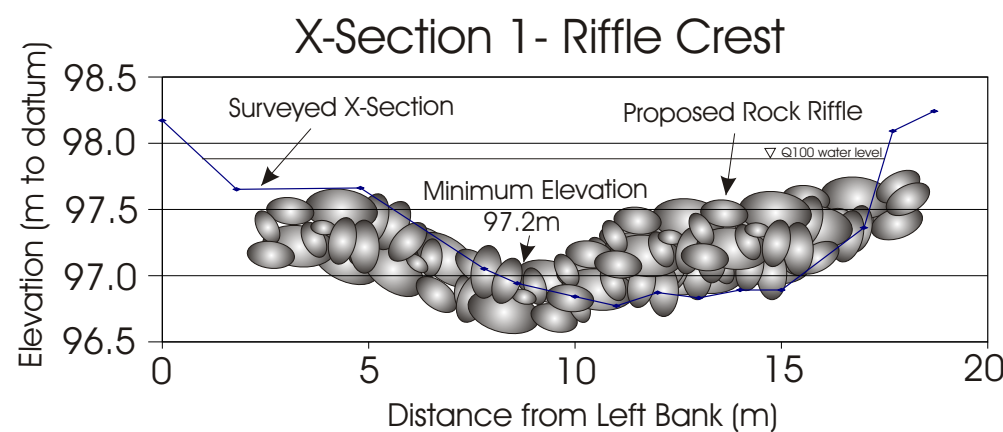
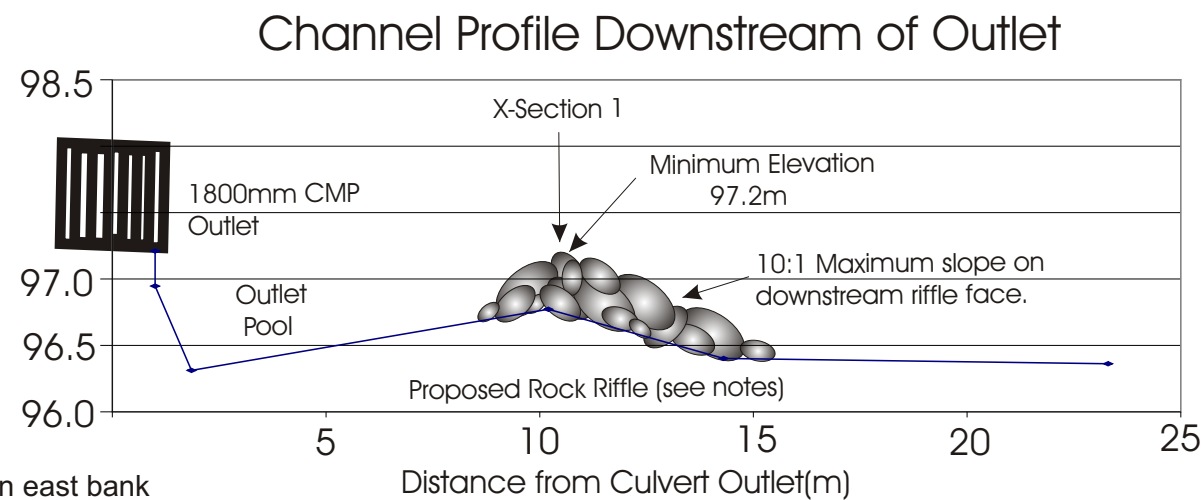
Monte Creek - Fish Passage Improvement ?? FSR Crossing Km ??

Downstream view of existing riffle and channels from above the culvert outlet

3. All equipment
4. Riffle to be constructed of well-graded competent rock and/or riprap (D50 = 50cm). Mix with available sands and gravel to ensure a tight matrix and prevent through-flow. Use larger nuggets to anchor riffle, dissipate energy and create low flow channels.

5. Tie riffle crest a minimum 2m into each bank. Ensure a gentle transition into existing substrates at the downstream edge of the riffle.
6. All areas disturbed during construction, including access trails, shall be seeded and replanted with appropriate riparian species.

Design Flows	
Adapted to project site from WSC Gauge 08LE103 Monte Creek above Monte Lake 1981-1994, 12 years of record.	
100 year	5.7 m ³ /s
10 year	3.7 m ³ /s
Estimated Culvert Capacity = 7.0 m ³ /s

It is estimated that the works proposed on the Streamworks Unlimited drawing will require approximately one (1) day to construct using a small to mid-sized excavator, a gravel truck, a compactor, 2 labours, 1 supervisor, water pumps, hose and non-woven geotextile fabric. The estimated probable cost to construct the designed works is approximately \$3,000.
