A FISHERIES INVENTORY
OF THE
GOSNELL CREEK WATERSHED

S.P. Hatlevik

April, 1981

Skeena Fisheries Report No. 35

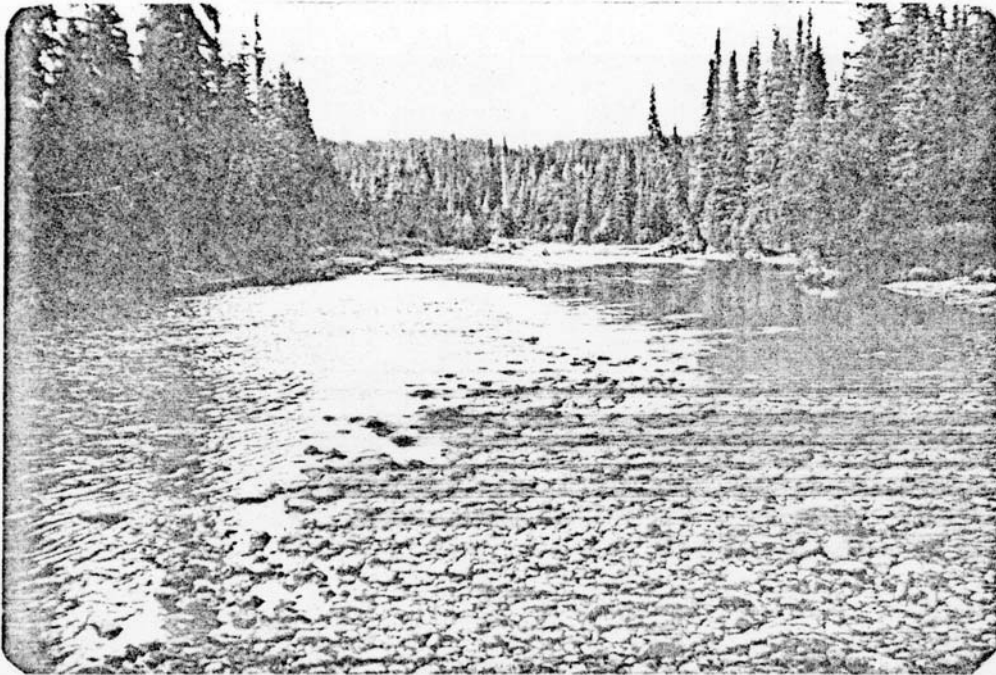
Photo 2. Gosnell Creek. Looking upstream from Northwood proposed bridge site. No. 1. (August 13, 1980).

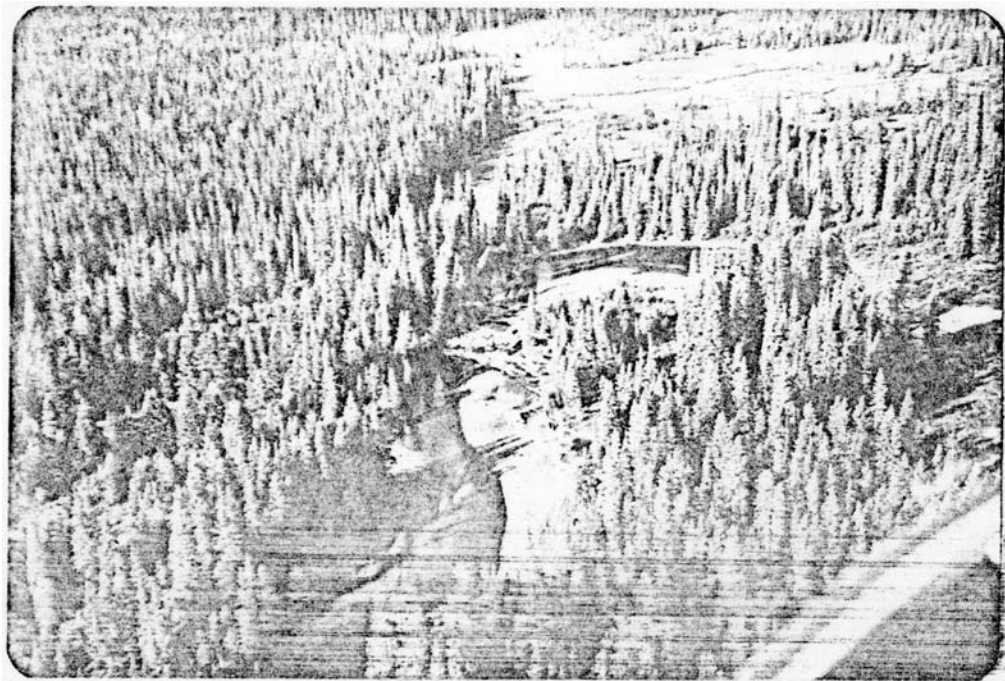
- frequent meandering, some ox-bows
- abundant back and side channels
- good rearing habitat for coho
- many areas of in-stream debris accumulations
- gravel bars frequent
- many areas suitable for spawning
- extensive swamp meadows adjacent to stream
- 3 point samples produced 6.1 coho, 6 Dolly Varden, 43 rainbows and 1 whitefish

Photo 3. A portion of Reach 3 on Gosnell Creek. Note the debris accumulation and the swamp meadow. (August 12, 1980).

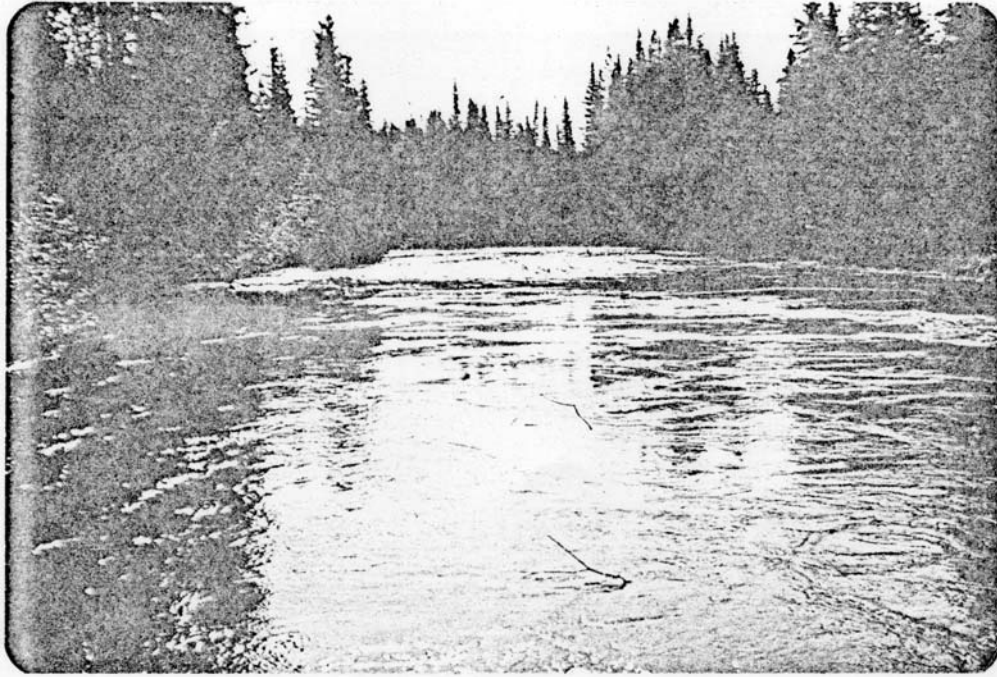
Photo 4. Within Reach 3, about 2 km downstream from mouth of North Fork. Note the high flows at this time of the year. (June 4, 1980)

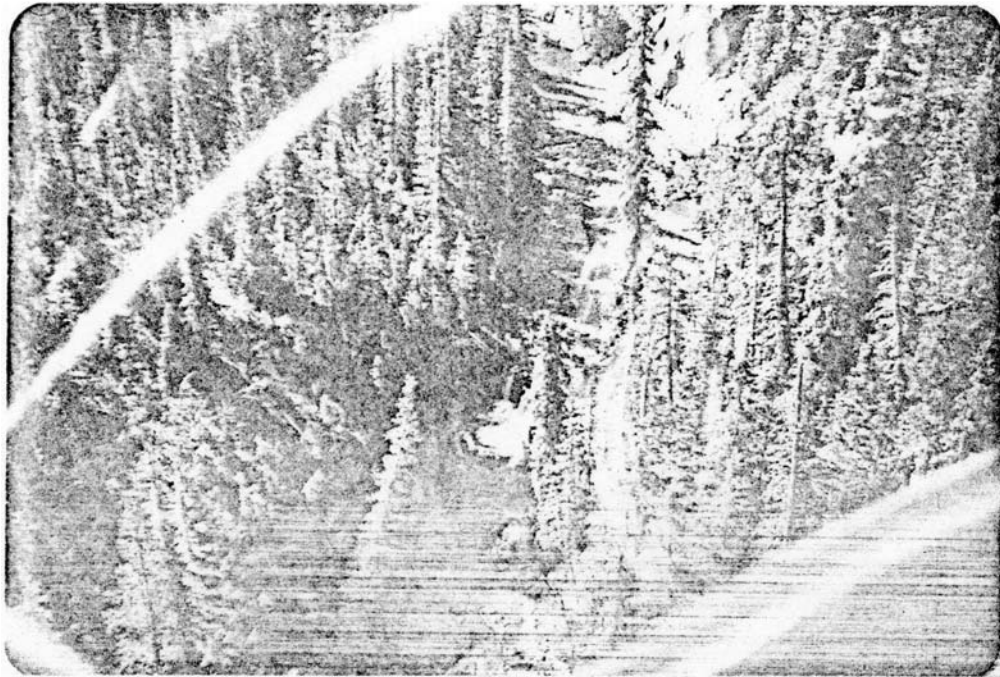
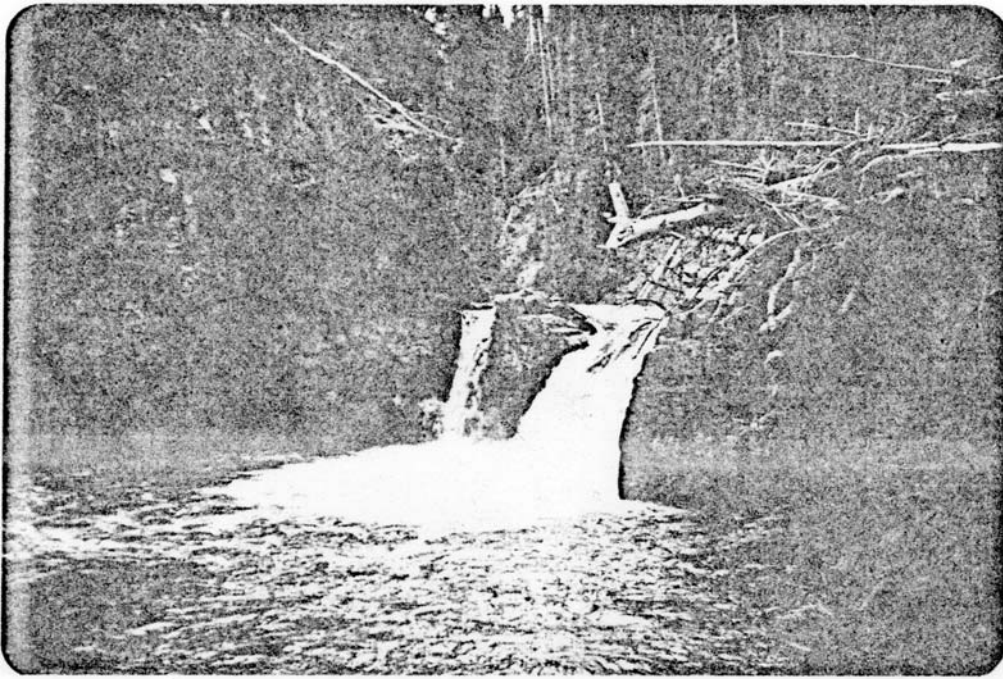
A 3 meter waterfall found within the lower end of Reach 5 (Appendix A, Photos 5 & 6) is of particular interest. While it was not considered to be a definite barrier, it could be a difficult point of passage. During adverse flows (stream either too high or too low) it could become a complete barrier to all upstream fish migration. About 15 km of stream offering good rearing and spawning habitat would be provided for coho

The waterfalls in the lower end of Reach 5 present a point of difficult passage for fish (Appendix A, photos 5-7). Under certain flow conditions, they could even be a barrier. The falls are about 3 meters high and 5 meters wide and are primarily bedrock controlled. A debris jam has accumulated on the left bank (looking downstream) and a large log extends part way across the top of the falls. It appears to create an additional $\frac{1}{2}$ meter of height. Removal of the debris jam or even just the log could result in lowering the water column. A deep plunge-pool (estimated depth 4-5 meters) is at the base of the falls and would enable fish to gain momentum for leaps.

- coniferous trees right to stream edge
- steeper gradient
- substrate contains a greater proportion of large rocks
- 3 meter falls at lower end of reach; not considered a barrier, but certainly a point of difficult fish passage; removal of falls is a possible habitat enhancement project
- many large Dolly Vardens seen and angled below falls for as far as was walked (about 100 meters). They were in spawning condition. This area is very important Dolly Varden spawning habitat.
- 3 point samples (electroshocking) produced 6 coho (above the falls) and 22 Dolly Varden.

Photo 5. Aerial view of 3 meter falls at lower end of Reach 5, on Gosnell Creek. (August 12, 1980).

Photo 6. Ground view of falls at lower end of Reach 5, on Gosnell Creek. (August 14, 1980).

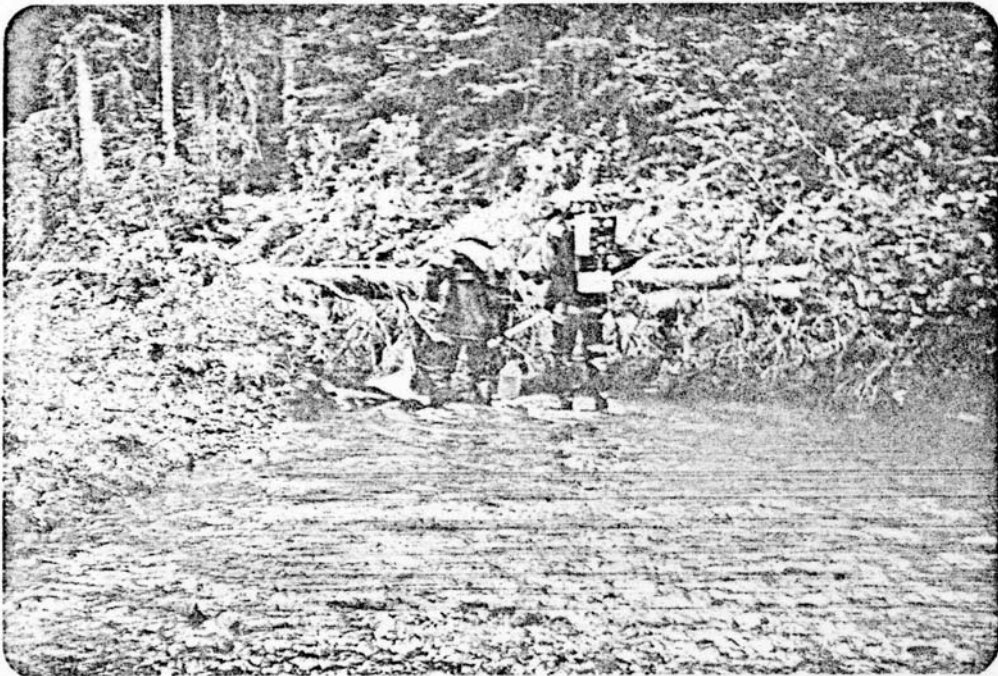
- wetted width 4 meters
- gravel abundant
- debris moderate and stable
- good rearing and spawning habitat
- sampling produced 2 Dolly Varden, but no cohos
- suspect beaver dams in marsh area downstream are probably a barrier
- debris jam at lake outlet
- outlet was dry down to trib coming from the south
- suspect cutthroat trout in the lake (ripples observed in the water while flying over)

Photo 13. At Sample Point in lower end of Reach 2 on Creek H. Note the abundance of Gravels. (August 14, 1980)

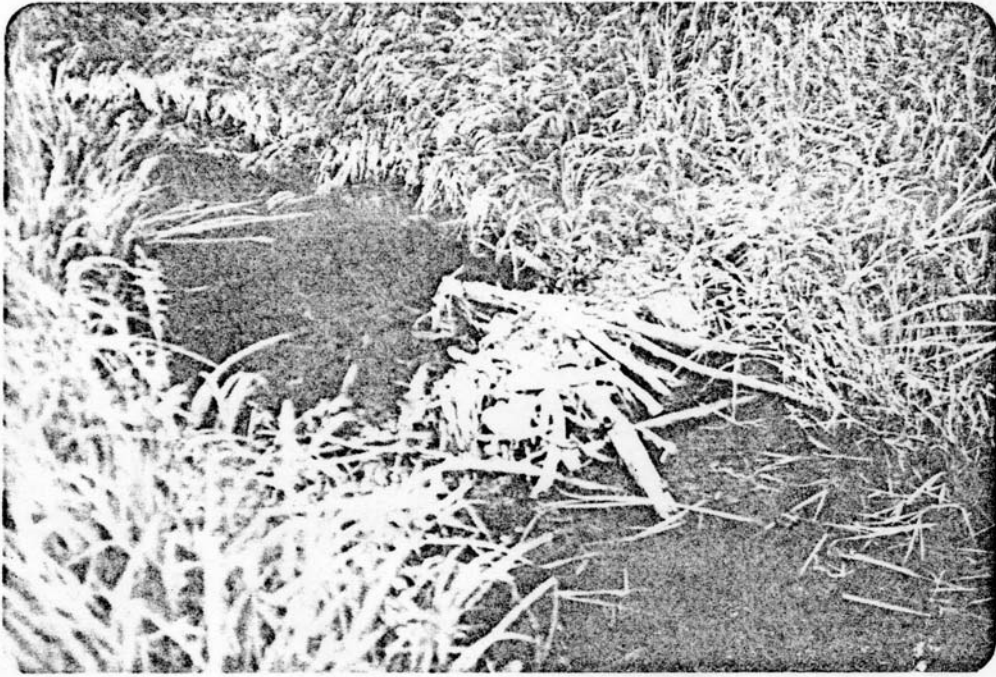
- lower end is alluvial fan similar to J
- possible spawning in fan area
- mainstem could support rearing for Dolly Varden and whitefish
- electroshocking produced no fish

Photo 14. Unnamed Creek K at sample point site (August 14, 1980)

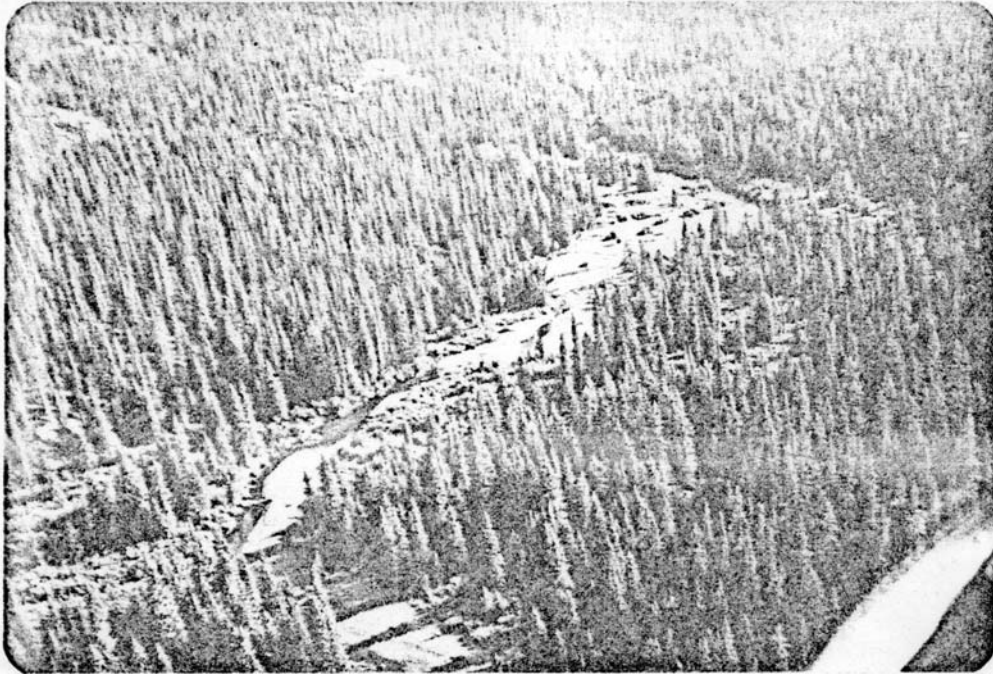
Photo 15. North Fork of Gosnell Creek in Reach 1.
(August 12, 1980.)

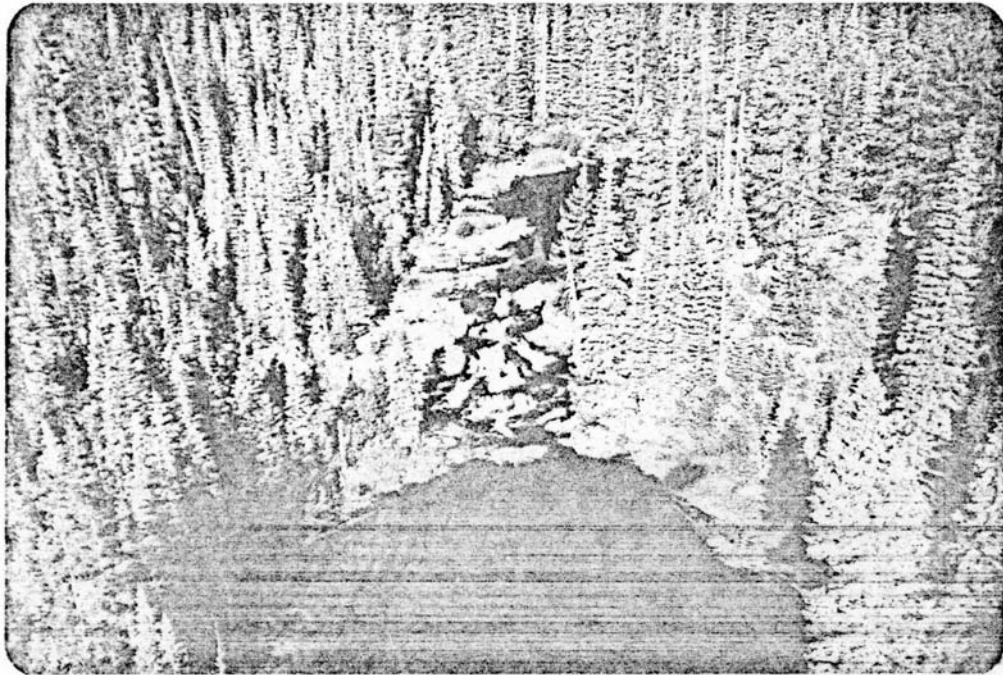
The waterfalls have been mapped as a Reach break between Reaches 2 and 3. They are considered a barrier under all flows and mark the uppermost limit of anadromous species like coho salmon and steelhead trout. The water tumbles down in several stages forming a steep cascade. The bedrock is in layers and looks like it would fracture easily. The area around Kluck Lake abounds in slow moving deep pools, with many slackwater side channels which appear to offer good rearing potential for coho salmon. Beyond Kluck Lake, frequent gravel bars, offering potential spawning habitat are scattered throughout the mainstem. There is approximately 16 km of stream above the falls. Removal of the falls offers an opportunity for a stream enhancement project and is discussed in more detail under "Enhancement Opportunities."

The falls are located at the Reach 2 map symbol, about 9 km from the mouth of the North Fork (see Appendix A, Photos 17-19). They are a series of cascades about 4 meters high and 7 meters across. The rock is in a series of layers, and looks like it would easily fracture. They are considered to be a complete barrier to fish. To date, anadromous fish have been found up to, but not beyond the falls.

- straighter, more confined channel
- steeper gradient
- greater percentage of larges in substrate
- extensive canyon area - no barriers
- 4 meter bedrock cascading falls at upper reach boundary
- falls considered to be a barrier - removal could be a possible habitat enhancement project
- 1 sample point (electroshocking) yielded 18 coho, 33 rainbows and 1 Dolly Varden. In addition, angling at several various times in pool below falls has produced whitefish, steelhead, cutthroats and Dolly Varden.

Photo 17. Aerial view of the falls on the North Fork of Gosnell Creek. Note the large pool at the base of the falls. This pool receives fairly heavy fishing pressure from people transported by helicopter. (August 12, 1980)

Photo 18. Falls on North Fork during high flows (June 3, 1980)

Photo 19. Falls on North Fork during low flows (August 13, 1980)
(Photo courtesy of G. Hazelwood)

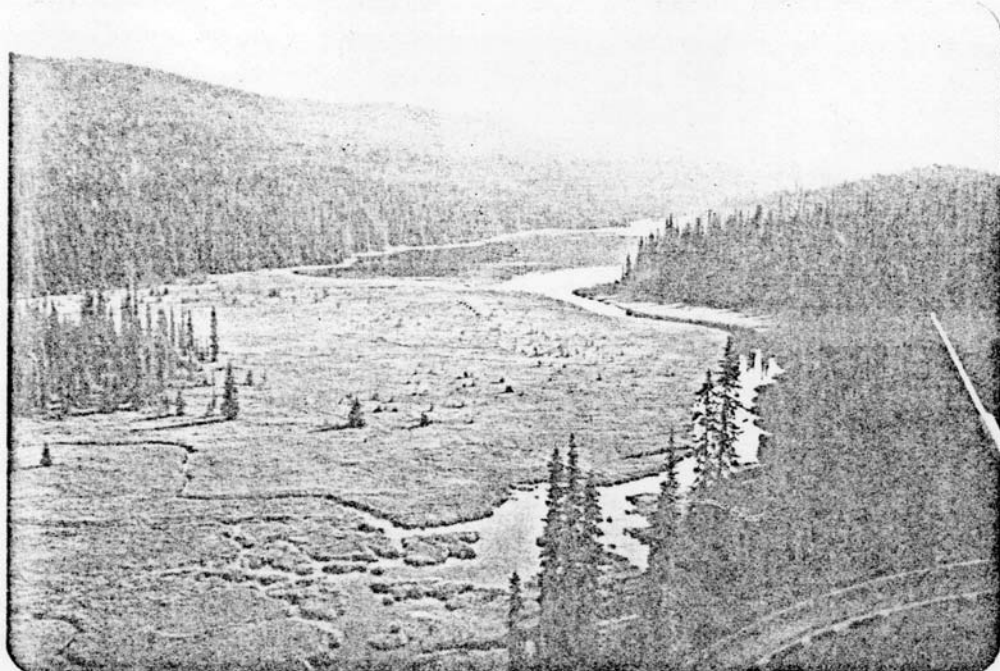
Reach 1 - (mouth to R1)

- confluence area has no defined channel

- immediately above, stream is confined by bedrock
- minor barriers scattered throughout for about 1 km. This probably restricts anadromous fish, especially during low flows
- sampling produced cutthroat trout and Dolly Varden in mainstem and cutthroat trout in tributary from small lake
- some beaver dams in vicinity of sample point
