KILTUIISH RIVER

The Kiltuish River originates in the Coast Mountains 50 km southwest of Kemano and drains into the tidal waters of Kiltuish Inlet, which joins Gardener Canal (Fig. 32). The Kiltuish was surveyed by M. Beere and J. Lough on April 18, 1989.

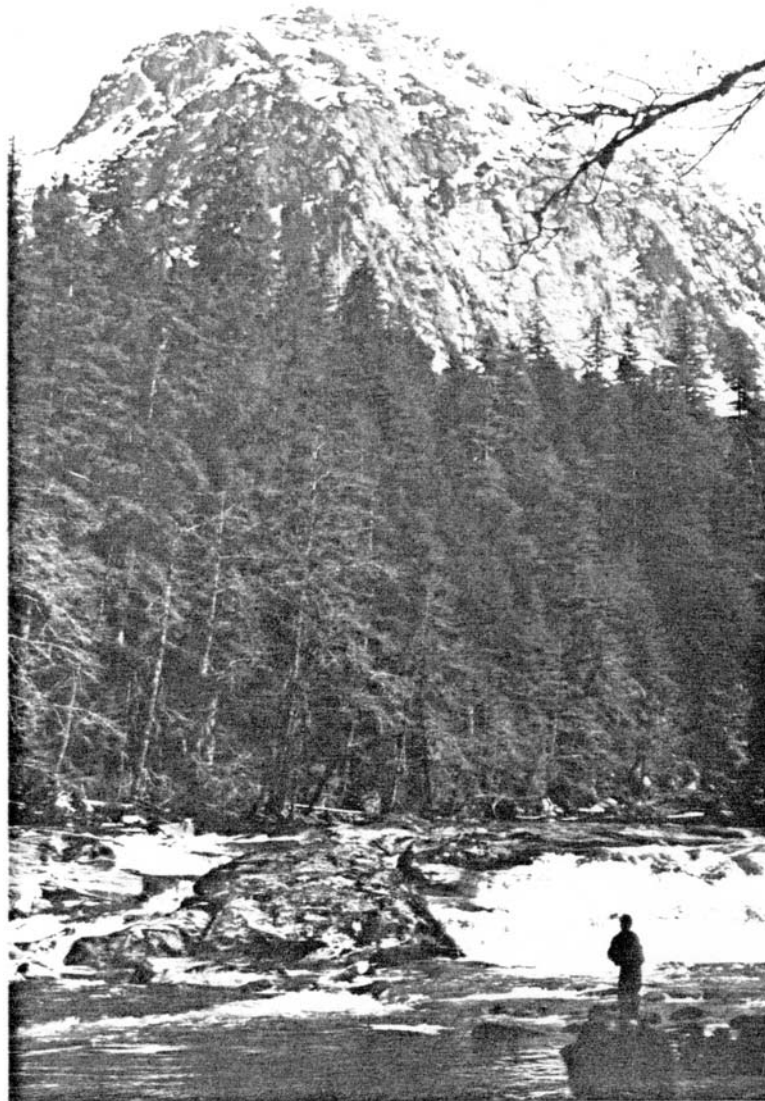
Figure 33. Cascading falls located 2.1 km upstream of estuary.
A male steelhead was caught just below these falls.

Investigations were limited to the lower 2.5 km of the Kiltuish: the only portion accessible to anadromous fish. Cascading falls at 2.0 and 2.1 km, with jumps no more than two meters in height, would be passable to steelhead (Fig. 33, 34). The survey was terminated at 2.5 km, where an impassable falls estimated to be 8 to 10 meters in height was located (Fig. 35). The average gradient of the area surveyed was estimated to be 0.6 to 0.9%.

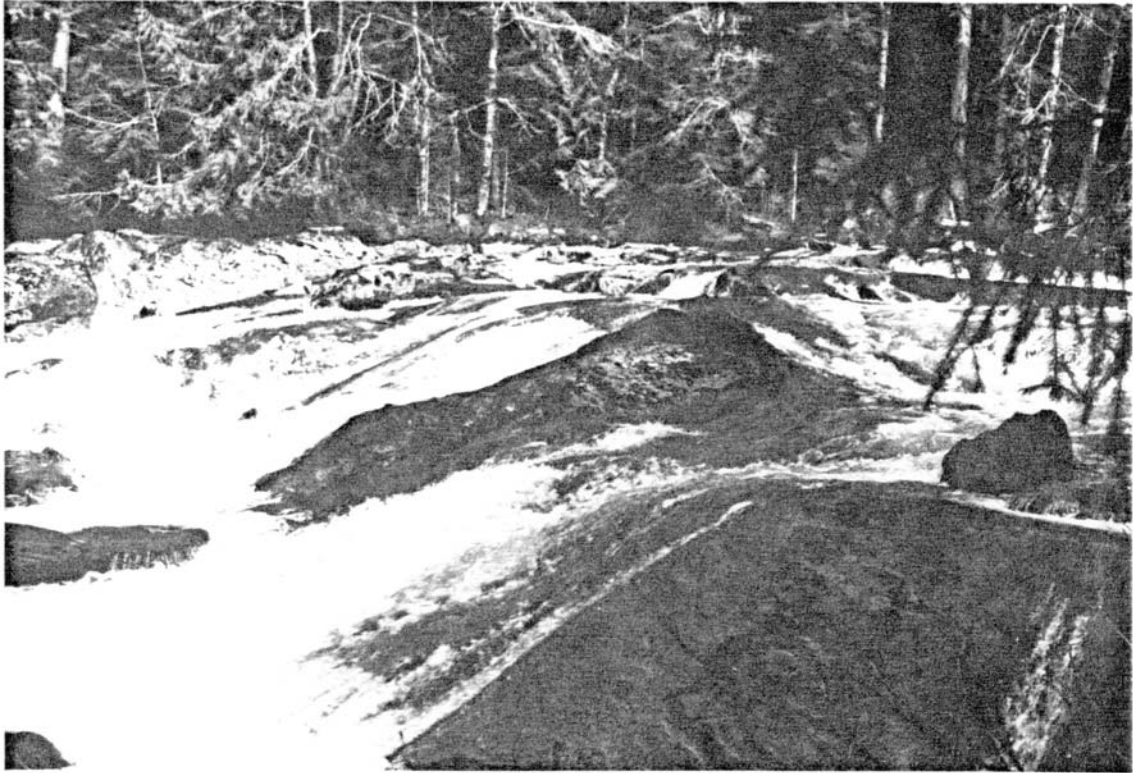
Figure 34. Cascading falls at 2.1 km.

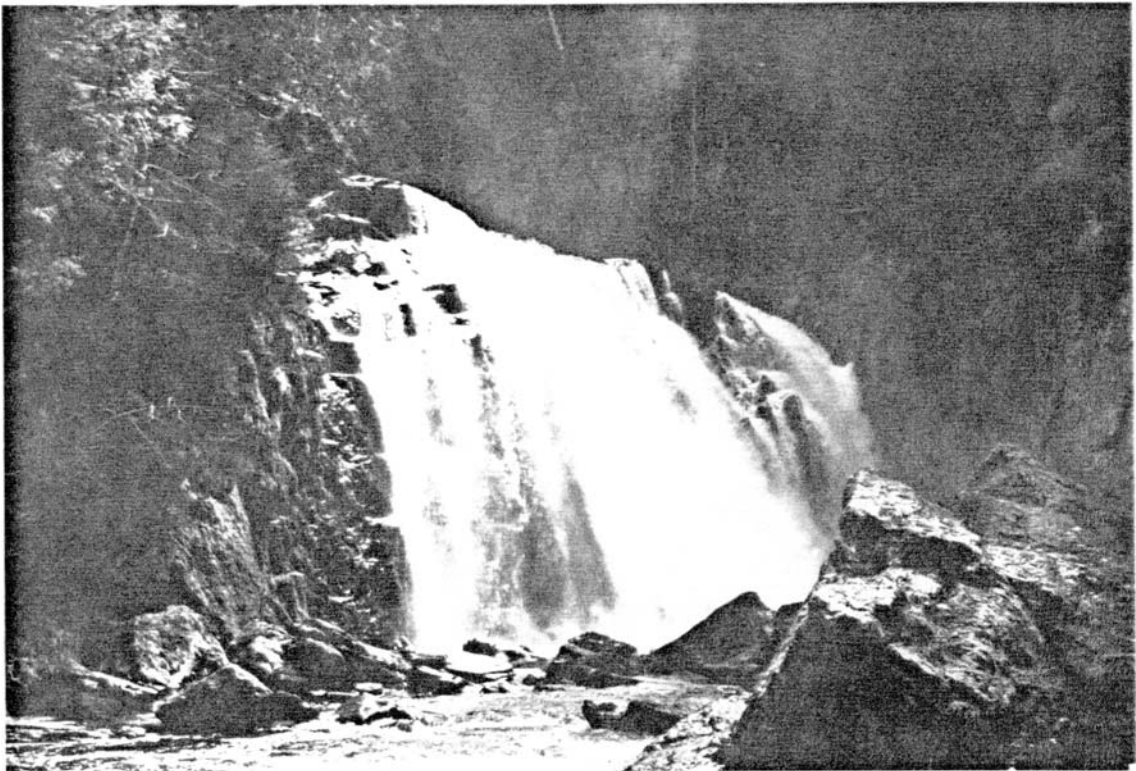
Figure 35. Impassable falls at 2.5 km.
