## **WEEWANIE CREEK**

## **LITTLE FOCH CREEK**

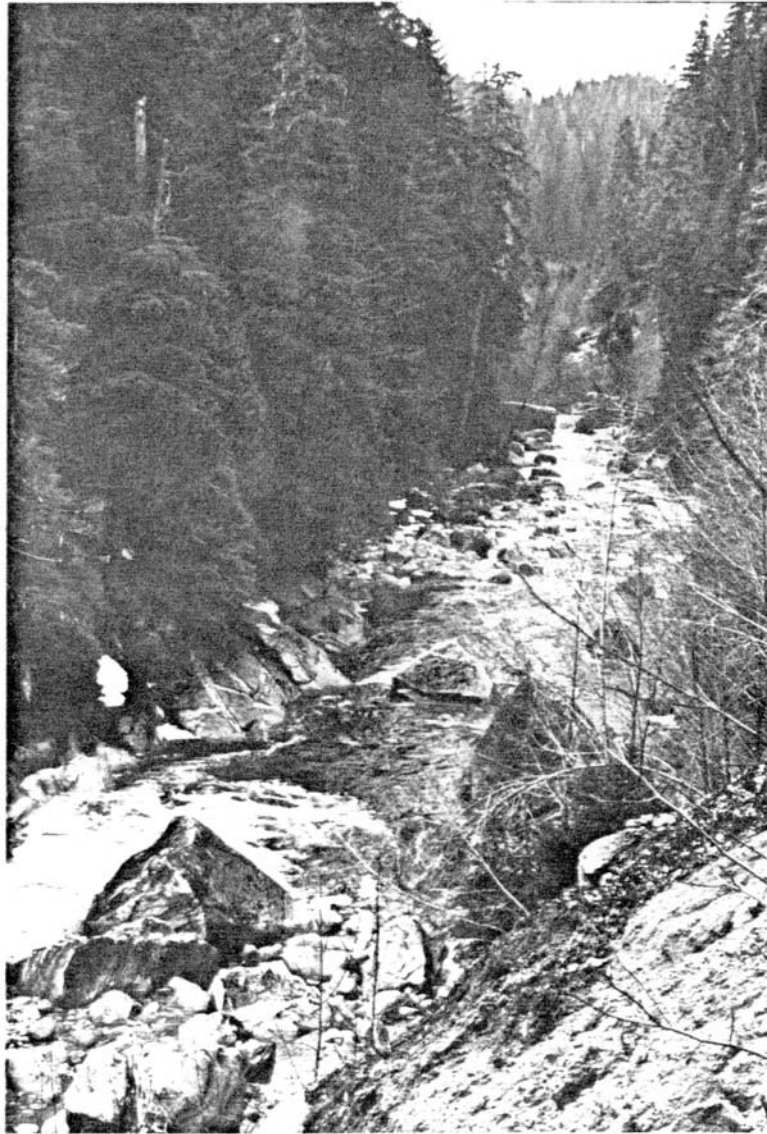
Figure 44. Weewanie Creek 1.5 km upstream of the estuary

Only the lower 3 km of the Weewanie was investigated in this survey. This section was characterized by a relatively high gradient, ranging between 0.7 and 1.5%. Our survey took place at a moderate discharge and the flow pattern at that stage consisted of cascades alternating with deep slower moving pools (Fig. 44). Sets of falls at 2.5 and 14.5 km are both passable by coho (Manzon and Marshall, 1981). The wetted width of the Weewanie ranged between 15 and 30 meters and had a flood width ranging between 15 and 40 meters.

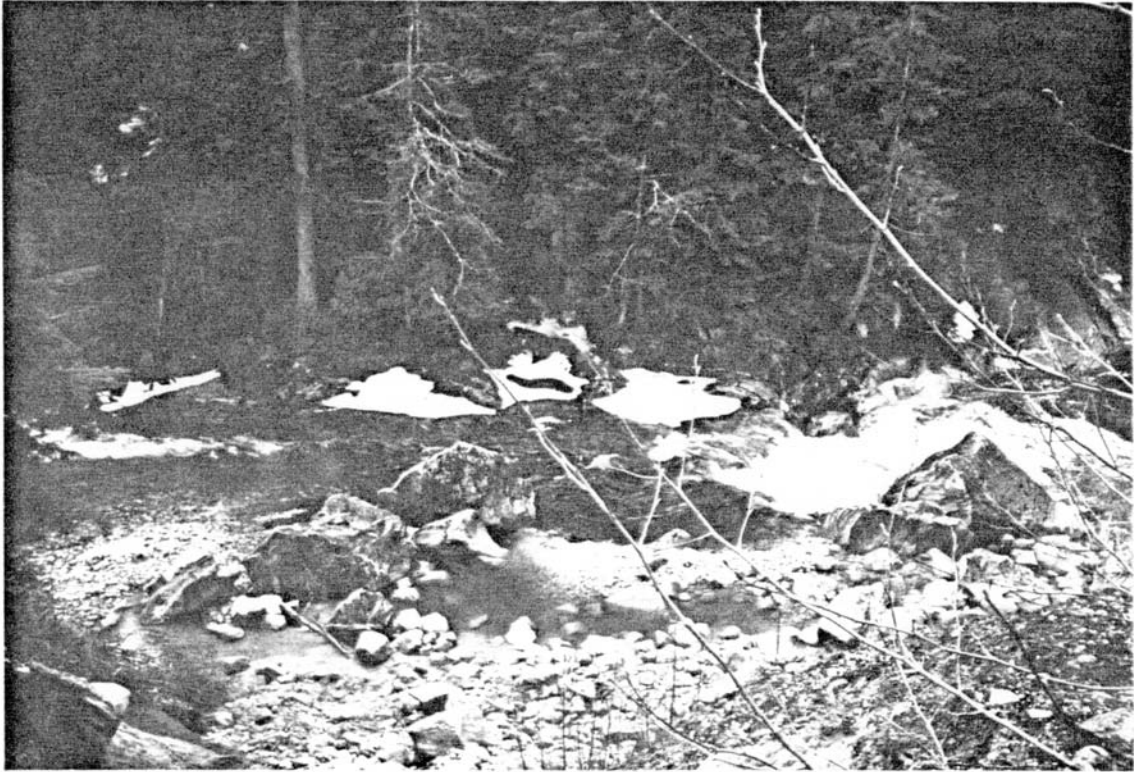
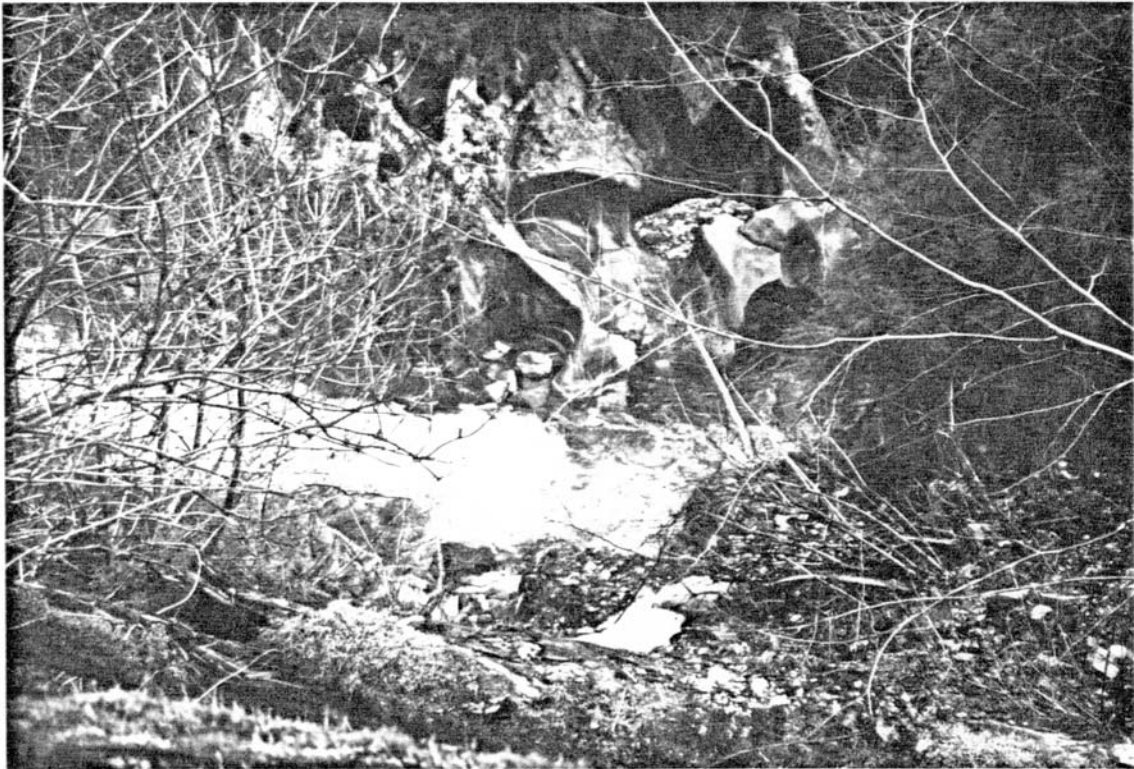
Figure 45, 46. Weewanie Creek 2 km upstream of the estuary.

Typical of many coastal streams, the Weewanie appeared to be oligotrophic and was tannic in colour during the survey (Fig. 45). The estuary was rather truncated.

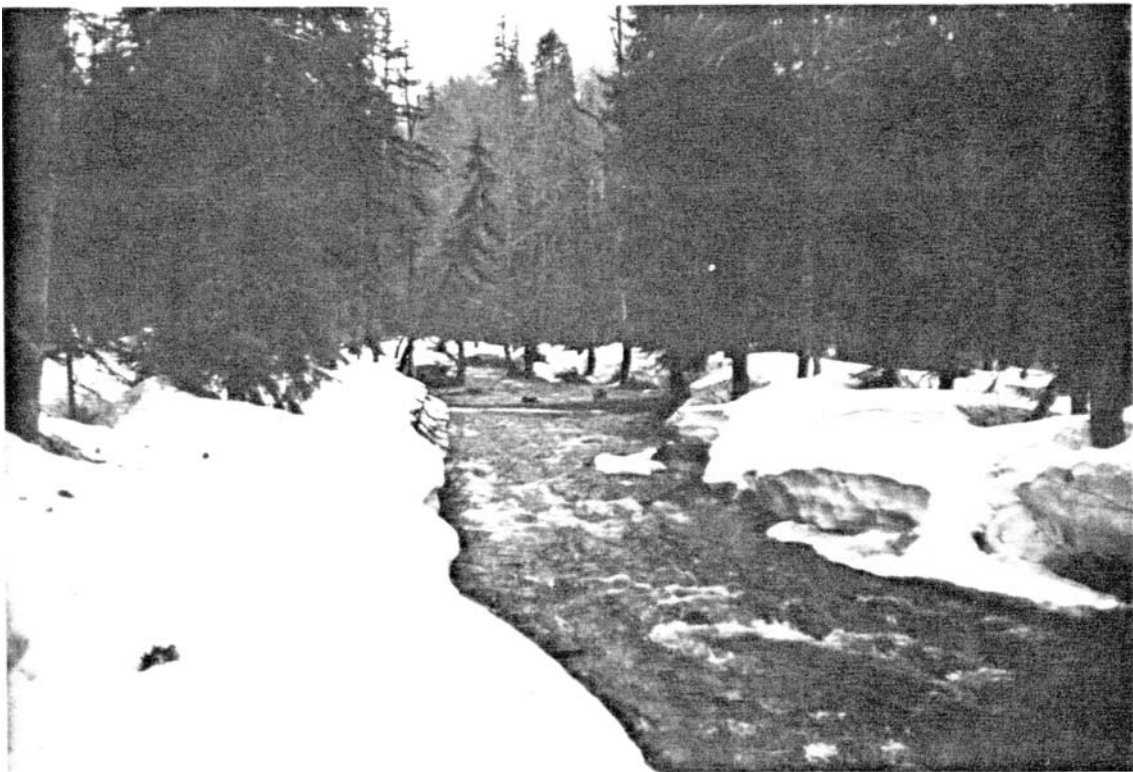
Figure 49. Little Foch Creek about 1 km upstream.

Little Foch Creek is a lake headed system which flows 2.5 km from Foch Lake to Foch Lagoon. The lower 2 km of the creek was investigated on foot commencing at the estuary. At the 2 km point, there was a 6 meter two step falls which appears to be impassable to fish. The creek had an estimated gradient of 0.5 to 1.5% and a substrate of primarily cobbles, some bedrock and a few small sections of spawning gravel. The creek channel was quite straight, with a wetted width of 5 to 8 m and an estimated flood width of 20 meters (Fig. 49).

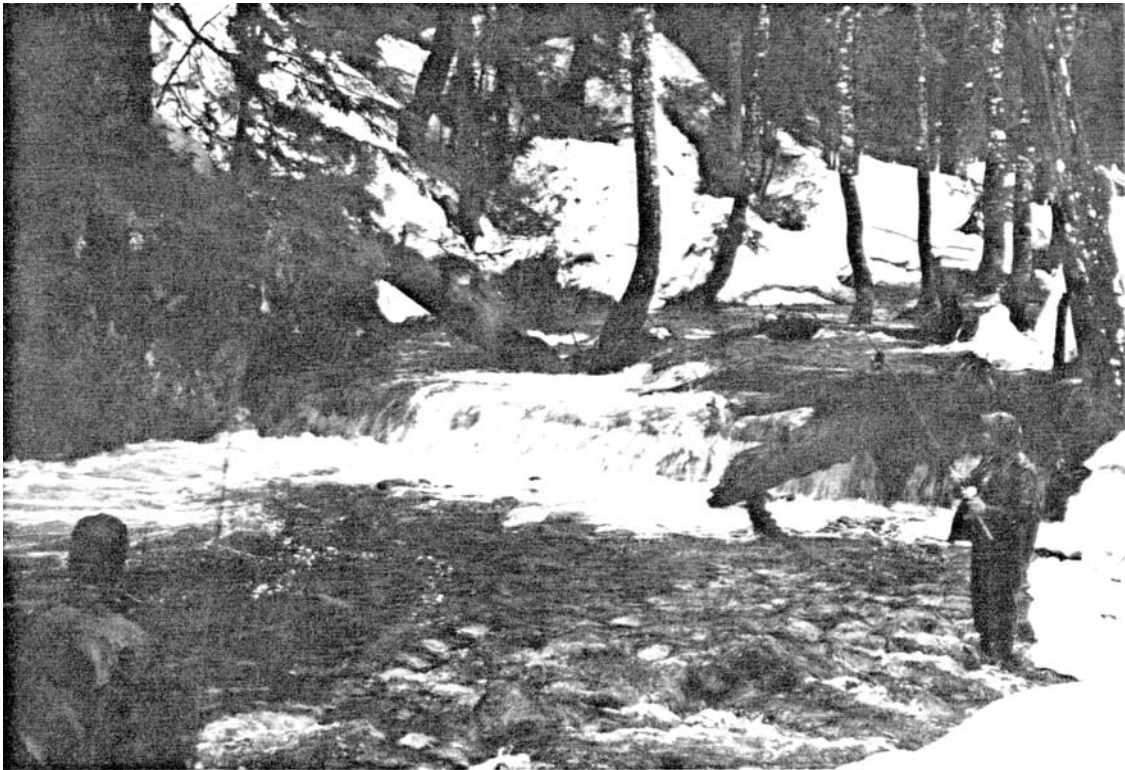
Figure 51. One of the "pools" 1 km upstream from the estuary.
