# **Mission Creek**

# **Hydrological Risk Assessment**

**BC Ministry of Environment**

**February, 2010**

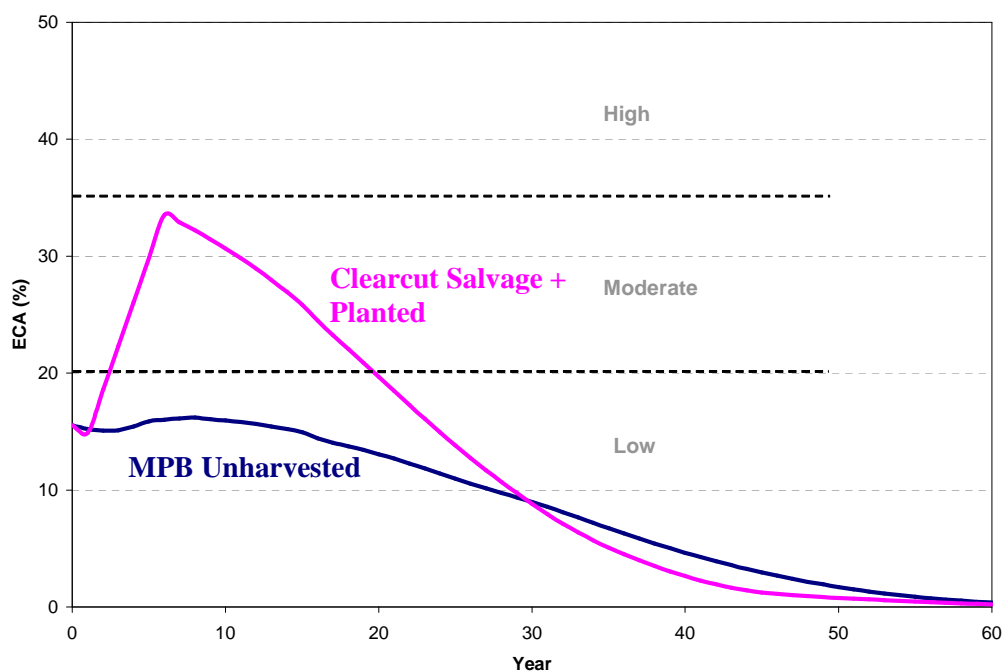
Figure 10. ECA progression for Mission Creek Watershed above BMID intake.

The current watershed ECA is low. Following full pine mortality and no harvesting there is, on average, a Low ECA hazard for approximately 25 years. That is, a significant increase in hillslope surface or subsurface runoff is not expected. For the full pine salvage harvest scenario there is a Moderate incremental ECA hazard lasting for 15 to 20 years. That is, a significant increase in hillslope runoff may or may not occur.

Similarly, the likelihood of increased peak flows following the unharvested MPB scenario is Low, and following the full salvage harvest scenario it is Moderate. However, Mission Creek has a history of excess sediment delivery to mainstem channels from numerous natural landslides, and to a lesser extent from forest and public road developments. Increased sediment from historic landslides has led to mainstem channel widening and erosion of thick unconsolidated stream bank sediments, which causes further erosion and channel widening in a negative feedback loop. This has resulted in long reaches of aggraded mainstem channel with excess sediment loads. These aggraded mid-watershed reaches are highly sensitive to any changes in peak flows and sediment loading, which could result in increased sediment mobilization to lower reaches. Combining the High channel sensitivity with a Low peak flow hazard following the unharvested MPB scenario there will be a Moderate watershed hydrologic hazard at the BMID water intake. Combining the High channel sensitivity with a Moderate peak flow hazard following the full salvage harvest scenario, there will be a High hydrologic hazard at the BMID intake.

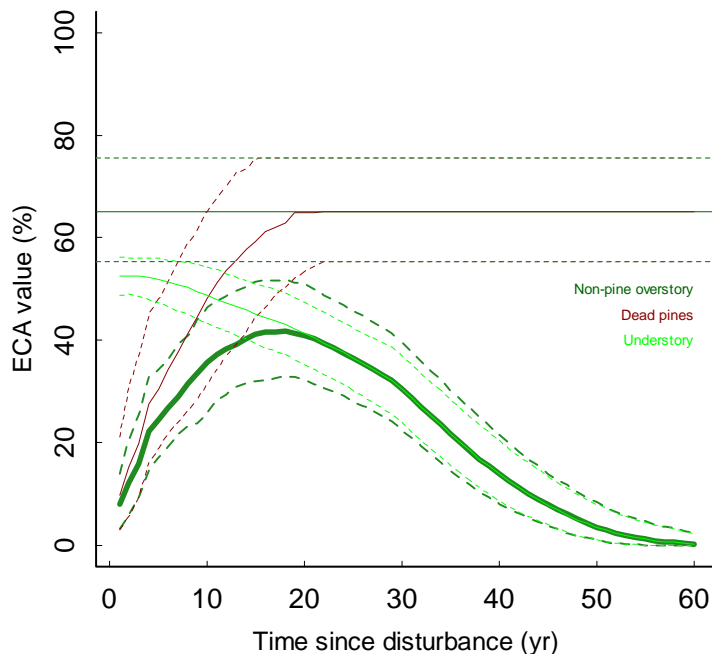
Huggard and Lewis (2008) also conducted sensitivity analyses on many of the critical input parameters, including percent mortality of natural understory, understory species composition, TIPSYP vs. VDYP regrowth modeling, different regeneration stocking delays, and other modeling components/assumptions. Generally the salvage vs. non-salvage ECA curves were found to be most sensitive to the percentage of non-pine overstory, as shown in Figure 3.

It should be noted that the solid lines in Figure 3 are average values of the many different individual site conditions one would encounter in actual stands throughout a particular BEC variant.

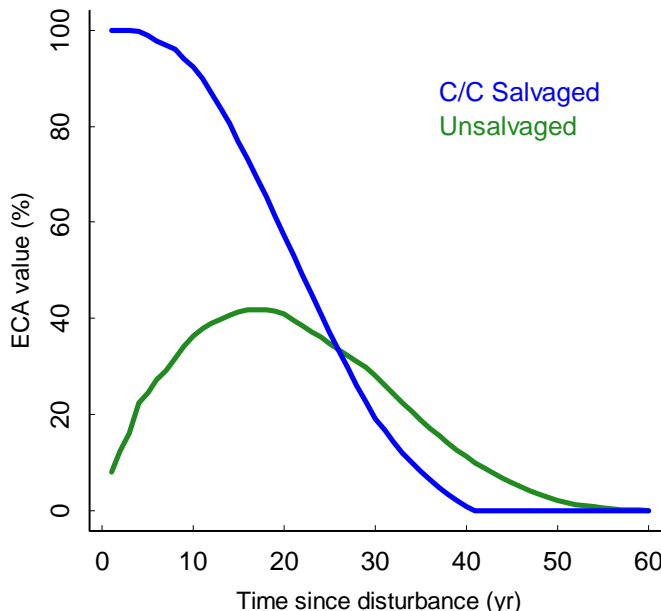
ECA curves for clearcut harvested attacked stands were also developed, based on expected regrowth rates of planted stands. Figure 4 shows a comparison of the unharvested and harvested ECA progression over time, for the same stand type shown in Figure 3. Similar curves were developed for all major BEC zones or subzones in the hydrologically important upper portion of the watershed. To arrive at a watershed ECA the cumulative effect of the different ECA progressions in different BEC zones in the watershed is calculated.

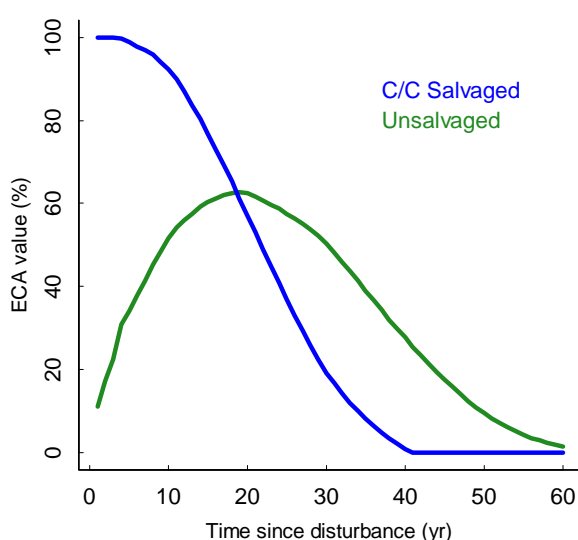
Figure 6. ECA progression in younger pine-leading MSdm stands (70 to 110 yr).

ECA progression curves for younger MSdm (Photo 20) are based on 64 plots in 8 pine-leading stands (Figure 6). The measured overstory pine component averages about 90%. Average understory is 280 well-spaced stems per ha (>1.3m tall) per ha. The older MSdm ECA curves (Figure 7) are based on 85 plots in 10 stands with an average overstory pine component of 74.0 % and an average understory of 560 well-spaced understory stems >1.3m tall per ha.

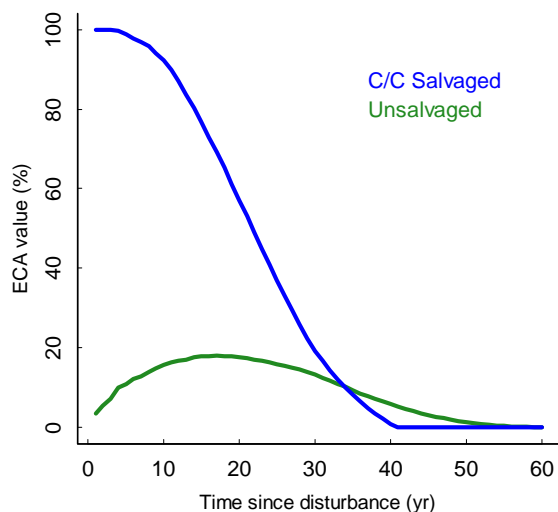
Figure 8. ECA progression in ESSFdc stands

ESSFdc ECA curves (Figure 8) are based on 56 plots in 7 stands. In stands labelled as 100% pine or >80% pine, the actual measured overstory pine component averages 30.7%. The rest of the overstory is approximately equal amounts of spruce and balsam. The average understory has 1,000 well-spaced stems (>1.3m tall) per hectare (Photo 21). So, based on the field data, these stands are not actually pine-leading, even though the Vegetation Resources Inventory (VRI) forest cover data indicates that it is.

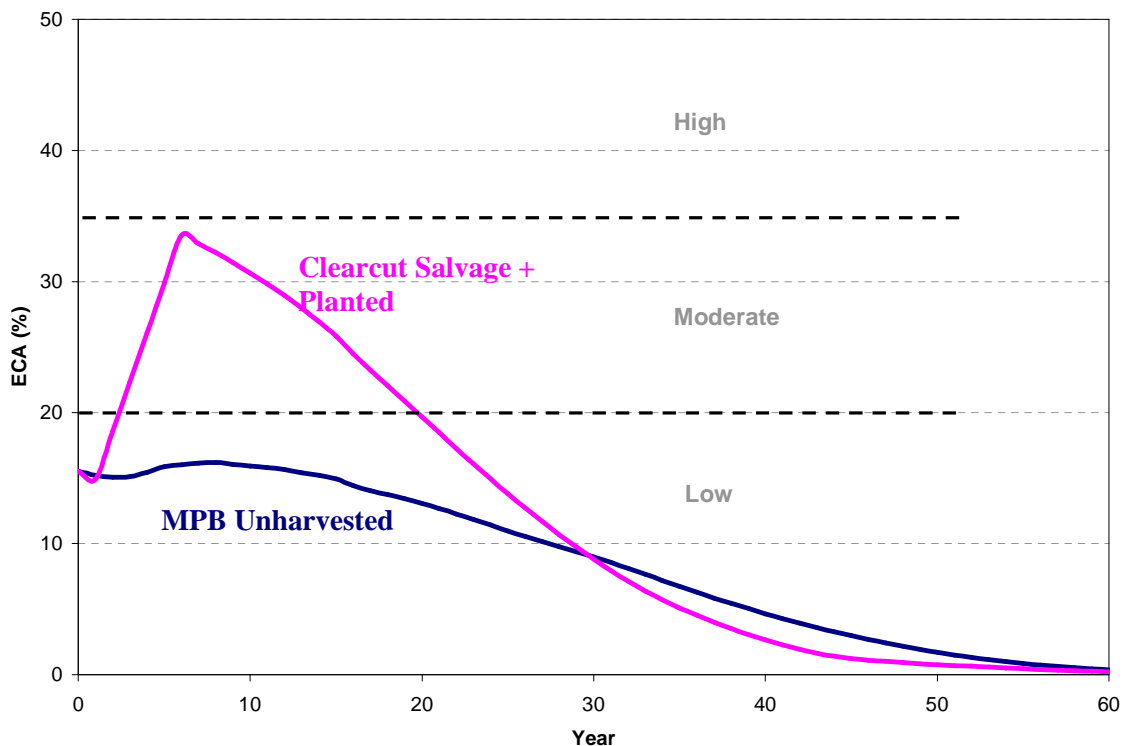
**Figure 9.** ECA progressions for Mission Creek Watershed above H<sub>54</sub> elevation, assuming full pine mortality from MPB infestation, full understory survival and no harvest scenario (blue) and full salvage harvest of pine-leading stands scenario (pink).

In Figure 9, the sustained ECA hazard for the MPB/unharvested scenario is approximately the centre of the area under the curve above the low hazard level. The current watershed ECA is low. Following full pine mortality and no further harvesting the ECA level remains low, slowly decreasing to 10% in approximately 30 years. That is, with the overstory and understory survival assumptions made, the ECA effects of MPB mortality (and no further harvesting) noticeable ECA (or snow accumulation and melt) effects are not expected. Similarly, the centre of the area under the ECA curve for the hypothetical full pine-leading stand salvage scenario, relative to the MPB/unharvested curve, suggests there is a sustained Moderate ECA hazard for about 15 years. Within this time period noticeable ECA effects may or may not occur.

While individual sub-basins show quite different expected ECA progressions over time, the cumulative effects of significant past harvesting and recovery, and of stand types at higher elevations with little pine to be attacked or salvaged - as measured to the BMID water intake, is a relatively low ECA effect following either management scenario (Figure 9).

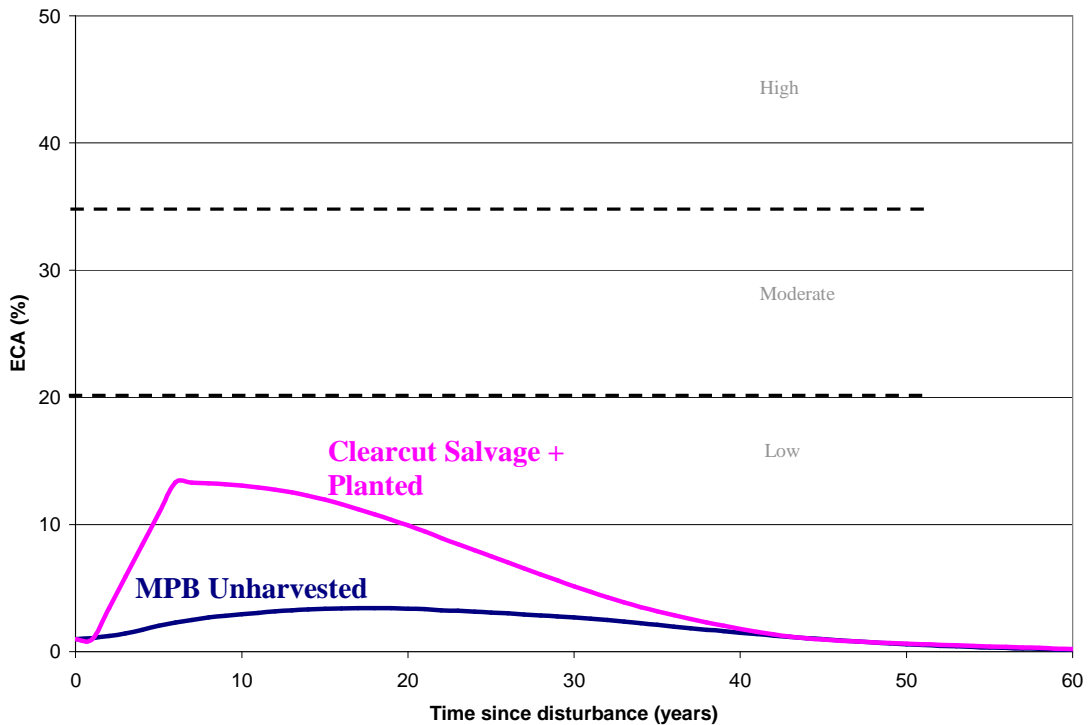
**Figure 11.** ECA progression for Upper Mission sub-basin, in Graystokes Provincial Park and with ESSFxc stands, which VRI data shows have very little pine-leading forest.

Upper Mission sub-basin (Figure 11) has a negligible (<1%) current ECA value. Post-unharvested and post-total harvest management scenarios yield very low to low ECA values, because most of the sub-basin is comprised of ESSFxc stands, which the VRI inventory shows have few pine-leading stands to either be attacked by MPB or to be salvage logged. Note that this assumes only MPB salvage harvest will occur in the watershed. Most of the sub-basin is also within Graystones Provincial Park where there will be no salvage harvesting. Upper Mission is entirely within the Mission watershed snow zone above 1400m elevation, and thus has a strong moderating influence on total watershed ECA.

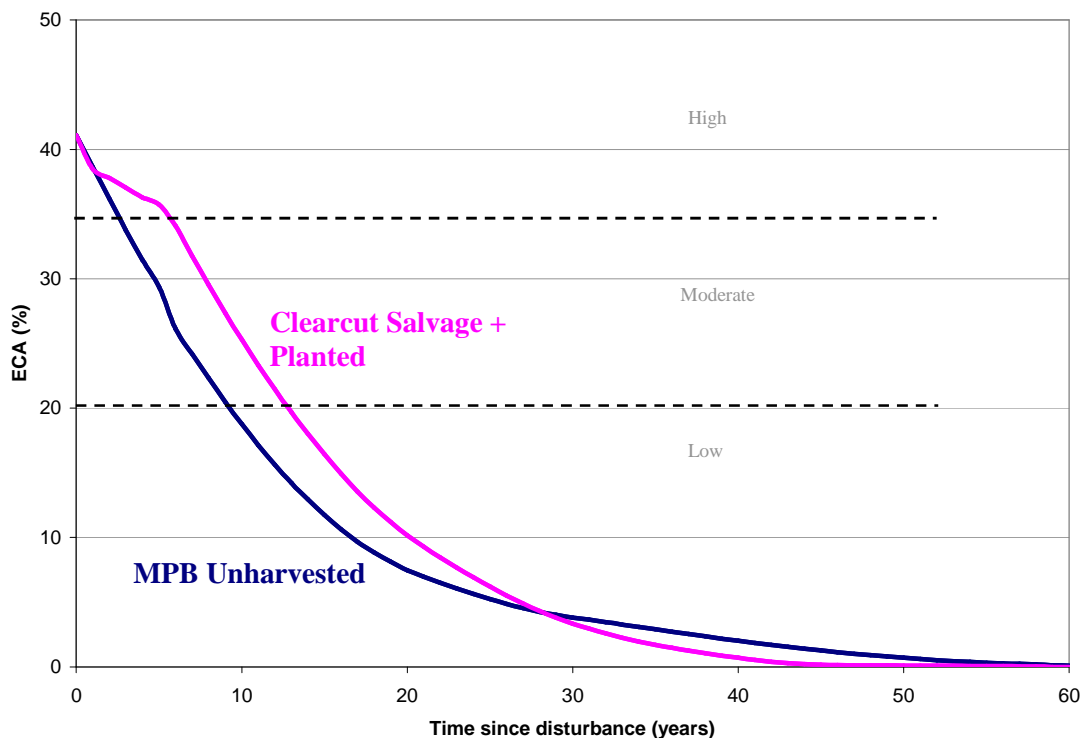
**Figure 12.** ECA progression for Daves Creek sub-basin with extensive harvesting between the late 1970s through the 1990s, resulting in a currently High ECA. There is little pine left to salvage, planted stands are recovering, and both scenarios decrease to a Low ECA level in about 10 years.

Daves Creek (Figure 12) and Mid Mission residual sub-basins have been extensively logged from the late 1970s through the 1990s. Those harvested areas are now presumed to be successfully planted and restocked, and experiencing ECA (and hydrological) recovery. In Daves Creek ECA due to harvesting alone in 1998 was 47% (Dobson, 1998), and has now decreased to a combined current harvest and MPB ECA of 42%, still the highest in the watershed. But because there is little pine left to harvest and planted stands are recovering, there is no increase expected in ECA from either the unharvested or full harvest scenario over time; and ECA values decrease to Low in about 10 years. In Mid Mission residual conditions are similar to Daves Creek in the lower part of the sub-basin, with extensive past harvesting and current recovery. Because the upper Mid Mission sub-basin is largely ESSFxc forest, there is little pine to be attacked or harvested, and current and future overall ECA levels in Mid-Mission are lower than in Daves Creek.

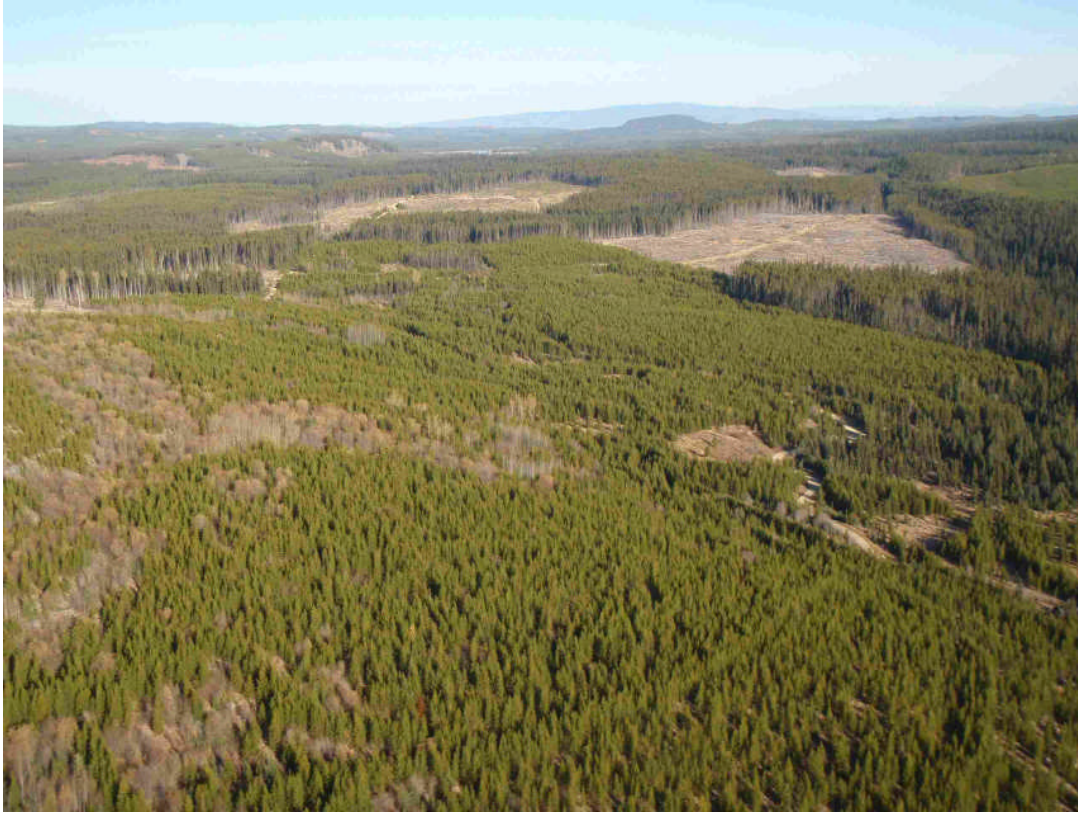
**Photo 1.** Broad gently sloping upland plateau of Mission Creek watershed, in Belgo Creek drainage. Large clearcut with regeneration in foreground harvested in 1980s.

The plateau area of the Mission Creek watershed is dominated by rolling, flat (<7%) to gentle (7 to 30%) sloping glaciated terrain (Photo 1). Upland plateau tributaries are generally weakly incised. It is apparent on mapping and aerial photography that the drainage pattern on the plateau trend in a north/south direction, an apparent artefact of historic glaciation in the region. Although the drainage density on the plateau is relatively high, slow routing of runoff through the complex system of low gradient channels, lakes and wetlands can be expected. Most of the

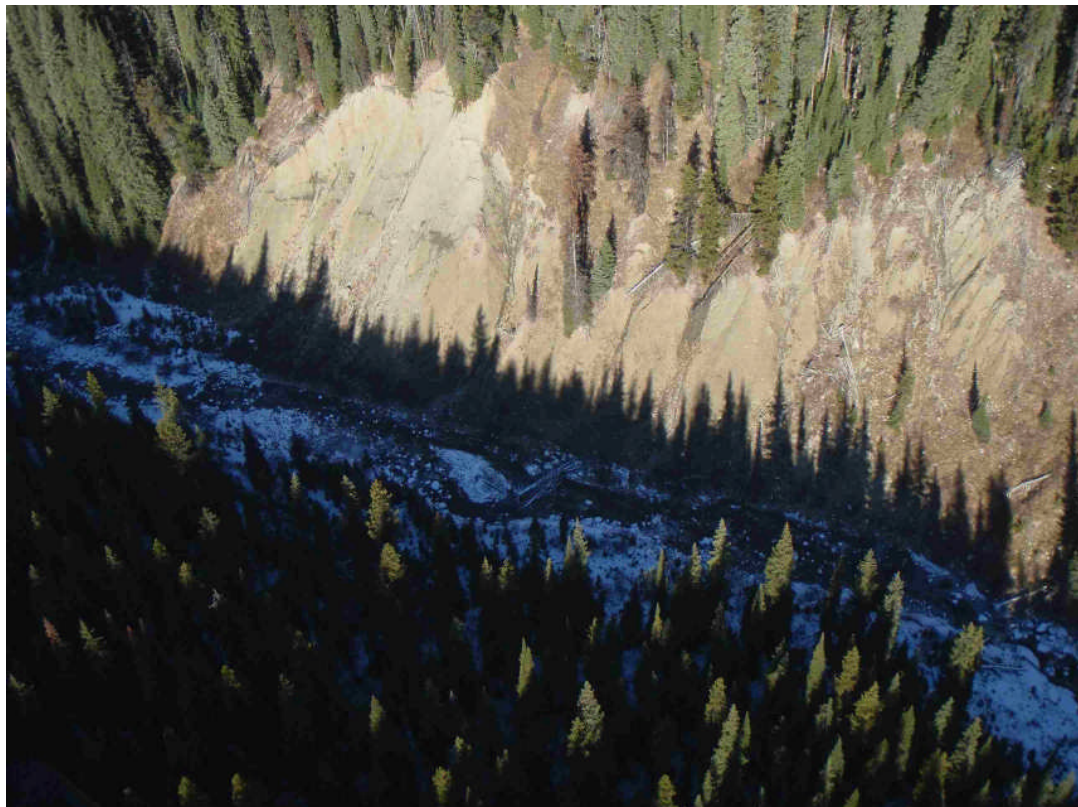
**Photo 2.** Typical failing till sideslope of lower Fish Hawk Creek, delivering sediment to channel.

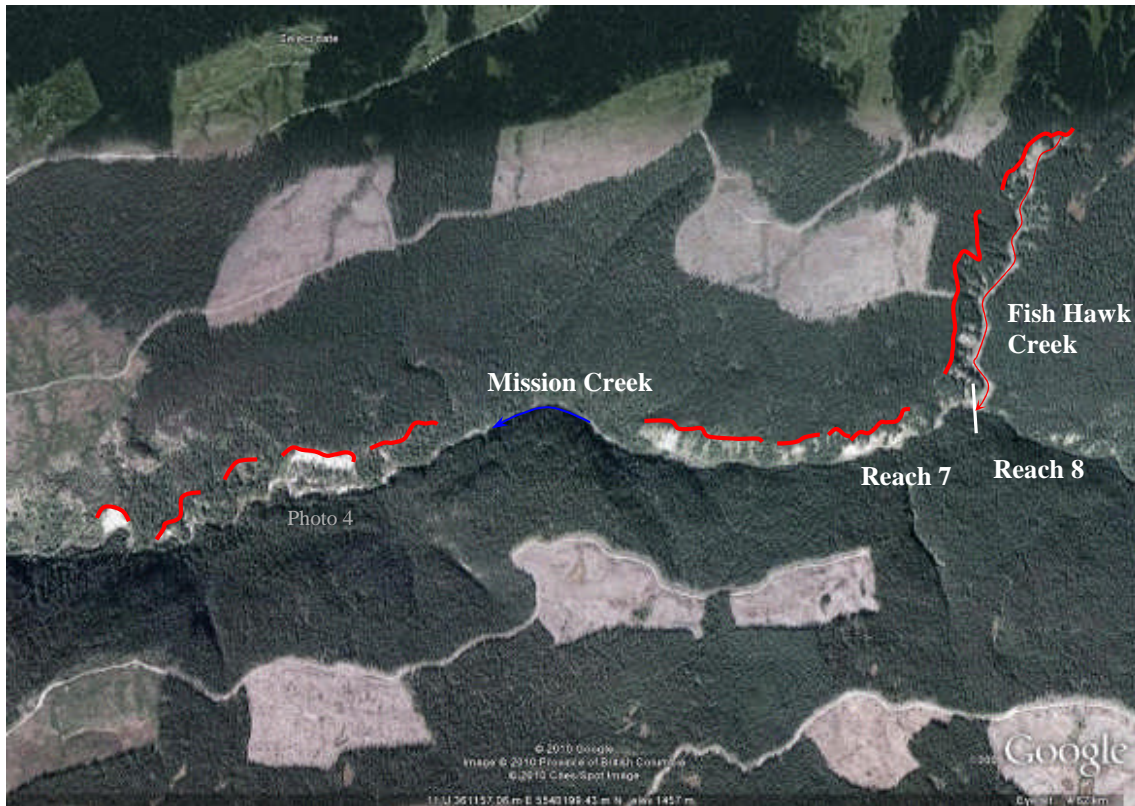
Photo 3. Lower Fish Hawk Creek debris flood/flow to junction of Upper Mission Creek (narrow red arrow), with numerous large landslides over time into both Creeks (thick red lines). Most cutblocks and roads in photo postdate landslides, which are not related to forest development (Google Earth image).

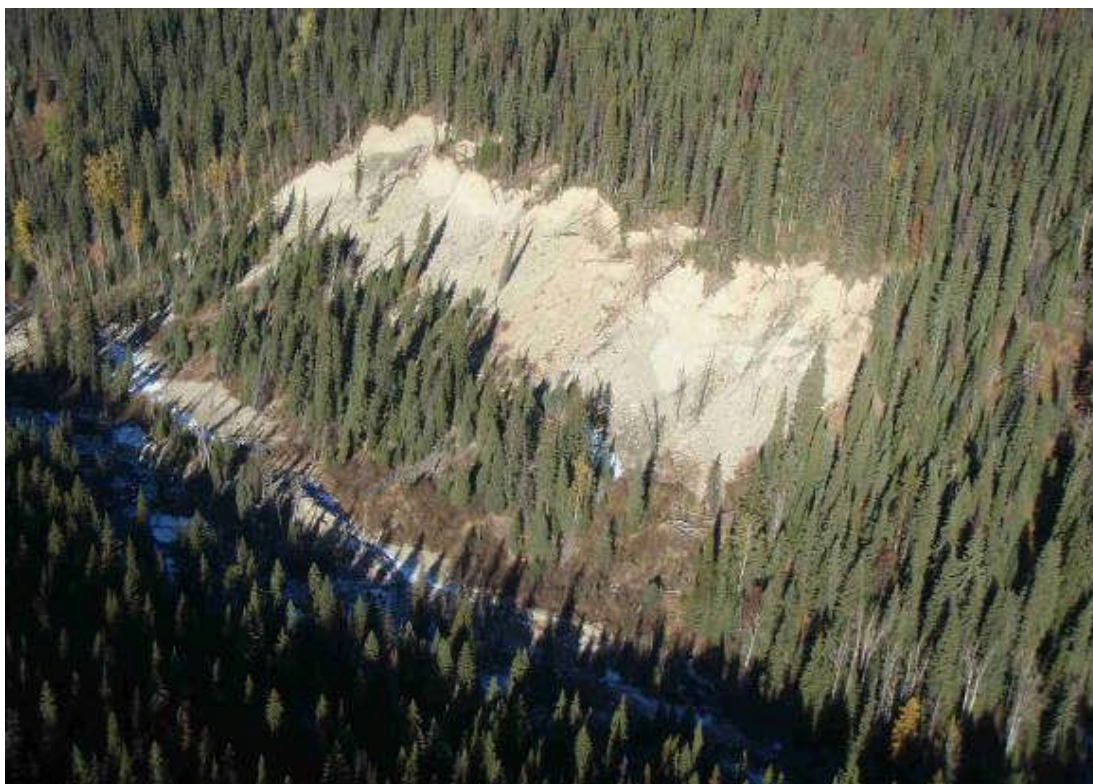
Photo 4. 250m long debris slump in Reach 6 Mission Creek. Initiated during 1997 high peak flows.

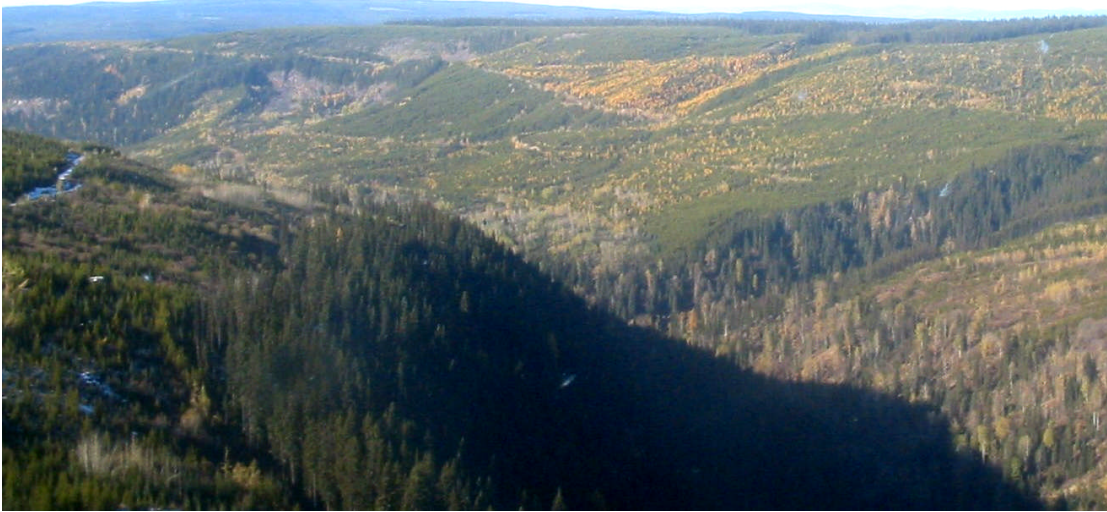
**Photo 5.** Regenerating valley sidewalls of Mission Creek in Reach 6, intensively harvested in 1980's.  
Note riparian reserve in steep gully to right of photo.

Lower in mid-Mission sub-basin, valley slopes and ridges on both sides of the creek have been extensively harvested during a previous MPB outbreak in the 1980's, with mixed riparian management practices (Photos 5 and 6). Where Mission Creek flows through salvage harvested area upstream of Pearson Creek confluence, Westrek (2000) noted 10 forest road-related landslides in the Mission Creek. Many of these impacted the creek directly, and were not present on pre-logging photographs. Westrek suggests that these could be related to redirection of surface drainage from road ditches, surfaces and cross-ditches onto open slopes that have not previously experienced such flows. Gooding (1998) notes that private land logging of riparian area up to stream banks along Mission Creek above and below the Pearson Creek confluence had weakened banks, with serious bank erosion and stream widening occurring in the 1997 flooding.

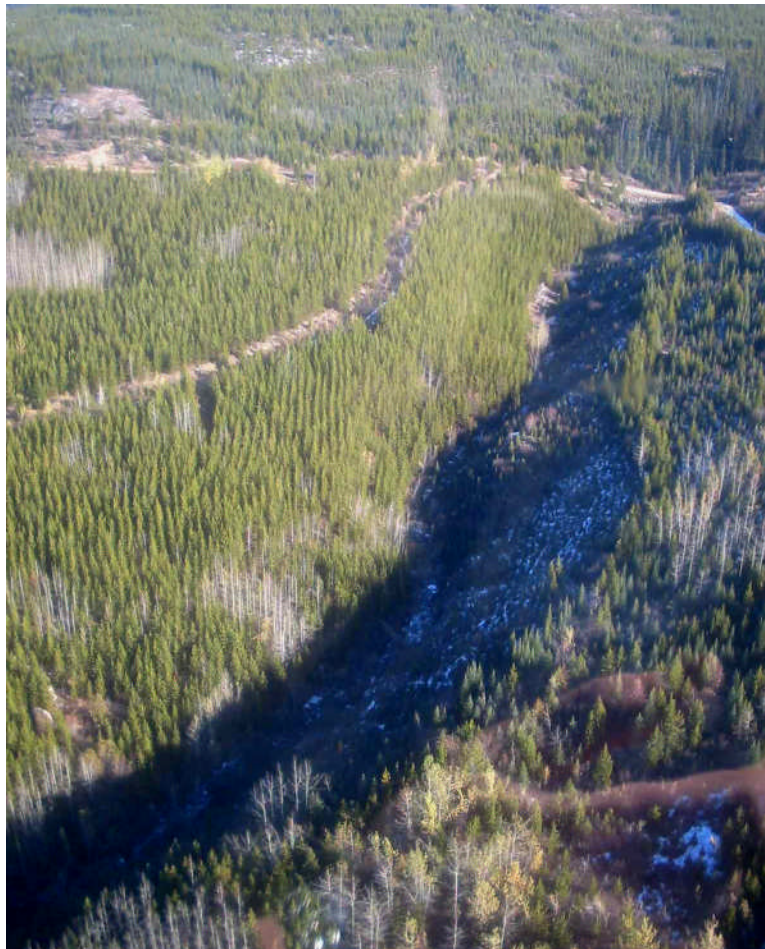
**Photo 6.** Regenerating 1980's harvesting, with no riparian retention  
around section of tributary gully to Mission Creek (Reach 6)

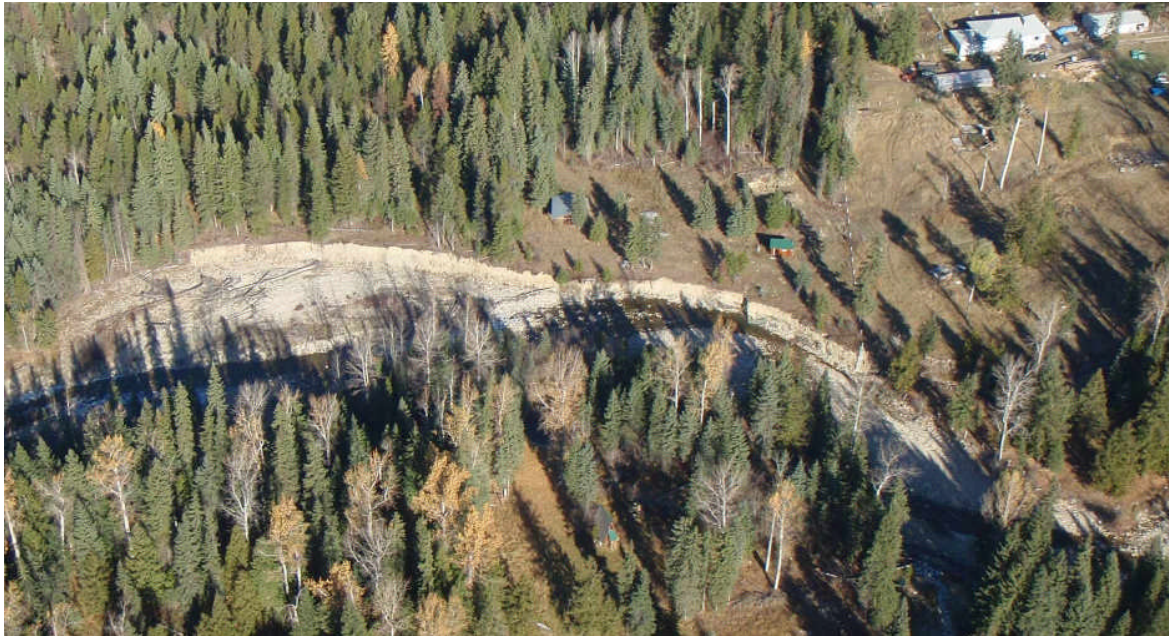
**Photo 7.** Mission Creek (Reach 5) bank erosion of thick sand, gravel and cobble glaciofluvial and fluvial sediments.

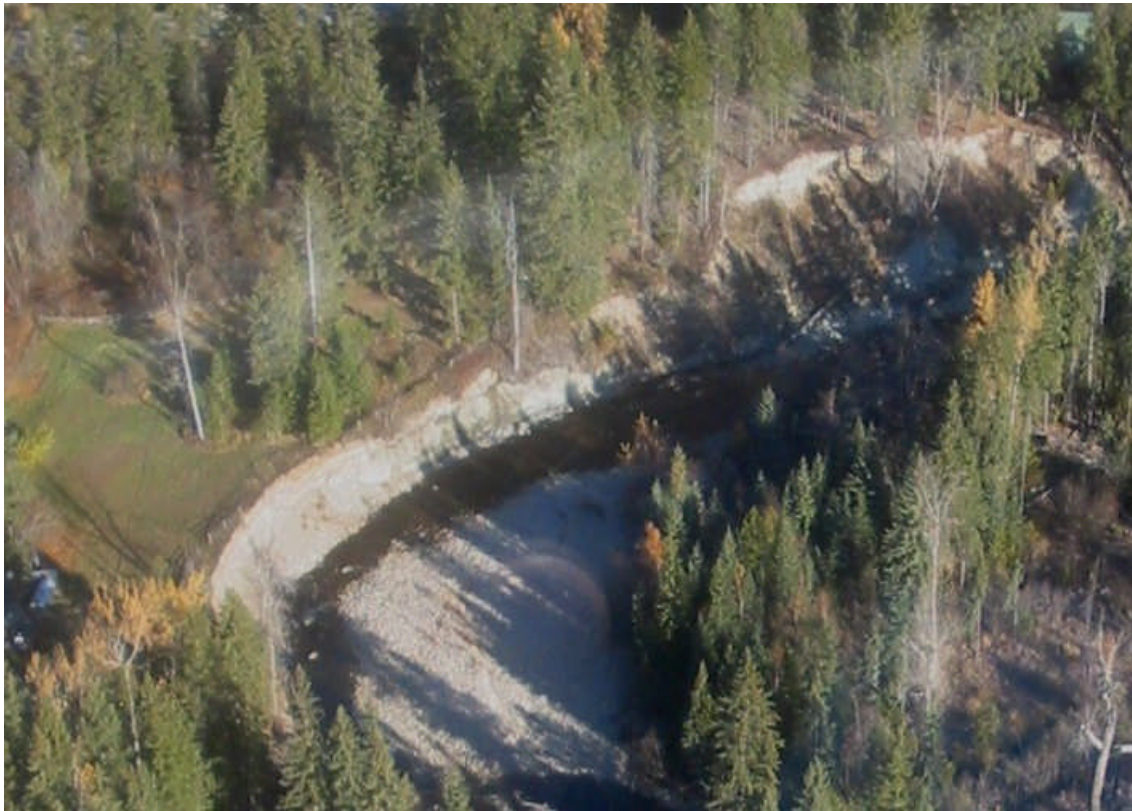
**Photo 8.** Mission Creek (Reach 4) bank erosion of thick sand, gravel and cobble glaciofluvial and fluvial sediments.

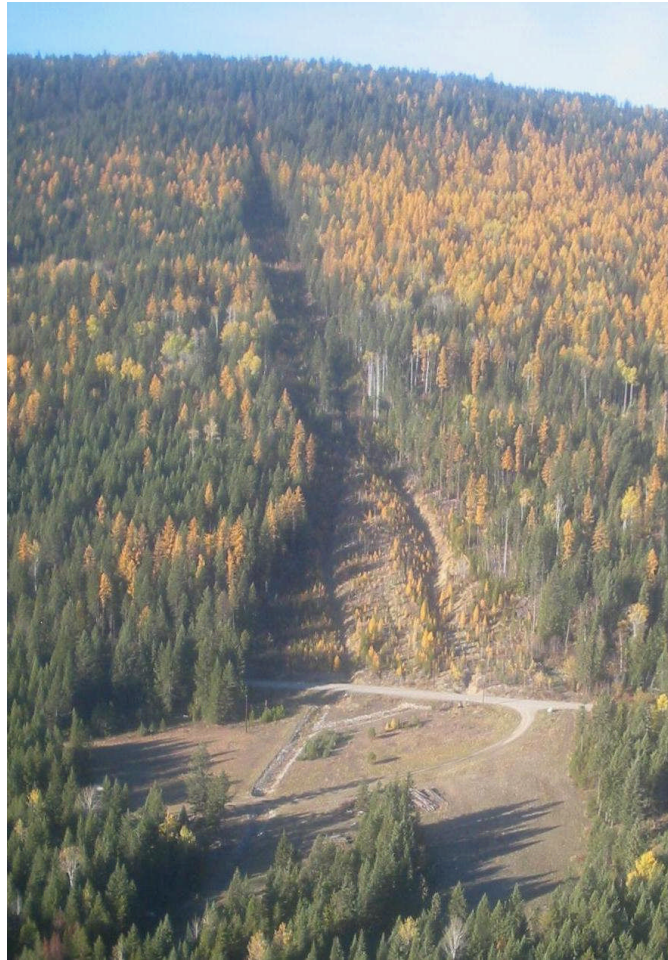
**Photo 9.** 1500m long, 17ha landslide responsible for 3 fatalities on Philpot Road in 1990, caused by drainage redirected along forest road.

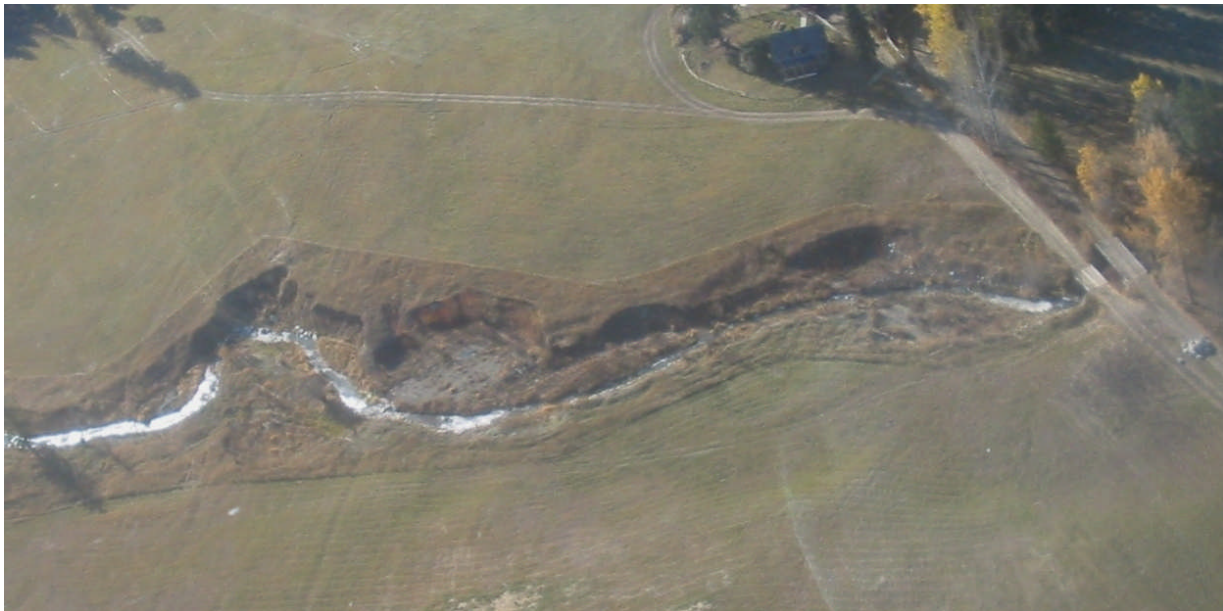
**Photo 10.** Section of Joe Rich Creek floodplain on private land, with flood plain vegetation removed and severe bank erosion.

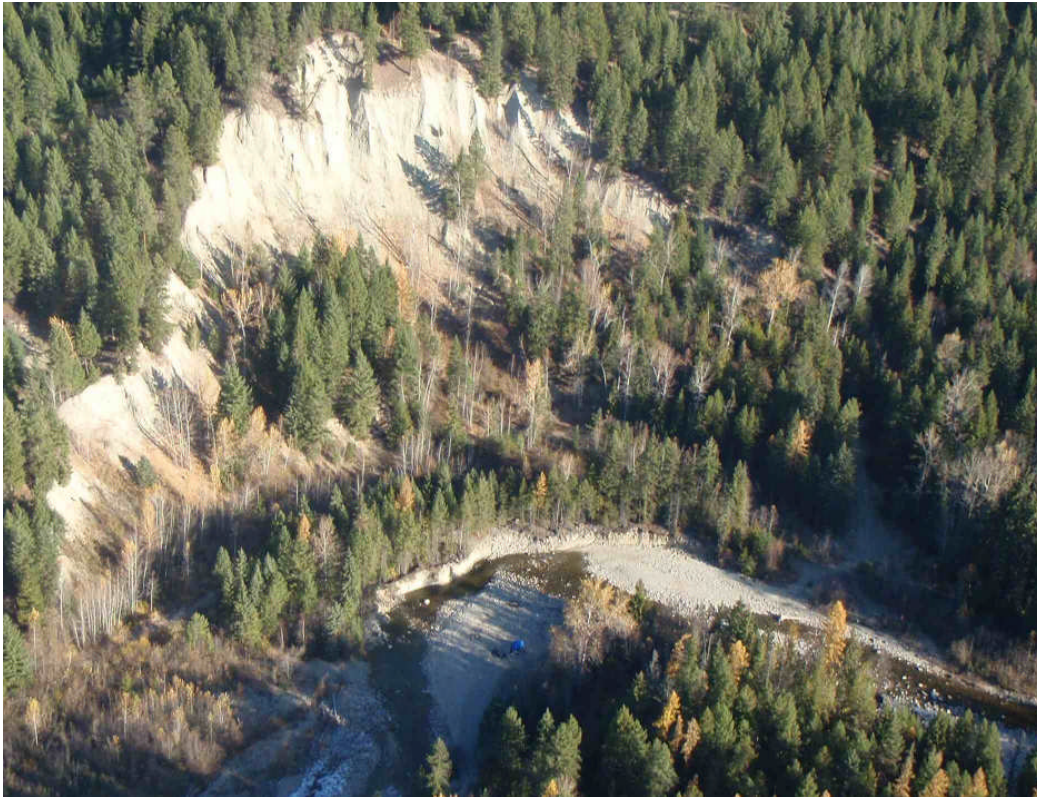
**Photo 11.** Reach 4, about 4.5km upstream of BMID intake. Large debris slump and Mission Creek eroding thick toe of slide

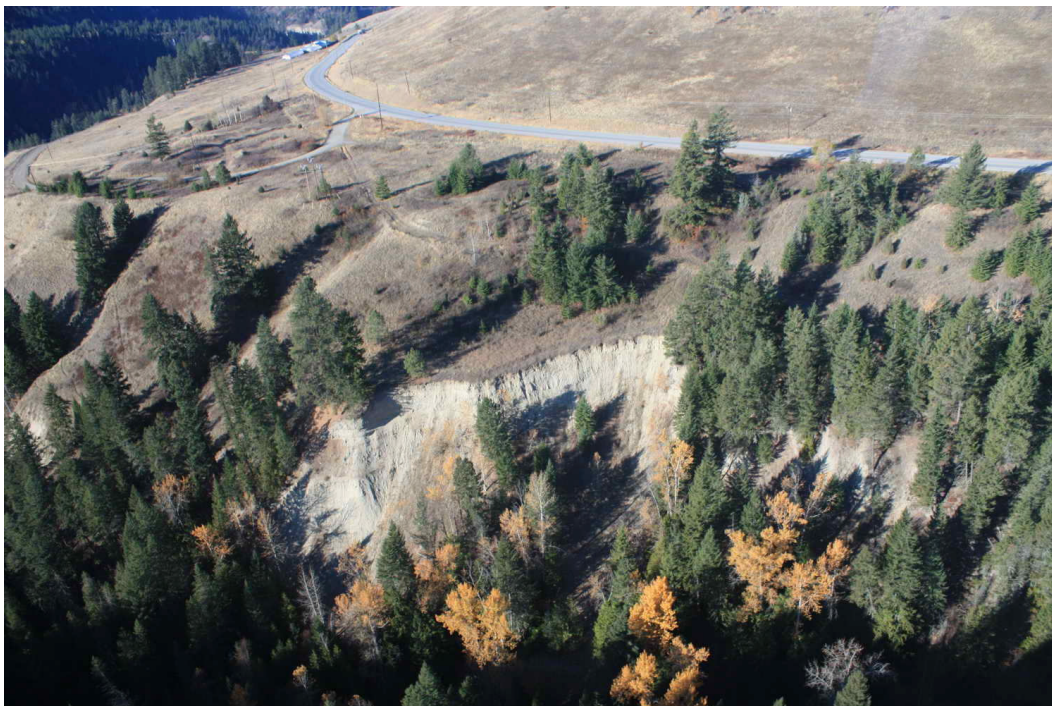
**Photo 12.** Typical large debris slump downslope of Highway 33 in lower Daves Creek.

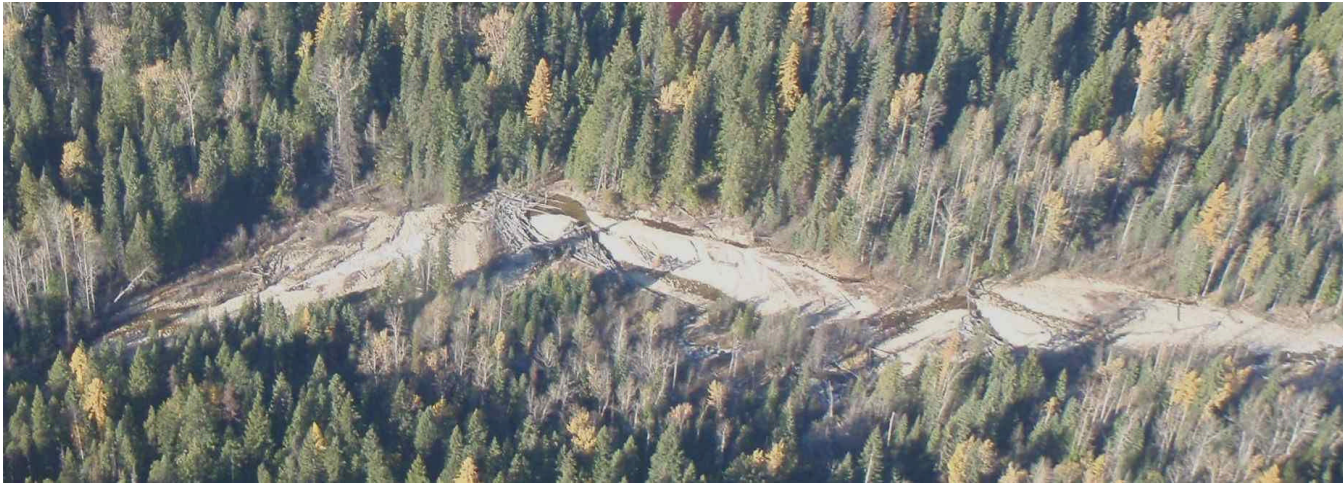
**Photo 13.** Reach 6 Mission Creek, aggraded and widened (Oct 27 2008)

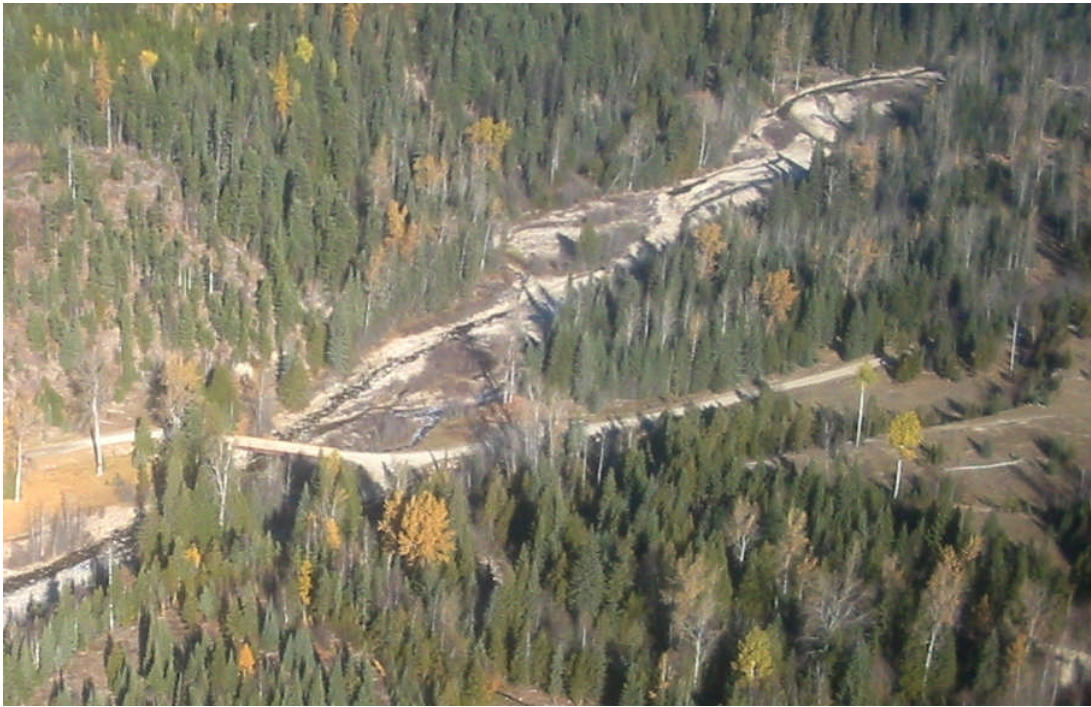
**Photo 14.** Lower end of Reach 6, aggraded and widened (Oct 27 2008).

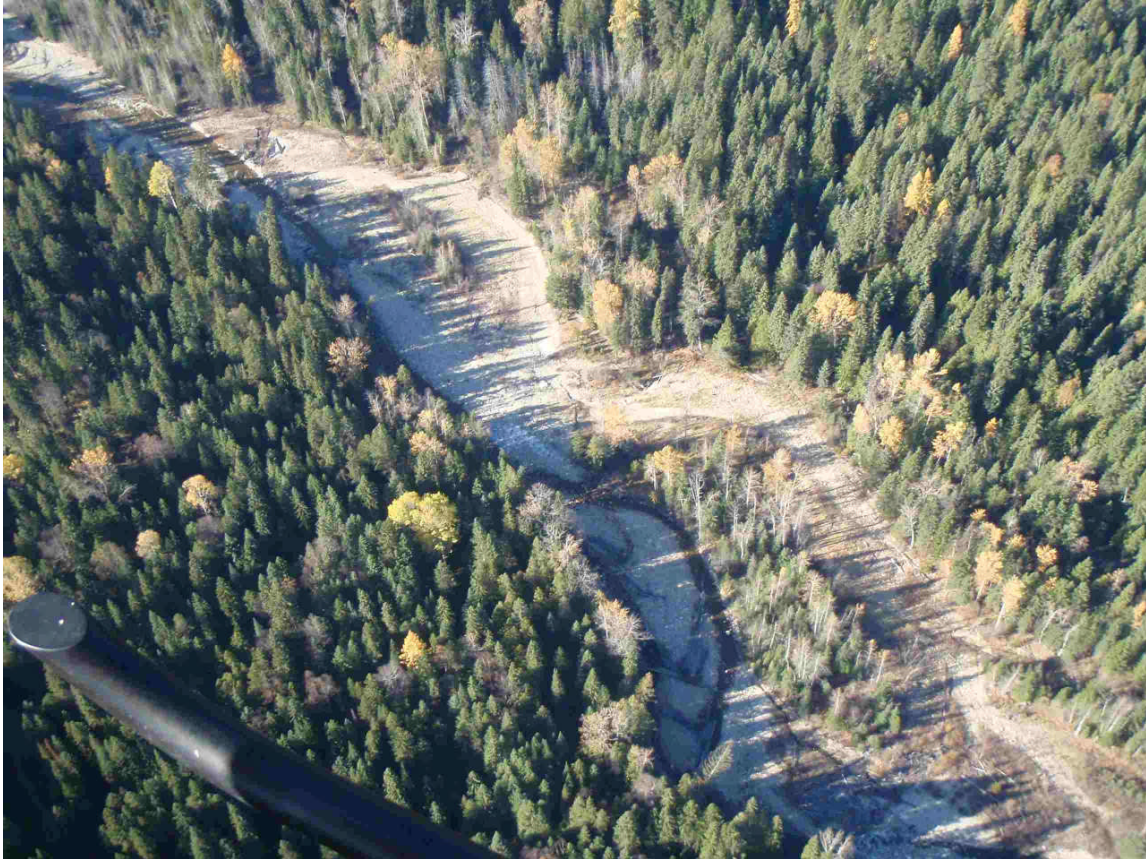
**Photo 15.** Reach 5 Mission Creek, aggraded and widened (Oct 27 2008).

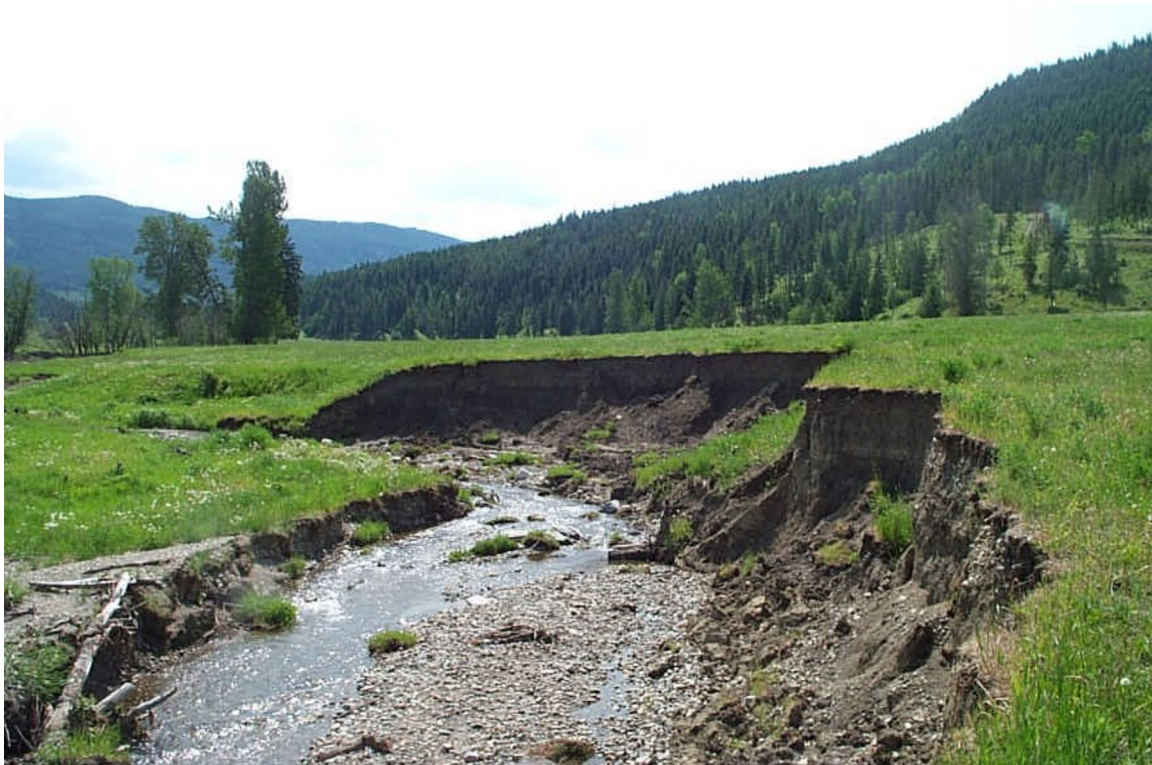
**Photo 16.** Joe Rich Creek Reach 2. Bank weakened by removal of riparian vegetation; eroding and causing channel aggradation.

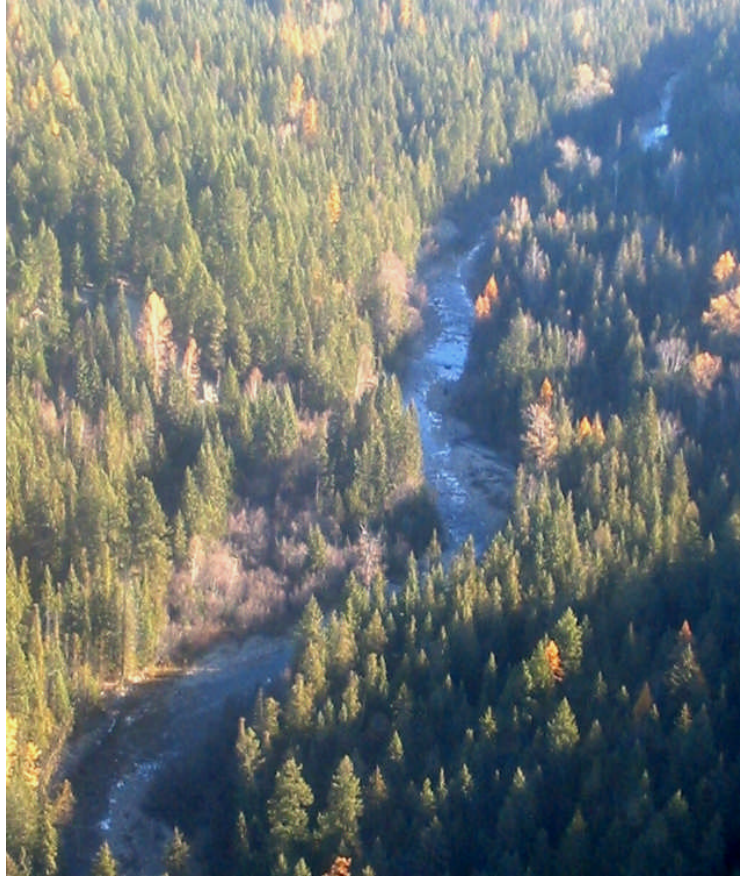
**Photo 17.** Mission Creek Reach 4, generally less aggraded than upstream reaches.

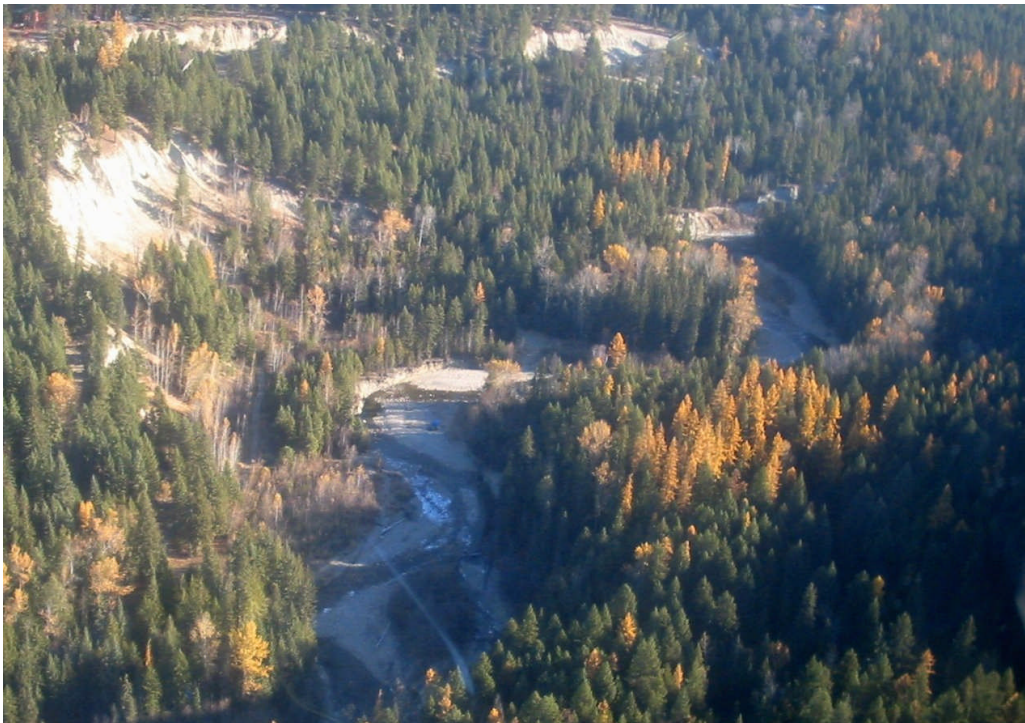
**Photo 17.** Reach 4, Mission Creek aggraded section of channel below large debris slump 4.5 km upstream of BMID intake.

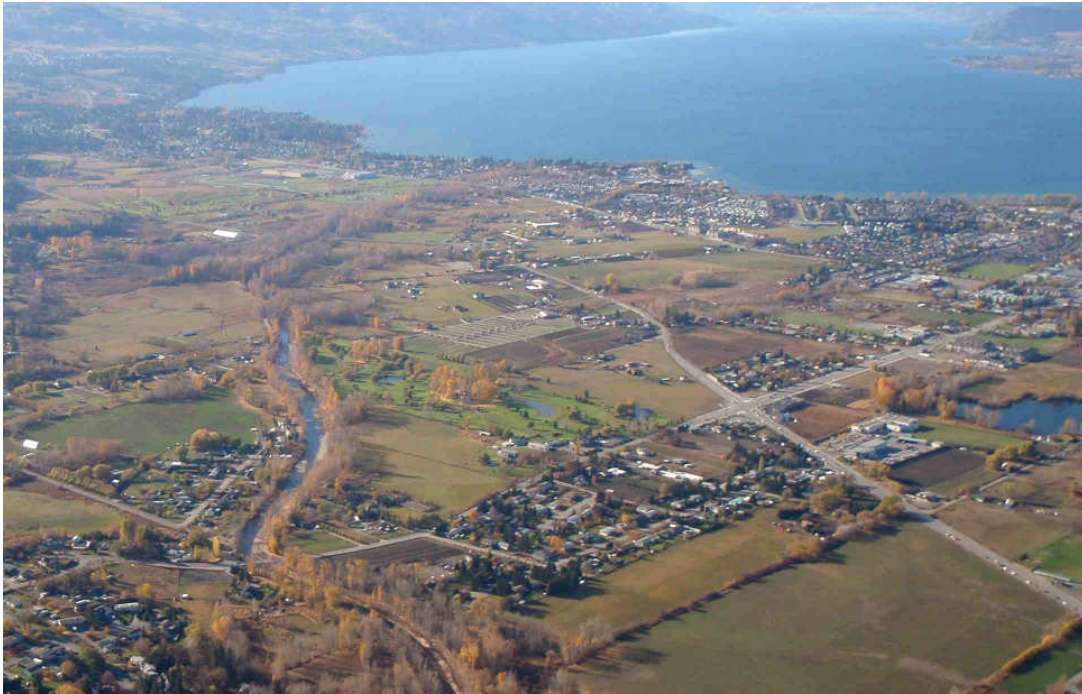
**Photo 19.** Reach 1 of Mission Creek, channelized and dyked. Okanagan Lake in background.
