# **Mission Creek**

# **Hydrological Risk Assessment**

**BC Ministry of Environment**

**February, 2010**

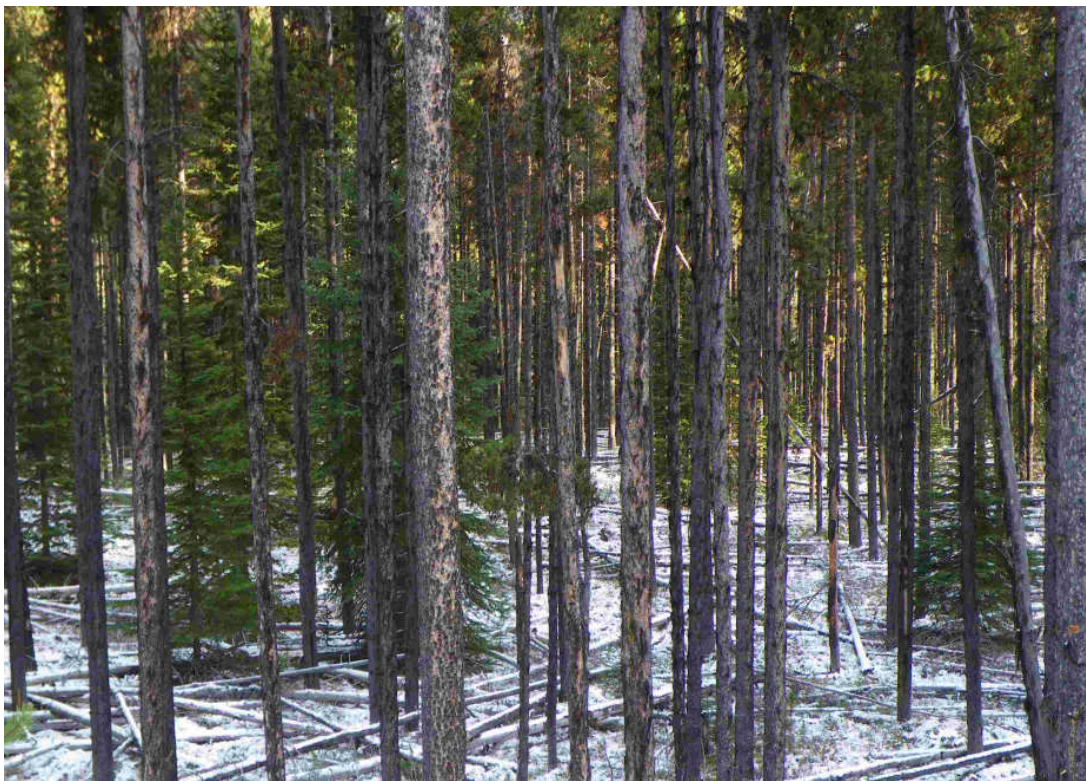
**Photo 20.** Young (70-110 yrs) MSdm stand in upper Belgo sub-basin.  
Almost pure pine overstory and limited Balsam understory (<200 stems/ha)

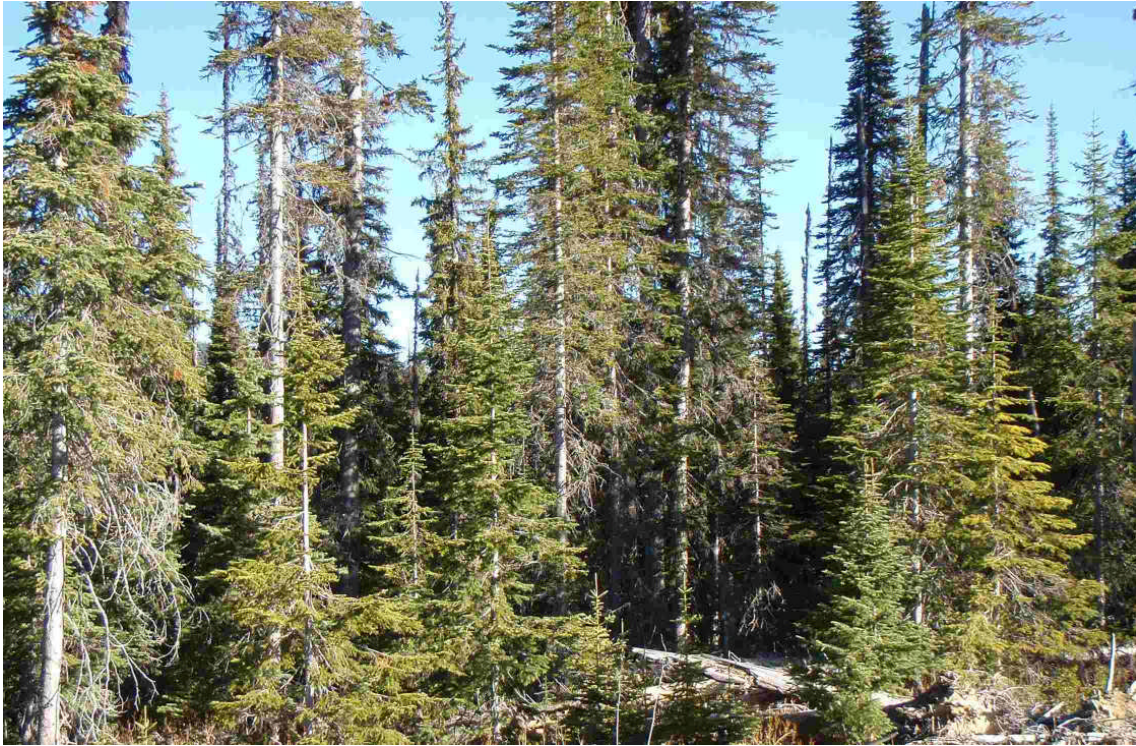
**Photo 21.** Typical ESSFdc stand with dominant Spruce and Balsam overstory and >1000 stems/ha understory seedlings, saplings and poles.
