CANADA / BRITISH COLUMBIA
FLOODPLAIN MAPPING AGREEMENT

PROVINCE OF BRITISH COLUMBIA
Ministry of Environment, Lands and Parks
Water Management Division

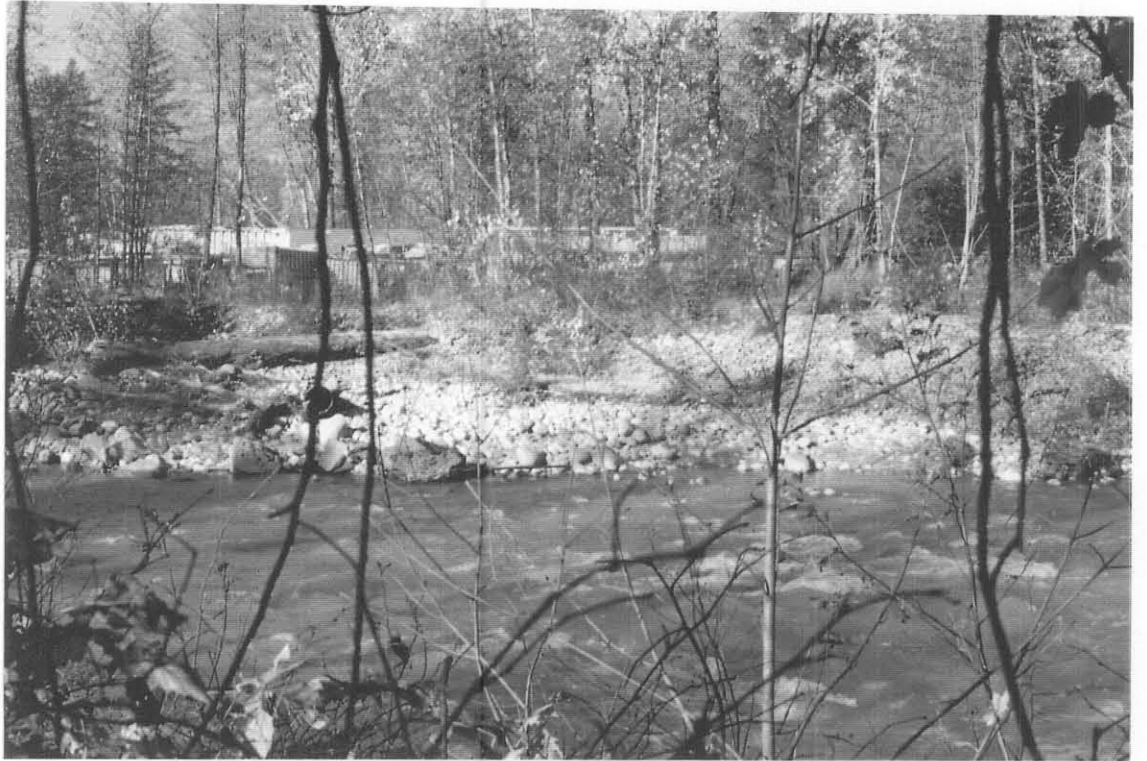
13. Looking toward the right (west) bank in the vicinity of XS-11 at Indian Reserve #2, after the 1981 flood.
