PEACHLAND CREEK AND TREPANIER CREEK

Watershed Assessment Report for Drinking Water Source Protection

Report Number: 09-1493-5018

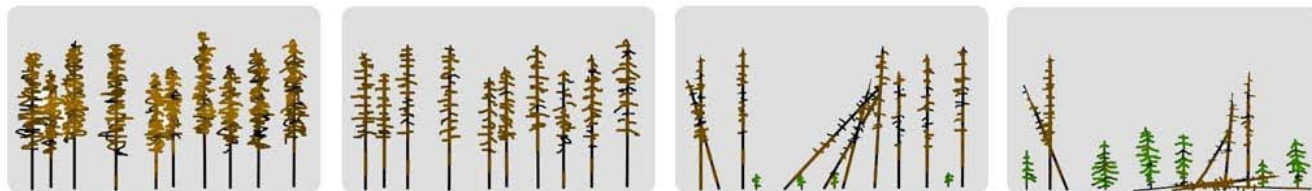
Figure 7: Stand Development as Dead Pine Trees Deteriorate and Natural Regeneration Becomes Established (Winkler, 2008). Used by permission of Patrick Teti, Research Hydrologist, MOFR.

Removal of natural barriers to stream courses during salvage logging could also increase disturbance of riparian zones. Maintaining an adequate buffer around streams and tributaries is important for cattle access management, as well as for channel health with respect to provision of large woody debris to help facilitate stream recovery. The natural regeneration of MPB impacted trees is provided in Figure 7. As stands deteriorate, the fallen trees may provide a natural buffer to riparian zones as shown in Figure 8.
