**Tsolum River  
Biophysical Assessment  
Hydrology and Channel Assessment**

**For  
The Tsolum River Restoration Society**

**By  
Dave Gooding, P.Eng.  
Gooding Hydrology  
Saltspring Island**

**January 2010**

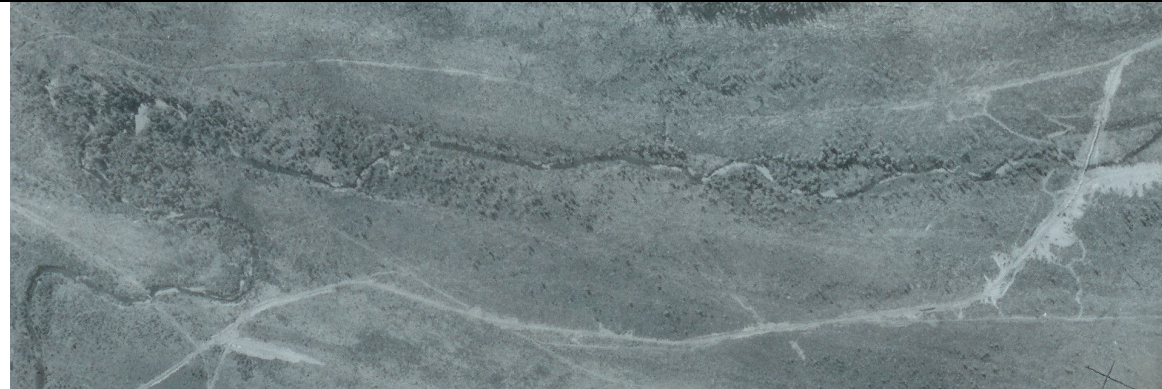
Figure 3 Deposition in Mainstem Tsolum below Murex

**1938 Tsolum channel from below Constitution Creek at right, downstream to the S-bend Oxbow at left. Note fairly narrow channel, with small bars.**

The aggradation in the Tsolum mainstem, from high bedload volumes moving out of the upper Tsolum and Murex tributaries, peaked from early 1960's to mid '70s upstream of Constitution Creek, slightly later on the bar complex upstream of HQ Creek. The pulse from Dove Creek peaked from around 1970 to 1980. From those peaks of deposition, and with growth of riparian vegetation, a gradual vegetation and slow stabilization of some of the material of these deposited bars has been occurring, becoming visible in the 1980's above Constitution Creek, and as late as the 1990's in the lower river.

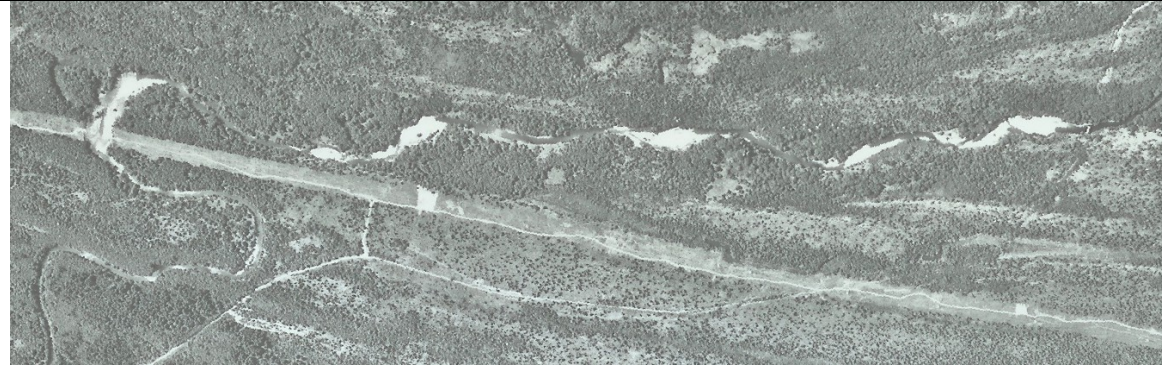
**1968 photos shows channel widening and extensive bar growth through the entire river segment.**

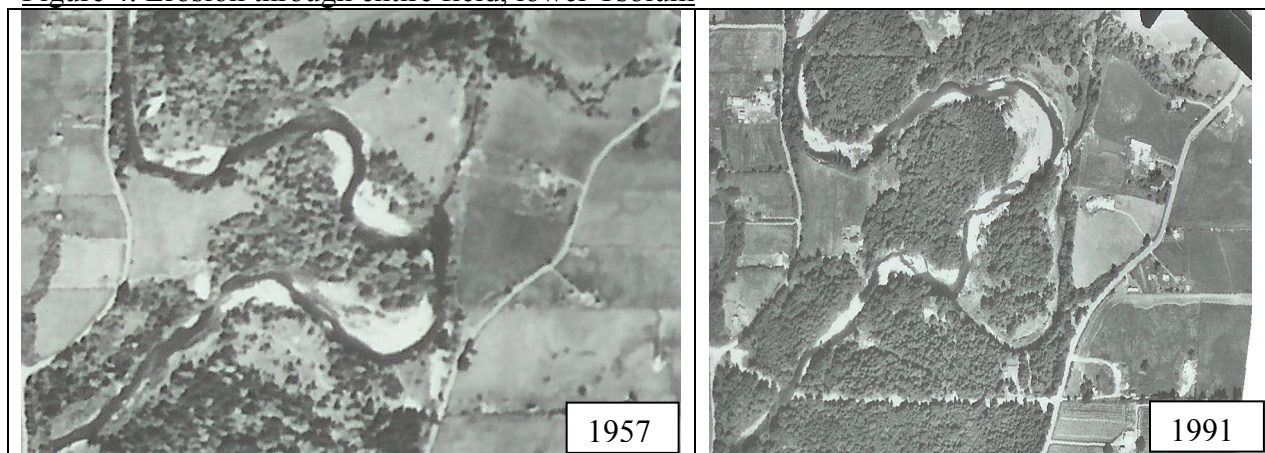
Figure 4. Erosion through entire field, lower Tsolum

All years' air photos show bank erosion through fields still ongoing at multiple sites along the lowest floodplain reach, with associated large gravel point bars, as shown in the example below.

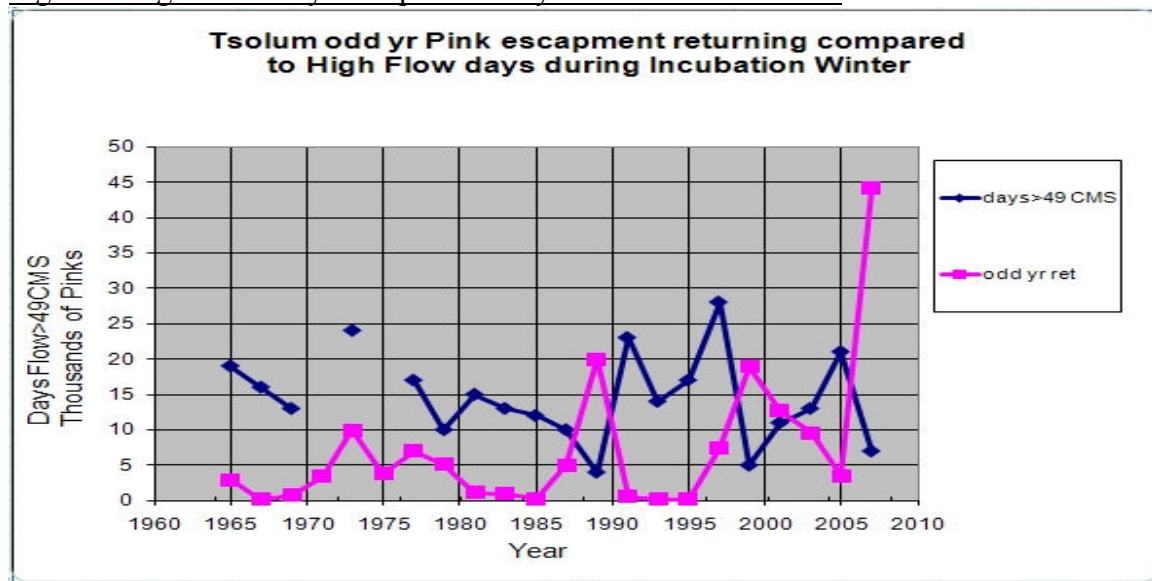
Figure 5 High Flow Days compared to 2 years later Pink Returns

Visual inspection of the graph of number of days 50+ CMS flow against returns 2 years later shows that since 1980, with only one exception in 1997, a low number of days (<10) of this flow or higher during the winter coincides with an improved return. The incubation years with 7 or less days over this flow have produced the best three returns since 1960.

The results show a good inverse correlation, growing stronger in the last decade, and would also indicate that flows as high, and higher than, bankfull flow (~100 CMS) have a more damaging effect than flows between 50 and 100 CMS.
