**CENTRAL  
OKANAGAN LAKE  
FORESHORE INVENTORY  
AND MAPPING**

**PART III**

**TECHNICAL ADDENDUM**

REPORT PREPARED BY Regional District of Central Okanagan Planning Services Department  
Brent G. Magnan, Environmental Technologist  
Todd W. Cashin, Environmental Coordinator

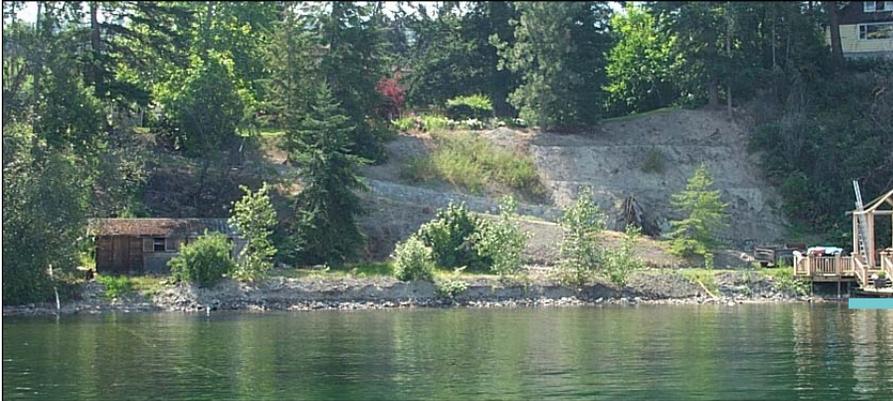
### Segment 13 – DL Moderate

This rural segment remains mostly natural (70%); large tracts of riparian vegetation are unaltered throughout much of the area. Shore type is primarily vegetated shore (90%) with small amounts of gravel beach (10%). Foreshore modifications include few docks (8 docks/km) and retaining walls that are found in association with riparian disturbance. An eroding bank was observed and identified as a potential sediment source. Rembler Creek is tributary to Okanagan Lake mid-segment. Although riparian disturbance is limited to isolated sites, disturbance is high within these sites.

Sediment source observed  
in Segment 13.

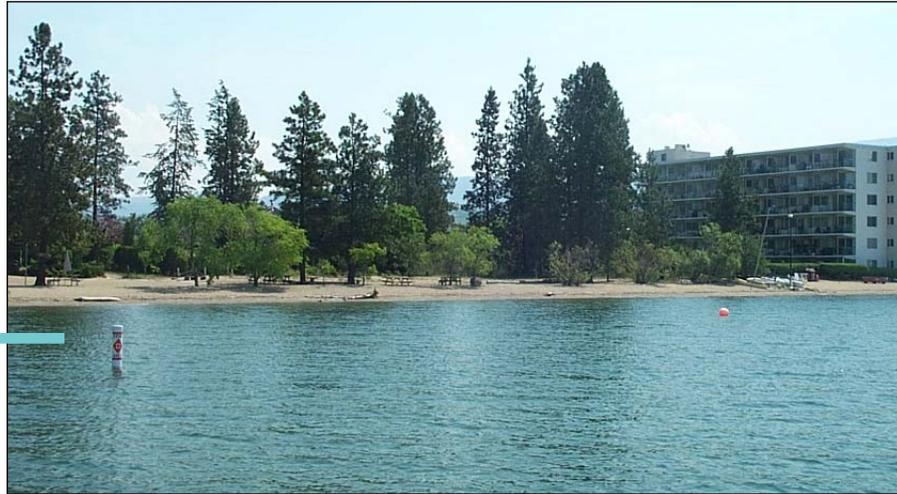
Representative foreshore type—Sandy beach. Often associated with alluvial fans or other shoreline deposition areas as seen in Segment 17.

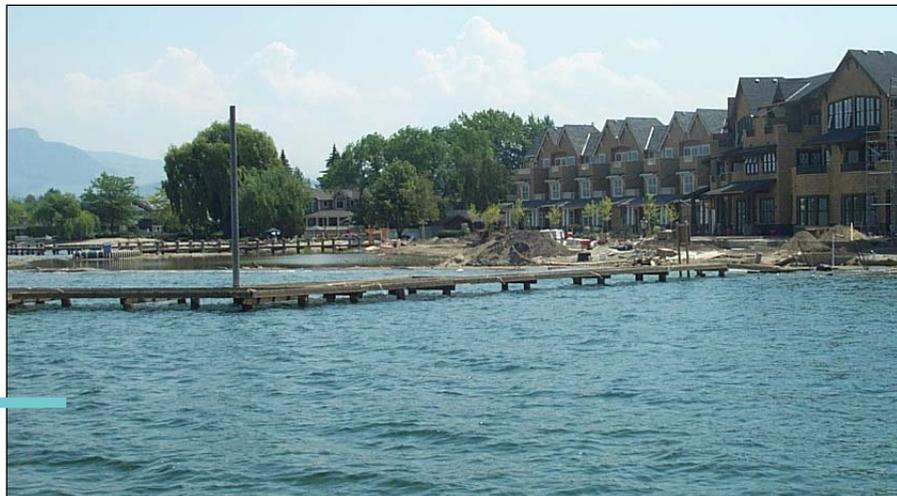
### Segment 18 – DL High

The foreshore in this segment has been entirely disturbed. High-density commercial development occurs immediately adjacent to the foreshore. Riparian vegetation has been completely removed, while modifications include several marinas, a public boat launch, docks (14/km), retaining walls and imported beach material. Foreshore materials have been altered throughout. Shore type is classified as sand beach; this segment contains a substantial sand bar at the confluence of Mission Creek. The littoral width in this segment averages 150 m.

Foreshore material being moved on site during development in Segment 18.

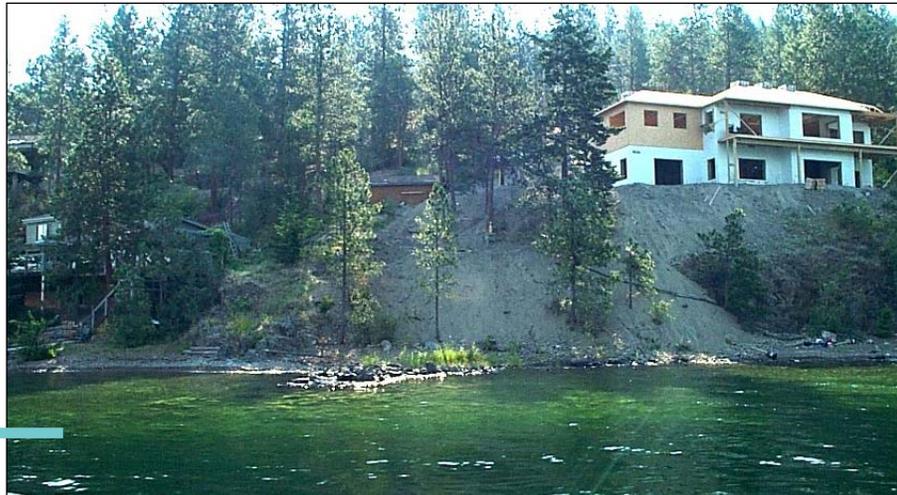
### Segment 50 – DL High

The shore type in this large segment is primarily low rocky shore (45%) with smaller amounts of gravel beach (35%) and cliff/bluff (20%). Although land use is rural, the segment has been substantially disturbed (80%) by residential development. Access to the lakeshore is limited by steep, rocky hill slopes, although recreational development along the foreshore is found throughout. Modifications are intensive including docks (23/km), groynes, and riparian vegetation removal. Most large substrate materials have been removed and used for retaining walls and groynes. This has generally been associated with lake infilling behind the retaining walls. Boat and beach houses are common, some of which are built below the high water mark. Several sediment sources were observed in association with recent residential development.

Sediment source in Segment 50.

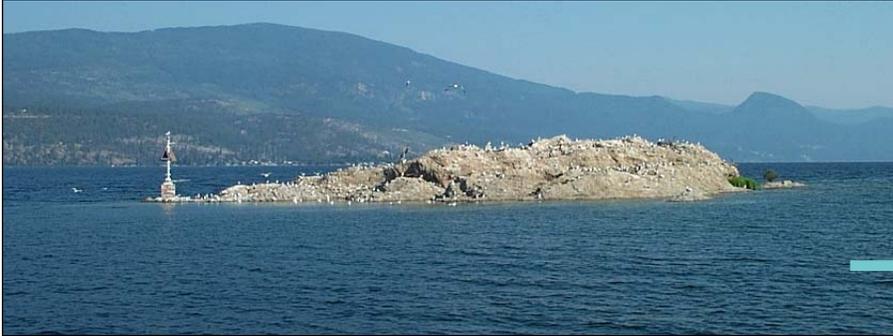
This small segment is characterized by a disturbed riparian buffer located adjacent to agricultural land. Shore type is primarily vegetated shore (60%), except in areas where significant riparian clearing has occurred, leaving gravel beach (40%). The littoral zone is wide and shallow (as compared to surrounding areas). This segment is adjacent to Whiskey Island, which is a large ring-billed gull colony and protected as an ecological reserve.

Island adjacent to Segment 79.  
Photo: T. Cashin

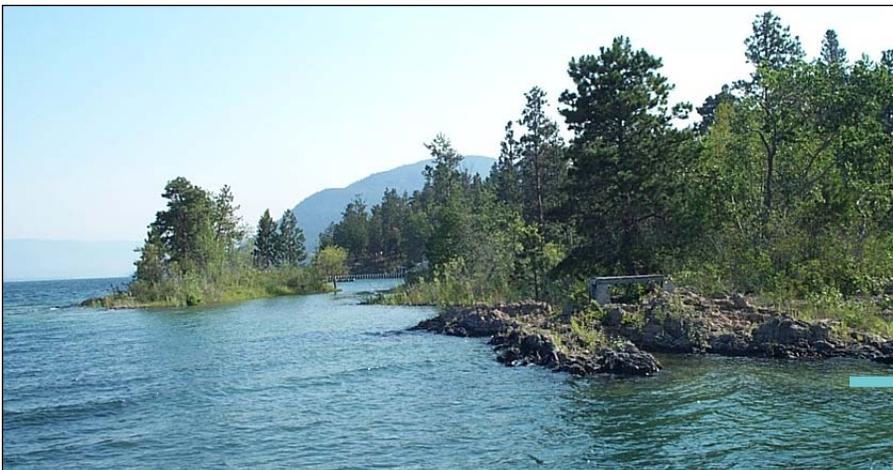
Shore type in this rural segment is primarily low rocky shore (60%) and vegetated shore (40%). Disturbance is minimal as over 90% of the shoreline remains natural. A small group of vegetated rock islands are located adjacent to this segment and a small backwater channel exists behind the islands. Riparian vegetation is mostly unaltered with the exception of one development site at the northern end of the segment. Modifications are limited to several docks within the segment.

Small vegetated island adjacent  
to Segment 81.  
Photo: T. Cashin

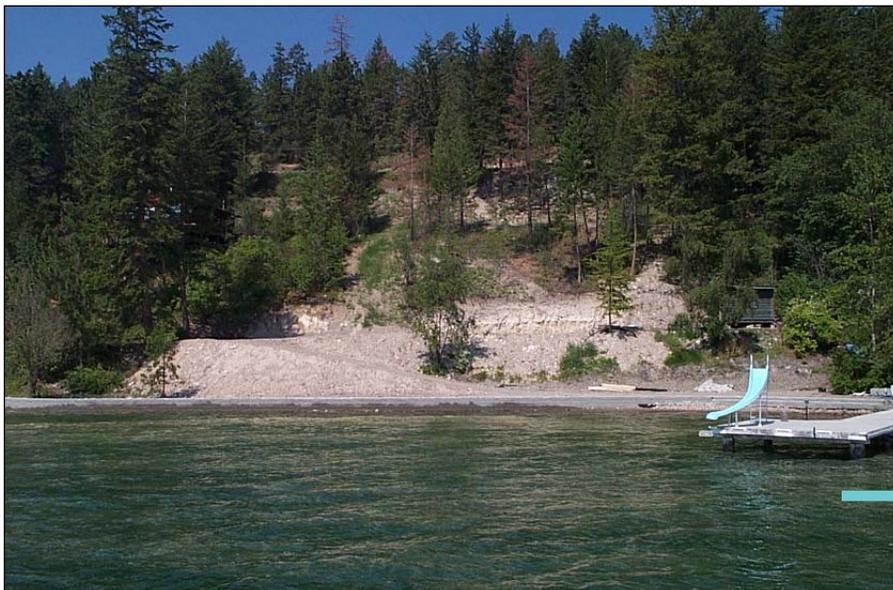
**Segment 88 – DL High**

This rural segment has been affected by residential development; approximately 80% of the foreshore has been disturbed, although the disturbance is not intense. Riparian vegetation has been largely removed, but many overstorey coniferous trees remain, including on developed sites. Understorey vegetation has been cleared in association with residences. Substantially less disturbance has occurred in the southern half of the segment where lot sizes are much larger. Shore type is primarily gravel beach (90%) with small amounts of vegetated shore (10%) where disturbance is nil. Modifications include docks (13/km), retaining walls, and lake infilling. Beach grooming has occurred in areas of coarse substrates, promoting the construction of groynes adjacent to residential properties.

Recent retaining wall and lake infilling in Segment 88.

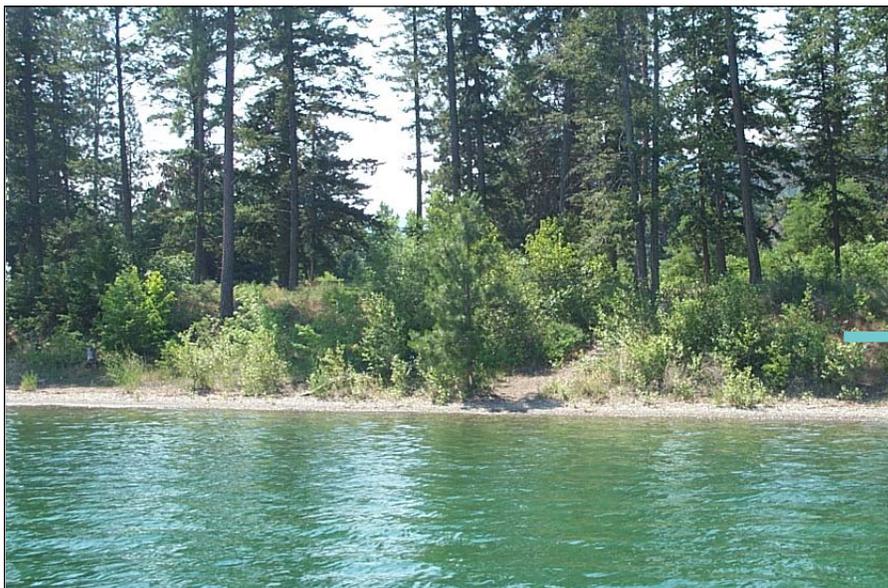
### Segment 96 – DL Low

Representative foreshore type— Gravel beach. Often associated with low gradient foreshore or coves with pockets of riparian vegetation among steeper hillsides. Sometimes associated with alluvial fans. Photo taken in Segment 96, Fintry Provincial Park. Photo: T. Cashin

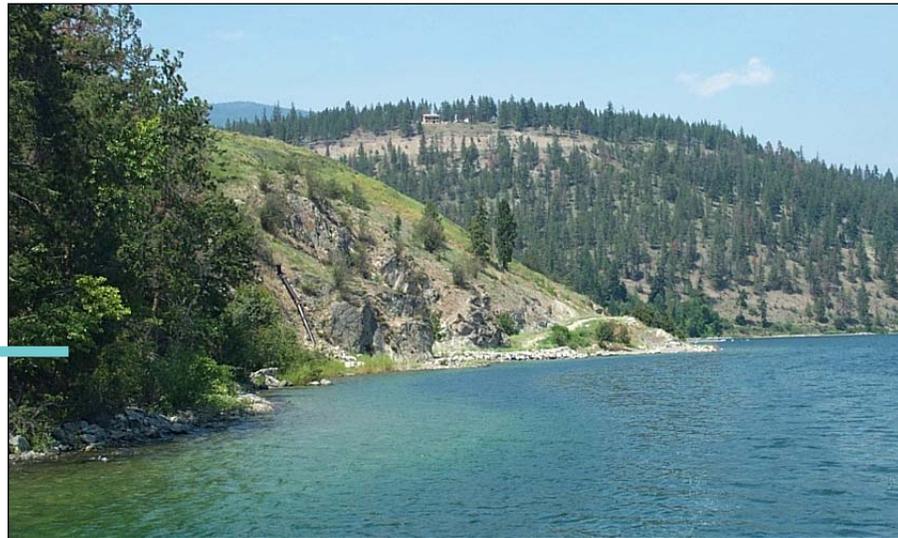
### Segment 99 – DL High

Representative foreshore type— Low, Rocky Shore. Cobble, boulder or bedrock substrate, prevalent along the base of steeper shorelines as evident in Segment 99.

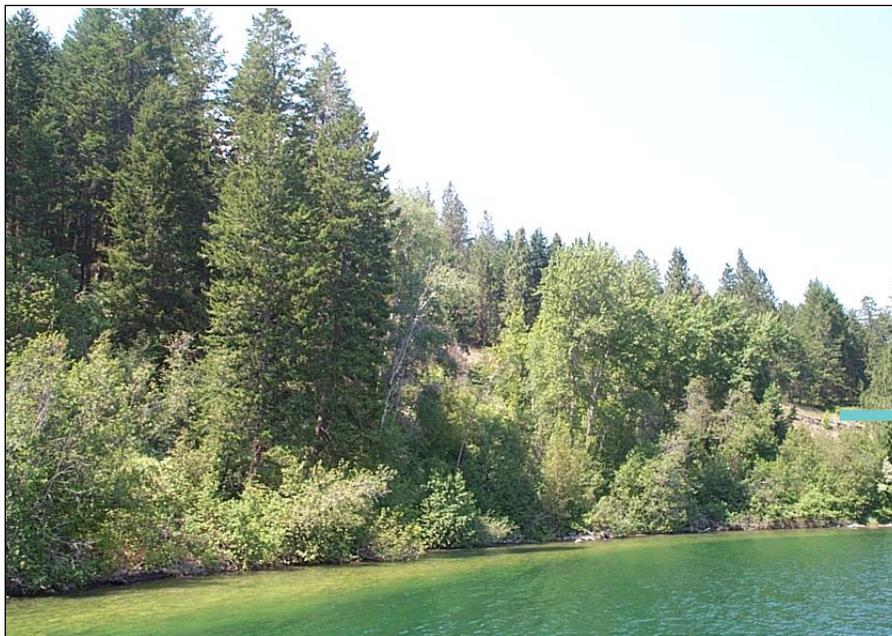
### Segment 102 – DL Low

Representative foreshore type–  
Vegetated shore. Characteristic of  
undisturbed foreshore with narrow  
littoral width. Vegetation is common-  
ly shrubs, small trees and overhanging  
vegetation as seen in Segment 102.  
Photo: T. Cashin

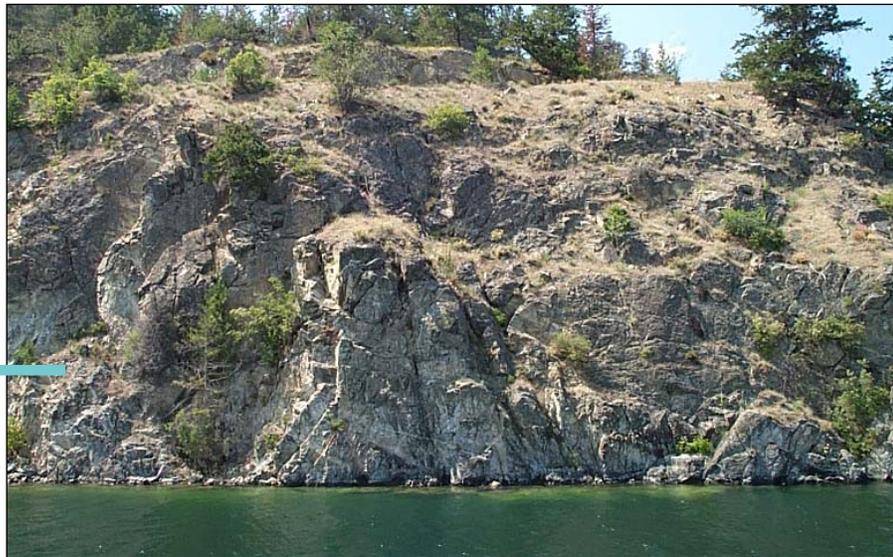
### Segment 106 DL – Low

Representative foreshore type—Cliff/Bluff. Areas adjacent to steeper slopes, usually indicating a steep-sided lake basin or sudden drop off as found in Segment 106.

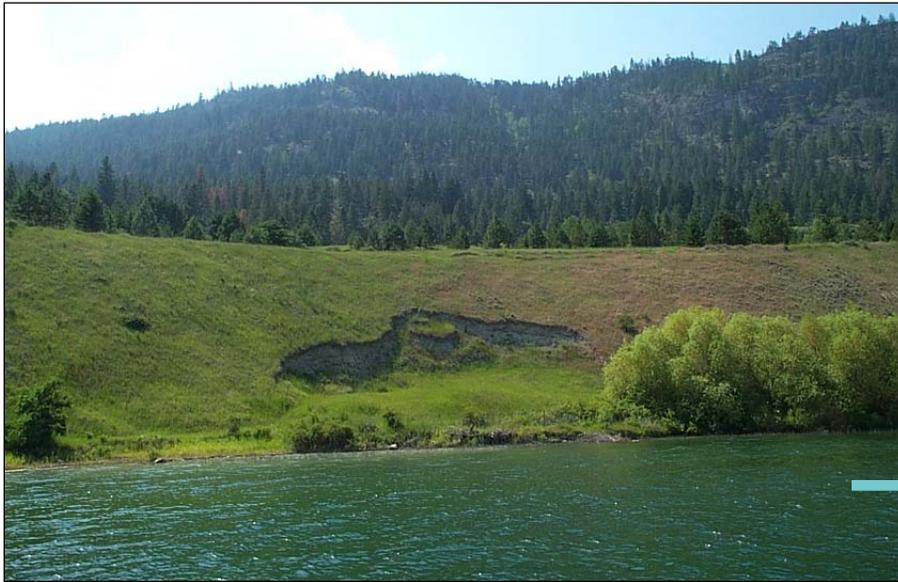
### **Segment 109 DL – Moderate**

This segment has been largely disturbed (80%) by the removal of upland and riparian vegetation, which varies from abundant to nil. Shore type is classified as vegetated shore (100%). A mature buffer of riparian vegetation remains at the north and south ends of the property, as well as an isolated patch in the centre. Shoreline stability has been compromised as indicated by a moderate-sized slump near the southern end of the segment.

Moderate-sized slump in Segment 109.  
Photo: T. Cashin

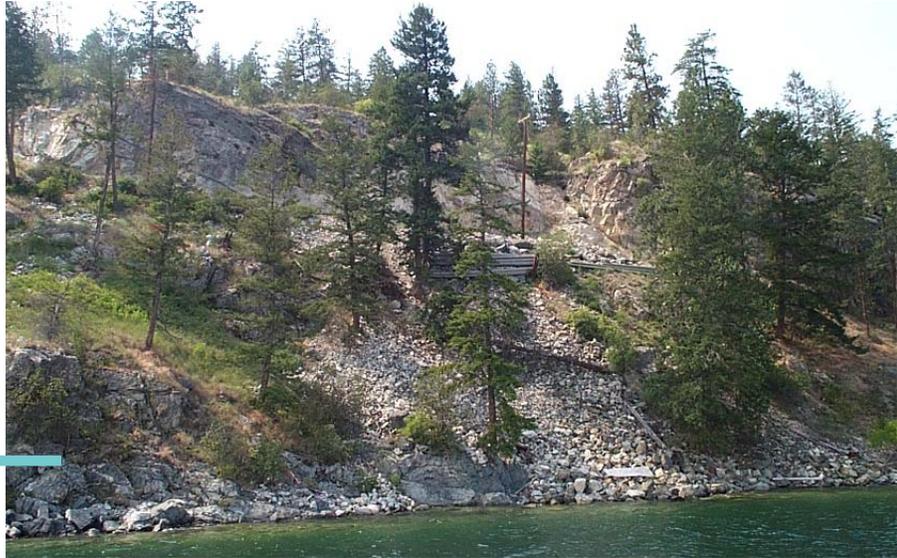
### Segment 111 DL – Low

The shore type in this natural segment is primarily cliff/bluff (70%) with small amounts of low rocky shore (20%) and vegetated shore (10%). Riparian vegetation is sparsely scattered amongst rock bluffs and proliferates in less coarse bed materials. Upland vegetation is largely undisturbed with the exception of a single primitive road access to the foreshore. No modifications are found in this segment. Disturbance is limited to an isolated road fill site that extends into the foreshore.

Example of road fill extending into foreshore as in Segment 111.

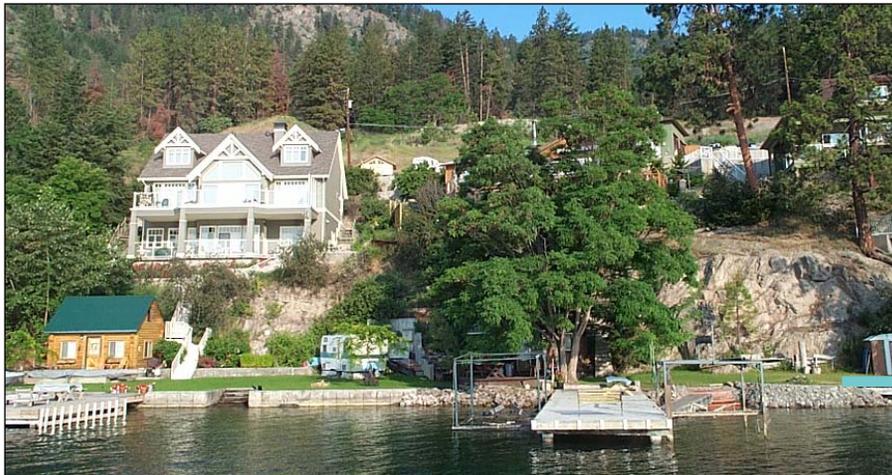
### **Segment 127 DL – High**

This segment has been heavily disturbed (90%) by residential development. Residences are located immediately adjacent to the foreshore where most riparian vegetation has been cleared. Modifications include a large number of retaining walls and one of the highest densities of docks in the study area (40/km). Several groynes, a marine railway, and a boat launch are also found. Beach grooming activities are commonly associated with these properties.

Continuous retaining walls and lake infilling as seen in Segment 127.  
Photo: T. Cashin

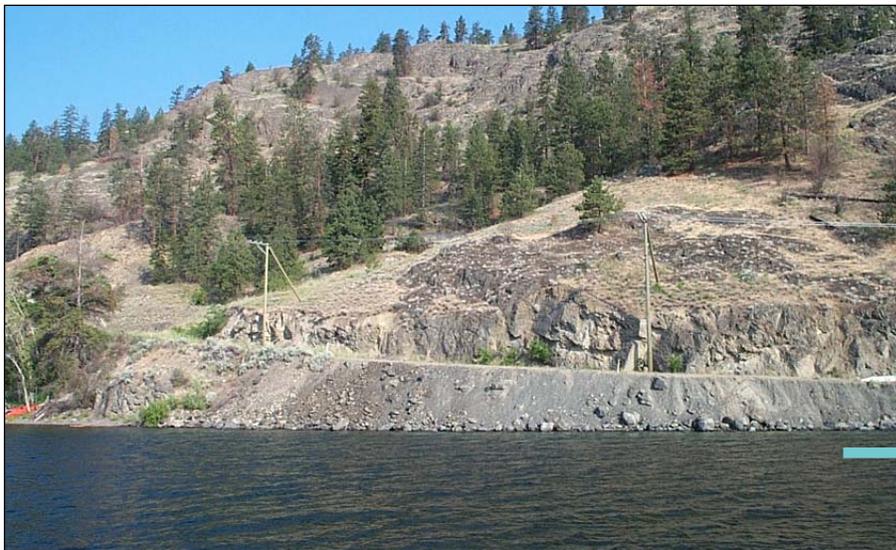
### **Segment 139 DL – High**

The segment break between segment 138 and 139 is at the southern boundary of the Bear Creek alluvial fan. Shore type is primarily low rocky shore (60%) to the south and vegetated shore (40%) to the north. Land use in this segment is primarily industrial (60%) as it coincides with Tolko Industries Ltd. Bear Creek log boom site. Most of the foreshore has been disturbed (90%) as it parallels Westside Road and falls within the road right-of-way. A substantial amount of blasting and lake infilling has occurred to accommodate the current road location. A continuous riprap retaining wall remains adjacent to the southern sections of Westside Road.

Fill slope from Westside Road as seen in Segment 139.

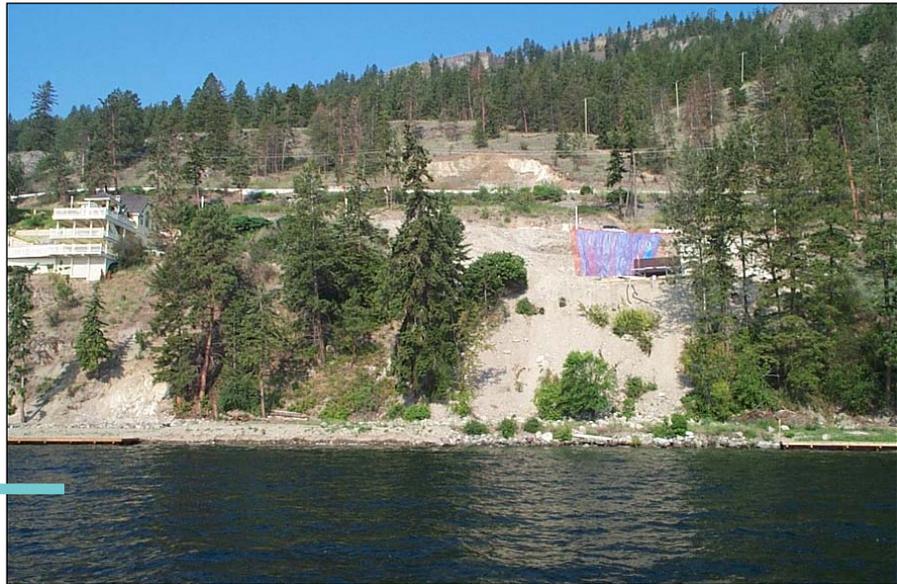
### **Segment 143 – DL Moderate**

This segment is primarily cliff/bluff (60%) and vegetated shore (20%). It has been moderately affected by urban development (60% disturbed). Most homes have large setbacks due to steep slopes and lake access via large stairways. Significant impacts to the foreshore have occurred with riparian vegetation removal, retaining walls, docks (15 docks/km), lake infilling, beach houses, and pump houses. Recent development has caused fill material to extend into Okanagan Lake at several locations.

Recent fill slope disturbance identified in Segment 143.

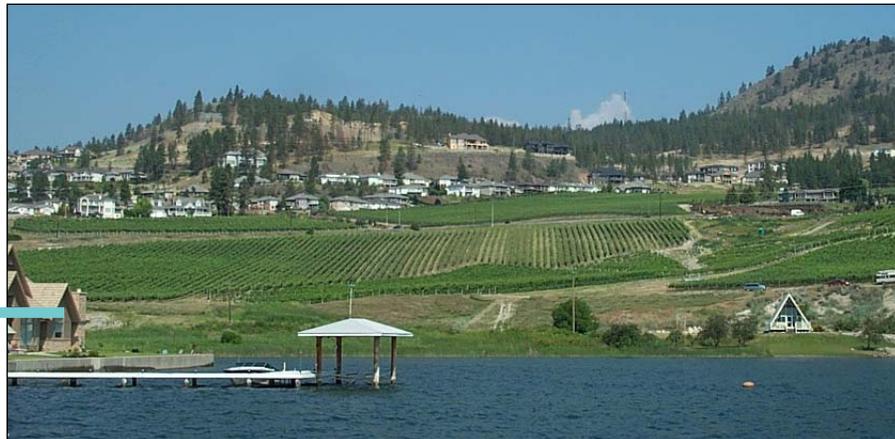
Agricultural activities adjacent to Segment 154. Note wetland vegetation dominating shore zone.
