**Reconnaissance (1:20,000) Fish and Fish Habitat  
Inventory  
of  
Bone and Clemina Creek Watersheds  
WSC: 129-754600 (Bone) and  
WSC: 129-838900-39800 (Clemina)**

Prepared for:  
**Slocan Forest Products Ltd.**

APRIL 2001

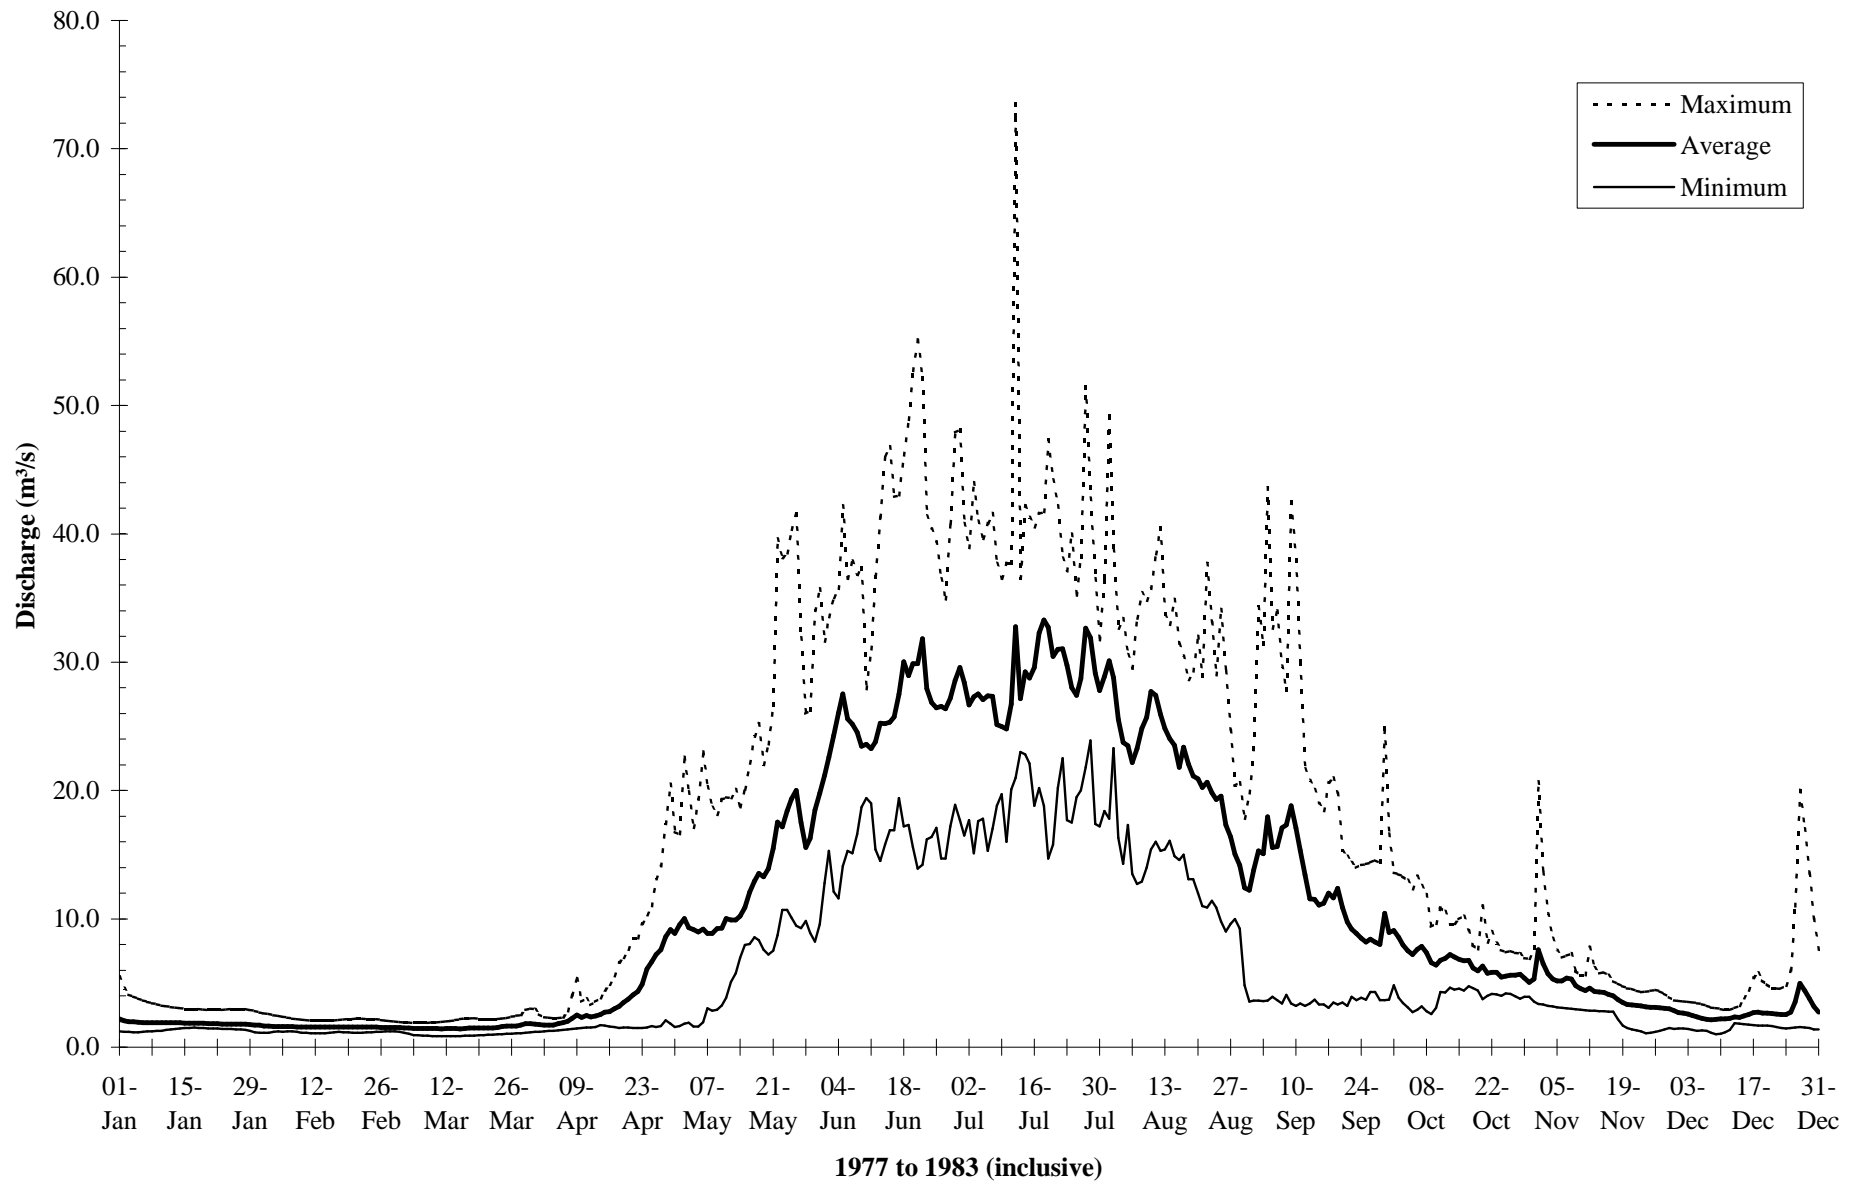
**Figure 2. Bone Creek Watershed: Mean daily discharges recorded at Bone Creek for the period of record from 1977 to 1983  
(Station No. WSC08LB077)**

The Bone Creek Watershed has a drainage area of 267 km<sup>2</sup>. Based on the period of record (1977-1983), low flow occurs in March, with an average minimum discharge of 1.5 m<sup>3</sup>/s (range 1.0 to 2.2 m<sup>3</sup>/s). The average maximum discharge occurs in July at 28.4 m<sup>3</sup>/s (range 20.7-36.5 m<sup>3</sup>/s) (Figure 2). The maximum daily discharge ranged between 36.5 m<sup>3</sup>/s on June 16, 1980 to 73.5 m<sup>3</sup>/s on July 12, 1983 (Environment Canada 1999).

Hydrographic data on the Bone Creek Watershed is provided by an Environment Canada watershed gauging station (Station Number 08LB077) located on Bone Creek. This station provided hydrographic information for the years 1977 to 1983, inclusive.

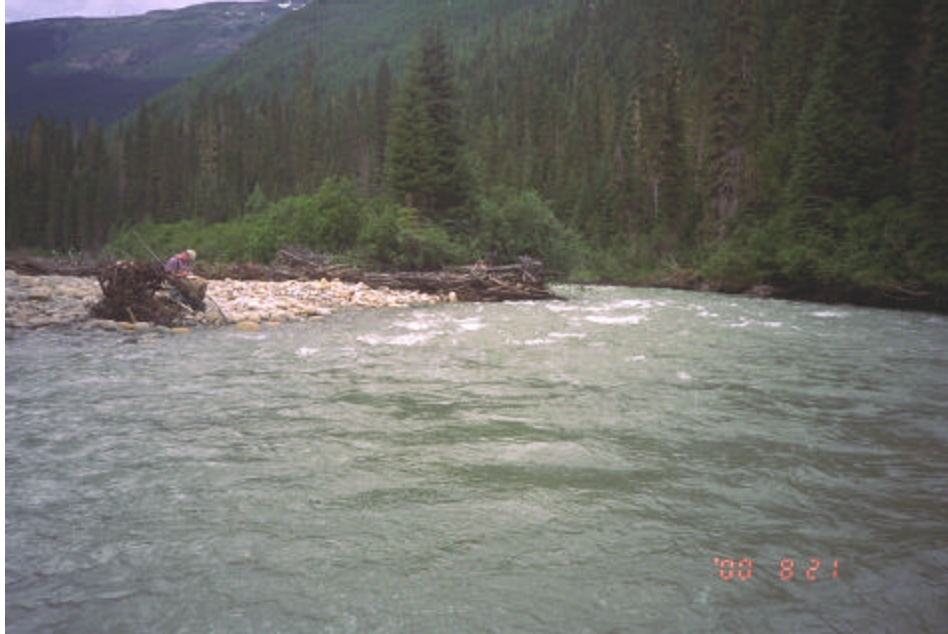
Figure 3. Bone Creek Watershed: Downstream view of typical habitat in the Bone Creek mainstem. Reach 6, ILP 1, Map 83D.025, Site 20, August 21 to 23, 2000.

Bone Creek mainstem is a high energy, turbid or moderately turbid stream with limited spawning and rearing values due mainly to large (boulder) substrate and limited channel complexity. High water marks and channel width indicate that flows vary greatly. High freshet flows typically scour the stream bed and remove and strand available Large Woody Debris (LWD) cover, conditions unfavourable to fish populations. High flows and rapid additions of sediment and LWD to the channel may cause scour of the channel bed and shifting of bedload gravels, which can seriously reduce the availability of food and habitat (Swanston 1991). Chan (1974) described Reach 1 of Bone Creek as having a heavy silt load that blankets the stream bottom and greatly reduces the area available for fish habitat.

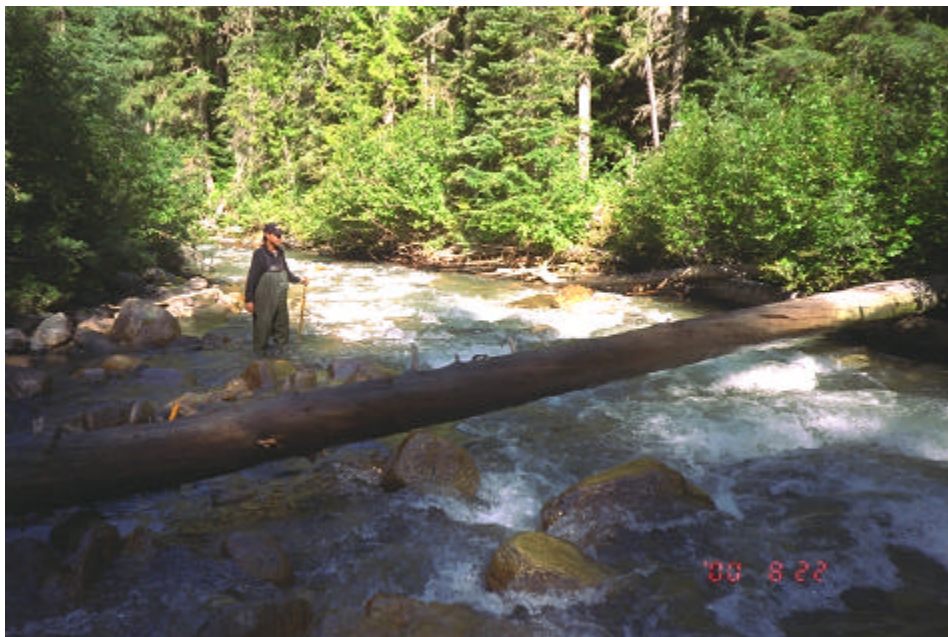
Figure 4. Clemina Creek Watershed: Downstream view of typical habitat in the Clemina Creek mainstem. Reach 2, ILP 1, Map 83D.055, Site 24, August 21 to 23, 2000.

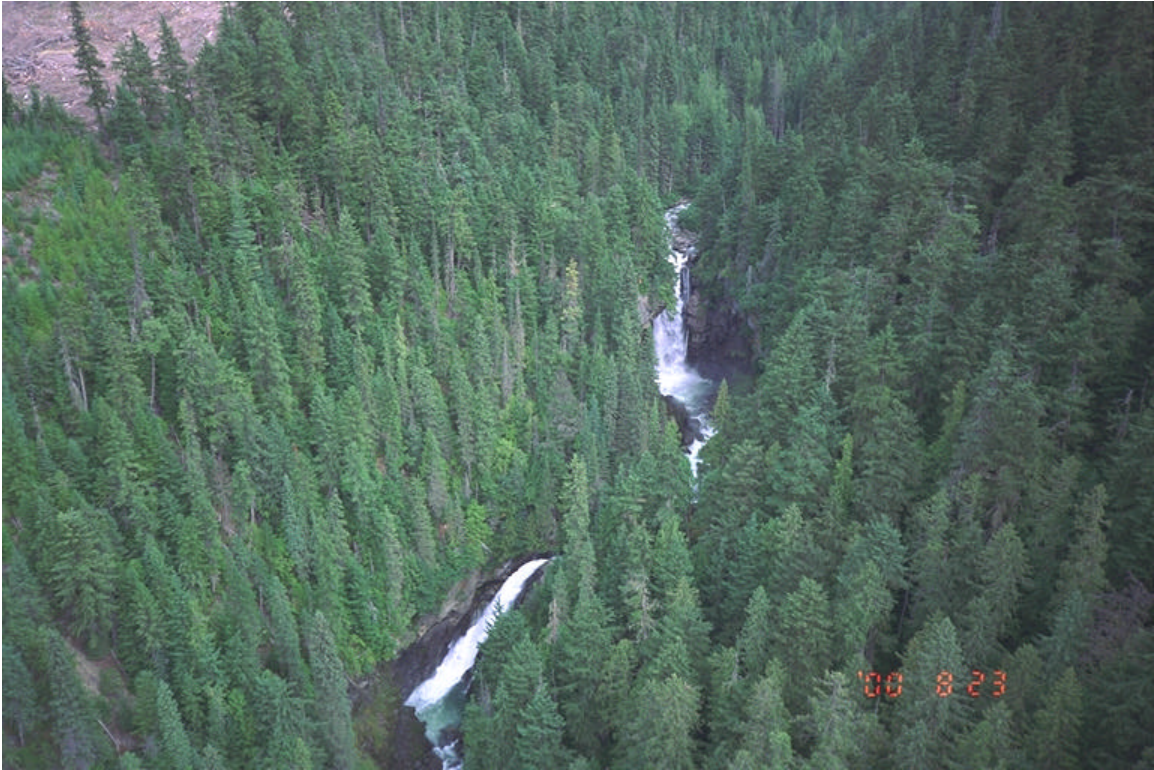
Figure 5. Clemina Creek Watershed: Aerial view of 24 m waterfall located at the Reach 1/Reach 2 break of Clemina Creek, August 21 to 23, 2000.

A 24 m waterfall located at the Reach 1/Reach 2 break of Clemina Creek, 1.9 km upstream of the Albreda River, is a barrier to fish migration (Figure 5). Twenty-two (22) sites surveyed upstream of the 24 m waterfall, including Site 24 immediately upstream, were found to be non-fish bearing. An over-flight of Reach 1 of Clemina Creek revealed no additional waterfalls downstream of the identified 24 m waterfall. Based on this, fish are assumed to be present up to the 24 m waterfall. Upstream of this, no fish are present within the Clemina Creek watershed.
