CAMERON LAKE WATER STORAGE WEIR UPGRADE FINAL REPORT

APRIL 2007

nhc northwest
hydraulic
consultants

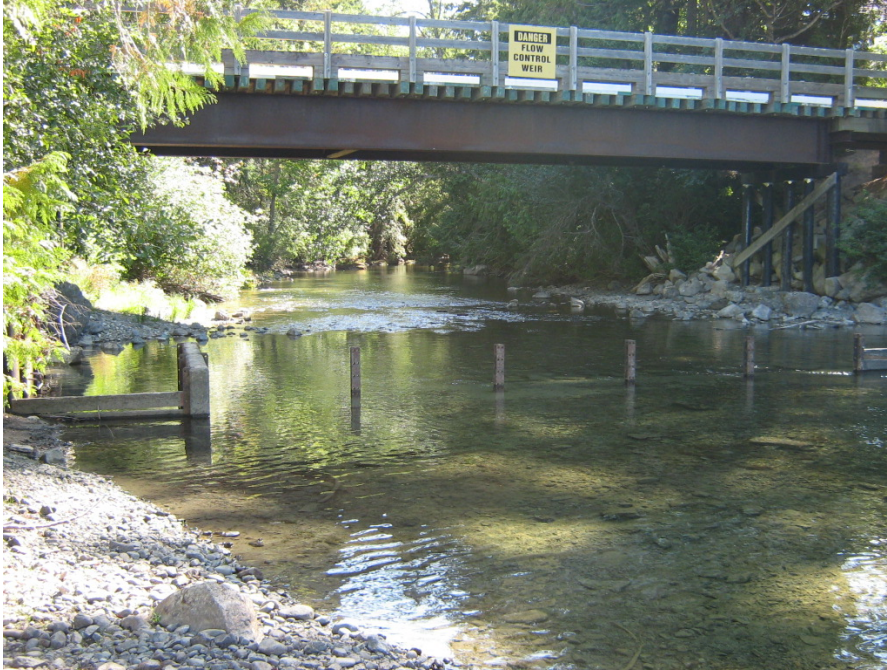
The weir, constructed in 1978, is a concrete slab spanning the channel with concrete abutments at each bank (Photo 1). Vertical steel beams and wood stoplogs form a 0.9 m high removable dam with approximately 0.5 m of pre-project usable storage. The left bank abutment incorporated a 2 m wide pool and weir fishway. The fishway pools were partially filled with sand, gravel, and organic debris in 2006.

Photo 1. Pre-project conditions – note the fishway on the river's left.

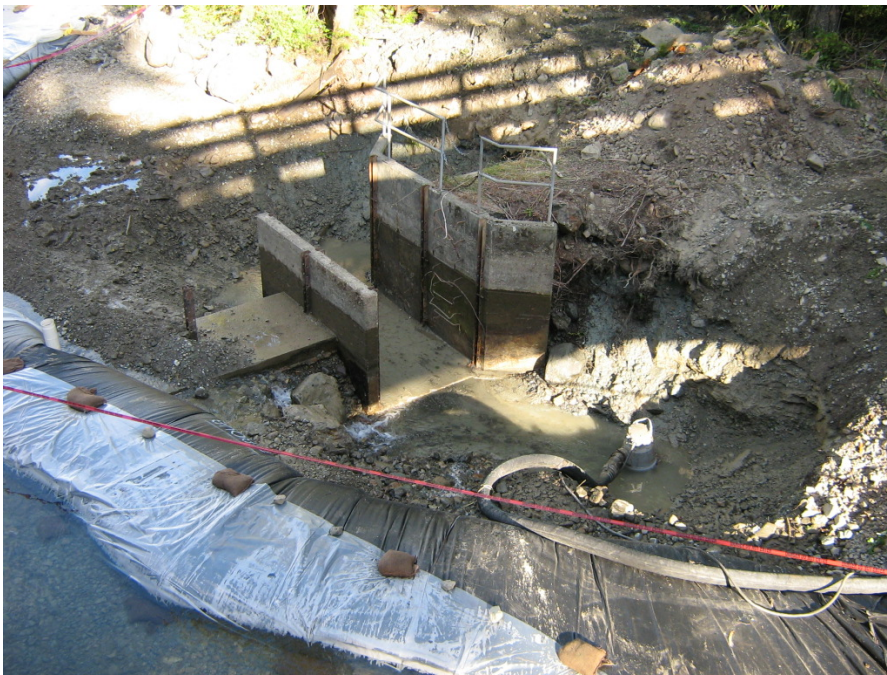
Photo 2. Aquabags and a 600 volt, 150 mm submersible electric pump were used to isolate the fishway area.

The area around the fishway was isolated using 2 – 1 m diameter by 15 m long Aquabags (Photo 2). A Flygt Model BS 2151.181 LT 30hp, submersible 150 mm pump was rented from Duncan Electric Motor Ltd. through ITT Flygt Canada to dewater the existing fishway and left bank of the river. A 600 volt diesel generator was borrowed from the DFO to provide power for the pump. Pumped water was discharged above the railway tracks on the left bank of the river approximately 15 m above the river elevation at a rate of approximately 65 L/s. The discharged water ran along the railway tracks for approximately 100 m and while slowly percolating into the ground.

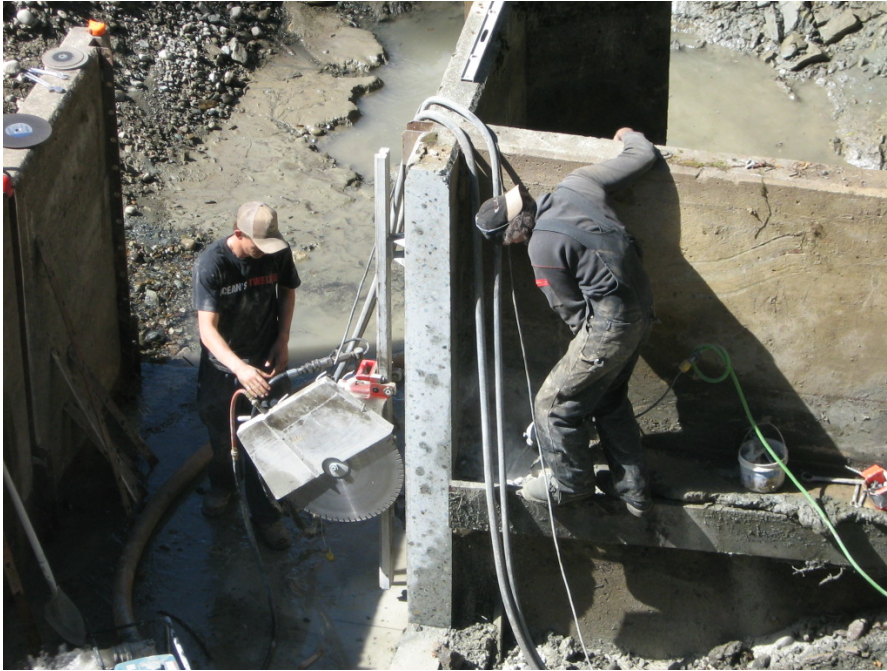
Photo 3. A concrete saw was used to cut the fishway and left bank abutment. An excavator lifted the concrete sections out of the way.

A concrete cutting company, Cancor Cutting & Coring, Ltd, used a hydraulic saw with a diamond blade to cut the left concrete abutment to accommodate the width of the aluminium fishway and gate chamber structure (Photo 3). The excavator removed the concrete from the fishway and prepared the site near the left bank where the fishway was placed.

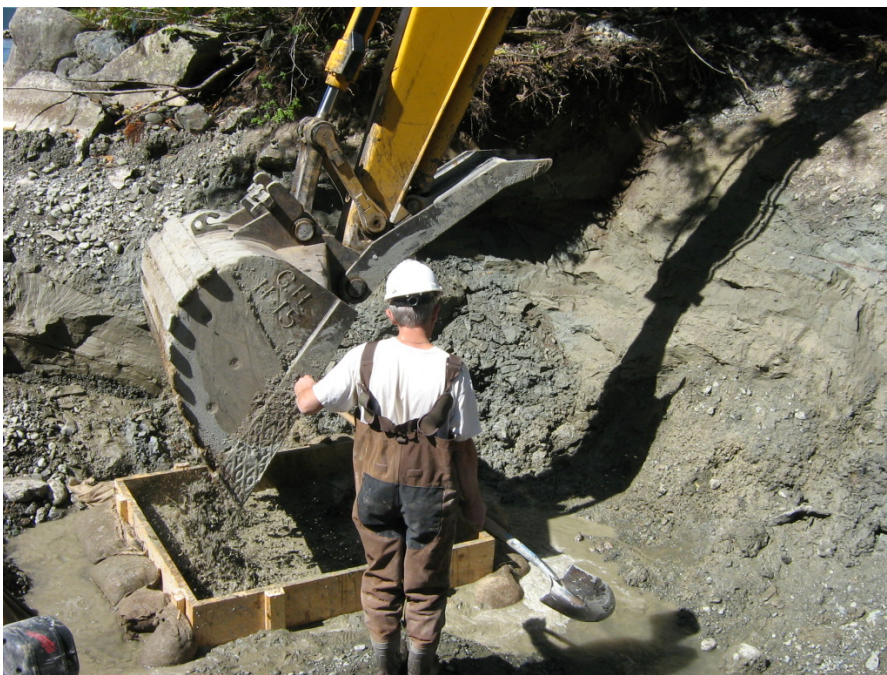
Photo 4. Reinforced concrete footings were constructed for the fishway structure.

Formwork and rebar was prepared for the upstream fishway footing and footing expansion near the left bank. Approximately 2 m³ of concrete was poured using the excavator to transfer the concrete from the ready-mix truck to the forms (Photo 4). The 600 volt electric pump was used to dewater the work site; a 75 mm gas pump was used to manage water within the site.

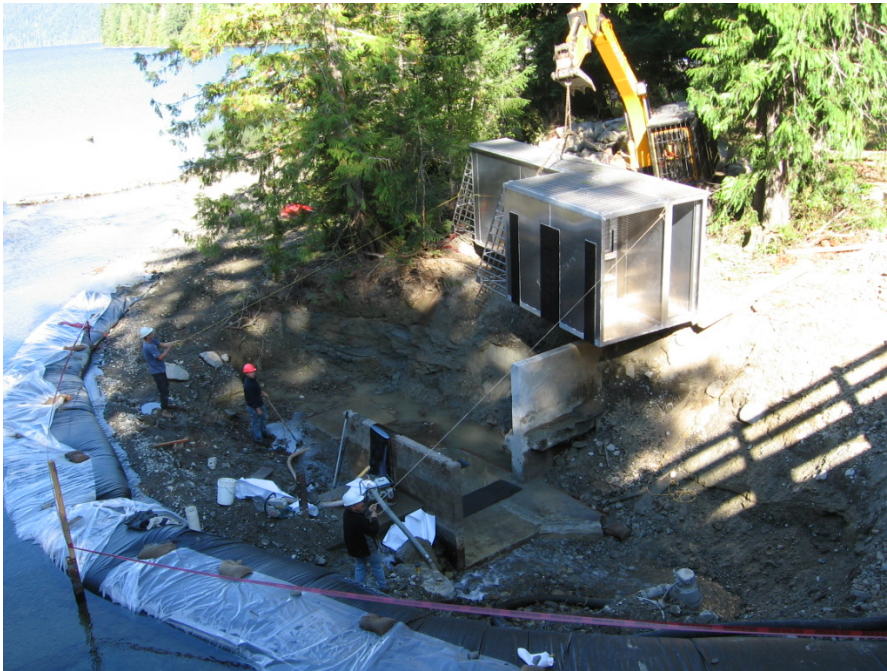
Photo 5. A hydraulic excavator positioned the fishway structure on the footings.

The fishway structure was positioned on the concrete footings and butted against the intact right concrete fishway wall using a John Deere 490D excavator (Photo 5). The fishway structure was secured to the footing and concrete wall using approximately 35 – 20 mm galvanized Hilti anchor bolts (Photo 6).

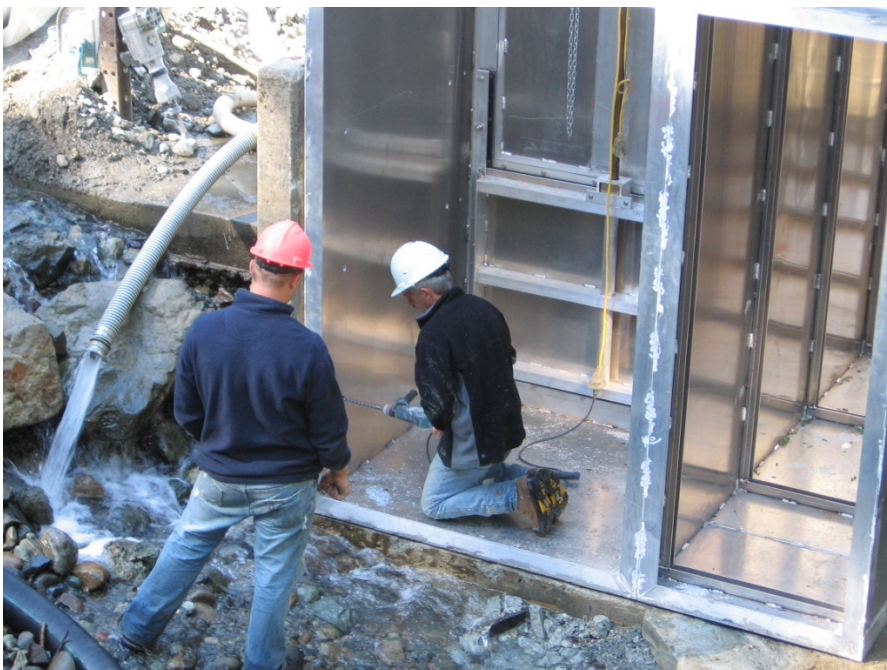
Photo 6. Concrete anchor bolts were used to secure the aluminium fishway to the concrete footings.

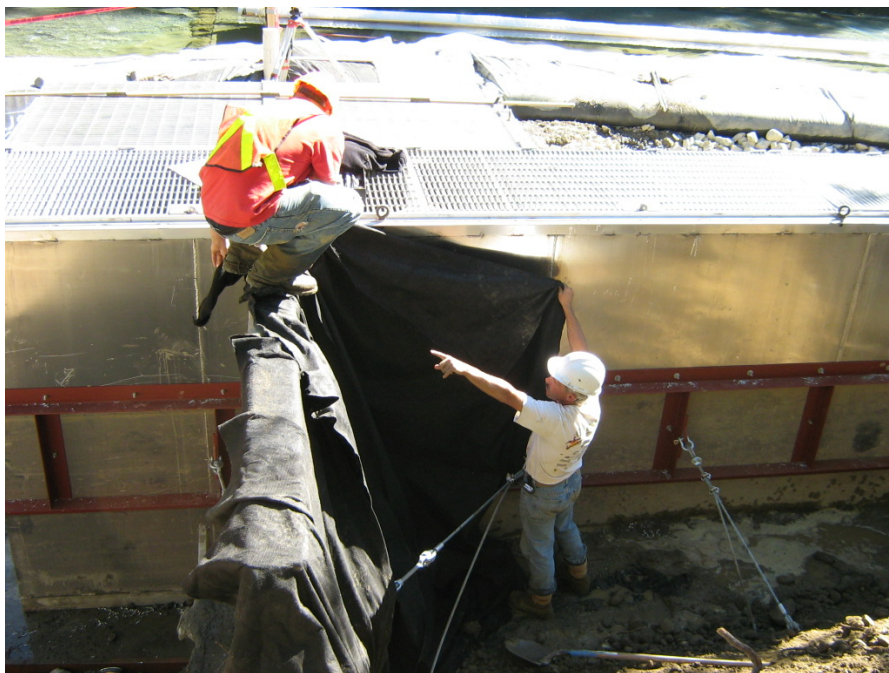
After the fishway was secured to the footings it was partially backfilled on the left bank. As the backfill was compacted the left fishway wall began to deflect under the load of the soil. The backfill was removed temporarily until a solution to reinforce the wall could be implemented.

Photo 7. A steel reinforcement ladder was bolted to the side of the fishway. Galvanized steel cables linked the ladder to the concrete abutment and a block buried in the bank.

A steel reinforcement ladder was fabricated and delivered to the site. The ladder was attached to the middle of the left wall of the fishway using approximately 40 galvanized nuts and bolts. A concrete lock-block was set in the left bank beside the fishway and galvanized cables and turnbuckles were attached between the block and ladder to support the fishway from lateral forces imparted by the soil backfill. The concrete cut-off wall was also used as an anchor point for the cables to the ladder (Photo 7).

The fishway was backfilled with sandy soil and compacted lightly. Filter cloth and bags of concrete mix were used to seal the space between the concrete cut-off wall and the fishway near the left bank. Minimal fishway wall deflection was observed after backfilling and reconstructing the left bank.

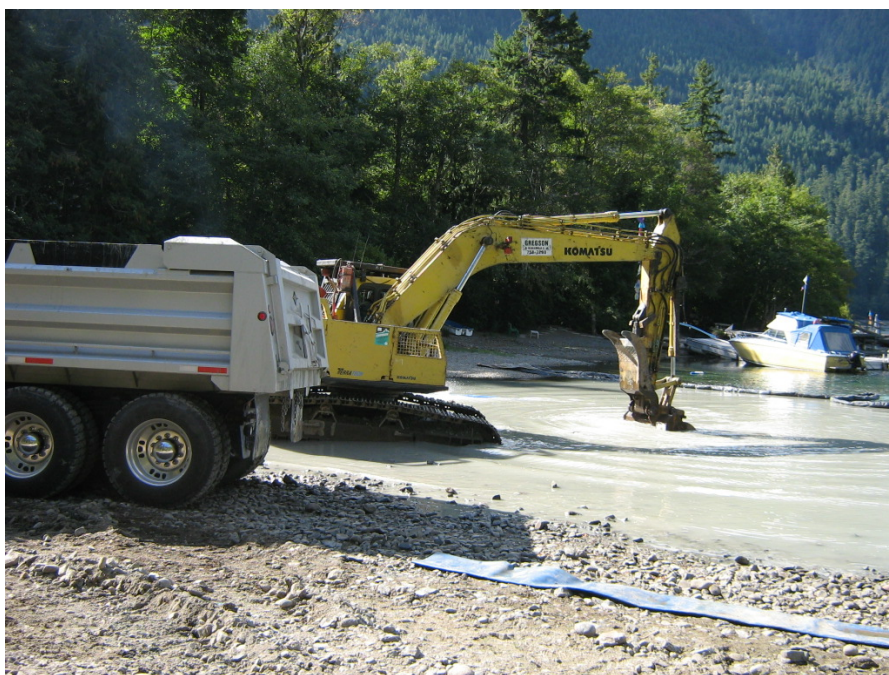
Photo 8. The area upstream of the weir was isolated and a low flow channel was excavated connecting the lake to the weir.

After the pumps were set up and running the site was isolated at the outlet of the lake and the excavator constructed a low flow connector channel 0.3 m lower than the concrete weir. The channel is approximately 50 m long and 4 m wide and extends between the weir and the lake. The substrate was primarily marine deposits comprised of very fine silts and clays; all of the material was hauled off site, and imported gravel was used to line the channel (Photo 8).

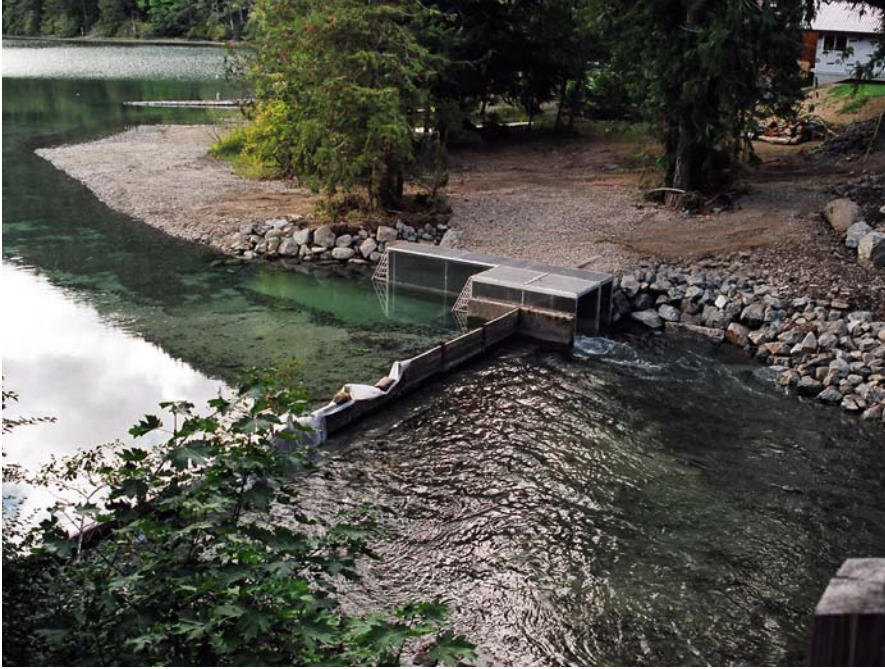
Photo 9. The gate was used to regulate flows in the river immediately after the construction was completed.

left bank amongst the vegetation. The invert of the re-graded channel is at approximately the same elevation as the weir. All of the instream work was completed September 15th (Photo 9).
