RECONNAISSANCE INVENTORY OF

CHISHOLM LAKE

WATERSHED CODE 460-6006-445-01

SURVEY DATES : SEPTEMBER 26 - 28, 1996

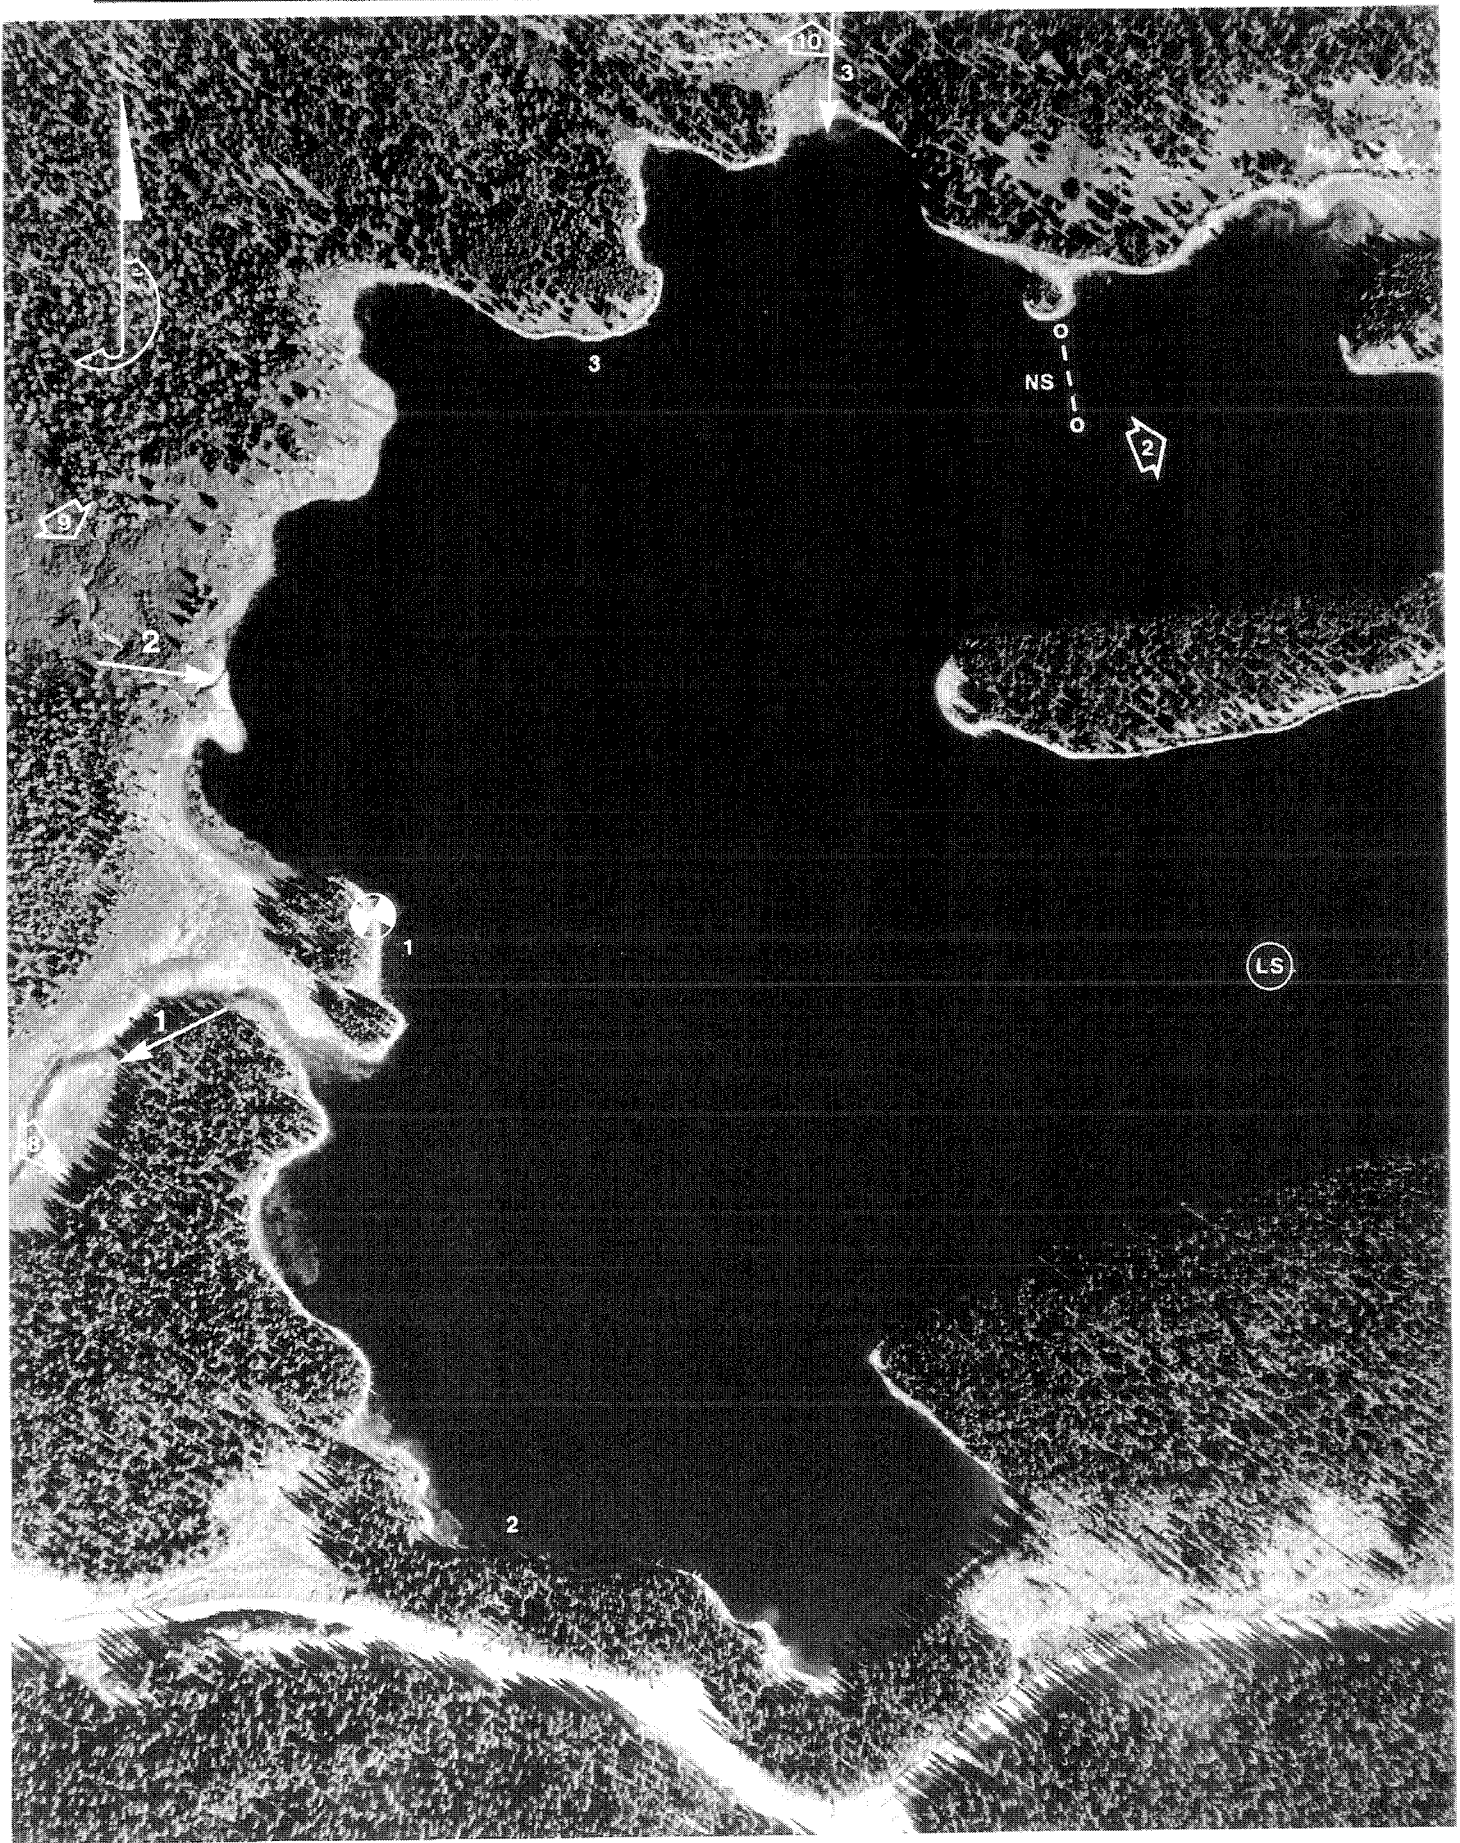
Figure 2. West half of Chisholm Lake, enlargement from air photo (see next page).

Figure 3. East half of Chisholm Lake, enlargement from air photo (see next page).

Quantitative characteristics of the stream surveys and fish sampling can be found on the stream survey forms in Appendix B and in Table 1. Numbering of channels (C1, C2 etc.) in this section corresponds to labels on Figures 2 and 3 and other figures and tables in this report. Four channels were examined.

Limnological sampling was conducted at midday on September 28, 1996 at the Chisholm Lake limnology station labelled on Figure 2. Weather during the survey was partly cloudy with up to 25 km/h westerly winds creating choppy surface conditions. Raw data and associated information were recorded on the RIC standard "Lake Biophysical Data Form" reproduced in Appendix D. Water samples were collected at 0.0 m, 10.0 m and 22.0 m depths, apportioned into aliquots for general chemistry and metals analysis, and shipped to Zenon Laboratories on ice for processing. Zenon's records show that the Chisholm Lake samples were received on Sept. 30, 1996 within the 72 hour RIC standard time frame for water sample transport.

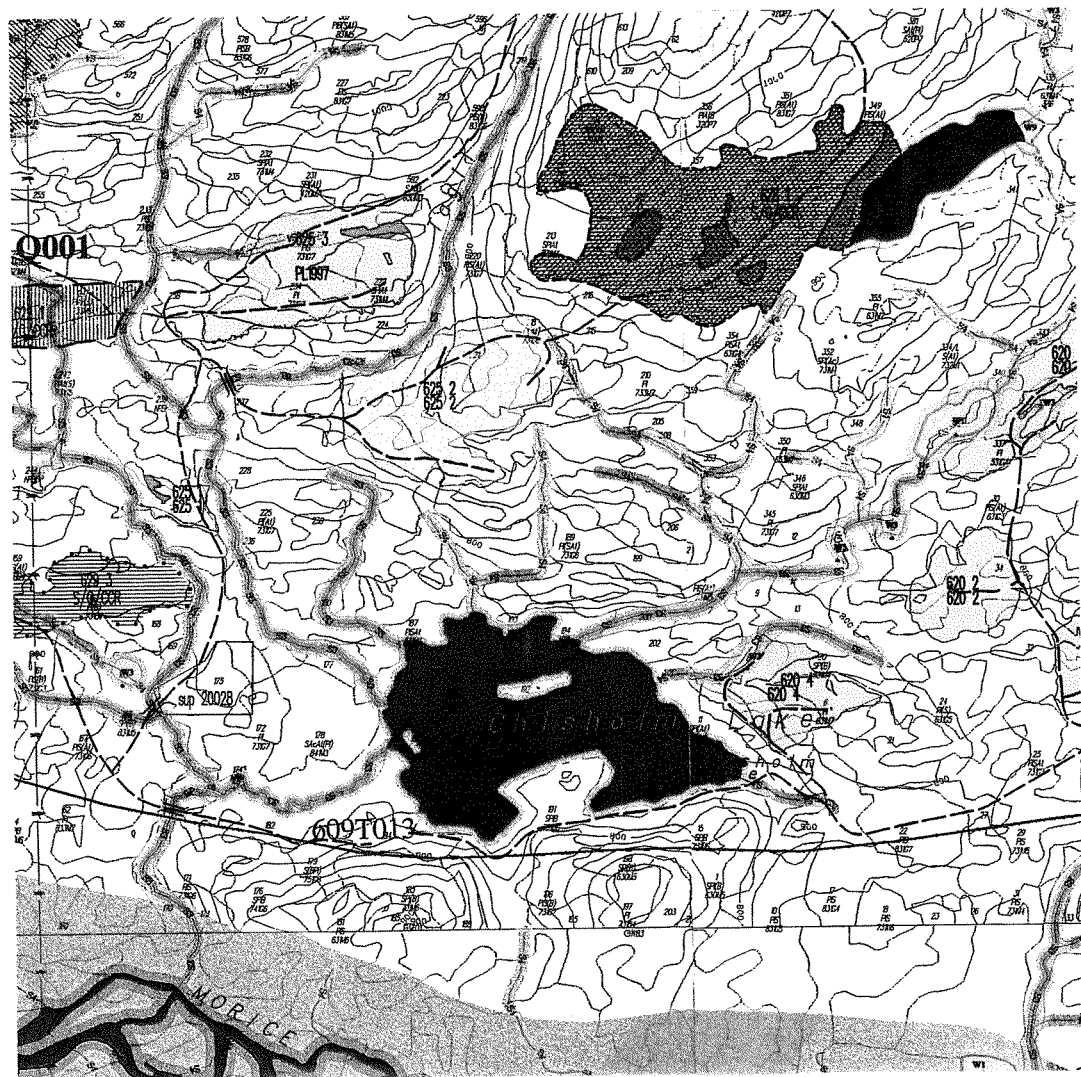
Figure 4. Planned cutblocks in the Chisholm Lake area. Reproduced with permission from Houston Forest Products.

The lake lies within the Houston Forest Products operating area in the Morice TSA. The closest existing cutblock to the lake lies 200 m to the northeast. The block was logged in 1994 and is visible from the west end of the lake. Another cutblock located 1.2 km northeast of the lake was also logged in 1994. A third cutblock was visible to the southwest from vantage points on the east side of the lake. The Chisholm Forest Service Road passes along the south shore of the lake, within 50 m to 100 m from the shore in many places. The road cut was visible from most vantage points on the lake surface. A cutblock is planned 1.2 km to the west of the lake in 2001 (see Figure 4).

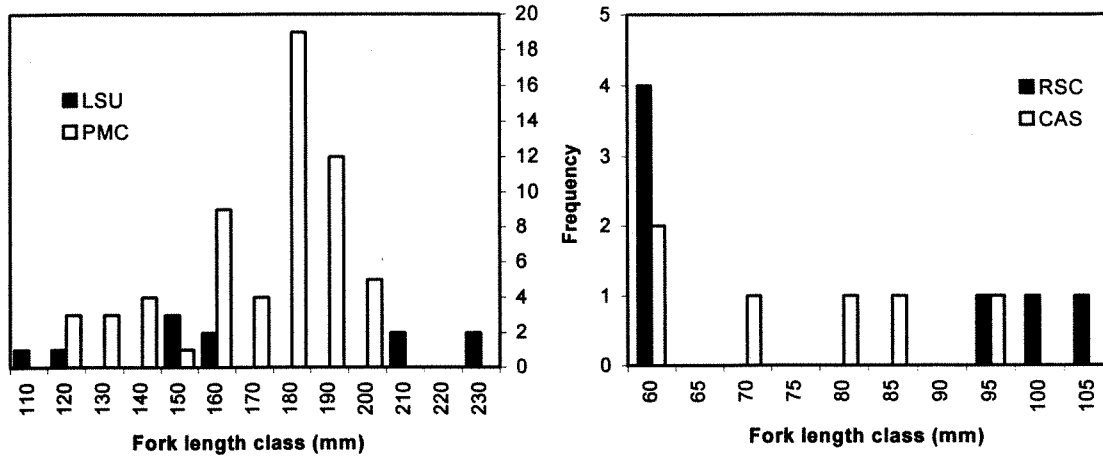
Figure 5. Length frequency histograms for abundant non-salmonid species captured by gillnet and minnow traps in Chisholm Lake. The x-axis class labels are lower bounds for the length classes.

Characteristics of the length distributions of fish captured by gillnet and minnow trap in Chisholm Lake and its inlets and outlet, are shown in Table 2, Figure 5 and Figure 6. Due to gear selectivity, the samples are probably not representative of the true length structure of Chisholm Lake fish populations. Cutthroat trout growth in Chisholm Lake does not conform well to the Von Bertalanffy model (Figure 8). This may be for any combination of the following reasons: early ages follow a different growth trajectory, sample sizes are small, or the growth model is inappropriate for this population.

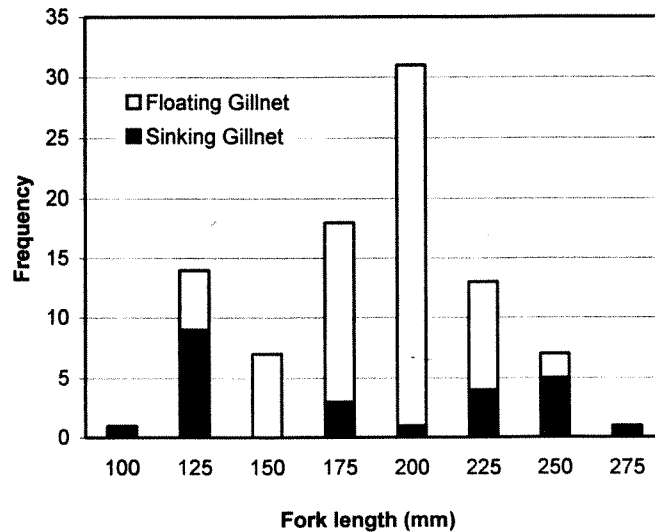
Figure 6. Length frequency distribution of cutthroat trout caught by sinking gillnet (shaded bar areas) and floating gillnet (open bar areas) at Chisholm Lake, September 26 - 28, 1996. The x-axis labels are the lower boundaries of length classes.

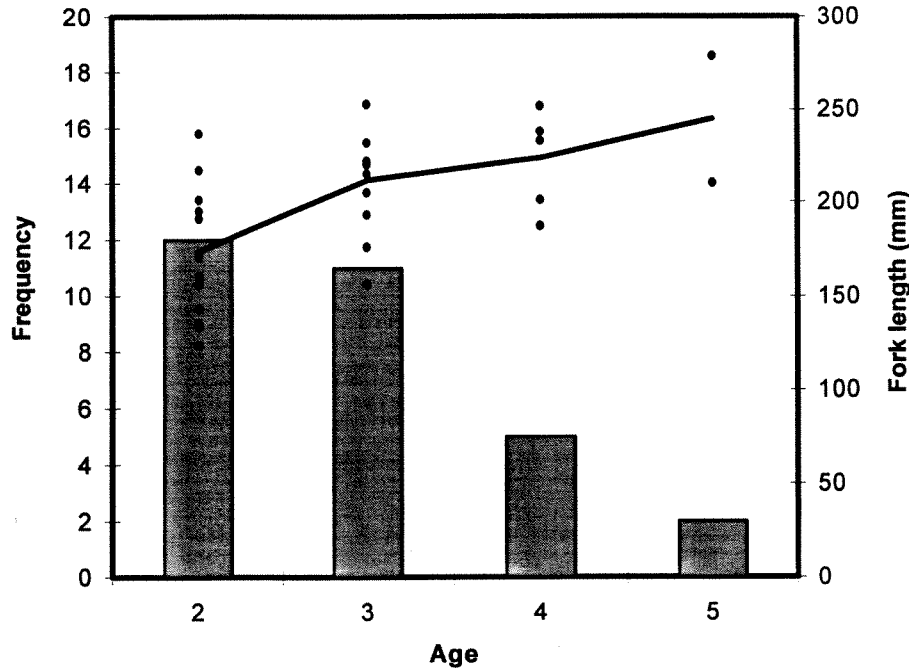
Figure 7. Age frequency histogram and length-at-age for cutthroat trout captured at Chisholm Lake and its inlets and outlet, September 26 - 28, 1996. The solid line shows mean fork length-at-age, while the filled circles indicate lengths-at-age for individual fish.

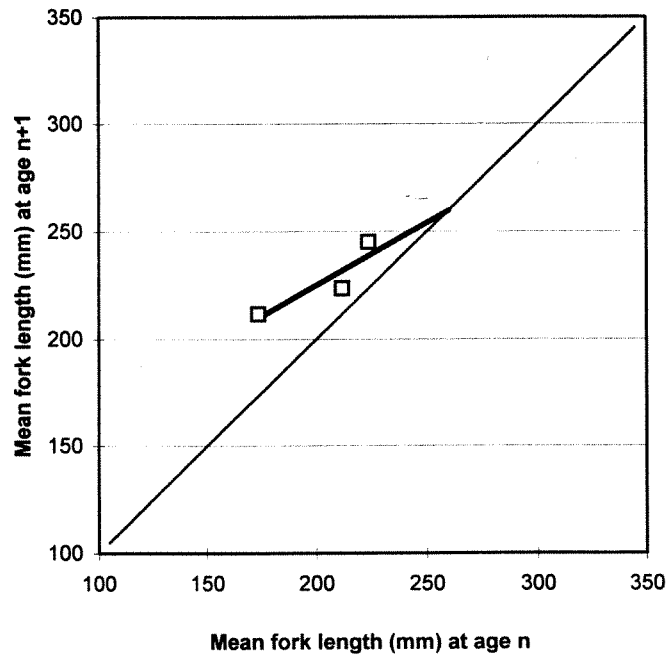
Figure 8. Ford-Walford plot for cutthroat trout captured at Chisholm Lake. Lengths-at-age are mean values. The heavy line shows the least-squares regression of {length-at-age n+1} on {length-at-age n}. The first two points were excluded from the fit. Estimated terminal length (L_{∞}) occurs at the intersection of the regression line with the diagonal reference line; the parameters from the regression give $k = 0.581$ and $L_{\infty} = 260$ mm.

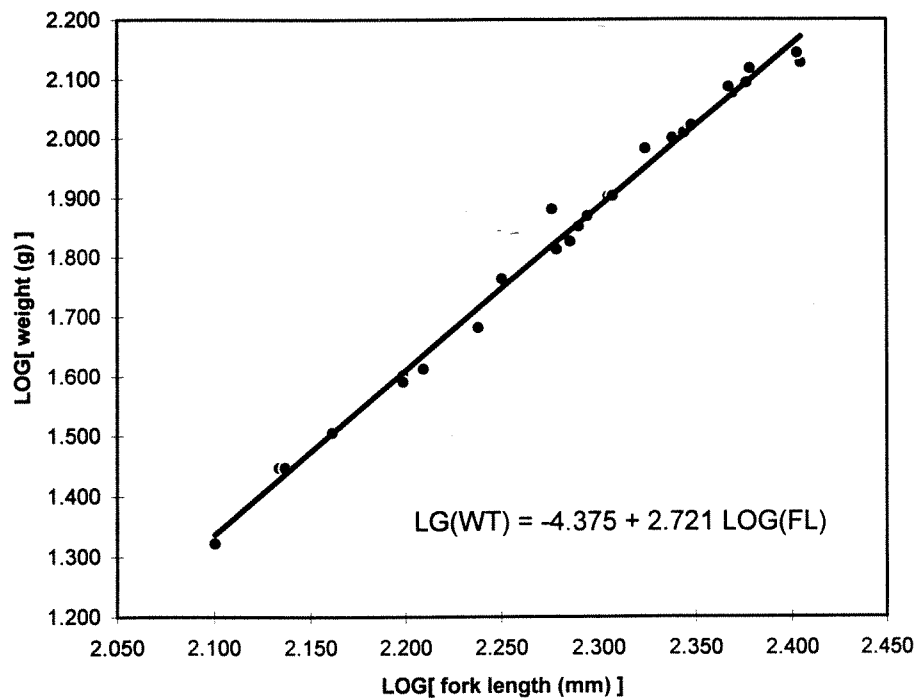
Figure 9. Estimated length - weight relationship for Chisholm Lake cutthroat. Both length and weight are \log_{10} transformed. The GM regression equation is shown; the resulting estimate of Fulton's condition factor is thus $10^{-4.375} \cdot 10^5 = 4.22$.

Sample sizes are low, but cutthroat trout sexual maturity appears to occur by age 3 or 4 for females in Chisholm Lake. The majority of males in each age class below age 4 were immature, while all age 5 males were mature. The population condition factor is very high, relative to other small lake cutthroat trout populations in Skeena region during late summer (Figure 9).

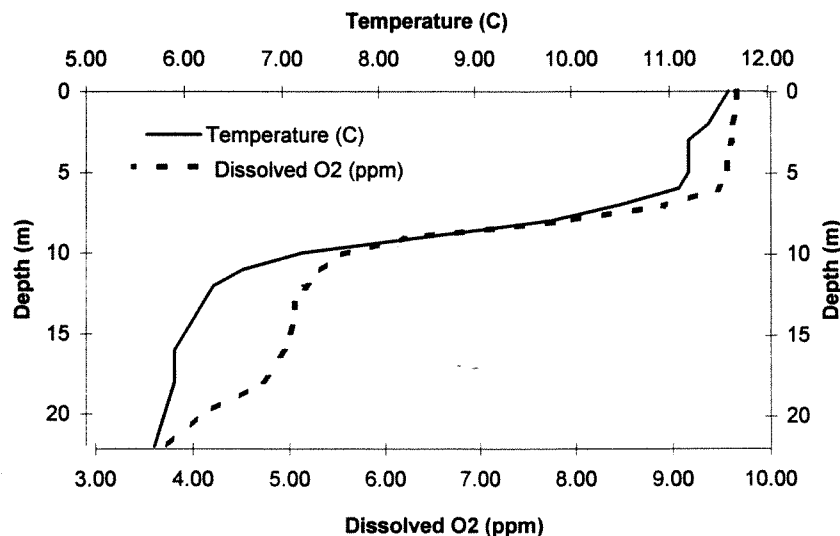
Figure 10. Temperature and dissolved O₂ profiles for Chisholm Lake on September 28, 1996. The sampling device was a YSI 57 temperature/oxygen meter. Sample interval was 1.0 m from the surface to 14.0 m depth and 2.0 m below this point.

The oxygen - temperature profile of Chisholm Lake on September 28, 1996 is shown in Figure 10. The lake was thermally stratified at time of survey. Dissolved oxygen in the hypolimnion was moderately depleted.

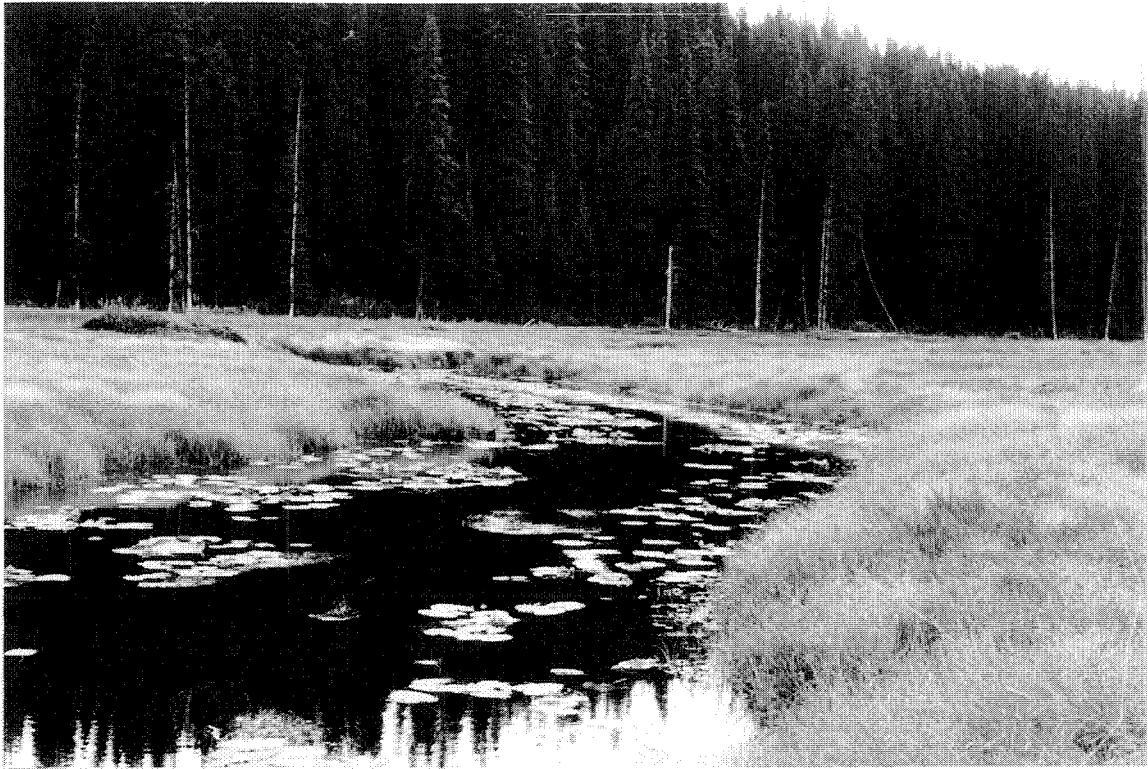
Photograph 8. Downstream view of Tagit Creek, C1, WC 460-6006-445, outlet of Chisholm Lake.

- C1. Tagit Creek WC 460-6006-445, outlet from the west shore of Chisholm Lake at UTM 09.615950.6008017 (NAD27). See Photograph 8. Proposed classification S2. The channel was surveyed to a breached beaver dam 630 m downstream of the lake. The entire reach consists of a continuous pool with barely discernible flow. *Nuphar polysepalum*, *Potamogeton epihydrus*, *Sparganium* sp. and *Hippuris vulgaris* grow in abundance in the channel. The bank and bed materials were made up of fines. Stage was medium at time of survey and discharge was estimated at 0.21 m³/s. Small pockets of fair to good salmonid spawning substrate were found and rearing potential is good to excellent. Three minnow traps fished overnight captured 2 reidside shiner and a white sucker.

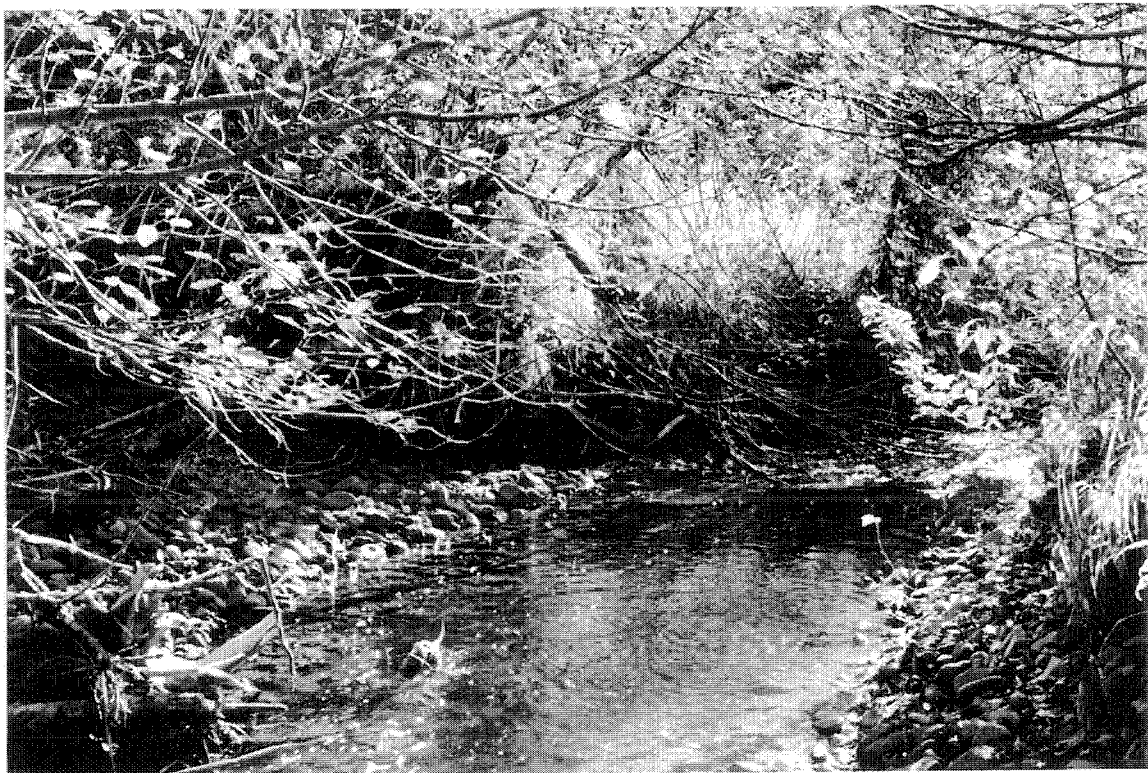
Photograph 9. Downstream view of Tagit Creek, C2, WC 460-6006-445, inlet to west shore of Chisholm Lake.

- C2. Tagit Creek WC 460-6006-445, inlet to the west shore of Chisholm Lake at UTM 09.615875.6008234 (NAD27). See Photograph 9. Order 3, magnitude 7, drainage area 20.7 km², proposed classification S3. The channel carries mostly run and riffle flow over gravel and larges at 2.0 % gradient. Stage was medium at time of survey and discharge was estimated at 0.12 m³/s. Excellent salmonid spawning substrate was found and rearing potential was fair to good. Three minnow traps fished overnight captured 2 cutthroat trout.

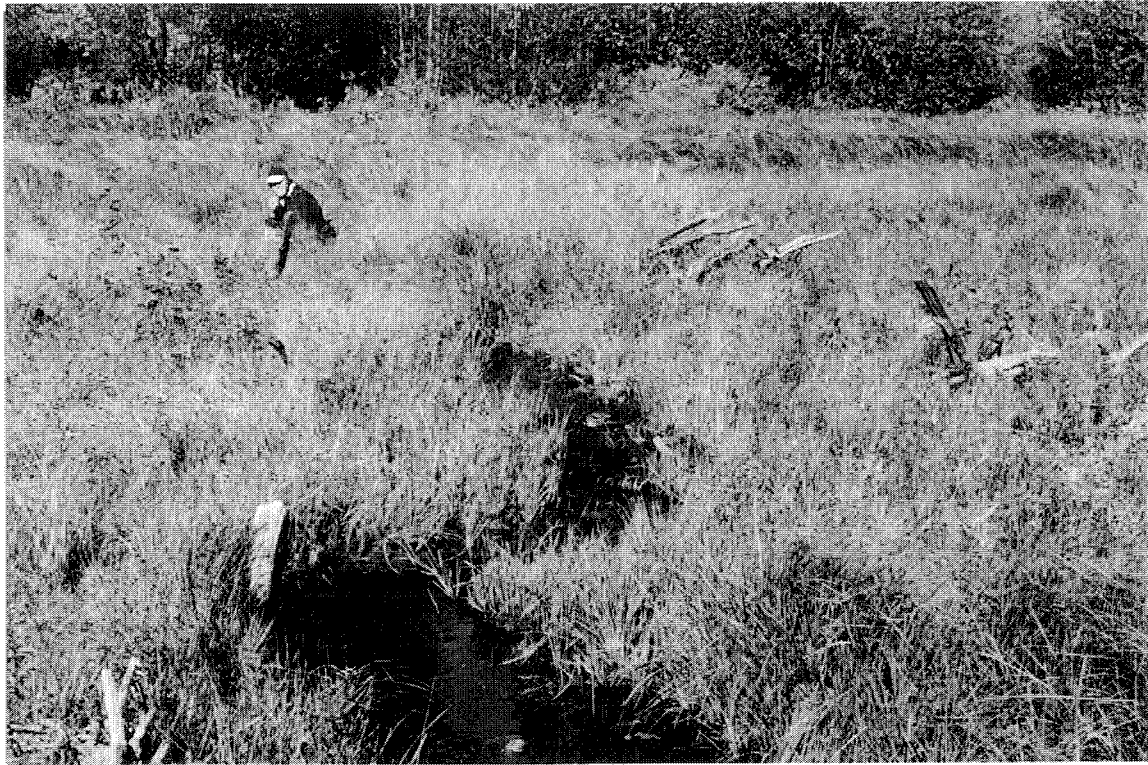
Photograph 10. Upstream view of C3, (WC pending) inlet to north shore of Chisholm Lake.

- C3. Unnamed channel (WC pending), inlet to the north shore of Chisholm Lake at UTM 09.616350.6008775 (NAD27). See Photograph 10. Order 1, magnitude 1, drainage area 1.5 km², proposed classification S4. Two reaches are contained in the 113 m survey length. The reach adjacent to the lake bears pool and riffle flow over fines at 2.5 % average gradient. At 45 m from the lake the average gradient increases to 7 % and flow is almost entirely run over gravels and larges. The survey ended at a 1.5 m high beaver dam that forms a barrier to fish passage. Further upstream a 15 m length of channel at 45 % gradient would also prevent fish passage. Some fair rearing habitat is located in the reach adjacent to the lake. Dip netting and visual observation revealed many juvenile cutthroat trout.

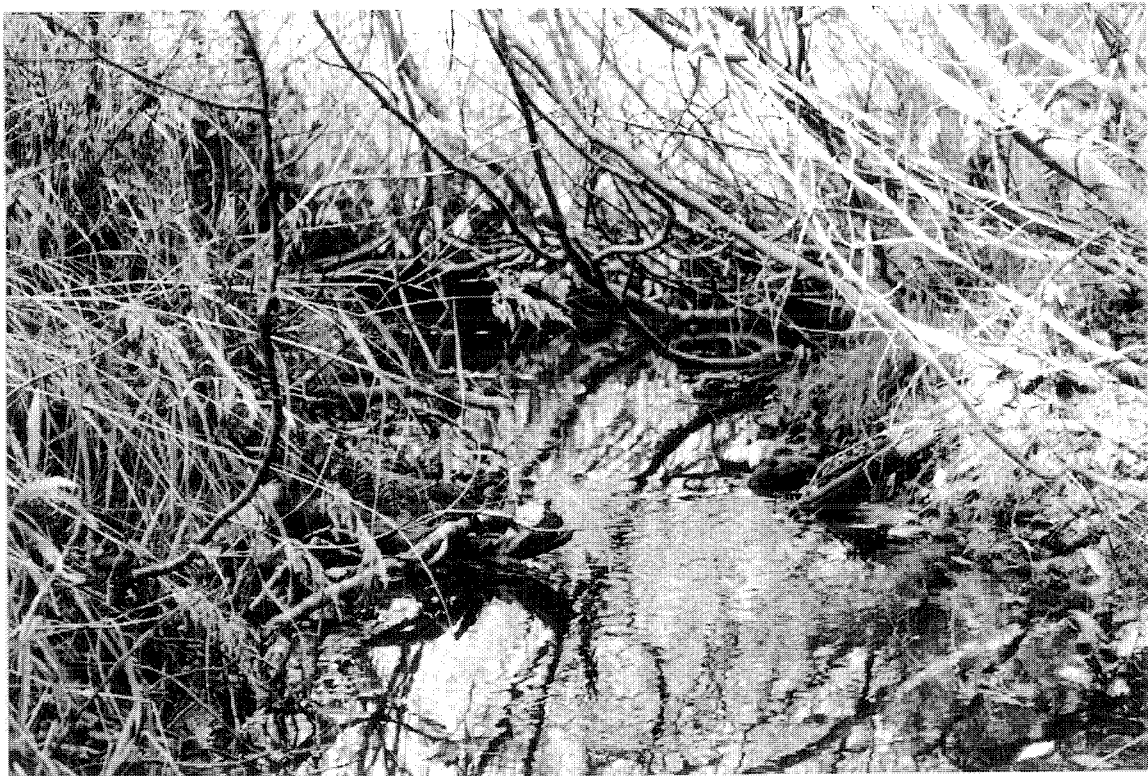
Photograph 11. Upstream view of C4, WC 460-6006-445-214, inlet to northeast shore of Chisholm Lake.

- C4. Unnamed channel WC 460-6006-445-214, inlet to the north shore of Chisholm Lake at UTM 09.617300.6008325 (NAD27). See Photograph 11. Order 1, magnitude 1, drainage area 2.02 km², proposed classification S4. A beaver dam is located 105 m upstream of the Lake. Much of the channel contains stagnant water. Most of the flow is in pools over organic fines. Stage was medium at time of survey and discharge was estimated at 0.01 m³/s. Salmonid spawning was poor due to lack of suitable substrate and rearing habitat was fair. Visual observation during the survey detected no fish.

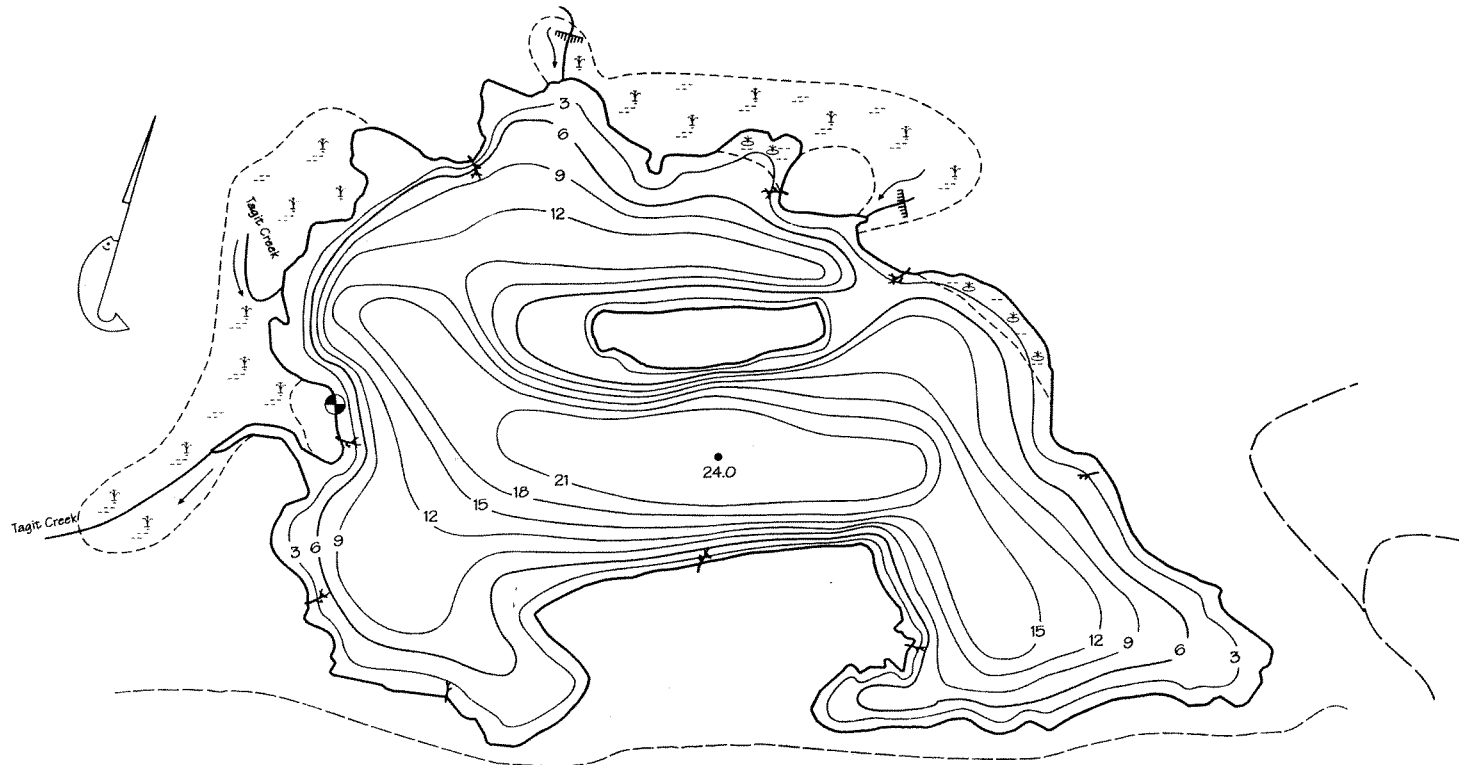
APPENDIX F. BATHYMETRIC MAP

NOTES: 1 - Depths are in Metres; 2 - Denotee Bench Mark; 3 - Not intended for navigational use. Uncharted rocks and shoals may exist.
