RECONNAISSANCE INVENTORY OF

BROWN PAINT LAKE

WATERSHED CODE 470-5259-01

SURVEY DATES : JULY 27 - 29, 1996

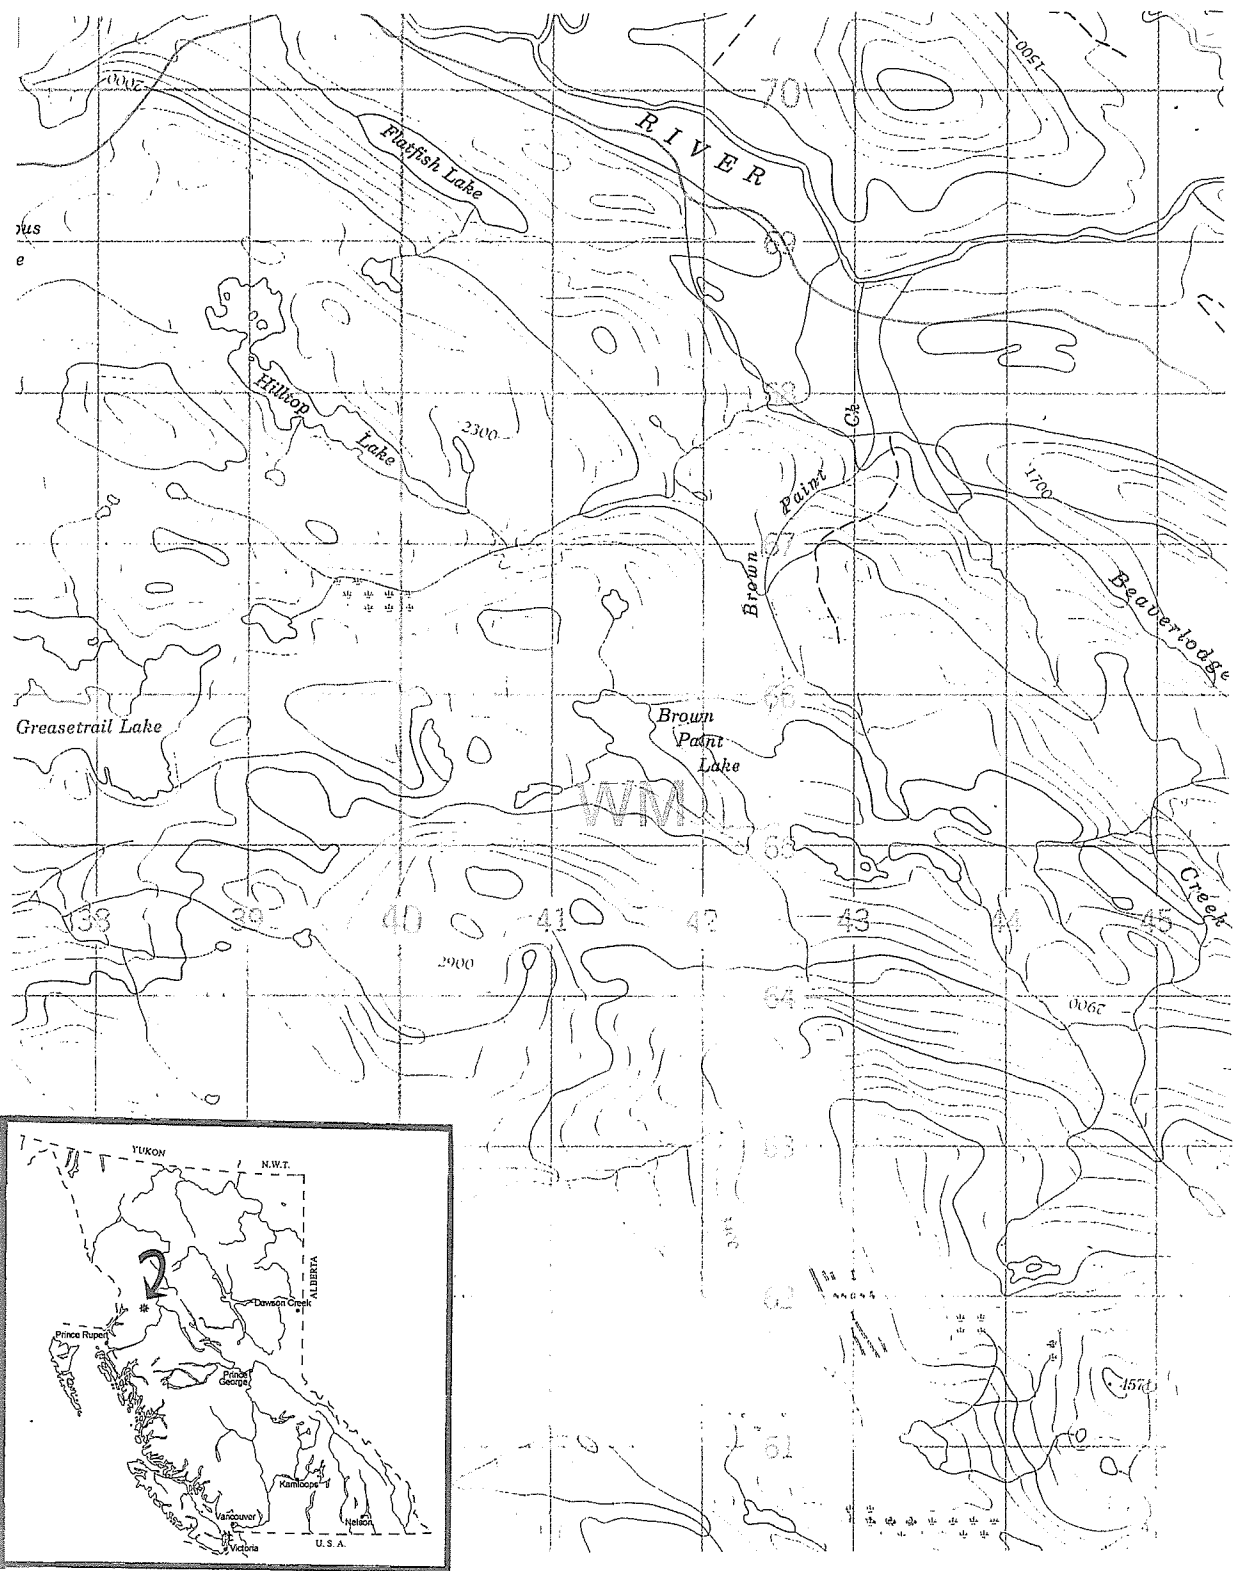
Figure 1. Brown Paint Lake and surrounding features, as depicted on NTS mapsheet 103P/09 (1:50,000 scale). Inset map shows the location within the province of British Columbia.

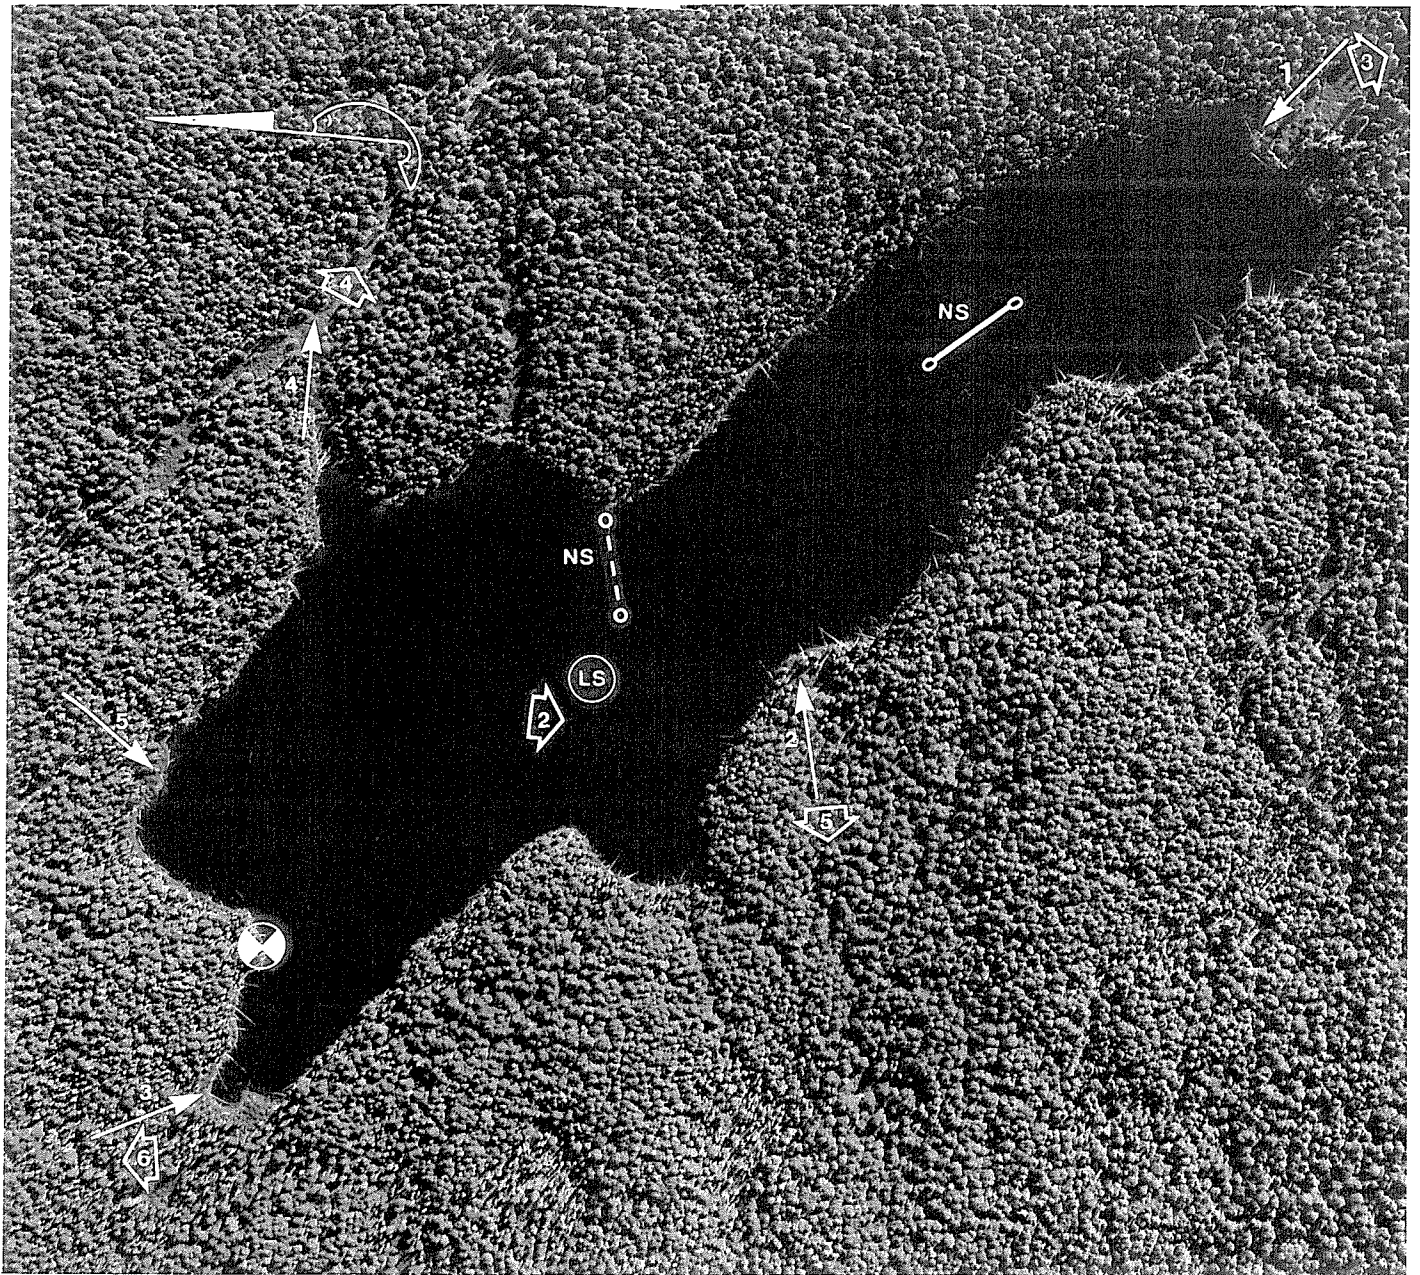
Figure 2. Enlargement from air photo.

AIR PHOTO #: 30BCC94057 #172

SCALE: 1 : 5560

OUTLET UTM: 09.541493.6166152

Quantitative characteristics of the stream surveys and fish sampling can be found on the stream survey forms in Appendix B and in Table 1. Numbering of the streams (C1, C2, etc.) in this section corresponds to labels on Figure 2 and other figures and tables in this report.

Limnological sampling was conducted at midday on July 29, 1996 at the Brown Paint Lake limnology station labelled on Figure 2. The sky was mostly clear at time of survey and a very light westerly wind created calm surface conditions. Raw data and associated information were recorded on the RIC standard "Lake Biophysical Data Form" which is reproduced in Appendix D. Water samples were collected at 0.0 m, 7.5 m and 20.0 m depths, apportioned into aliquots for general chemistry and metals analysis, and shipped on ice to Zenon Laboratories for processing. Zenon's records show that the Brown Paint Lake samples were received on August 01, 1996, within the 72 hr RIC standard time frame for water sample transport.

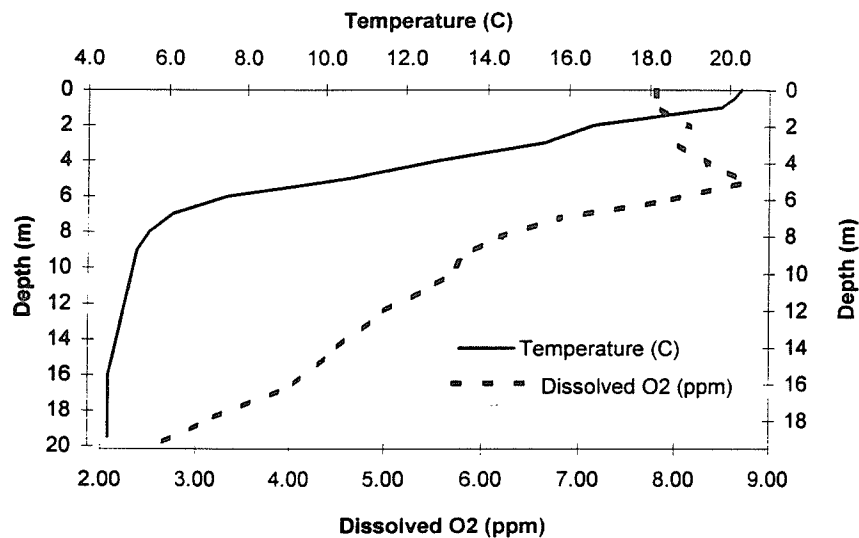
The oxygen - temperature profile of Brown Paint Lake on July 29, 1996 is shown in Figure 4. The lake was thermally stratified at time of survey. Dissolved oxygen was depleted in the hypolimnion but not to anoxia.

Figure 4. Temperature and dissolved O₂ profiles for Brown Paint Lake on July 29, 1996. The sampling device was a YSI 57 temperature/oxygen meter. Sample interval was 1.0 m from the surface to 12.0 m depth, and 2.0 m in deeper water.

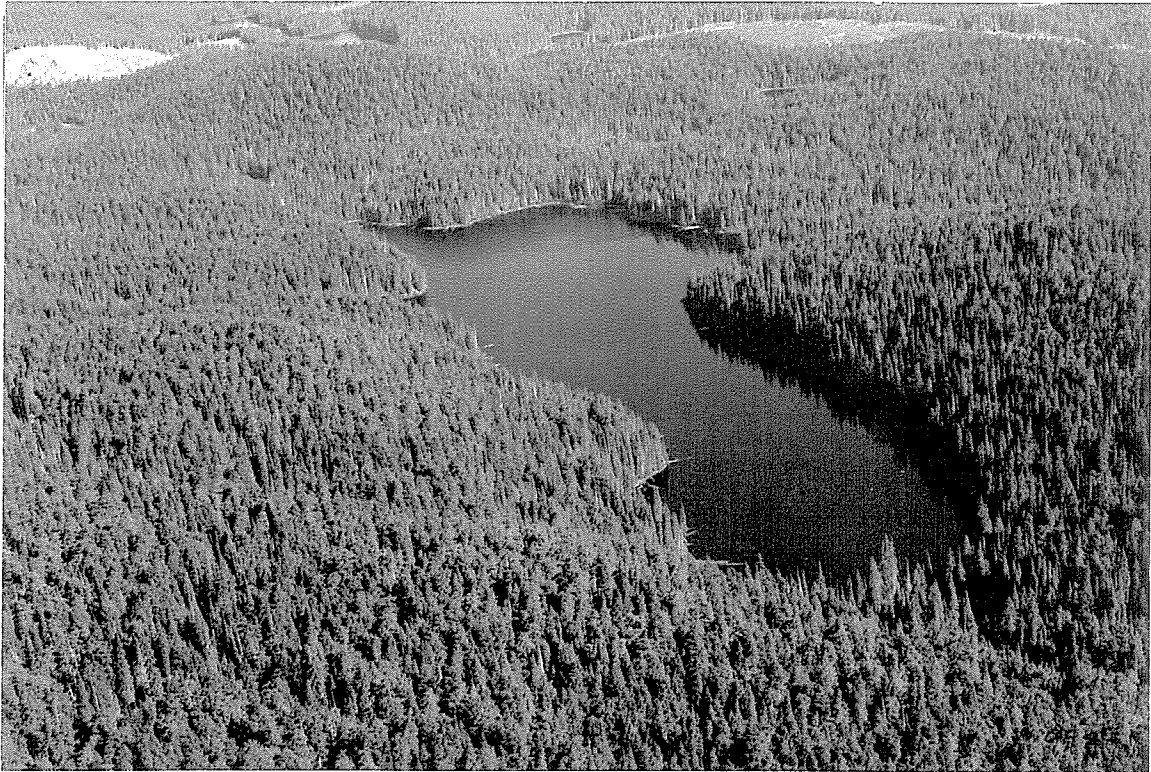
Photograph 1. Aerial view of Brown Paint Lake, on approach from the south.

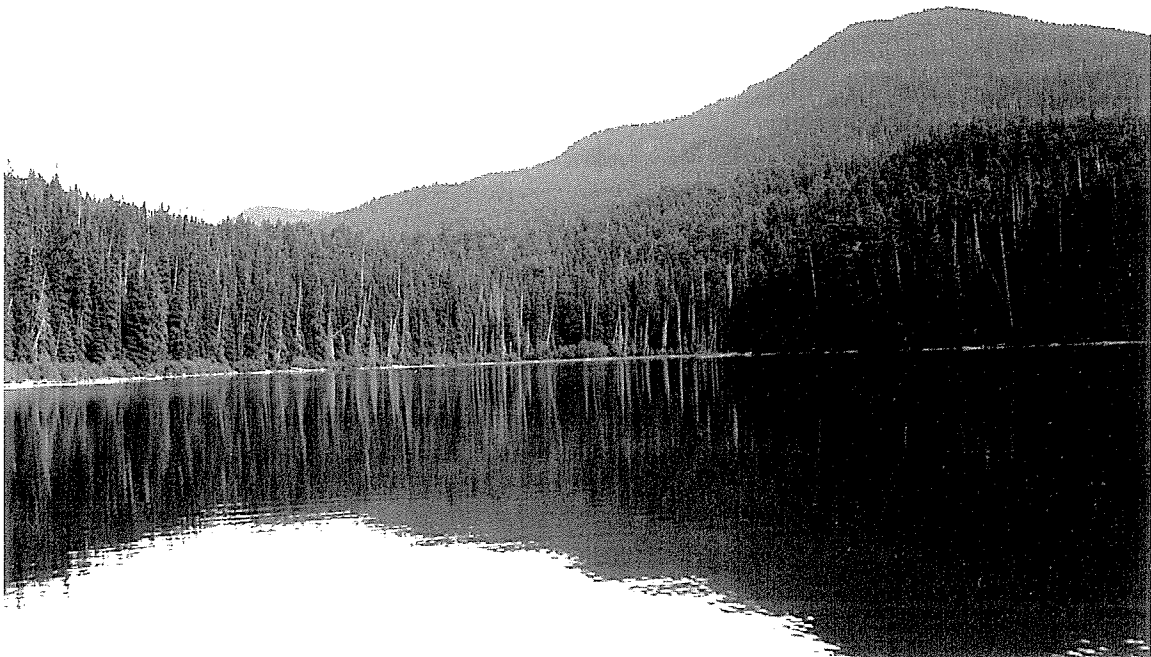
Photograph 2. View to the south from mid-lake.

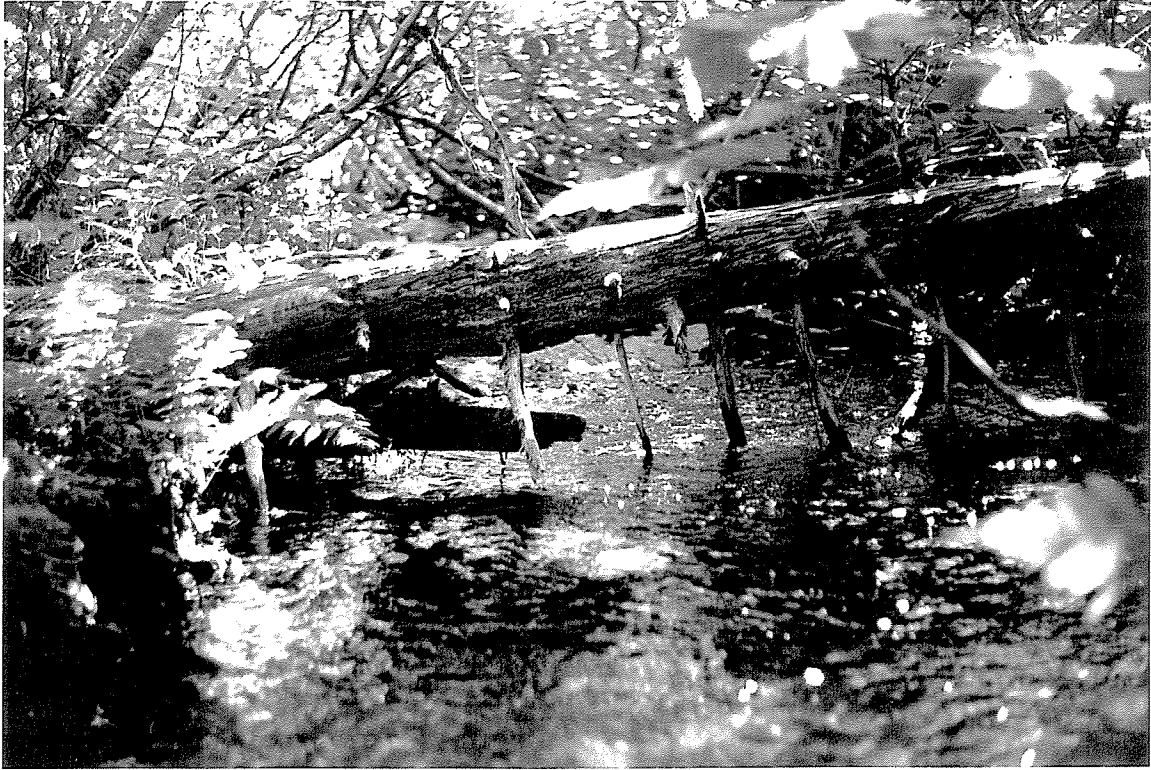
Photograph 3. Upstream view of Brown Paint Creek, WC 470-5259, inlet to southeast end of Brown Paint Lake.

- C1. Brown Paint Creek, WC 470-5929, inlet to the southeast shore of Brown Paint Lake at UTM 09.542015.6165234 (NAD27). Order 1, magnitude 1, drainage area 5.1 km², proposed classification S5. Several debris dams and chutes (1.0 m max. height) were observed, some of which would form seasonal barriers to fish passage. The channel bears mostly riffle flow over larges and bedrock substrate. Average gradient is 17 % and the channel is entrenched. Adjacent to the lake gradient is lower and bed material is predominantly gravels. Discharge was estimated at 0.04 m³/s. Electrofishing for 79 seconds captured no fish.

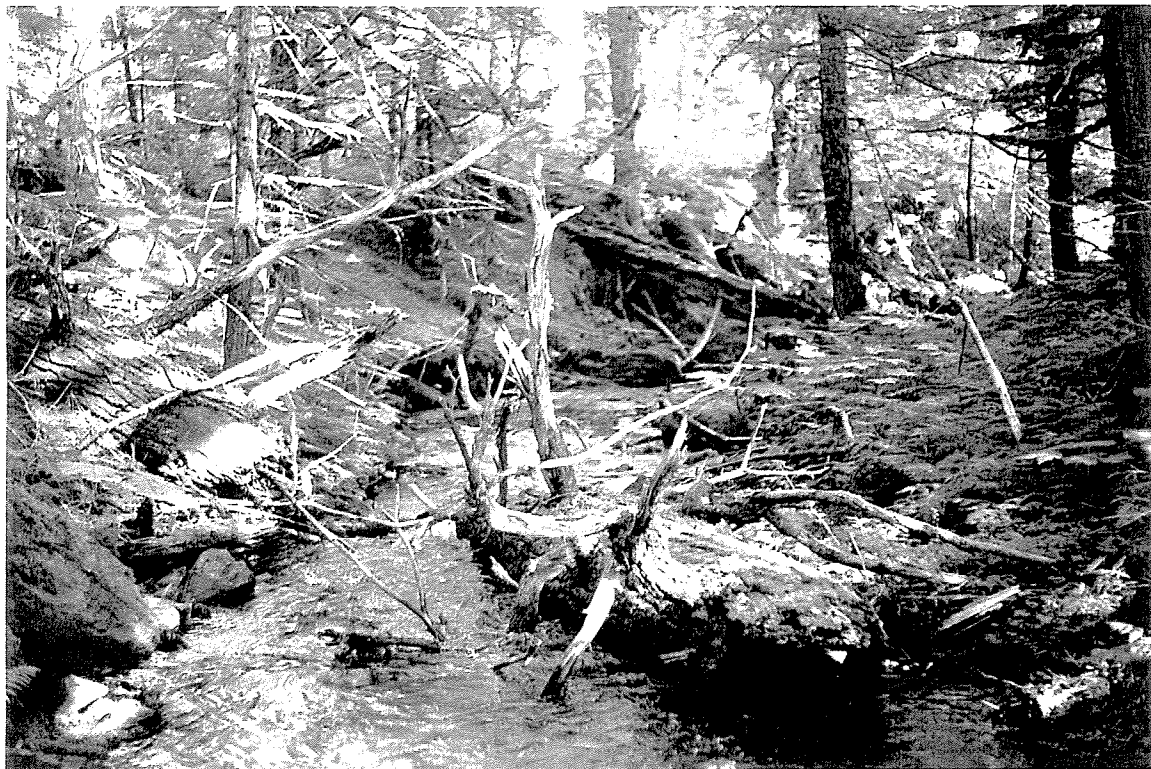
Photograph 4. Downstream view of Brown Paint Creek, WC 470-5259, outlet of Brown Paint Lake.

- C4. Brown Paint Creek, WC 470-5929, outlet from the northeast shore of Brown Paint Lake at UTM 09.541650.6165935 (NAD27). Proposed classification S5. Two reaches are contained within the 500 m surveyed length of stream. Near the lake the channel gradient is low and much emergent vegetation grows in the organic fines bed material. Further downstream the channel steepens and carries riffle and run flow over cobble, boulder and bedrock substrates. Electrofishing for 202 seconds captured no fish.

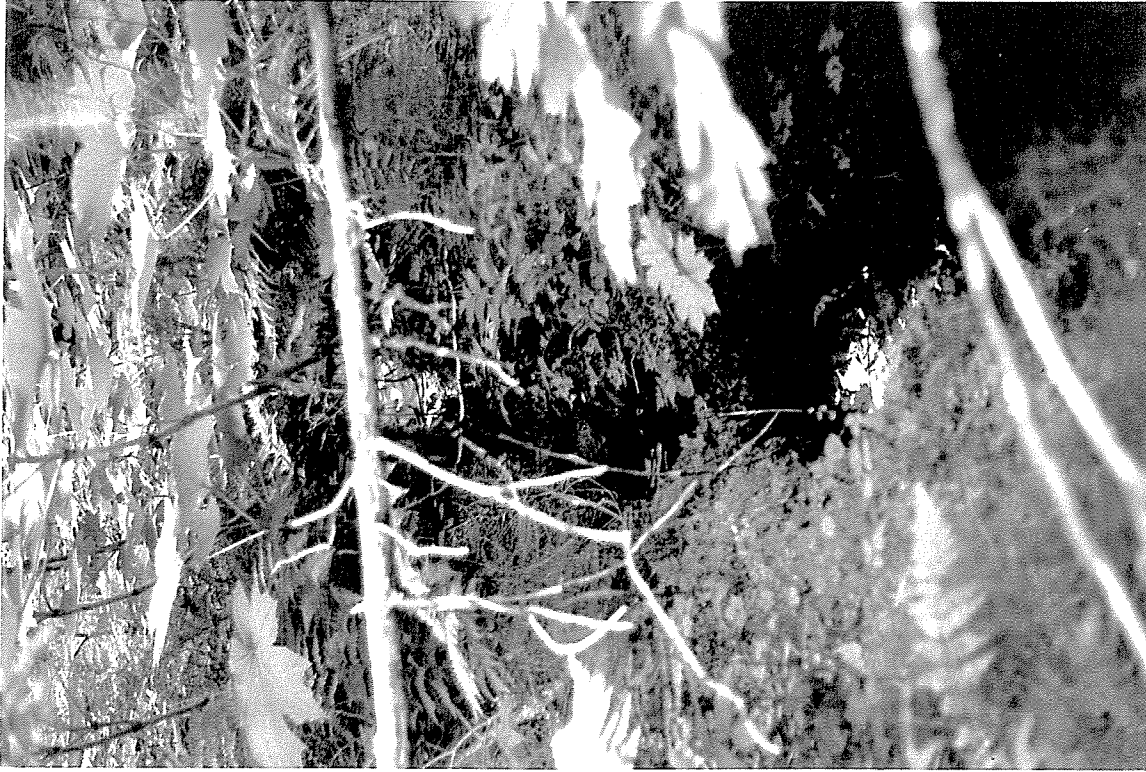
Photograph 6. Upstream view of C3 (WC pending), inlet to northwest bay of Brown Paint Lake.

- C3. Unnamed channel (WC pending), inlet to the northwest bay of Brown Paint Lake at UTM 09.541150.6165950 (NAD27). Order 1, magnitude 1, drainage area 0.22 km², proposed classification S6. Channel bears intermittent and ephemeral flow over organic fines. The stream is too shallow to constitute fish habitat. Visual observation during the survey detected no fish. t

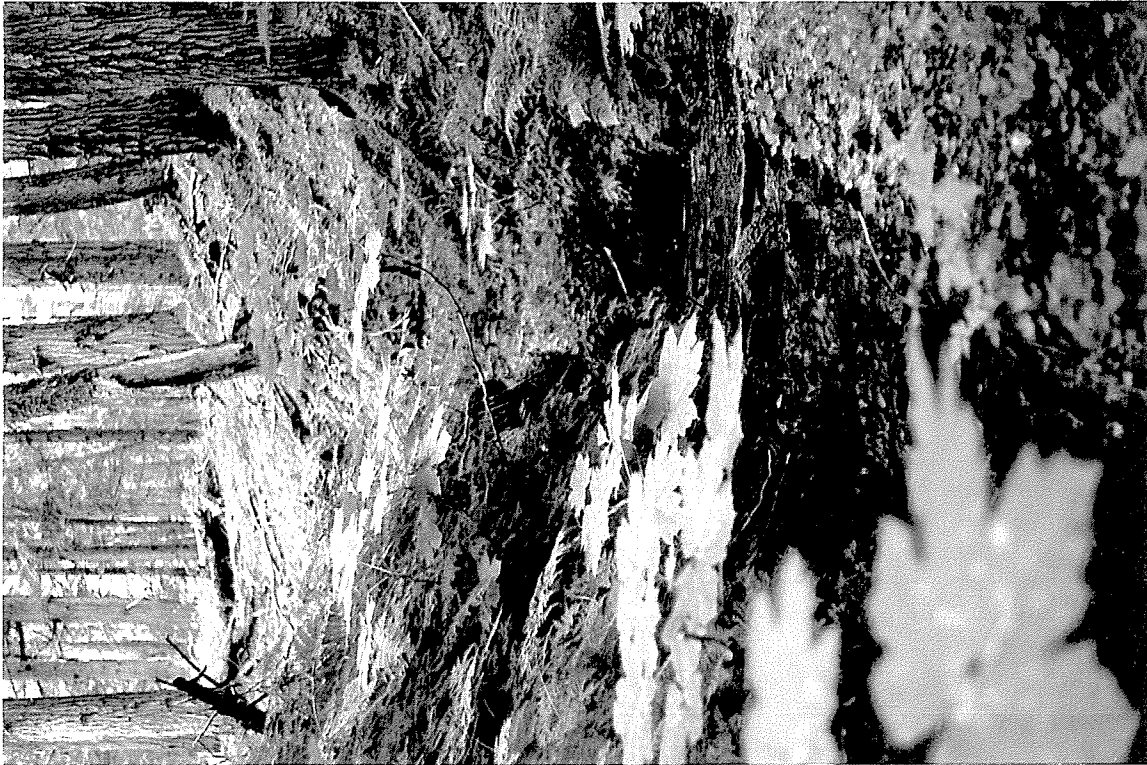
Photograph 5. Upstream view of C2 (WC pending), inlet to southwest shore of Brown Paint Lake.

- C2. Unnamed channel (WC pending), inlet to the southwest shore of Brown Paint Lake at UTM 09.541575.6165550 (NAD27). Order 1, magnitude 1, drainage area 0.77 km², proposed classification S6. The stream is too shallow to constitute fish habitat and flow appears ephemeral. Discharge was estimated at 0.002 m³/s. Chutes (< 1.0 m max. height) would form seasonal barriers to fish passage. The channel bears riffle habitat over gravel and cobble. Visual observation during the survey detected no fish.

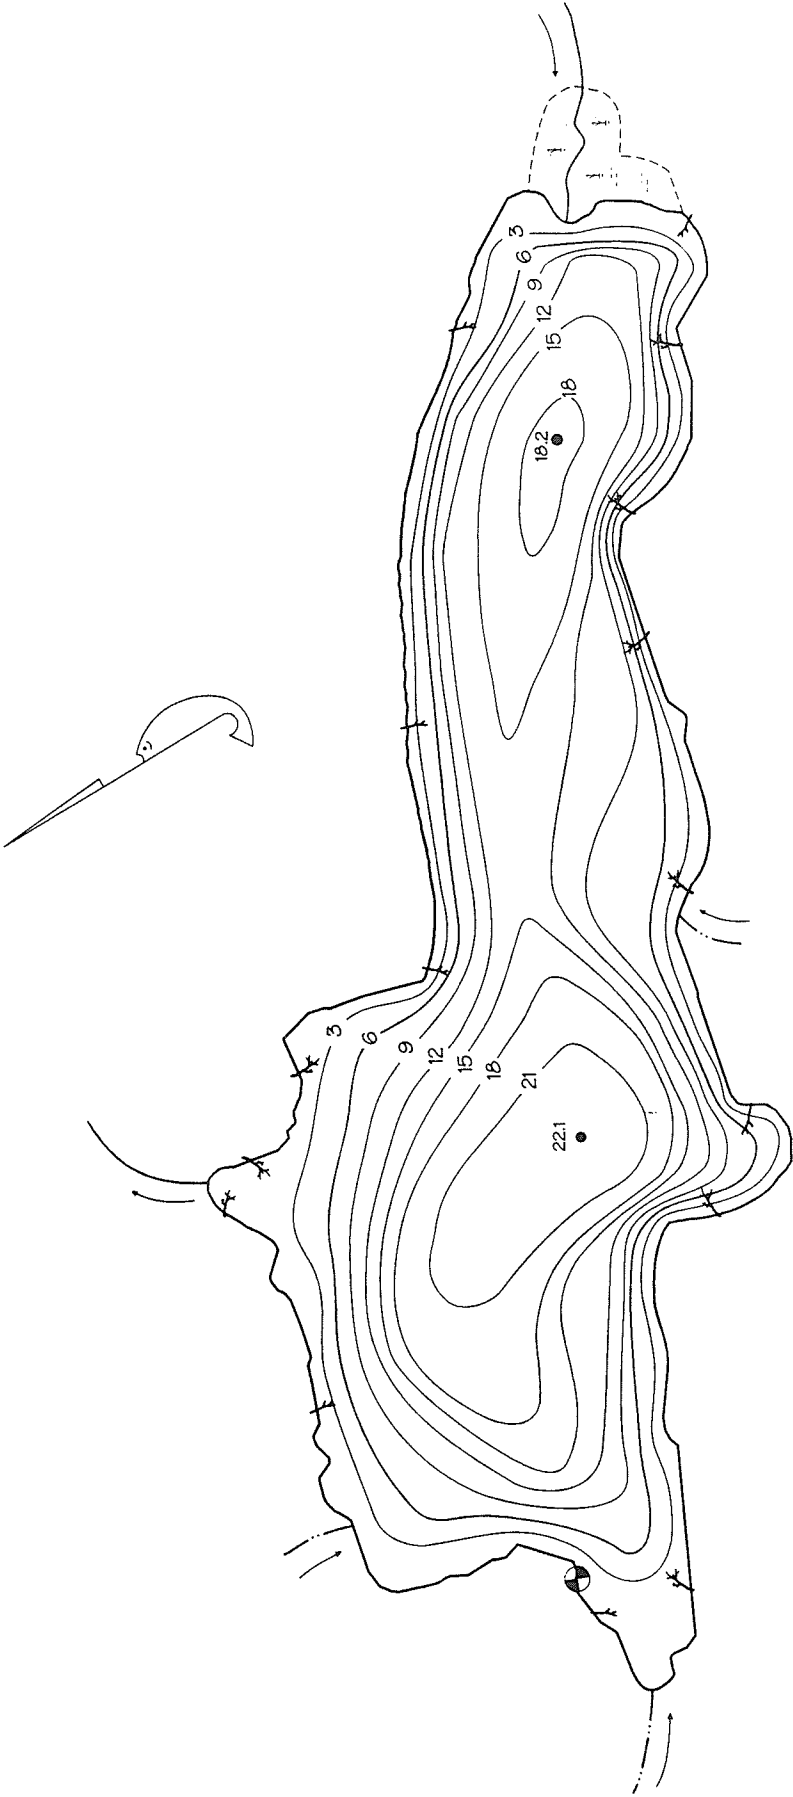
APPENDIX F. BATHYMETRIC MAP

NOTES: 1. Depths are in Metres; 2. Datum: British Columbia Datum; 3. Not included for navigational use. Uncharted rocks and shoals may exist.
