AN INVENTORY OF THE KAGER LAKE
INLET AND OUTLET STREAMS

S. Hatlevik

B.C. Fish & Wildlife Branch,
Smithers, B. C.

June 1978

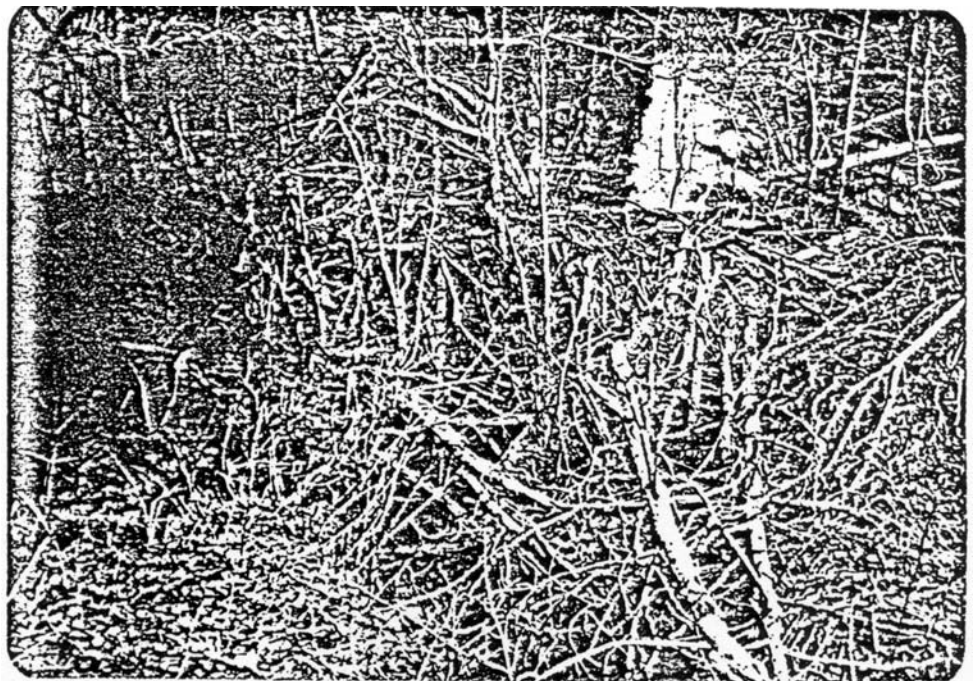
Photo 1.

A beaver dam 2 meters high by 10 meters wide located right at the lake outlet (see photo 1) prevents passage of migrant fish and severely restricts stream flow. The average wetted width was 2 meters, depth 13 cm., velocity of 0.4 m/sec. resulting in a calculated discharge of 0.1 m³/sec.

Impassable beaver dam at outlet of Kager Lake.

Beaver Dam 2 m. high by 10 m. long at lake outlet is a barrier and severely restricts outlet flow.

1. The beaver dam should be completely removed about the end of April and should receive periodic monitoring to ensure it is not rebuilt.
2. Reach 1 should be observed about the middle of May to determine the extent to which it is being utilized by spawning rainbow trout.

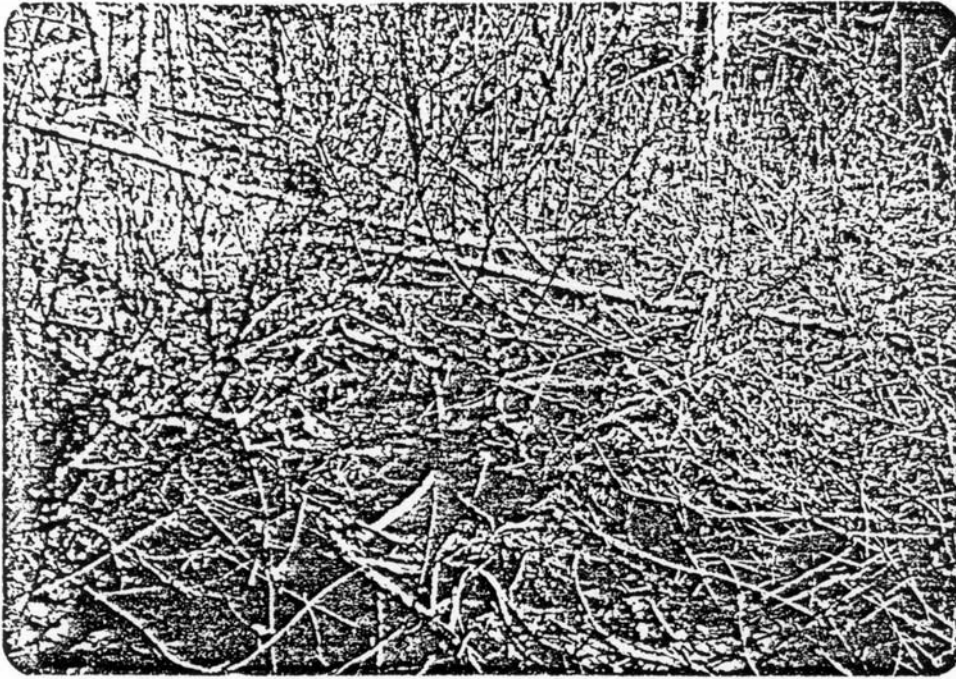
The stream flows through a very narrow V-shaped valley and is irregular in form, single thread and confined by about 60% vertical banks and 30% undercut banks. (see photos 2 and 3). Substrate composition was 20% fines, 40% gravels, and was rated as "fair to good" for spawning potential.

Photo 2. Upper portion of reach 1 (looking downstream).

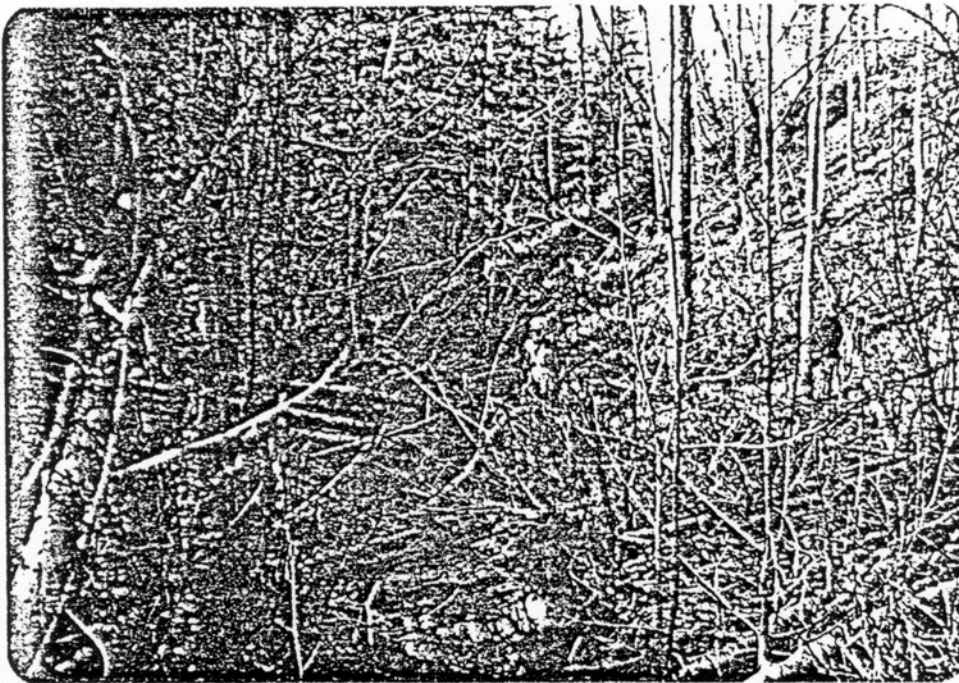
Photo 3. Lower portion of reach 1.

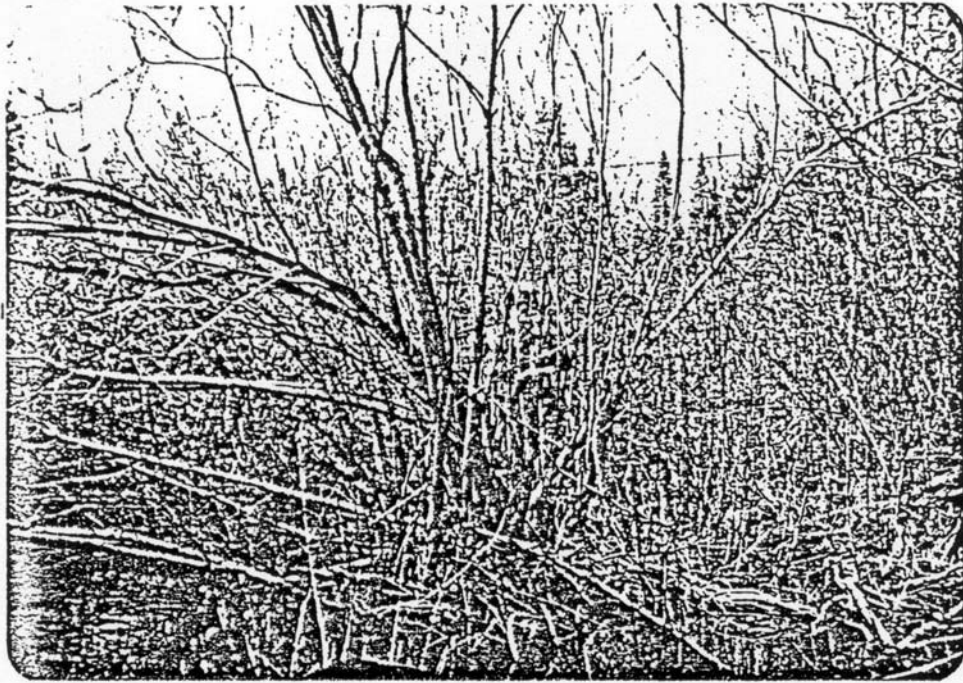
The lower portion of this creek is an unconfined, low gradient (0.5%) multiple channel flowing through willow vegetation (see photo 4) and containing a substrate of almost 100% fines. Then there is a 42 meter section traversing under the road crossing which contains a few patches of gravel suitable to spawning and has a more confined, slightly deeper entrenched channel (see photos 5, 6 and 7). About 12 rainbow trout, in spawning colours, were observed in this area. It seemed only "fair" for spawning as there were only a few patches of suitable gravel available and the rest was quite silty. Powerline clearing has removed streamside cover and resulted in an adjacent accumulation of debris. Upstream from this section, the stream channel becomes similar to the area near the mouth and is undefined and flows through willow vegetation containing numerous debris piles and a quite heavily silted bottom (see photo 8).

Photo 4. Mouth of inlet to Kager Lake (looking upstream).

1. In reach 1, the scrub willows and accompanying debris should be removed and a definite stream channel created from the lake upstream for about 100 meters (start of steeper section).
2. It may be necessary to add suitable spawning gravel to this channel.
3. This may be suitable for a local stream enhancement project to improve spawning habitat for rainbow trout.

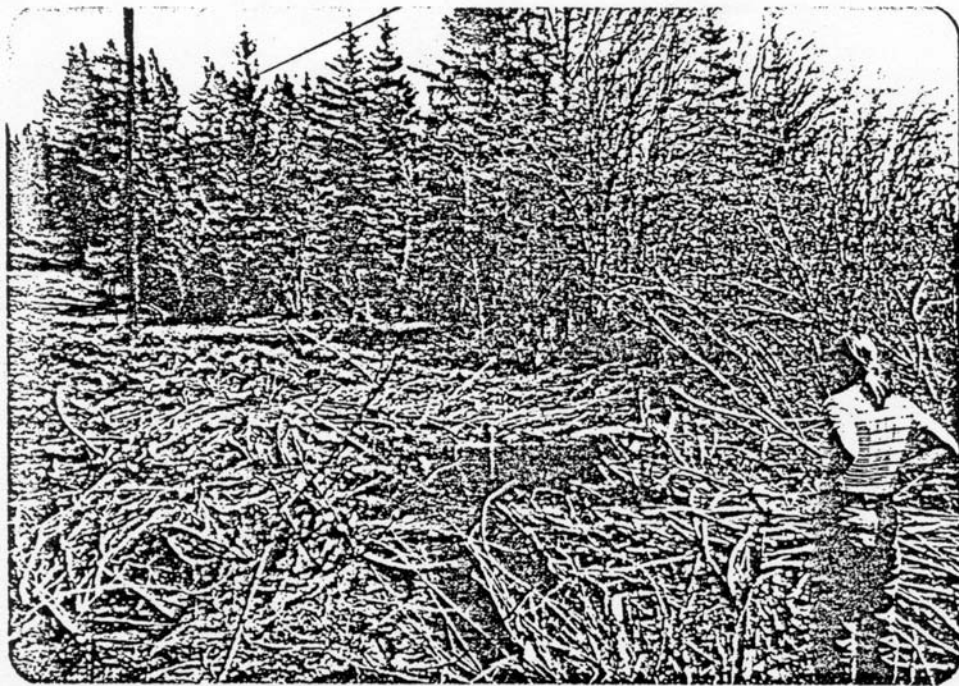
Photo 5. Area below road crossing utilized by spawning rainbow trout (looking downstream).

The 42 meter section mentioned above contained some patches of suitable spawning gravel but was mainly quite heavily silted. The remainder of this reach was unsuitable for spawning.

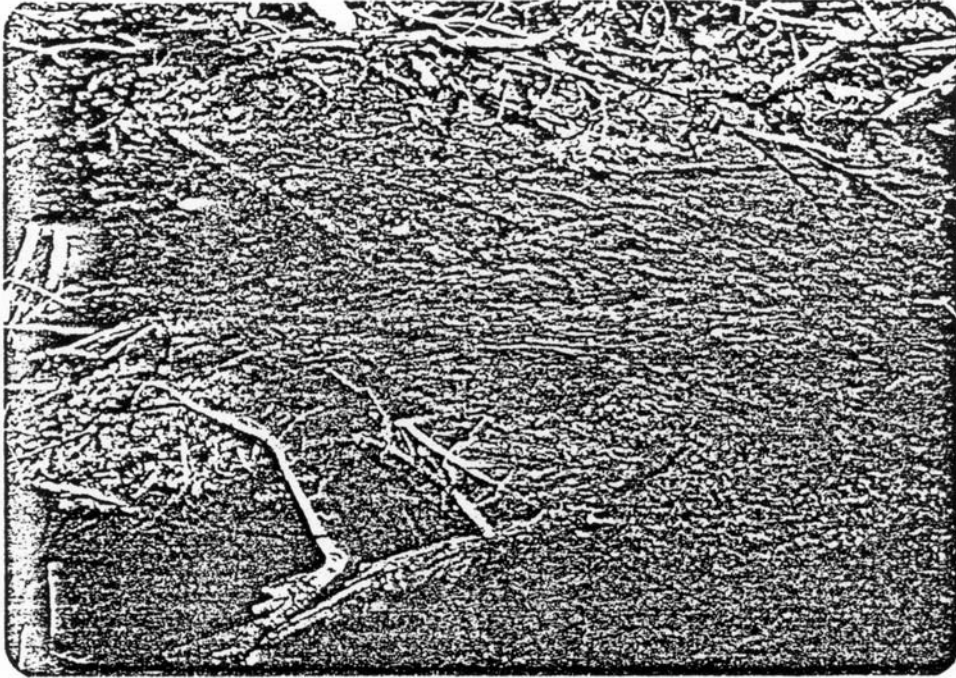
Photo 6. Substrate in area shown by photo 5.

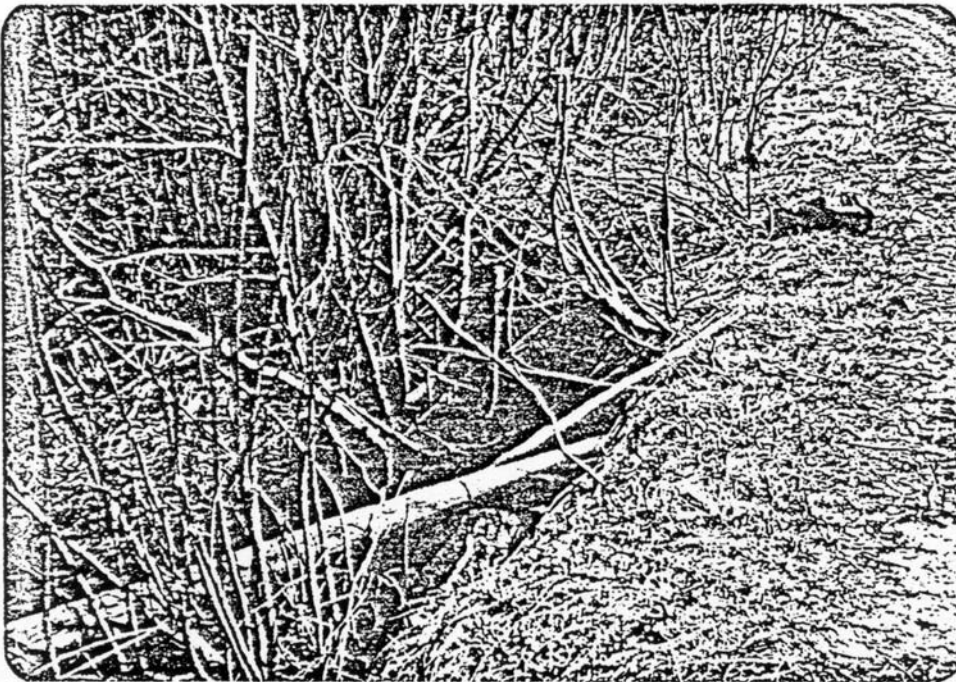
Photo 7. Area above road crossing where a few rainbow trout were observed (looking upstream).

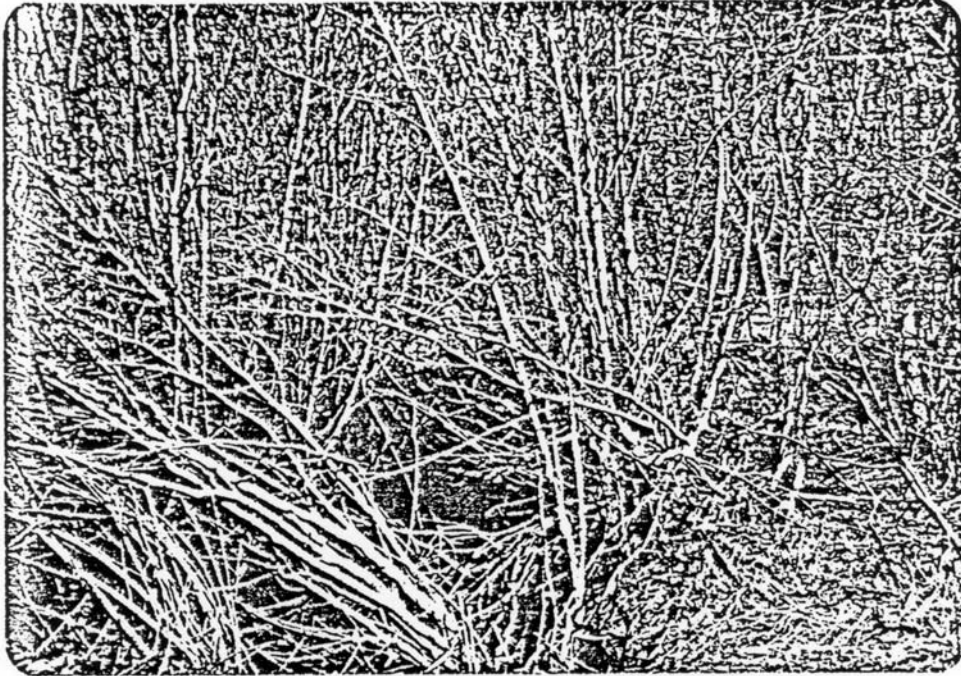
Photo 8. Upper portion of reach 1 (looking upstream).

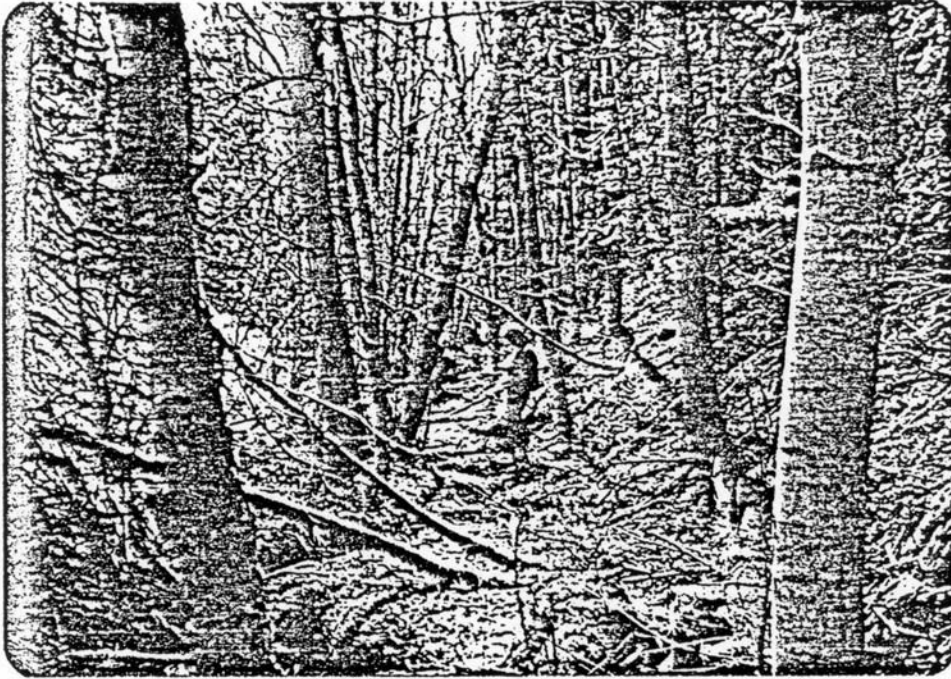
This section is characterized by a steeper gradient (5%) narrow V-shaped valley, single channel, confined with mainly vertical and undercut banks (see photo 9). There are many falls varying from 15 cm. to 45 cm.-some of them are barriers for a stream this small (wetted width averages 0.8 meters). There is fair rearing habitat in the pools and undercut banks, but probably not accessible to small fish due to the cascades. Spawning habitat is rated poor. No fish were observed in this reach.

Photo 9. Lower portion of reach 2 (looking downstream)
