SAN JUAN RIVER WATERSHED
2011 Landslide Assessment Update

The San Juan Round Table

Alan N. Chatterton, RPF, PGeo, EngL

Chatterton Geoscience Ltd.

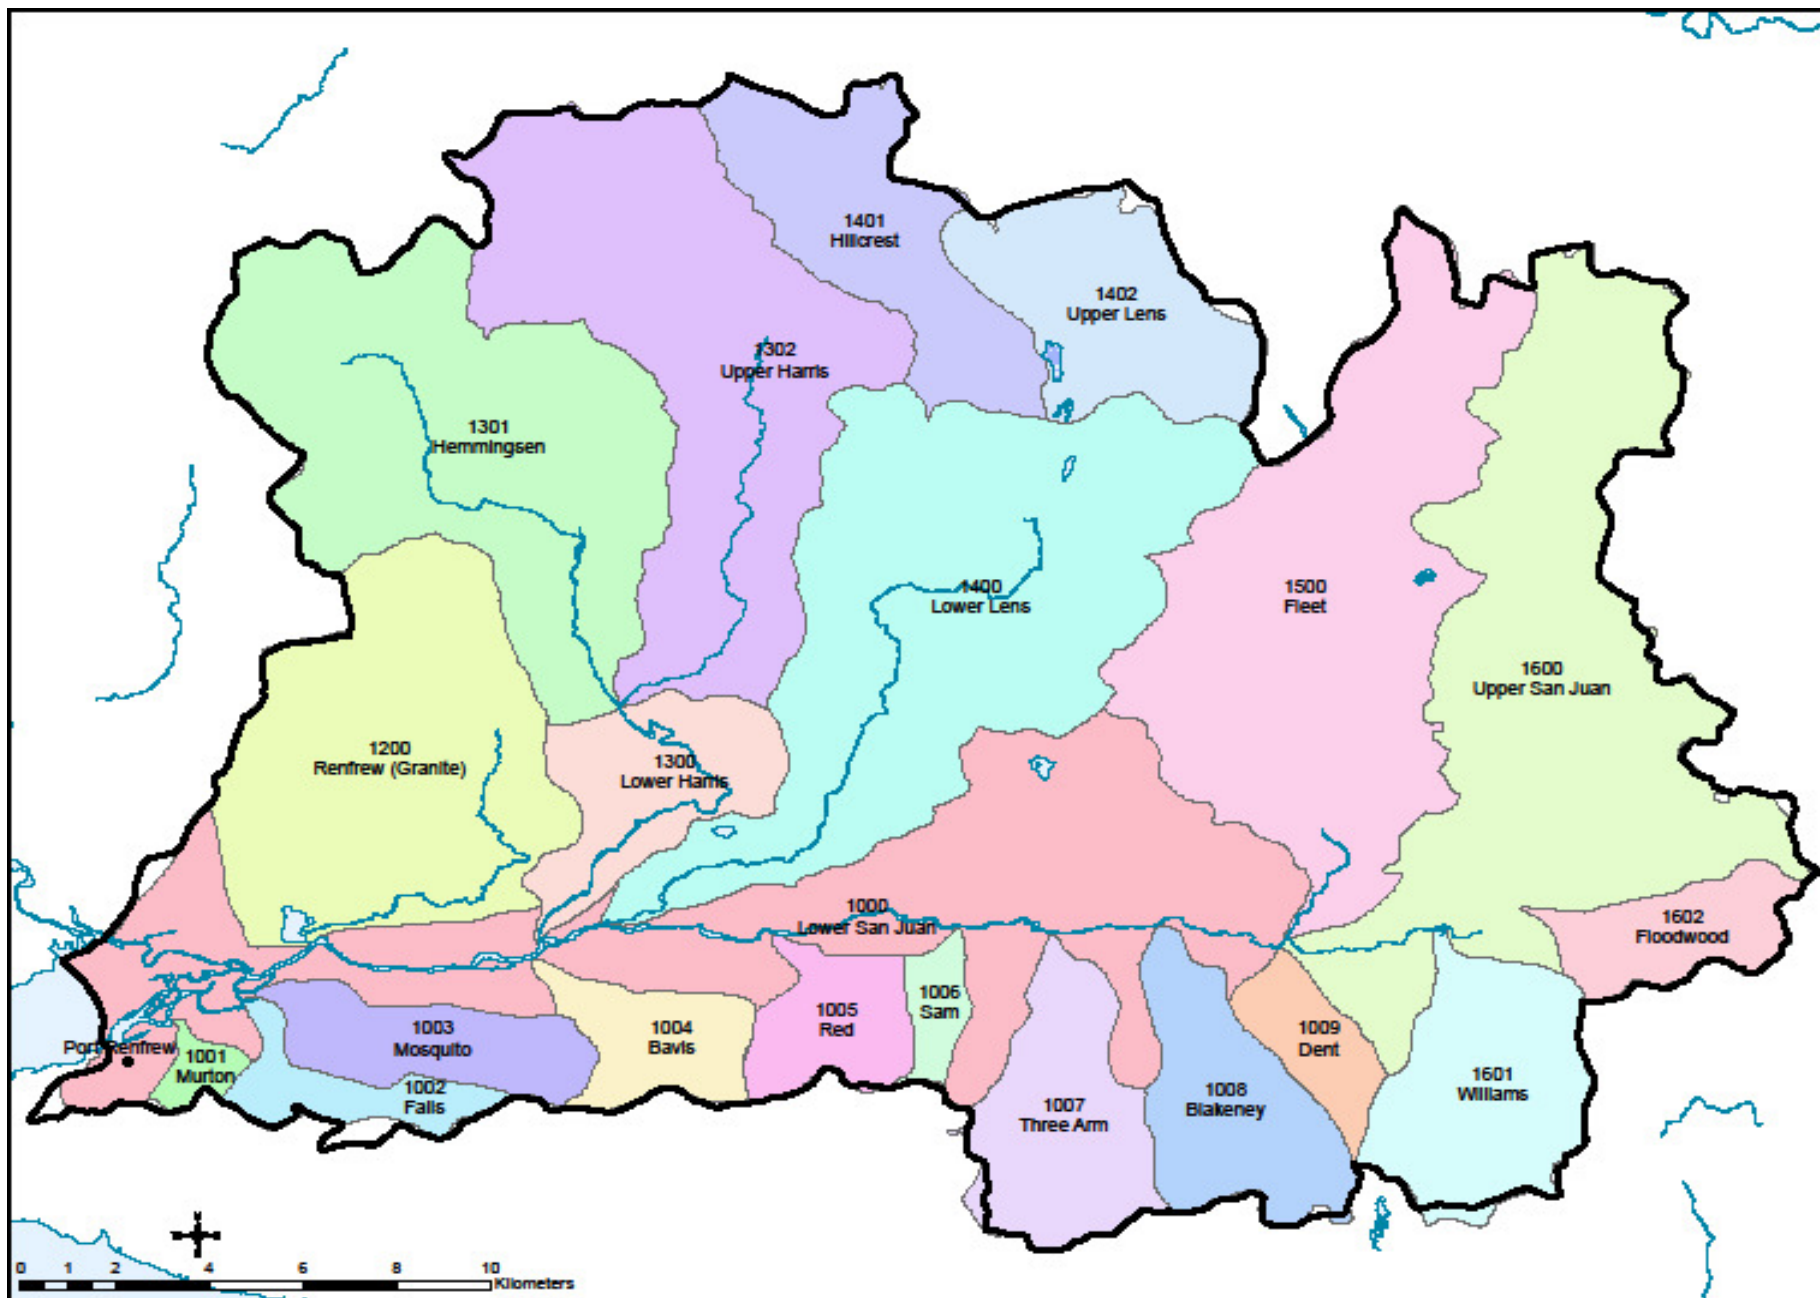
Figure 2: San Juan River Watershed Sub-basins

The 1996 project covered the approximately 73,000 ha of the San Juan River watershed exclusive of the Gordon River drainage. The project area was subdivided into 21 (Figure 2) numbered sub-basins for the purpose of discussion and reporting. In order to facilitate the objective of comparing the landslide
