Salmon River Diversion Wildlife Overpass Pilot Project (BCRP Project No. 01.W.08) Final Report

November 30, 2004

**Salmon River Diversion Wildlife Overpass Pilot Project
(BCRP Project No. 01.W.08)
2004 Final Report**

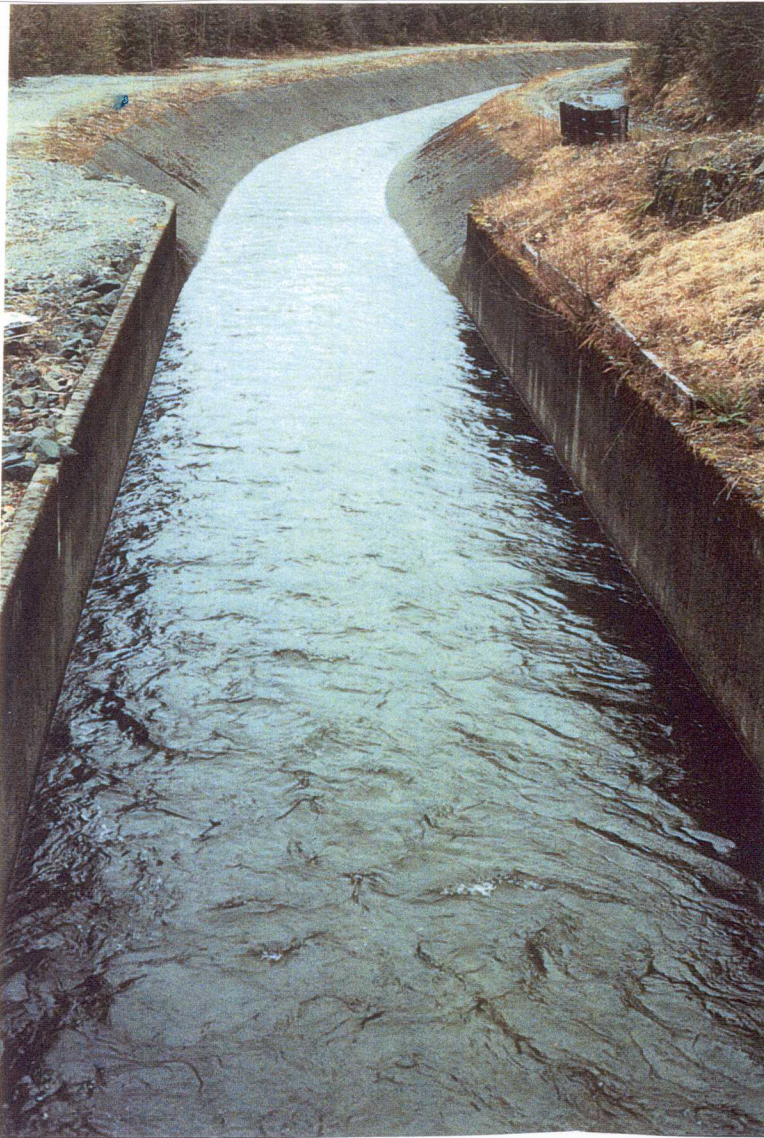
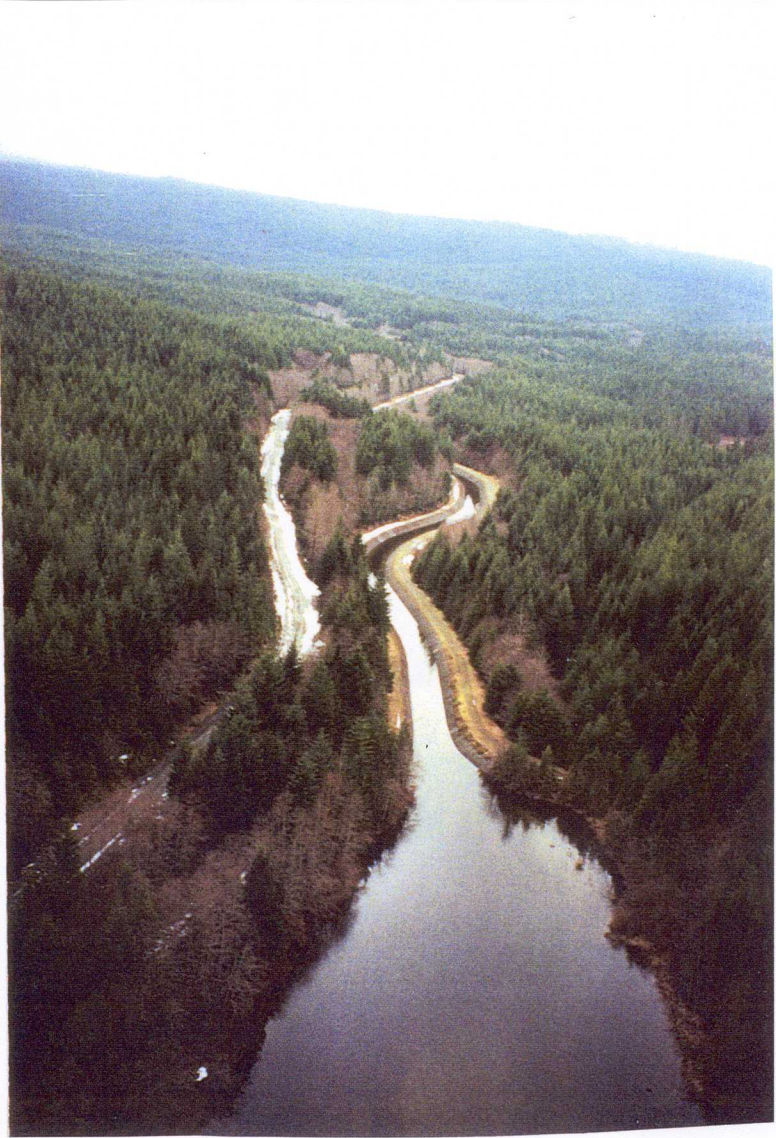
Figure 1. Typical view of the Salmon River Diversion canal walls.

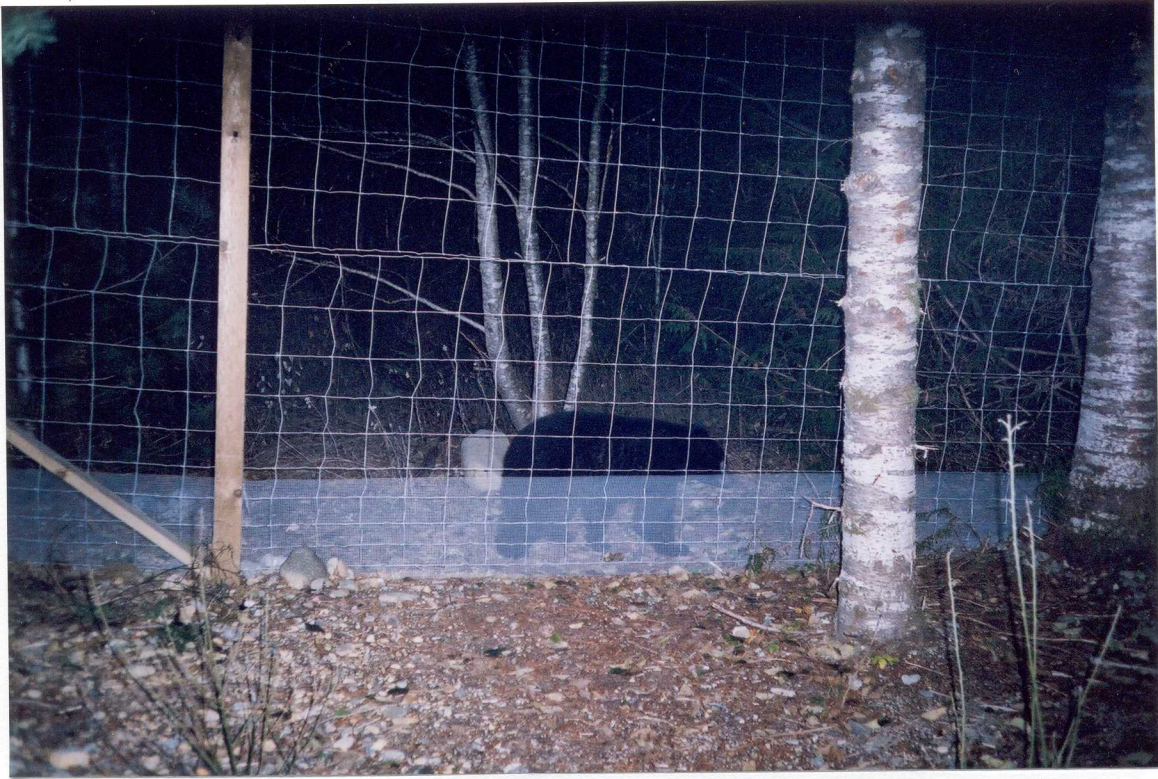
Figure 9. Lead fencing directs animals towards the overpass.

A prominent feature of the overpass design was lead fencing running perpendicular 30 m across the two approaches to the overpass and out into the adjacent forest (Figure 9). The 8 ft. high page wire fence design was to function to direct animals traveling on either side of the diversion toward the overpass until they become familiar with the crossing location. The lead fencing was not designed to extend across the overpass to ensure that the option of traveling east-west along the SRD was not eliminated. Gates were designed into the lead fencing to permit continued vehicle use of the maintenance roads paralleling the SRD.

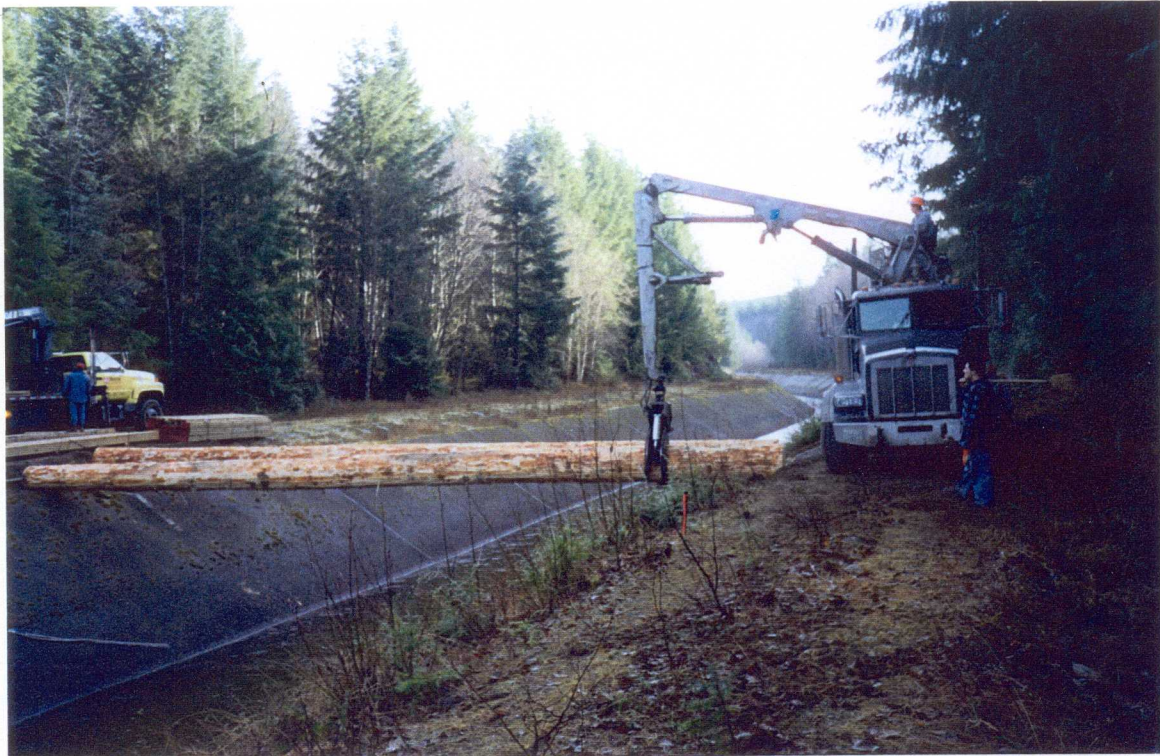
Figure 10. Mounting overpass stringers on mudsills, October 2002.

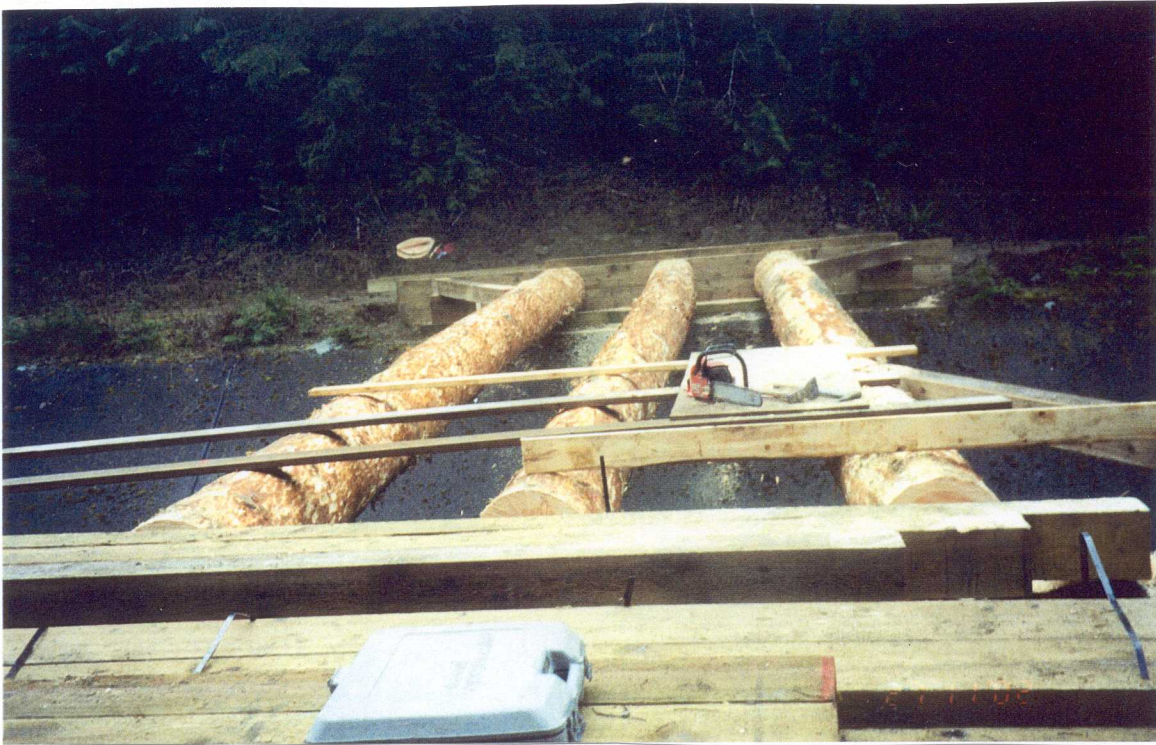
Figure 11. Attaching deck planks to stringers, October 2002.

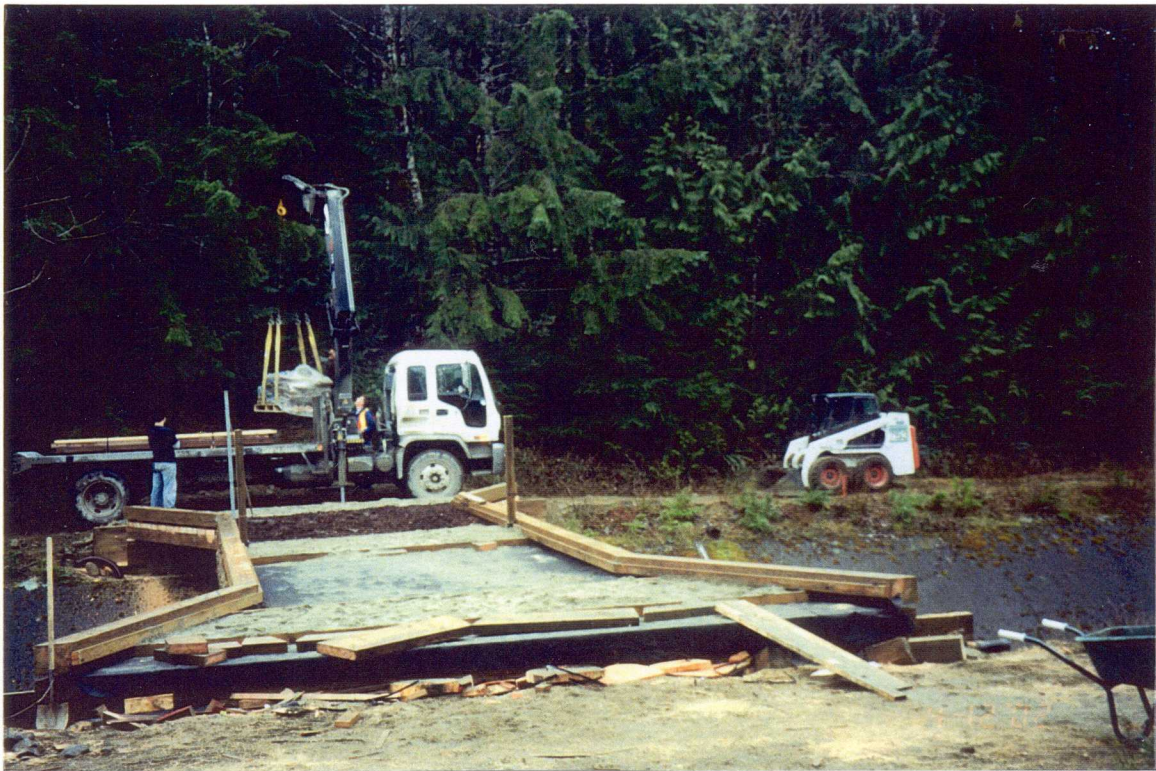
Figure 12. Structural component of overpass nearing completion, November 2002.

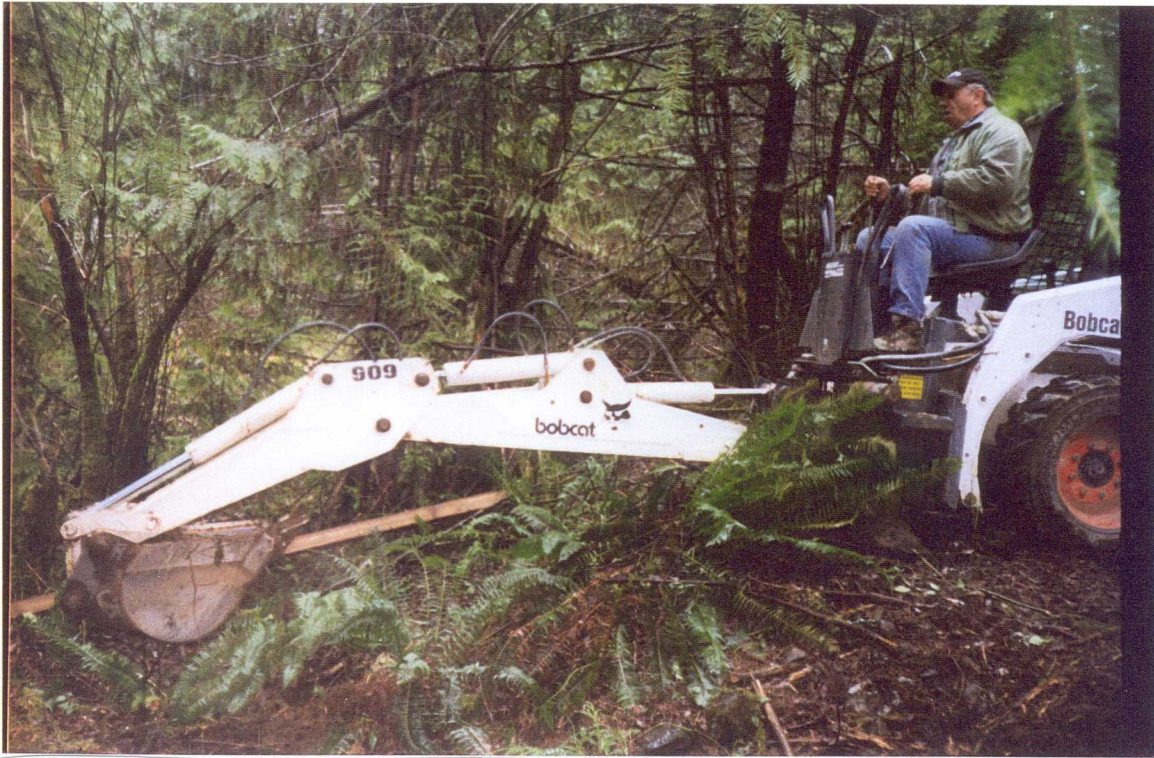
Figure 13. Small excavator installing posts for lead fencing, December 2002.

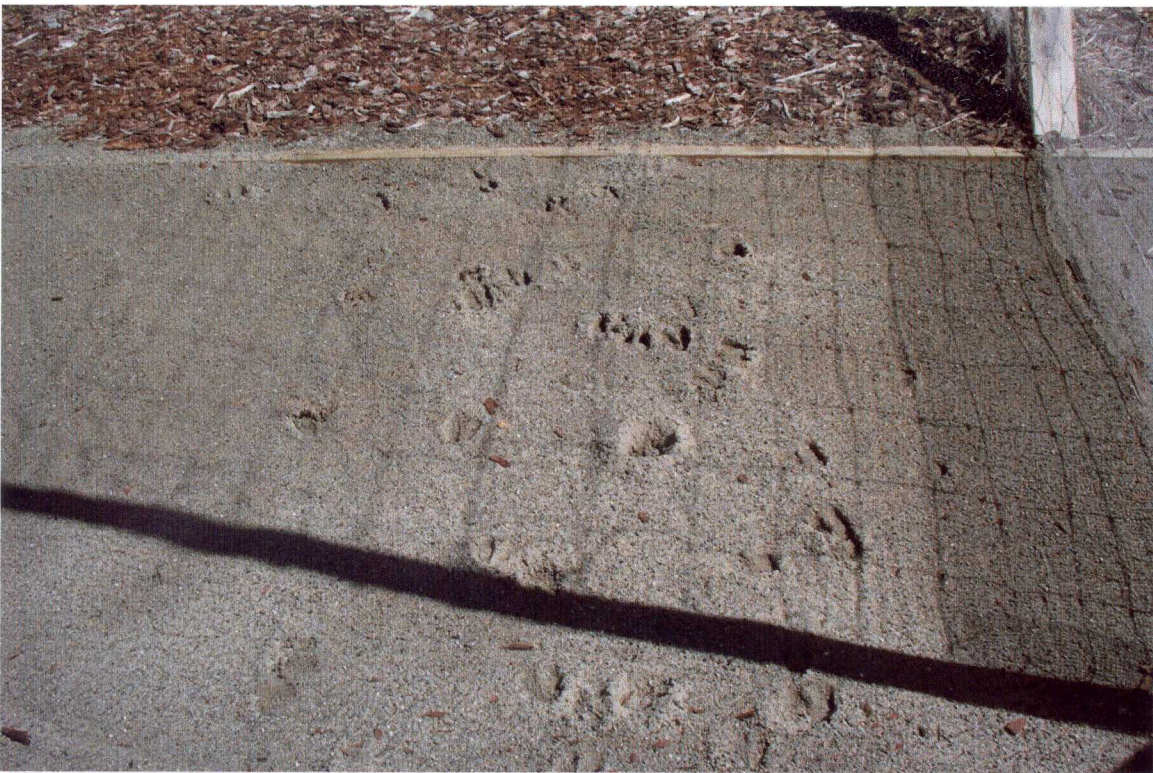
Figure 15. Track beds of sand installed on overpass approaches and mid-span.

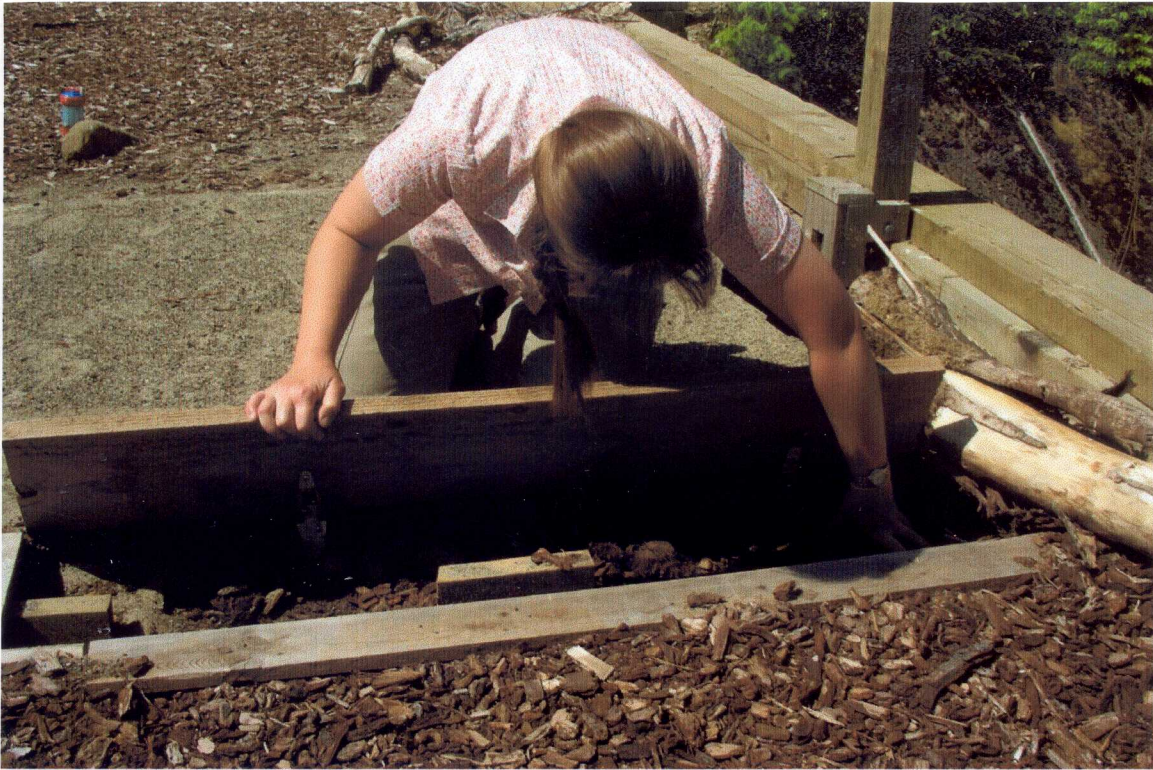
Figure 16. Pitfall trap used to study small wildlife use.

In the spring of 2004 pitfall traps were installed on the overpass and maintenance bridge, to document amphibian use. The pitfall traps, constructed of 2" x 4" frames partially covered by hinged 1" cedar board, spanned the width of the overpass and maintenance bridge (Figure 16). To maintain appropriate microclimates, the bottom of the pitfall traps were lined with moistened bark chips and moss. Three pitfall arrays were also installed in the adjacent forest to assess the relative amphibian abundance. Pitfall arrays consisted of covered 1 litre buckets with three 3 m lengths of plastic lead fencing (Figure 17). Pitfall buckets were also lined with moistened moss. Pitfall traps and arrays were checked on a weekly basis from mid-March through late May 2004. All the traps were removed in late May, for a total of 73 to 88 monitoring days per location.

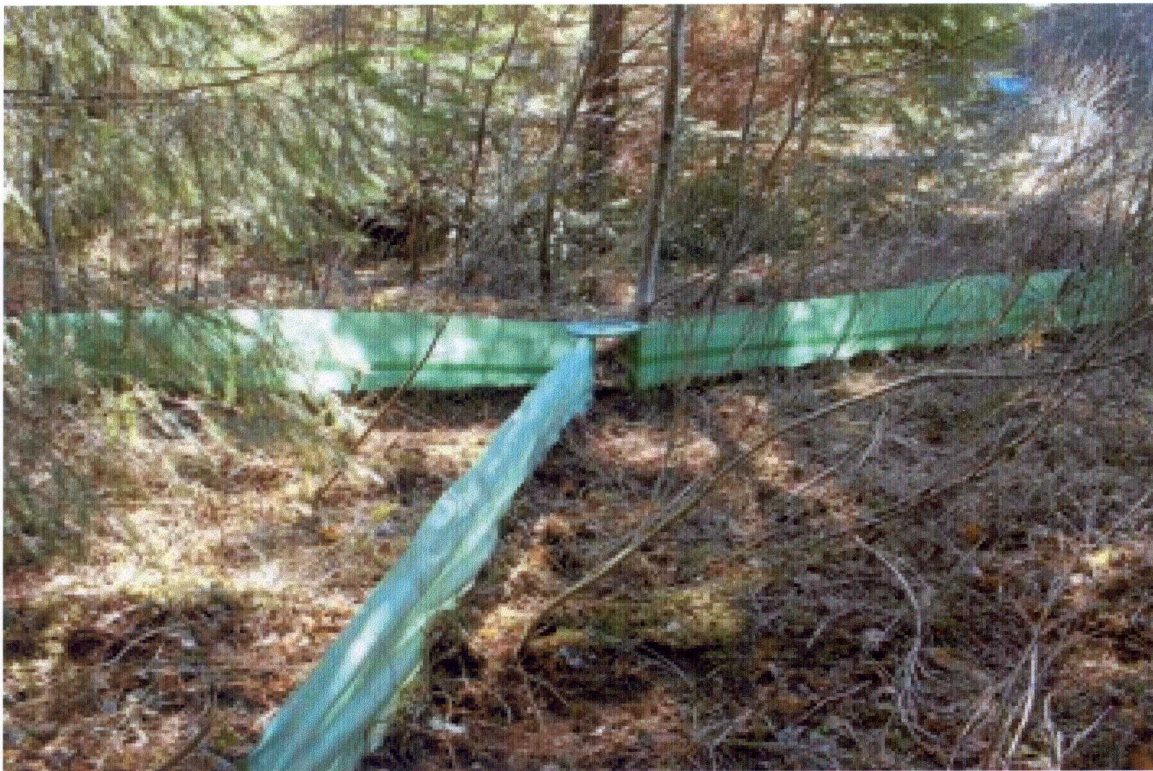
Figure 17. Pitfall array installed in adjacent forest to document amphibian presence.

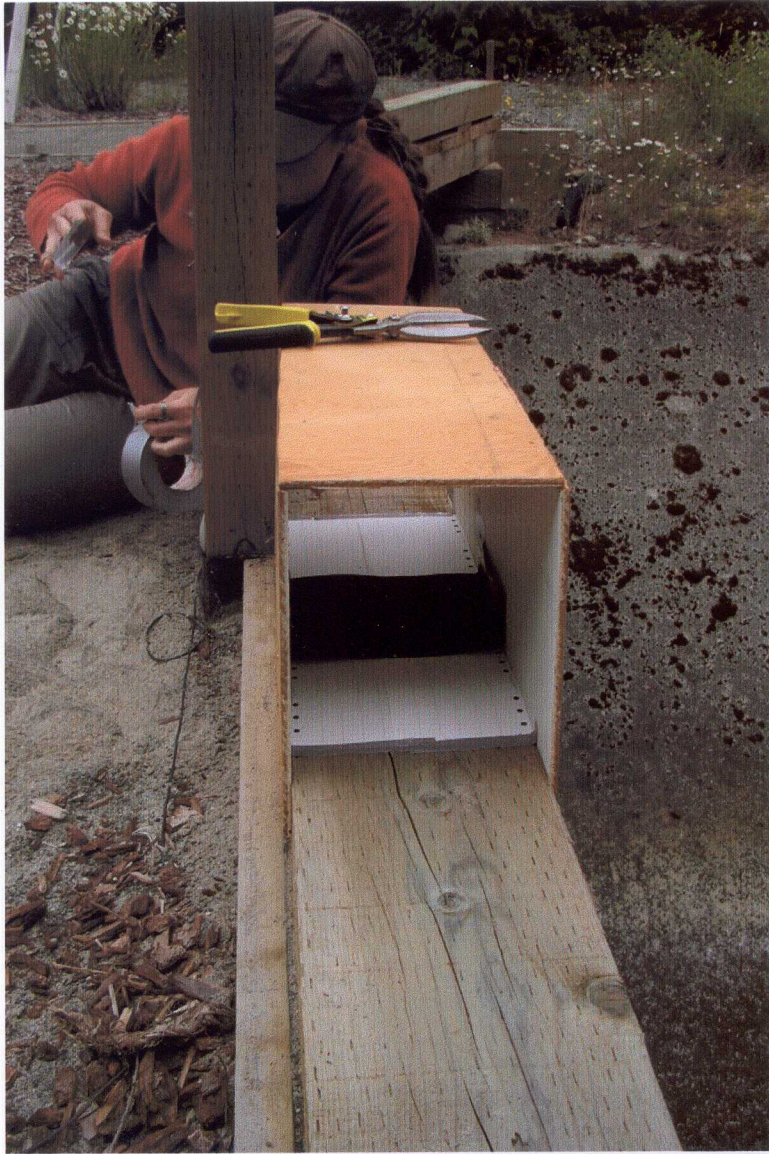
Figure 18. Track plates installed on overpass and bridge curb timbers (Fall 2004).

Over the summer and autumn of 2004, attempts were made to document small wildlife travel along overpass and maintenance bridge curb timbers, which were outboard of remote camera sensors. A covered 15 cm x 20 cm track plate was installed on both the east and west curb timbers of both structures. Trials involving different track plate coverings included the use of soot, photocopier toner, non-skid material and mortar sand (Figure 18).
